# NATIONAL TRANSPORTATION SAFETY BOARD

## MATERIALS LABORATORY FACTUAL REPORT

Report No. 18-011

Place : Frederick, Maryland  
Date : December 3, 2017  
Vehicle : Cessna 180, N399F  
NTSB No. : ERA18LA043  
Investigator : Leah Read, ASI-ERA

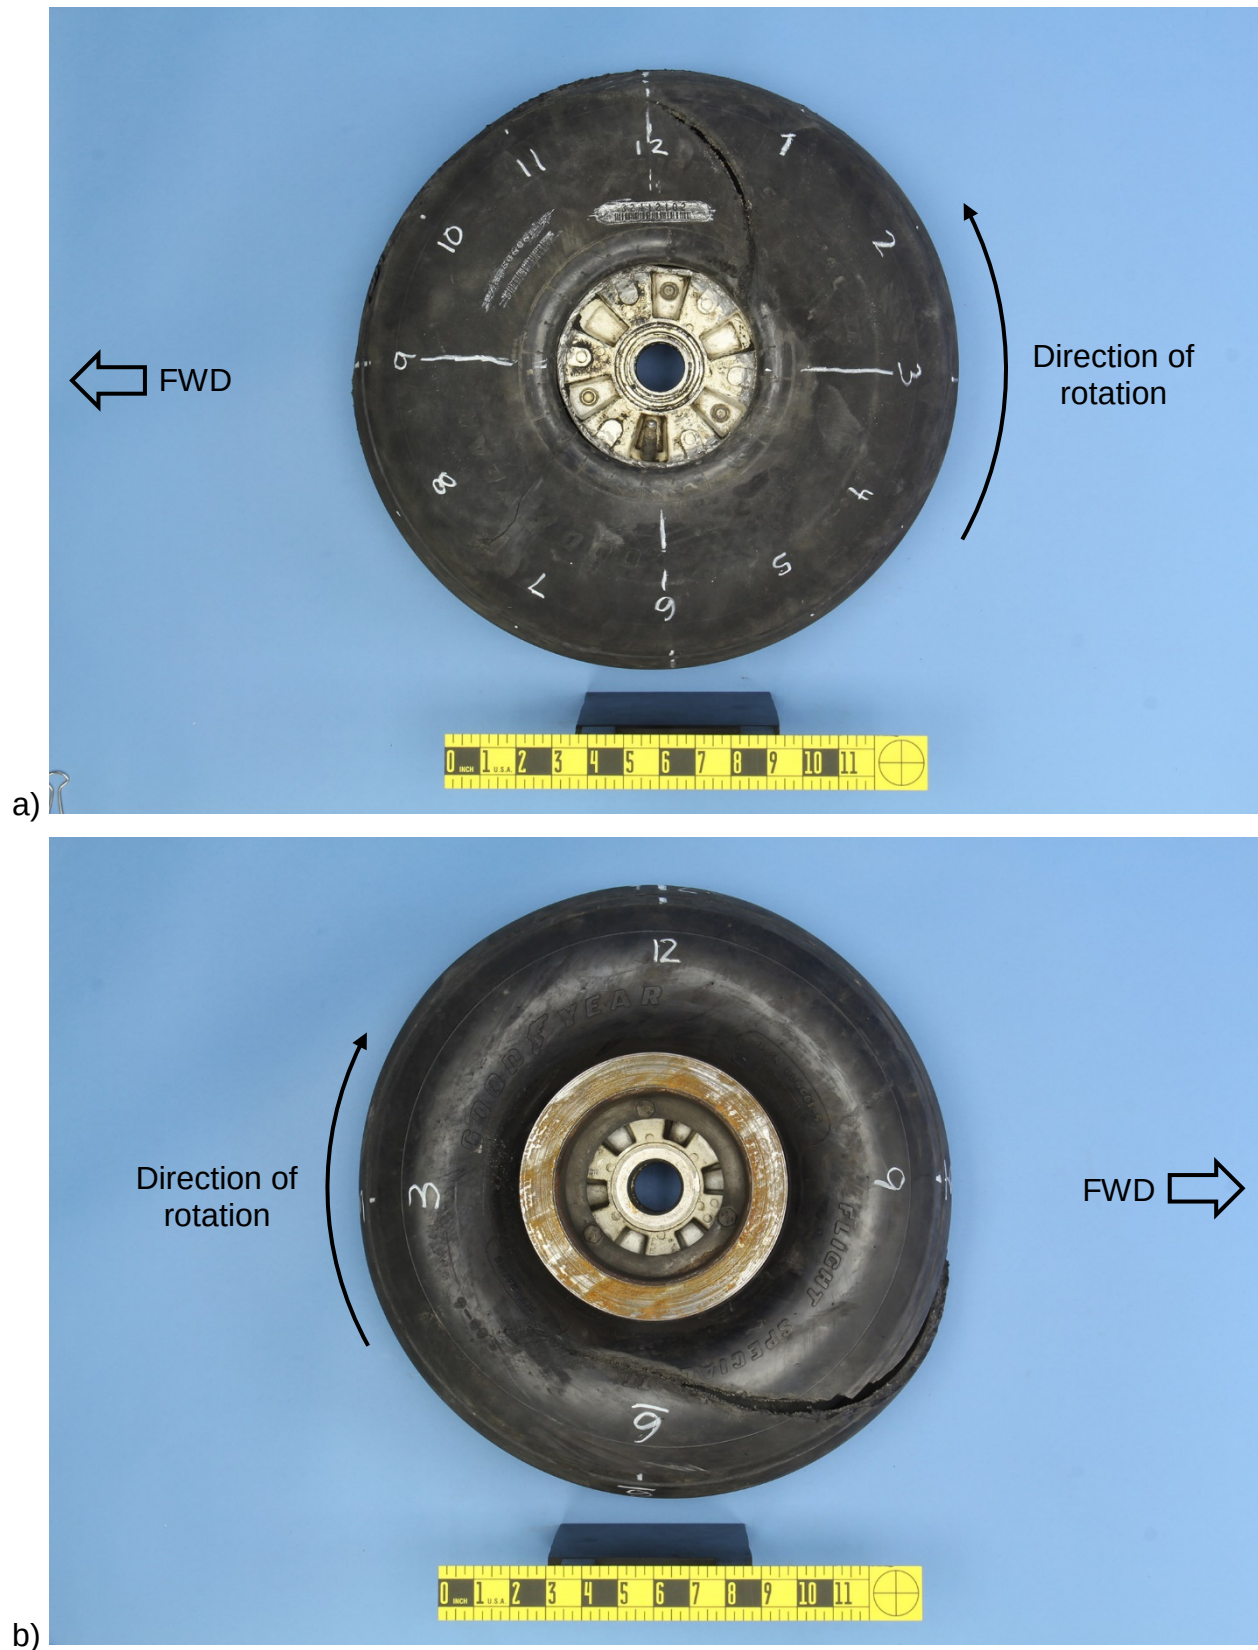
Visual examination of the tire revealed a fracture across the tire tread that generally followed one of the bias directions from approximately the 7:30 position on the NSS to the 10 o'clock position on the SS. The cords on the opposing bias were all fractured in this region. On the SS, the fracture continued circumferentially along the shoulder until it approached the 12 o'clock position at which point the fracture curved into the sidewall

terminating at the bead near the 1 o'clock position, as shown in figures 1a and figures 3a – d. On the NSS, the fracture continued following an approximately linear path terminating between the 5 o'clock and 6 o'clock positions, as shown in figure 1b and figures 4a – b. Finally, a circumferential fracture was observed branching off the bias fracture starting near the groove between ribs 1 and 2 at approximately the 9 o'clock position and continuing in the clockwise direction along the center of rib 2 (the middle rib) to approximately the 2 o'clock position.

**Figure 1:** Images of the left main landing gear tire: a) serial side (outboard side); b) non-serial side (inboard side).

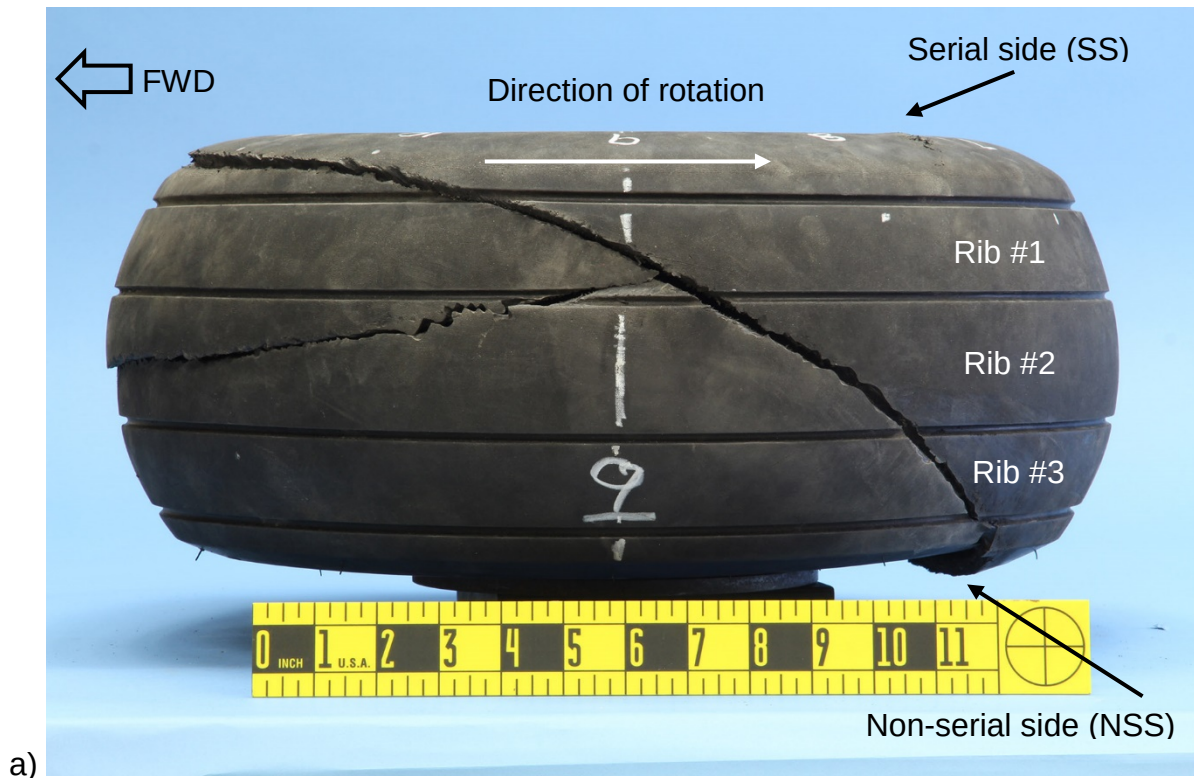
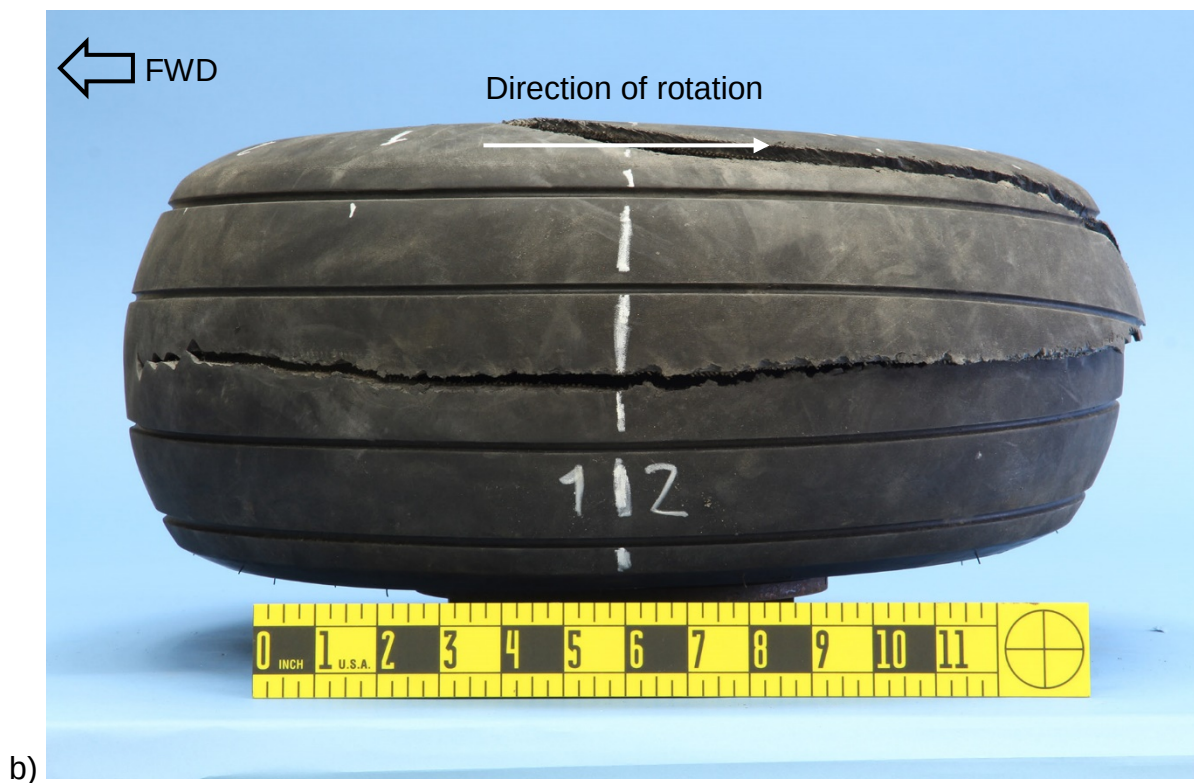
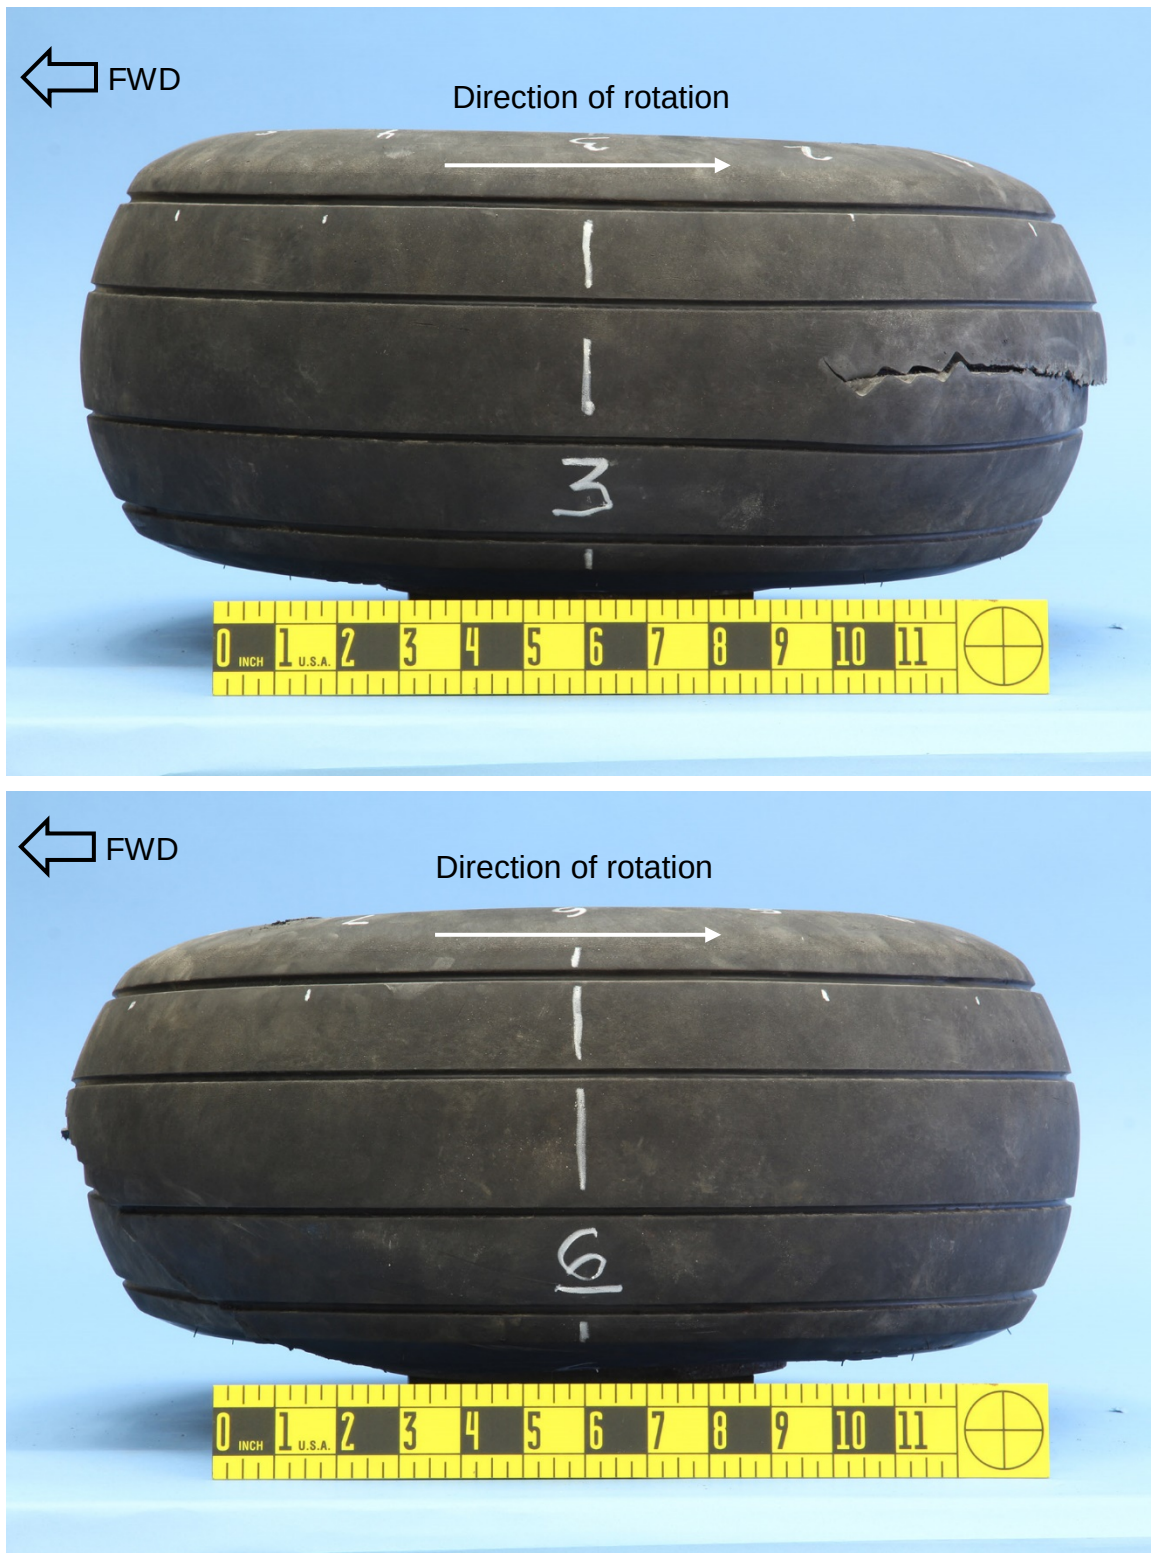
**Figure 2:** Images of the tire tread: a) 9 o'clock position; b) 12 o'clock position;

Figure 2 (cont.): c) 3 o'clock position; and d) 6 o'clock position.

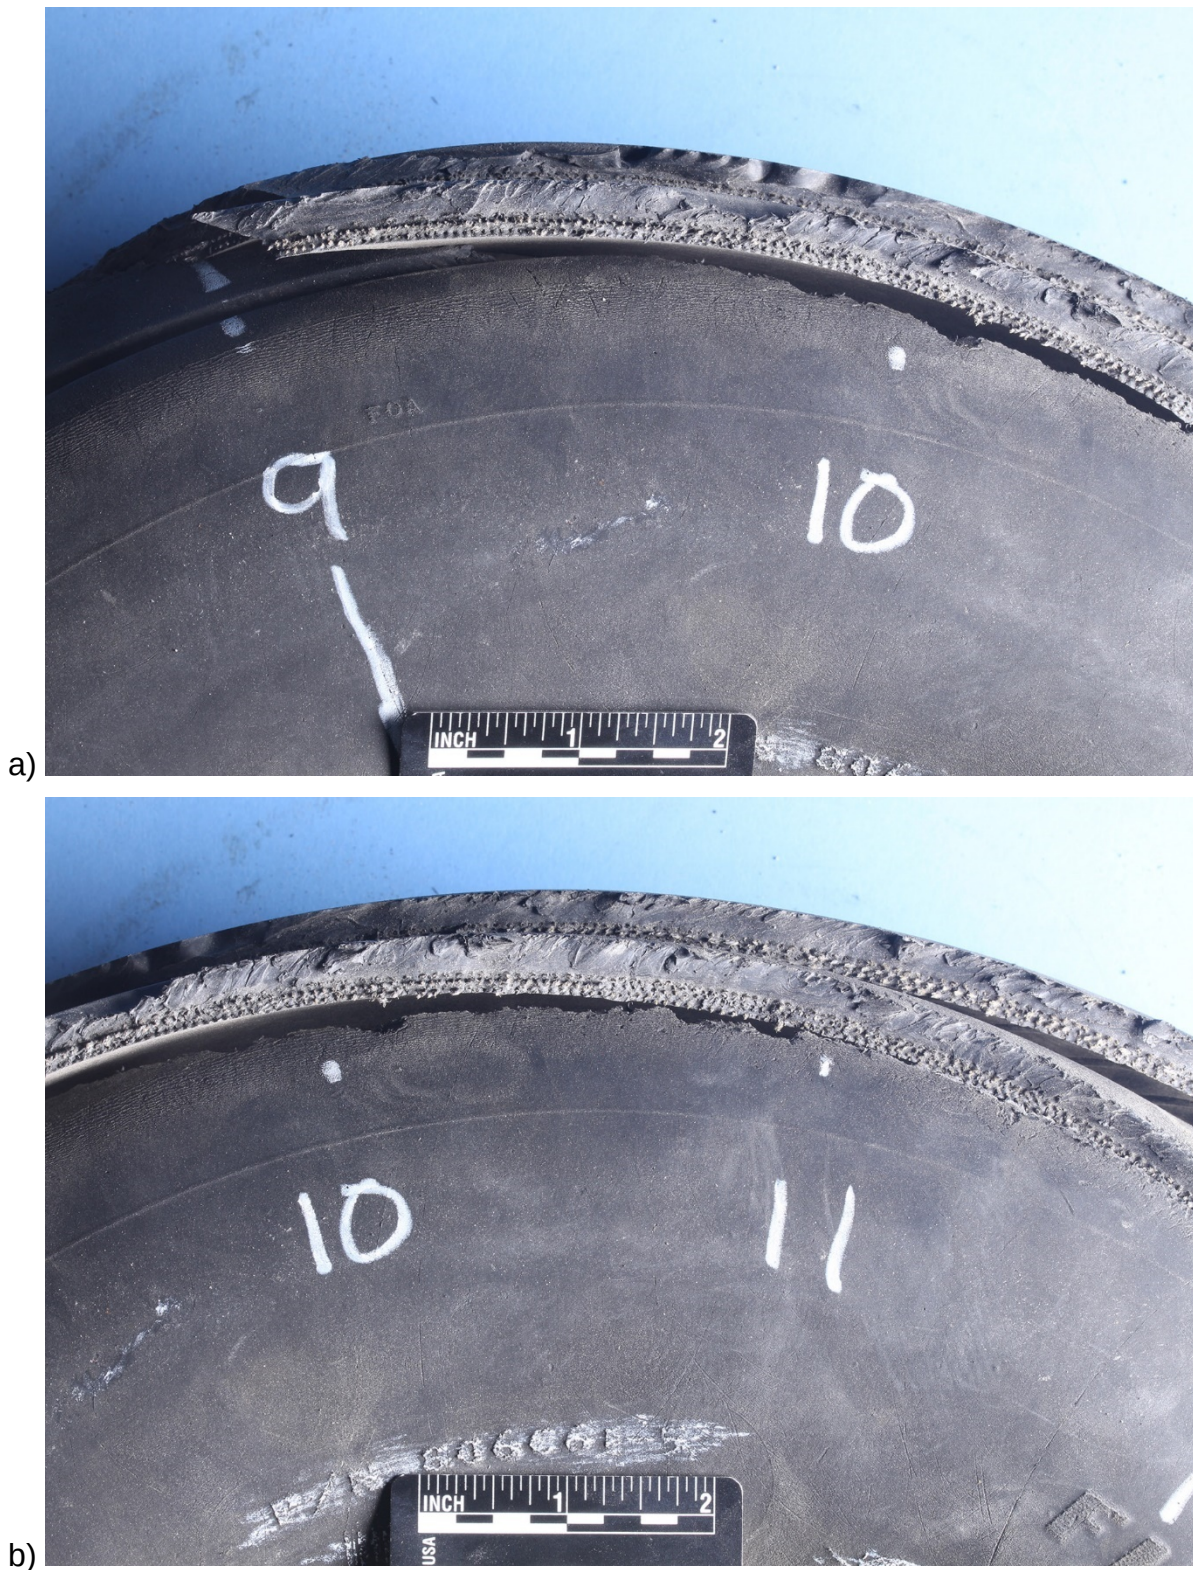
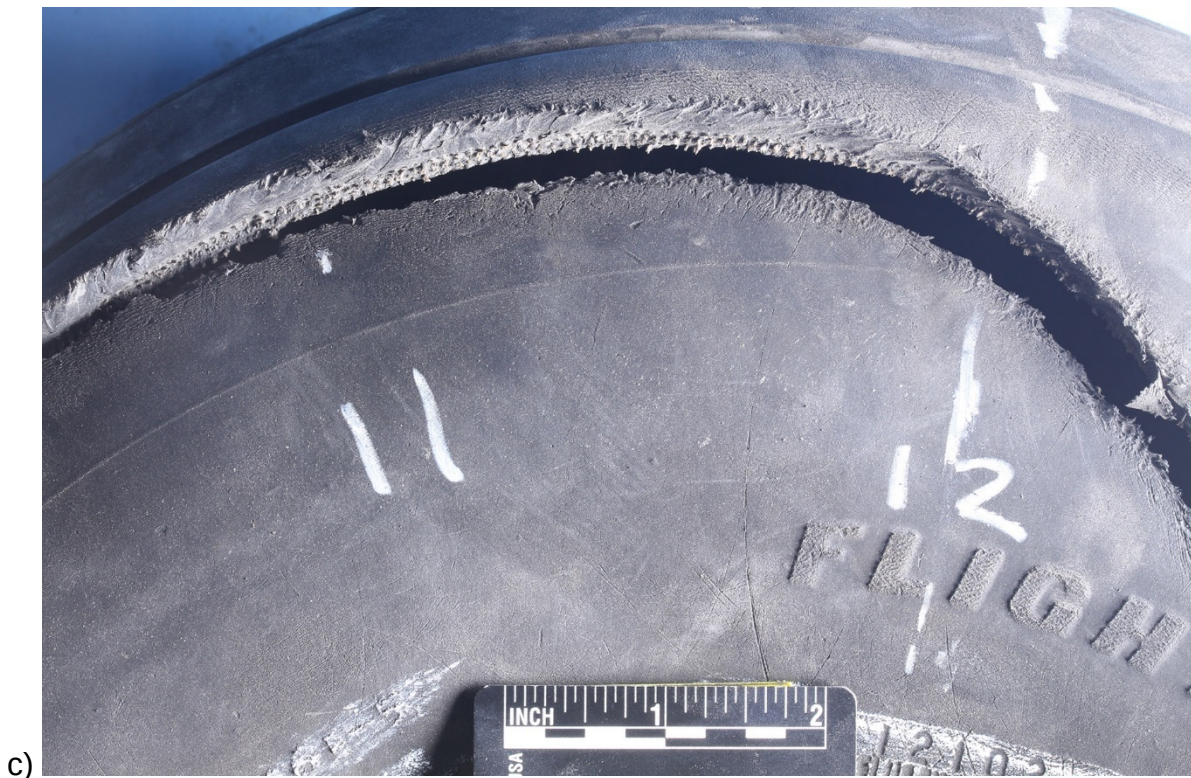
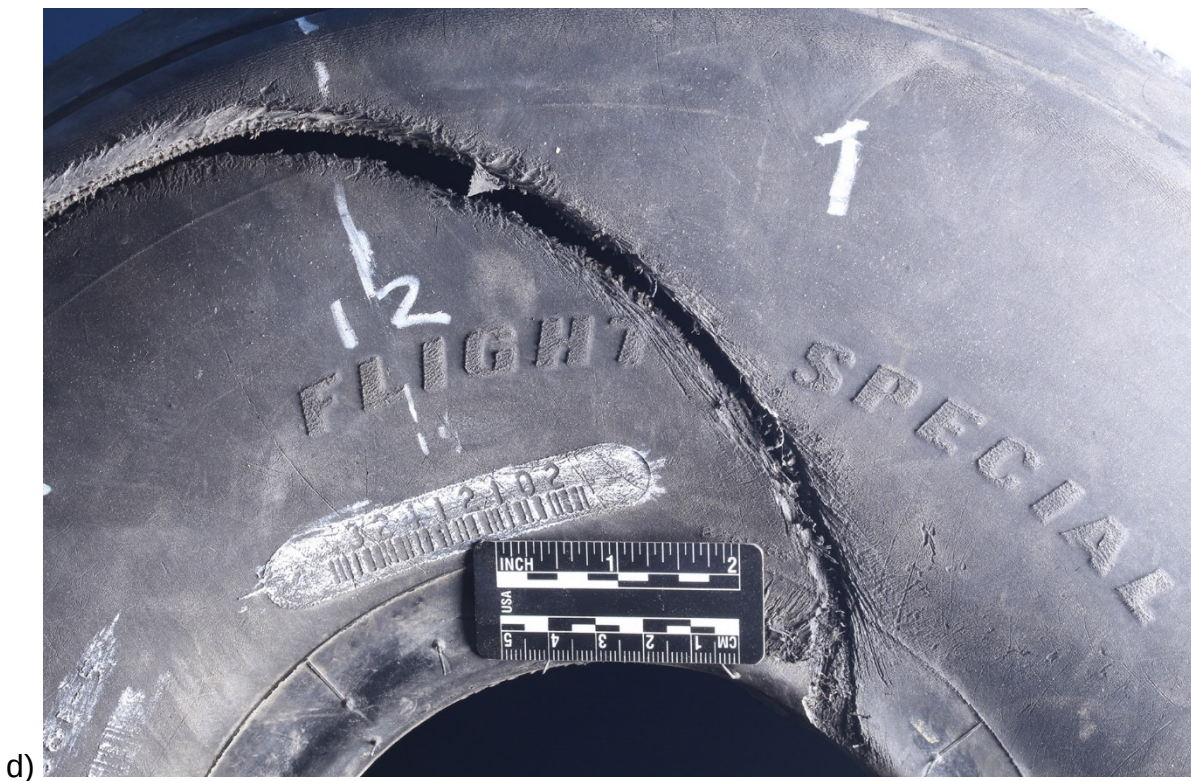
**Figure 3:** Images of the fracture along the SS shoulder: a) between 9 o'clock and 10 o'clock; b) between 10 o'clock and 11 o'clock;

**Figure 5 (cont.):** c) between 11 o'clock and 12 o'clock; and d) between 12 o'clock and 1 o'clock where the fracture diverted into the sidewall.

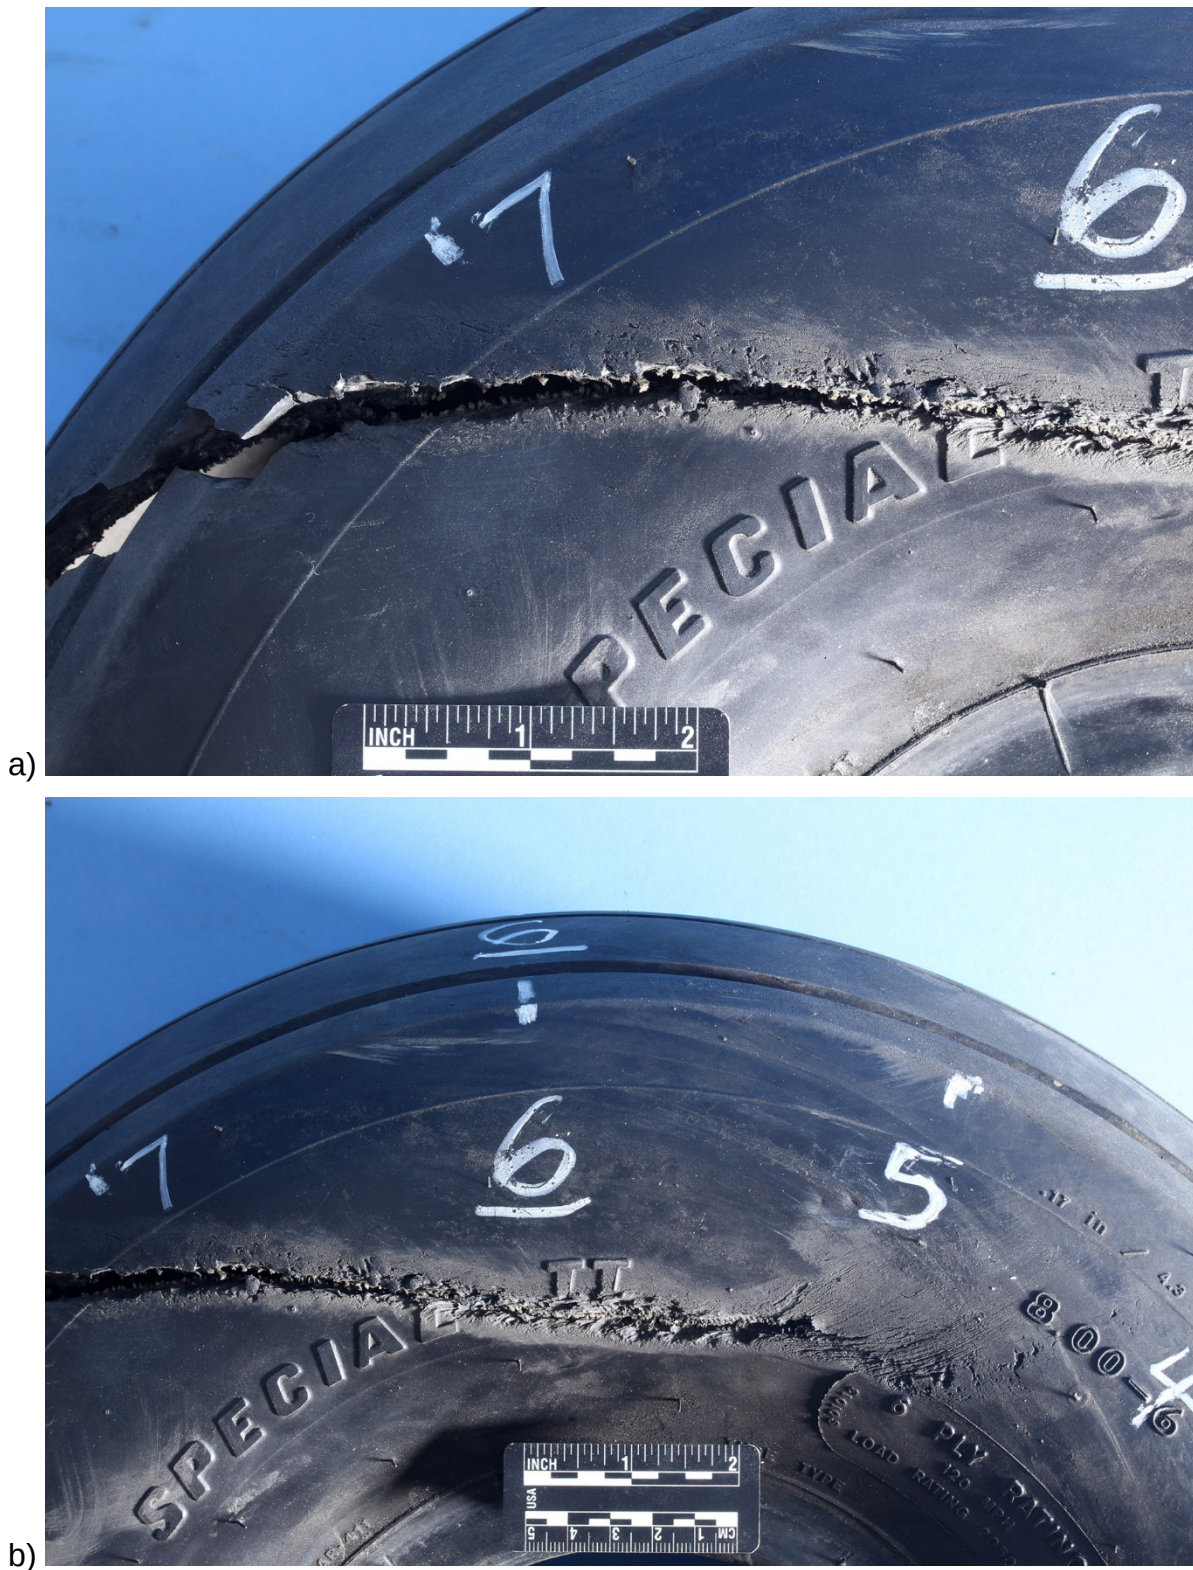
**Figure 4:** a) and b) Images of the fracture along the NSS starting near the 7:30 position and ending near the 5 o'clock position.

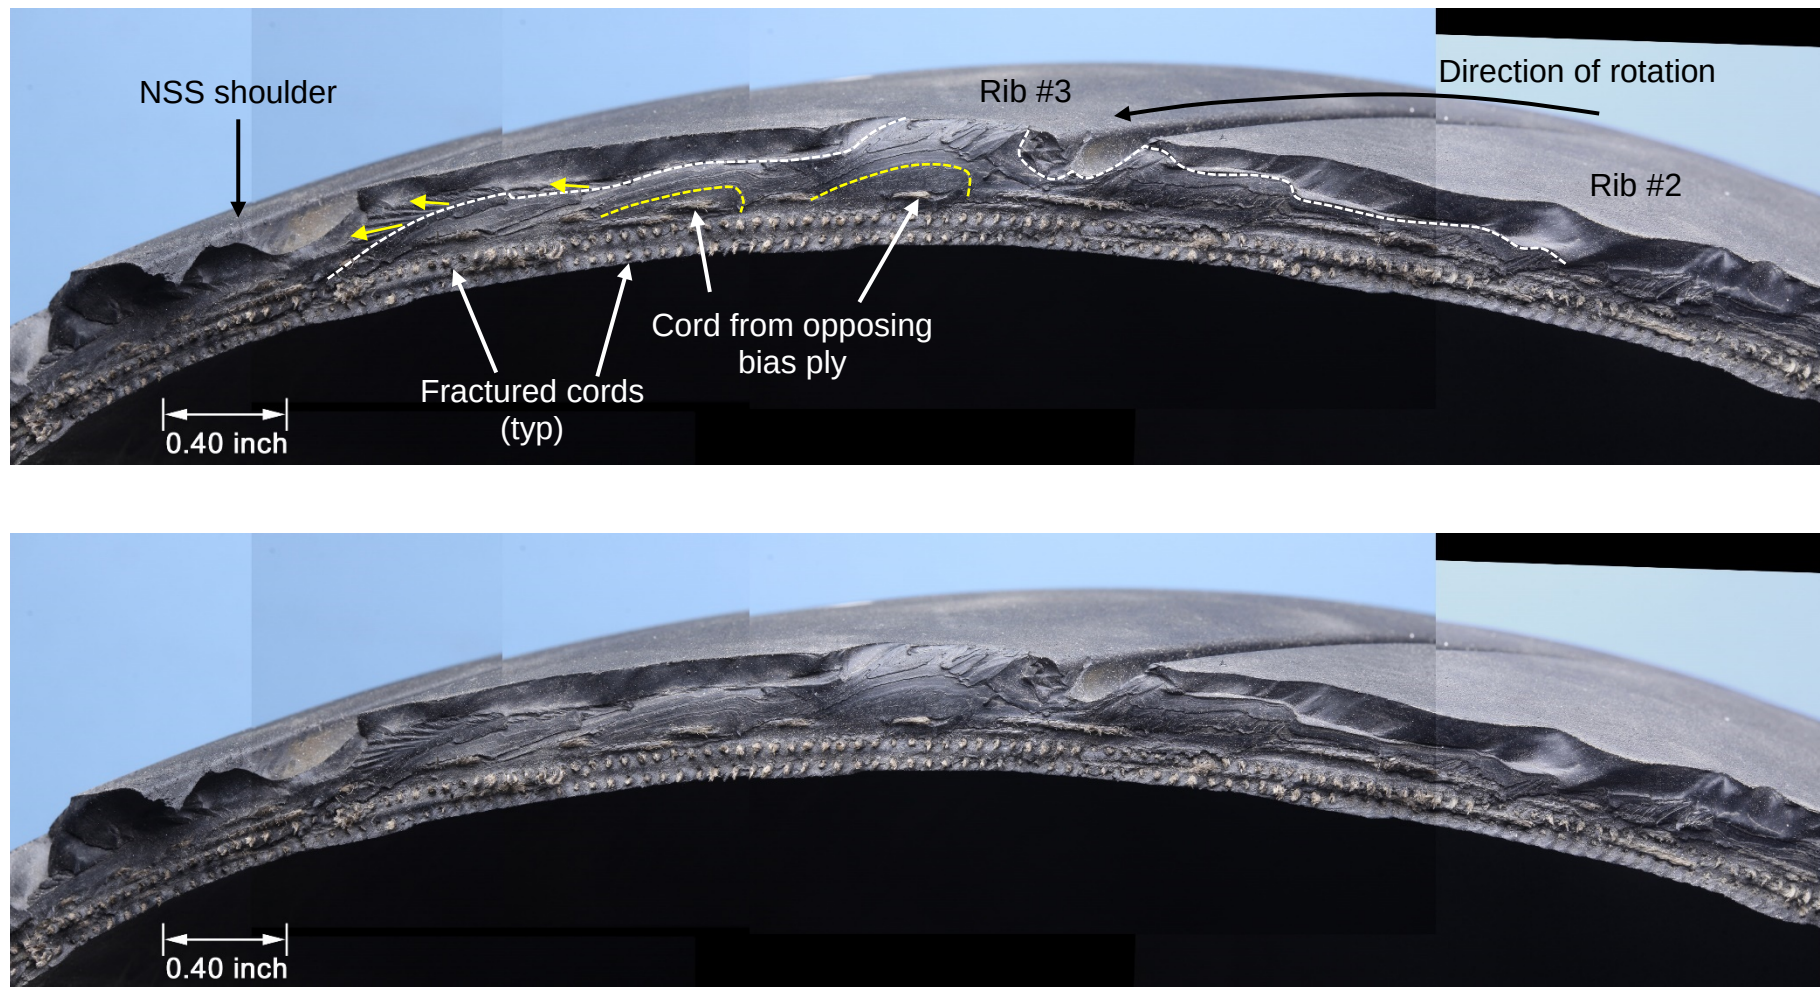
Stereomicroscopic examination of the fracture surfaces revealed the presence of a comparatively smooth progressive fracture region along the bias ply fracture located along ribs 1, 2, and 3. The portion of the progressive fracture region near the NSS shoulder (at approximately the 8 o'clock position) is shown in the montage image in figure 5 with image annotations on the top and an unannotated version on the bottom. At this location, multiple curved crack arrest lines were observed in the rubber, two of which are indicated by yellow dashed lines in the figure. The orientation and curvature of the lines were consistent with cracks progressing from the cord region outward toward the outer running surface of the tread. Following the crack progression marks back to the origin indicated at least two crack origins where cords of the opposing bias plies crossed the fracture.

The progressive fracture region extended up to the white dashed boundary indicated in figure 5. Along rib 3, most of the progressive fracture region extended through approximately 50 percent of the rubber thickness except for an approximately 0.4-inch long region near the groove between ribs 3 and 2 where the progressive fracture extended completely through the rubber. Similarly, along rib 2, in the areas that could be interpreted, the progressive fracture region extended through approximately 50 percent of the rubber, increasing toward full thickness as the fracture approached the groove between ribs 3 and 2. Beyond the progressive fracture region near the NSS shoulder, multiple radiating crack lines were observed, several of which are indicated by yellow arrows in the figure, consistent with the onset of overstress fracture. The rest of the fracture in the tread region exhibited features consistent with overstress tearing.

Taken together the features were consistent with a progressive fracture through the rubber due to an overload failure of the underlying cords along one of the bias directions.

**Figure 5:** Montage of the fracture along the bias near the NSS shoulder spanning rib 3 and part of rib 2.

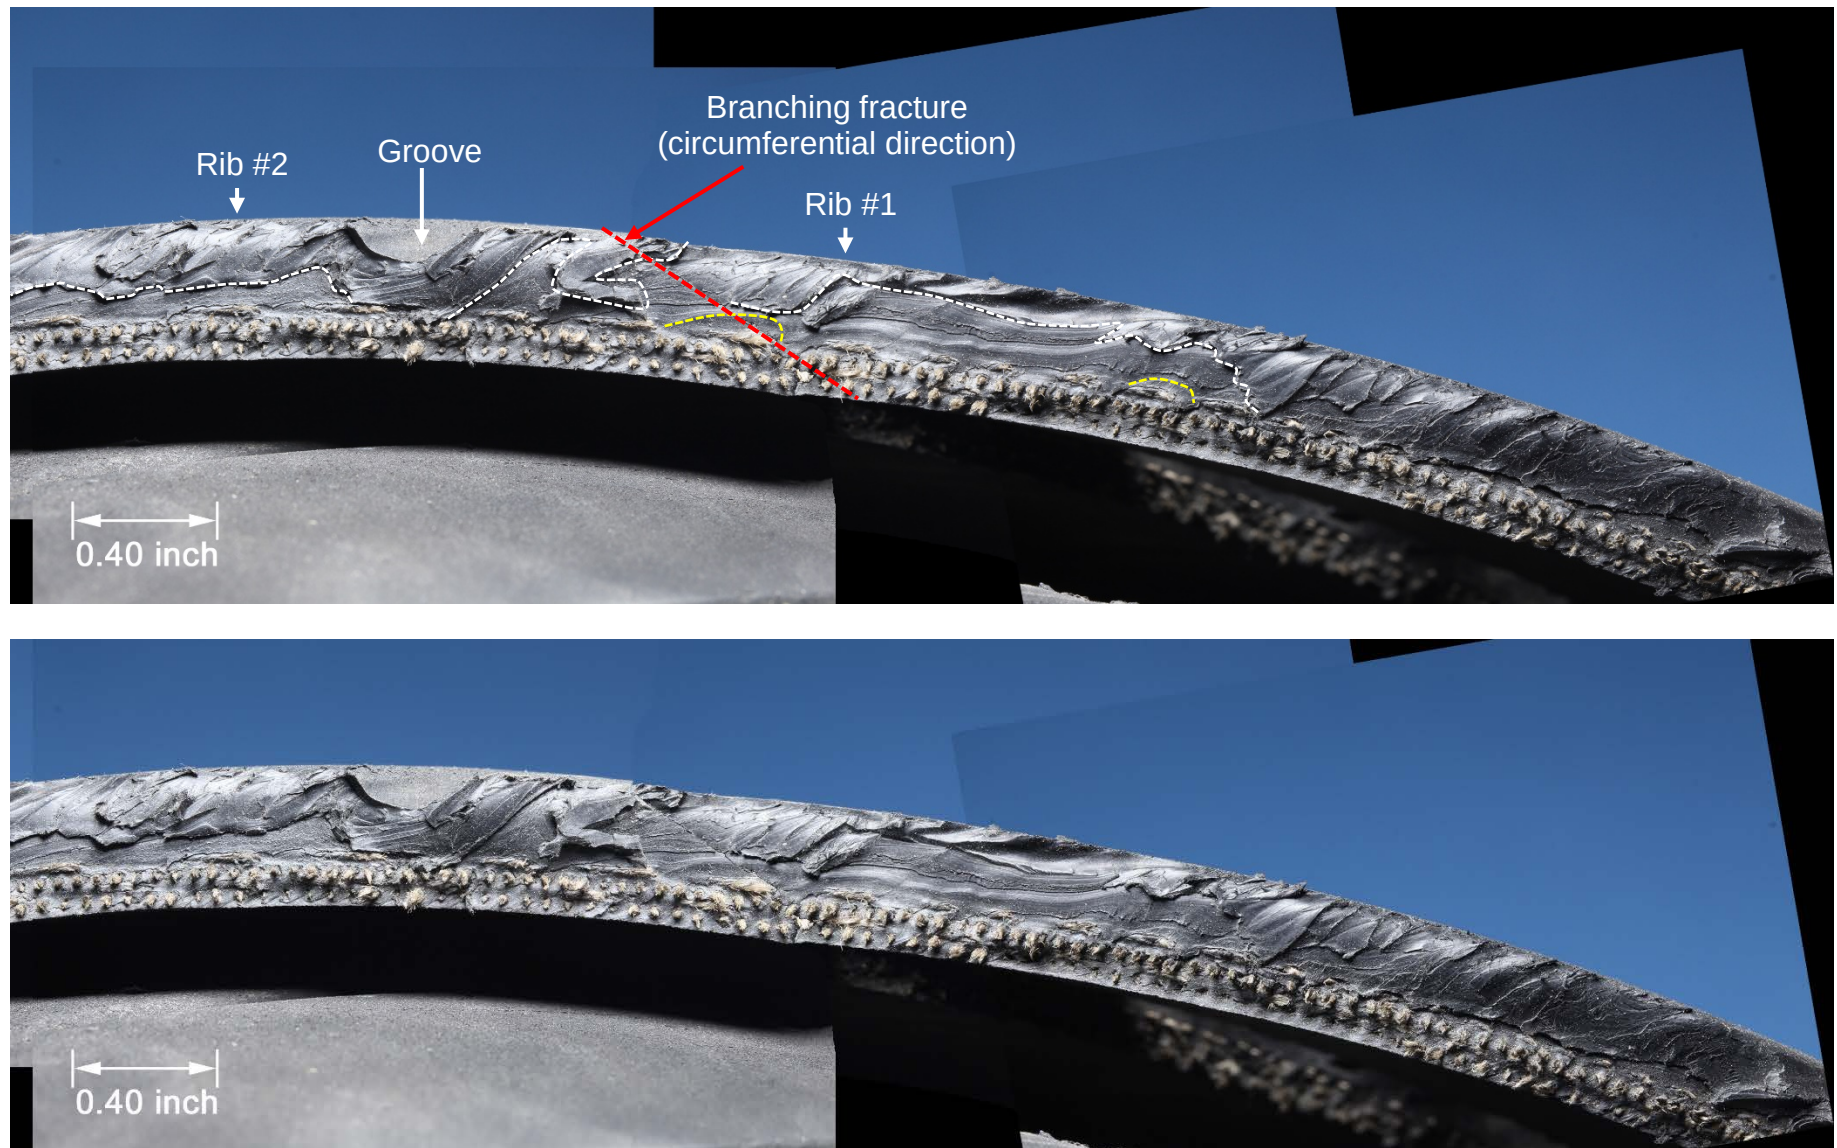
Progressive fracture features were also observed near the groove between ribs 1 and 2, as shown in figure 6. The circumferential branching crack was located in this region and the fracture surface images were spliced together at the branching crack. Similar to the region described above, progressive fracture features were observed starting at the cords and progressing toward the tread surface. A white dashed line indicates the extent of the progressive features where their extent could be determined.

**Figure 6:** Montage of the bias fracture near the SS shoulder spanning ribs 1 and 2.

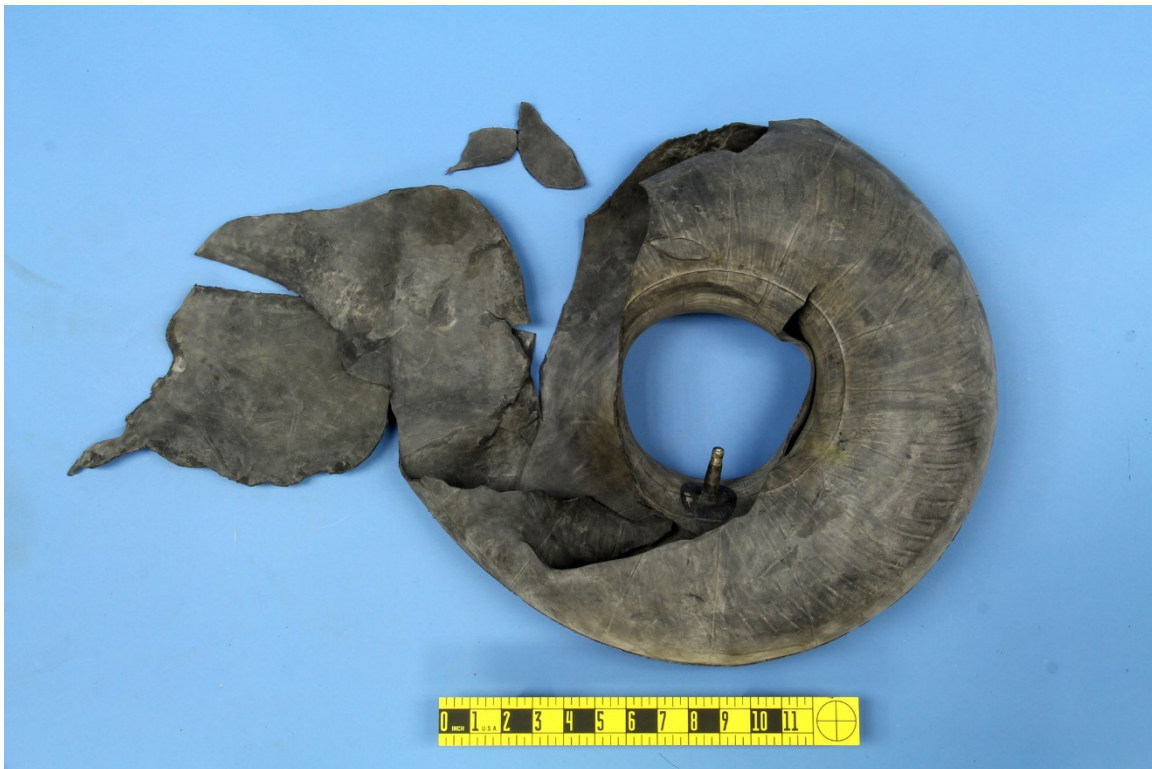
Stereomicroscopic examination of the remaining fracture surfaces revealed features consistent with tearing, cutting, and abrasion. Examination of the tire tube (see figure 5a) and fractured wheel outboard rim pieces (see figure 5b) revealed features consistent with overstress fractures. There were no notable tread wear patterns, cuts, or gouges on the tread surface. There was no evidence of rubbing or blue tinting to indicating a long-term internal separation.

**Figure 7:** a) Image of the fractured tire tube and b) image of the fractured outboard rim pieces.
