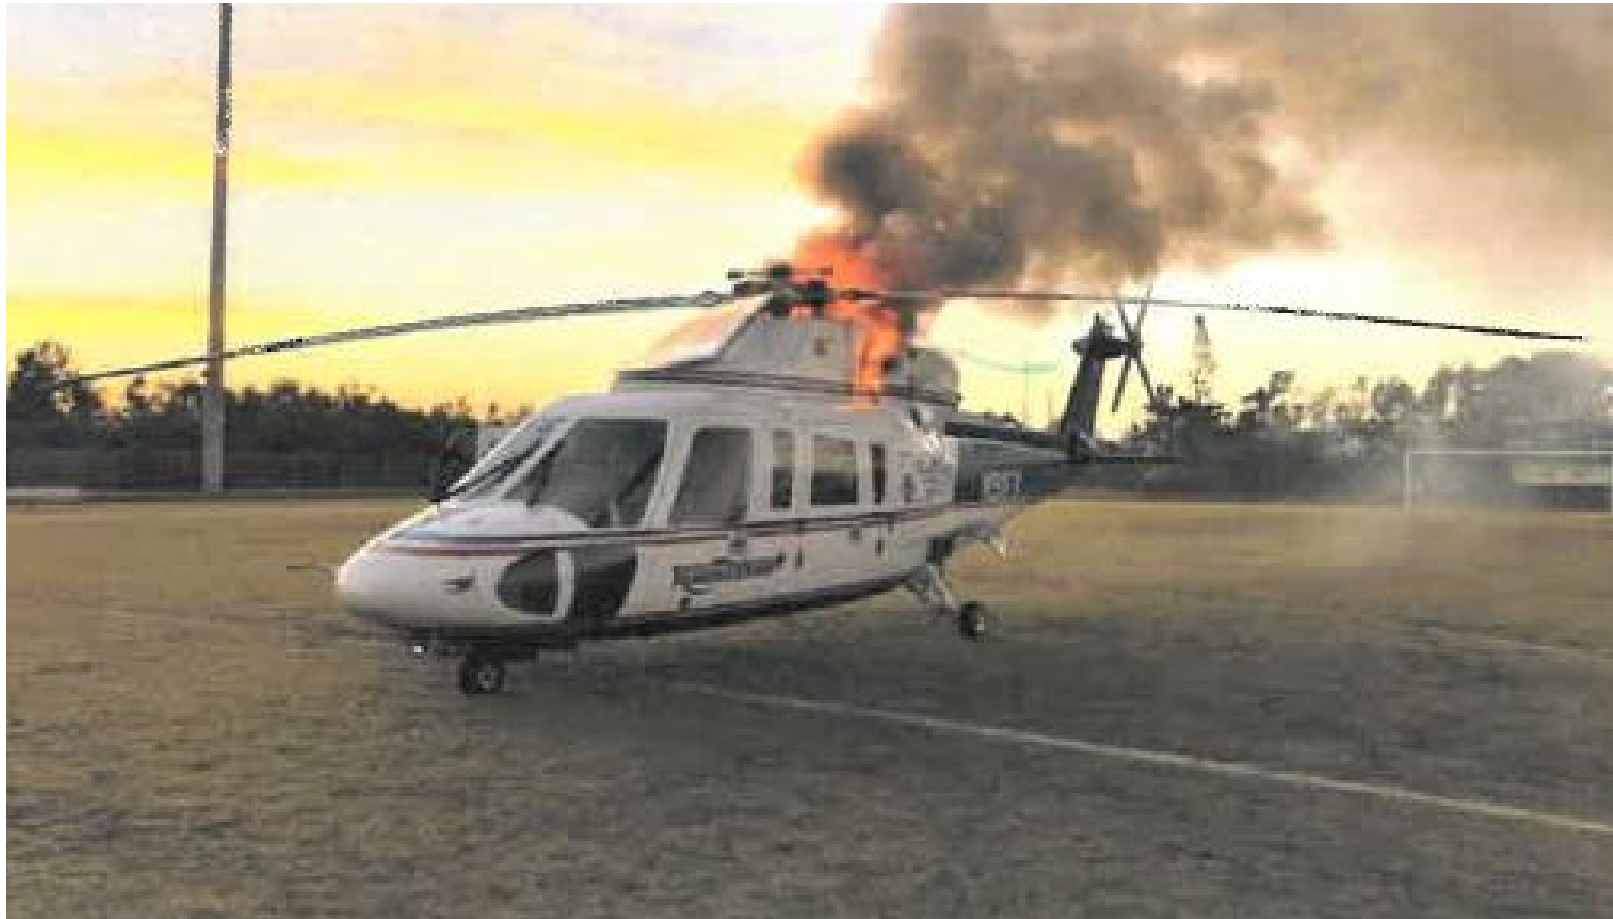
**Photo 1 – Fire in Engine/Transmission Compartment. (Unknown Photographer)**

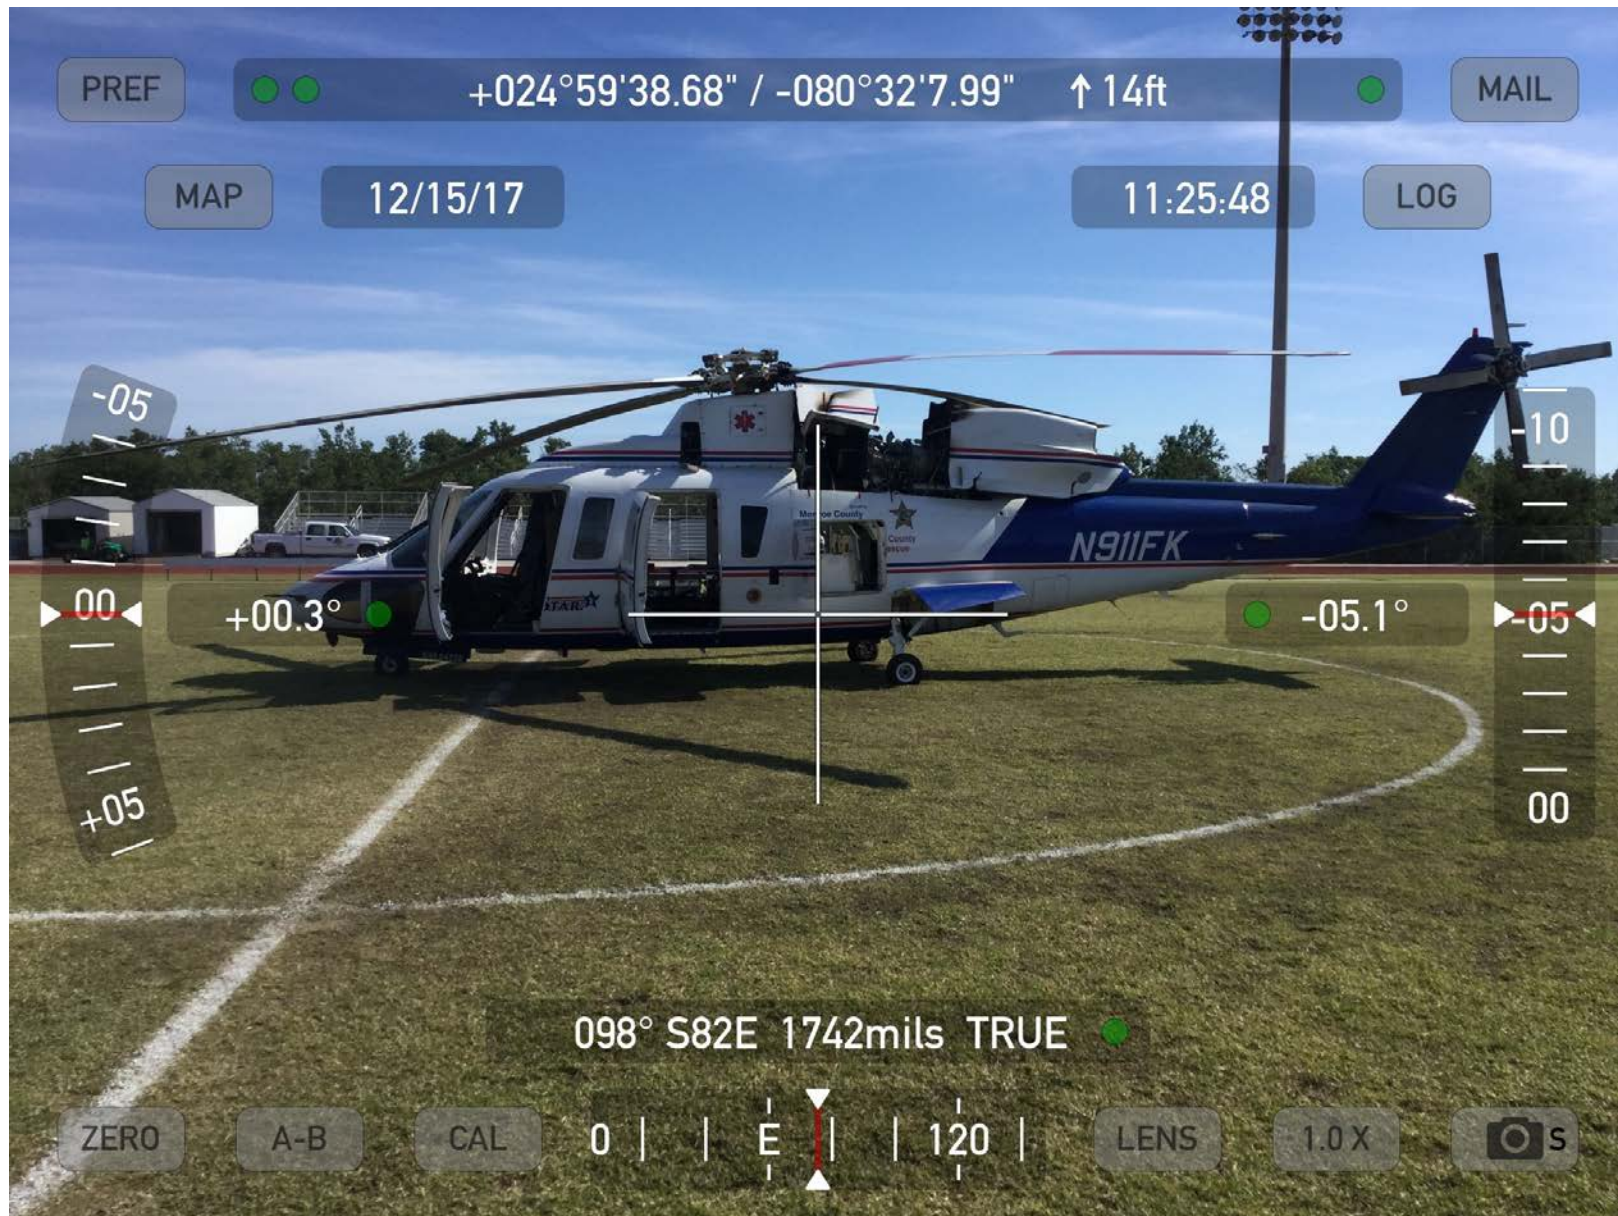
**Photo 2 – Overall Condition of Helicopter Prior to Removal of Blades and Transport. (Courtesy of Monroe County Sheriff's Office)**

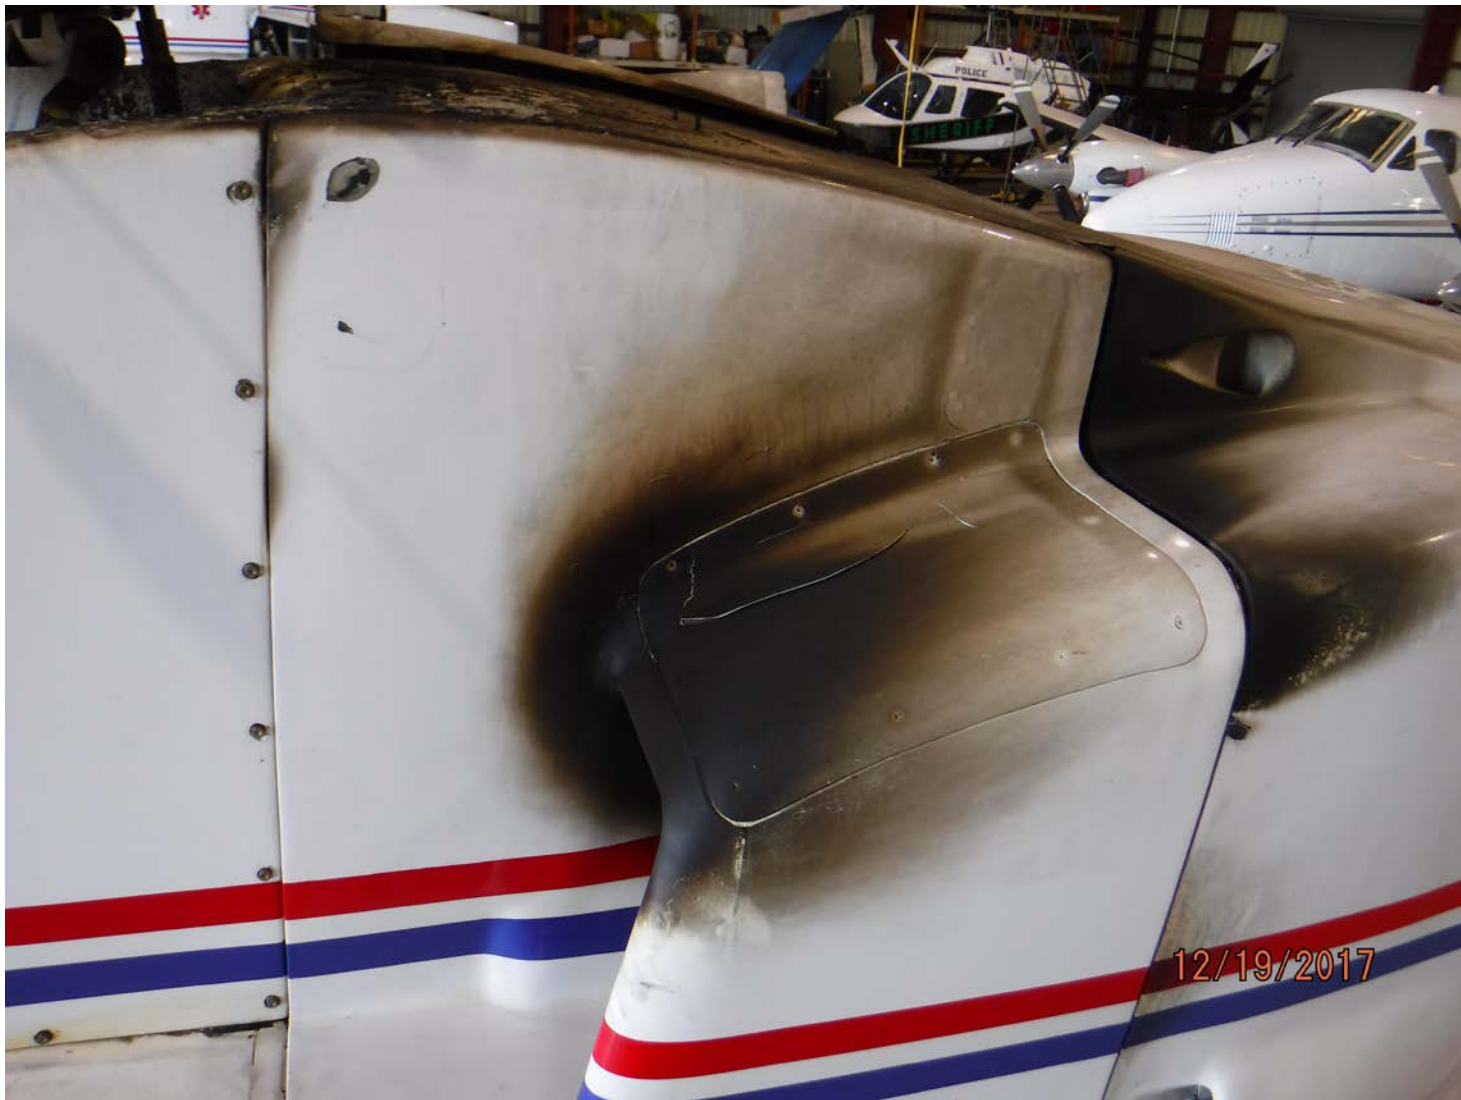
**Photo 3 – Left Side, Number 1 Engine Intake and Aft Engine Cowling Soot and Thermal Damage. (Courtesy of Sikorsky)**

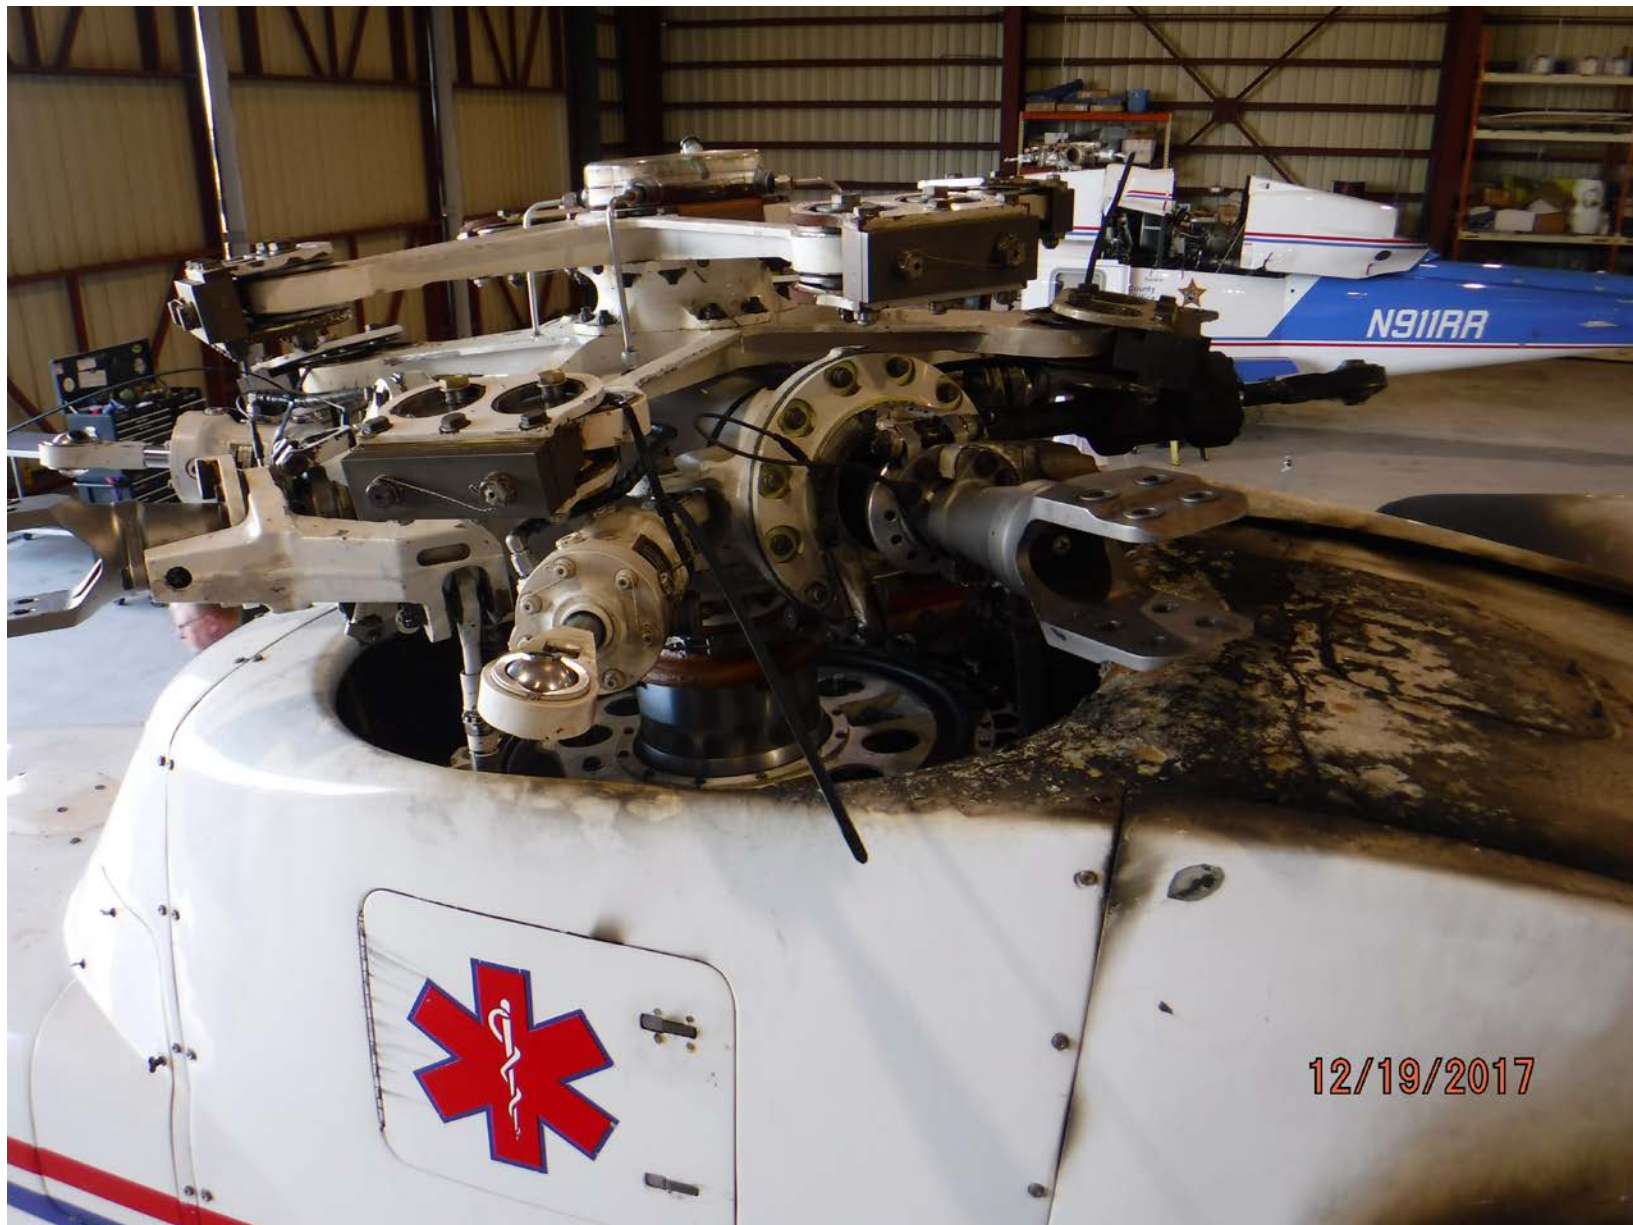
**Photo 4 – Top View of Rotor Head and Engine Cowl Thermal Damage. (Courtesy of Sikorsky)**

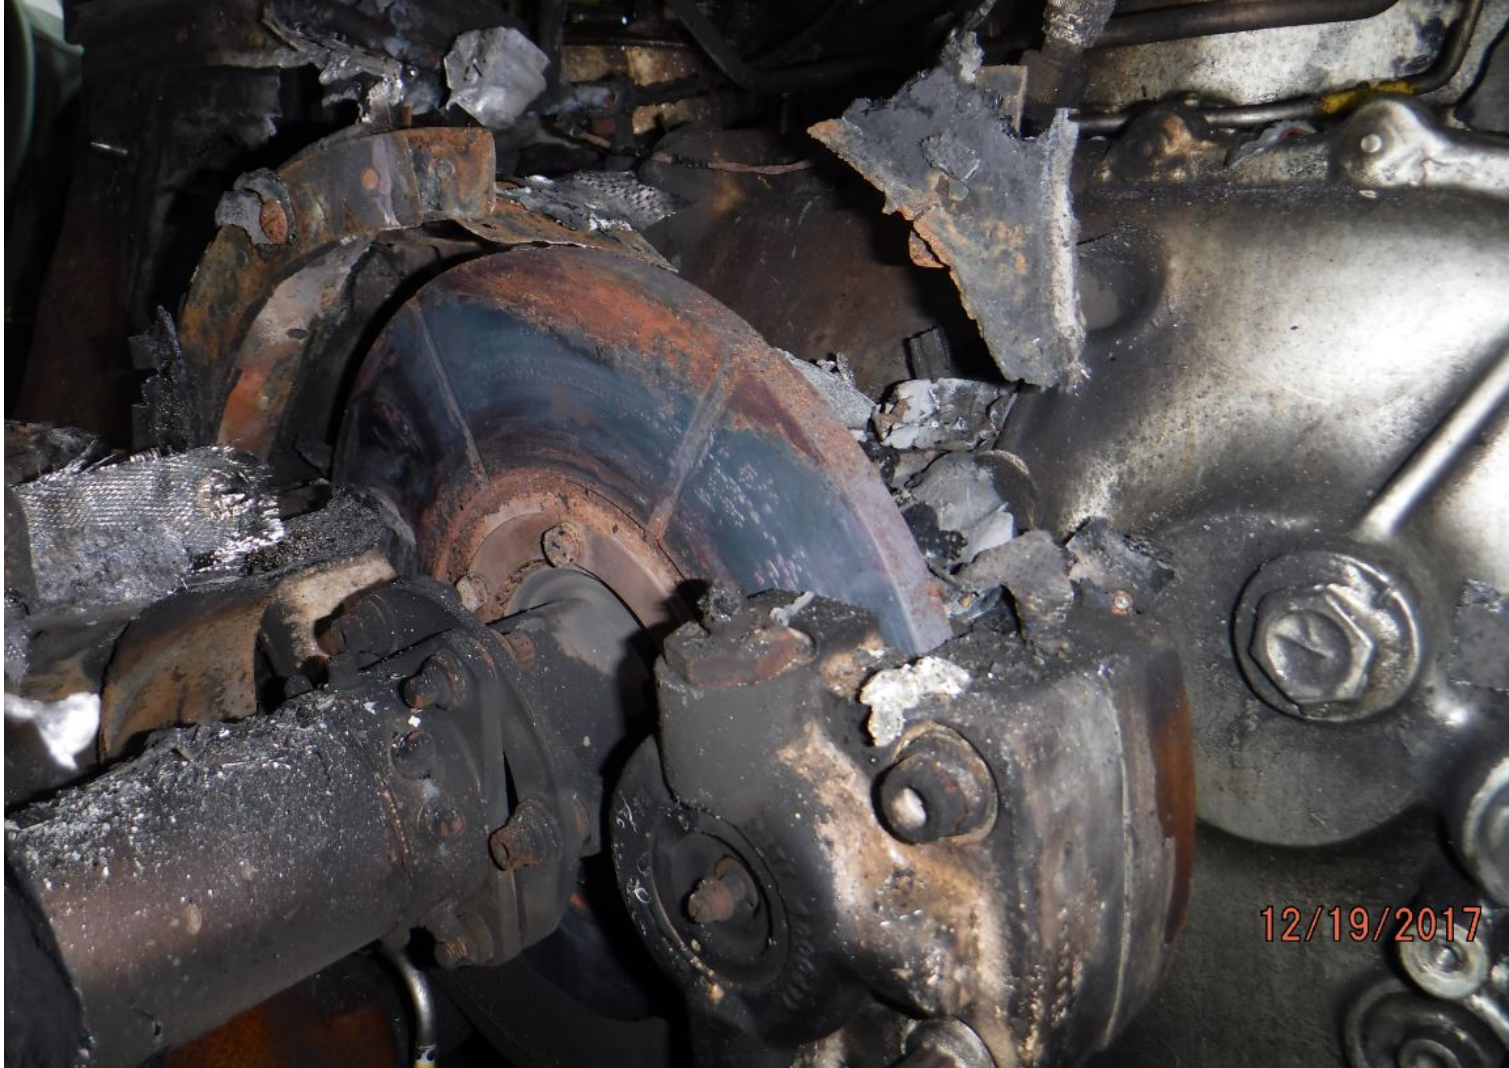
**Photo 5 – Rotor Brake and Caliper Damage Right Side. (Courtesy of Sikorsky)**

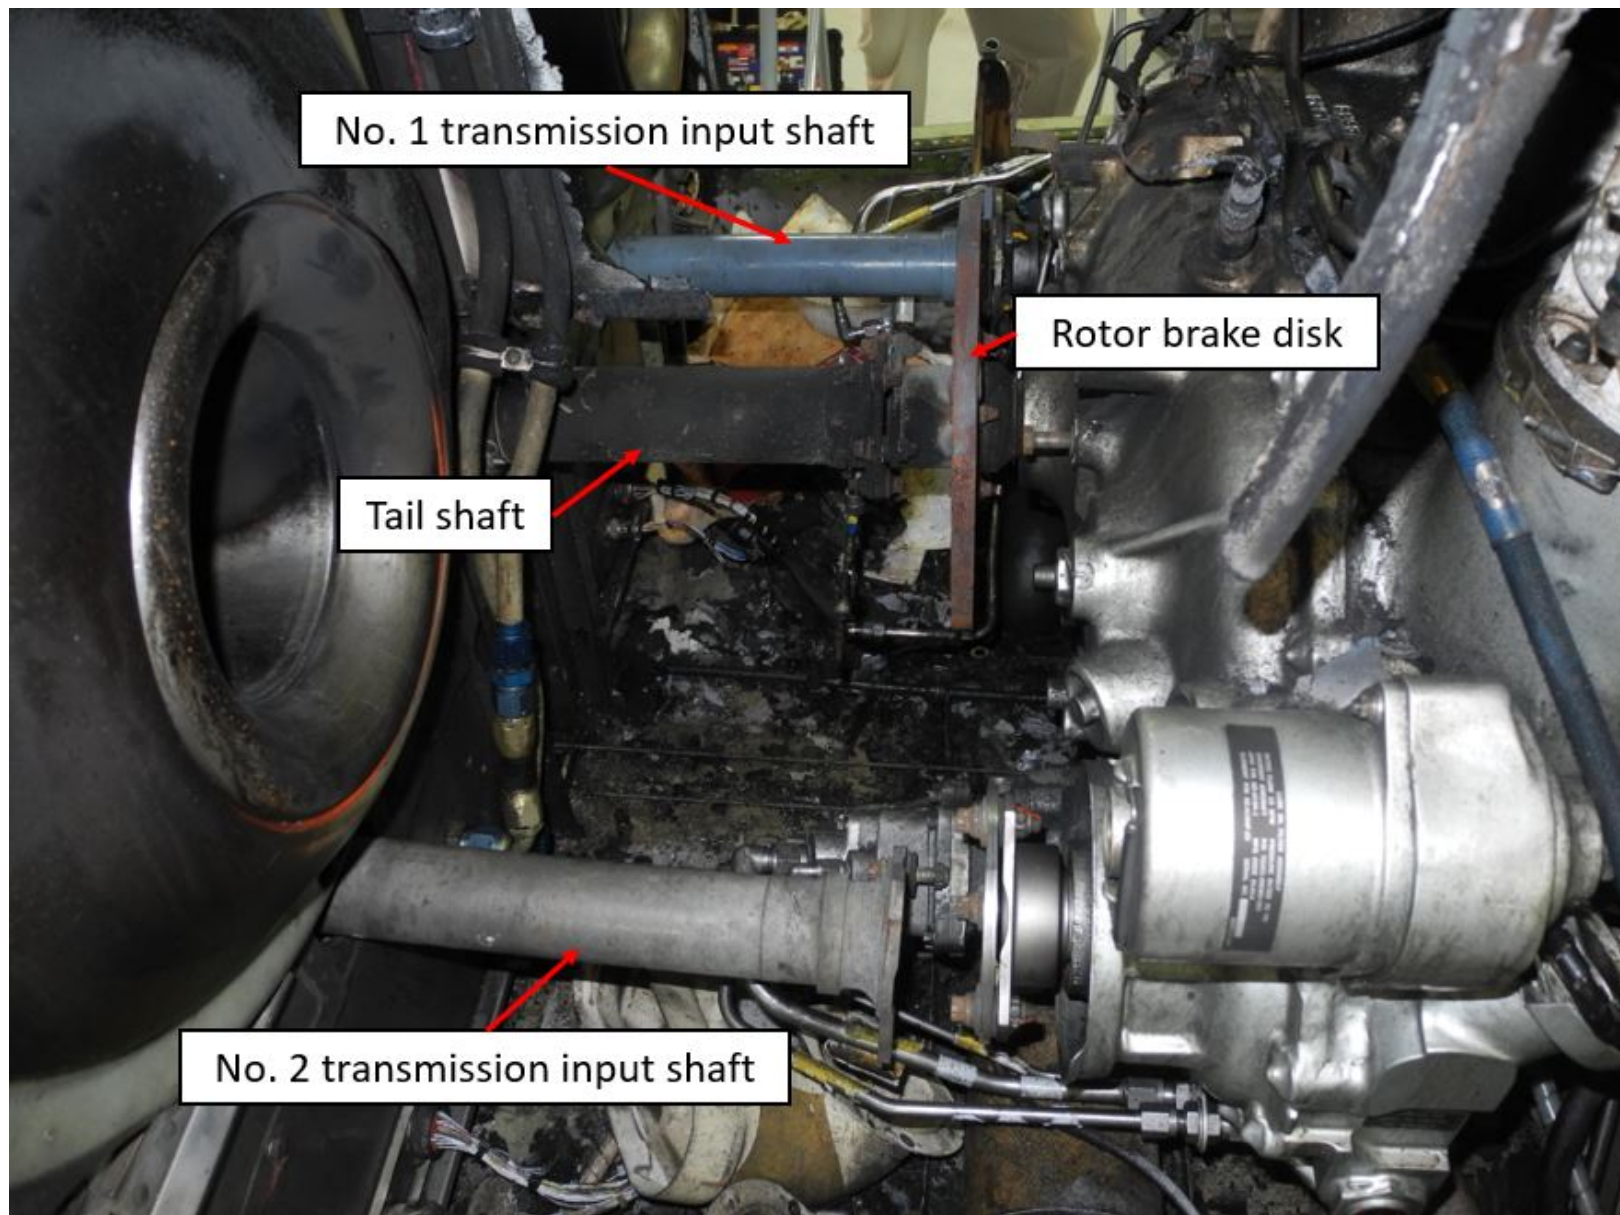
**Photo 7 – Overall View of Intake, Transmission and Rotor Disk Compartment After Removal of Several Components to Facilitate Examination. Note that Both Input Shafts, the Rotor Brake Disk and Tail Shaft are Identified.**

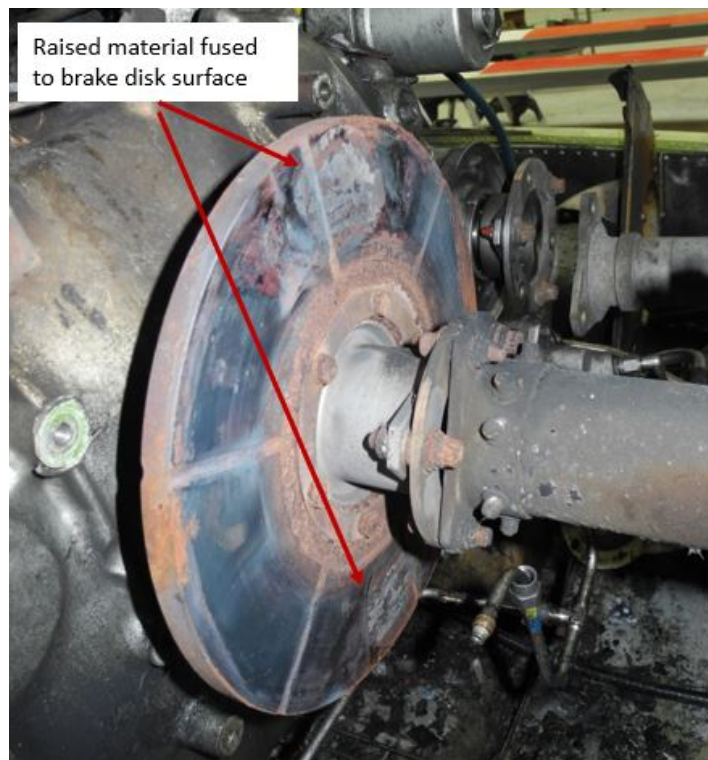
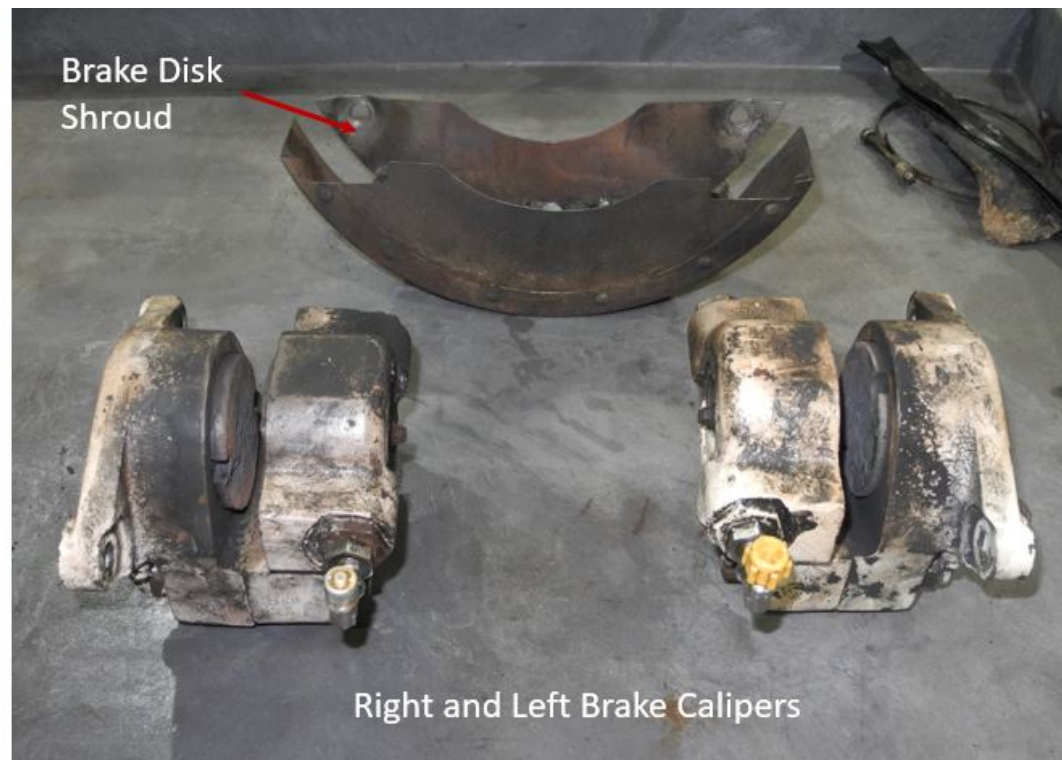
**Photo 8 – Close up View of Rotor Brake Disk and Calipers After Removal. Note the Raised Material Fused to the Surface of the Disk.**

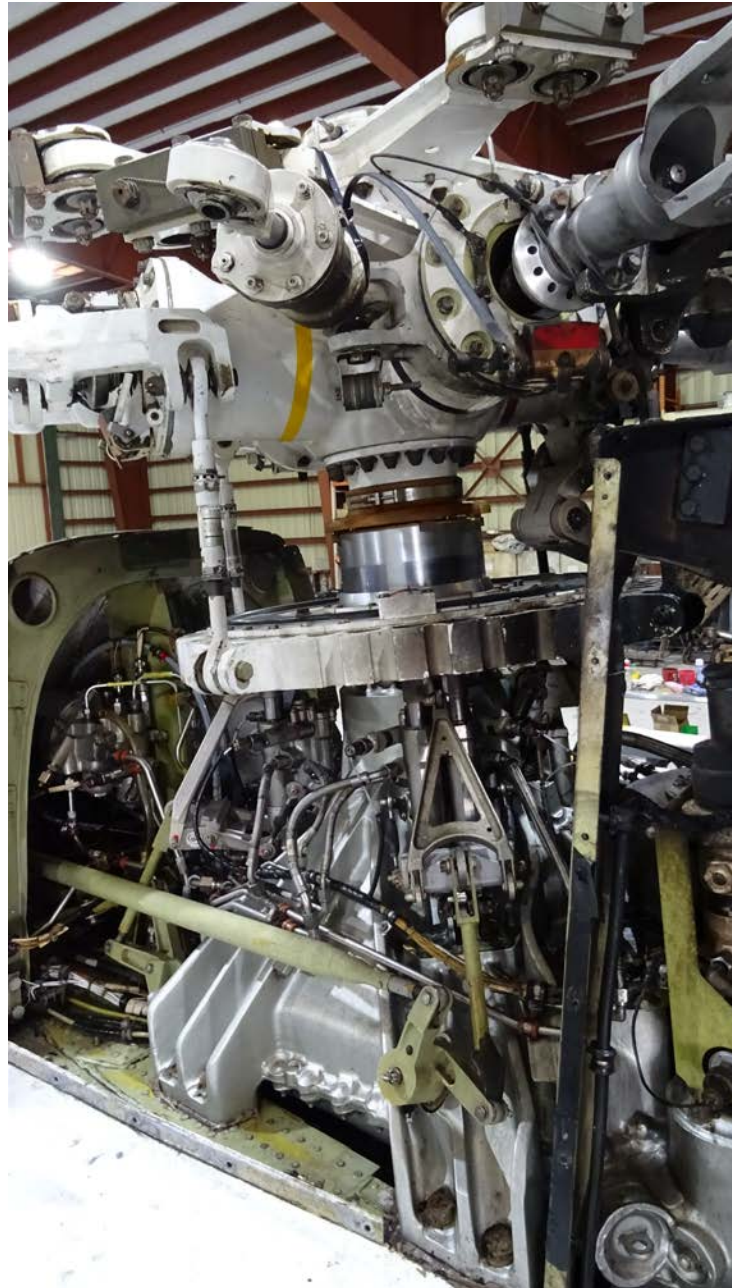
**Photo 9 – Overall View of Transmission and Rotor Head Assembly with the Cowl Off.**

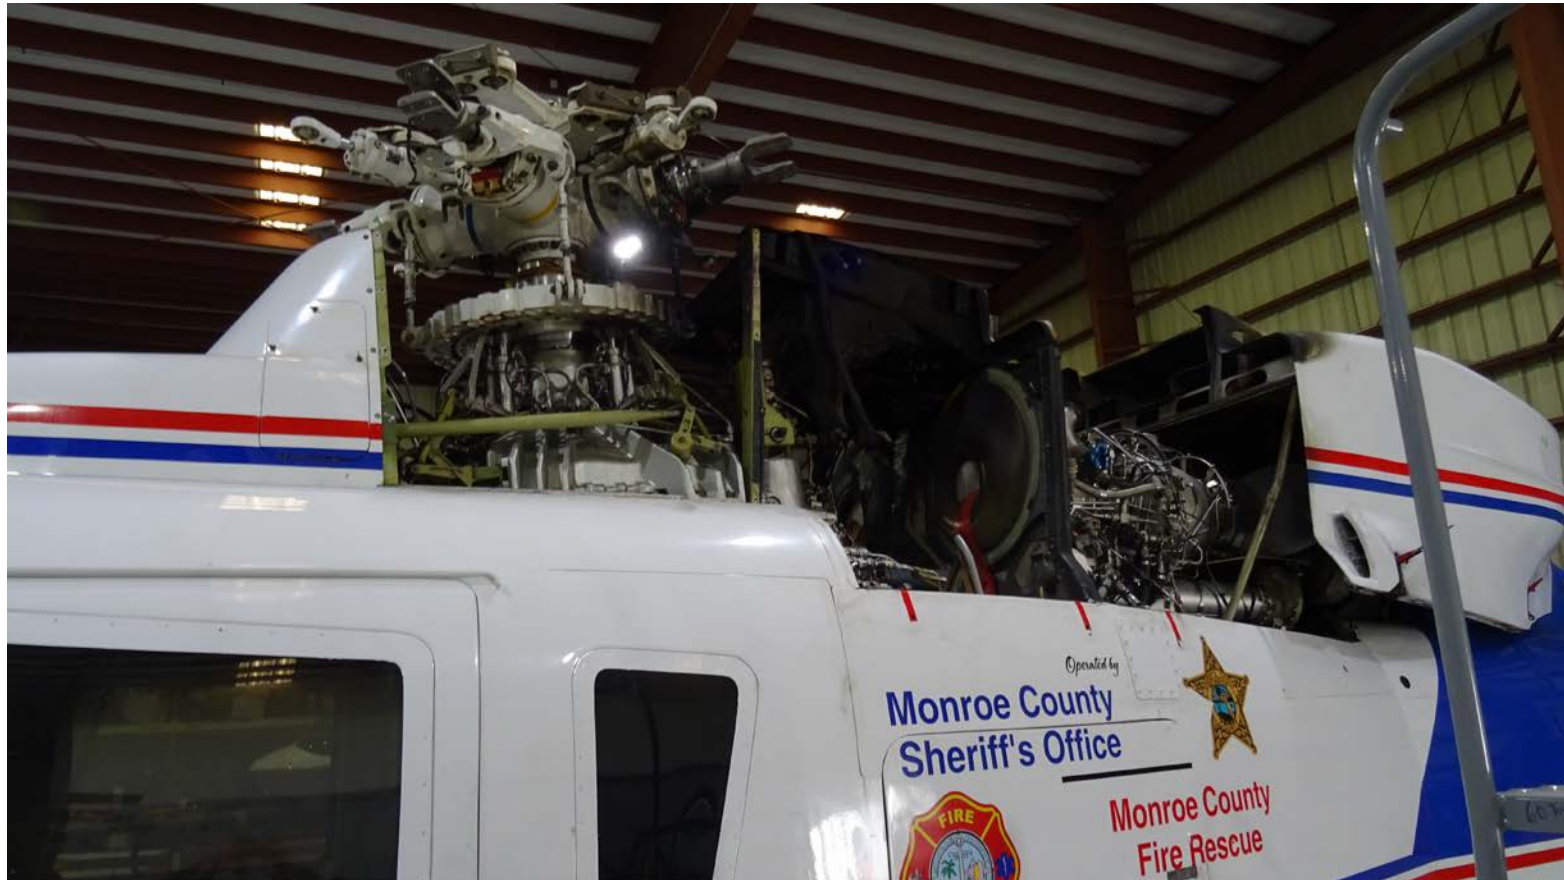
**Photo 10 – Left Side View of Entire Engine and Transmission Compartment with the Cowls Off.**

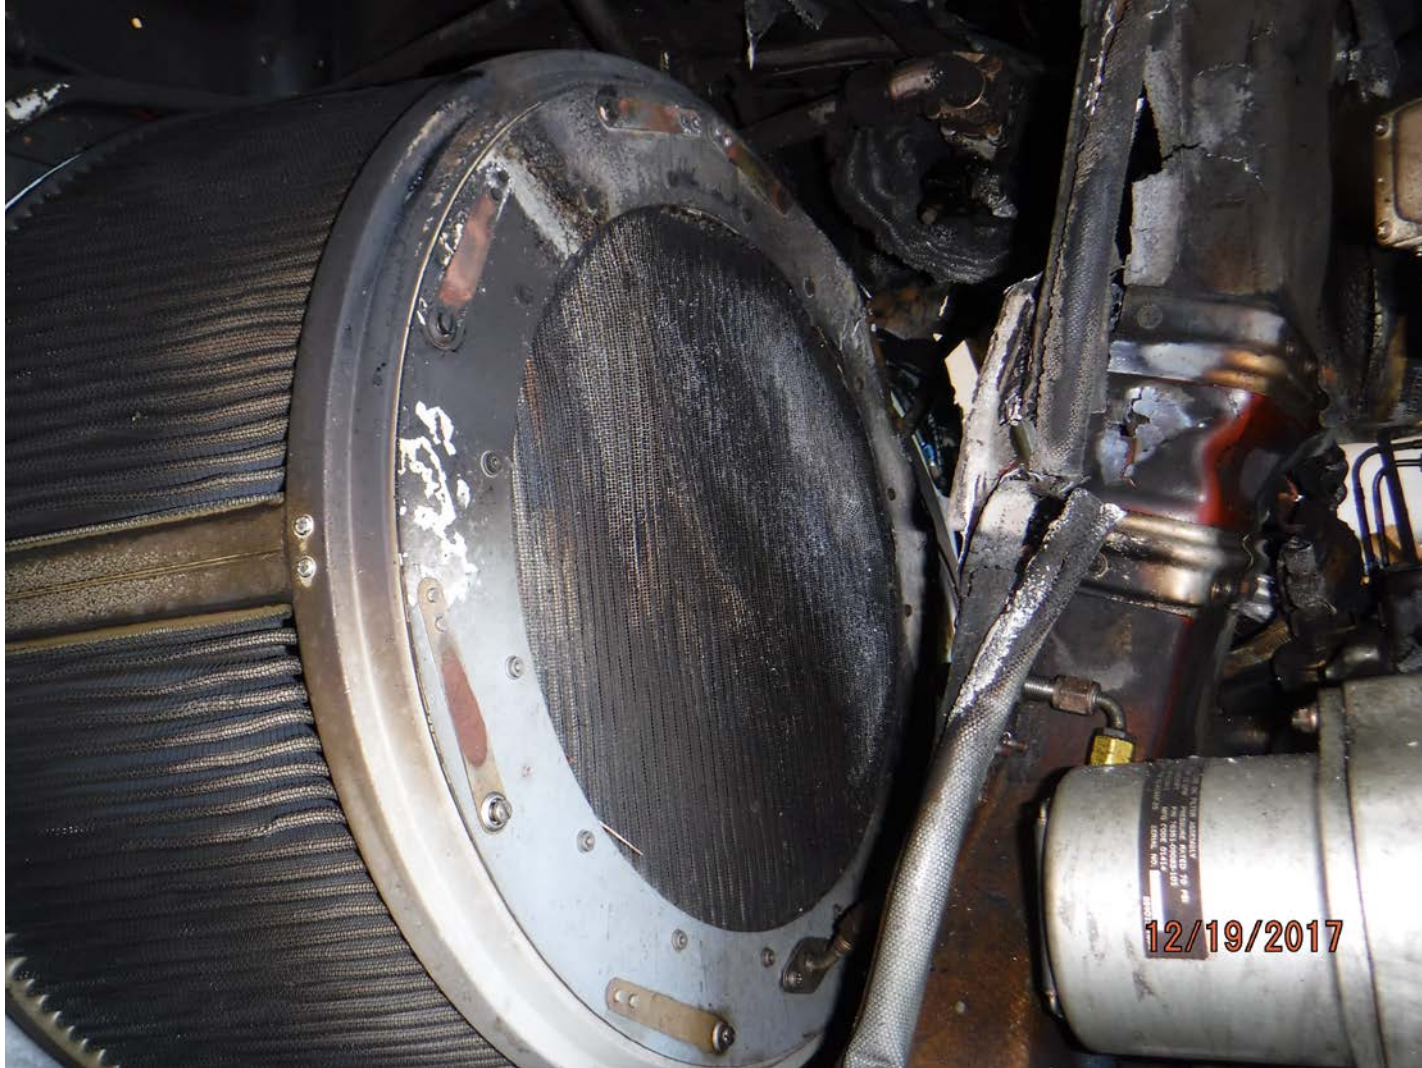
**Photo 11 – Number 2 Engine Barrier Filter Damage. (Courtesy of Sikorski)**

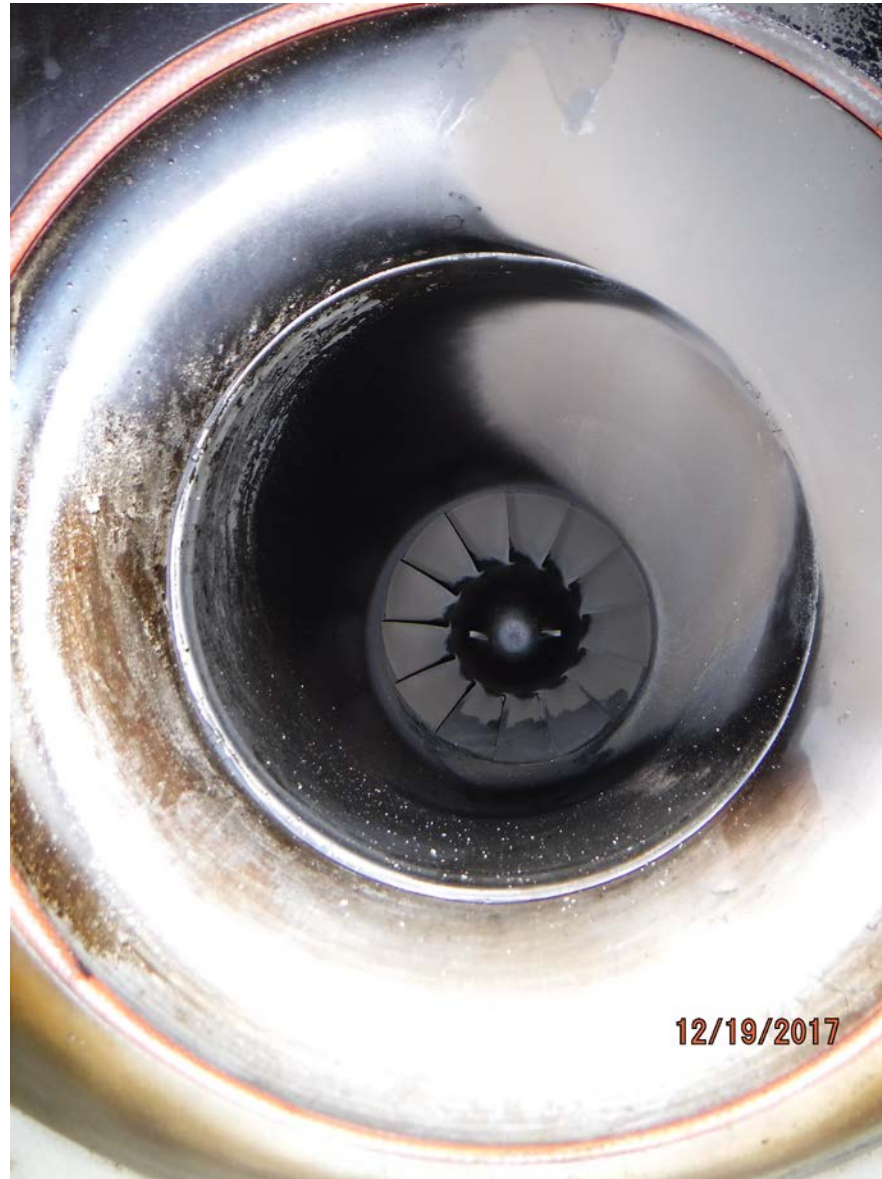
**Photo 12 – Number 2 Engine Inlet with Barrier Filter Removed. (Courtesy of Sikorsky)**

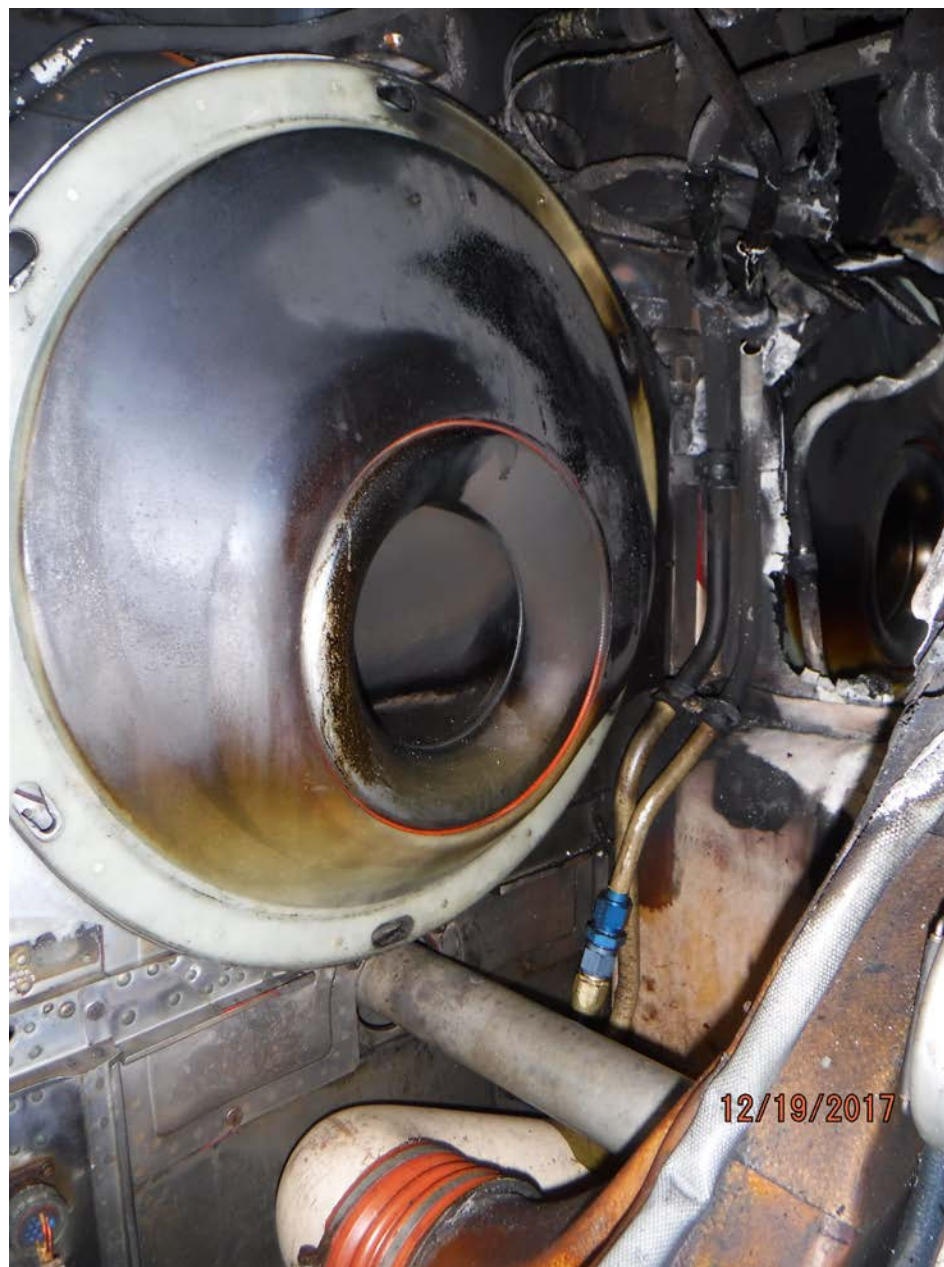
**Photo 13 – Number 2 Engine Intake with Barrier Filter Removed. (Courtesy of Sikorsky)**

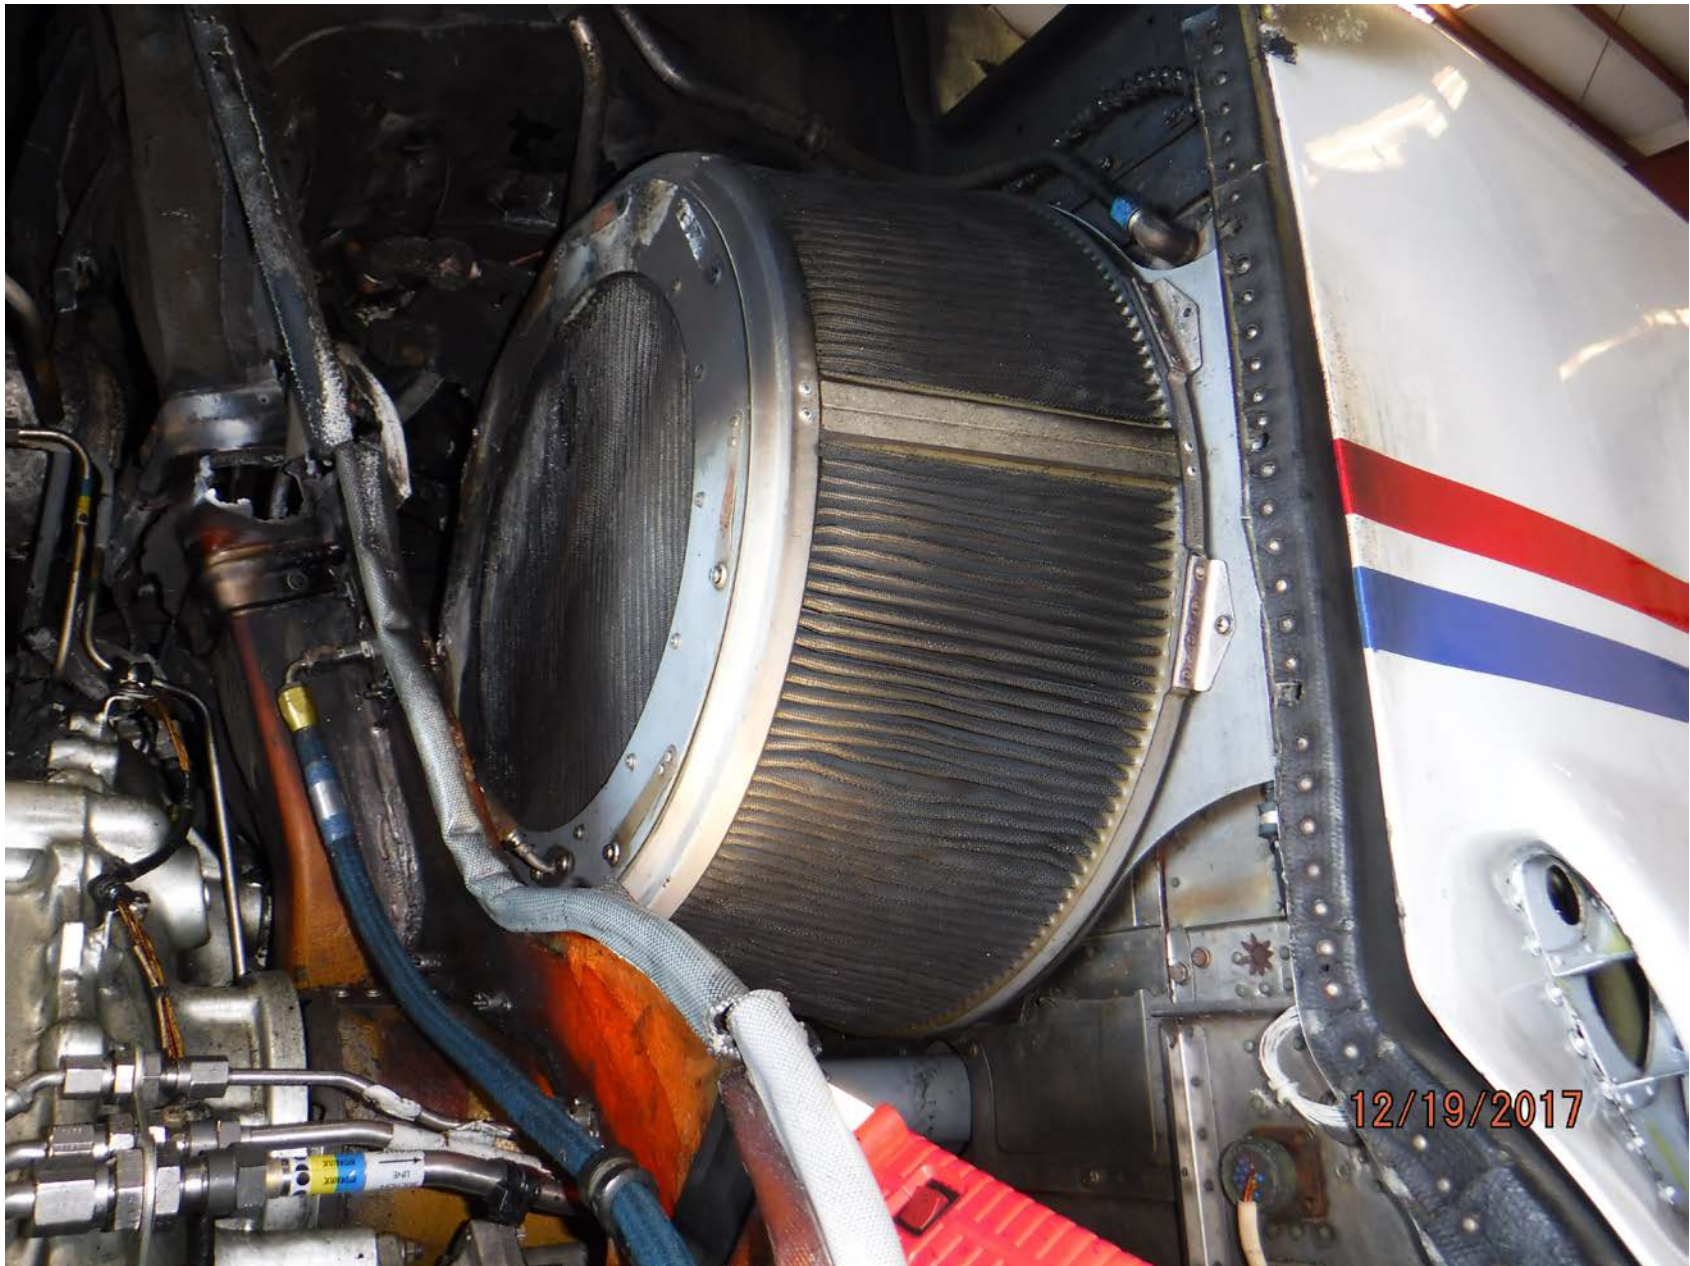
**Photo 14 – Number 1 Barrier Filter Installed. Note Soot and Heat Damage. (Courtesy of Sikorsky)**

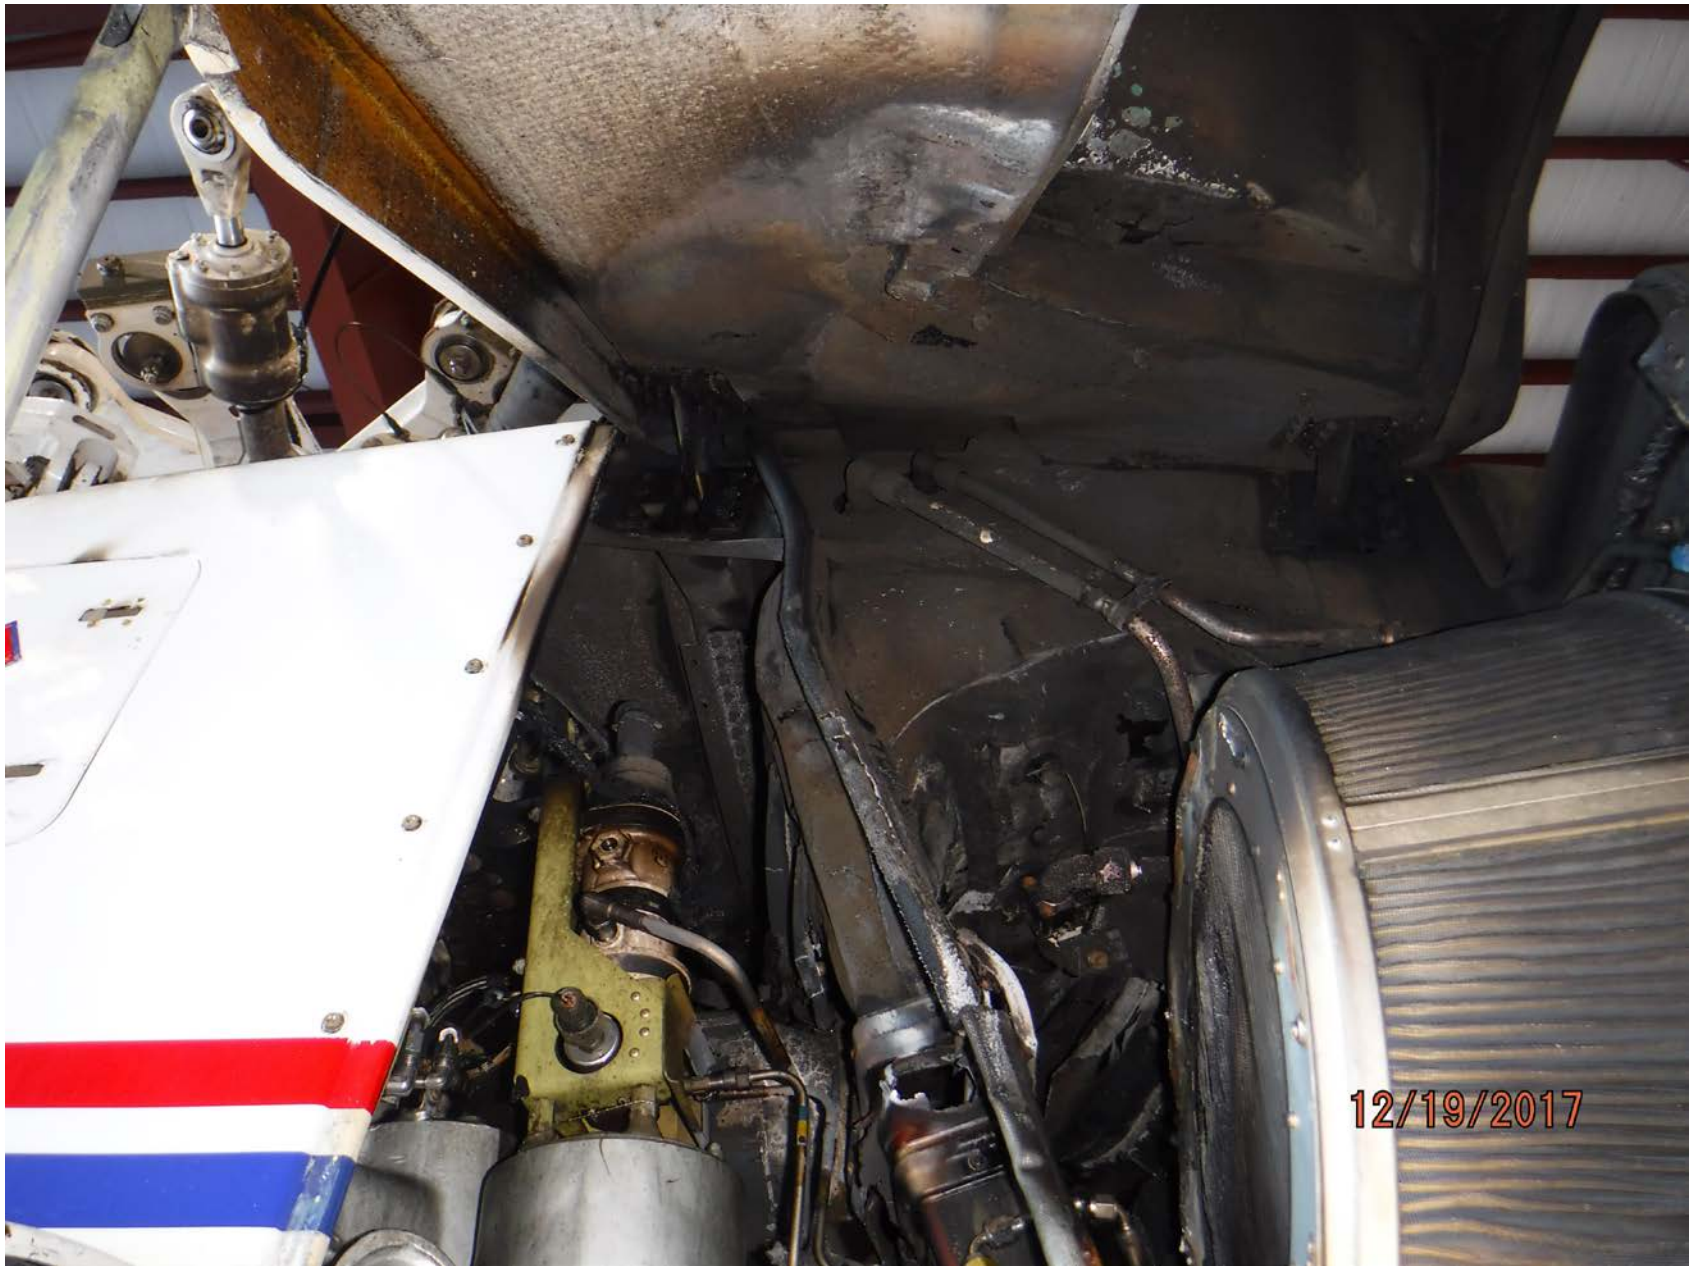
**Photo 15 – Number 1 Engine Intake Area Soot and Heat Damage. (Courtesy of Sikorsky)**
