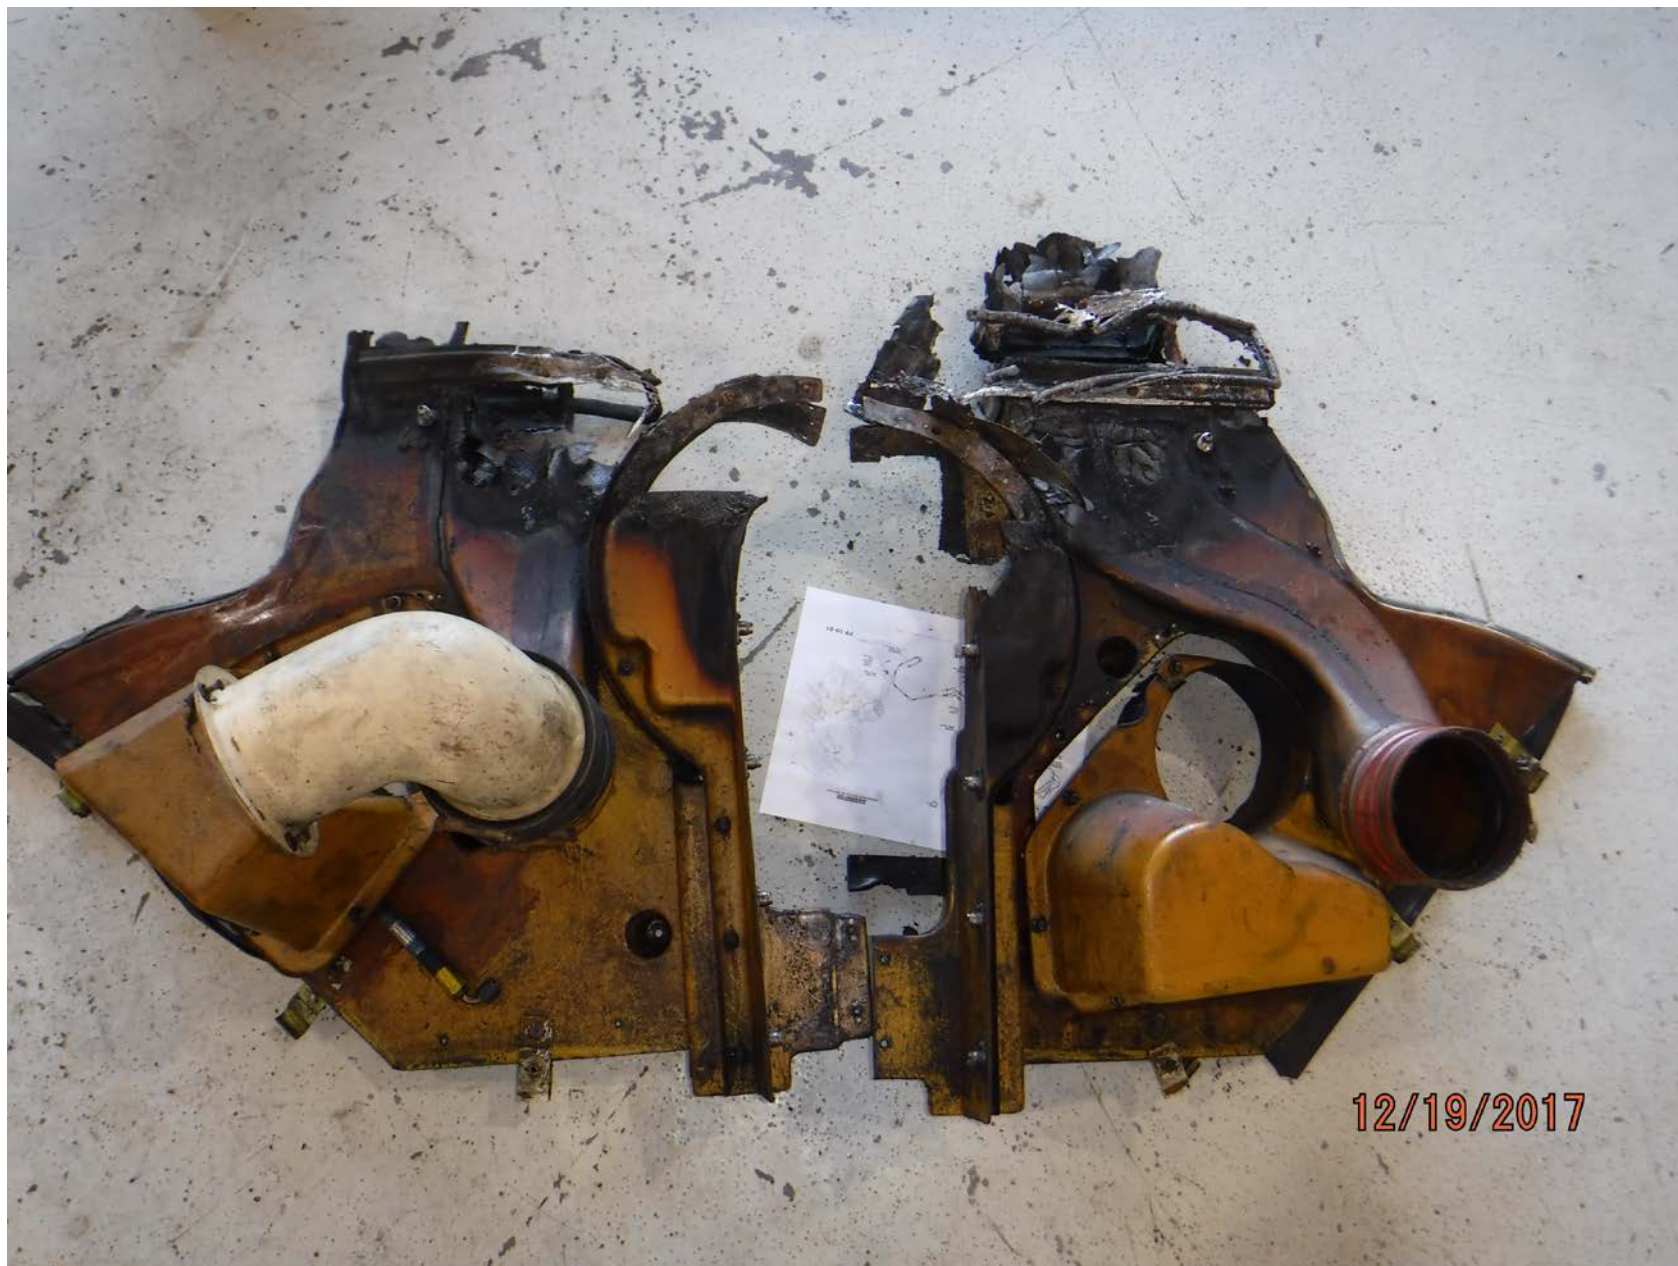
**Photo 16 – Aft View of Oil Cooler Assembly. Note Soot and Thermal damage. (Courtesy of Sikorsky)**

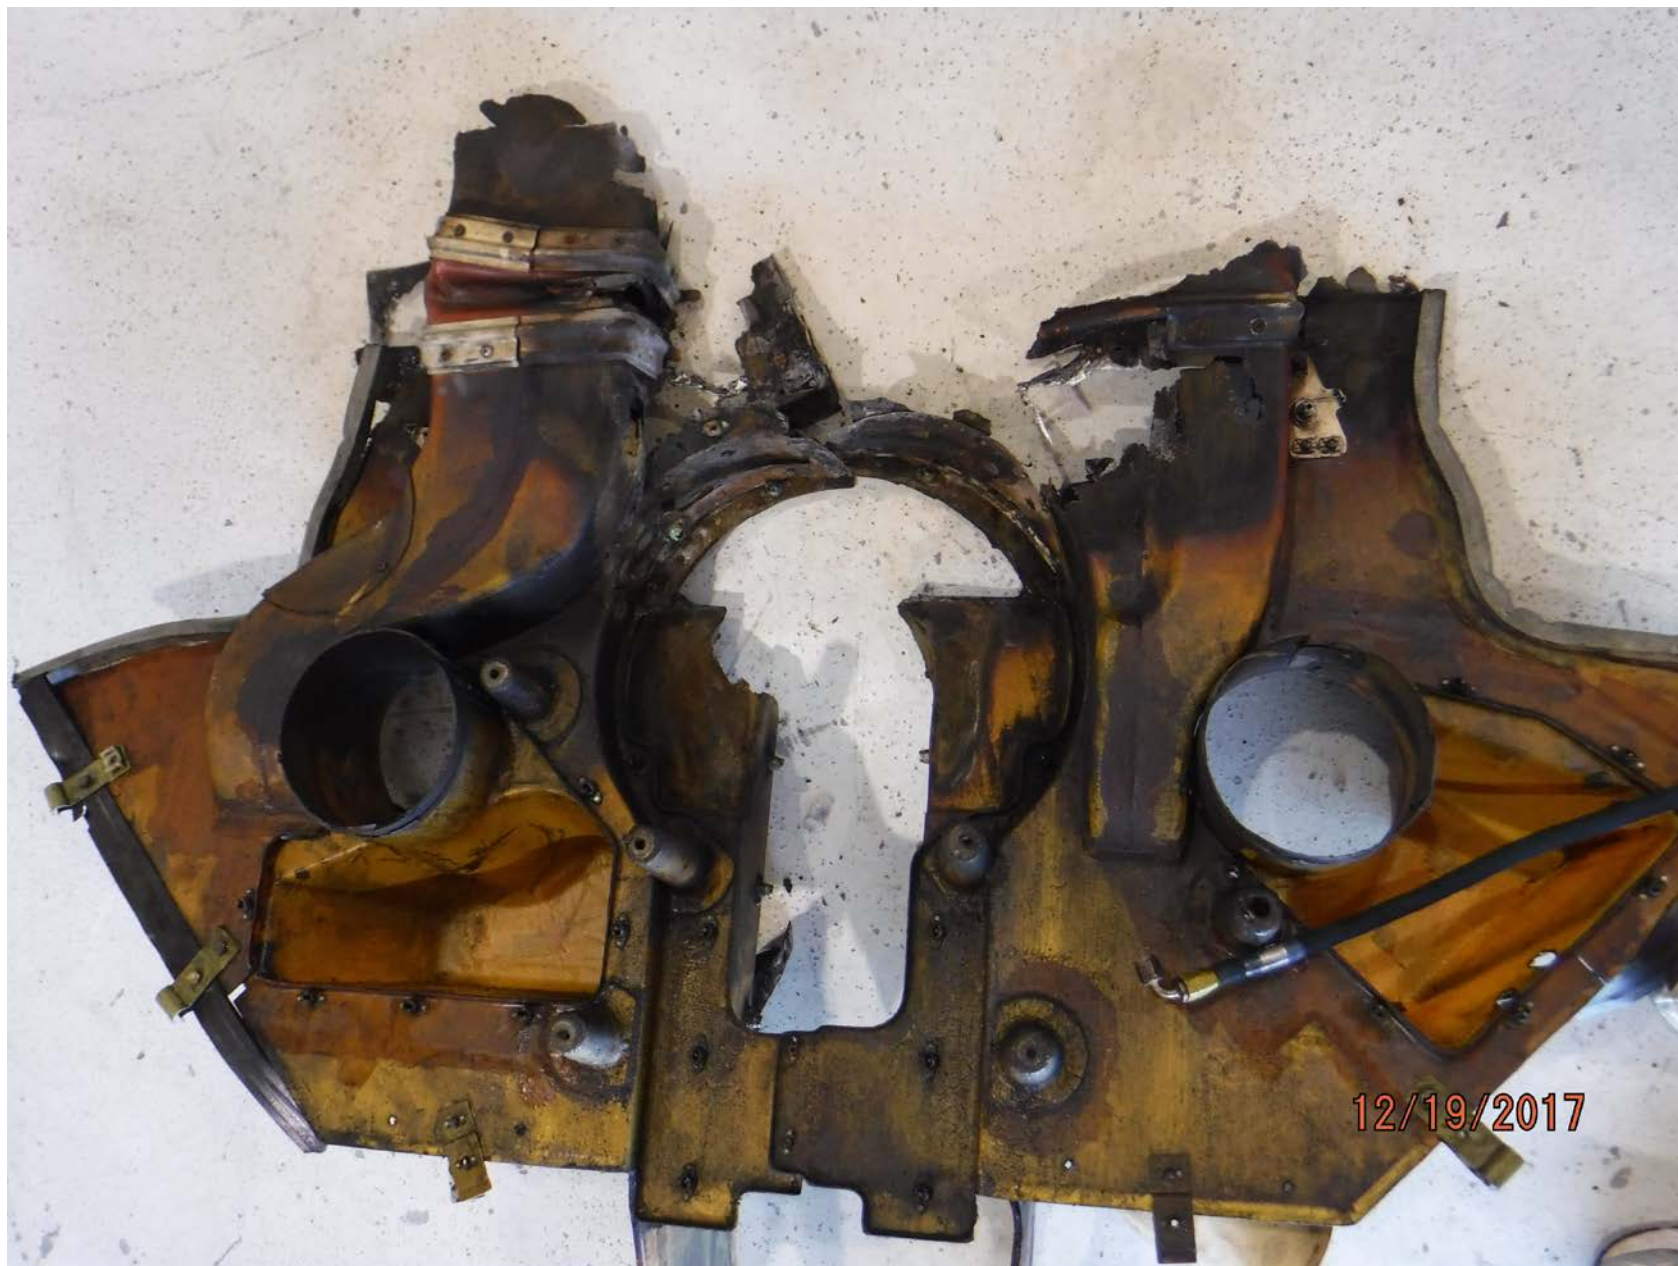
**Photo 17 – Front Side of Oil Cooler Assembly. Note Soot and Thermal Damage.(Courtesy of Sikorsky)**

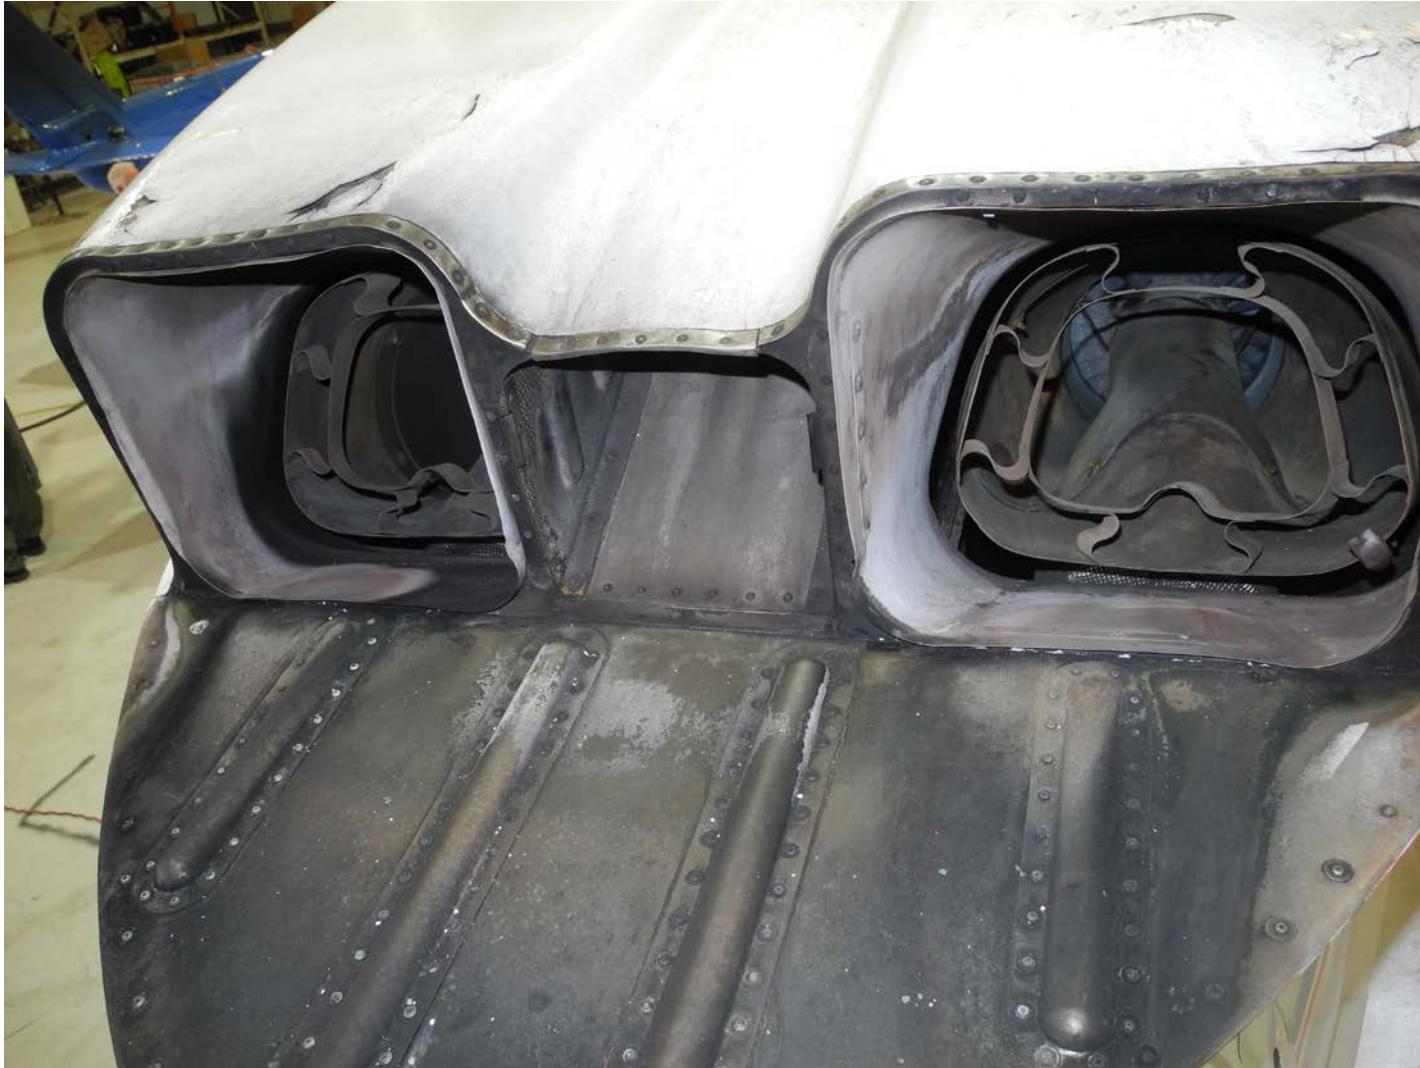
**Photo 18 – Number 1 (L) and Number 2 (R) Engine Exhaust.**

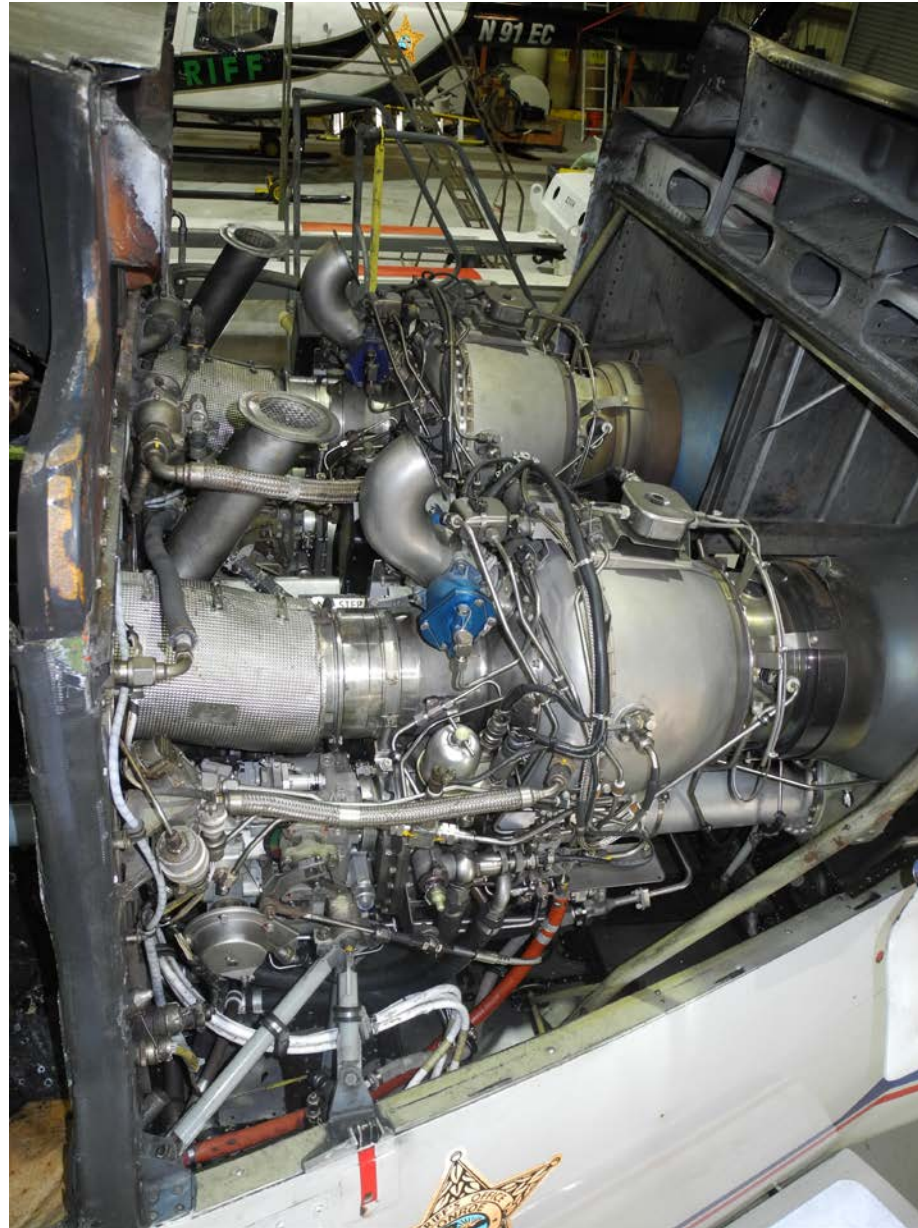
**Photo 19 – View of Engine Exterior Condition. Left Engine in Foreground.**

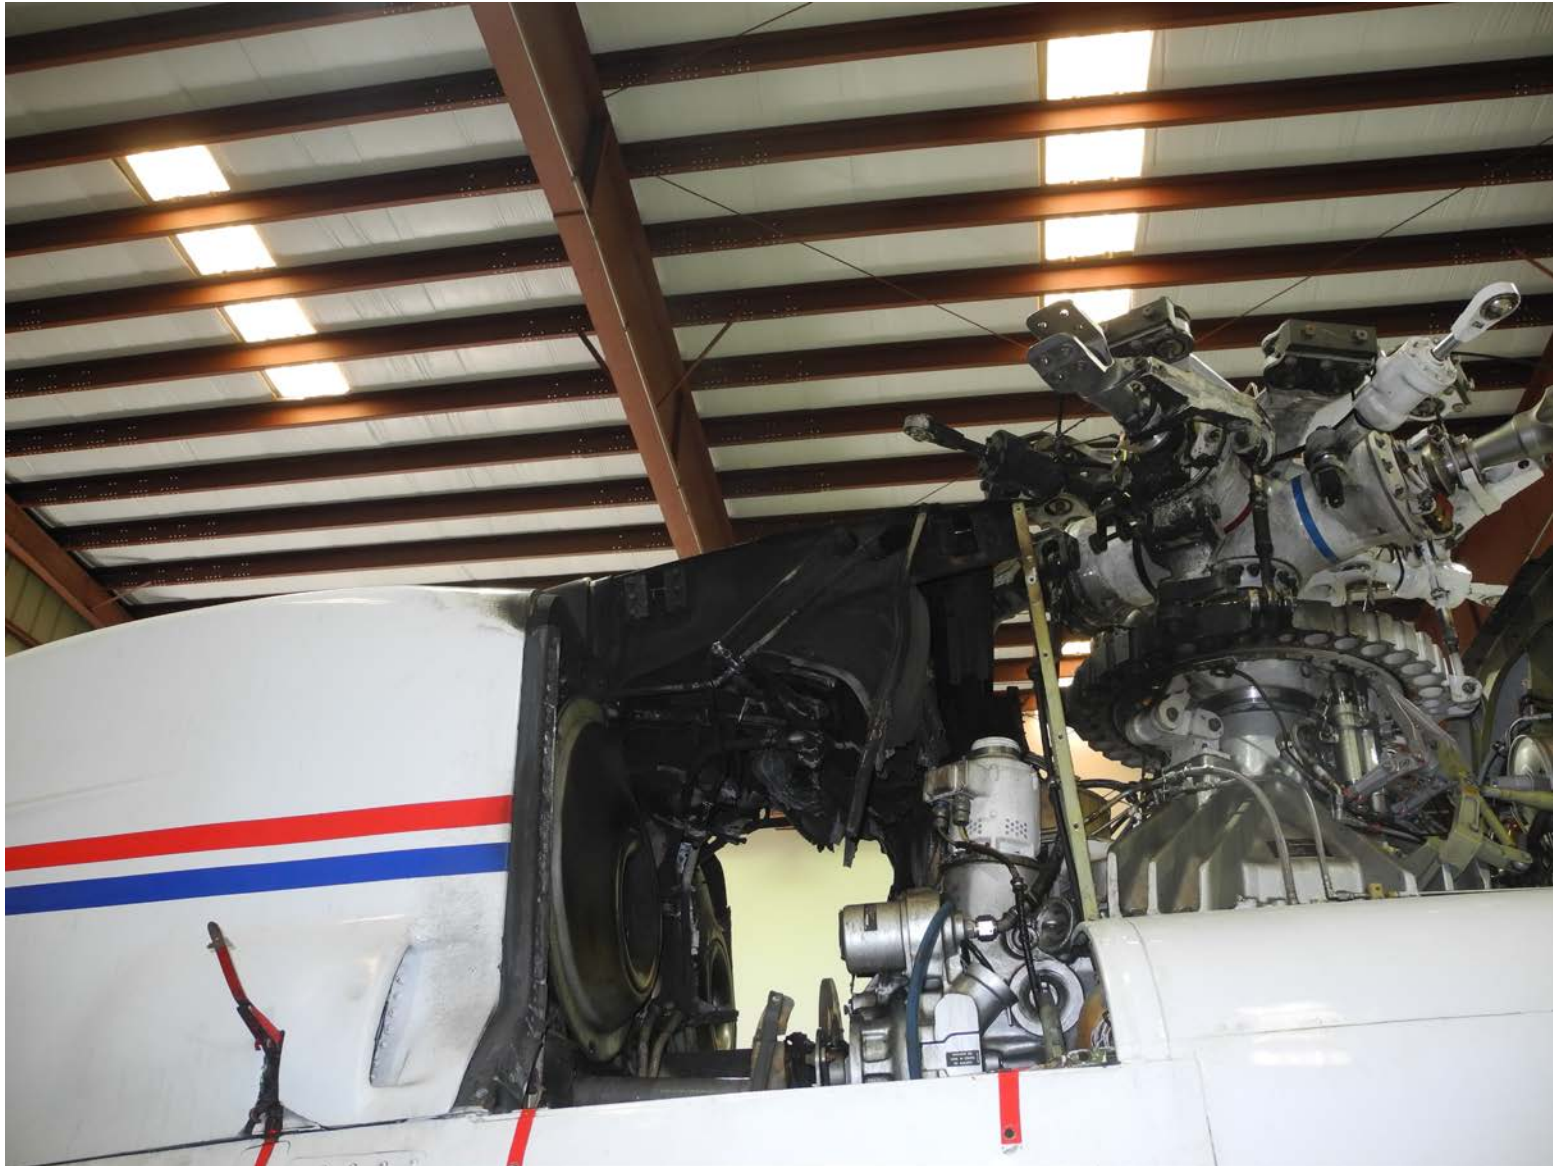
**Photo 20 – Right Side View of Damage.**
