**NATIONAL TRANSPORTATION SAFETY BOARD**  
**Office of Aviation Safety**  
**Washington, D.C. 20594**

**AIRWORTHINESS GROUP CHAIRMAN'S FACTUAL REPORT**

**NTSB No: ERA18LA053**

Operator: Global Sky Air Charter Corporation  
Aircraft: Sikorsky S-76A++, Registration N911FK  
Location: Islamorada, Florida  
Date: December 15, 2017  
Time: 0652 eastern standard time

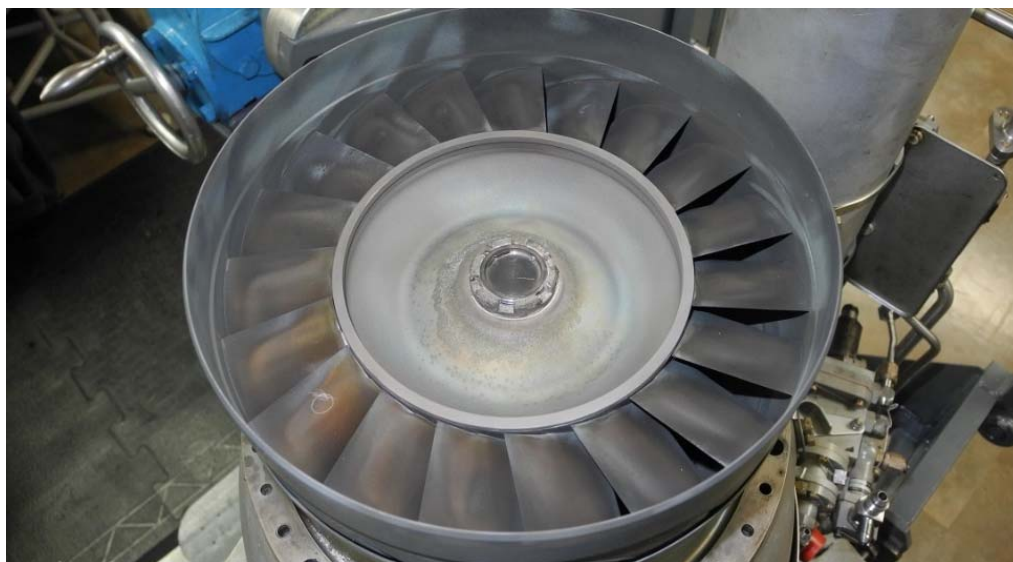
Removal of the turbine inlet (T5) thermocouples revealed no anomalous damage. The electrical resistance of each of the three T5 thermocouples were measured and were within the acceptable range per Safran specifications. No evidence of cracks or fractures were observed on the external lines removed from the engine. Manual rotation of the power transmission shaft resulted in a corresponding rotation of the power turbine with no evidence of binding. The reduction gearbox was removed; the splined connection between the power turbine and the reduction gearbox exhibited no anomalous damage. The reduction gearbox splined nut index mark was present and did not exhibit misalignment.<sup>7</sup> All power turbine blades were present and none exhibited evidence of anomalous damage. The power turbine rotated freely with no evidence of binding. The power turbine inlet stator vanes did not exhibit anomalous damage (**Figure 4**). Soot deposits were observed on the inner diameter wall, adjacent to the tip end of the stator vanes.

**Figure 4. Power turbine inlet stator vanes for the No. 1 engine.**

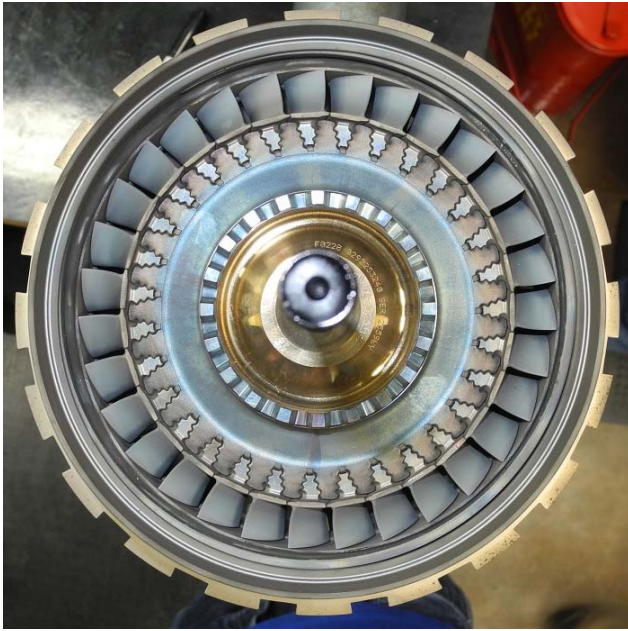
All first stage and second stage gas generator turbine blades were present and none exhibited anomalous damage (**Figures 5 and 6**). The curvic coupling between the first and second stage gas generator turbines exhibited no anomalous damage. The first and second stage nozzle guide vanes exhibited no evidence of anomalous damage. Soot deposits exhibiting a “wavy” pattern was observed on the first stage nozzle guide vane surfaces. The second stage nozzle guide vane surfaces exhibited abnormal bluing in a “U” shaped pattern.

**Figure 5. The first stage gas generator turbine blades on the No. 1 engine.**

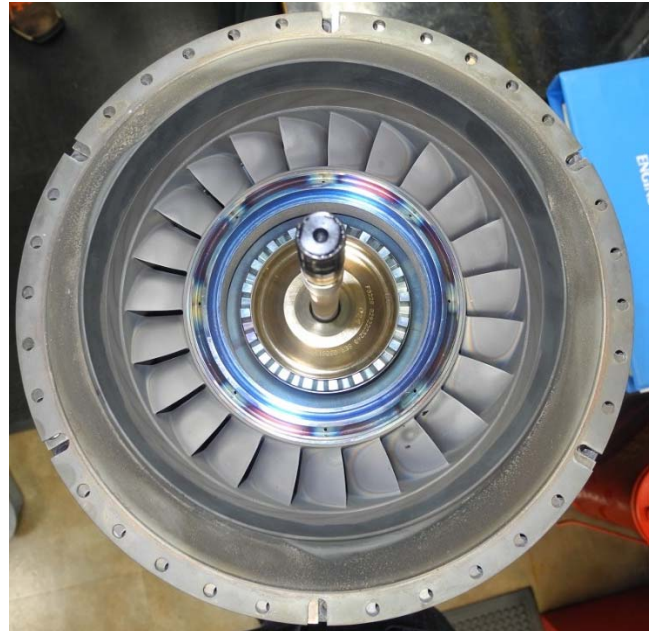
**Figure 6. The second stage gas generator turbine blades on the No. 1 engine.**

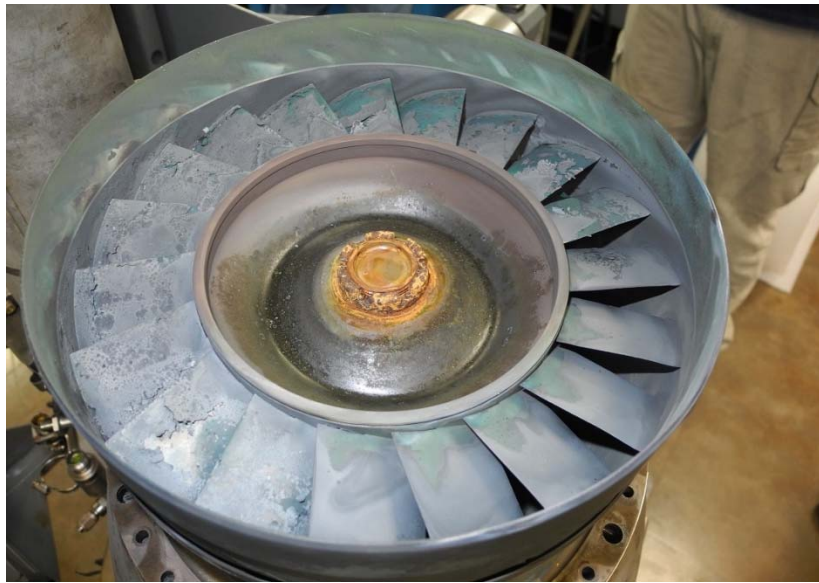
The power transmission shaft and the gas generator were not able to be manually rotated. Removal of the T5 thermocouples revealed the two of the three thermocouples, left and right, were partially melted. The majority of the third, center, thermocouple was missing and exhibited thermal damage. The reduction gearbox was removed and the gearbox and power transmission shaft rotated freely with no evidence of binding; the power turbine still could not be manually rotated. The reduction gearbox splined nut index mark was present and did not exhibit misalignment. The overspeed sensor and muff coupling were removed and did not exhibit anomalous damage. After the power turbine section was removed, the power turbine was able to be manually rotated. The power turbine bearings exhibited a chattering noise when manually rotated. The turbine inlet stator vanes had a dull gray coating that was flaking off its surfaces (**Figure 7**).

**Figure 7. Damage observed on the turbine inlet stator vanes for the No. 2 engine.**

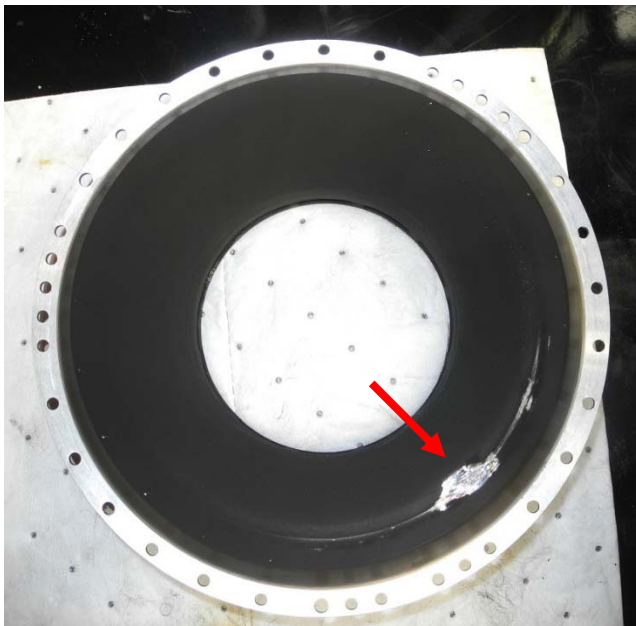
The gas generator was removed from the engine assembly and the axial compressor was removed from the gas generator. The axial compressor was able to be manually rotated but its rotation was not smooth. Soot deposits were observed on the axial compressor surfaces, which also exhibited a black coloration. Soot deposits were also observed on the centrifugal compressor surfaces. Removal of the centrifugal compressor revealed a shiny, silver-colored rub mark near the 6 o'clock position on the interior surface of the centrifugal compressor cover (**Figure 8**). A dull, silver-colored marking was observed on the exterior surface of the centrifugal compressor cover near the 6 o'clock position, corresponding in location to the marking on the interior of the cover. Shiny, silver-colored rub marks were observed on the exducer of the centrifugal compressor blades matching the location of the rub marks observed on the interior surface of the cover (**Figure 9**).

**Figure 8. Rub mark on the centrifugal compressor cover of the No. 2 engine.**

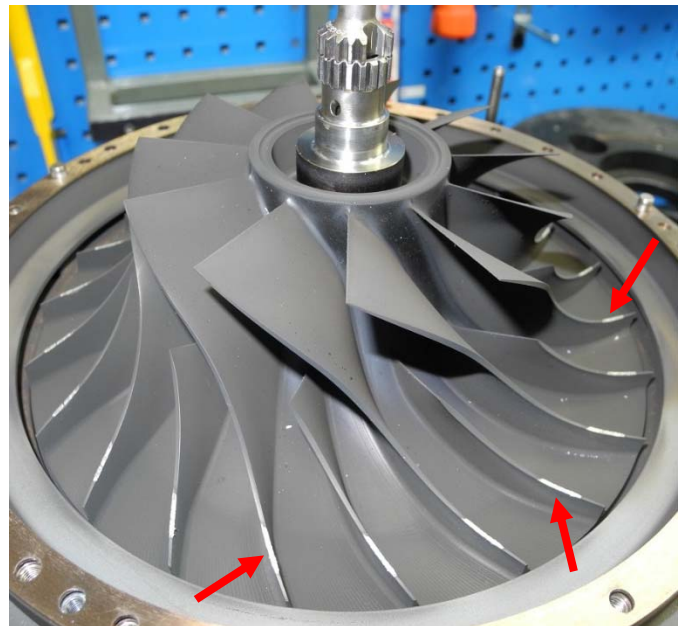
**Figure 9. Rub marks on the centrifugal compressor of the No. 2 engine.**

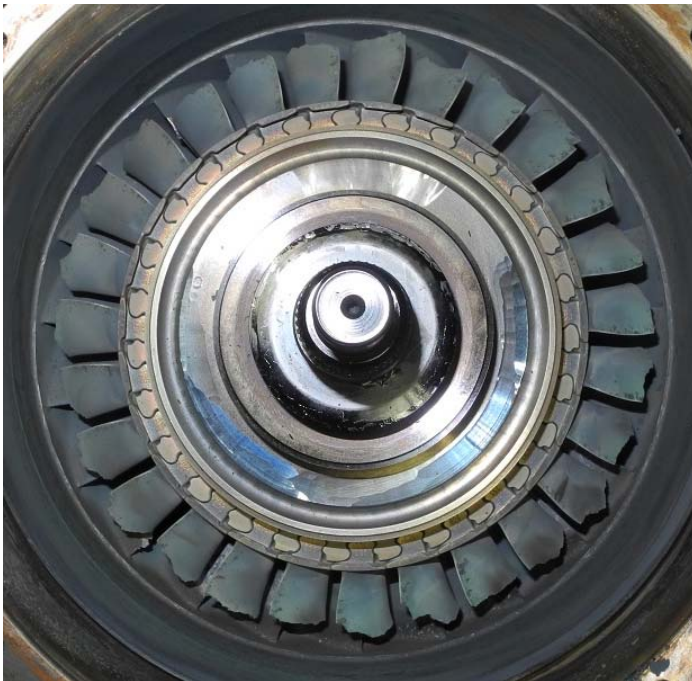
All second stage gas generator turbine blades were present but their tips were missing (**Figure 10**). The surface coating of the second stage nozzle guide vane surfaces exhibited flaking with a couple of the vanes' mid-section exhibiting partial melting (**Figure 11**). All first stage gas generator turbine blades were present and their surface coating was missing at their tip ends, with the missing coating being biased toward the trailing edge of the blades (**Figure 12**). The first stage gas generator turbine blades were contacting the shroud near the 1 o'clock position. The first stage nozzle guide vanes exhibited a brown coloration but did not exhibit evidence of melting. The curvic coupling between the first and second stage gas generator turbines exhibited no anomalous damage. The combustor liner contained debris similar to the flaked coating observed on the turbine inlet guide vanes.

**Figure 10. The No. 2 engine second stage gas generator turbine blades exhibiting missing tips.**

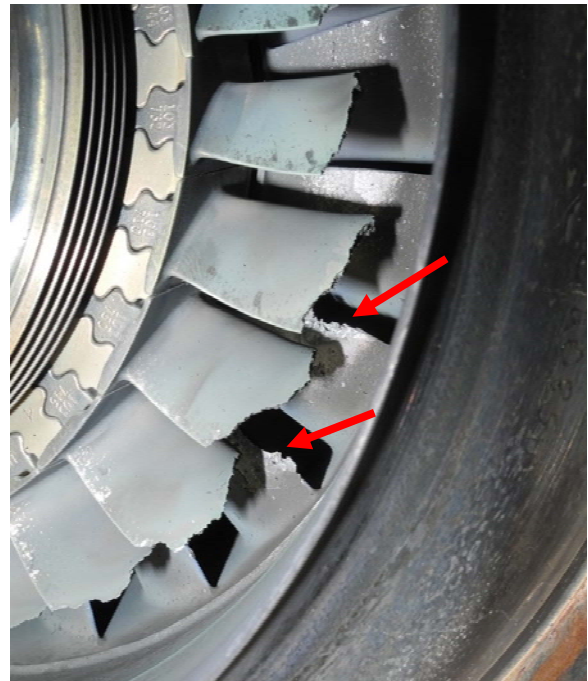
**Figure 11. A close up showing partial melting of the second stage nozzle guide vanes for the No. 2 engine.**

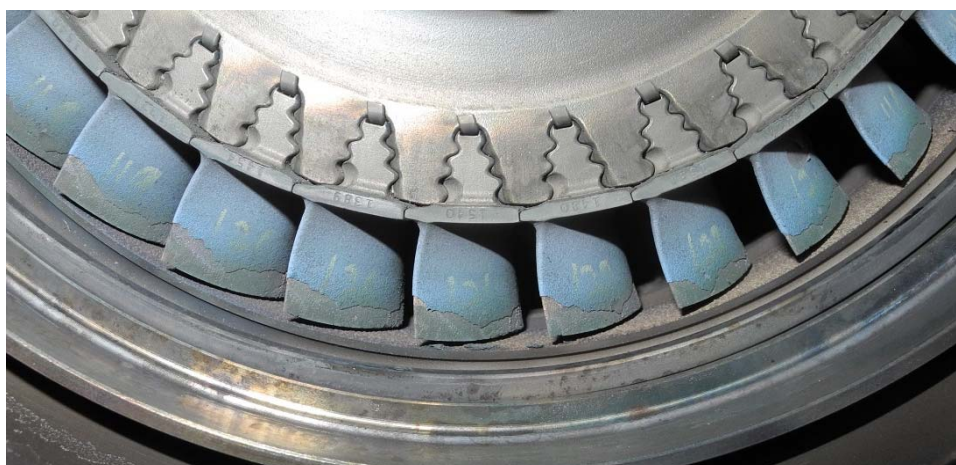
**Figure 12. Damage to the first stage gas generator turbine blades.**

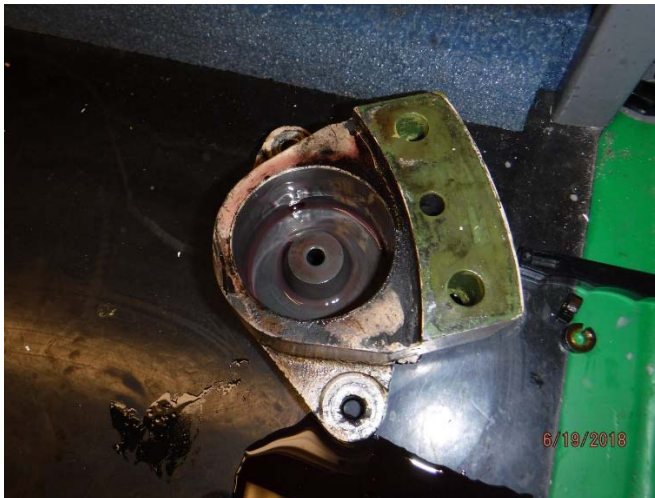
The caliper was disassembled into its two halves, identified as the forward and aft housings. The transfer tube remained with the aft housing and its o-ring appeared to be in good condition. The forward and aft puck assemblies were disassembled from their respective housings (**Figures 13 and 14**). There was no evidence of grooves or gouges between the piston and bore. Residual hydraulic fluid was observed within the bore and on the piston surfaces. The piston o-ring had no evidence of anomalous damage and remained elastic to the touch. The spring and pin were disassembled from the forward and aft puck assemblies and revealed no evidence of anomalous damage. The aft spring force was measured to be about 120 pounds at 0.476 inches of spring compression.<sup>11</sup> The forward spring force was measured to be about 125 pounds at 0.476 inches of compression.

**Figure 13. The forward caliper housing.**  
(photo courtesy of Sikorsky)

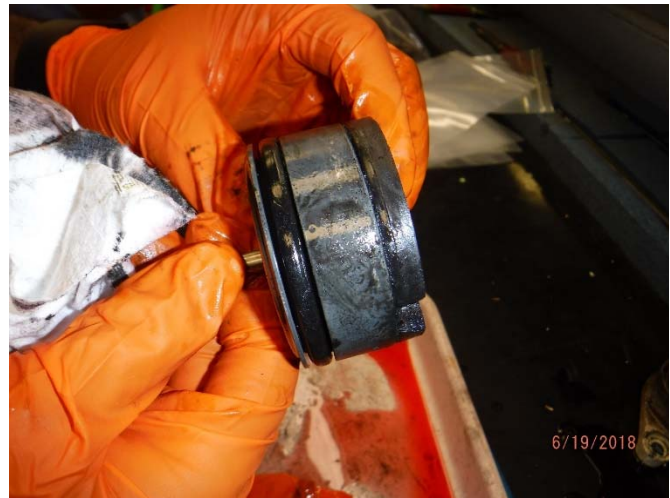
**Figure 14. The puck from the forward caliper.**  
(photo courtesy of Sikorsky)

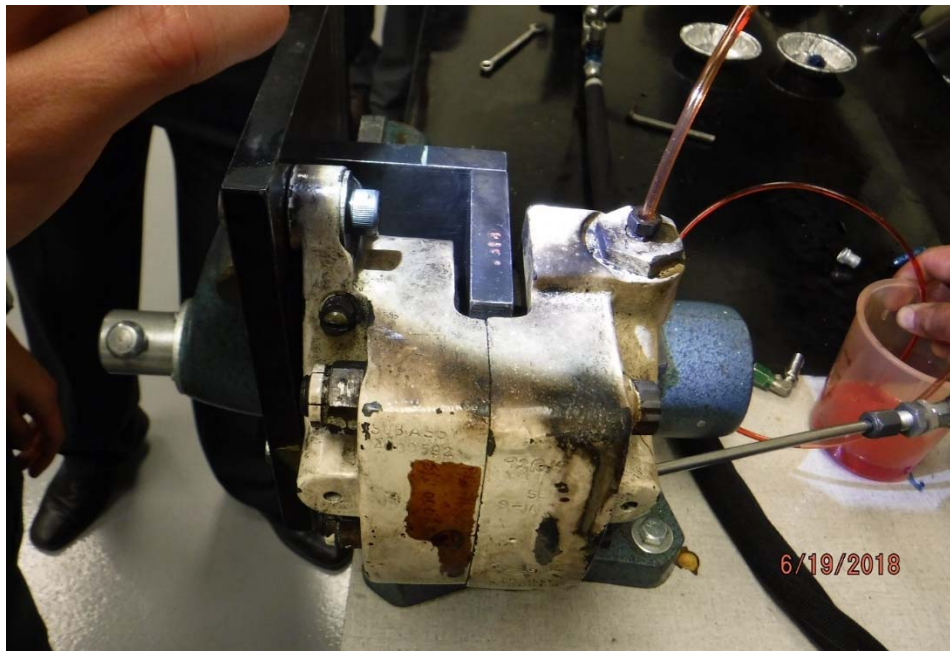
Both brake pucks remained retracted at the beginning of the examination. Air was bled from the caliper using about 10 psi of hydraulic pressure via a manual hydraulic pump (**Figure 15**). During the bleeding process, the forward puck extended but the aft puck did not extend. The forward puck was able to be manually moved to the retracted position without difficulty. For the first test, about 230 psi of hydraulic pressure was applied to the caliper, resulting in extension of both pucks. No evidence of leaks was observed. When hydraulic pressure was removed, the aft puck retracted but the forward puck remained extended. The forward puck was manually retracted without difficulty. For the second test, as the manual hydraulic pump was increasing in hydraulic pressure, the forward puck extended at about 46 psi and the aft puck extended at about 130 psi. There was no evidence of leaks when hydraulic pressure of 230 psi was attained. When hydraulic pressure was removed, the aft puck retracted but the forward puck remained extended. Testing of the left brake caliper assembly was stopped at this point.

**Figure 15. The left brake caliper assembly mounted on the test setup.**
