# NATIONAL TRANSPORTATION SAFETY BOARD

## MATERIALS LABORATORY FACTUAL REPORT

Report No. 18-085

Place : Farmington, Pennsylvania  
Date : January 29, 2018  
Vehicle : Cessna P210N, N34VF  
NTSB No. : ERA18LA072  
Investigator : Aaron McCarter, AS-ERA

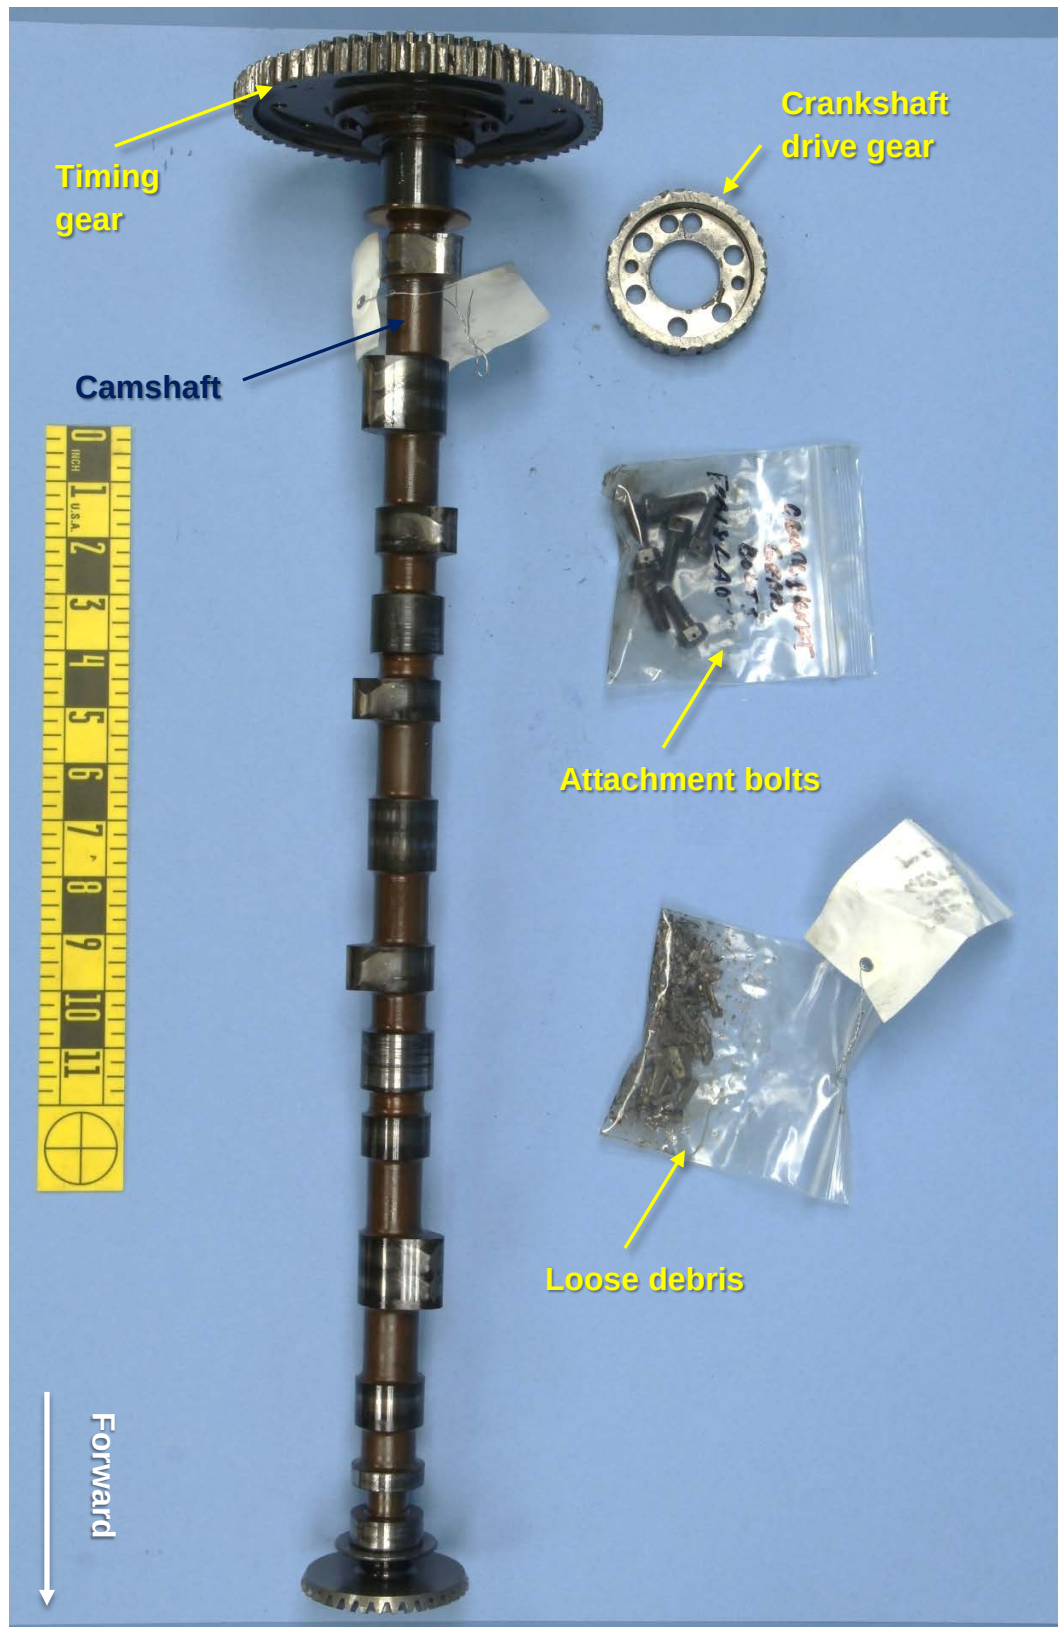
Figure 1 shows the parts from the engine, as received. This included a camshaft assembly, complete with a forward governor bevel gear and an aft timing gear. The camshaft had been stamped with "TCM 655384 B". As shown in Figure 2, the aft timing gear assembly consisted of two gears (one smaller on the aft side and one larger forward). These gears were attached to the camshaft mount flange by four bolts secured with safety wire. While the smaller aft gear did not exhibit any indications of damage, the teeth of the larger timing gear did. All these teeth were deformed, consistent with rotational contact by an adjacent gear. However, the direction of the deformation varied from one gear tooth to the other, either being in one direction or both in some circumstances.

Figure 1 – The components from the camshaft assembly and drive gear, as received.

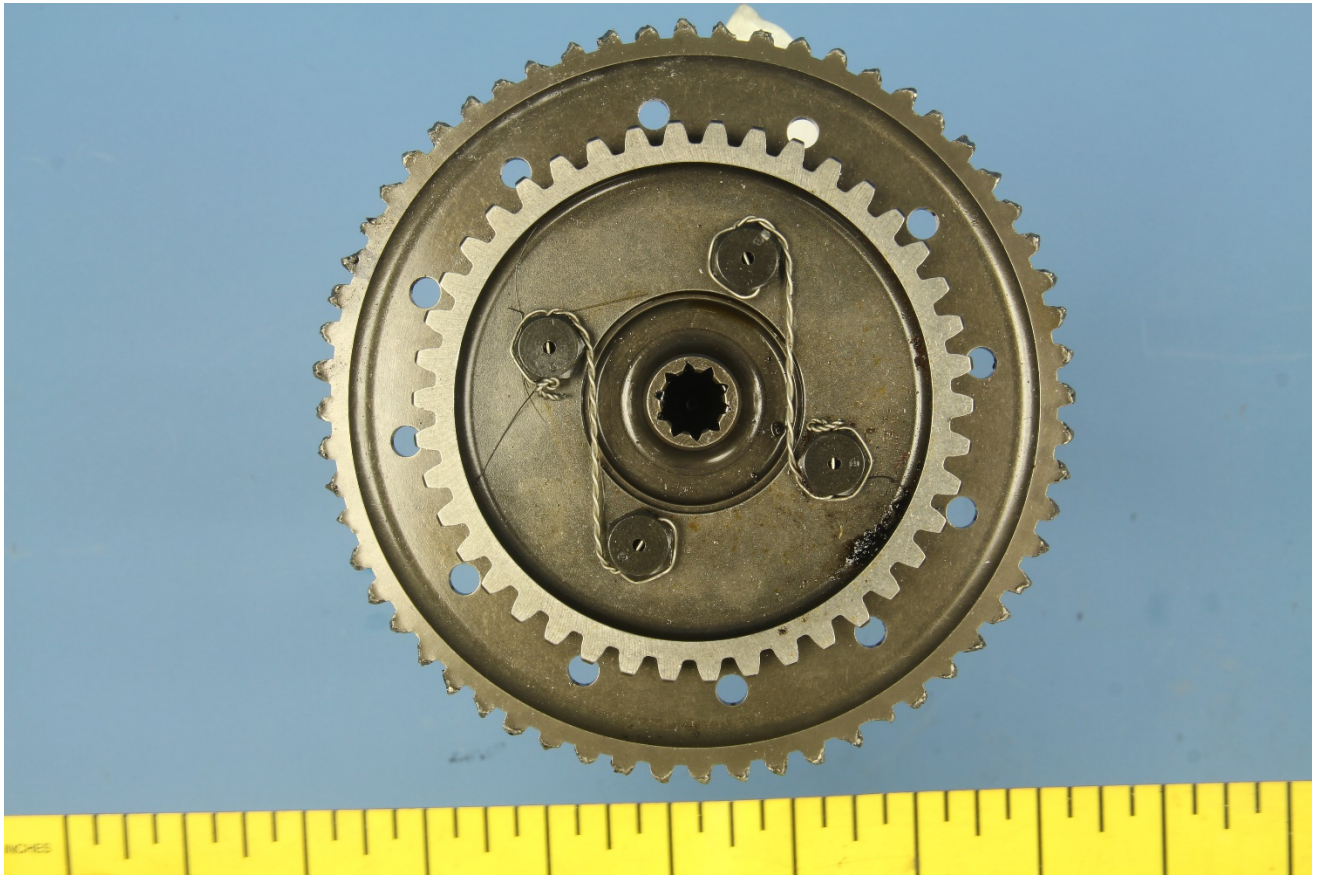
Figure 2 – View of the camshaft assembly from the timing gear, showing the attachment bolts to the mount flange in place with safety wire.

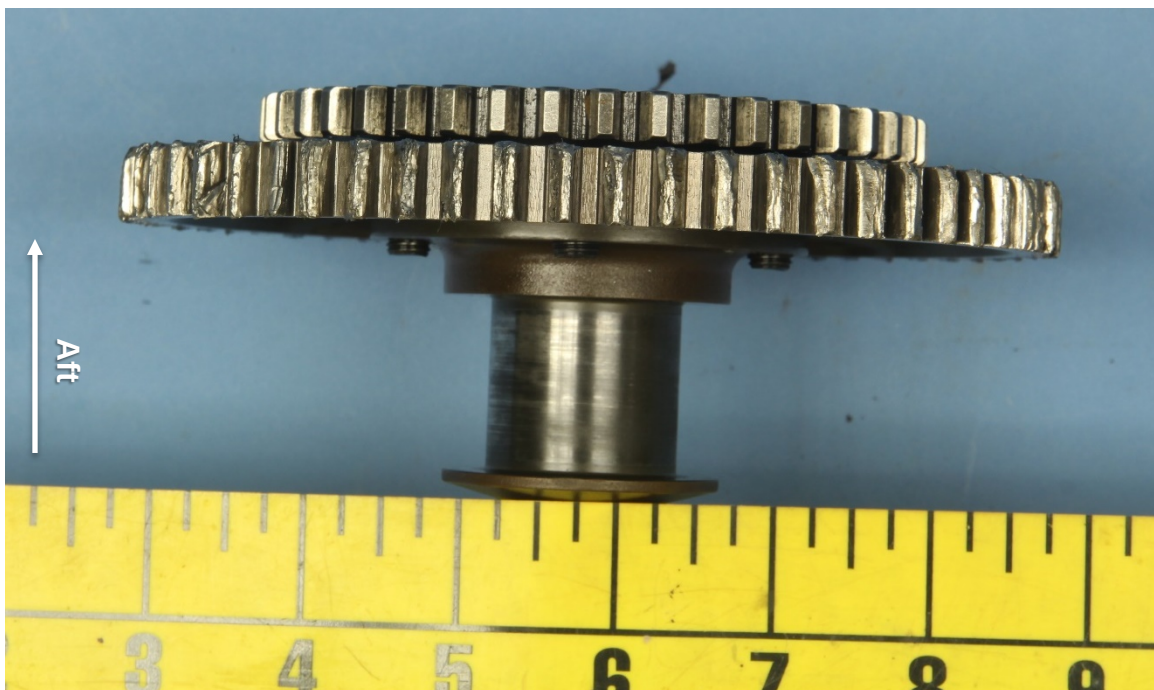
Figure 3 – View of the timing gear, showing the worn gear teeth.

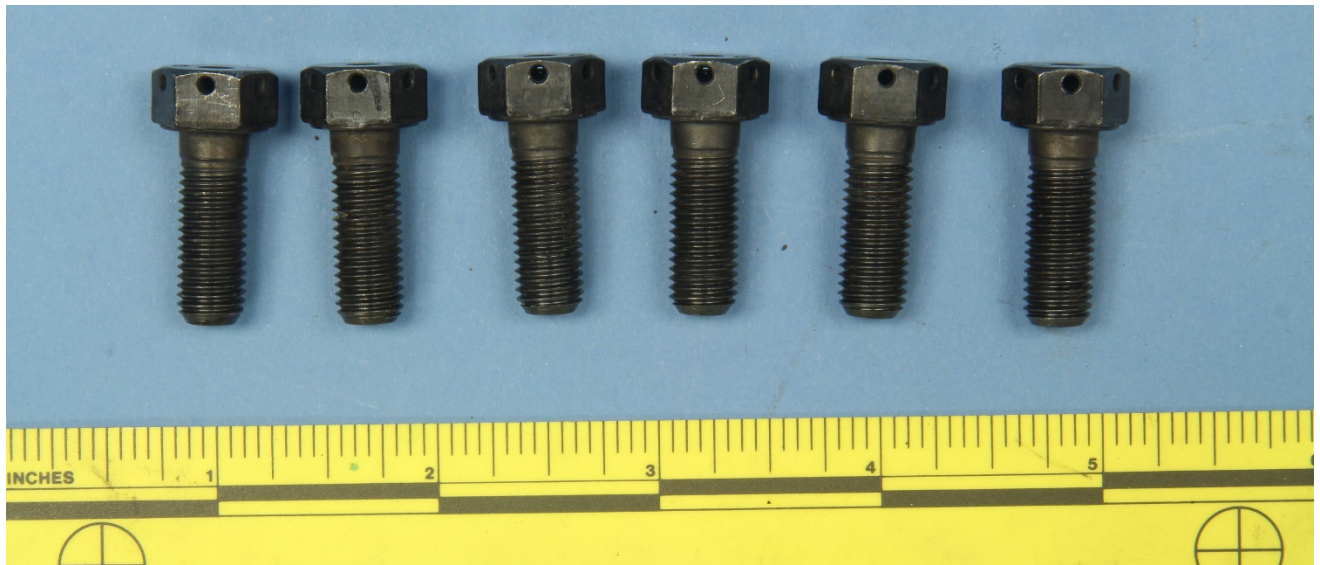
Six attachment bolts were received. These bolts had already been removed from their previous locations. As shown in Figure 4, the attachment bolts did not exhibit any plastic deformation, wear, or other notable damage.

Figure 4 – The loose six attachment bolts, after cleaning to remove oils and particles.

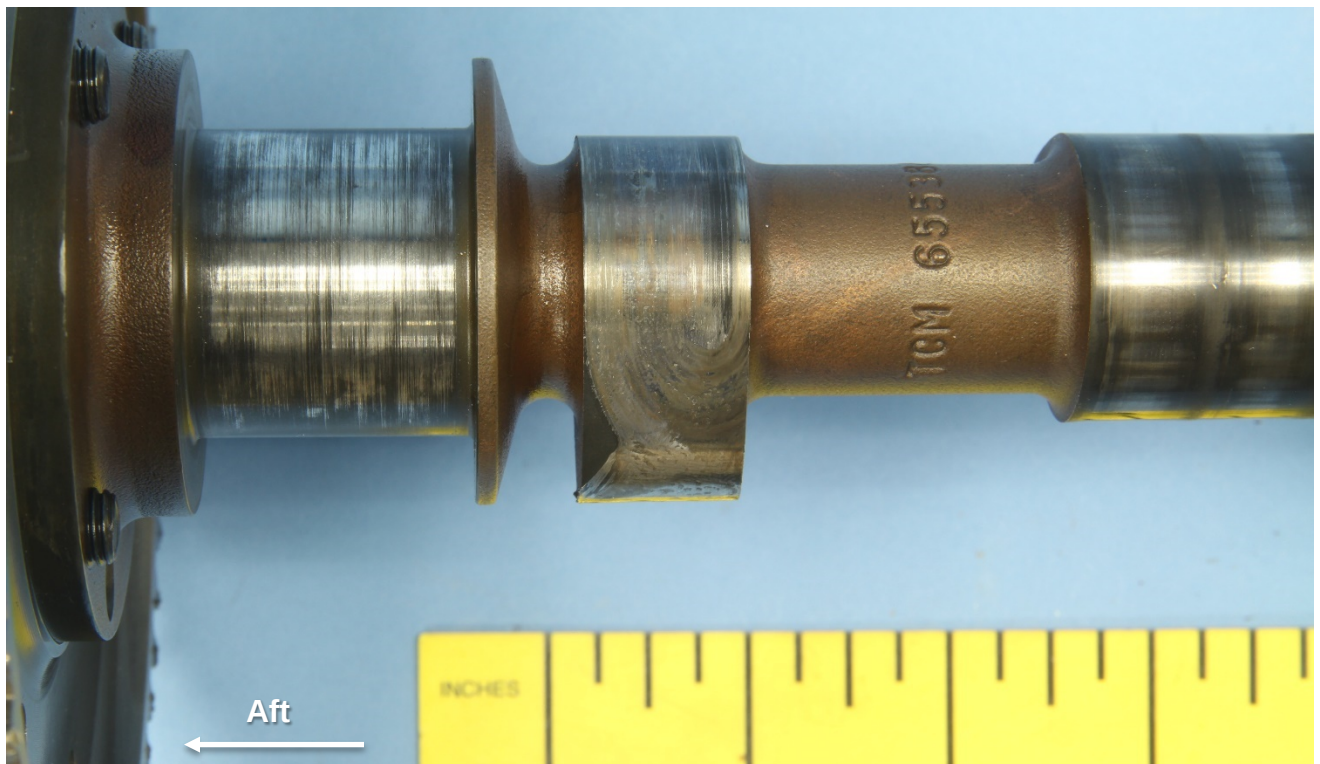
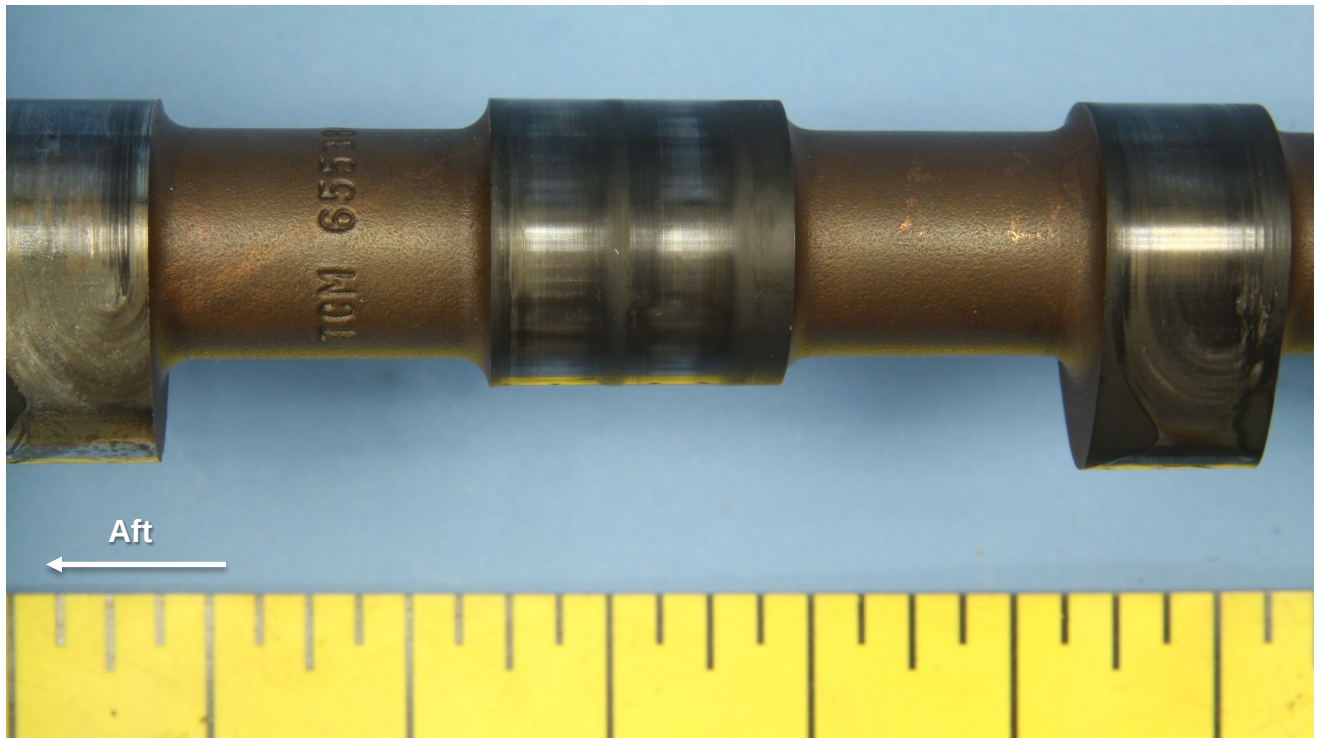
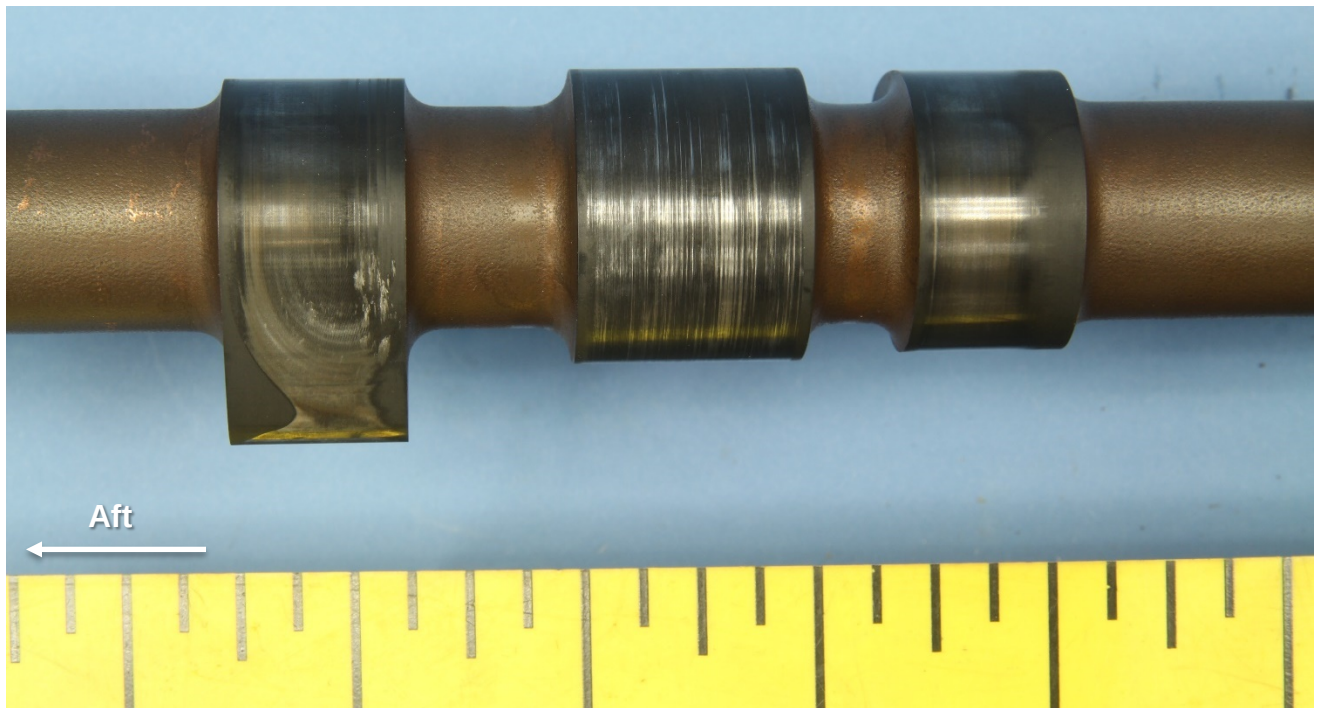
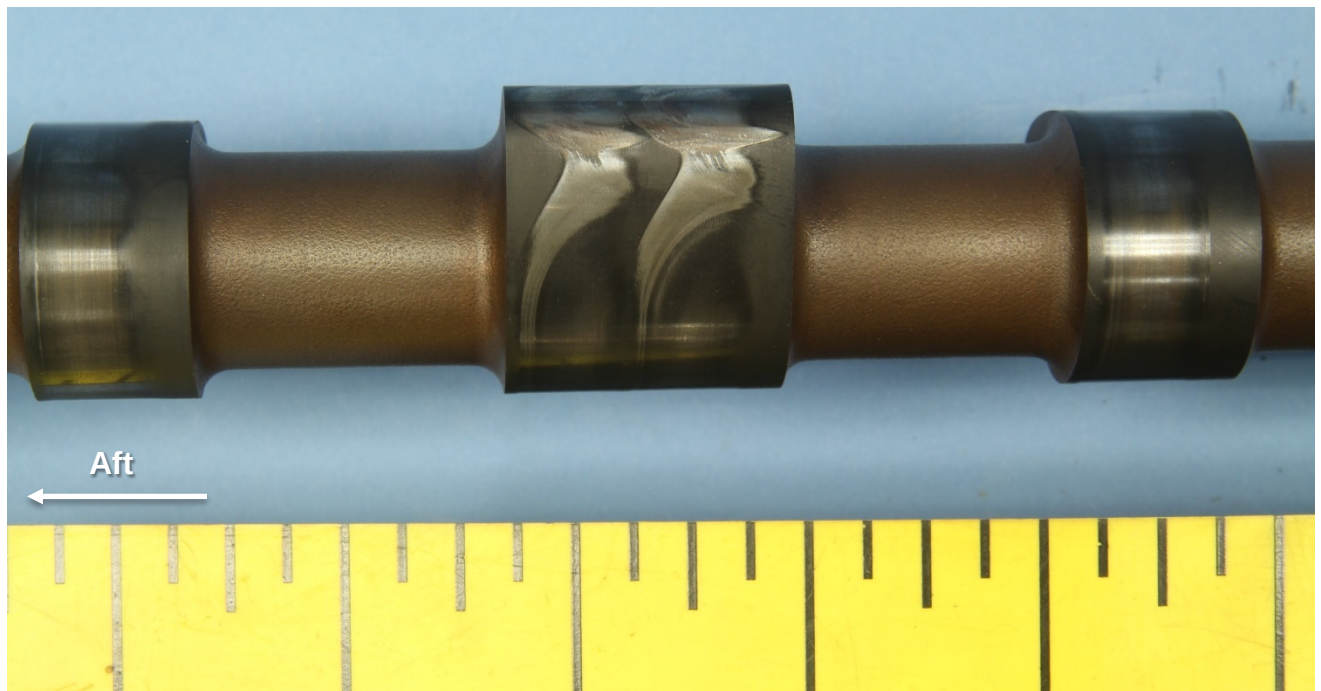
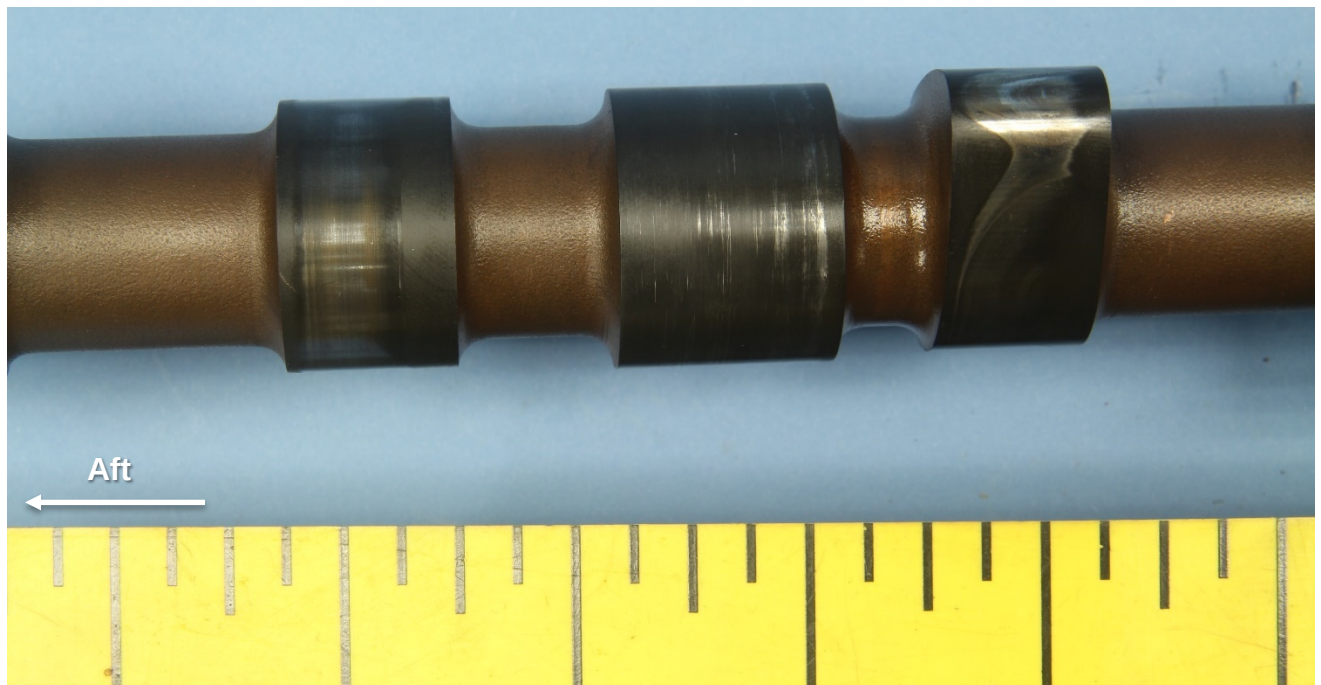
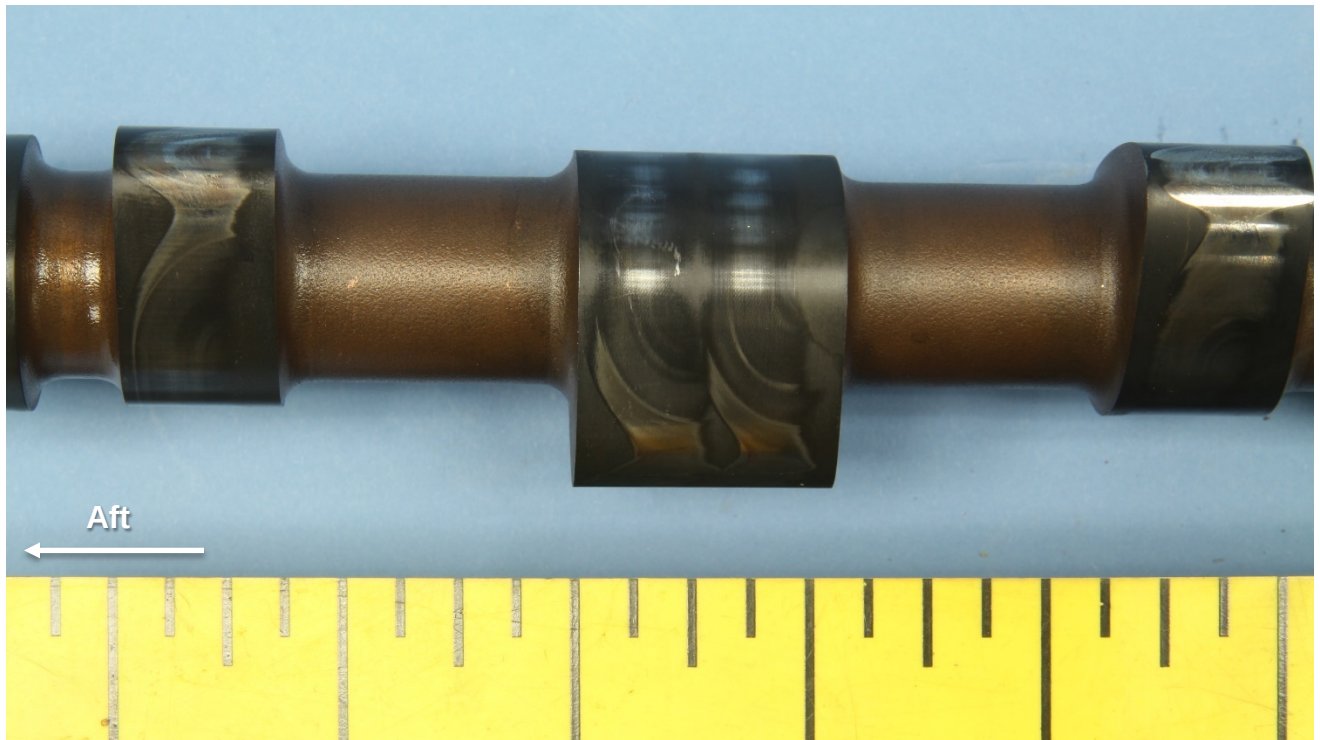
The journals and cam lobes of the camshaft are shown in Figures 5 through 10, organized from aft to forward positions. The journal surfaces all exhibited rotational wear marks typical of camshafts in reciprocating engines after time in service. The cam lobes exhibited S-shaped swirling wear marks on all the surfaces. The bevel gear on the forward side of the camshaft is shown in Figures 11 and 12. The gear was vibroetched with the following marks: "534655 AB PG 34/01". No indications of wear or damage were observed on this gear.

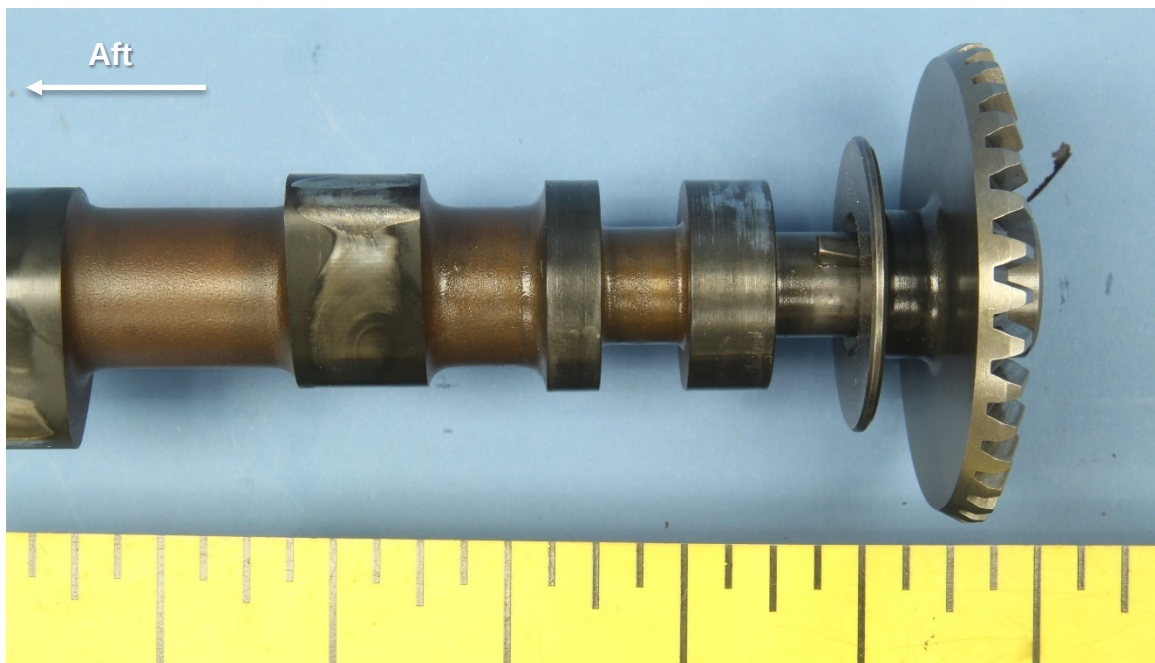
Figure 11 – Some of the journal bearings and lobes of the forwardmost part of the camshaft, including the governor bevel gear.

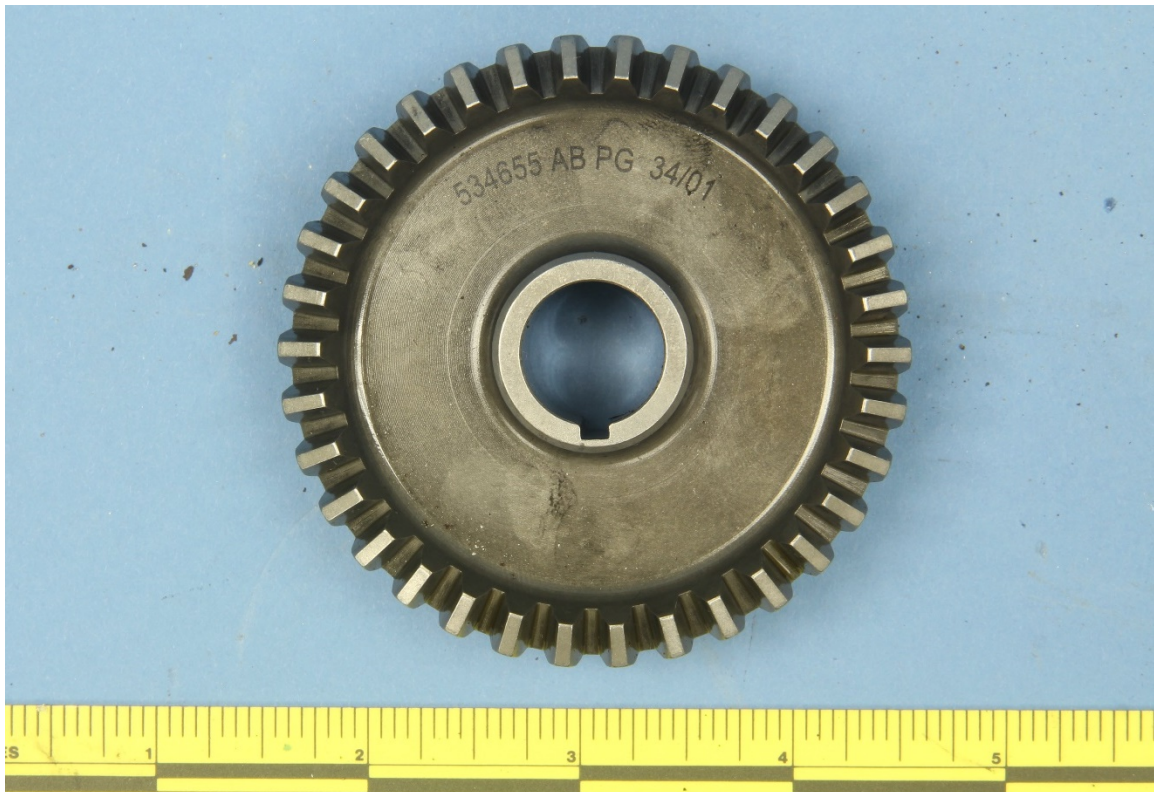
Figure 12 – The bevel gear from the forward side of the camshaft assembly, after removal from the camshaft.

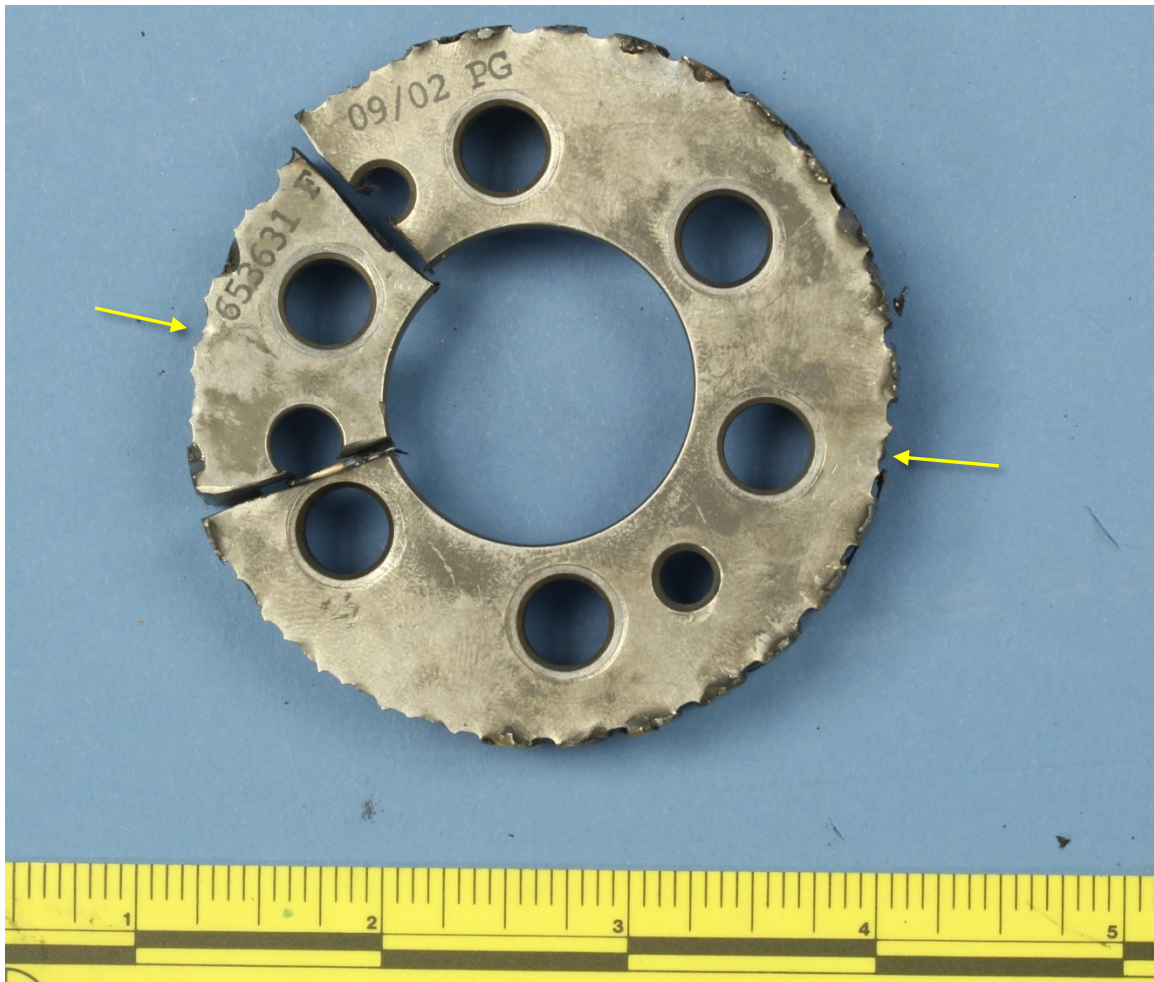
Figure 13 shows the crankshaft drive gear. The figure shows the gear after sectioning of a quadrant for later examination. The flat gear face exhibited the following vibroetched markings: "653631 F 09/02 PG". None of the gear teeth were on the drive gear. Of the missing gear teeth, 10 had fractured, and 20 had been worn and smeared. Two of the teeth, annotated in Figure 13, exhibited features such as crack arrest marks and heat tinting, consistent with progressive cracking prior to fracture.

Figure 13 – The drive gear, from the flat side, after sectioning. The fractured teeth remnants later found to be fatigue are annotated with yellow arrows.

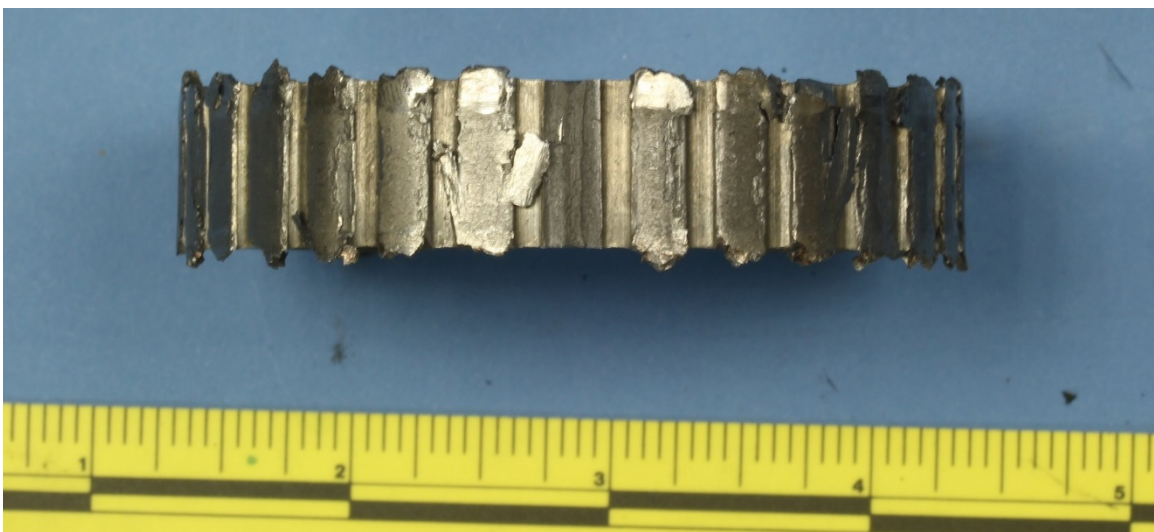
The gear teeth fracture surfaces of note are illustrated in Figures 14 and 15. One of the fractured teeth was an isolated fracture surface, surrounded by worn and smeared gear teeth remnants (Figure 14). Located 180° on the opposite side were a cluster of four gear teeth fracture surfaces (Figure 15). The second fracture surface from the left in Figure 15 exhibited a progressive crack that comprised approximately 60% of the surface area. This progressive region exhibited crack arrest marks which were oriented consistent with the crack propagation from the tooth edge located near the thread root, as shown in Figure 16. Ratchet marks were present near the initiation side of the crack, consistent with multiple crack initiation sites.

Figure 14 – View of the drive gear teeth, showing fractured and smeared teeth remnants.

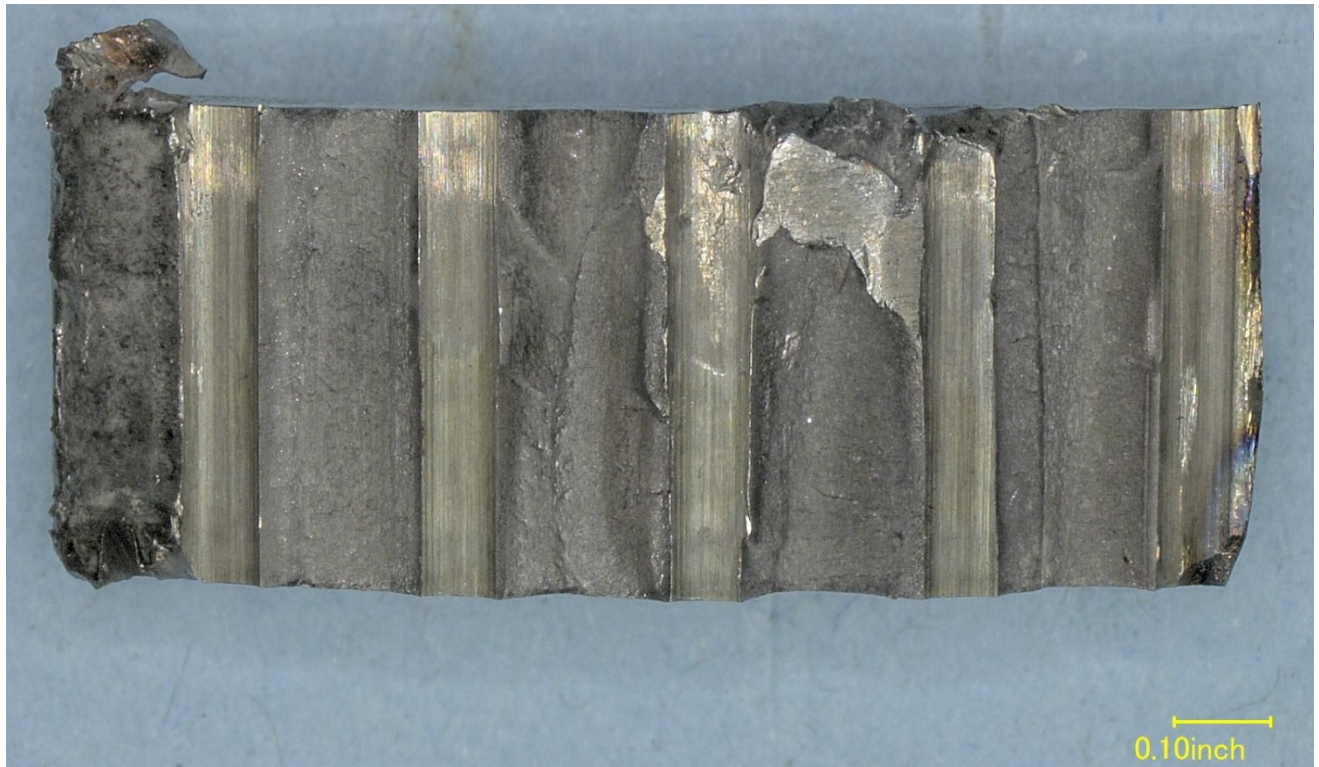
Figure 15 – View of the series of fractured teeth on the drive gear, sectioned from the part.

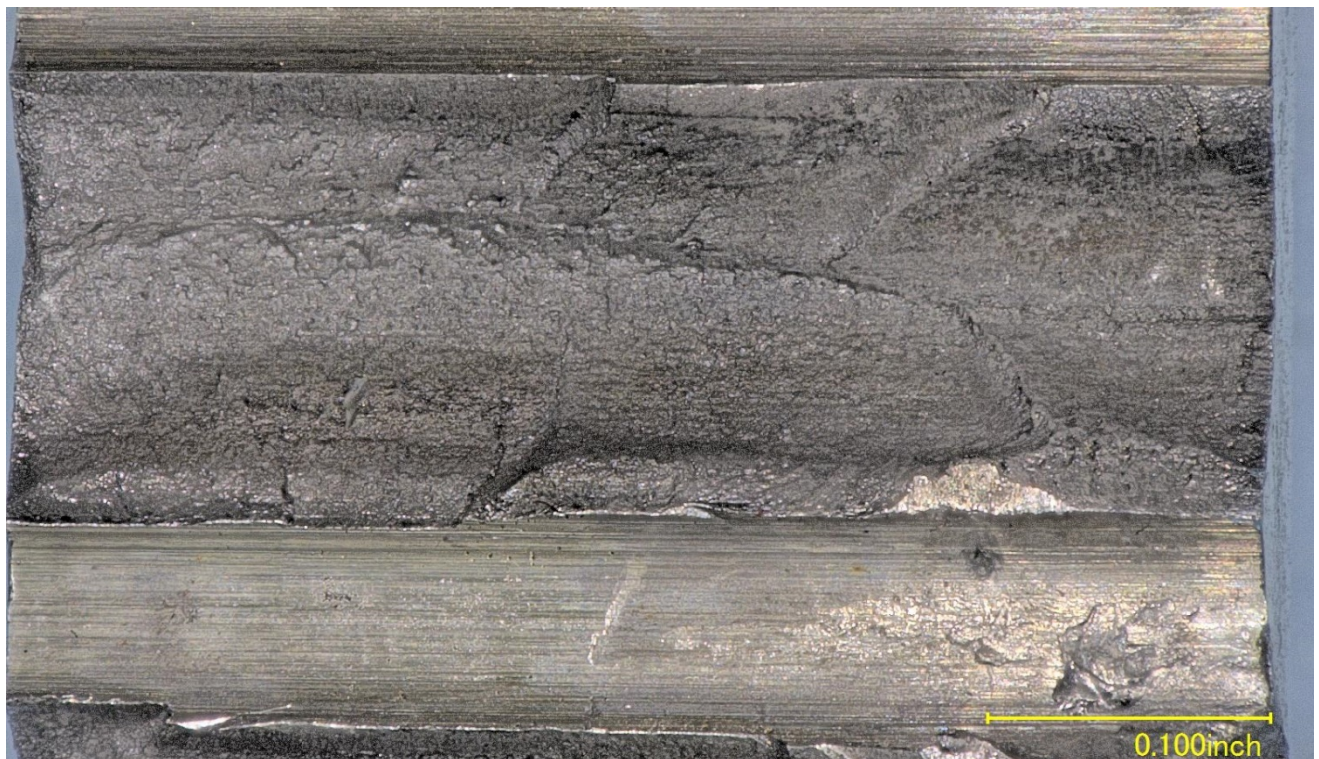
Figure 16 – Closer view of the fractured tooth exhibiting progressive cracking, later determined to be fatigue.

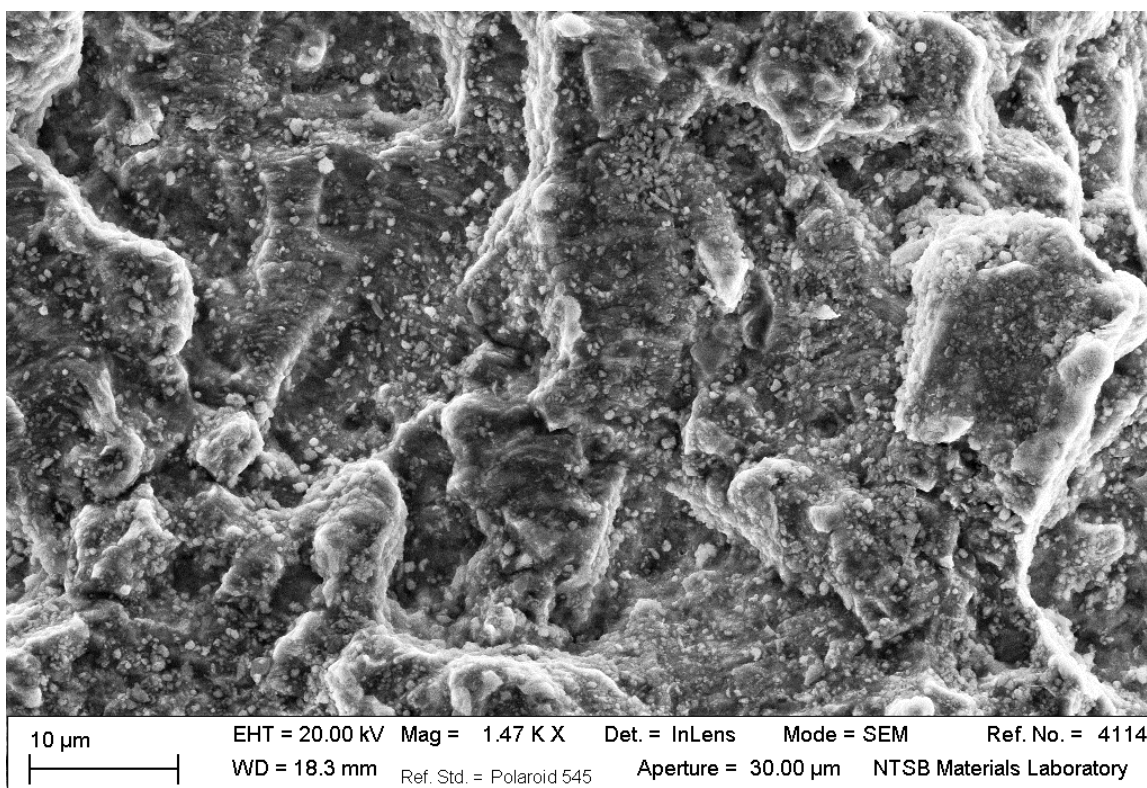
This section of the drive gear was examined using a scanning electron microscope (SEM). As shown in Figures 17 and 18, the progressive region of the fracture surface exhibited fatigue striations, consistent with fatigue crack propagation. Outside this region, the fracture surface exhibited dimple rupture, consistent with subsequent overstress fracture of the tooth (Figure 19).

Figure 17 – Secondary electron (SE) micrograph of the progressive region of the tooth in Figure 16, showing fatigue striations.

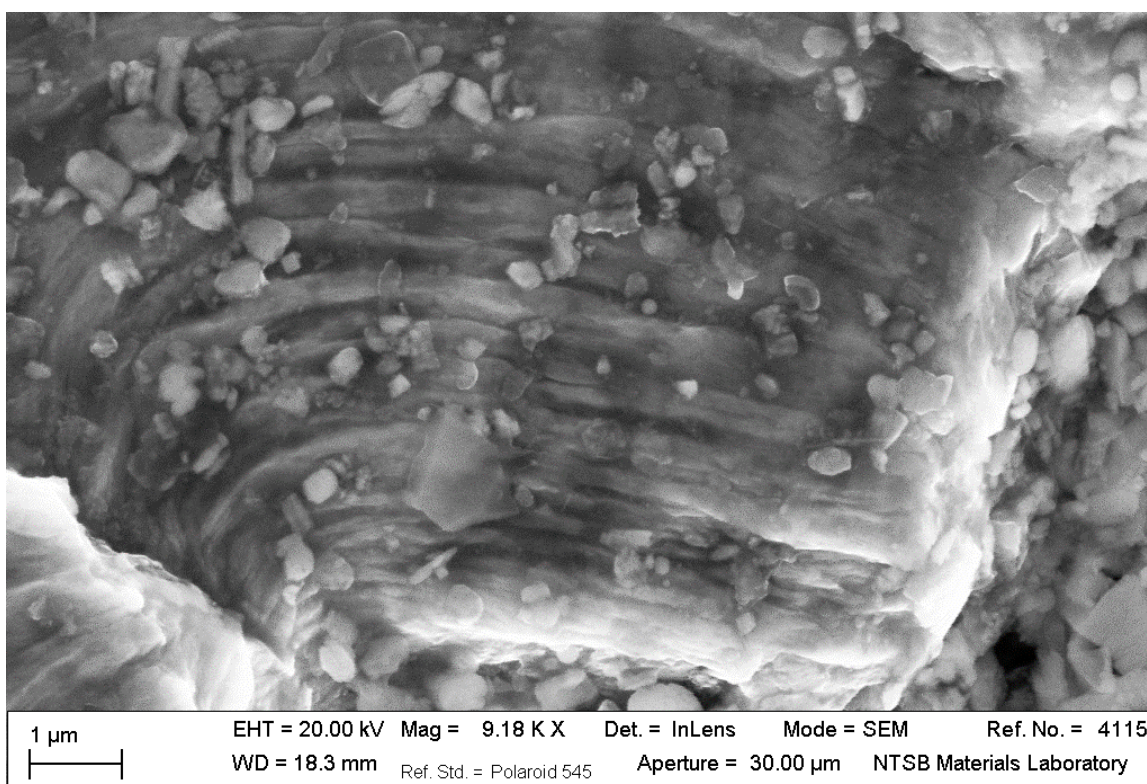
Figure 18 – SE micrograph showing a closer view of the striations in Figure 17.

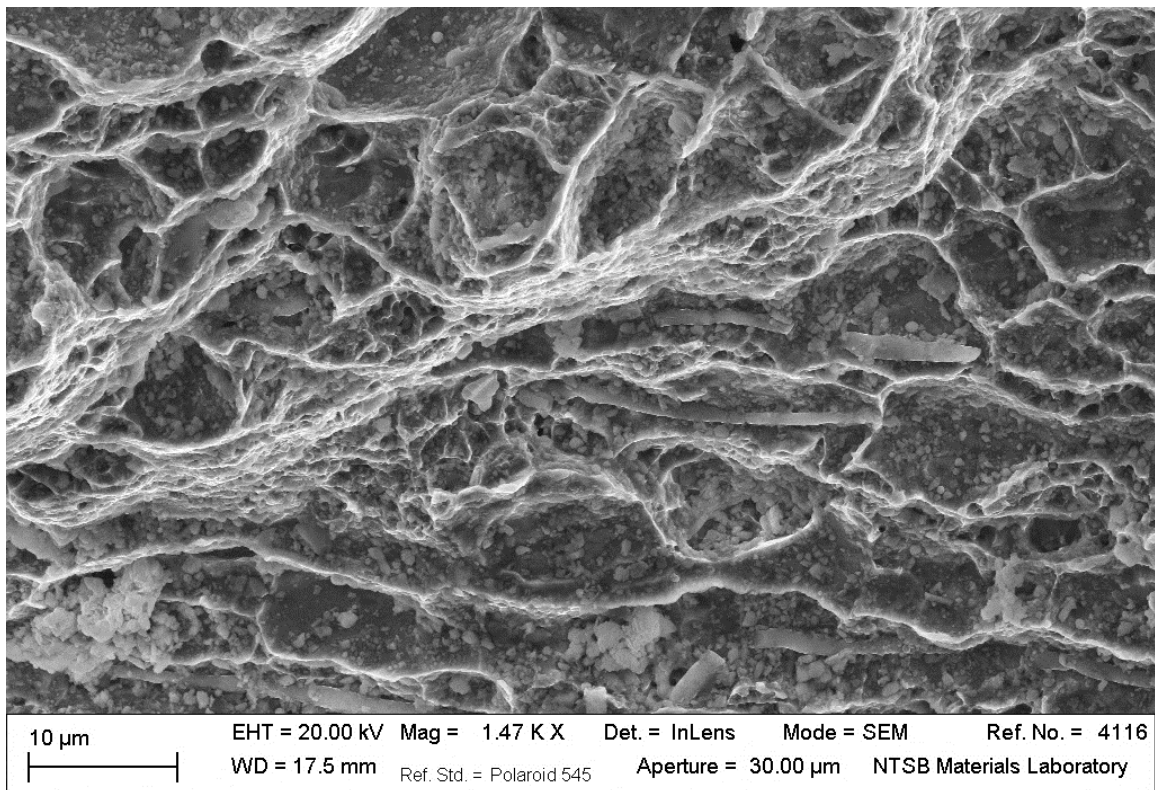
Figure 19 – SE micrograph of dimple rupture on the fractured tooth in Figure 16.

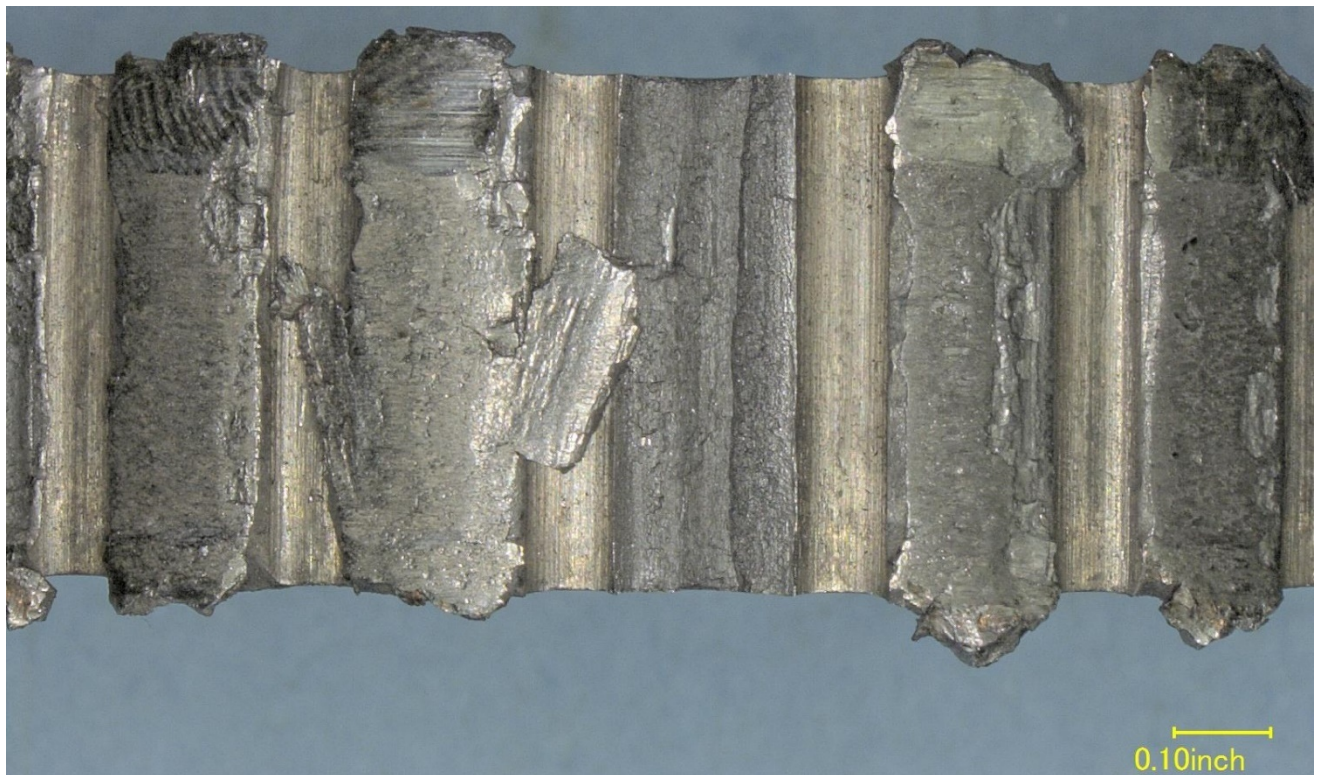
The gear tooth located 180° from the one in Figure 16 is highlighted in Figures 20. This fracture surface was examined in a SEM, and the fracture surface revealed fatigue stations (see Figure 21). As shown in the micrographs, the fracture surfaces were heavily damaged and contained embedded particles, consistent with post-fracture damage, oxidation, and contamination. All the fatigue crack initiation sites had been obliterated by post-fracture smearing damage, as typified in Figure 22.

Figure 20 – View of the fractured gear tooth in Figure 14, located 180° opposite of the fractured teeth in Figure 15.

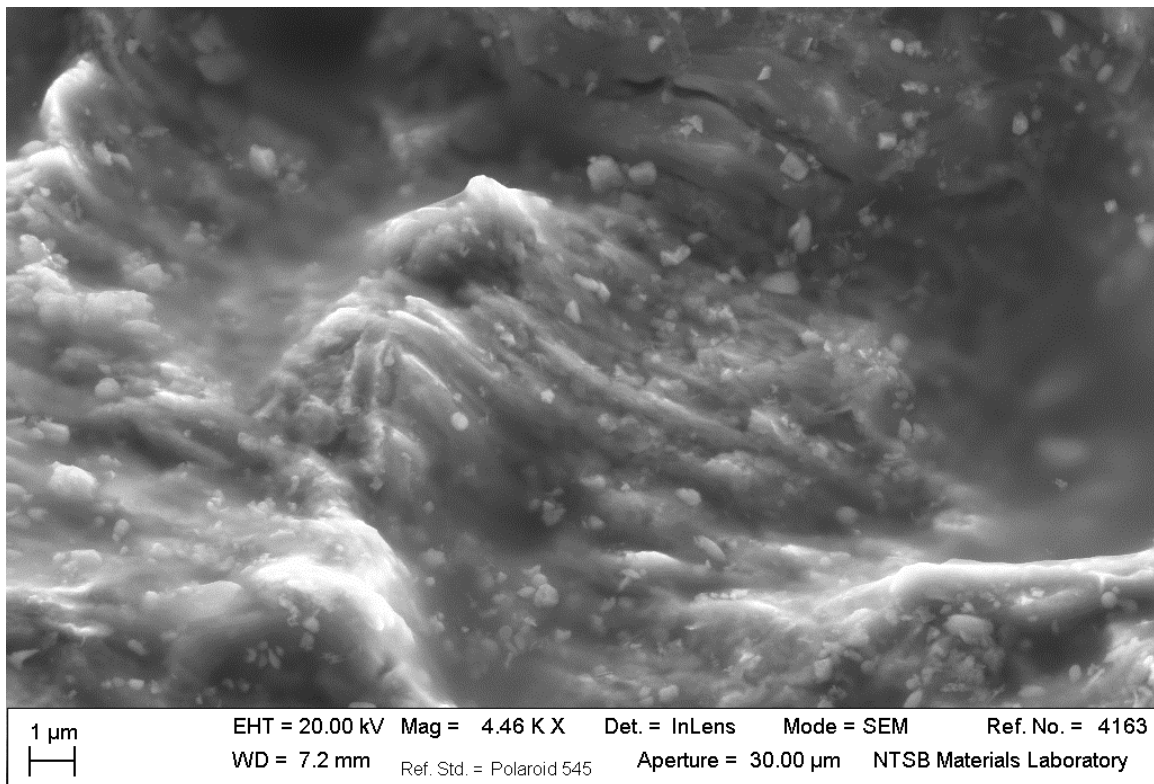
Figure 21 – SE micrograph of fatigue striations on the fractured tooth in Figure 20.

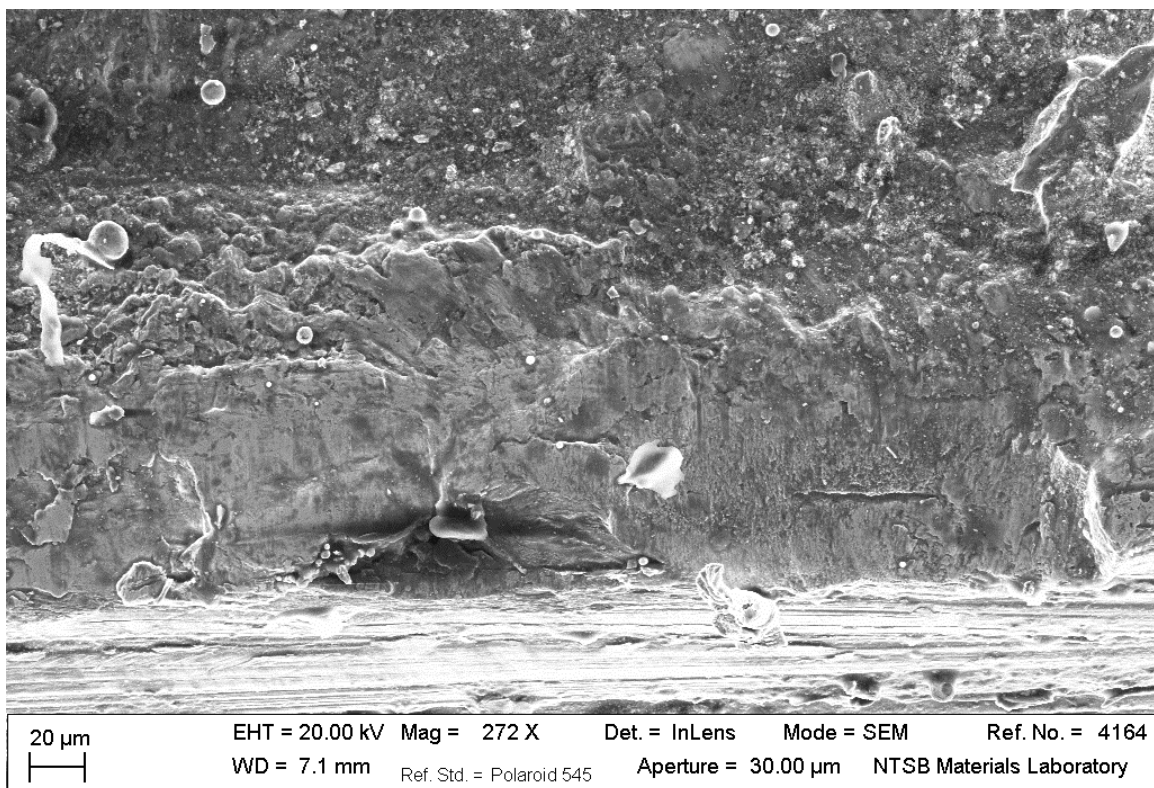
Figure 22 – SE micrograph of a fatigue crack initiation site, showing smearing.
