# NATIONAL TRANSPORTATION SAFETY BOARD

## MATERIALS LABORATORY FACTUAL REPORT

Report No. 18-085

Place : Farmington, Pennsylvania  
Date : January 29, 2018  
Vehicle : Cessna P210N, N34VF  
NTSB No. : ERA18LA072  
Investigator : Aaron McCarter, AS-ERA

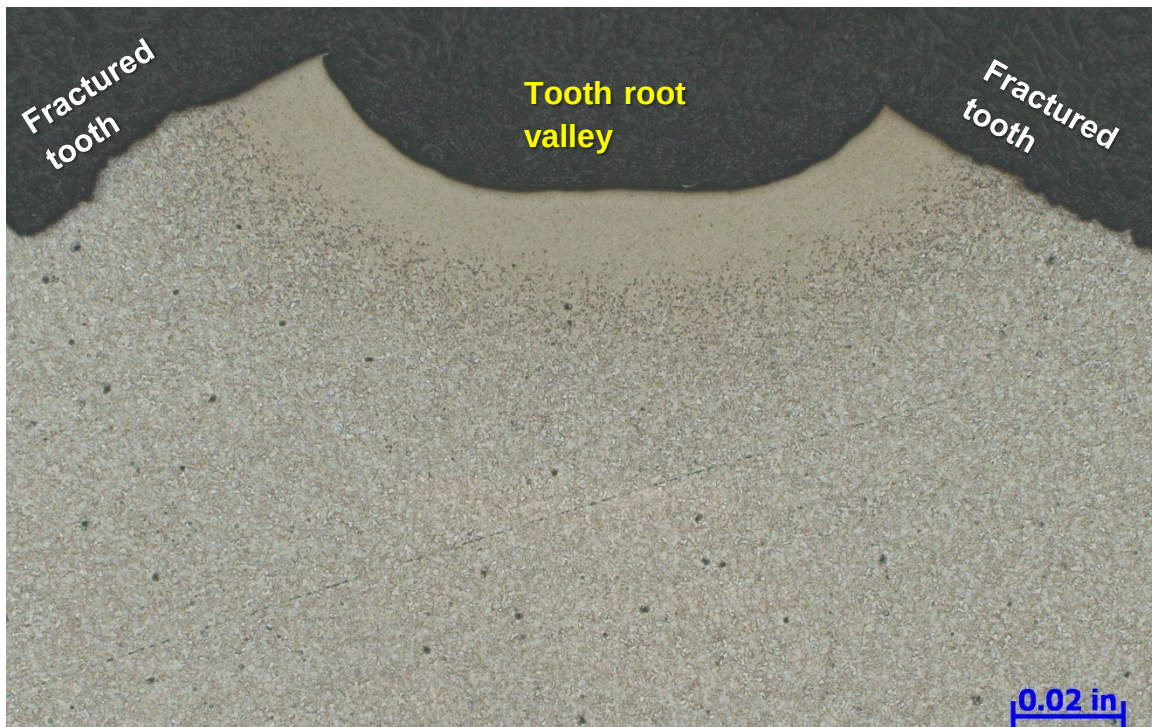
A section of the drive gear was mounted, polished, and etched. An area of the cross section through two of the tooth fracture surfaces and a gear tooth valley is shown in Figure 23. While the microstructure adjacent to the fracture surfaces of the missing teeth on the left and right of the figure were consistent with the microstructure further inward, the microstructure near the undamaged thread root valley exhibited a more uniform, darker morphology. The core microstructure, highlighted in Figure 24, exhibited globular ferrite (colored white) surrounded by higher carbon constituents, such as fine pearlite and/or bainite (brown colored).<sup>2,3,4</sup> In contrast, the microstructure near the thread root valley, shown in Figure 25, did not exhibit the large ferrite, instead consistent with higher carbon phases such as fine pearlite, bainite, and/or tempered martensite. This microstructure was consistent with a case hardening surface treatment, typical in gear manufacturing.

Figure 23 – Bright-field (BF) optical micrograph of fractured gear teeth cross-section, showing the surface modification in the undamaged thread valley (~25X, etched 2% Nital).

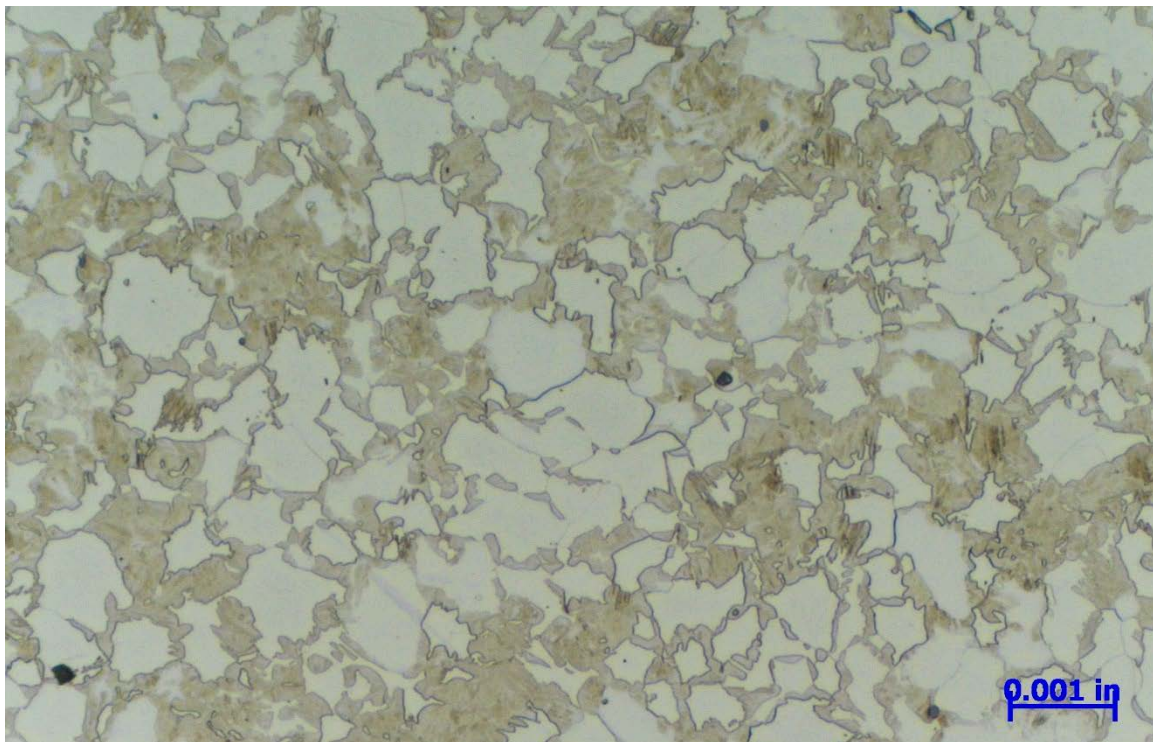
Figure 24 – BF optical micrograph showing a typical area of the core microstructure showing ferrite (light) surrounded by higher carbon phases (brown) (~500X, etched 2% Nital).

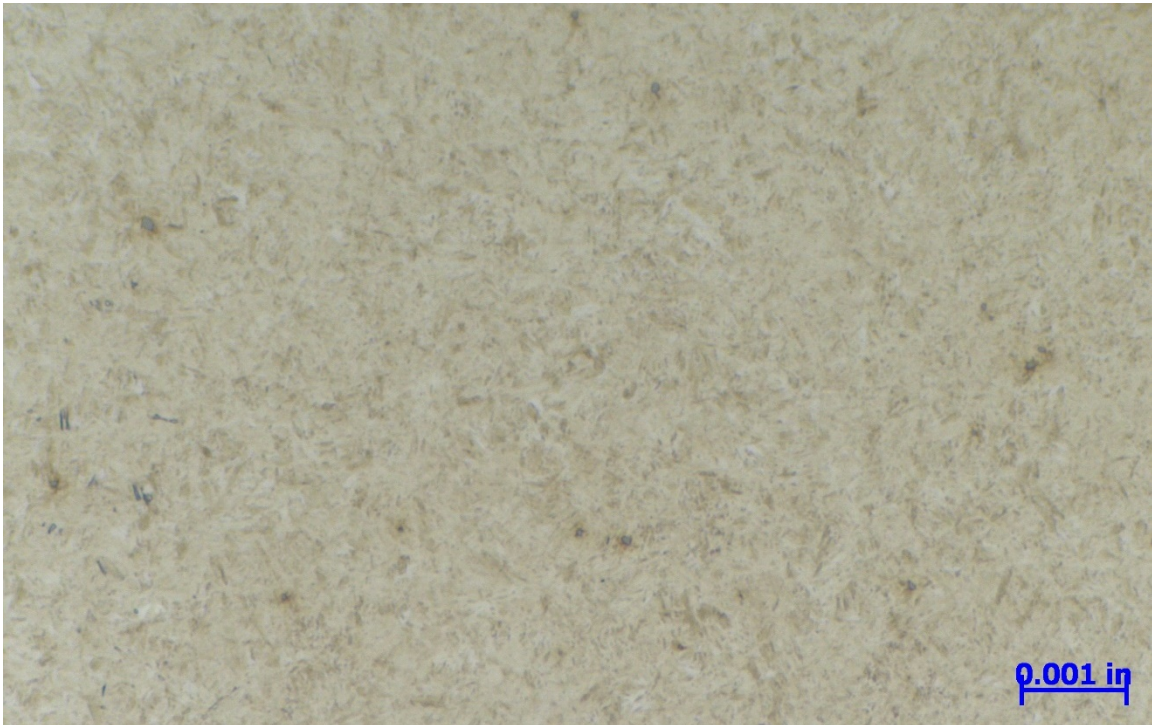
Figure 25 – BF optical micrograph showing a typical area of the surface microstructure showing high carbon phases (~500X, etched 2% Nital).

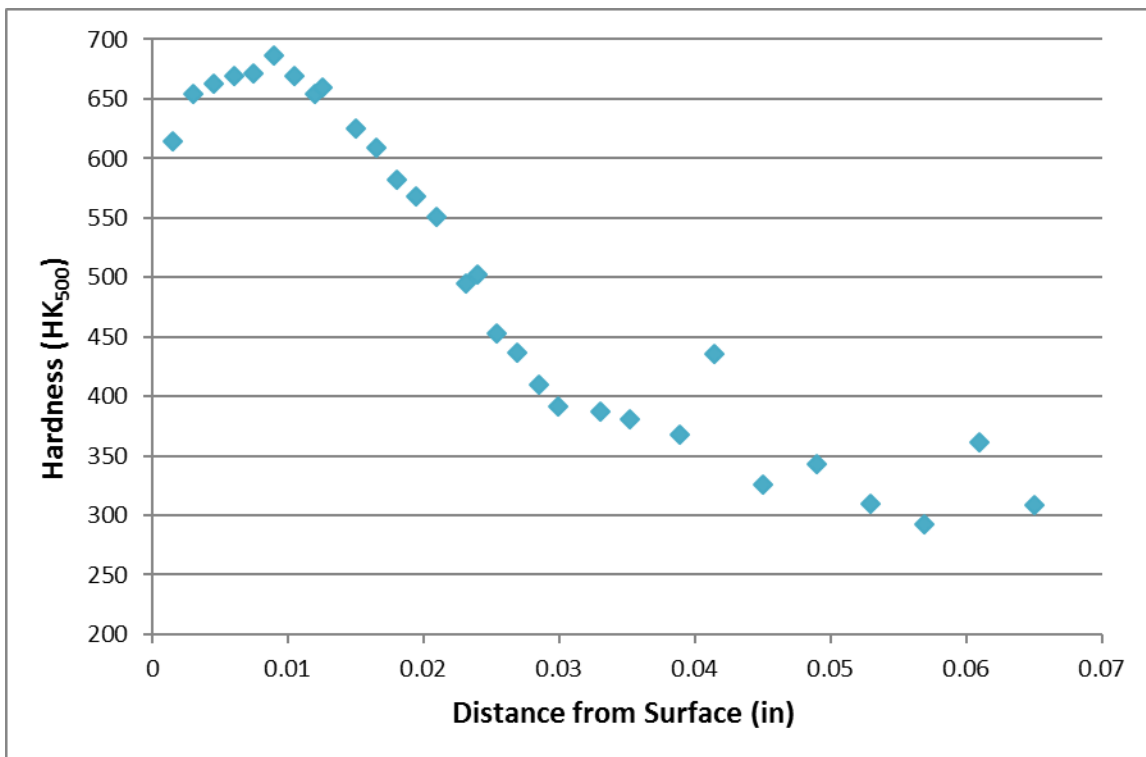
This aforementioned cross section at the thread root was hardness tested using microindentation hardness per ASTM E384.<sup>5</sup> Figure 26 shows the data from the microindentation hardness tests. The hardness peaked at 58 HRC (686 HK<sub>500</sub>), 0.009 inches from the surface. The average hardness of the core was 32 HRC (324 HK<sub>500</sub>). The effective case depth was 0.022 inches. These data were typical for a case-hardened alloy steel.

Figure 26 – Chart showing the microindentation hardness data (in HK<sub>500</sub>) relative to surface depth (in inches) of the gear tooth valley cross section in Figure 23.
