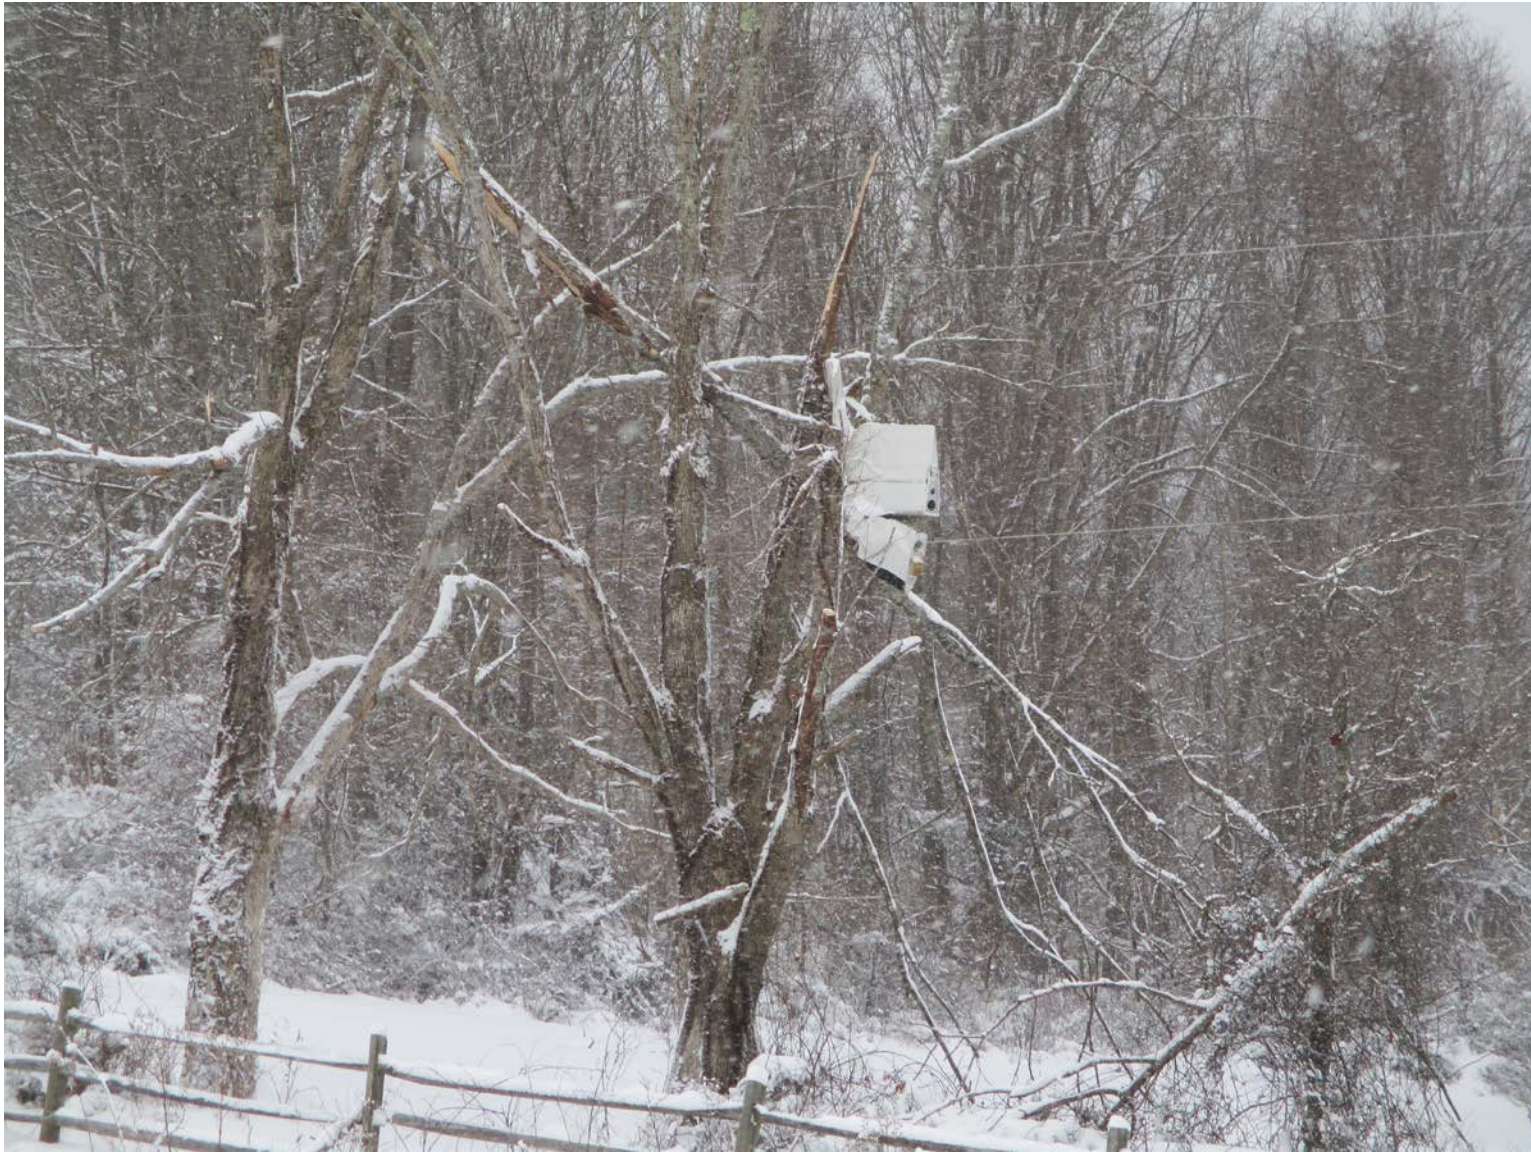
**Photo 1 – View of tree and powerline with portion of wing wrapped around tree. (Courtesy of FAA)**

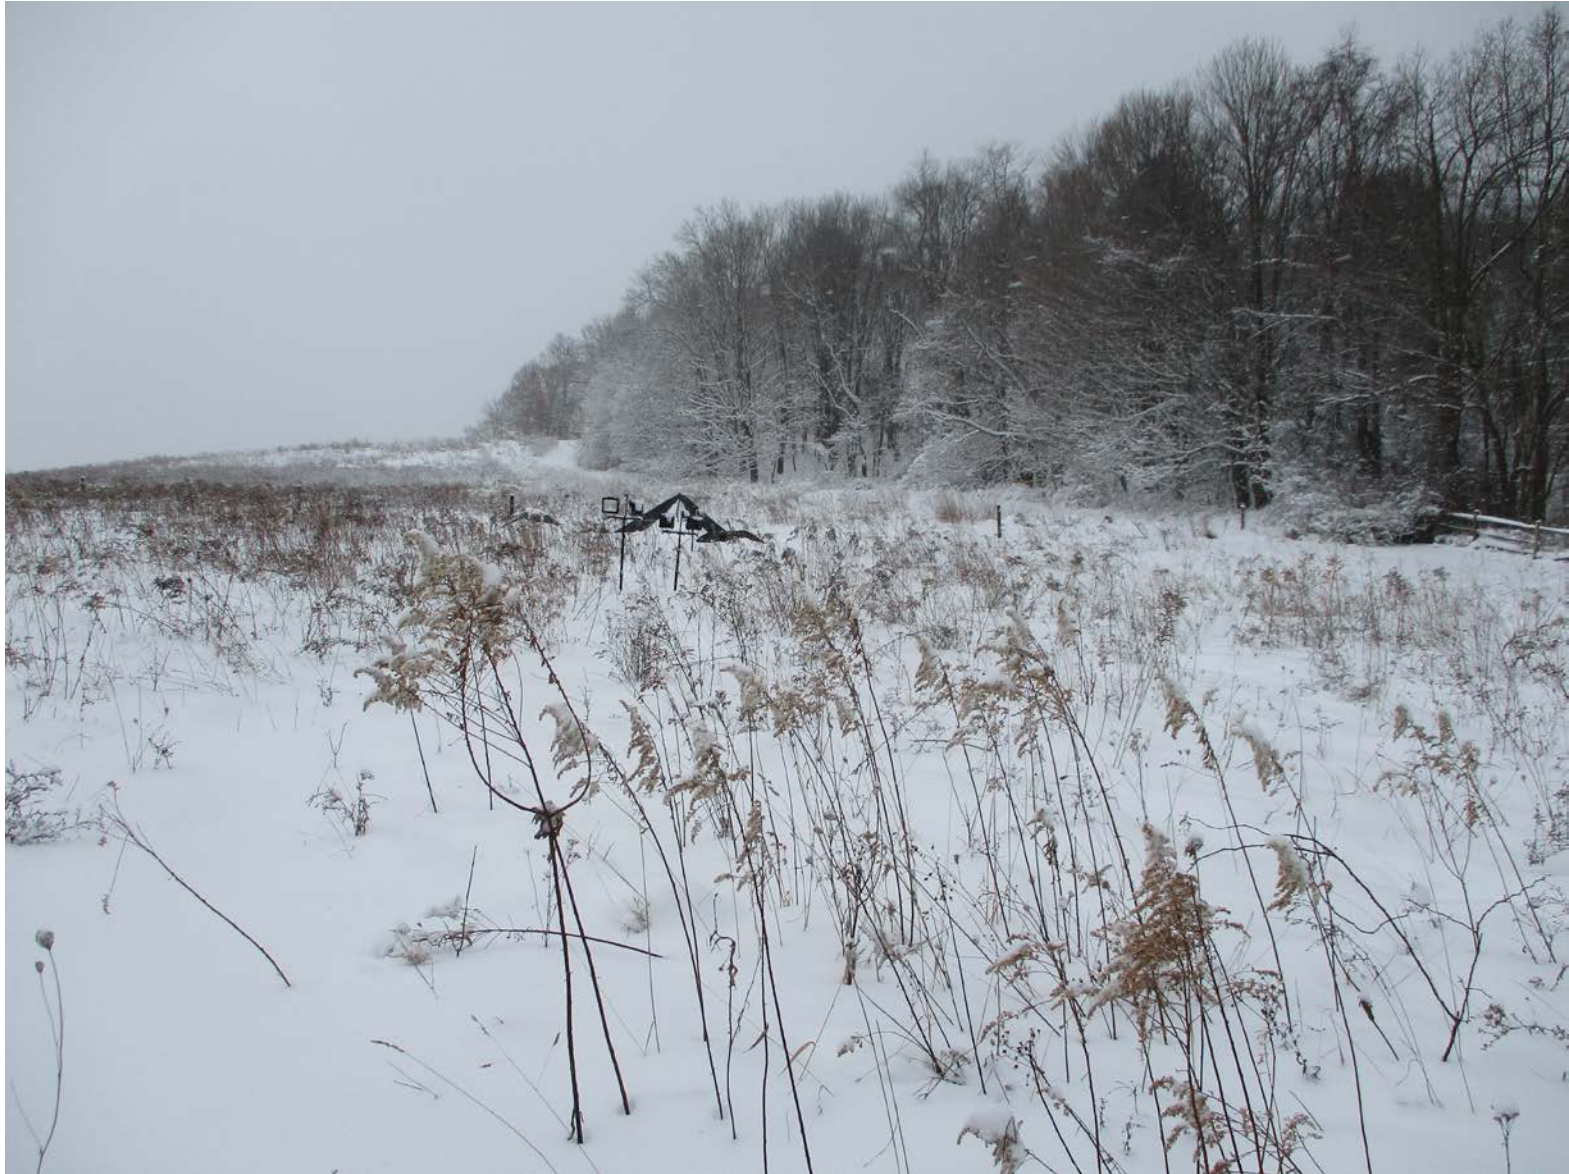
**Photo 2 – View of wreckage under a tarp about 300 feet from first impact with trees. (Courtesy of FAA)**

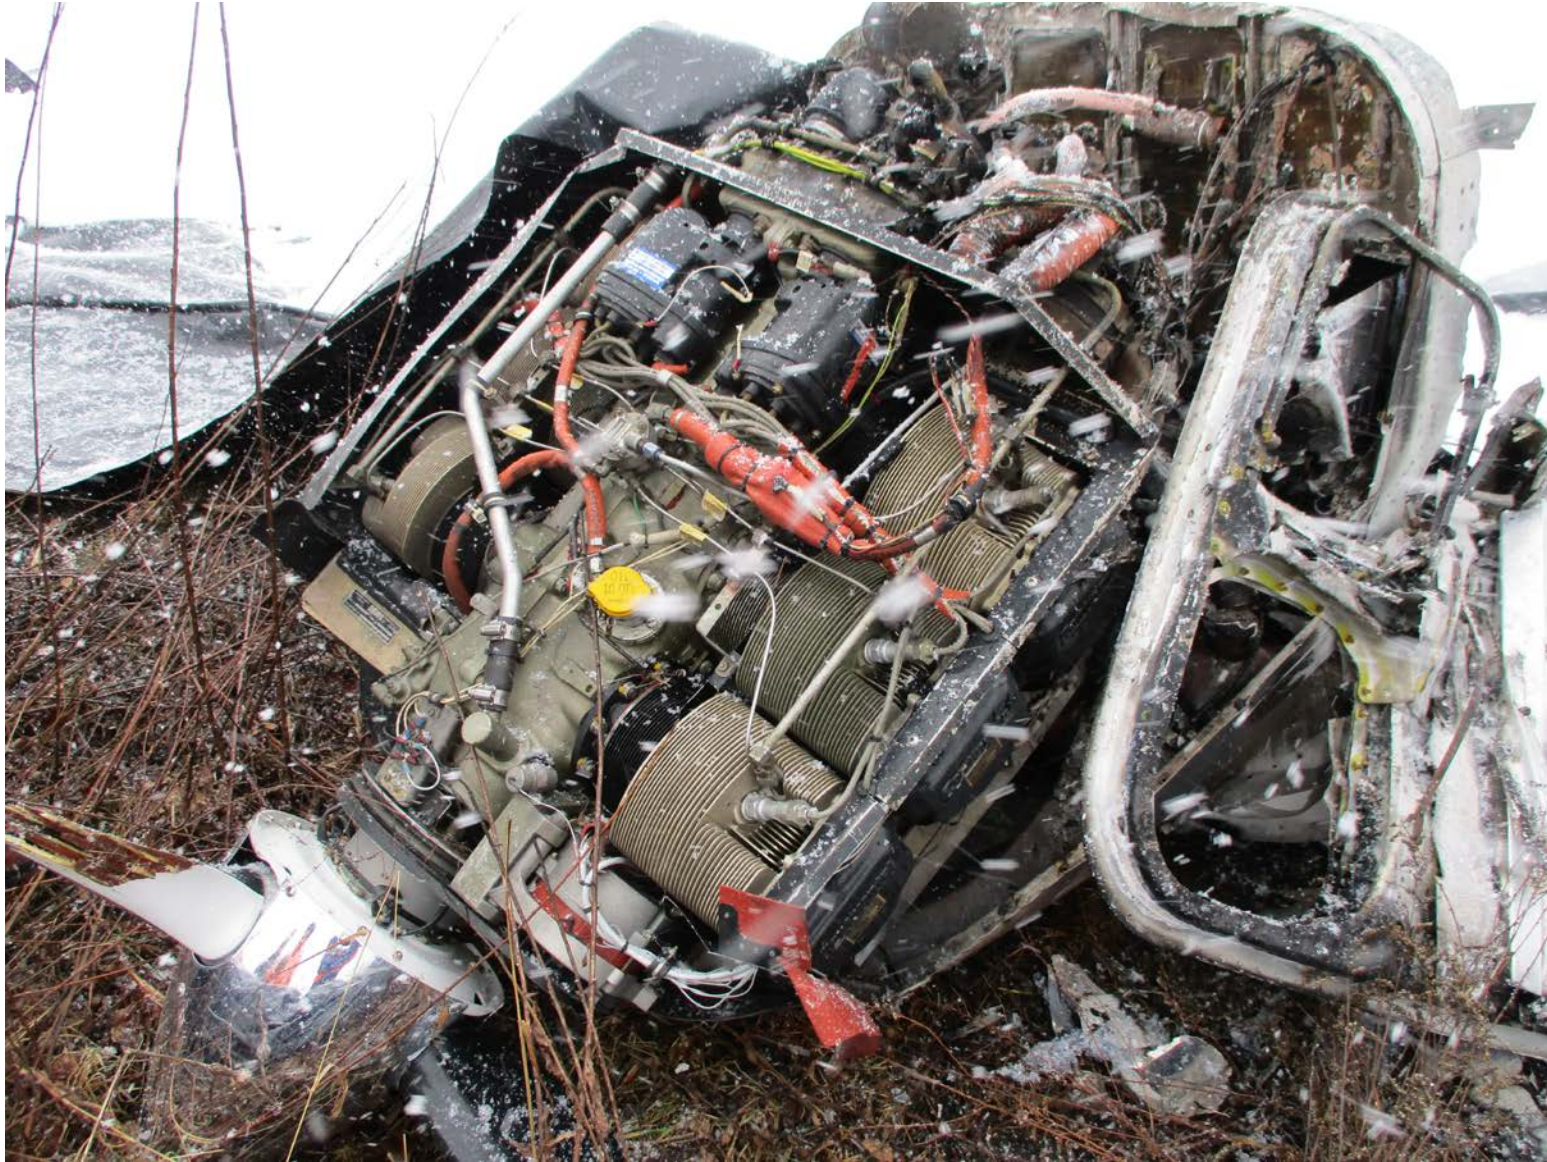
**Photo 3 – View of engine and propeller hanging off firewall. (Courtesy of FAA)**

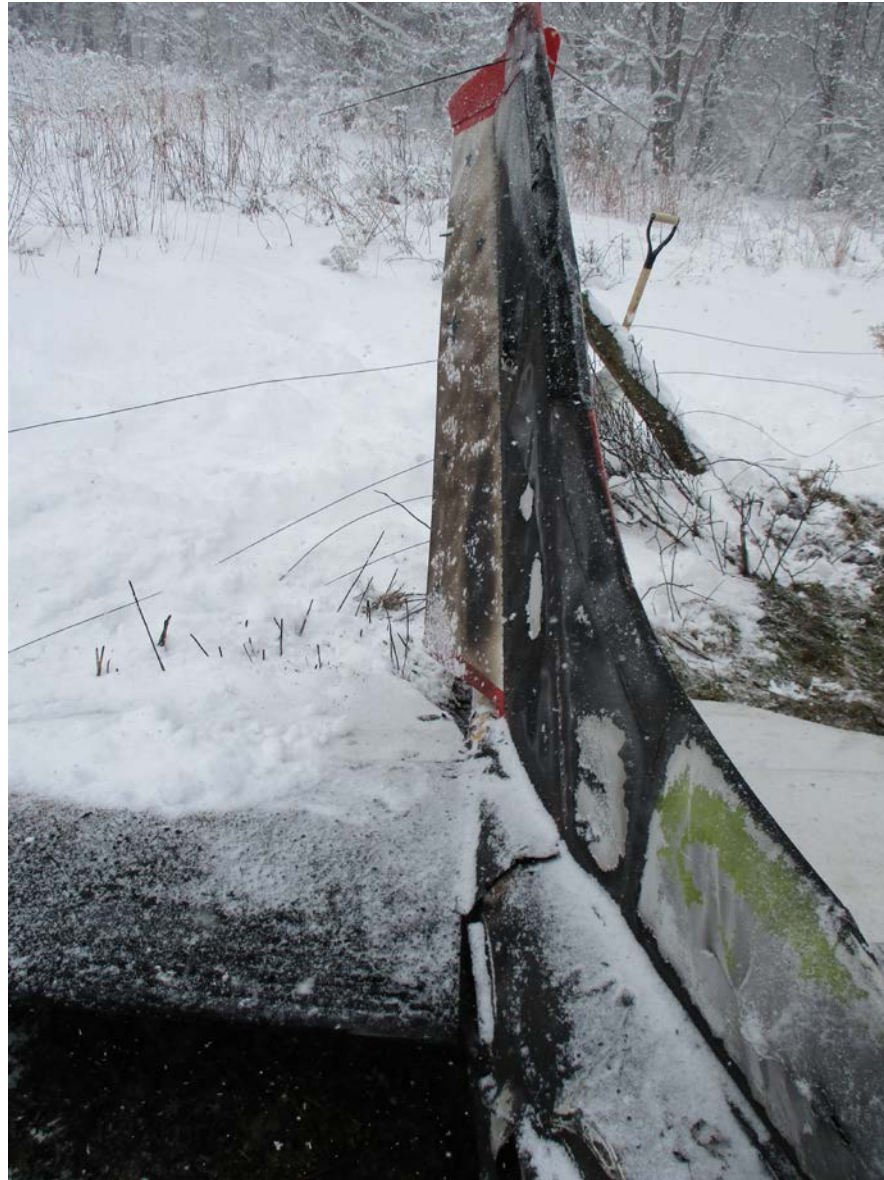
**Photo 4 – View of vertical stabilizer looking aft. (Courtesy of FAA)**

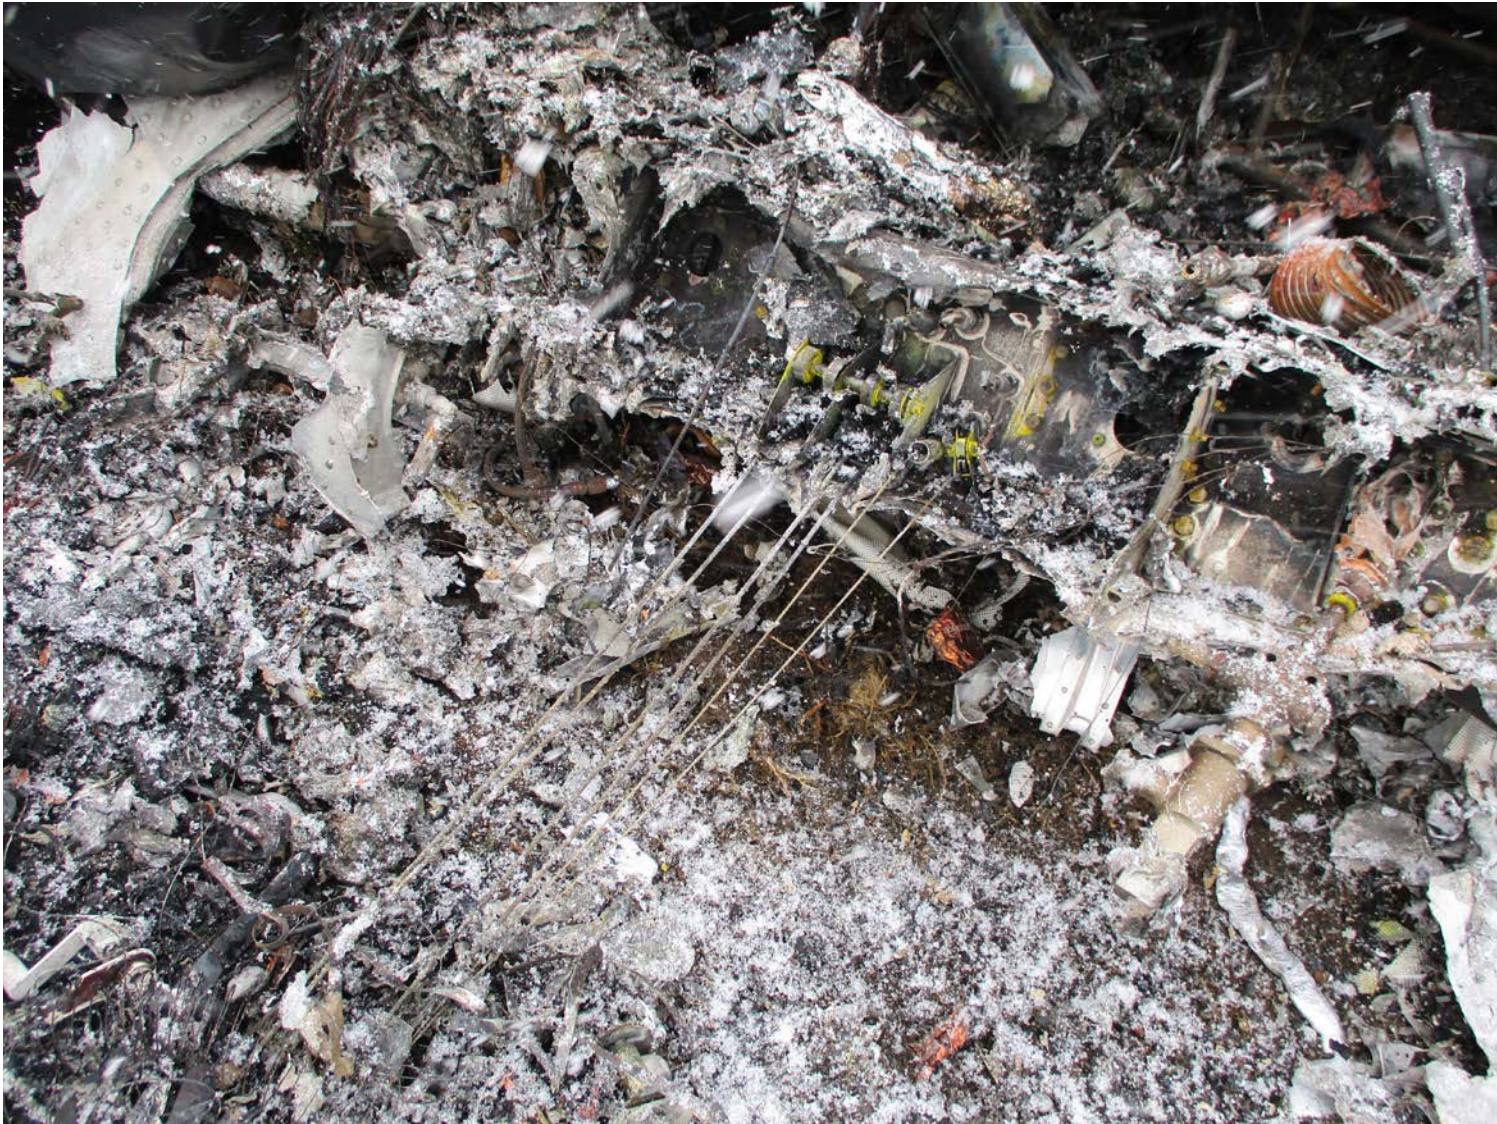
**Photo 5 – Control cables and thermal damage to airframe. (Courtesy of FAA)**

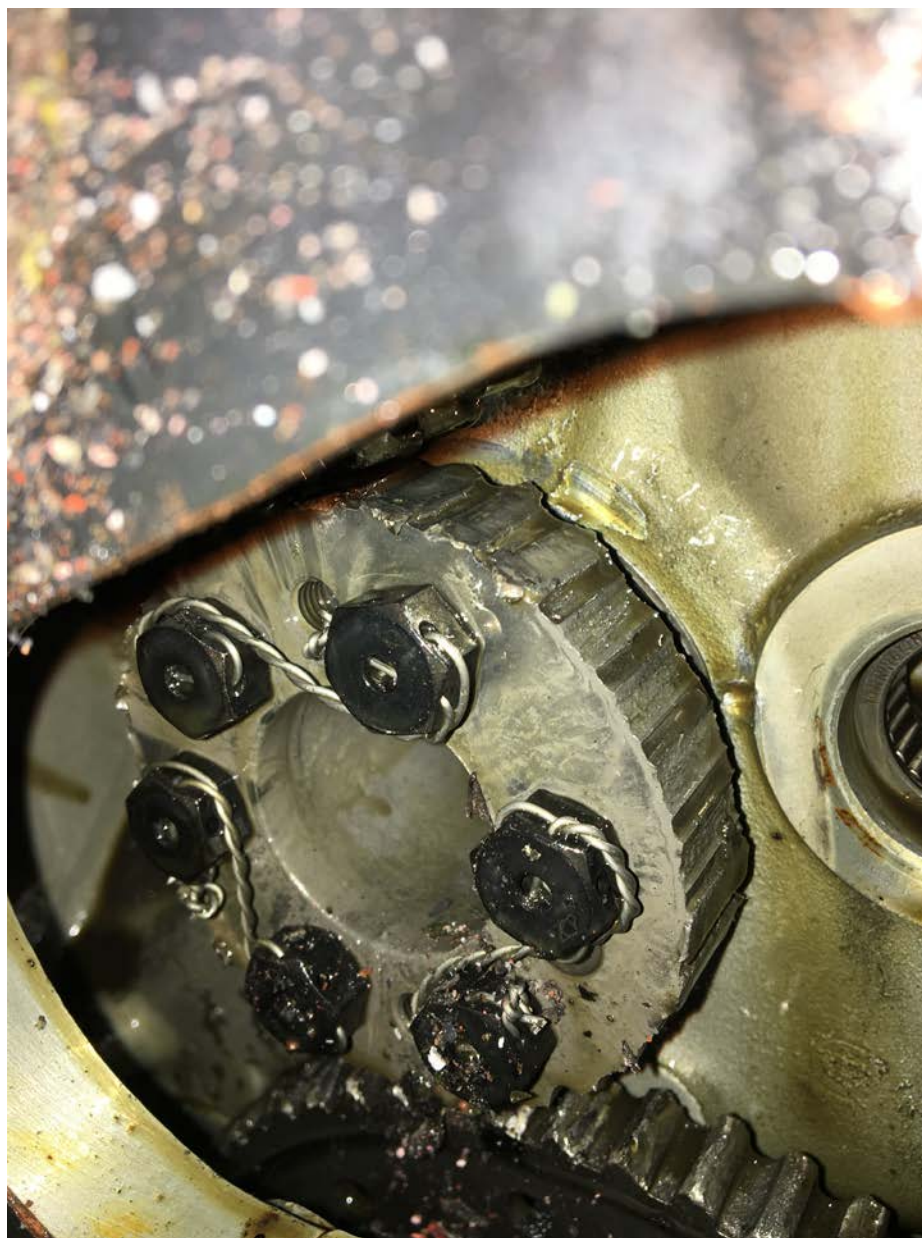
**Photo 6 – View of damaged crankshaft drive gear through engine accessory section.**

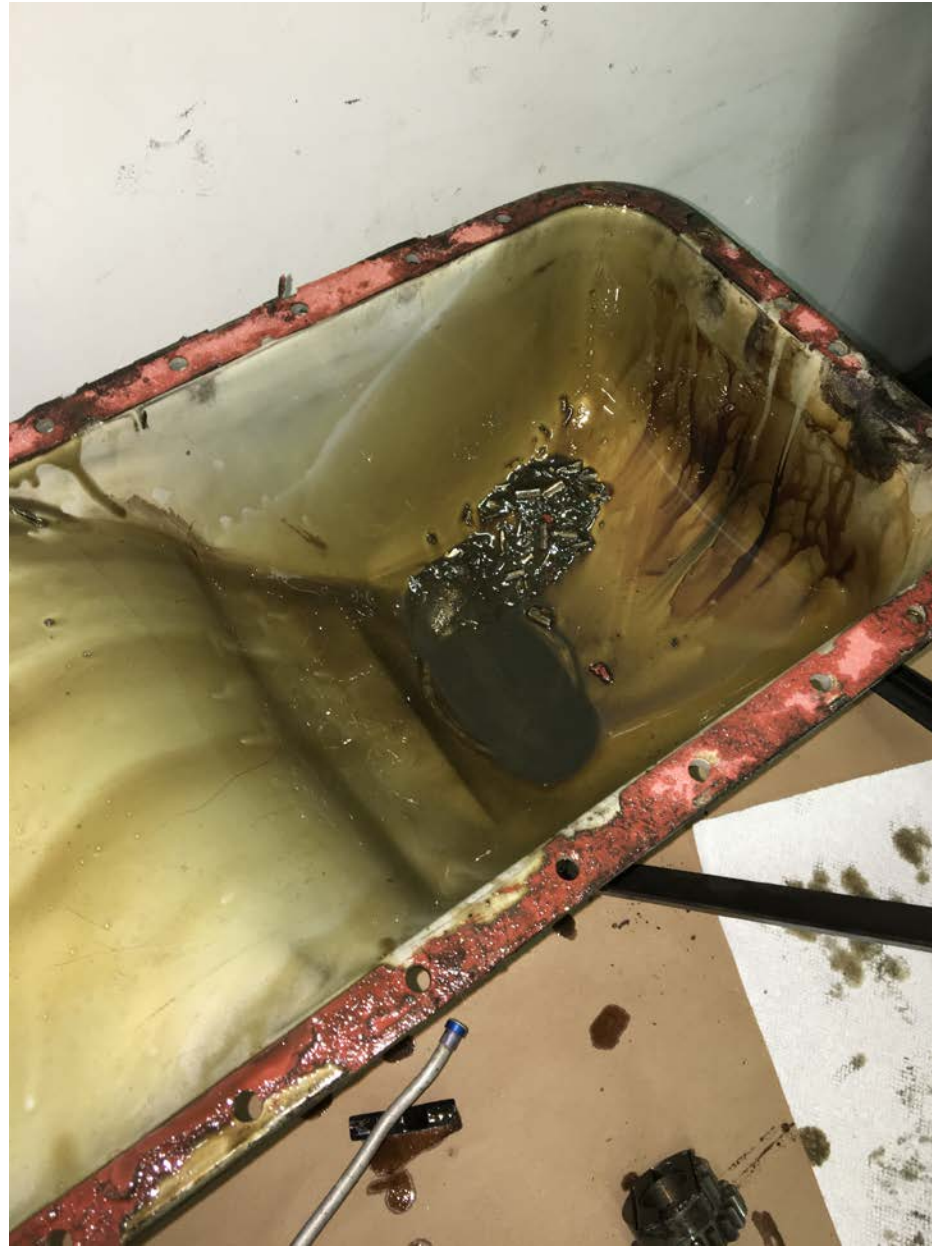
**Photo 7 – View of metal and gear teeth in oil sump.**

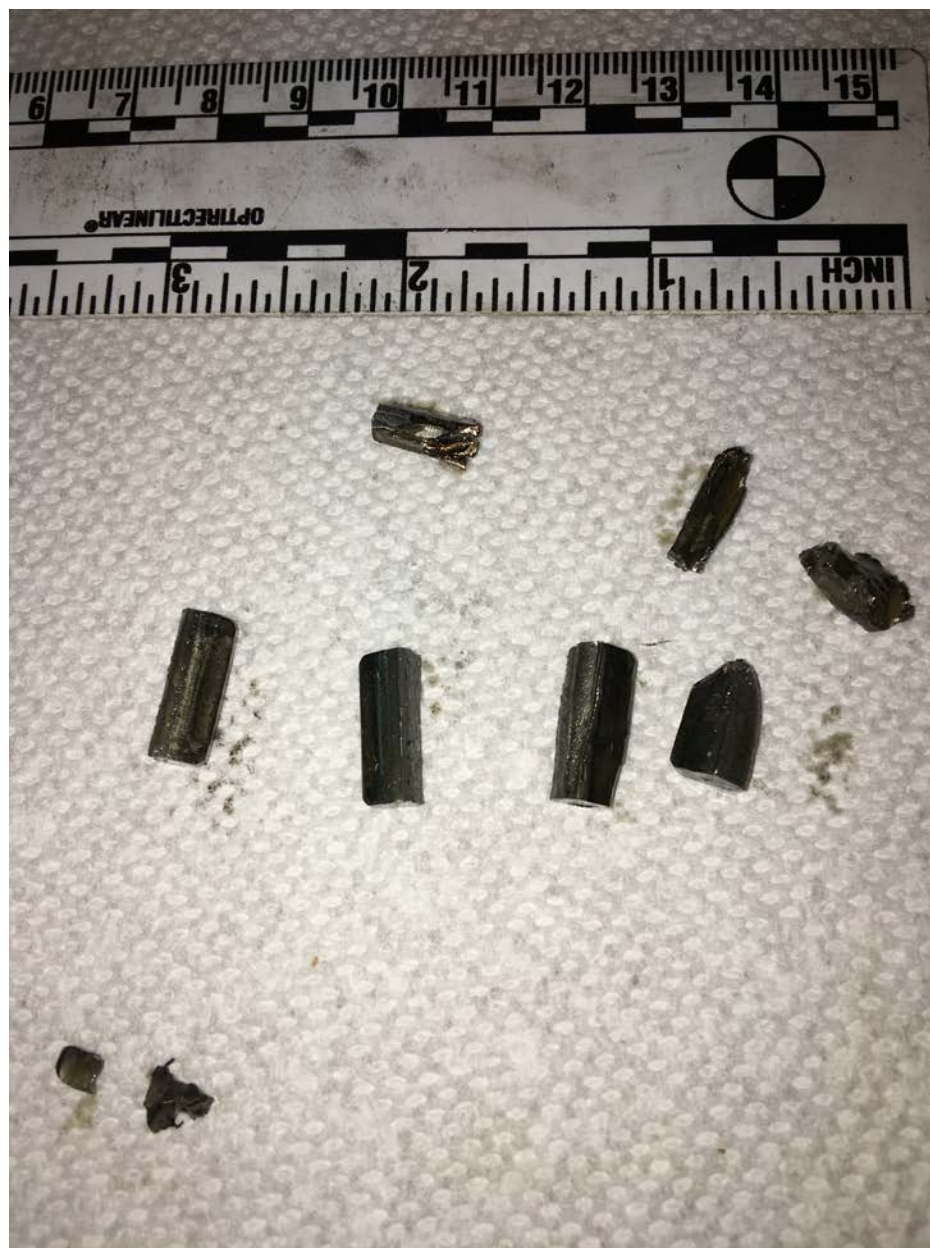
**Photo 8 – View of gear teeth with ruler for scale.**

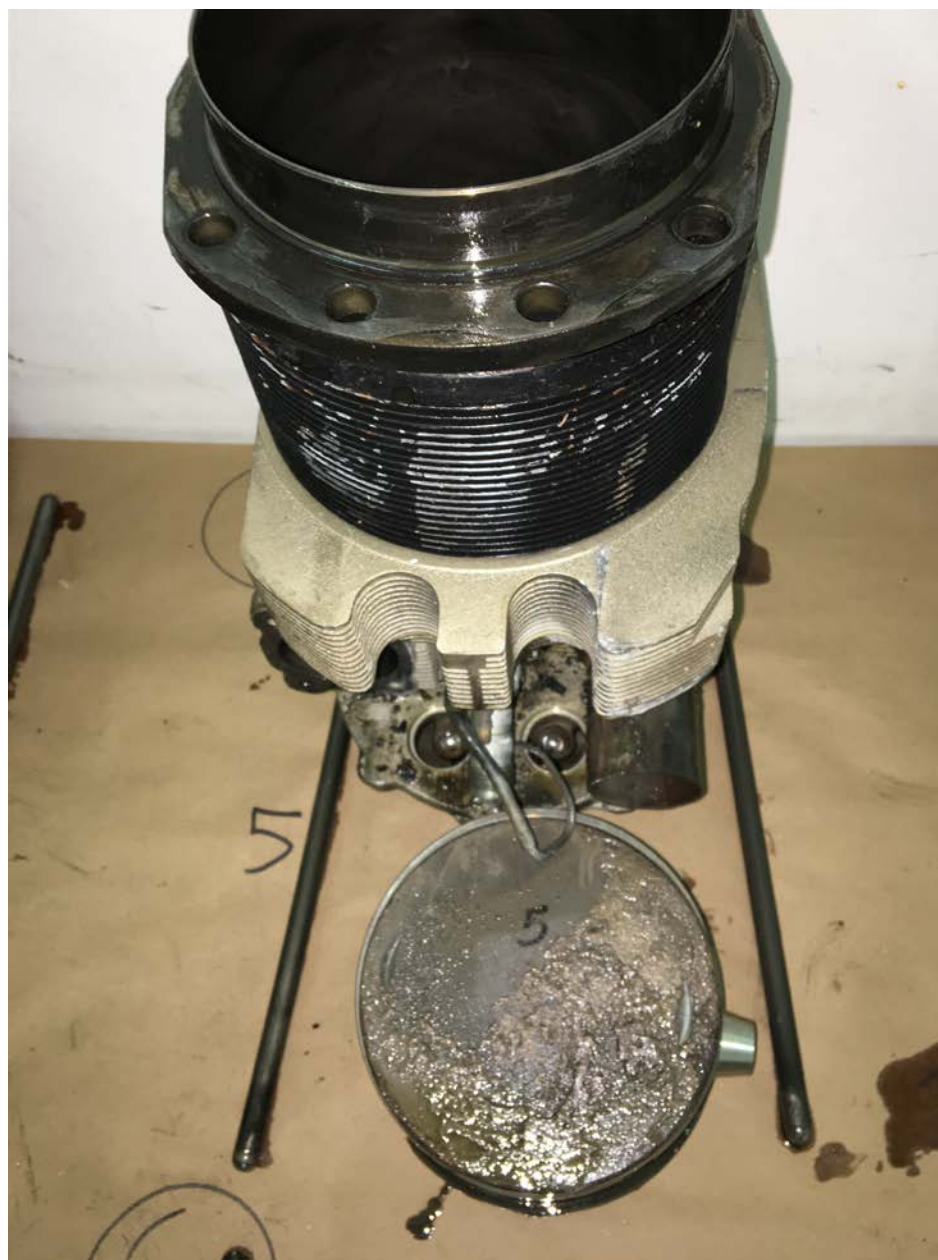
**Photo 9 – Number 5 cylinder assembly showing piston valve impact damage.**

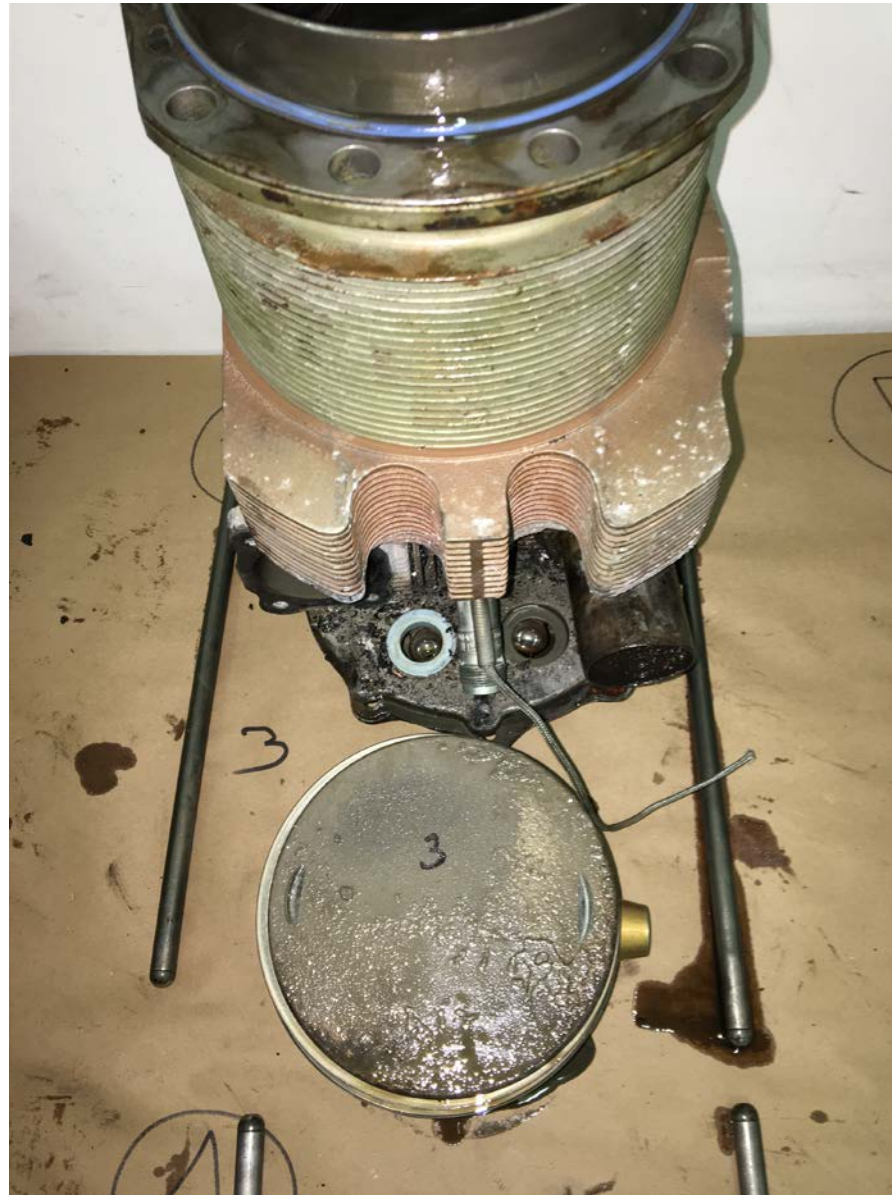
**Photo 10 – Number 3 cylinder assembly showing piston valve impact damage.**

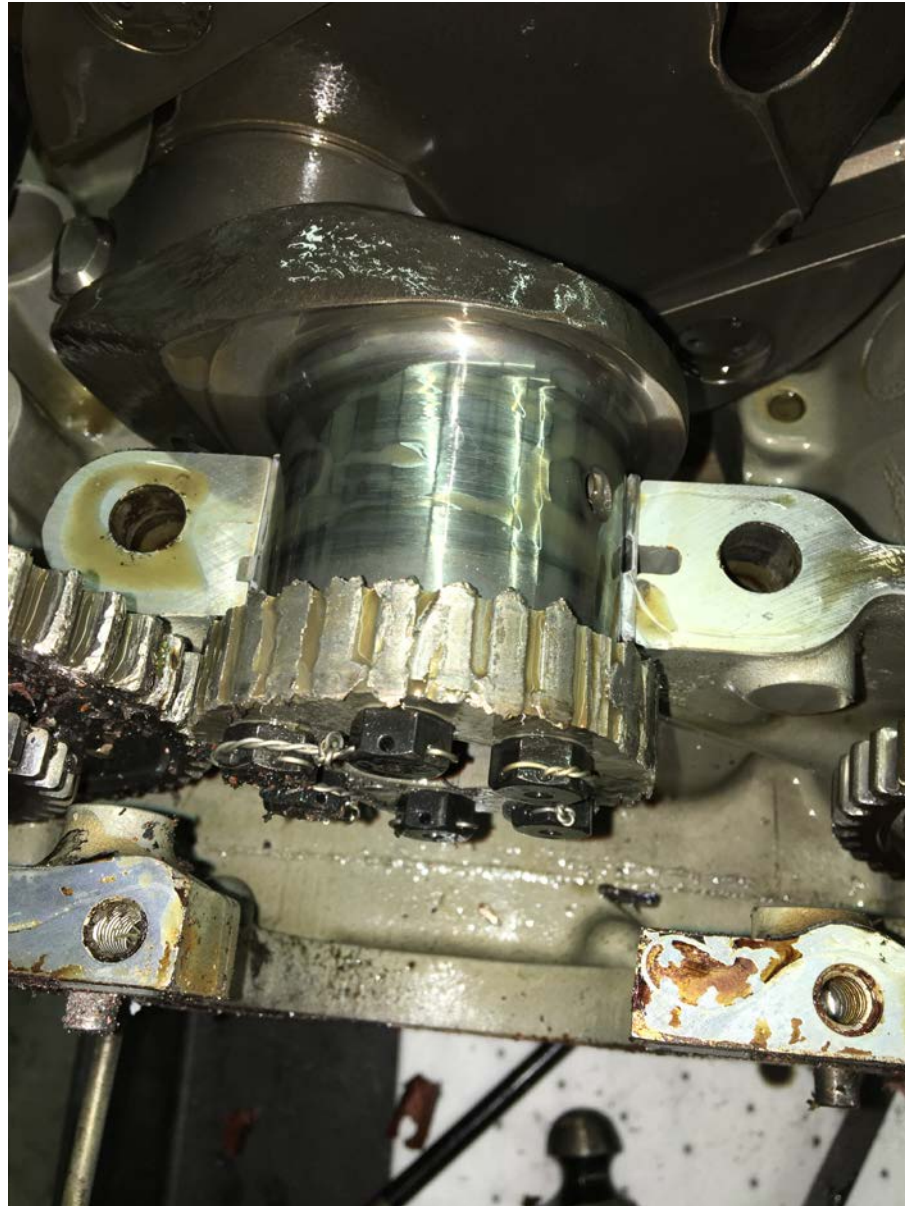
**Photo 11 – Crankshaft gear damage after engine case disassembly.**

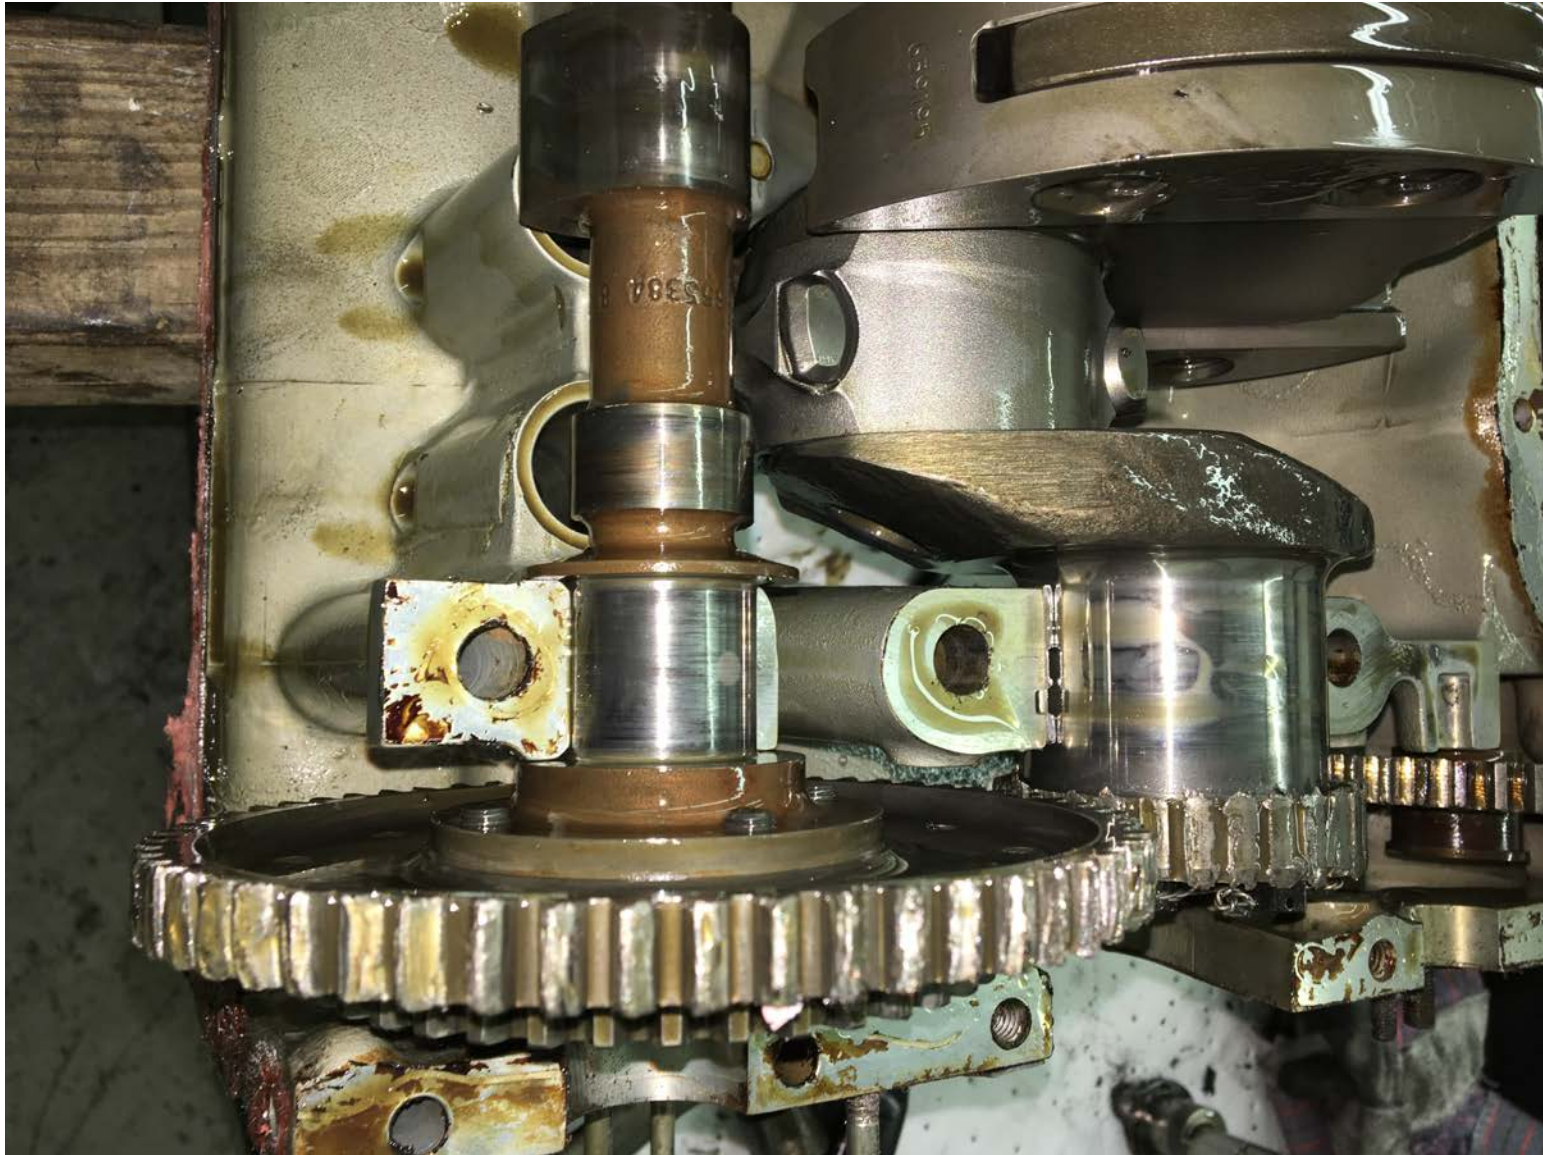
**Photo 12 – View of camshaft gear and crankshaft gear damage.**
