## Engine Investigation Report

**Rolls-Royce Corporation  
Model T63-A720  
Engine AE-405936**

**Model: Bell OH-58C  
Registration: N942SC  
Serial: 68-16872**

**Accident Date: 29 January 2018  
Investigation Date: 22 February 2018  
Engine Test Date: 6 March 2018  
Report date: 21 March 2018**

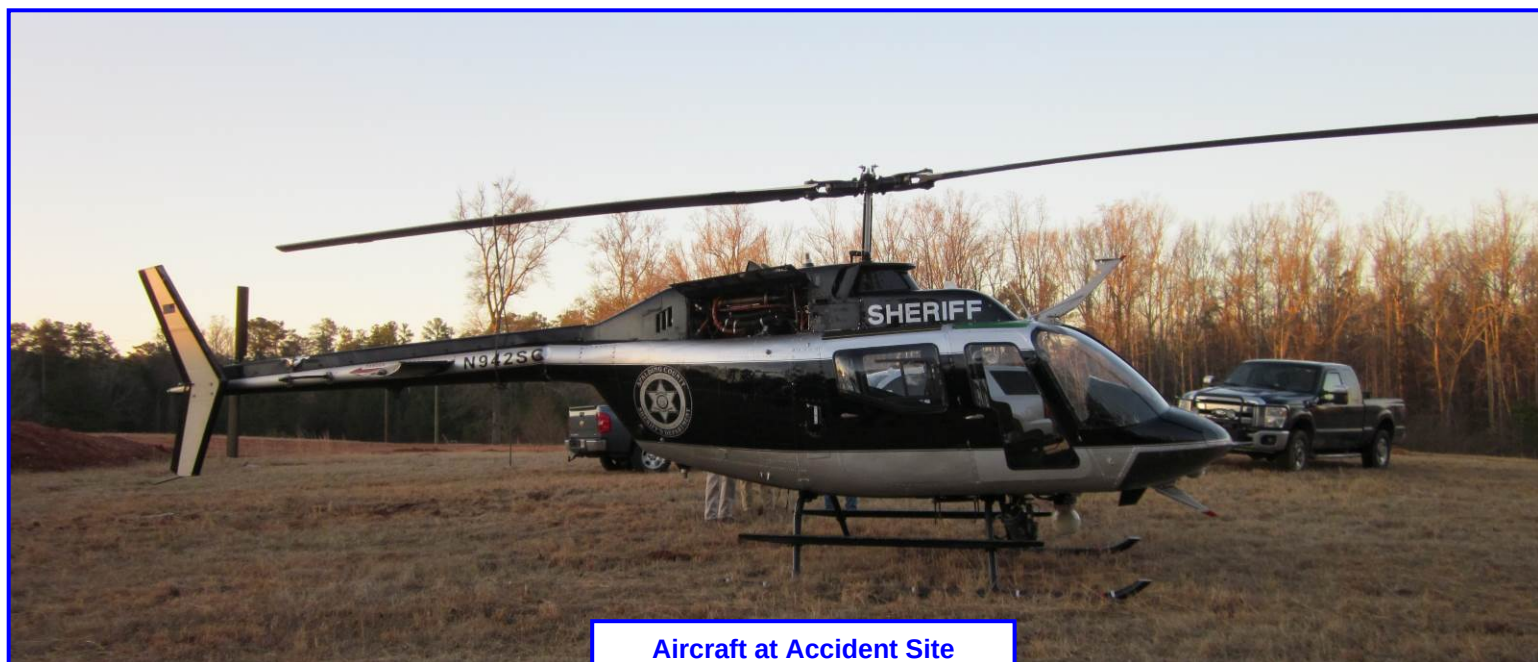
Aircraft at Accident Site

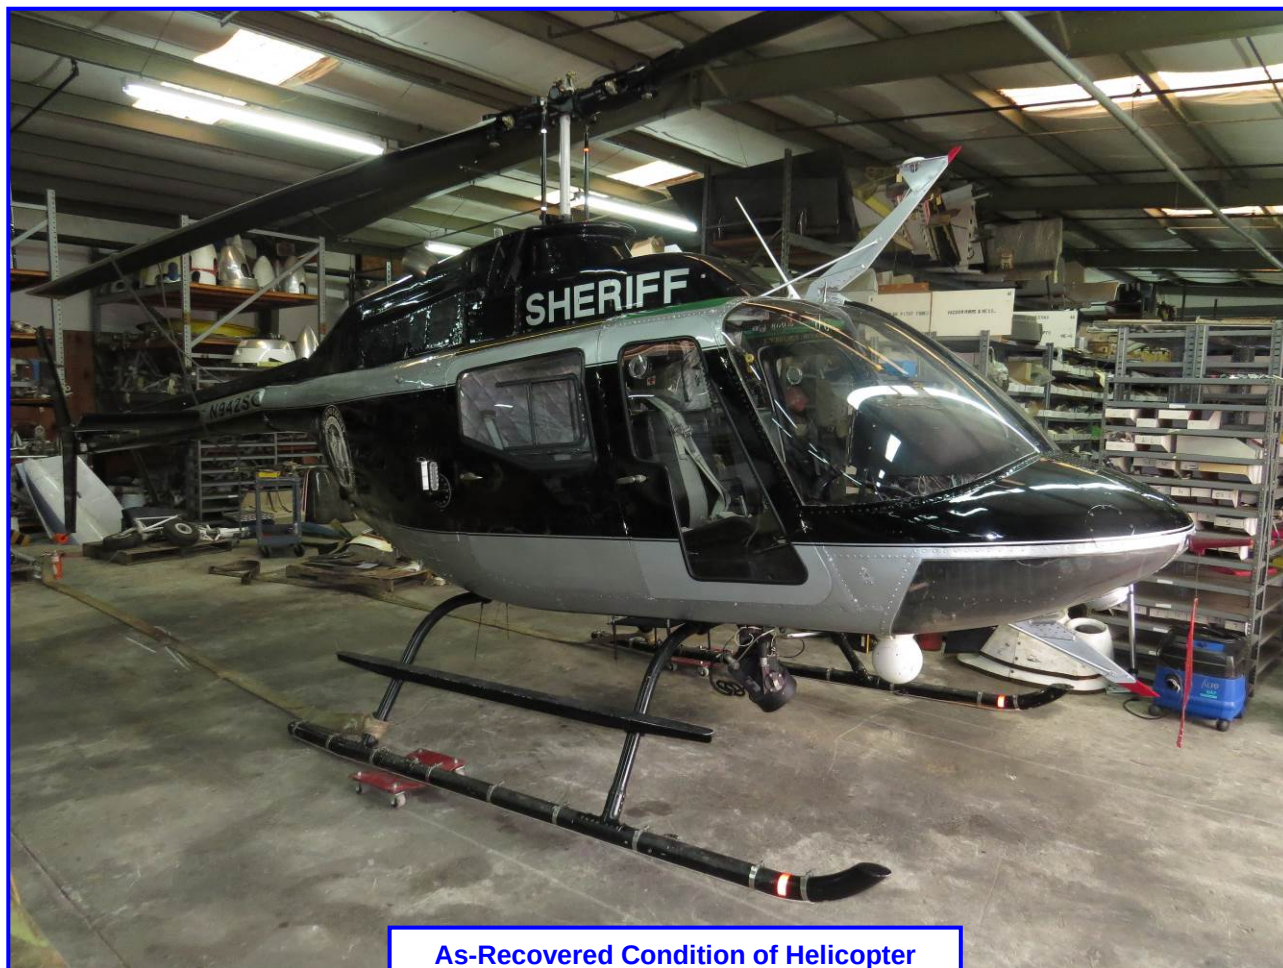
As-Recovered Condition of Helicopter

The aircraft exhibited damage consistent with the pilot's statement of a run on landing while traversing slightly undulating terrain. The tail boom was buckled and partially fractured approximately 12-18" aft of its attachment point with the fuselage. The top of the tail rotor drive shaft cover was damaged from contact with a main rotor blade tip. Neither of the main rotor blades exhibited visually extensive damage indicating the blade strike was relatively light.

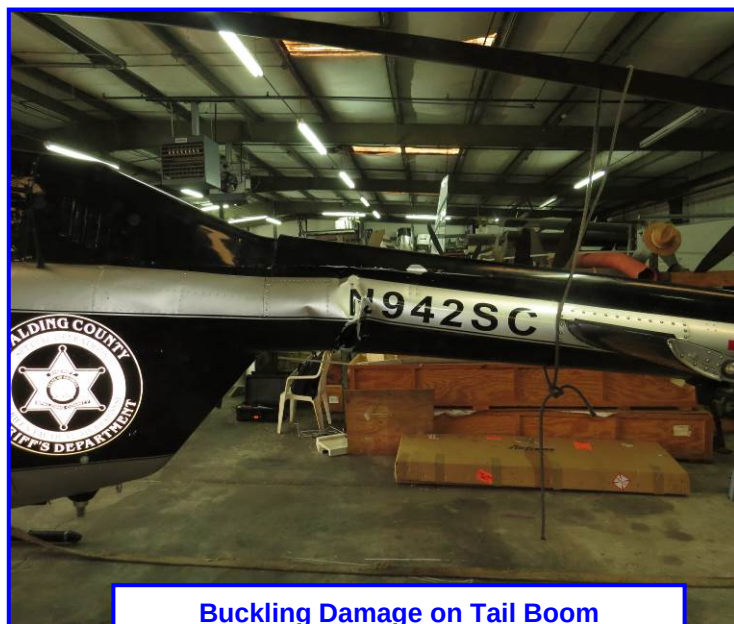
Buckling Damage on Tail Boom

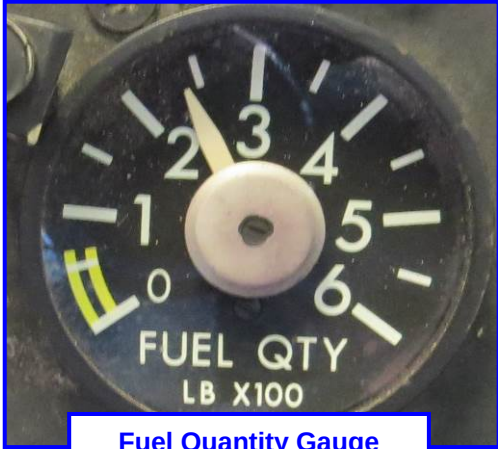
Fuel Quantity Gauge

When aircraft power was applied the fuel quantity gauge read 240 lbs. The airframe fuel shutoff valve was in the ON position and the boost pump circuit breaker was pushed in. Power was applied and the boost pump functioned properly as indicated by fuel flowing out of the discharge side of the aircraft fuel filter housing. The fuel appeared clean and clear. The aircraft fuel filter was not removed and inspected.

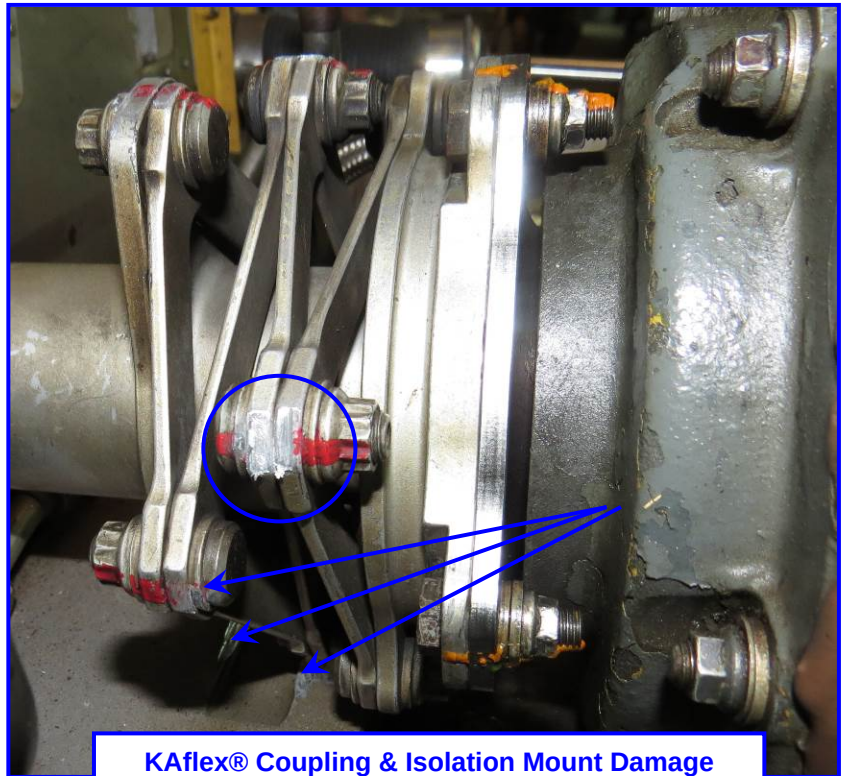
The engine to transmission drive shafting (KAflex® style) was completely intact. There was contact between the forward flex coupling at the transmission and the isolation mount. The rotating portion of the swash plate contacted the shroud around the main rotor mast.

KAflex® Coupling & Isolation Mount Damage

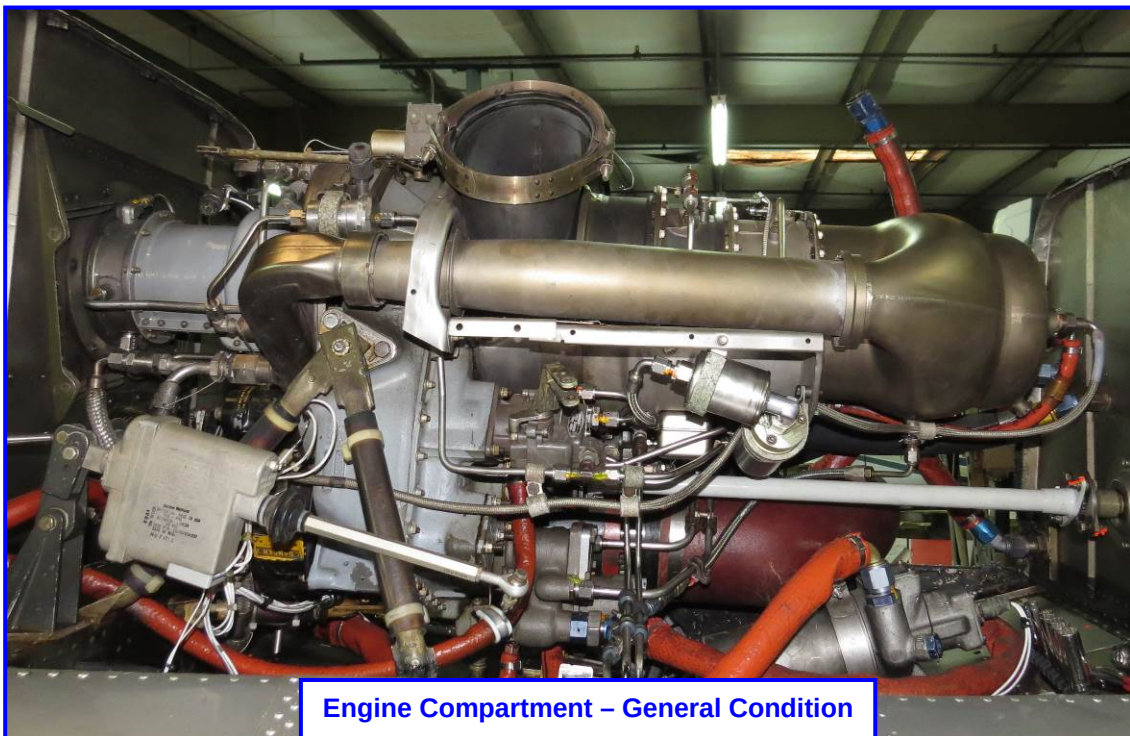
Engine Compartment – General Condition

The engine remained within the engine compartment and the engine mounts showed no immediate signs of damage. Initial inspection of the engine exterior did not reveal any obvious signs of damage from impact forces, internal engine failure, or evidence of fire. All B-nuts were found to be at least hand tight and torque stripe painted.

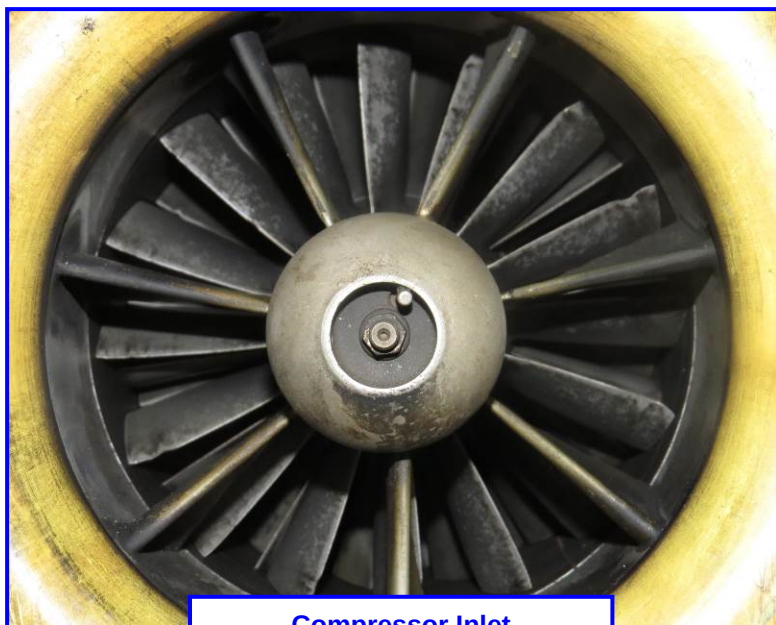
Compressor Inlet

The compressor inlet guide vanes, struts, and 1st-stage airfoils were noticeably dirty with random blacken color throughout. The 1st-stage blades were void of any noticeable impact damage or FOD but did contain a number of blades with leading edge blends. The 4th-stage turbine blades appeared undamaged as did the surrounding turbine sections and exhaust plenum.

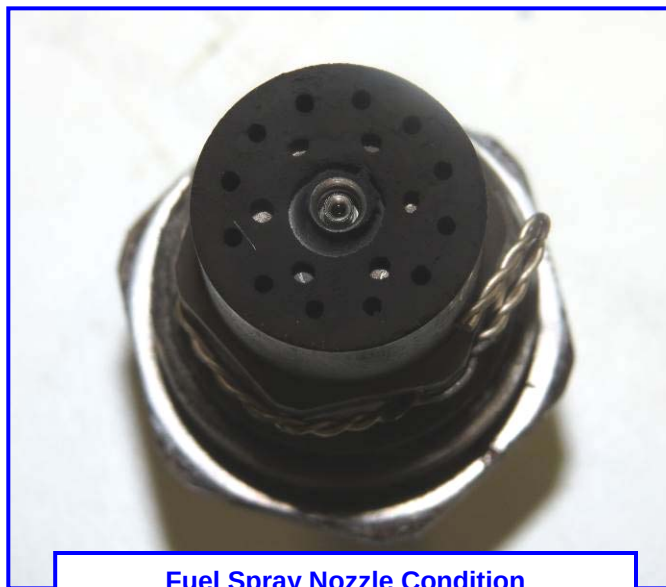
Fuel Spray Nozzle Condition

The fuel spray nozzle was removed and examined. There was no evidence of obstruction in the fuel spray nozzle inlet. The spray face exhibited a heavy carbon and soot appearance. There did not appear to be any blockage within the air distribution holes. The nozzle was not disassembled further.

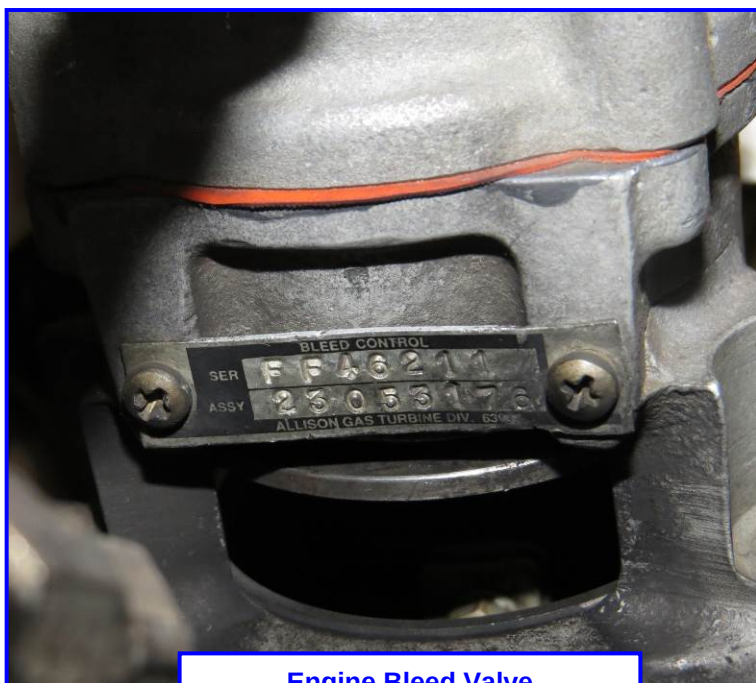
Engine Bleed Valve

The bleed valve was operated by hand. The poppet valve smoothly travelled its full stroke and exhibited no radial play. A functional check of the bleed valve using shop air pressure was not performed.

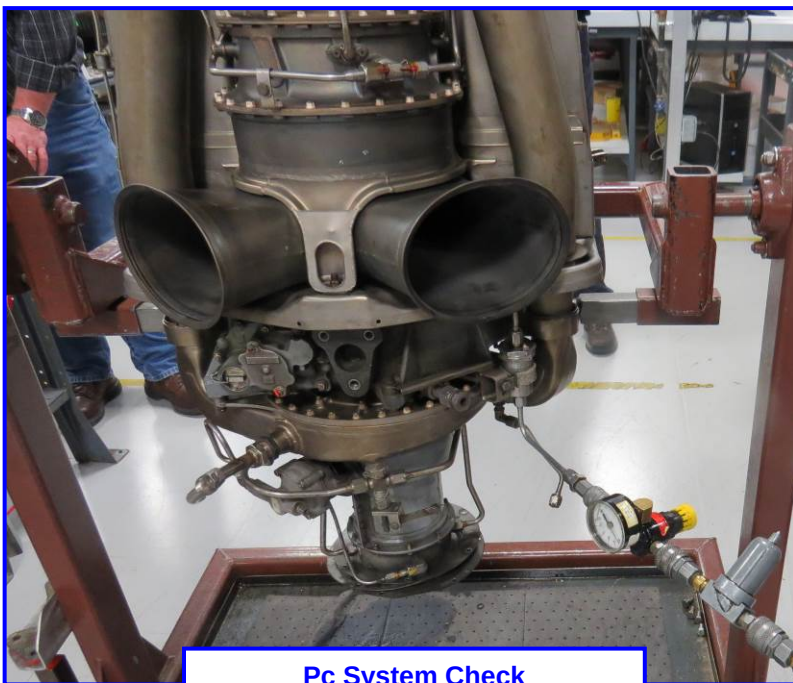
Pc System Check

A check of the Pc system was performed using shop air at the inlet side of the Pc air filter at 80 psi. A soapy water solution was applied to the Pc system B-nuts and rigid tubing. Pressure was then reduced to 20 psi to check for leakage at the governor diaphragm. No leaks were detected anywhere throughout the system.

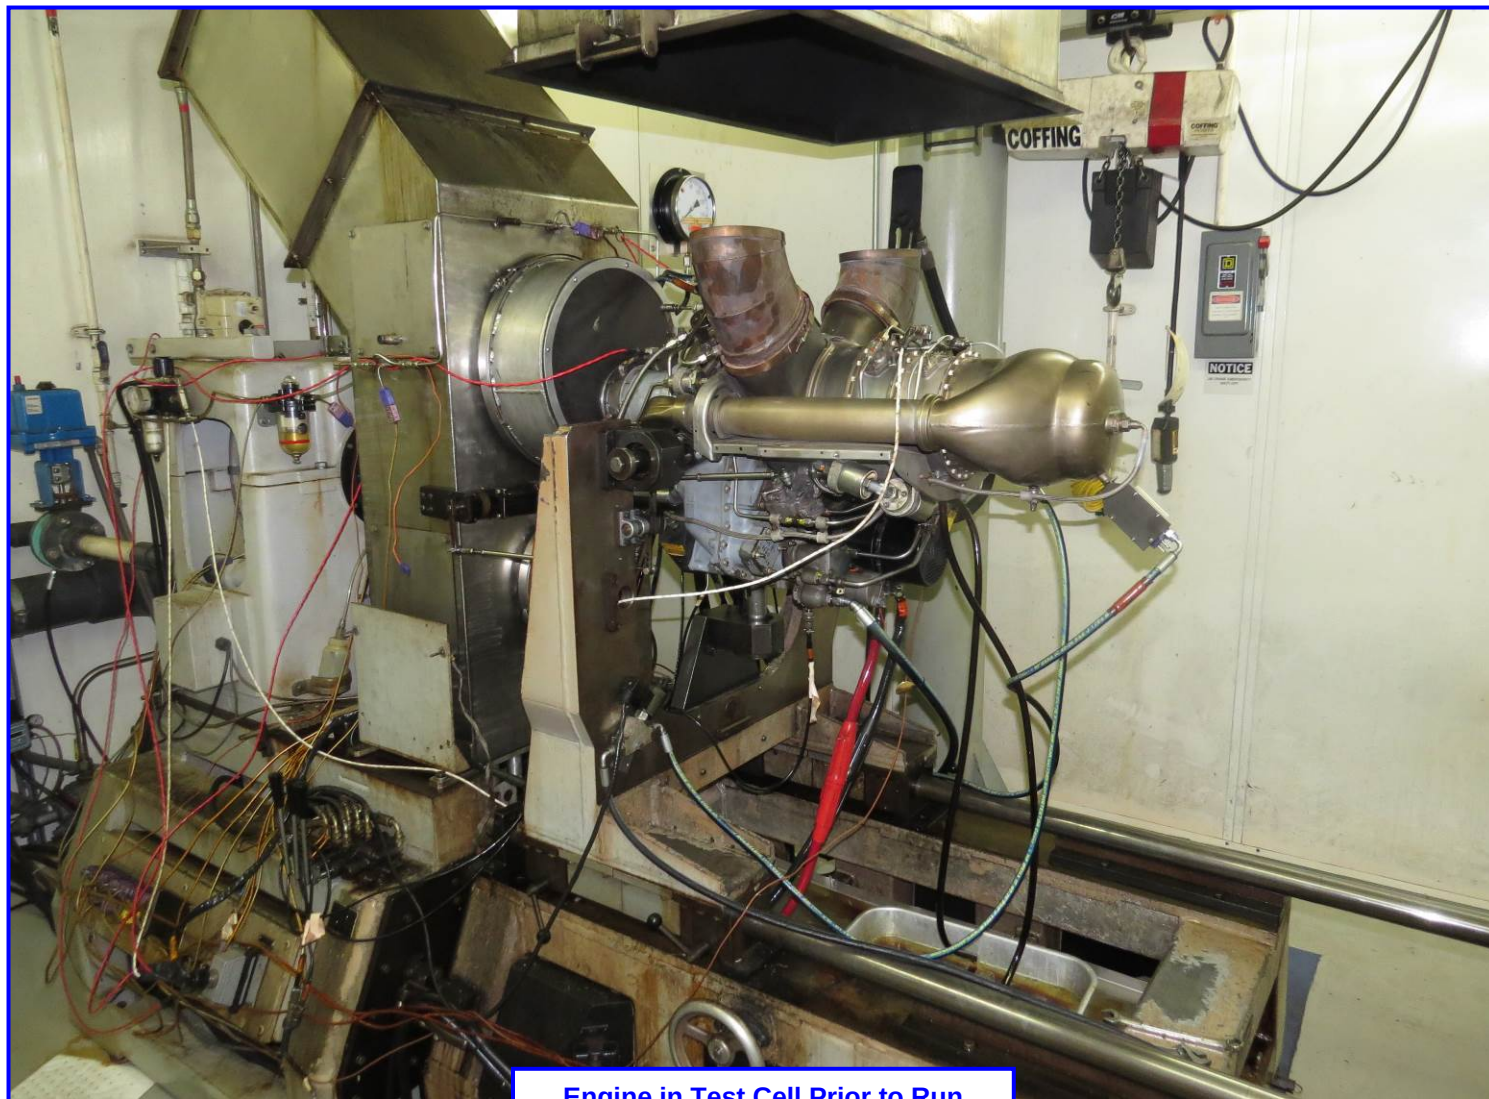
Engine in Test Cell Prior to Run

The engine successfully started, ran and shut down. The engine successfully completed ground idle, flight-idle, max-continuous-power, and take-off power runs. When corrected for standard atmospheric conditions, the engine yielded performance 6.3% above new-production standards at "low cruise" (300 horsepower), 4.9% above new-production standards at normal cruise (370 horsepower), and 10.5% above new-production standards at maximum (Take-Off) power (420 horsepower). The engine then completed "wave-off" max-power transients where the power was reduced to flight idle and then rapidly increased to take-off power. The engine responded normally and responded with maximum power without surging or hesitation.
