FAA Inspector Statement, Callair A-9 Inspection

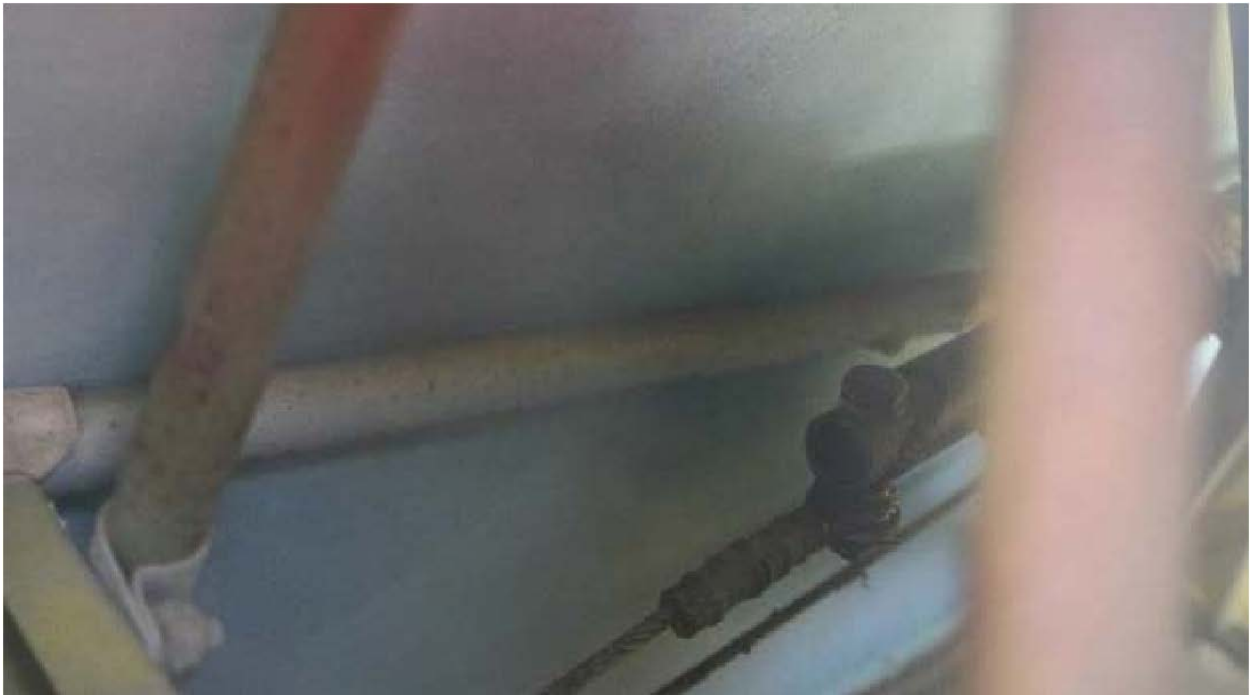
Figure: FAA Digital Photograph. View of the nicopress sleeving for the elevator flight control cable. Note there is no visible cable protruding from the nicoproess afer it made its loop through the control horn fitting.

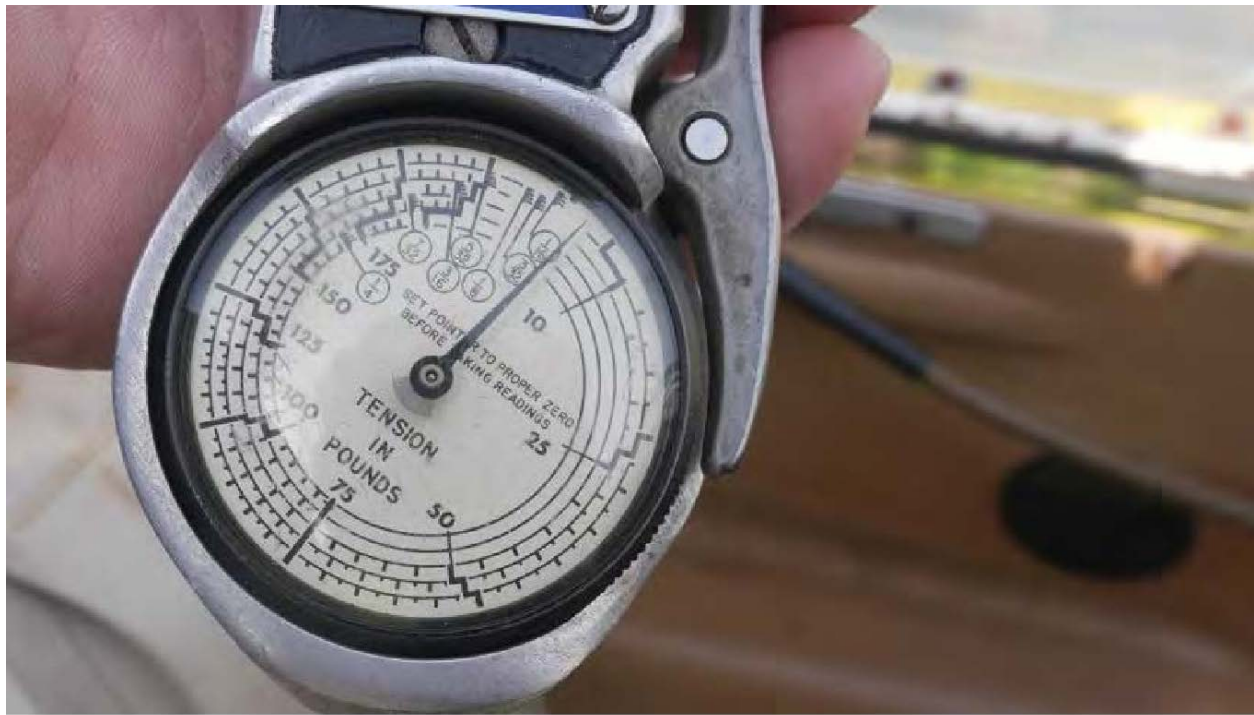
Figure 1: FAA Digital Photograph. View of the actual tensionometer reading that day during examination of the elevator flight control cable.

The rigging of the elevator was off as it relates to the position relative to the horizontal stabilizer and the control stick. When pulling on the primary control stick in the cockpit, most of the travel was likely simply taking slack out of the cable with less control movement enabled for the intended aerodynamic control function.

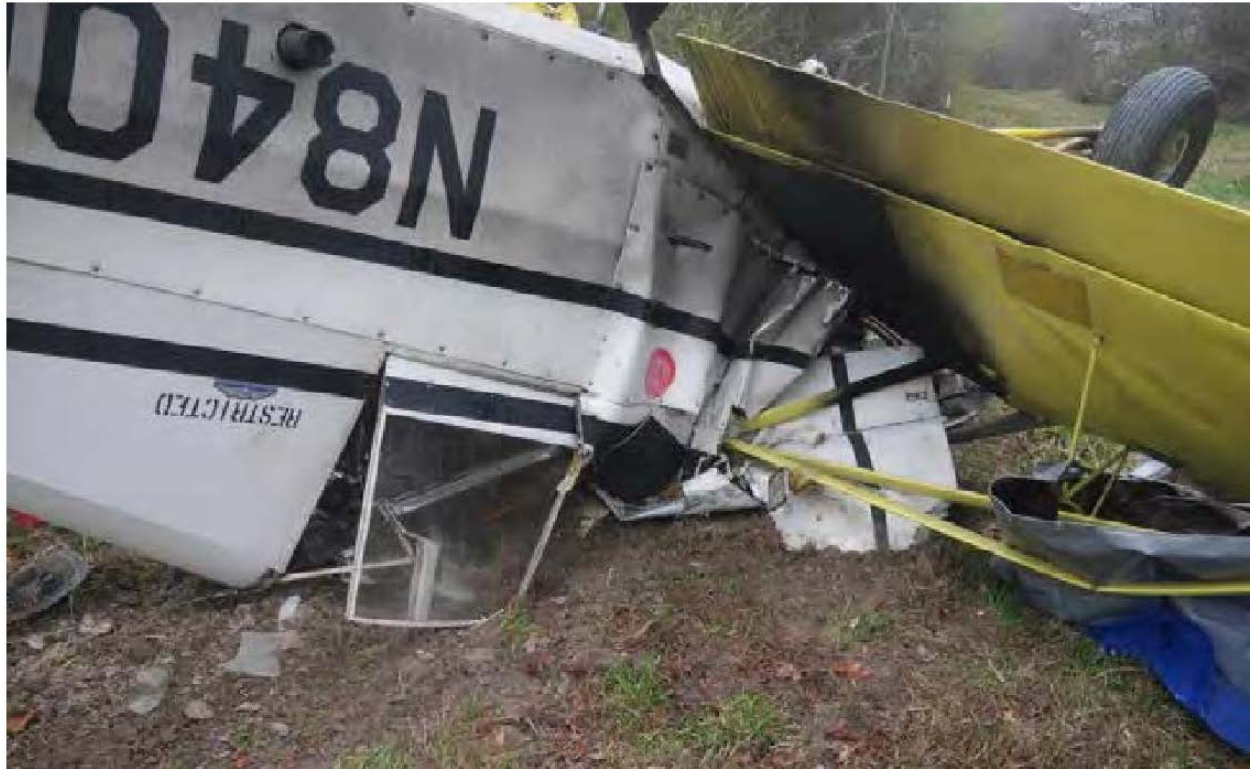
Figure 2: FAA Digital Photograph. Left Side View of the Wreckage at the Accident Site.
