# NATIONAL TRANSPORTATION SAFETY BOARD

## MATERIALS LABORATORY FACTUAL REPORT

Report No. 19-026

Place : Eustis, Florida  
Date : February 25, 2018  
Vehicle : Airborne Windsports Edge XT-912L, N98YW  
NTSB No. : ERA18LA089  
Investigator : Todd Gunther, AS-ERA

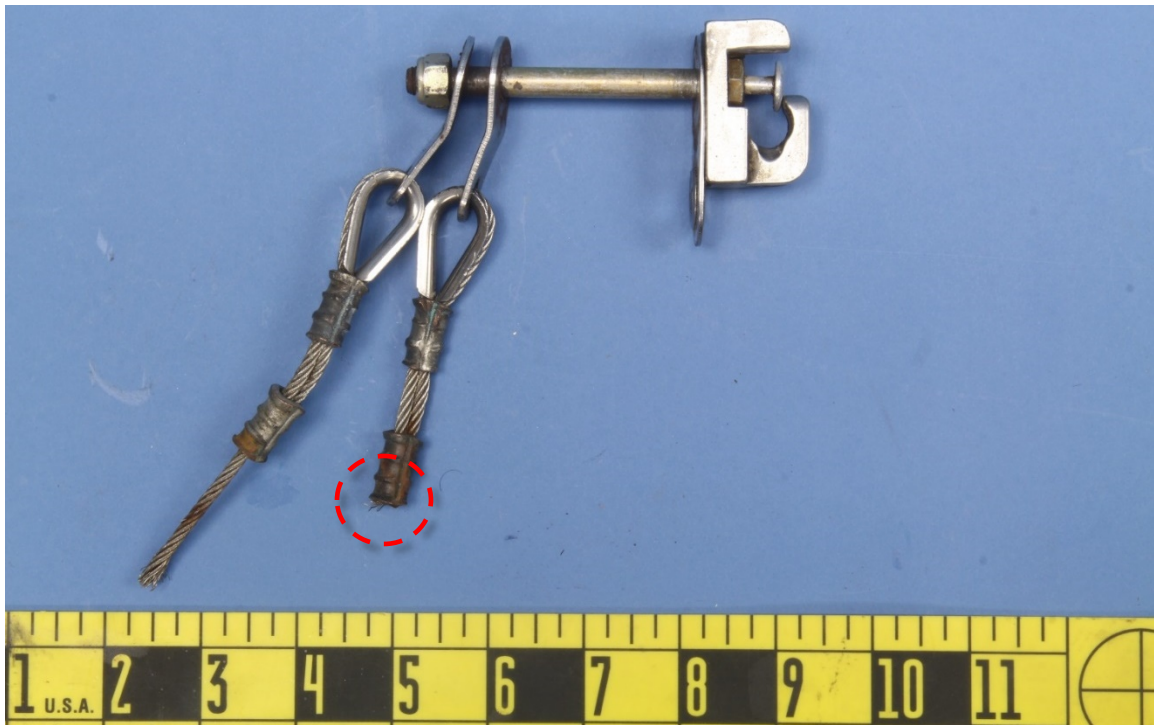
Figure 1 shows the remnants of the rear bracing cable assembly, as received. The assembly consisted of a threaded bolt with a nut positioned through a fitting. The bolt shaft also ran through the holes of two clevises, each attached to an incomplete, swaged wire cable fragment. The cable fragment on the left in Figure 1 exhibited features consistent with having been cut, such as shiny V-shaped thread ends with identical termini. The cable fragment on the right in Figure 1 exhibited corrosion, cable pullout and deformation, and irregular termini on each wire. This cable fragment end was examined in more detail, as described below.

Figure 1 – Remnants of the rear bracing cable assembly, as received. The fracture surface (circled) is shown in Figure 3.

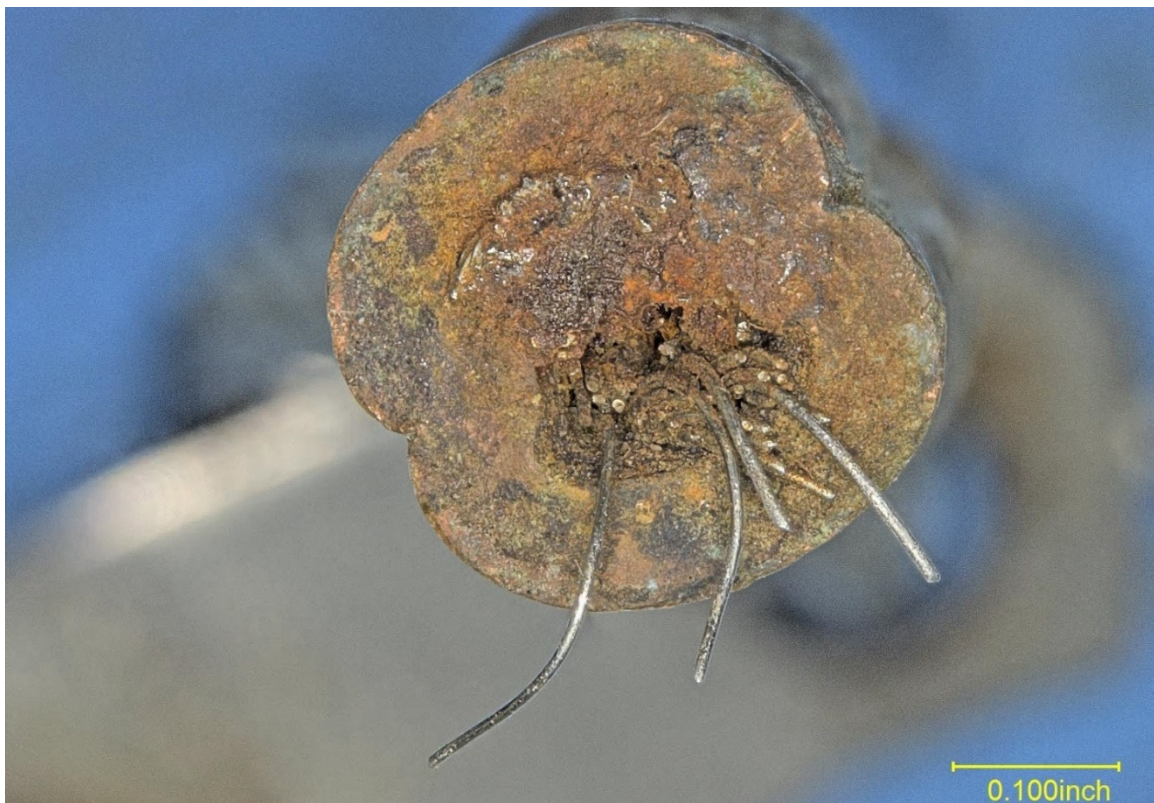
Figure 2 shows the terminus of the right cable fragment, as received. The wires generally terminated at the outward swaged end—five of the wires protruded away from the swaged end, and they were deformed downward in Figure 2. Figure 3 shows a closer view of the wire ends at the swaged end. This end exhibited enough corrosion product to cover and obscure the majority of the wire ends. This corrosion product was consistent

Figure 2 – View of the fractured cable bundle from the crimped fitting, highlighted in Figure 1.

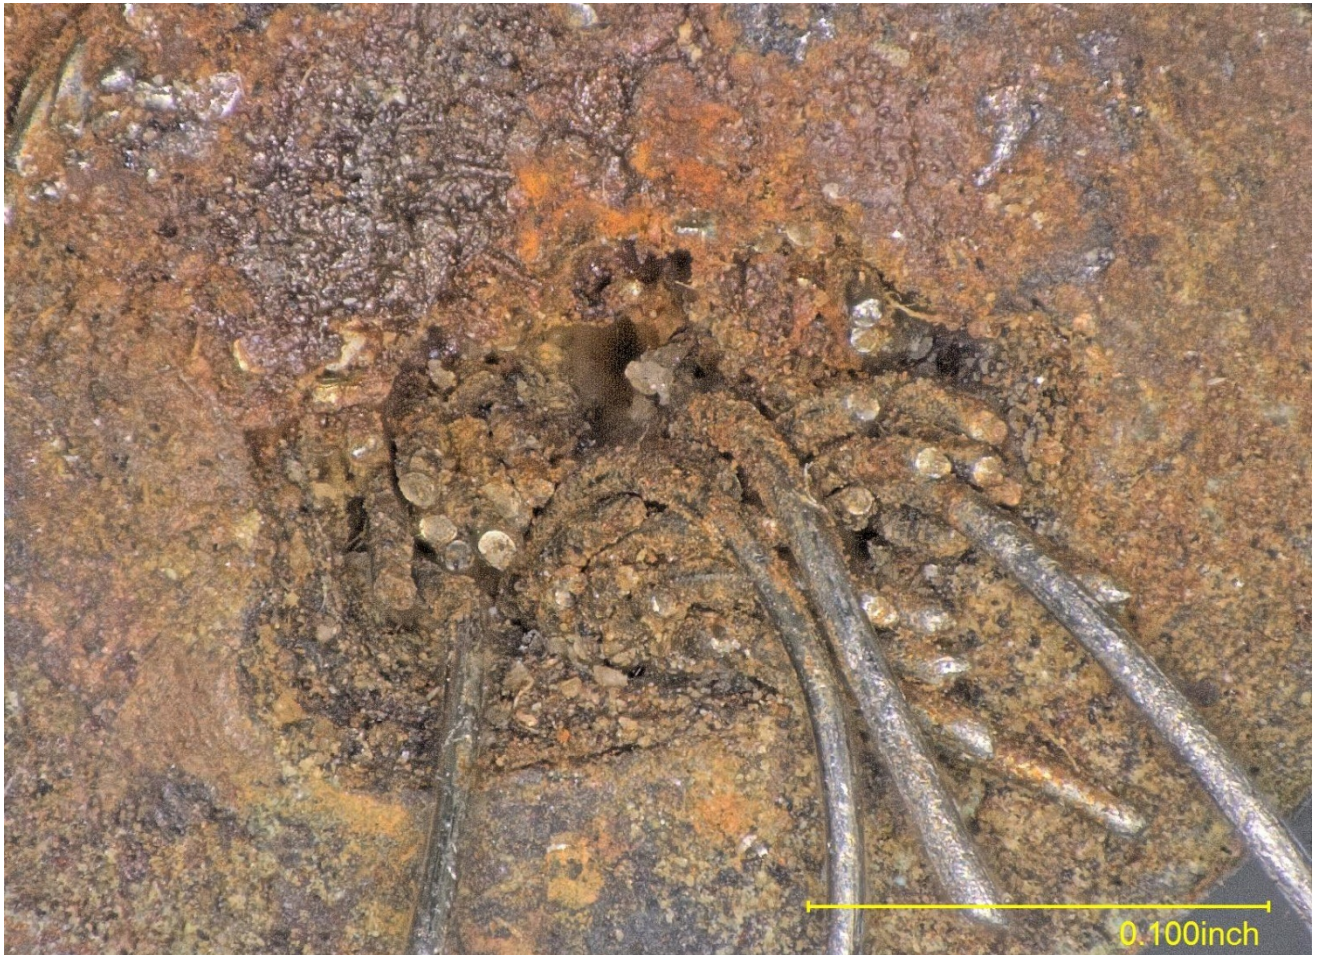
with iron oxide (rust), as later confirmed using energy dispersive x-ray spectroscopy (EDS).

Figure 3 – Closer view of the fractured wires from the cable bundle in Figure 2, as received.

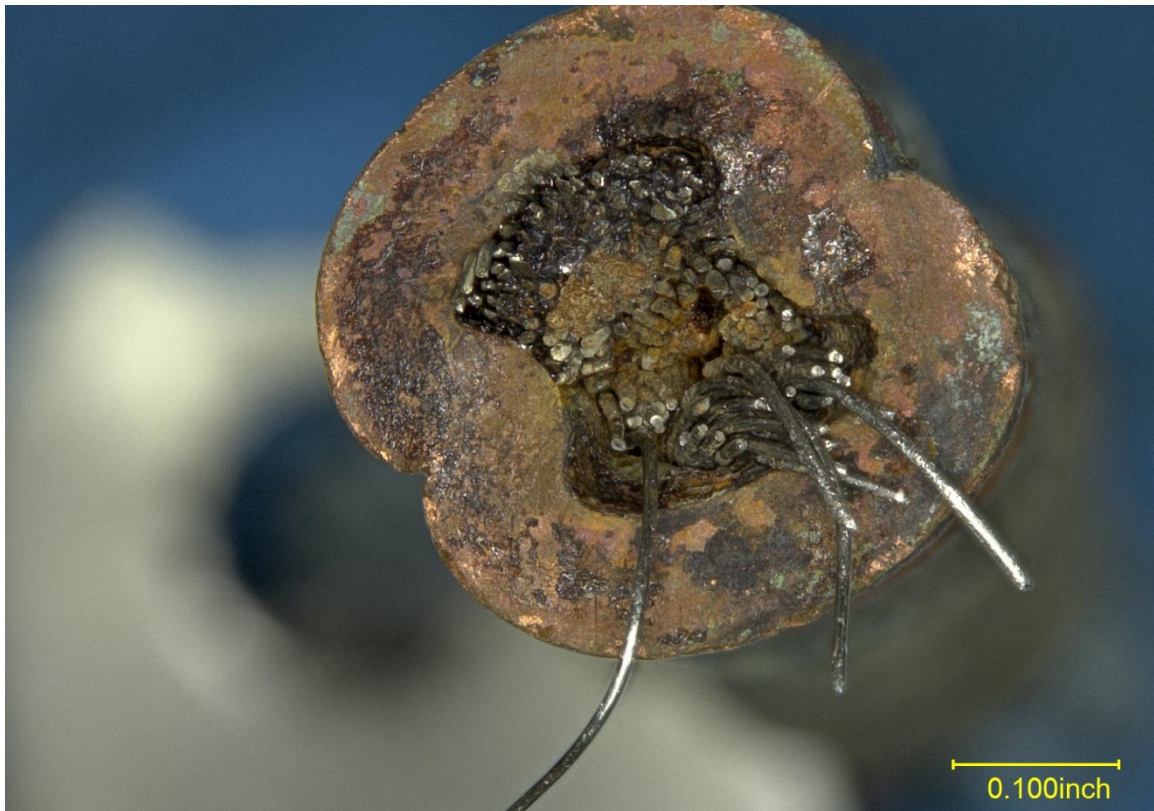
This oxide was removed using an ultrasonic bath of acetone followed by a dilute solution with Evapo-Rust.<sup>1</sup> Figure 4 shows the outboard swaged end after this cleaning procedure. The swaged fitting had been deformed, consistent with having been pressed inward from opposite sides. This left the wire bundle arranged in a rounded-I shape. Figure 5 shows a closer view of the wire termini. These ends were consistent with having fractured. The wire ends were generally oriented in random directions, with the exception of the longer wires, shown on the right in Figure 5. These were generally bent outward. Towards the interior of the swaged coupling, the wires generally exhibited a spiral orientation, consistent with wire twisting during cable manufacture.

Figure 4 – View of the cable bundle fracture surface, after cleaning to remove corrosion.

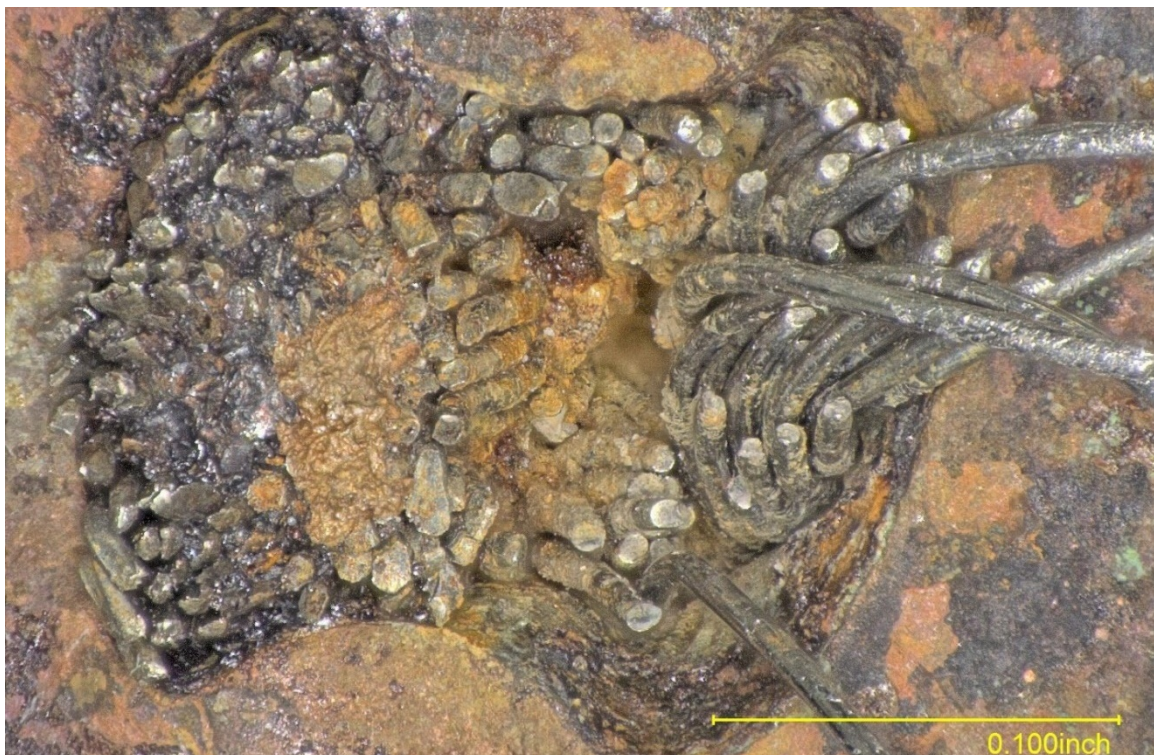
Figure 5 – Closer view of the fractured wires of the cable bundle, after cleaning.

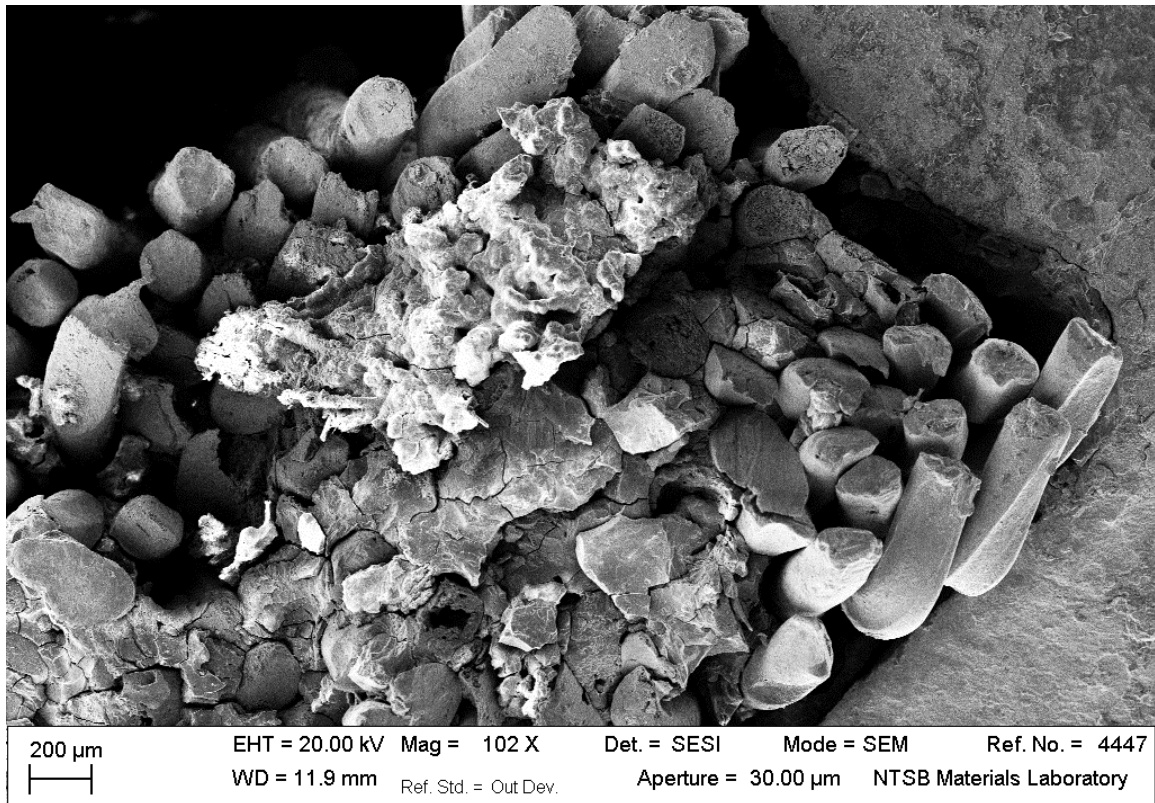
This swaged cable end was sectioned from the rest of the remnant and was examined using a scanning electron microscope (SEM). An outer and center cluster of the wire fracture surfaces are shown in Figure 6 and Figure 7, respectively. Figure 8 shows a typical cluster of fractured wires. These ends were generally smooth, consistent with the destruction of fracture features from rubbing or oxidation. The sides of several of the wires exhibited crescent-shaped divots and triangular-shaped ends. These features were consistent with material loss from wear during repeated contact with adjacent wires.

Figure 6 – Secondary electron (SE) micrograph of the wire fractures of the cleaned cable bundle.

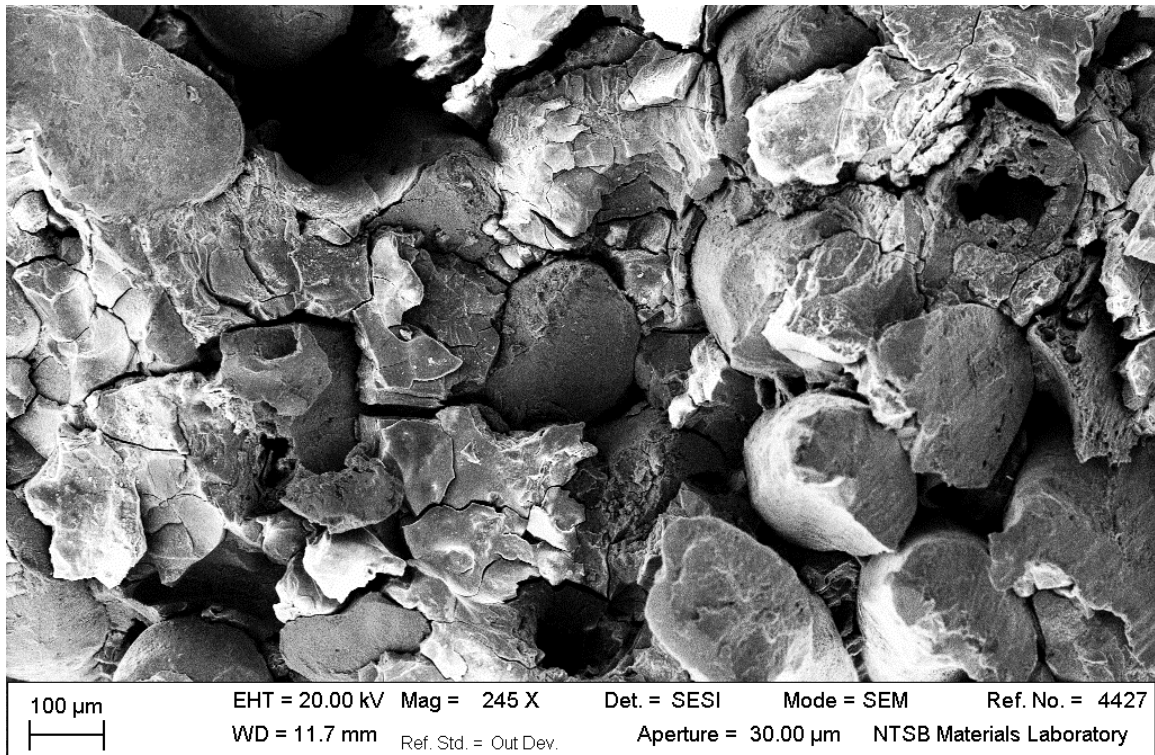
Figure 7 – SE micrograph of a closer view of the center wire fracture surfaces.

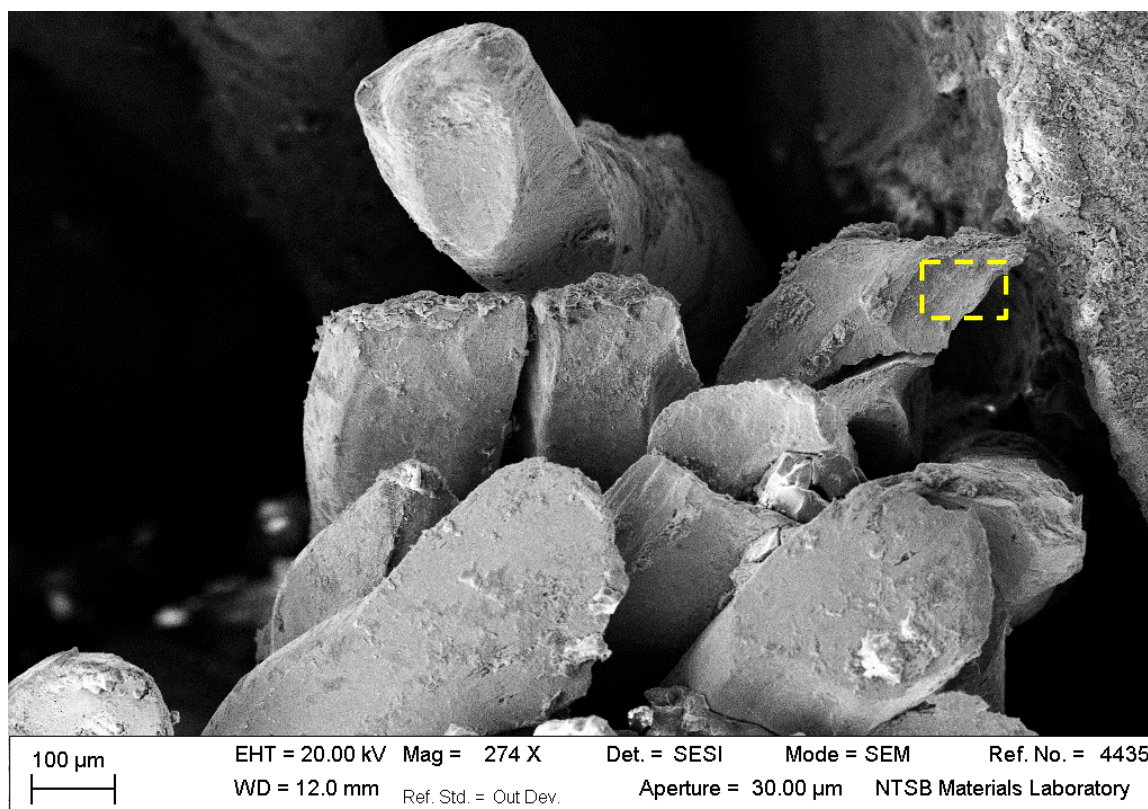
Figure 8 – SE micrograph of several wire fractures, showing pinching and rubbing wear. The boxed area is shown in Figure 9.

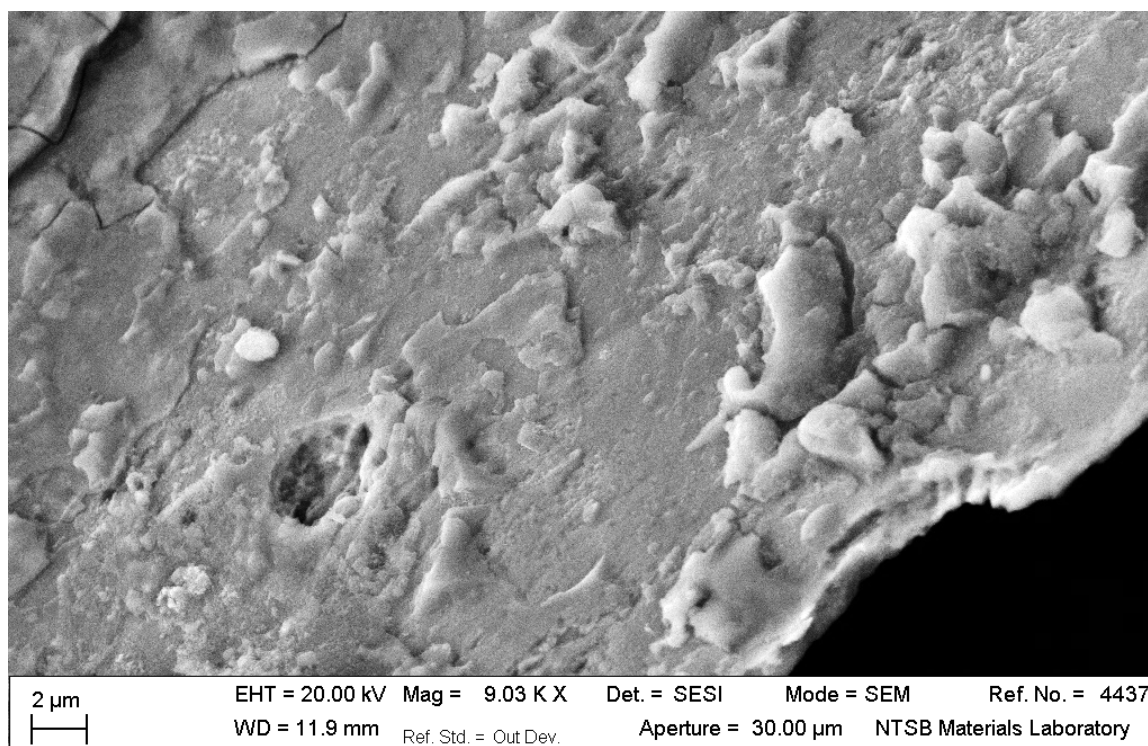
The relatively undamaged ends of the wire fracture surfaces (such as the yellow box in Figure 8) were examined more closely. As shown in Figure 9, the end surface features were consistent with elongated dimple rupture, indicative of overstress fracture in shear. Figures 10 and 11 show a closer view of one of the crescent-shaped wire ends. The fracture surface exhibited multiple streaks on the surface, consistent with post fracture smearing. The undamaged area, highlighted in Figure 12, exhibited dimple rupture features, consistent with fracture from tensile overstress.

Figure 9 – SE micrograph of one of the above wire fractures, showing dimple rupture.

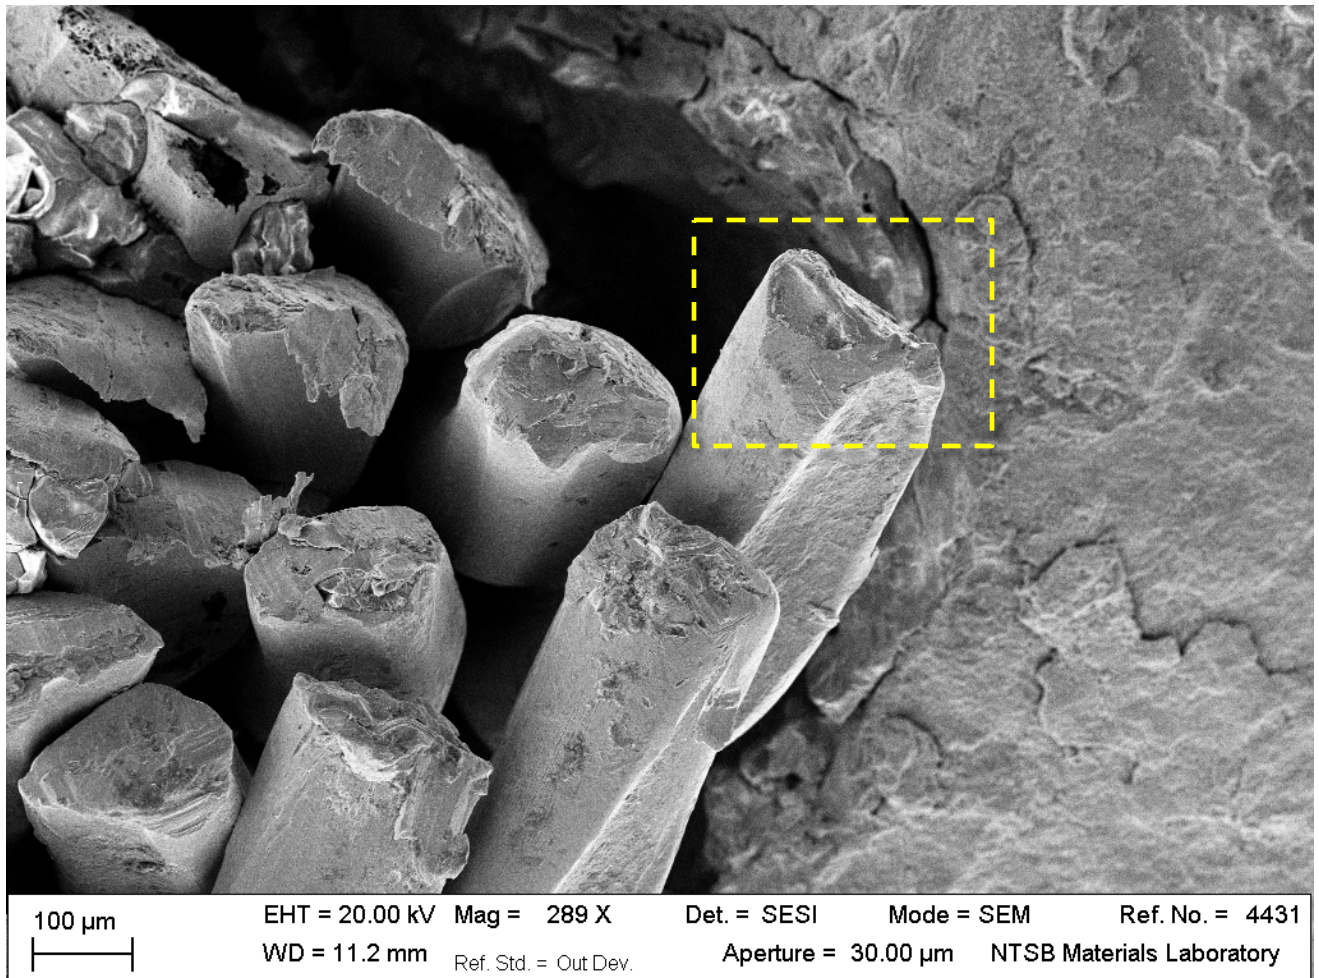
Figure 10 – SE micrograph of the wires to the right in Figure 6, showing rub wear and necked material near the fracture surfaces. The boxed area is shown in Figure 10.

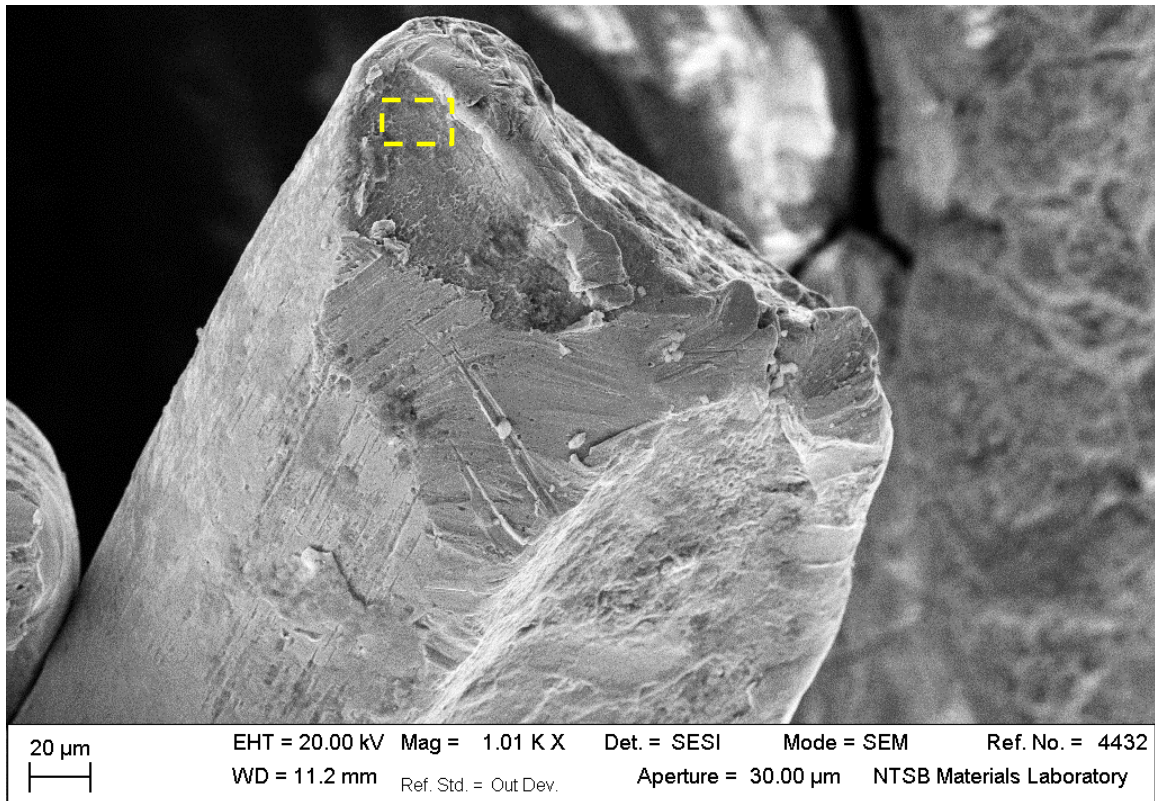
Figure 11 – SE micrograph of the boxed area in Figure 10, showing the wire fracture surface. The boxed area is shown in Figure 12.

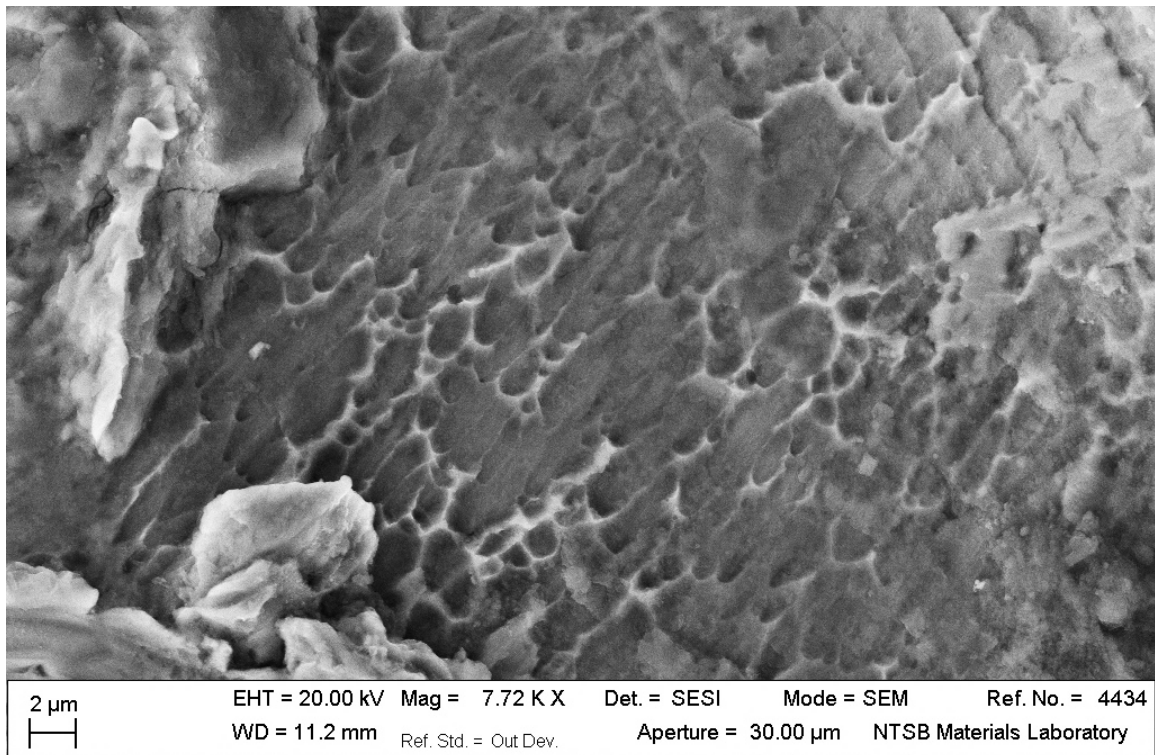
Figure 12 – SE micrograph of the boxed area in Figure 11, showing dimple rupture.

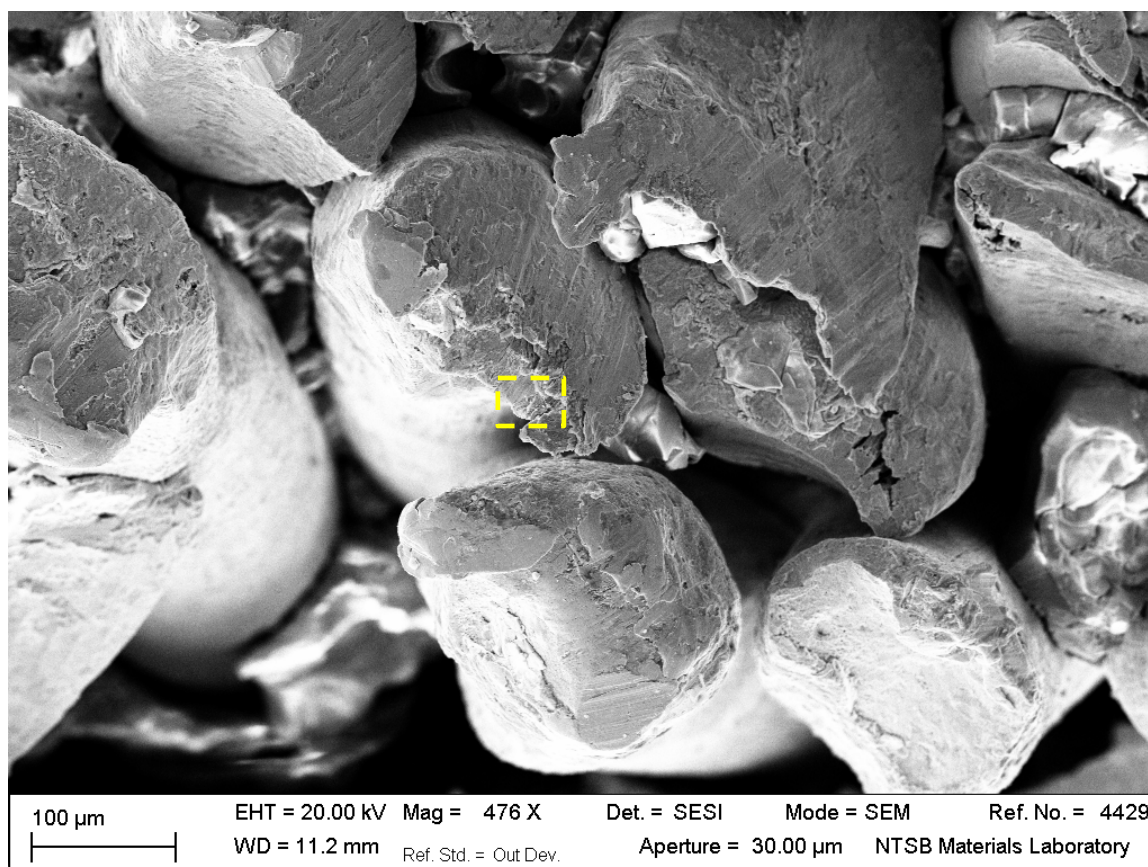
Figure 13 shows a cluster of wire ends that had narrowed at the ends with some material bulging out the sides. The ends of these wires exhibited a slight bend in one direction. The ends exhibited streaks parallel with the wire longitudinal direction. A closer view of the undamaged portions revealed dimple rupture, as shown in Figure 14. This cluster of wires was consistent with overstress fracture after pinching or cutting.

Figure 13 – SE micrograph showing a series of smeared wire fractures. The boxed area is shown in Figure 14.

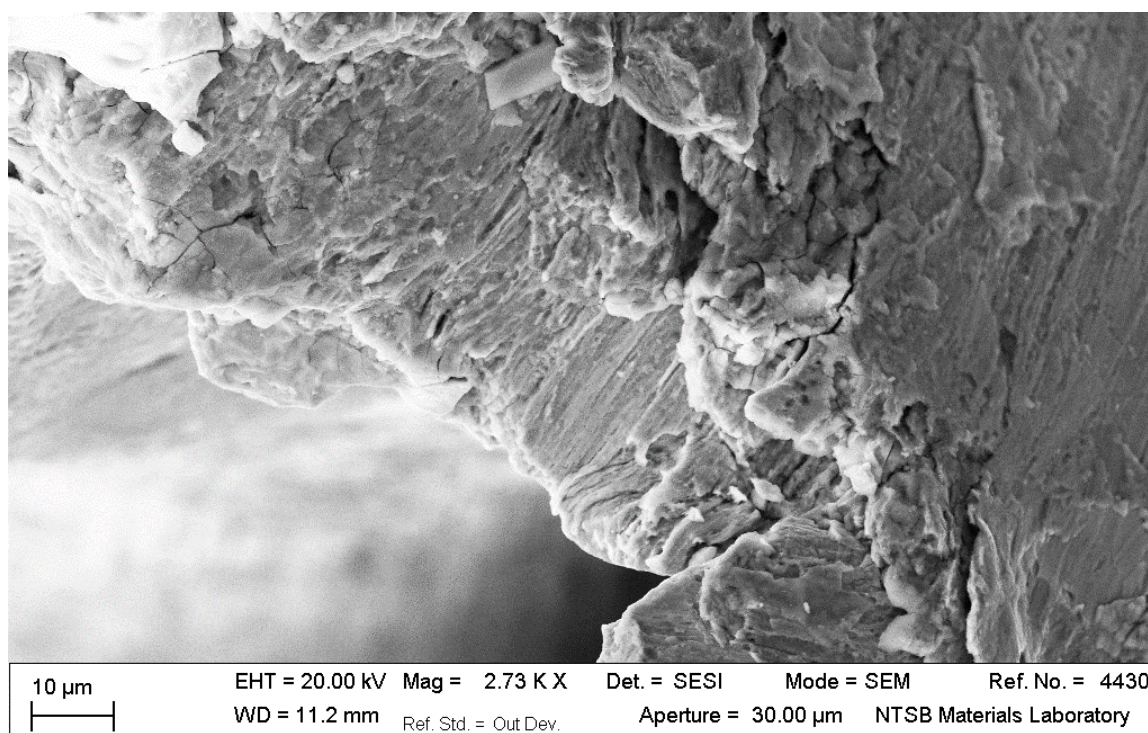
Figure 14 – SE micrograph of the boxed area in Figure 13, showing dimple rupture.

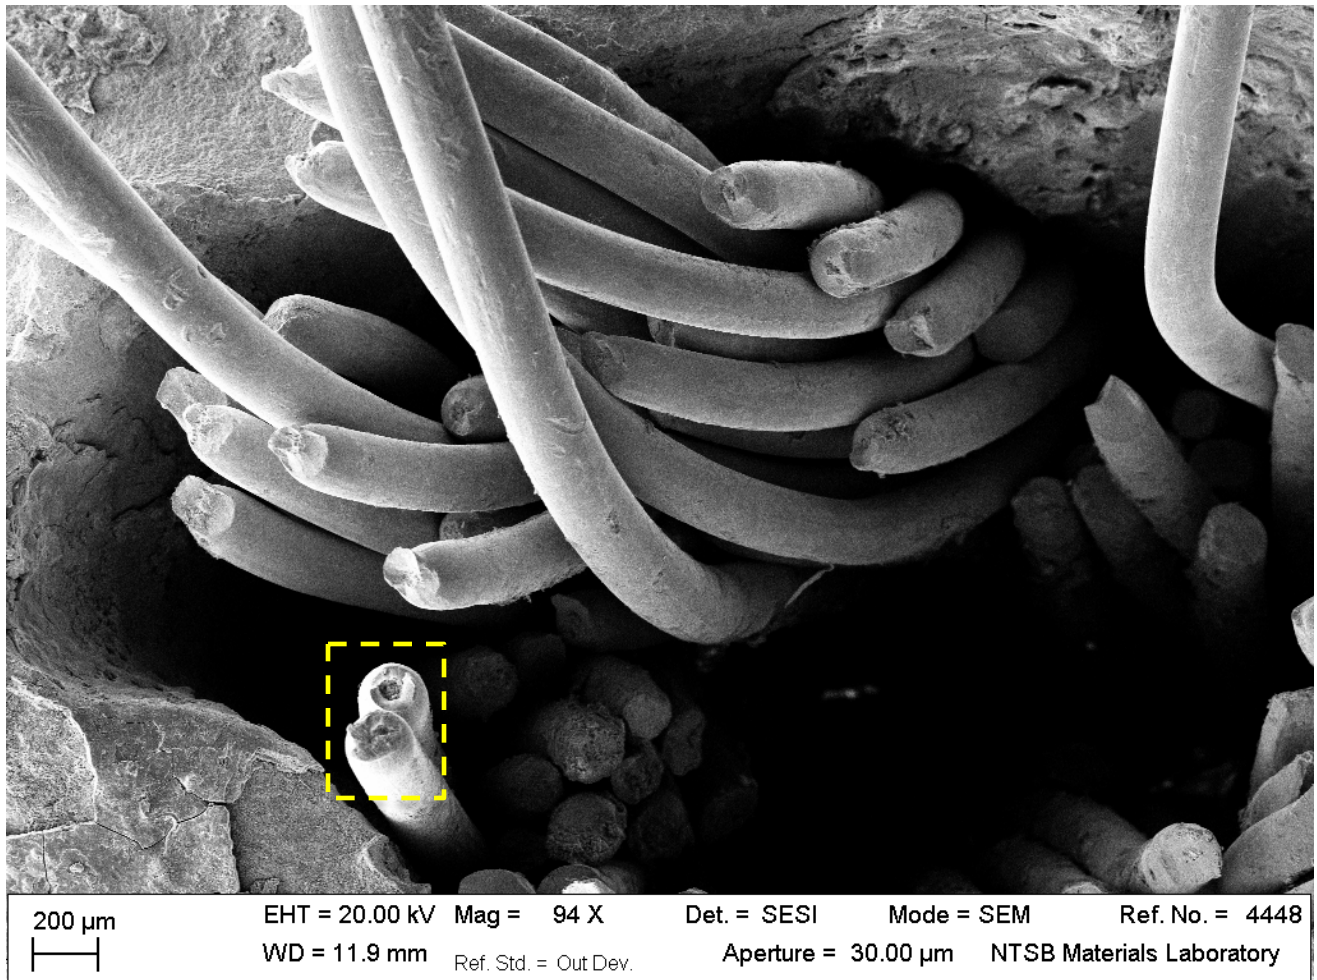
The cluster of longer wires on the side consistent with wire pullout is illustrated in Figure 15. A pair of the less damaged wires, highlighted by the yellow box in Figure 15, are detailed in Figure 16. The wire fractures exhibited a cone shapes, and the wires had exhibited necking adjacent to the fracture surfaces. Examination of the fracture features revealed dimple rupture, consistent with tensile overstress (see Figure 17).

Figure 15 – View of the wire fractures in the upper part of Figure 6, showing cup and cone fractures. The boxed area is shown in Figure 16.

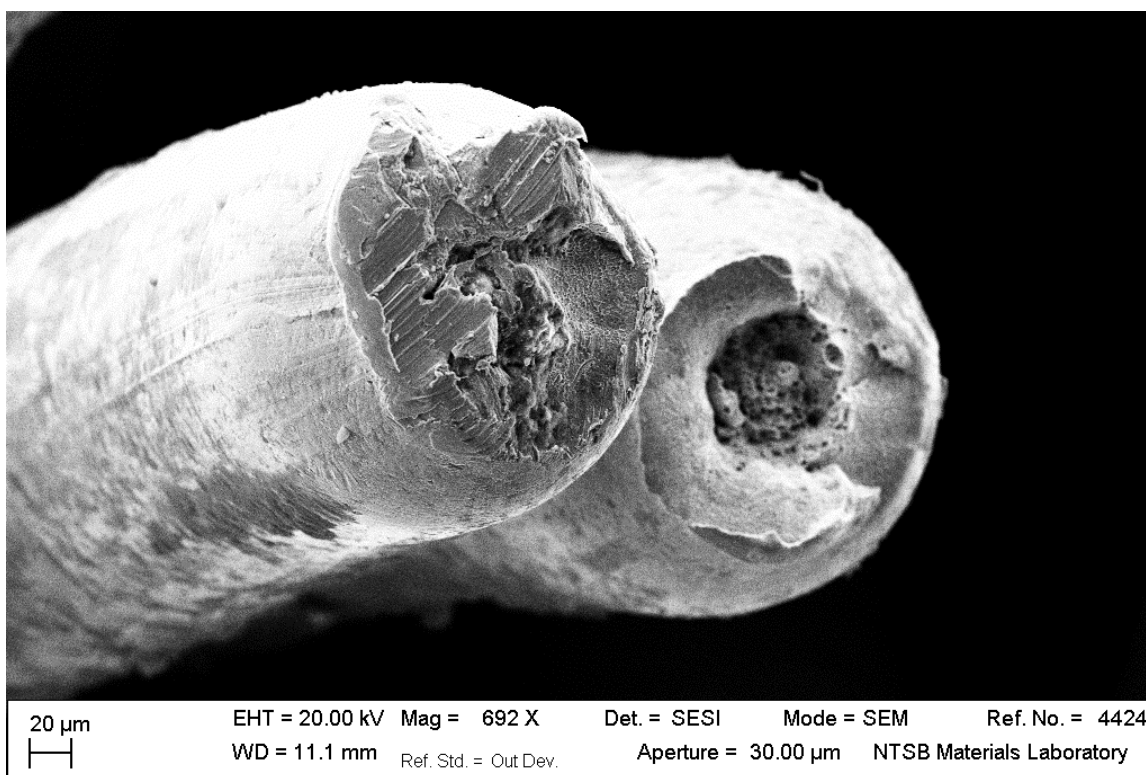
Figure 16 – SE micrograph of the boxed area in Figure 15, showing two necked fractured wires.

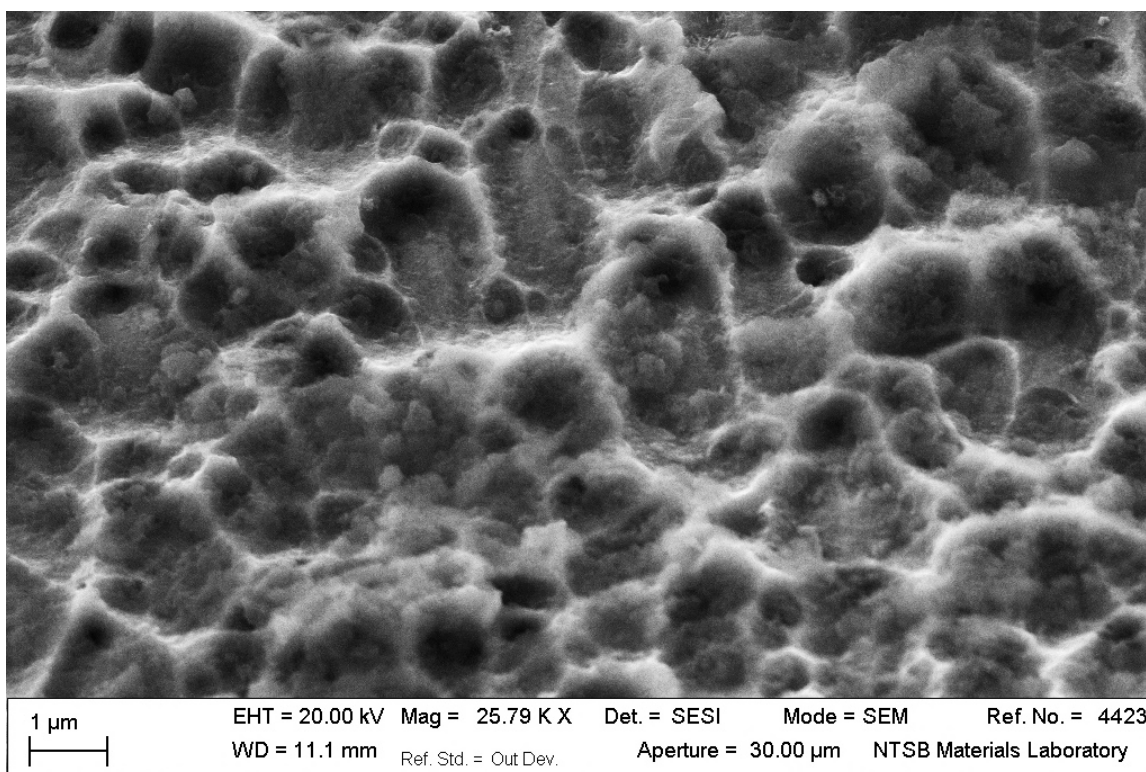
Figure 17 – SE micrograph of the right fracture in Figure 16, showing dimple rupture.

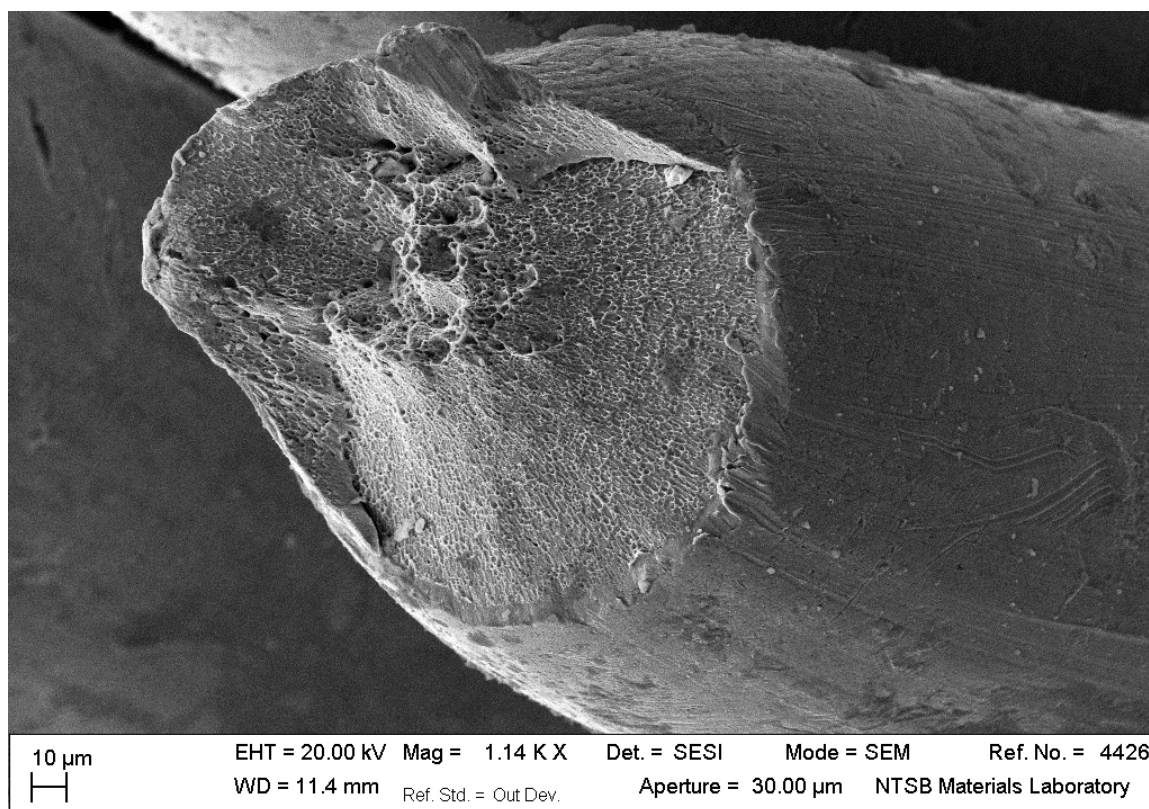
The fracture surfaces of longer wires shown in Figure 15 were examined and exhibited characteristics typified in Figure 18. The fractures were rough in orientation, with a downward-to-flat angled fracture on one half (to the right in Figure 18), and an outward

remnant angled in the opposite direction on the other half (to the left in Figure 18). The fracture features present on these wire ends were consistent with dimple rupture, as typified in Figure 19.

Figure 18 – SE micrograph of a slant wire fracture surface.

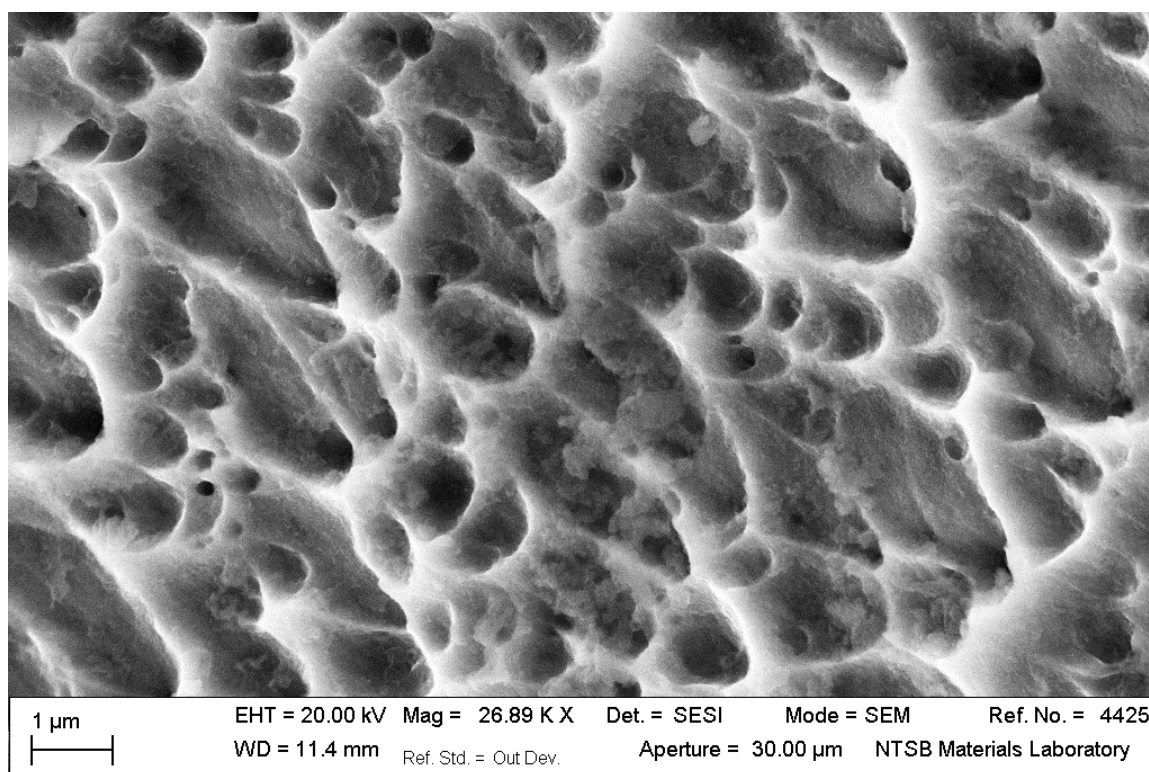
Figure 19 – SE micrograph of a closer view of Figure 18, showing slanted dimple rupture.
