## Report of Accident Investigation

Date of Accident: 11 January 2018, 1350

Name & Project Location: Grid Repair Puerto Rico, Contract: W912DY-18-F-0003; Caguas Area Line 50800 (18.24153, -65.81926)

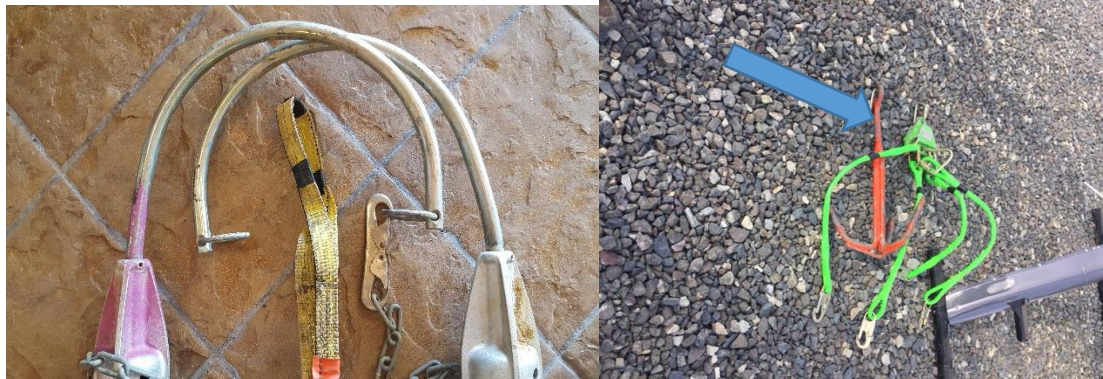
Ladder hooks &amp; Lanyard

Grapple &amp; A-frame

(NOTE: A frame is used to carry personnel while a grapple is used to move cable and equipment. Positive safe connection, required by fall protection standards for personnel cannot be obtained using a grapple.)

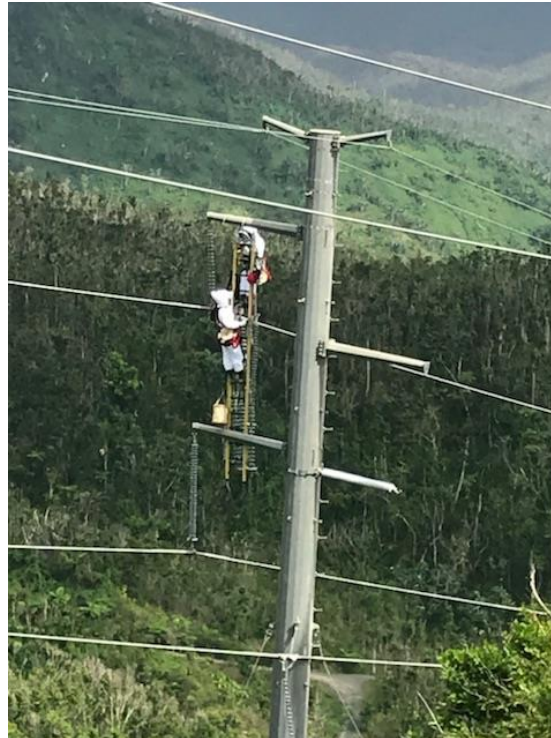
Lineman 1 & Lineman 2 on Pole 2  
11 January 2018

1350 – Time of accident. According to eye witnesses the ladder was situated on the top arm on the left side of the pole. Lineman 1 was stationed on the ladder while Lineman 2 was on the middle arm on the right side of the pole. Pilot once again presented the grapple to Lineman 1 and he attached it to the lanyard on the ladder. One of the safety chains on the ladder was still connected to the arm as Pilot began lifting the ladder. We believe that Lineman 1 communicated with Pilot to stop lifting the ladder while he unlatched the safety chain. The assumption is that Pilot noticed Lineman 1's actions and began to lower the ladder. At this point the board concludes that the hooks on the ladder rested on the top of the arm and the grapple continued in a downward motion which caused it to slip off the lanyard causing Lineman 1 and the ladder to fall to the ground.
