# **NATIONAL TRANSPORTATION SAFETY BOARD**

## **ENGINE and FUEL SYSTEM**

### **Factual Report**

NTSB Number: ERA18LA097

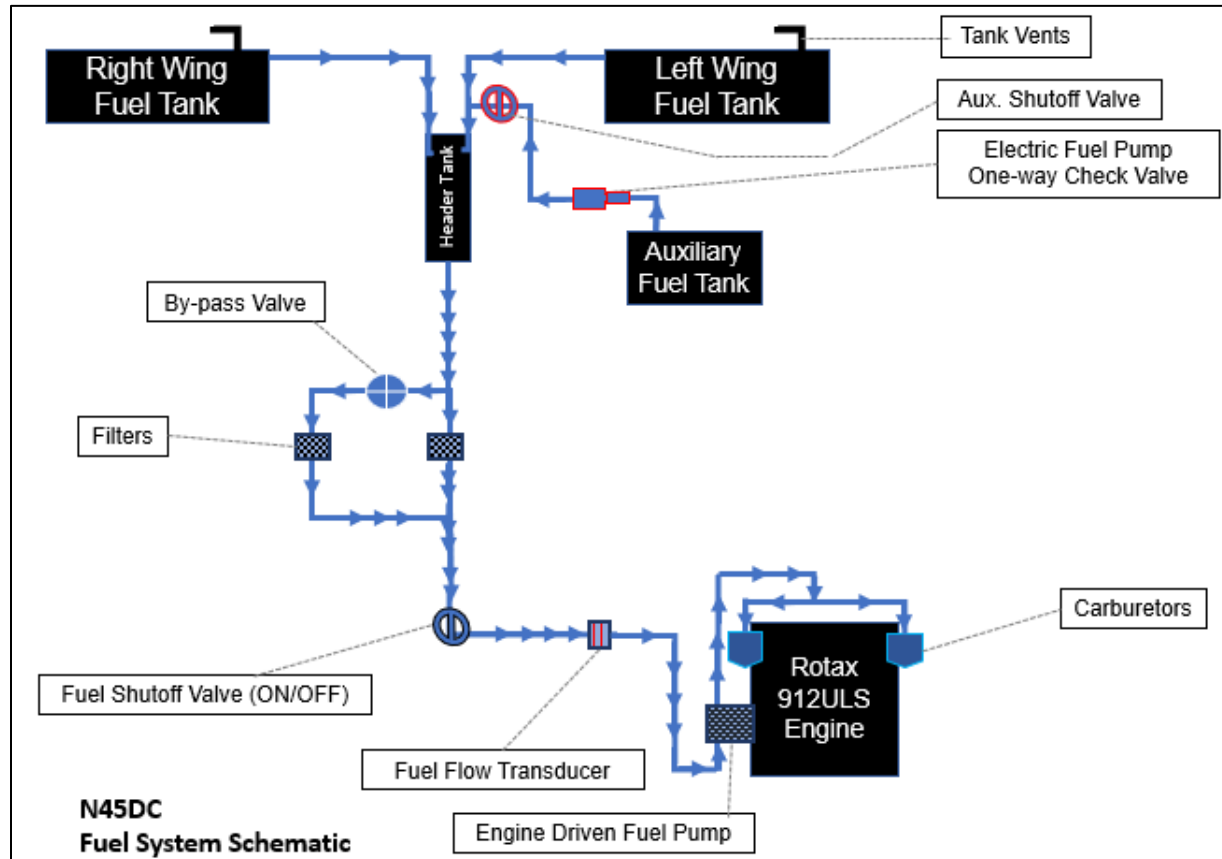
Figure 1: N45DC Fuel System Schematic

and a fuel shutoff valve, which could only shutoff the fuel from the auxiliary tank. Refer to figure 1 for a fuel system schematic, sketched by the investigative team.
