**NATIONAL TRANSPORTATION SAFETY BOARD**  
Office of Aviation Safety  
Washington, D.C. 20594

**Electronic Flight Instrument System  
Engine Monitoring System  
Cockpit Display Electronic Device**

**Factual Report  
By Adam M. Gerhardt**

Location: Palatka, Florida  
Date: March 6, 2018  
Aircraft: REILLY CHARLES W., ESCAPADE  
Registration: N45DC  
Operator: Individual  
NTSB Number: ERA18LA097

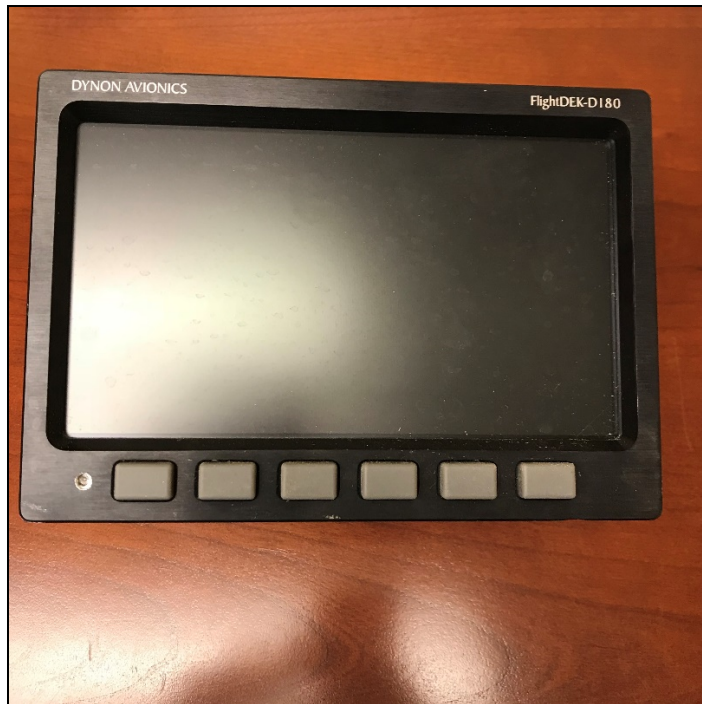
The device was undamaged and was downloaded normally using the manufacturer's software. Figures 1 and 2 show the front and back of the device.

**Figure 1: Photo of the front of the undamaged device.**

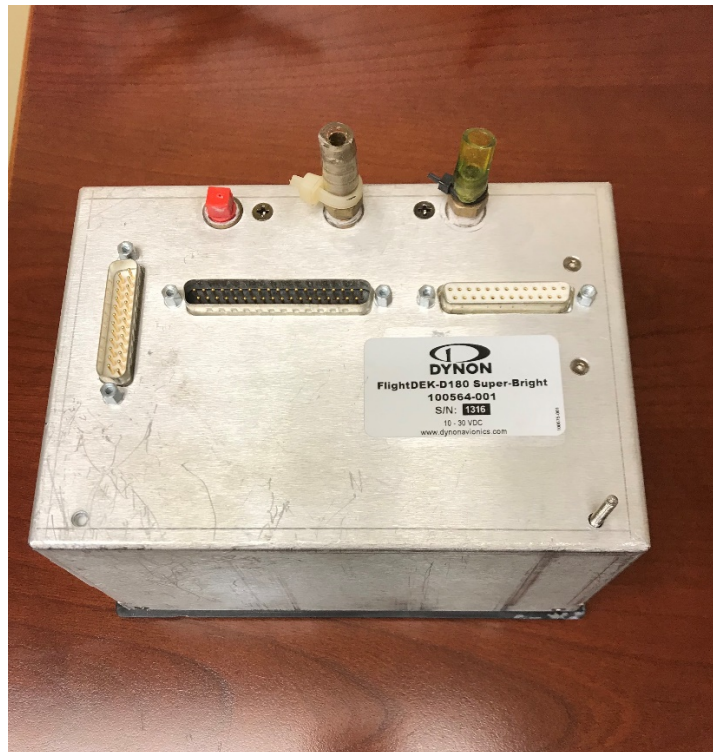
**Figure 2: Photo of the back of the undamaged device.**

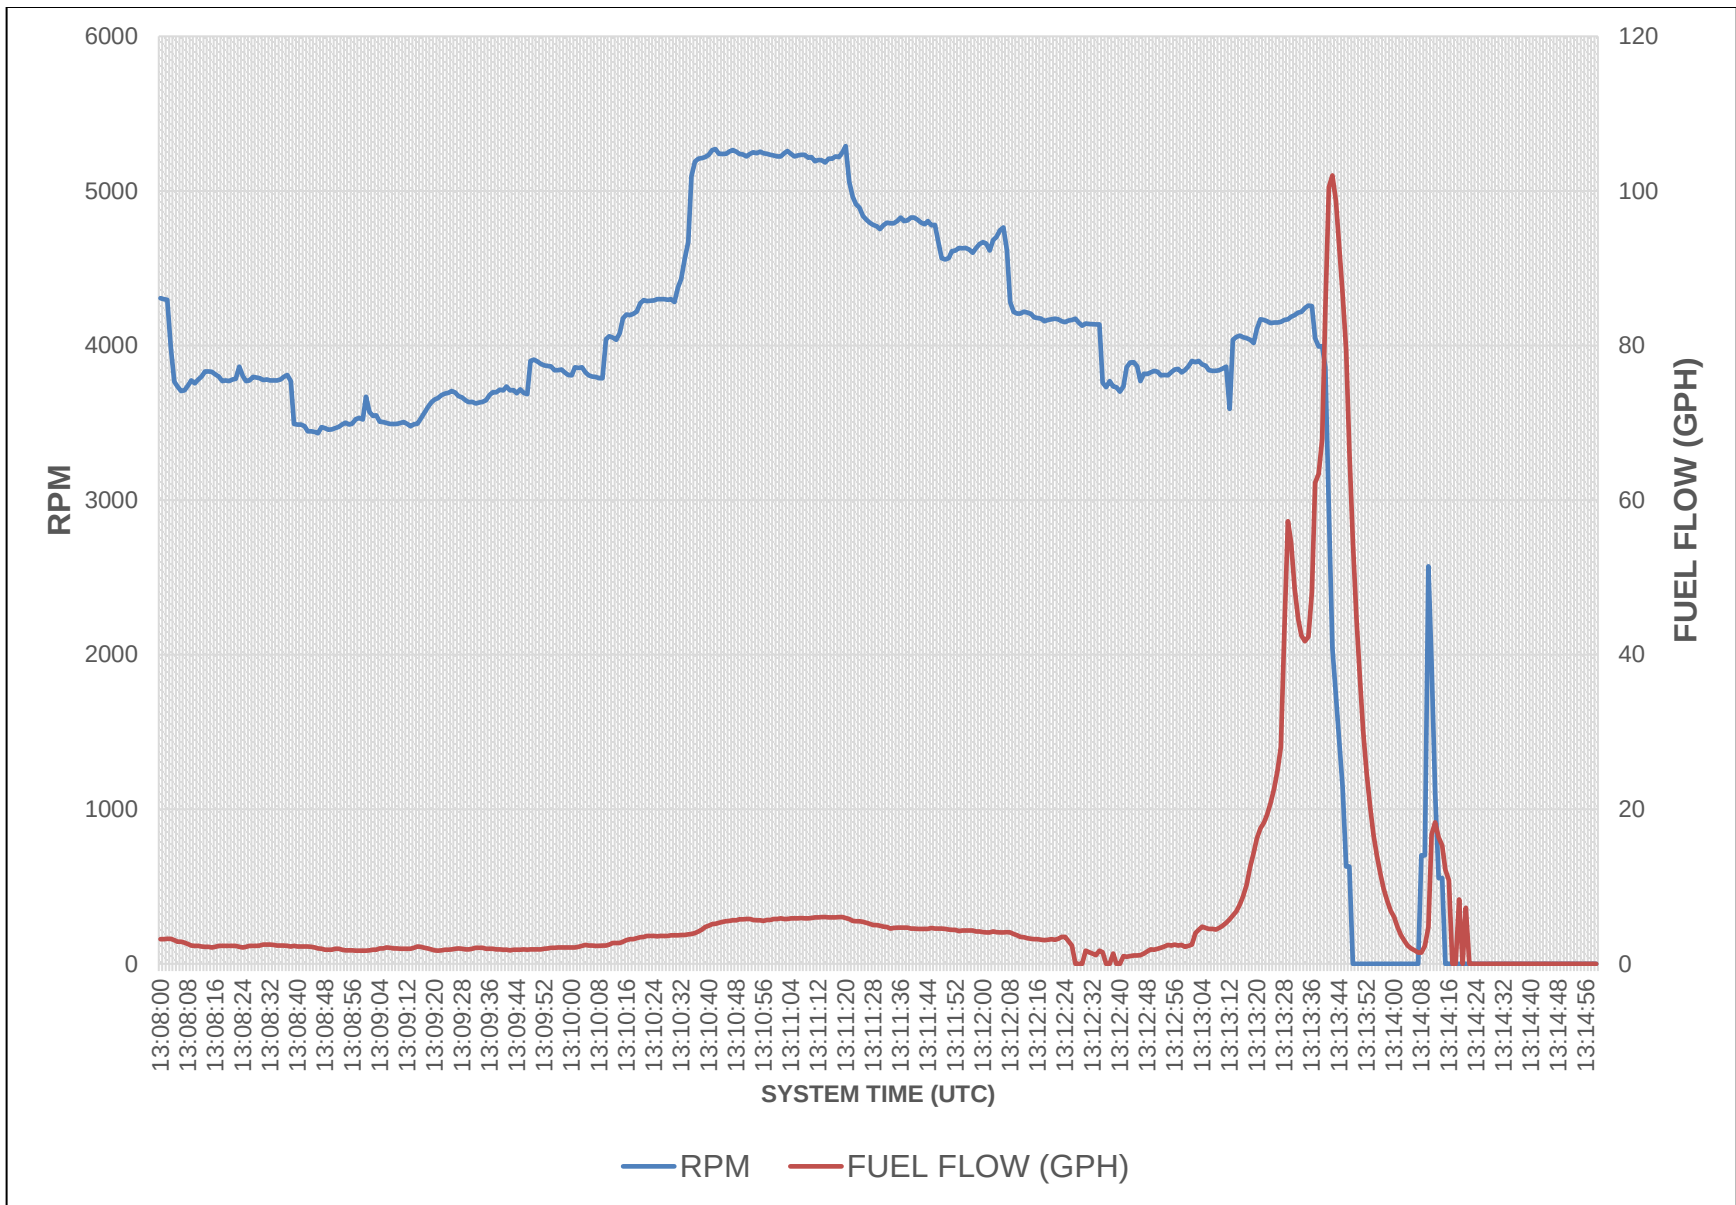
Figure 3: Fuel Flow and RPM Data

- Between 13:13:40 – 13:14:15, the rpm, manifold pressure, oil pressure, and exhaust gas temperatures each show abrupt variations. At 13:13:48 the RPM was 0. Following the rpm drop, indicated airspeed decreases, altitude sharply decreases, and the vertical speed rate sharply decreases.

- Preceding the first 0 rpm reading that occurred at 13:13:48, about one minute and twenty seconds prior, at 13:12:27, fuel flow dropped to 0 momentarily, then returned to 2-GPH. About 50 seconds later, at 13:13:16, fuel flow increases rapidly through 8 GPH, then 13 seconds later shows 57 GPH, and peaks at 102 GPH at 13:13:41. The fuel flow then rapidly declines to 1.5-2.0 GPH at 13:14:10, then spikes to 20 GPH, and then drops to 0 for the remainder of the recording.

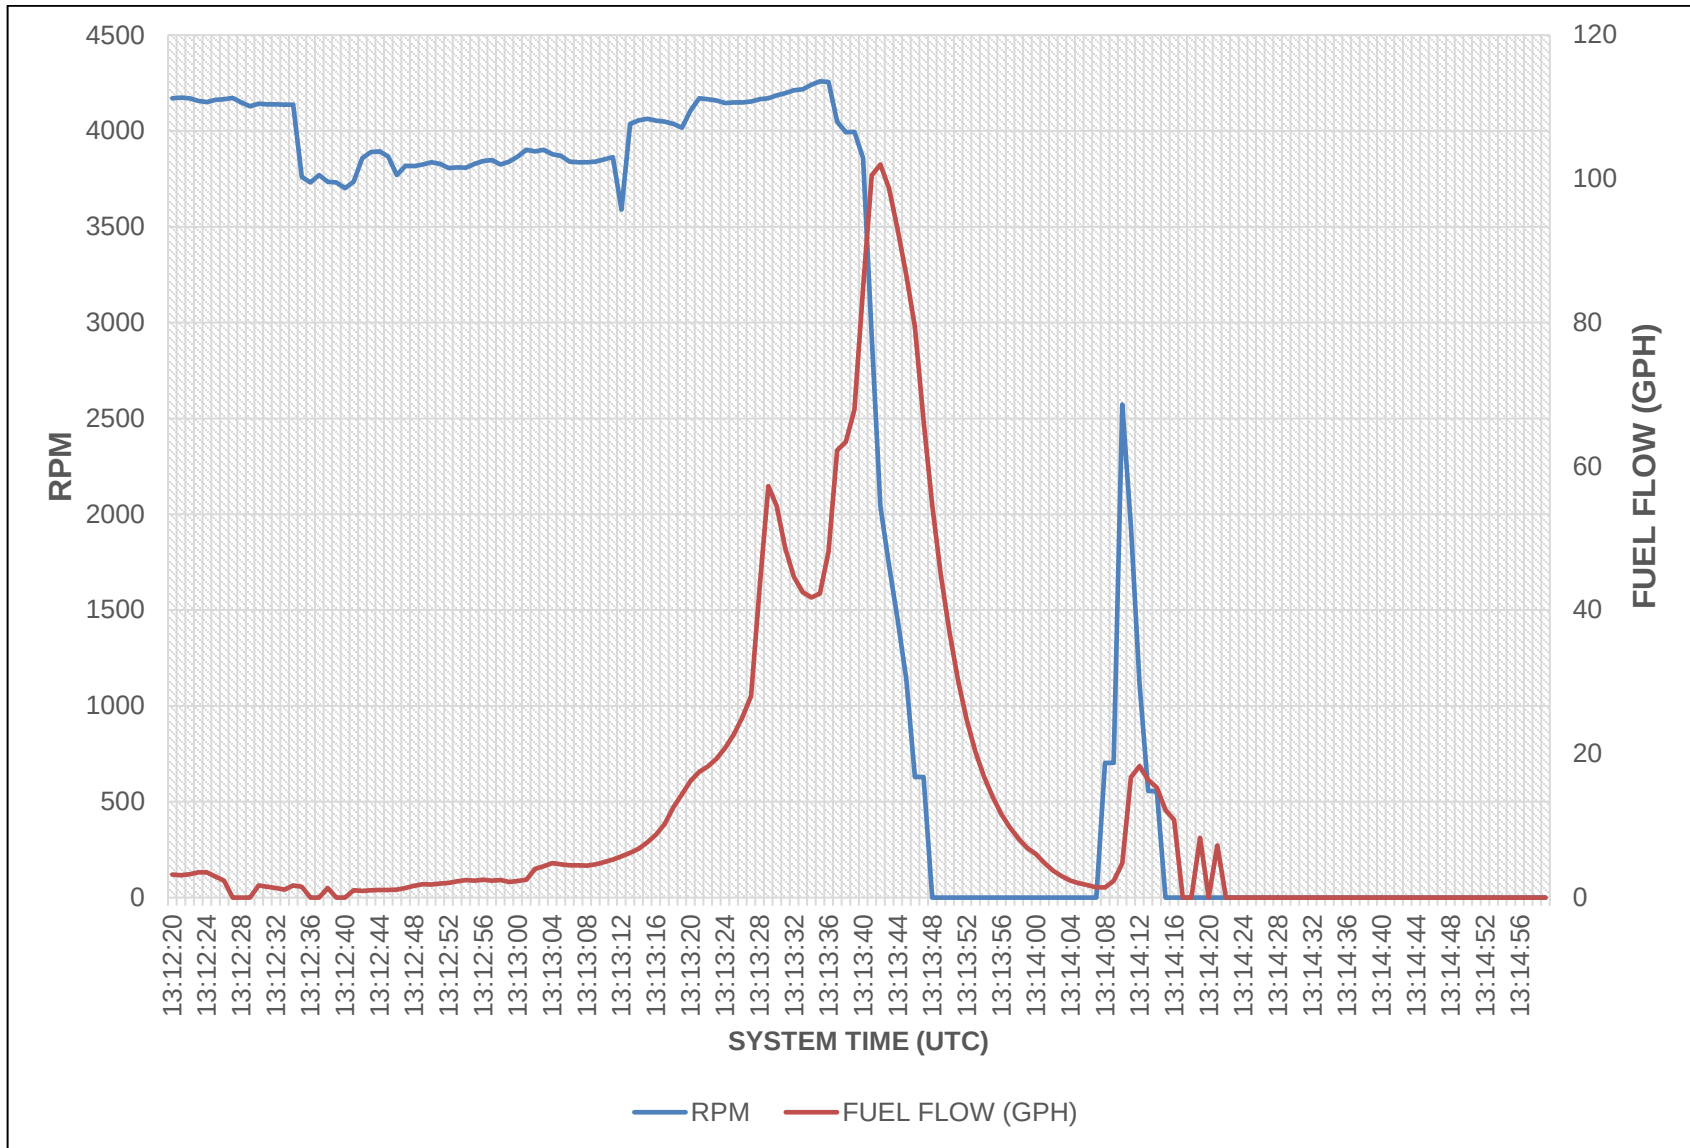
**Figure 4: Fuel Flow and RPM Data, Last Two Minutes of Flight**

- About 13:14:10, rpm spikes from 0 to 2500 rpm momentarily, but returns to 0 about five seconds later for the remainder of the recording, where the airspeed data showed 0 and altitude levels at 99 for the remainder of the recorded data.
