## **NATIONAL TRANSPORTATION SAFETY BOARD**

# **ENGINE EXAMINATION**

**ERA18LA103**

The engine was separated from the airframe and shipped to Continental Motors, Inc for examination/engine run. The engine is a six-cylinder Continental TSIO-520 engine.

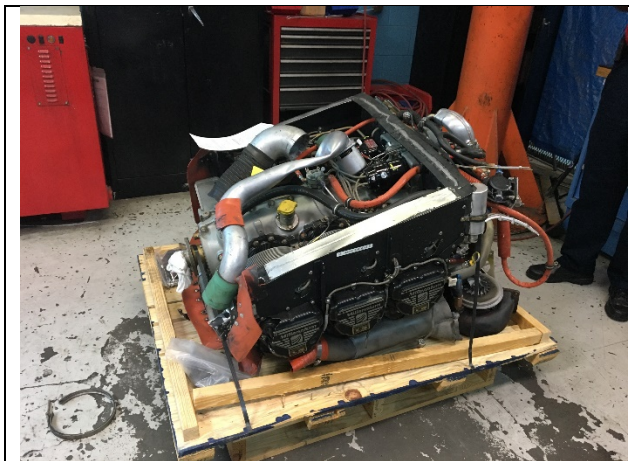
Overall condition of the engine, when the shipping crate was opened.

Exhaust/turbo components were separated from the engine and was in the shipping crate.

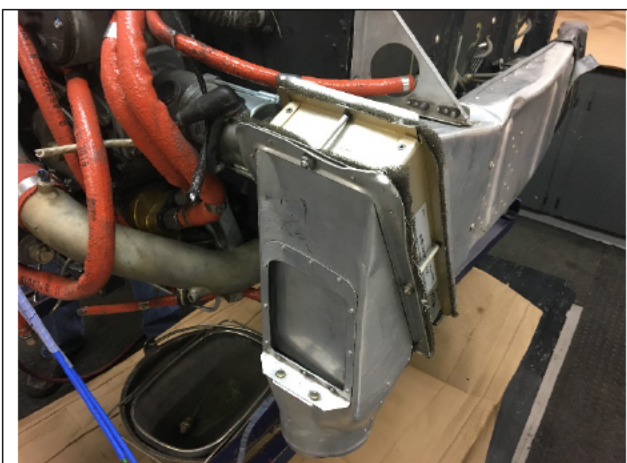
In order to accommodate an engine run, the following items were removed/corrected.

The engine intake/plenum system was removed

The #6 cylinder valve cover was replaced.

The engine's cooling baffling was removed

#4 bottom ignition lead was repaired

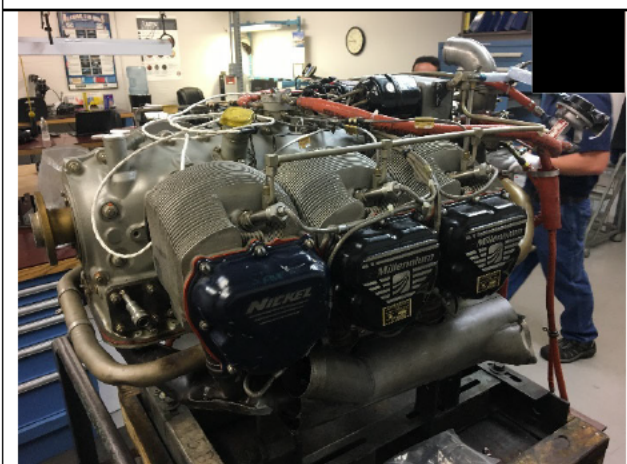
Vacuum pump, alternator, propeller governor were removed

Engine oil was drained; water was observed in the oil

It was also noted that the back of the engine, (damage to throttle bracket and a pulley, etc), had sustained an impact.

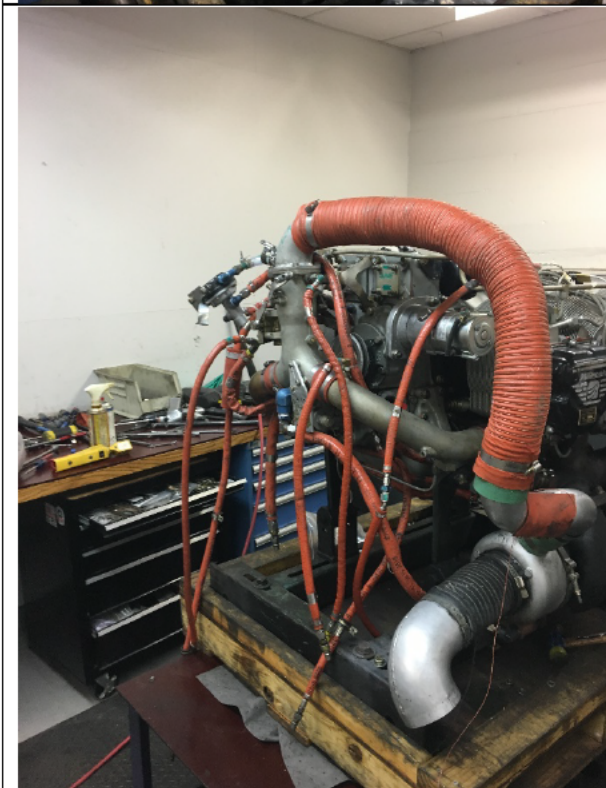
The left side induction tube (connected to the throttle body) was replaced.

Piping to the turbo was installed along with a SCAT tube to the throttle body. The turbo pressure relief valve ("pop off" valve) and tubing was not installed, due to damage to the tubing.

Several additional lines, such as fuel, oil lines were connected to the engine

The exhaust stack on the right side was loose, it was assumed this was done during engine removal from the airframe. The exhaust pipes received impact damage, and a small hole in the pipe, on the left-front side was plugged with JB weld.

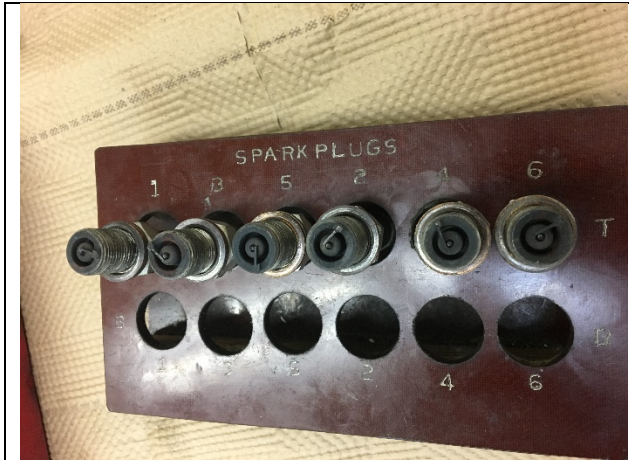
The top set of sparkplugs were removed, the plugs had a black color to them; however, it was noted that the engine was run after the accident and prior to the exam/run at CMI.

A cold compression test was done:

21/59/9/25/58/35

After the engine run the compression test was redone, with a “hot” engine

65/65/59/66/70/74

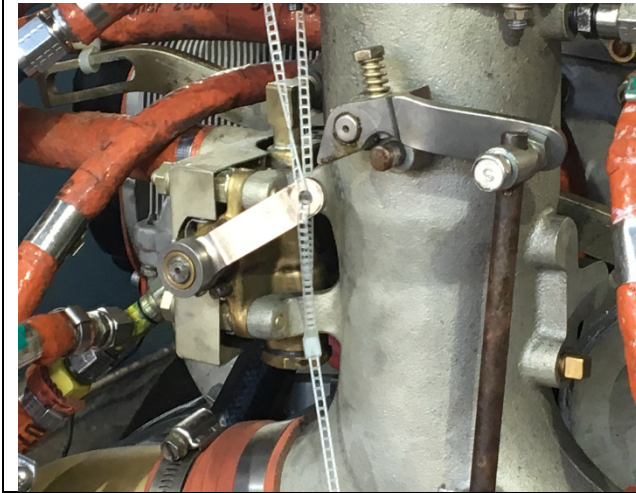
The mixture control was initially “wired” to the full rich position, for the test.

As tested the engine timing was set at 23 degrees. (timing per dataplate is 20 degrees)

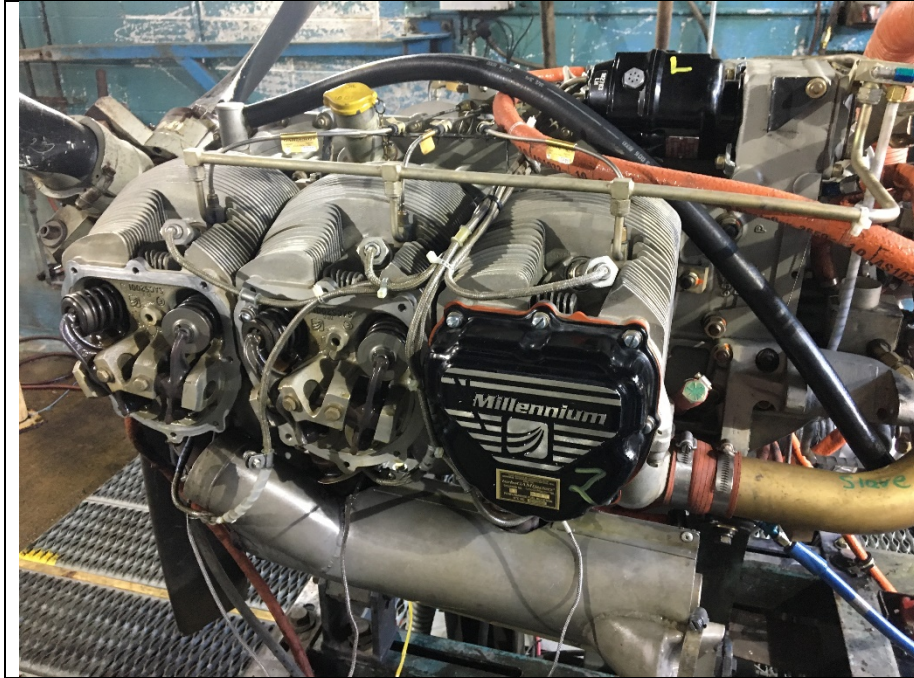
During the set-up it was noted that a fuel and oil were leaking from the engine. A fuel line was replaced, along with valve cover/gaskets.

However, a slight oil leak remained during the test. The oil leak was attributed to impact damage during the accident.

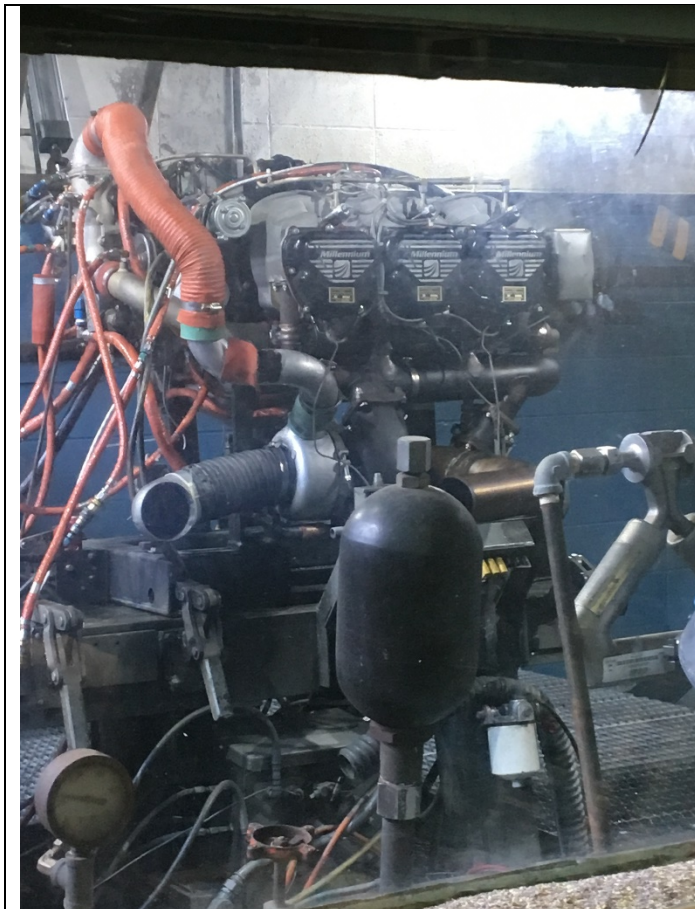
Engine during test run.

The engine started and was run through a series of test points.

The engine would not run to full power settings; the engine appeared to be running too rich. Though the engine would not produce full power, the engine did not "quit".

The fuel pump was adjusted (4 turns – lean) additionally, the propeller pitch was reduced by 1 degree.

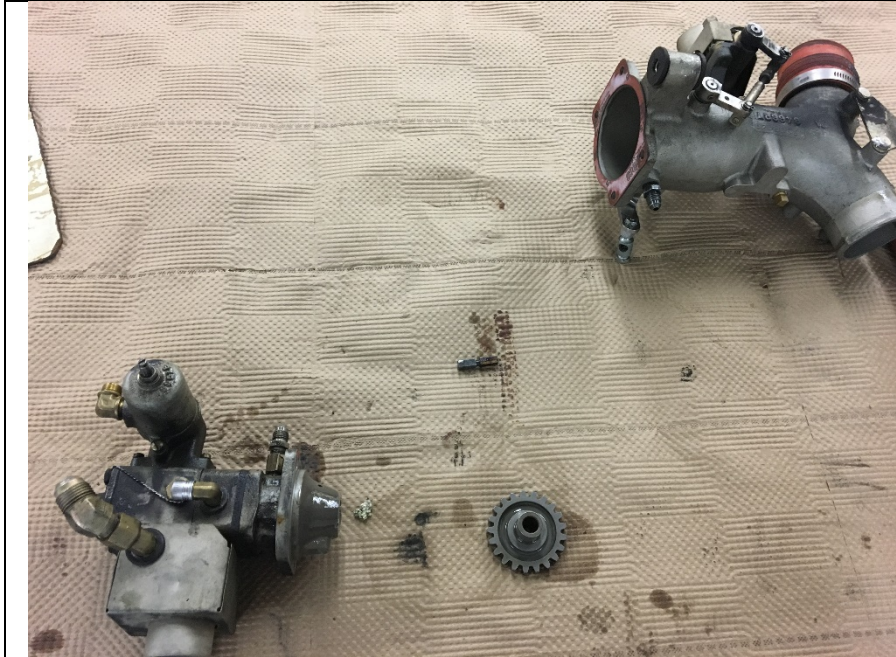
After the test run, the throttle body and fuel pump were bench tested; the units failed to meet production standards for both units.

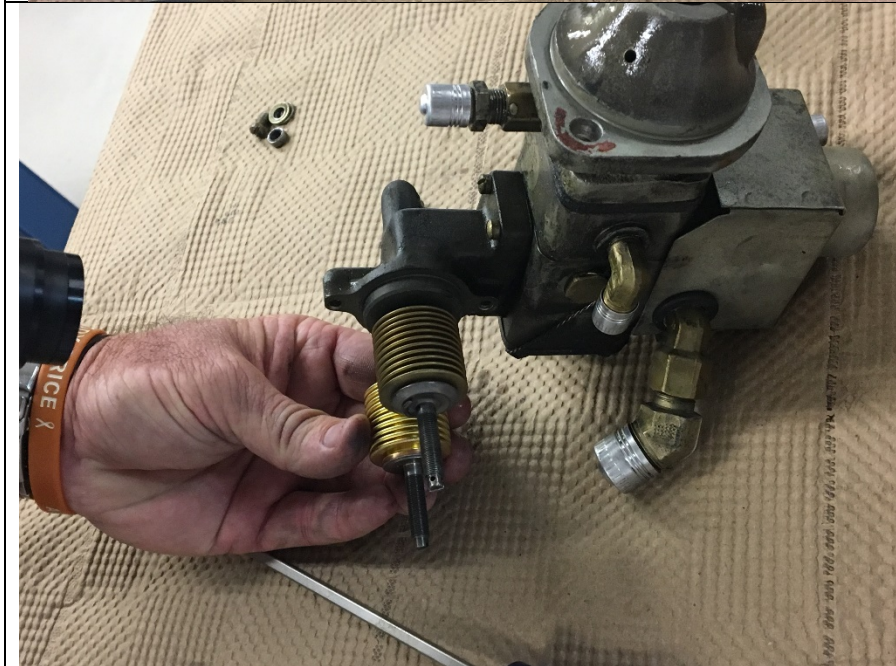
The aneroid on the accident engine fuel pump is compared to an exemplar unit.

The engine's fuel mixture was overly rich at high power settings, however, a reason why the engine performed satisfactory on previous flights, but lost power on the accident flight was not determined.
