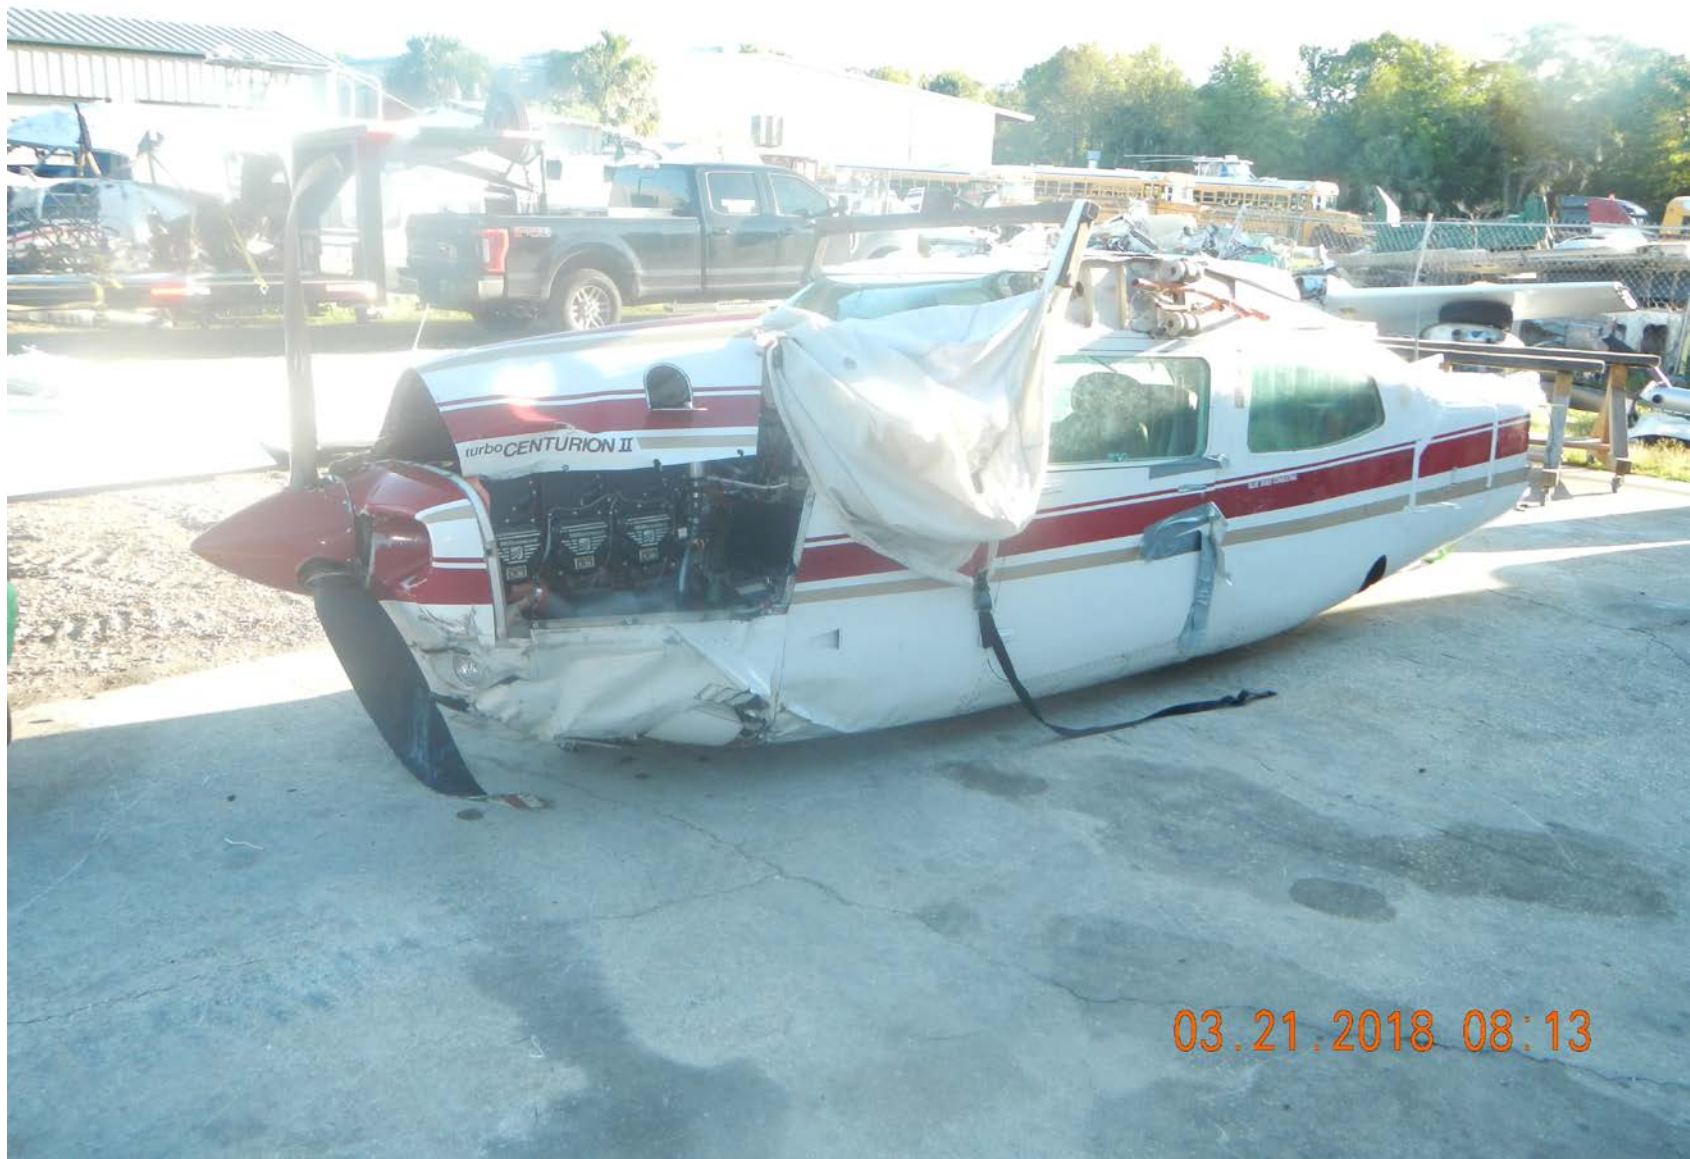
**Photo 1 – View of fuselage showing crush damage**

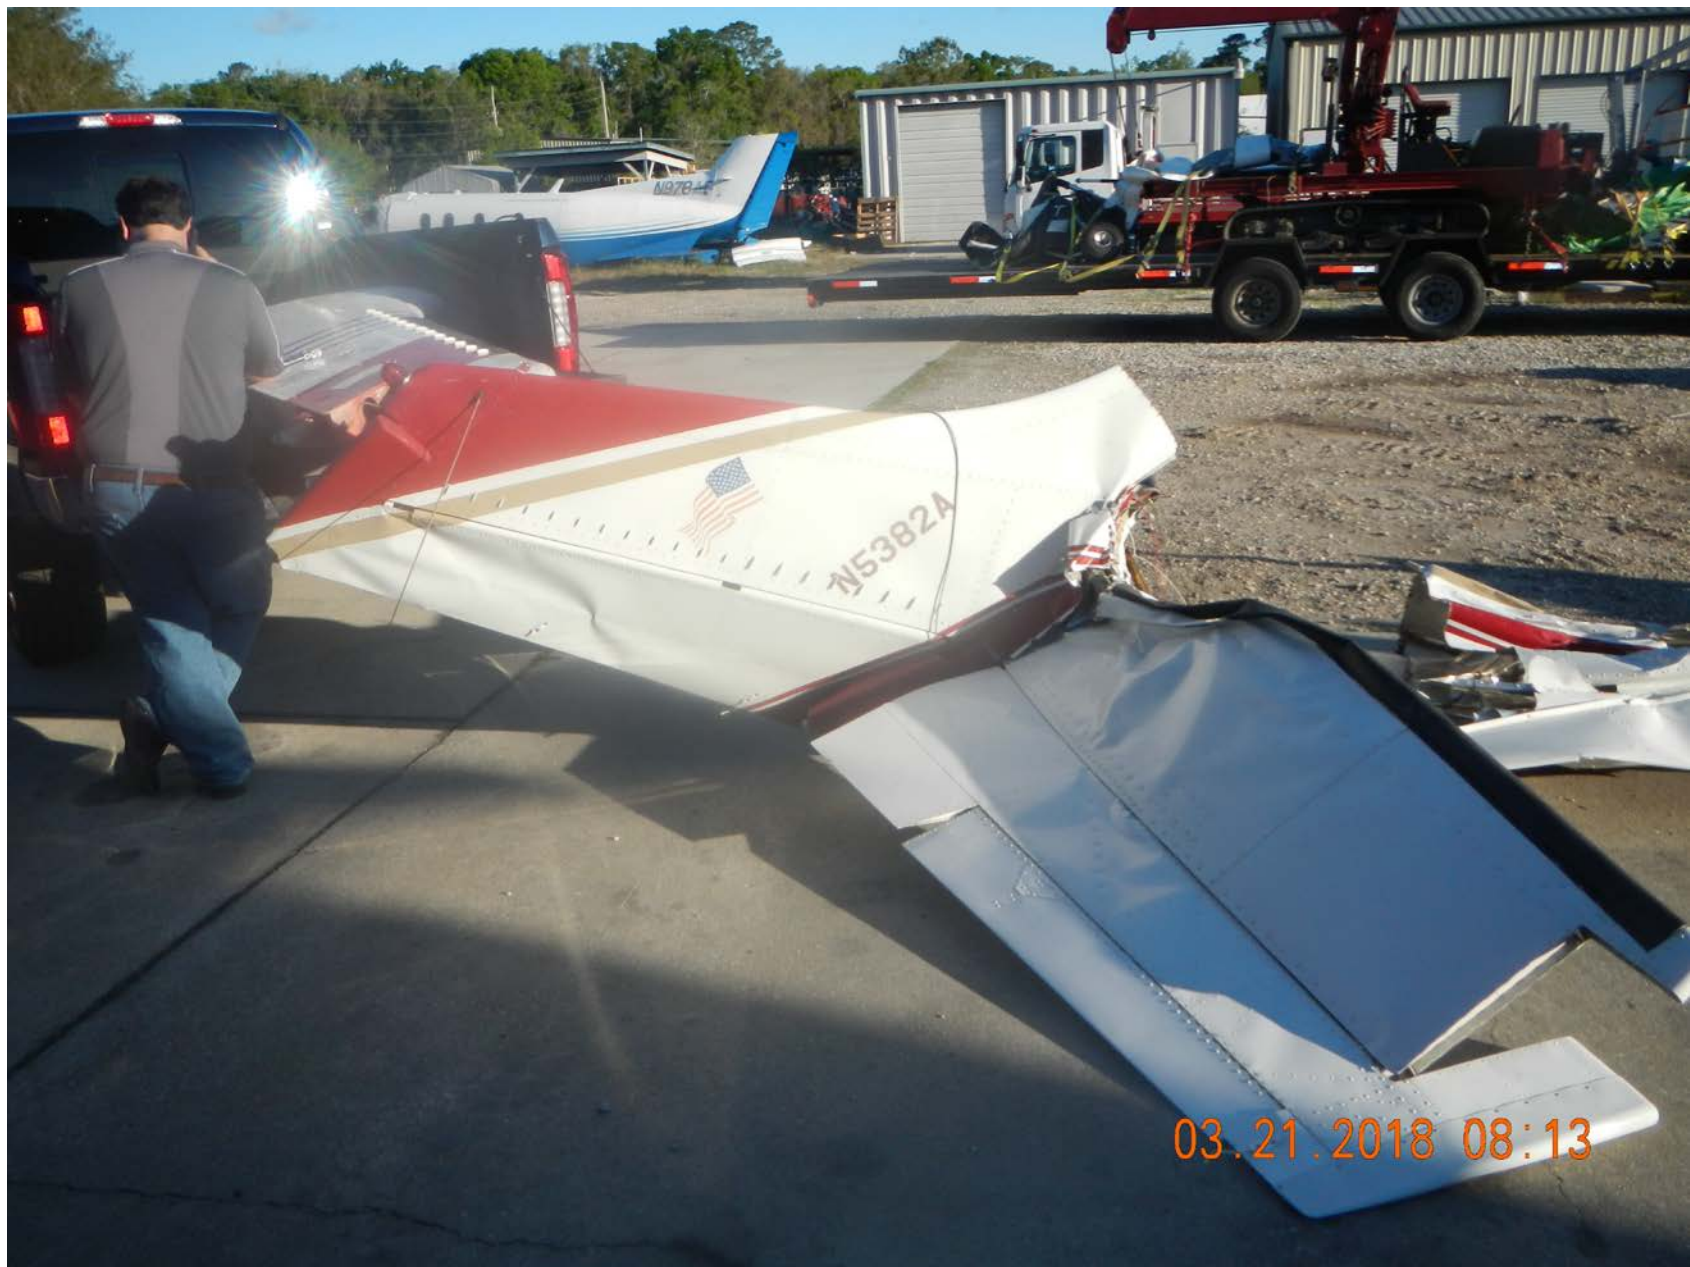
**Photo 2 – View of separated empennage with buckling and crush damage on horizontal stabilizer**
