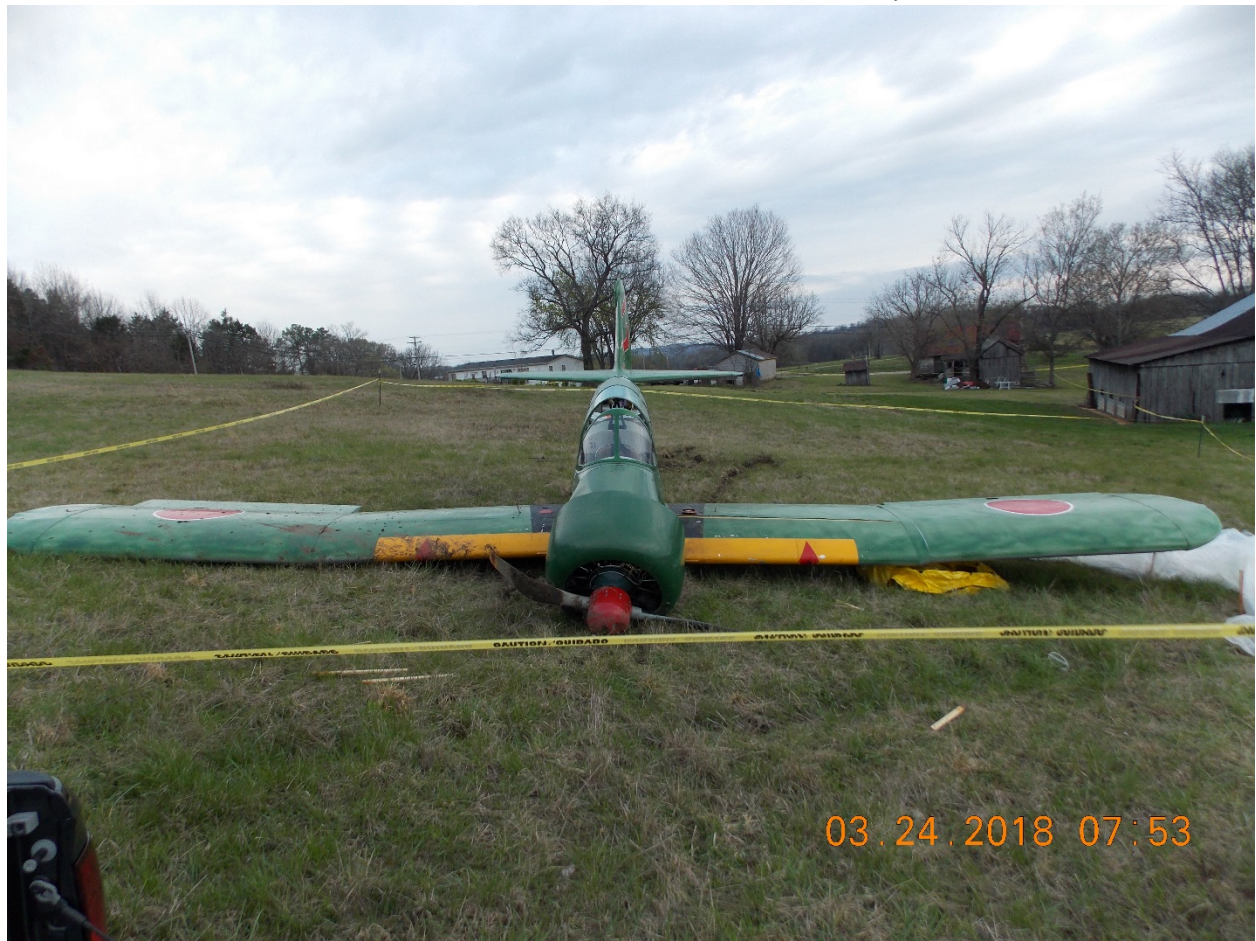
Condition of the aircraft when I arrived (March 24, 2018) the day after the accident.

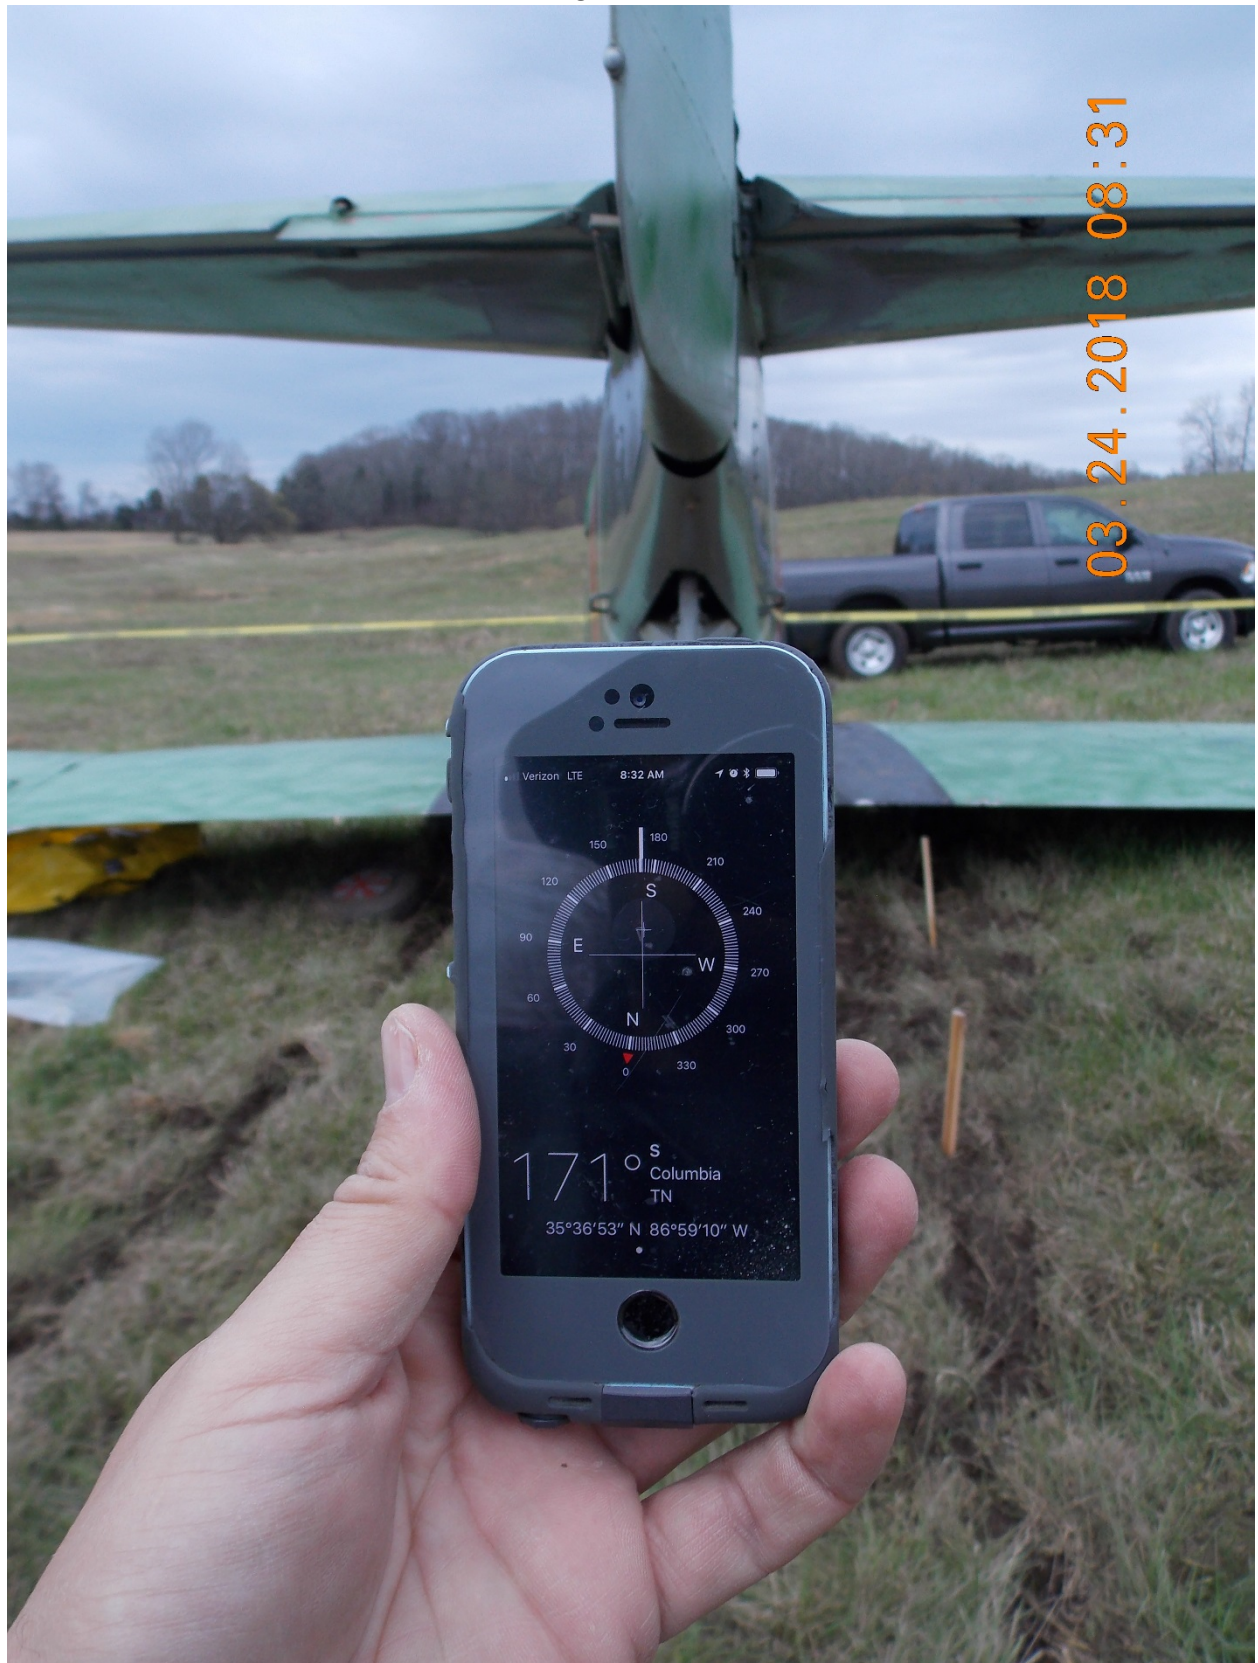
The coordinates and heading of the aircraft when it came to rest.

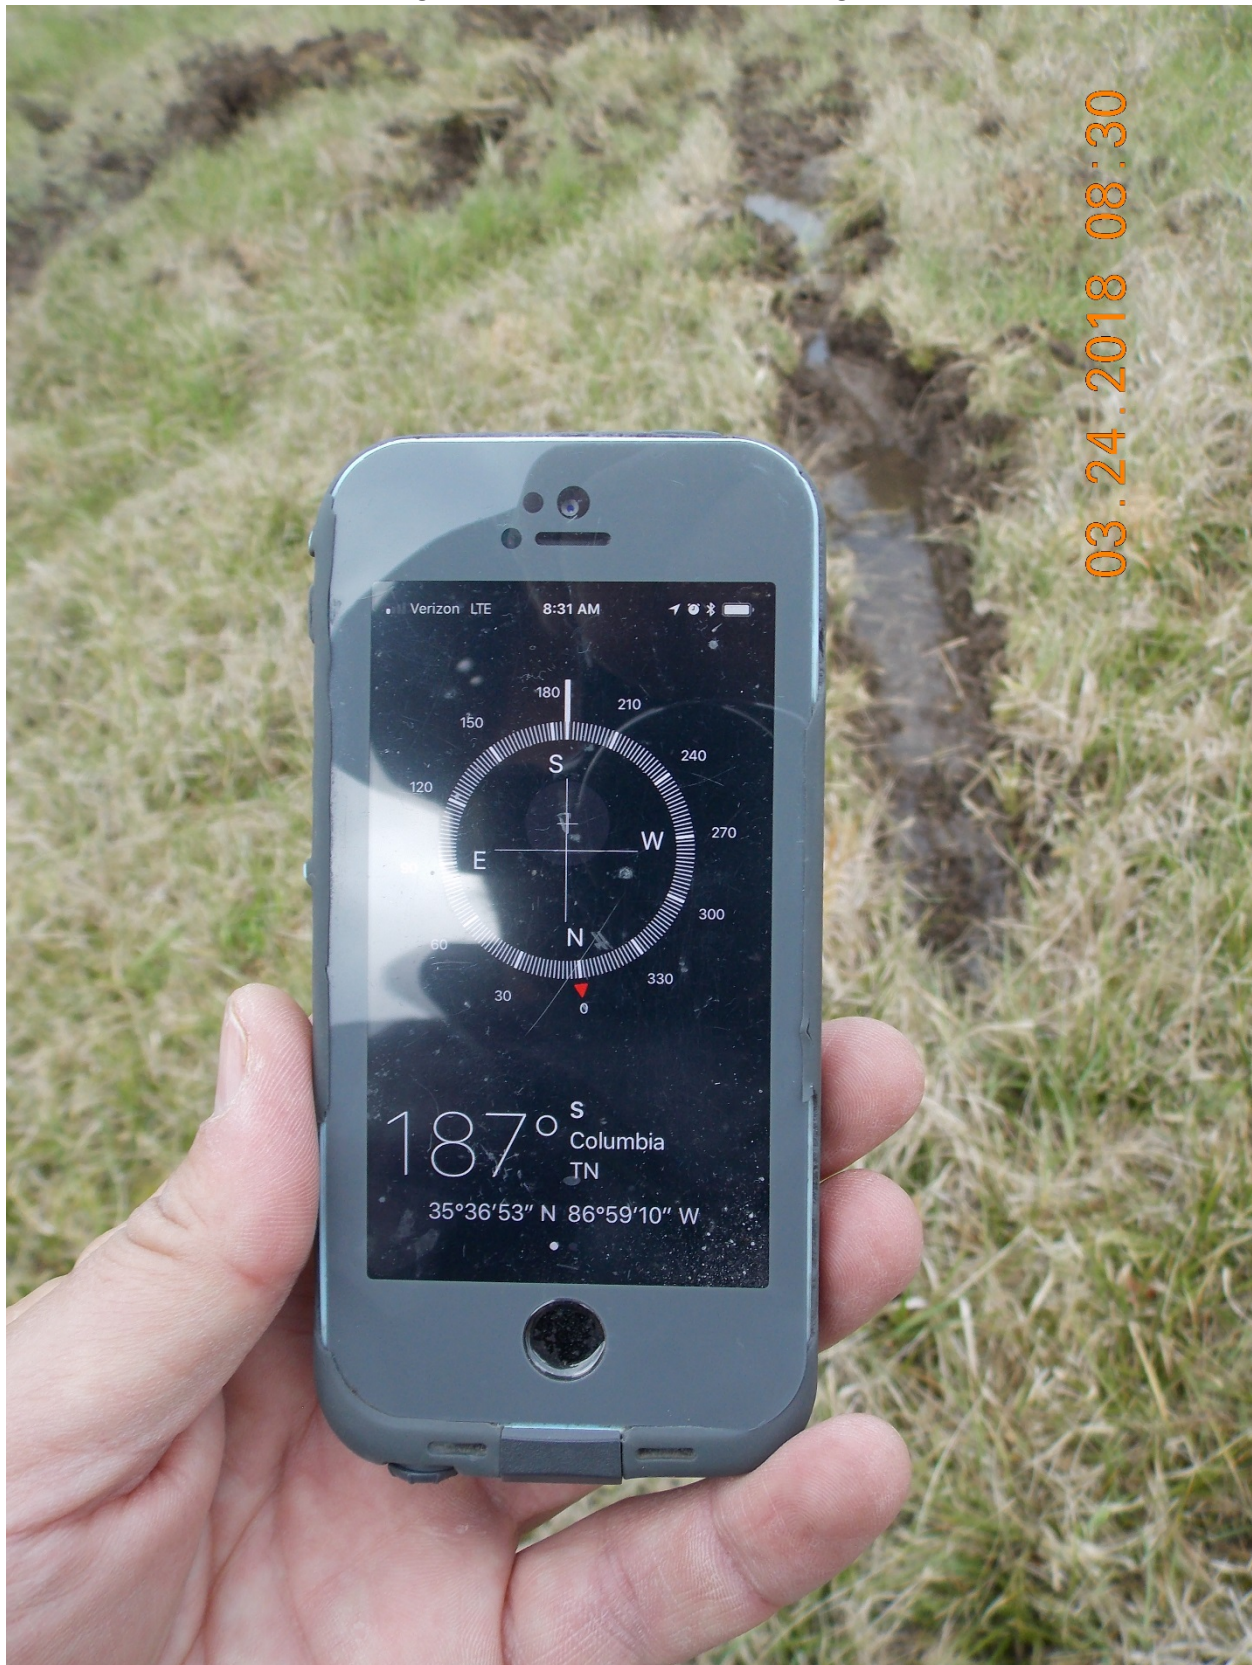
Heading of aircraft at its first contact with ground.

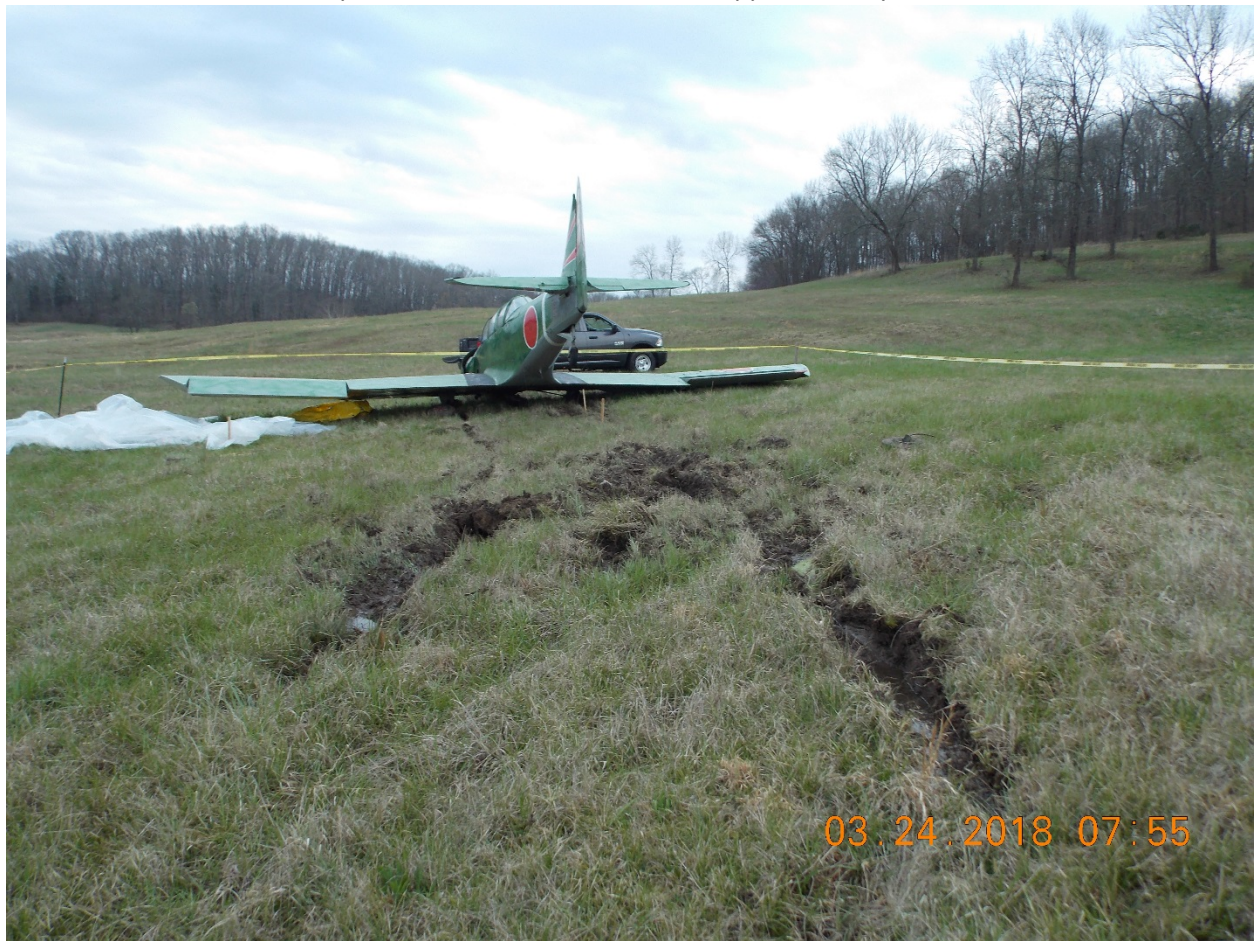
From point of touchdown to rest was approximately 78 feet.

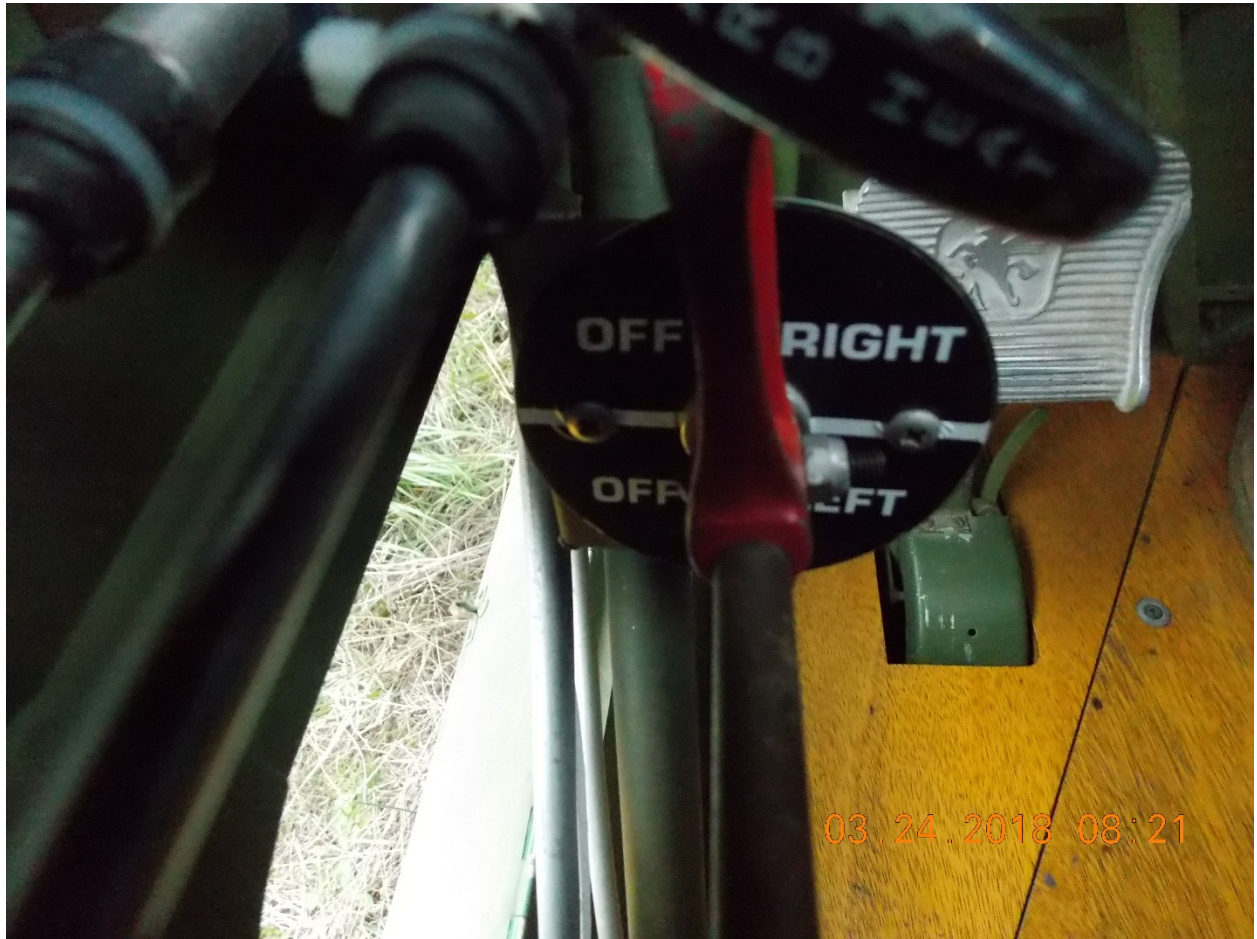
Fuel selector valve was in the off position when I arrived. Fuel selector rotated freely.

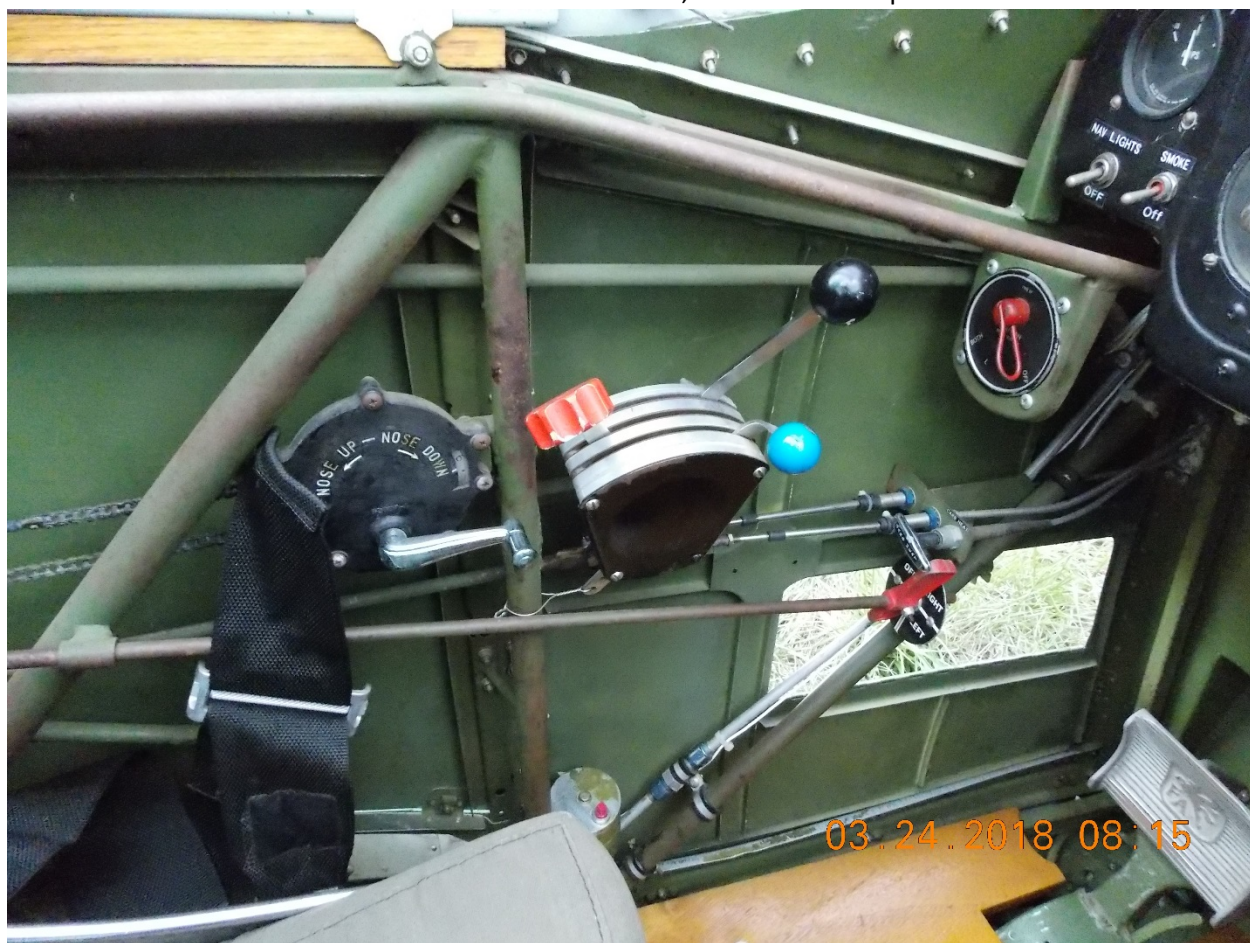
I was unable to move the Throttle, Mixture and Prop Lever.

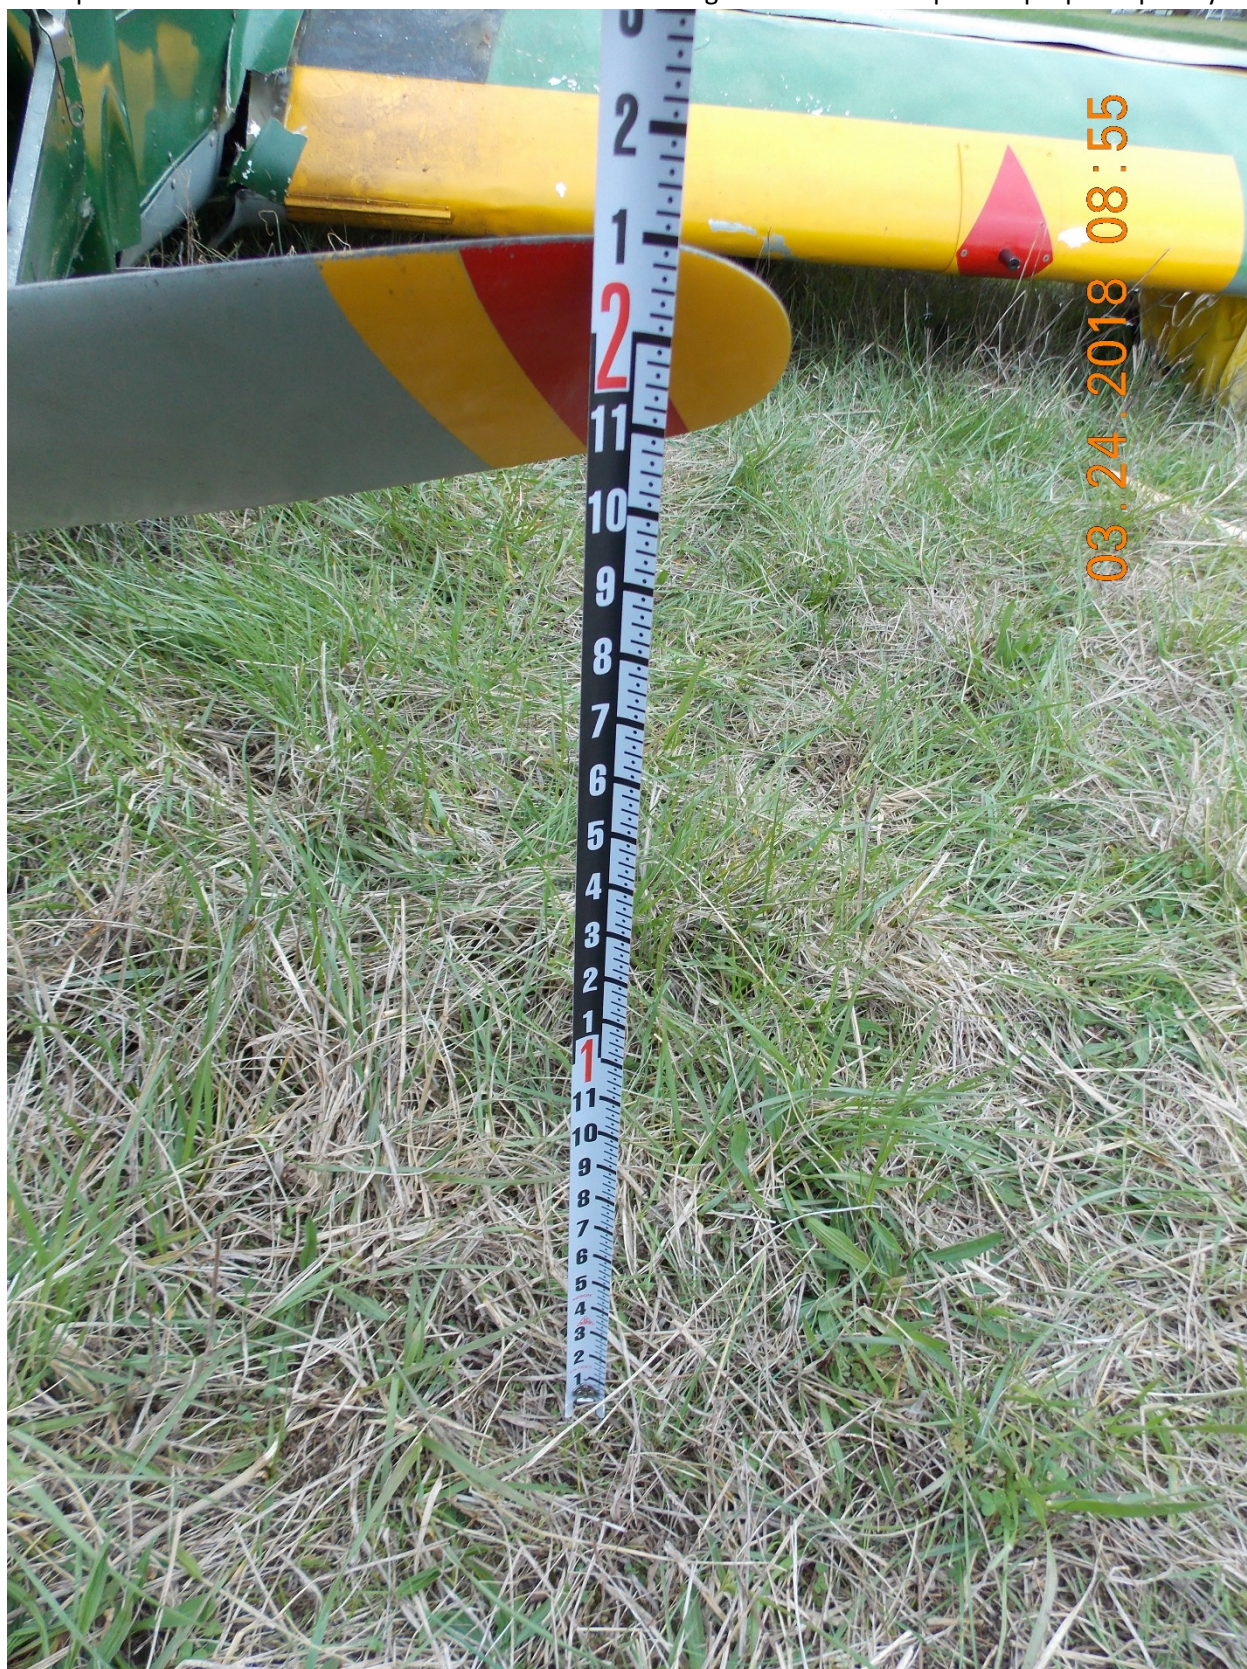
Prop moved without resistance 23". I was unable to bring the tail down to spin the prop completely.

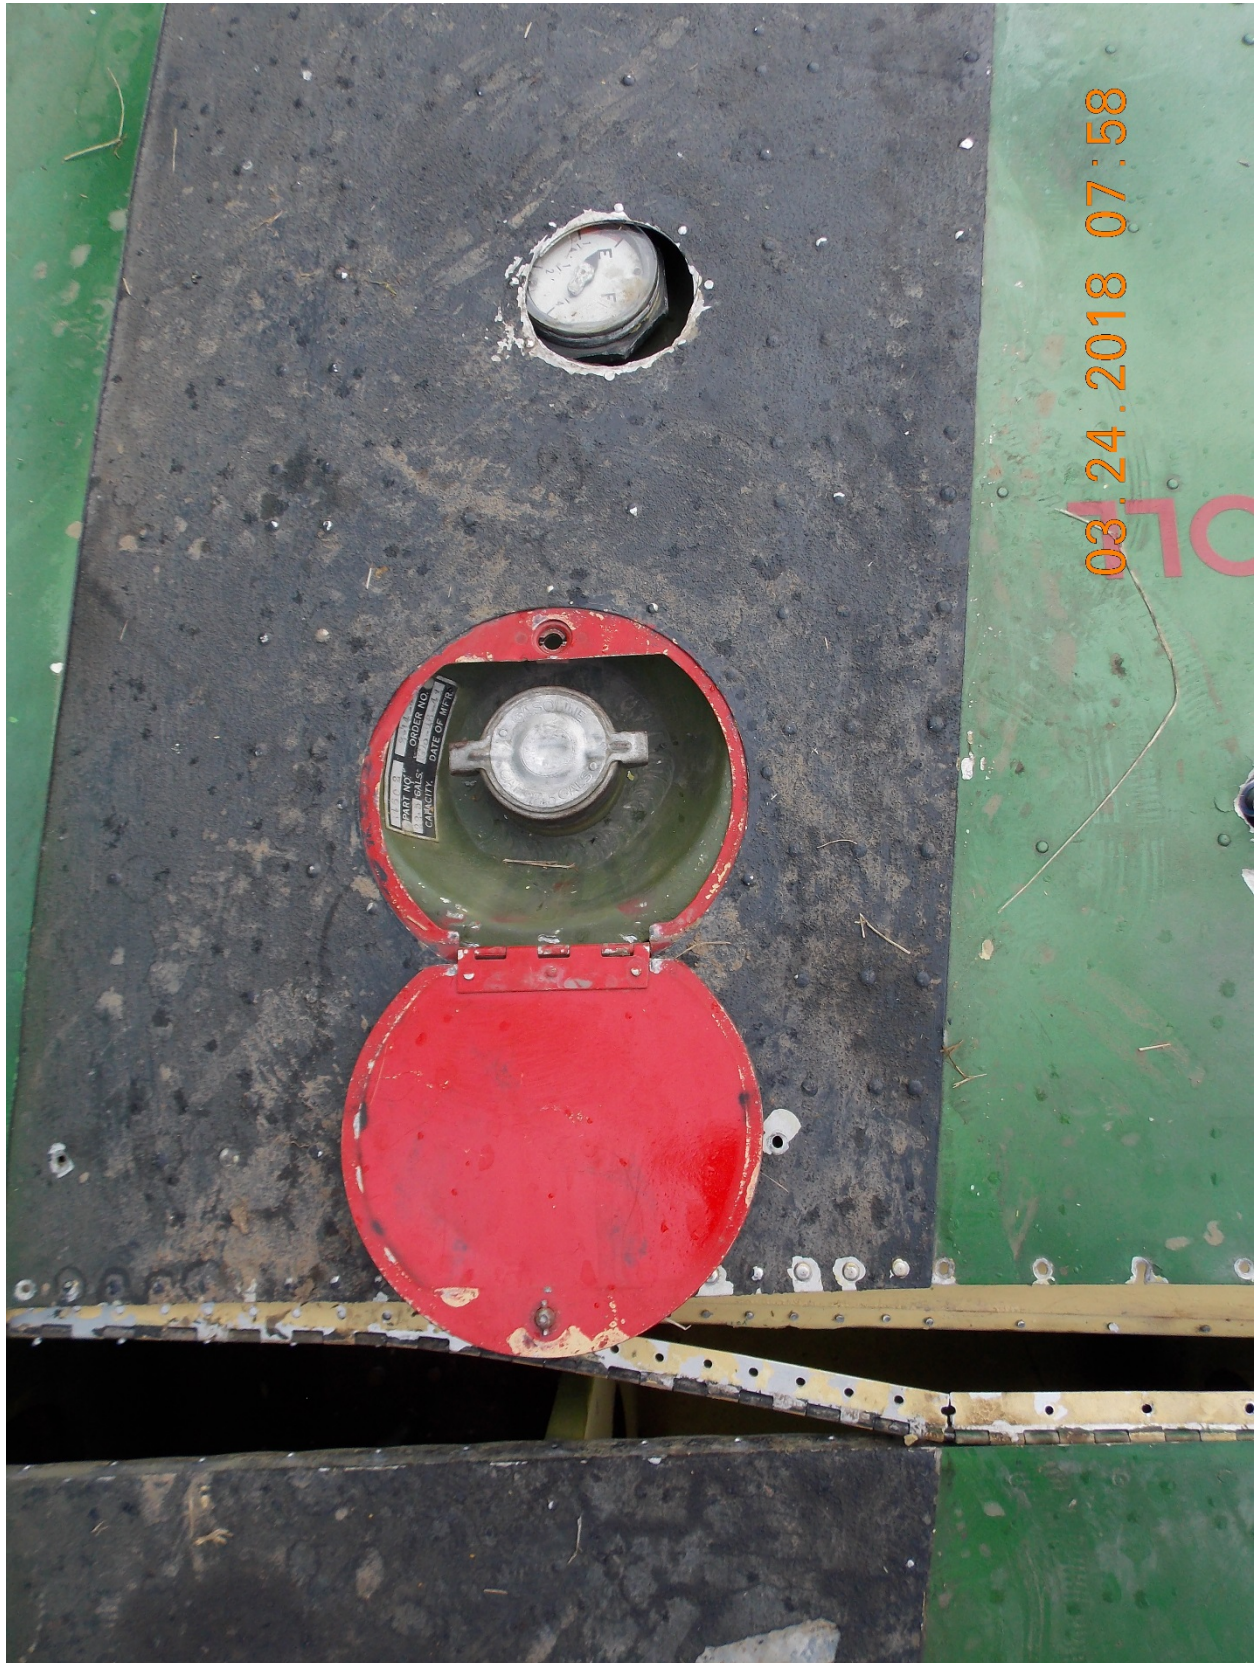
Fuel quantity shows empty.

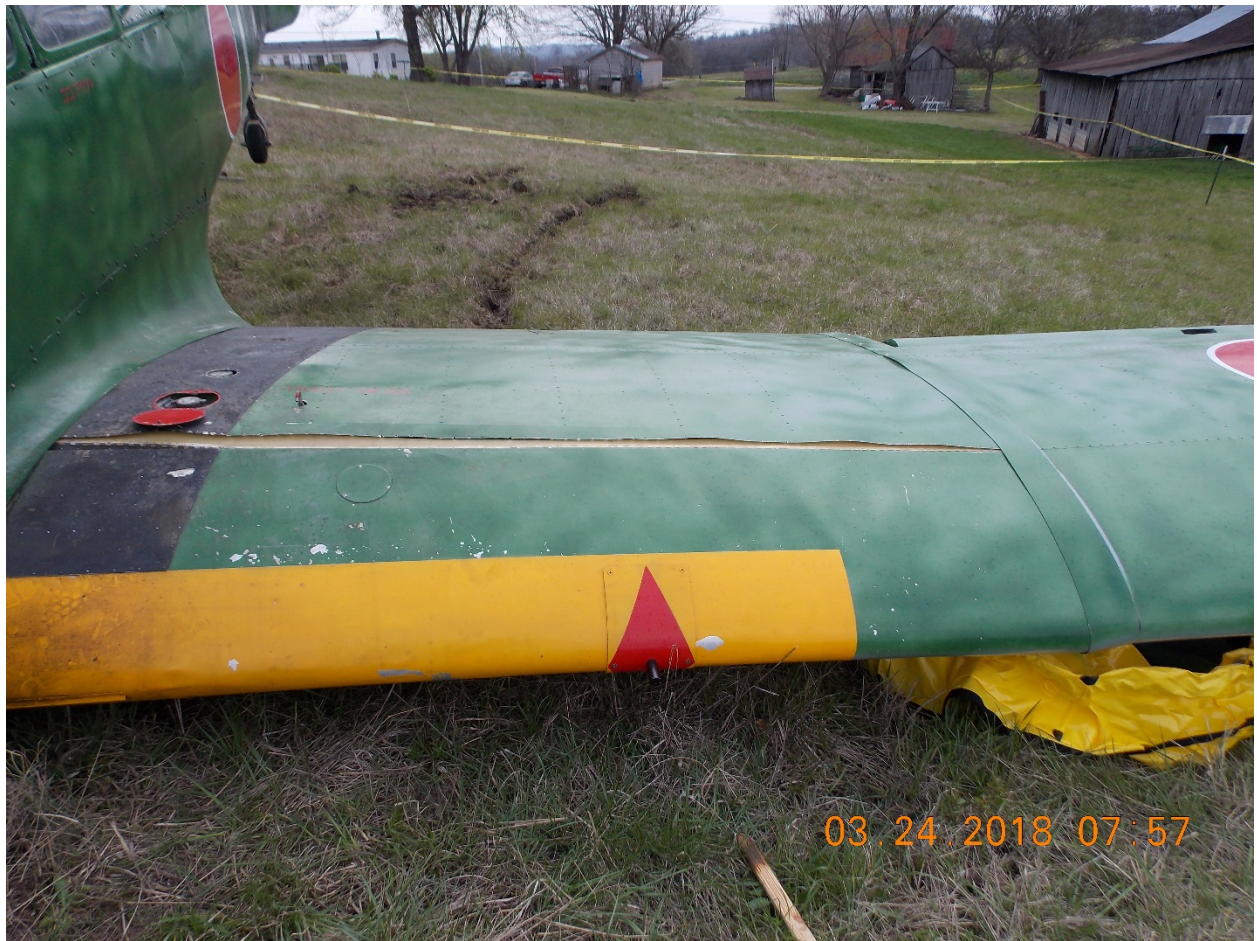
Left Wing fuel tank ruptured.

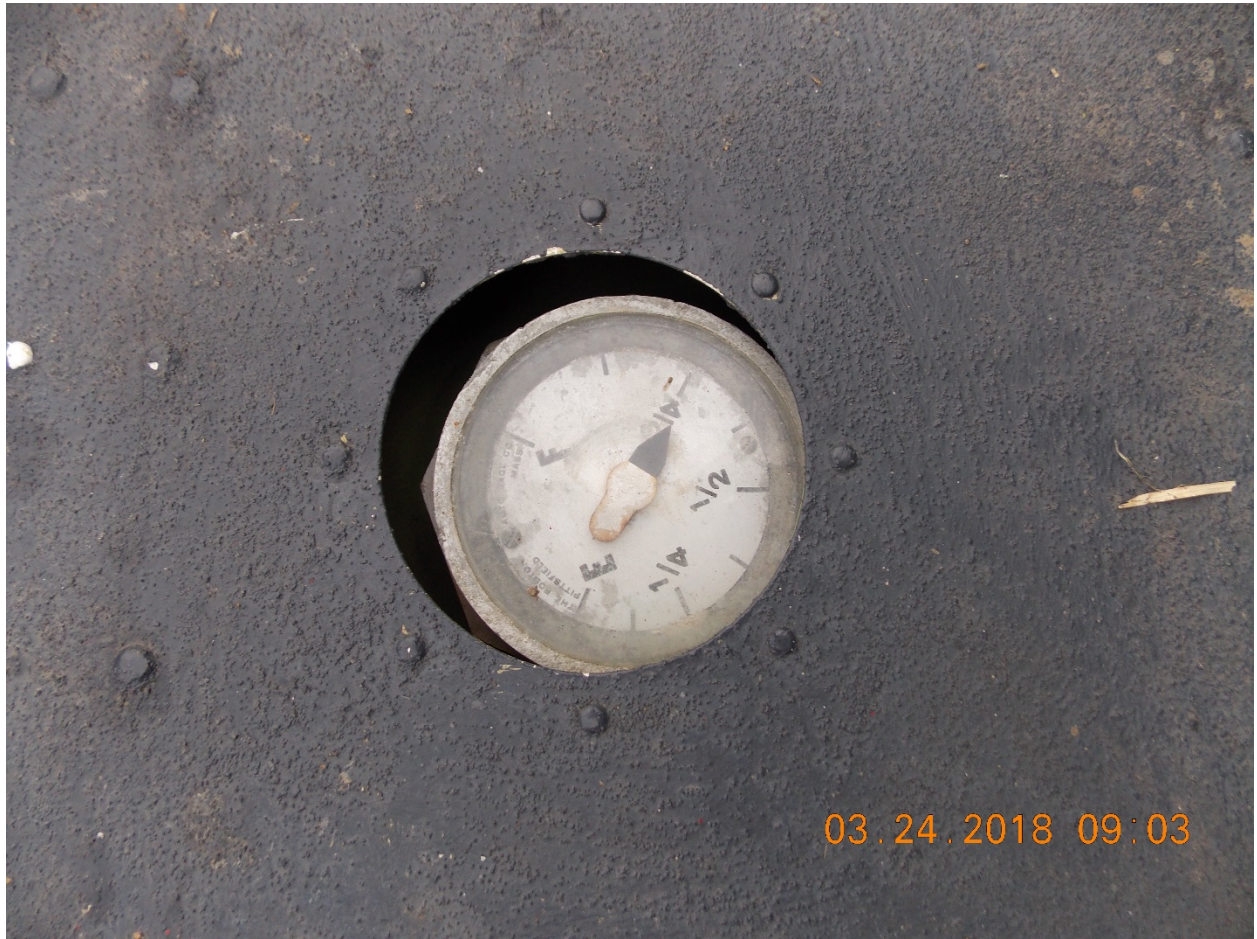
Right wing fuel quantity shows  $\frac{3}{4}$ .

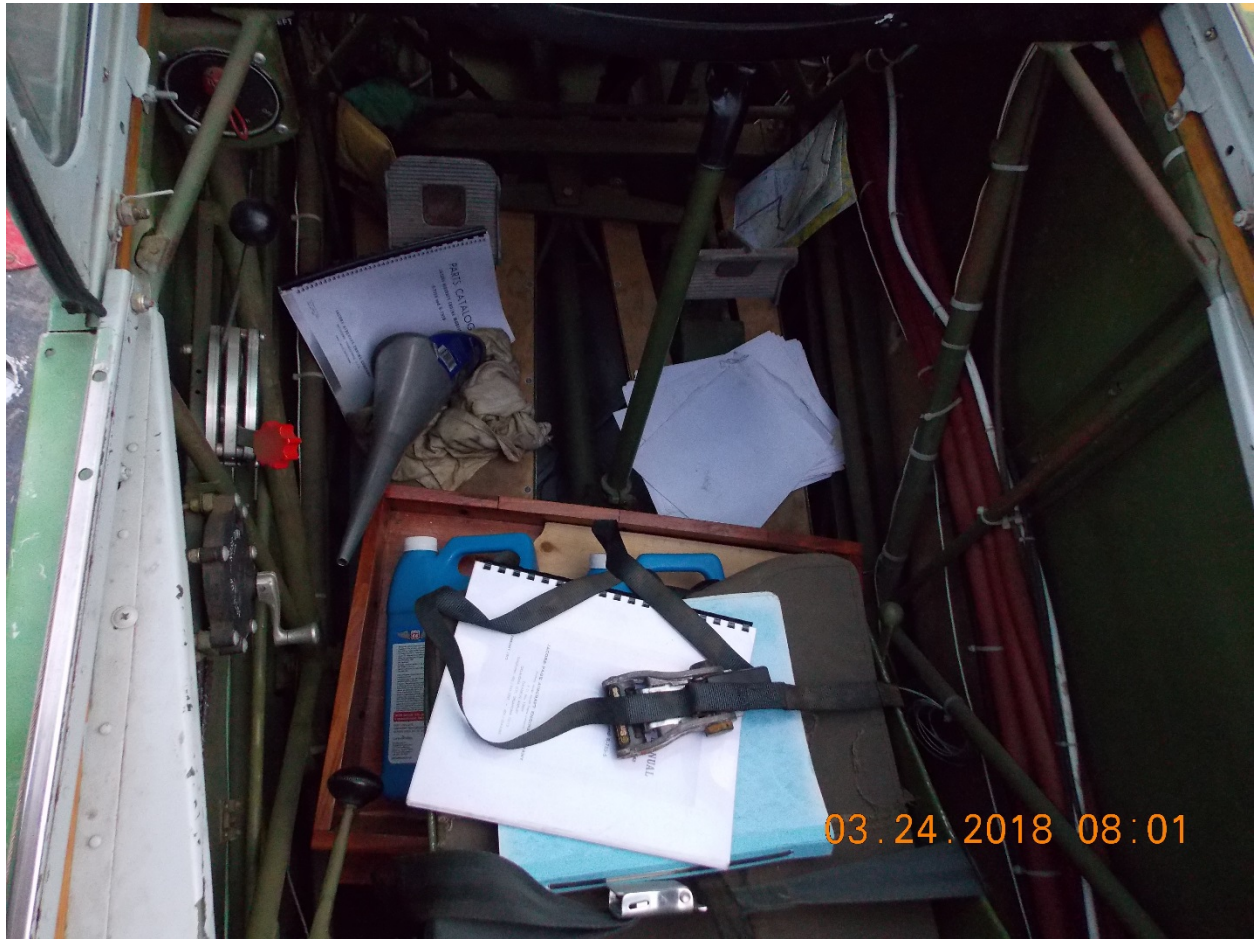
Wood Tray under rear seat slid forward.

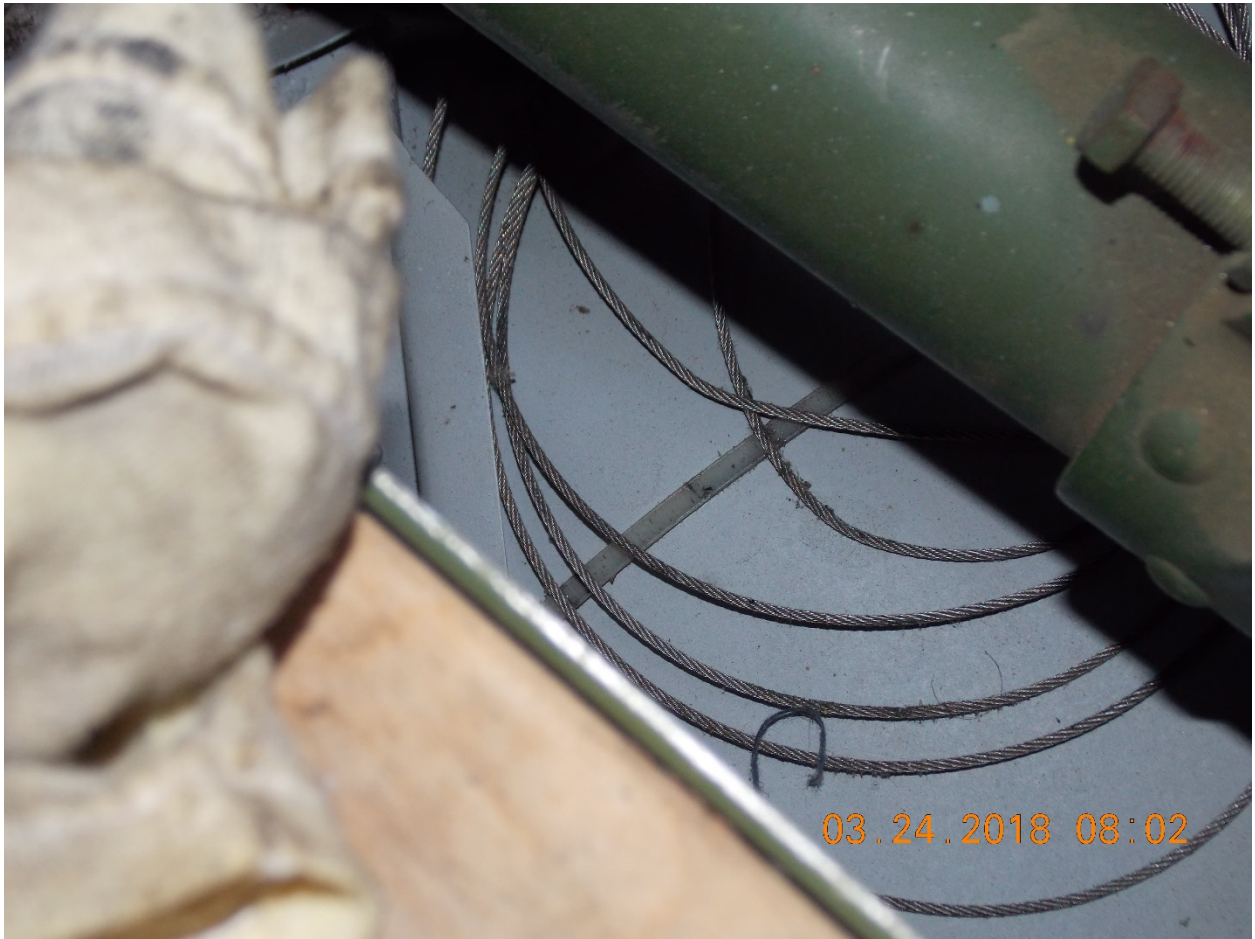
Coiled cable found under rear seat flight controls.

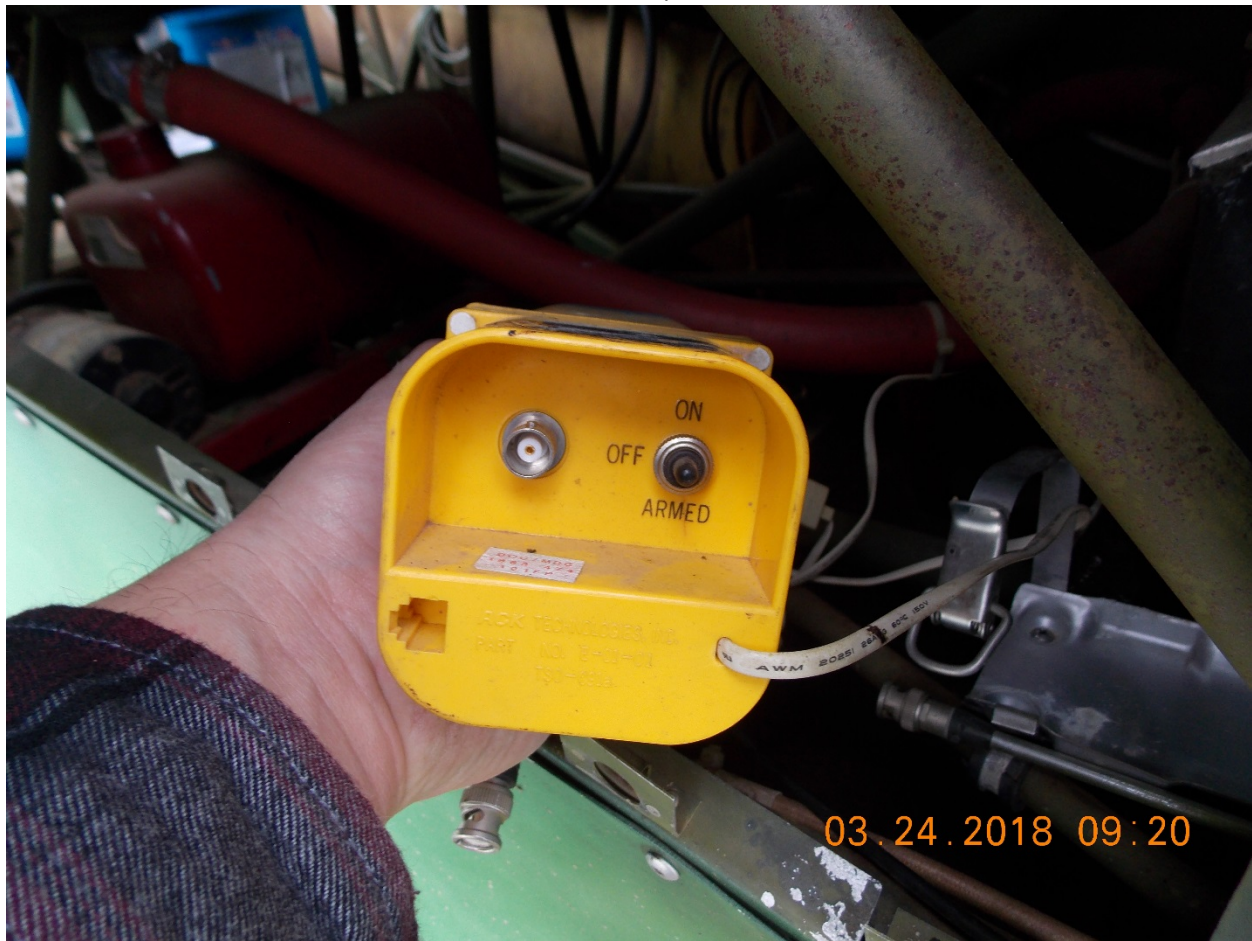
ELT was in off position.

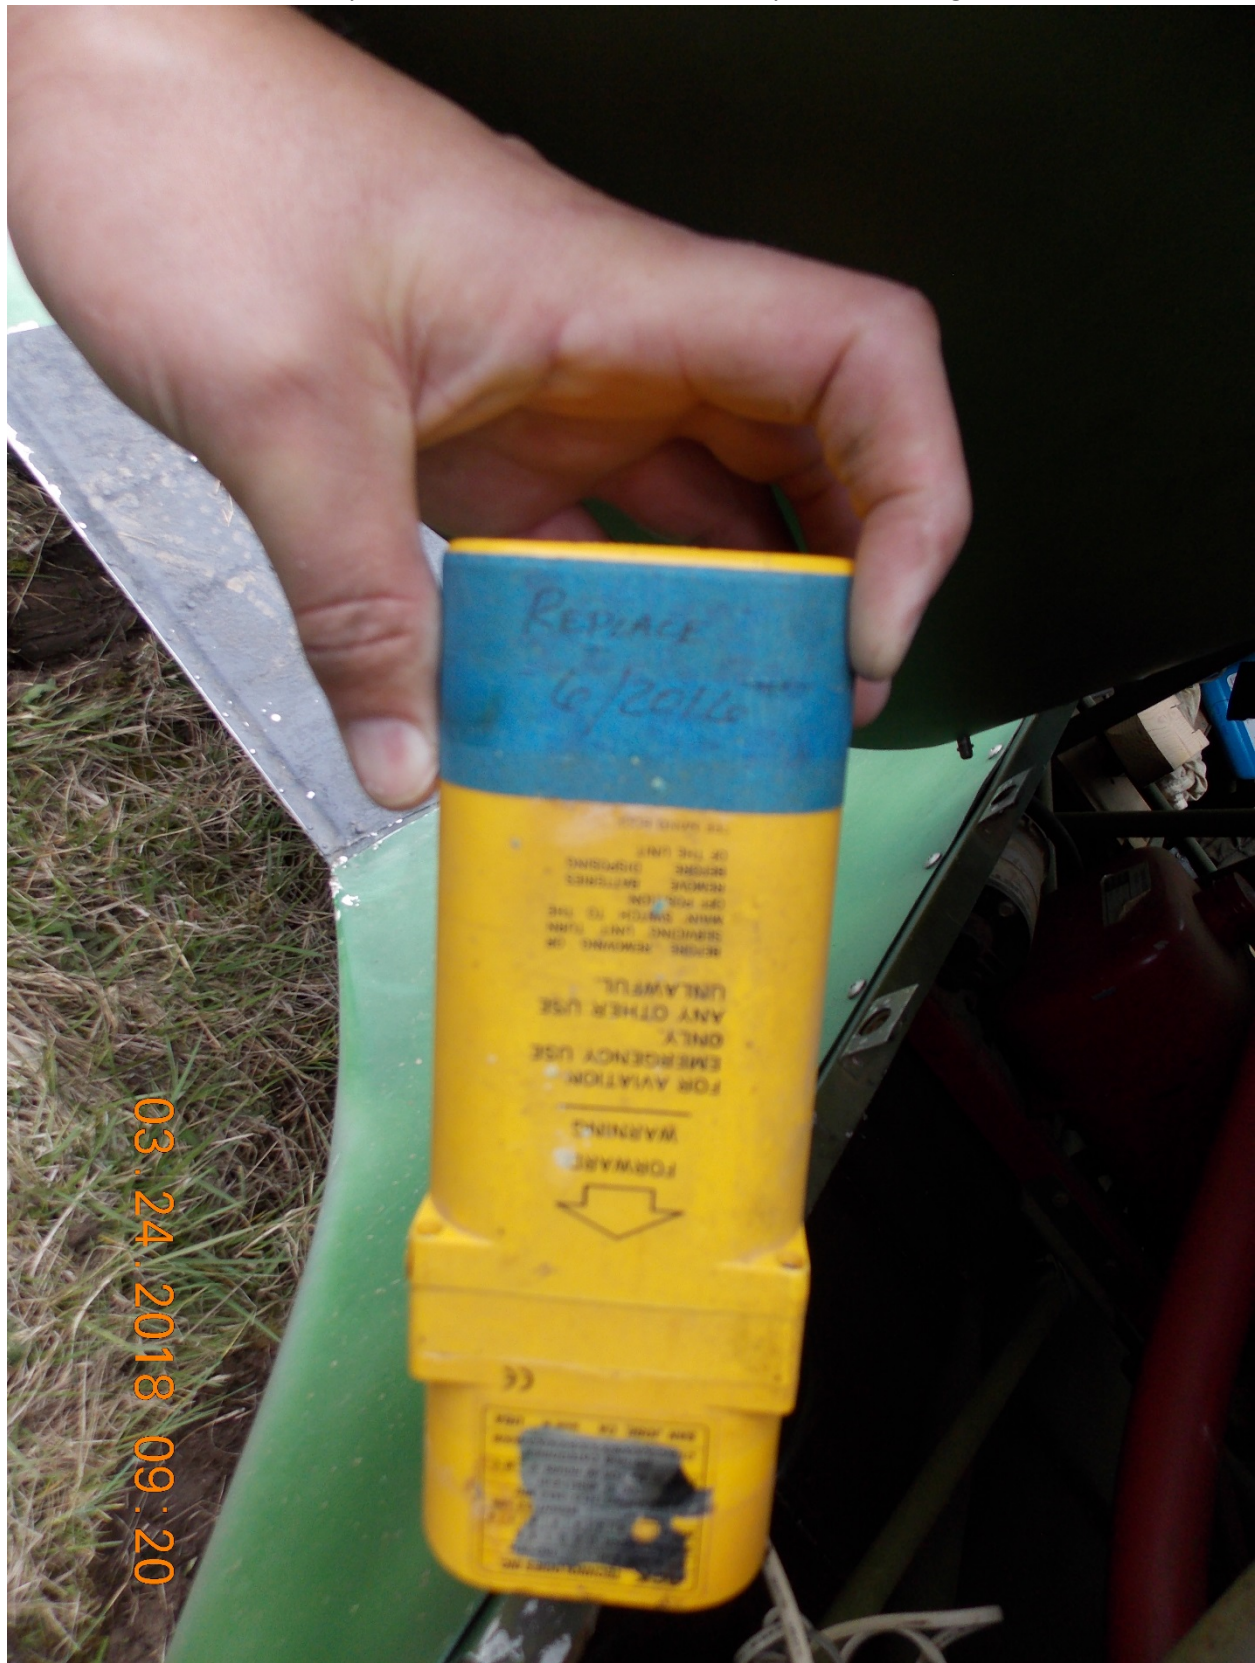
ELT Battery due 2016. No record of ELT battery installed in log book.
