## RECORD OF CONVERSATION

**Date: April 5, 2018**  
**Person Contacted: Antonius Ketelaars**  
**NTSB Accident Number: ERA18LA117**

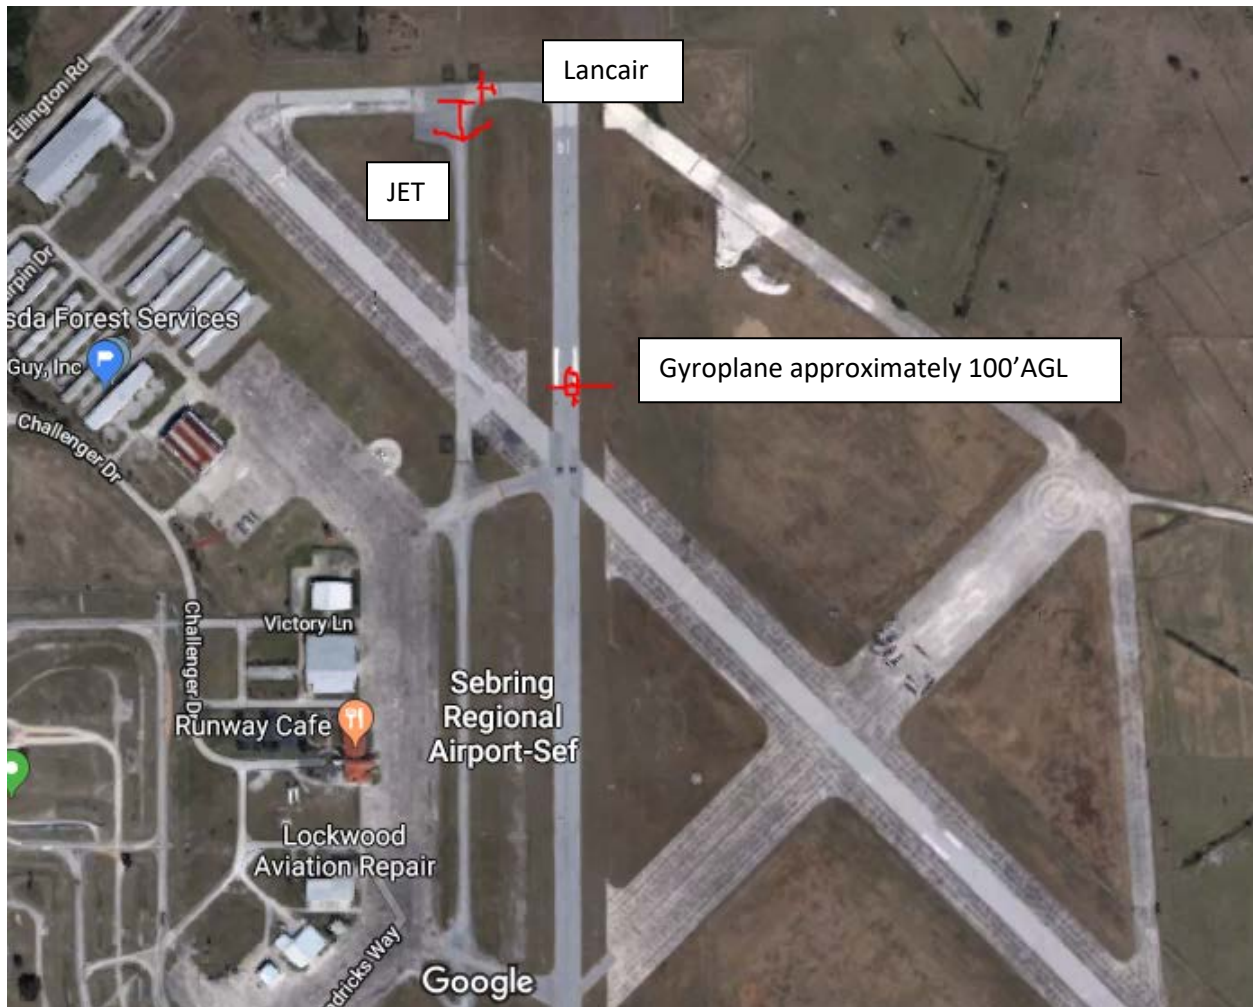
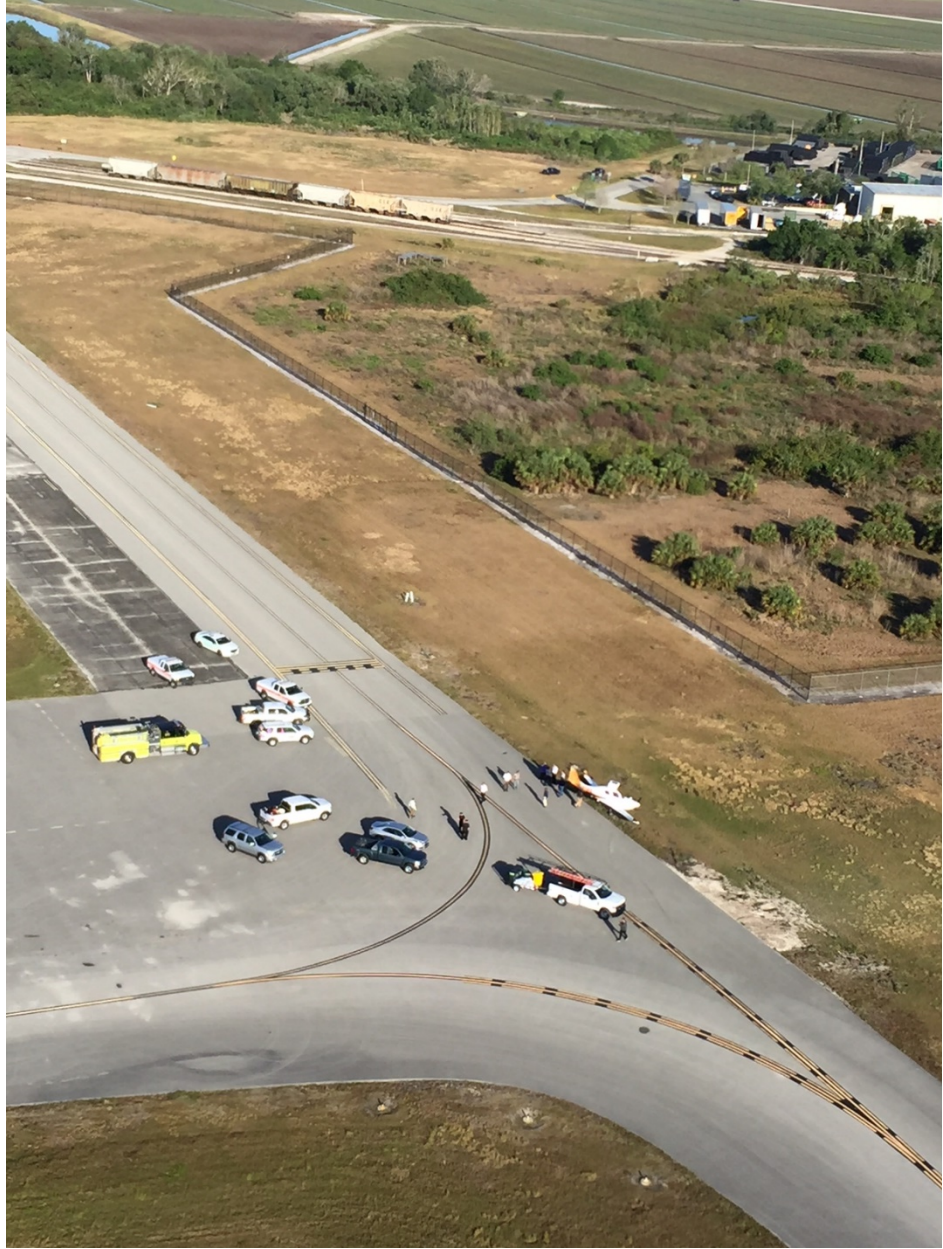
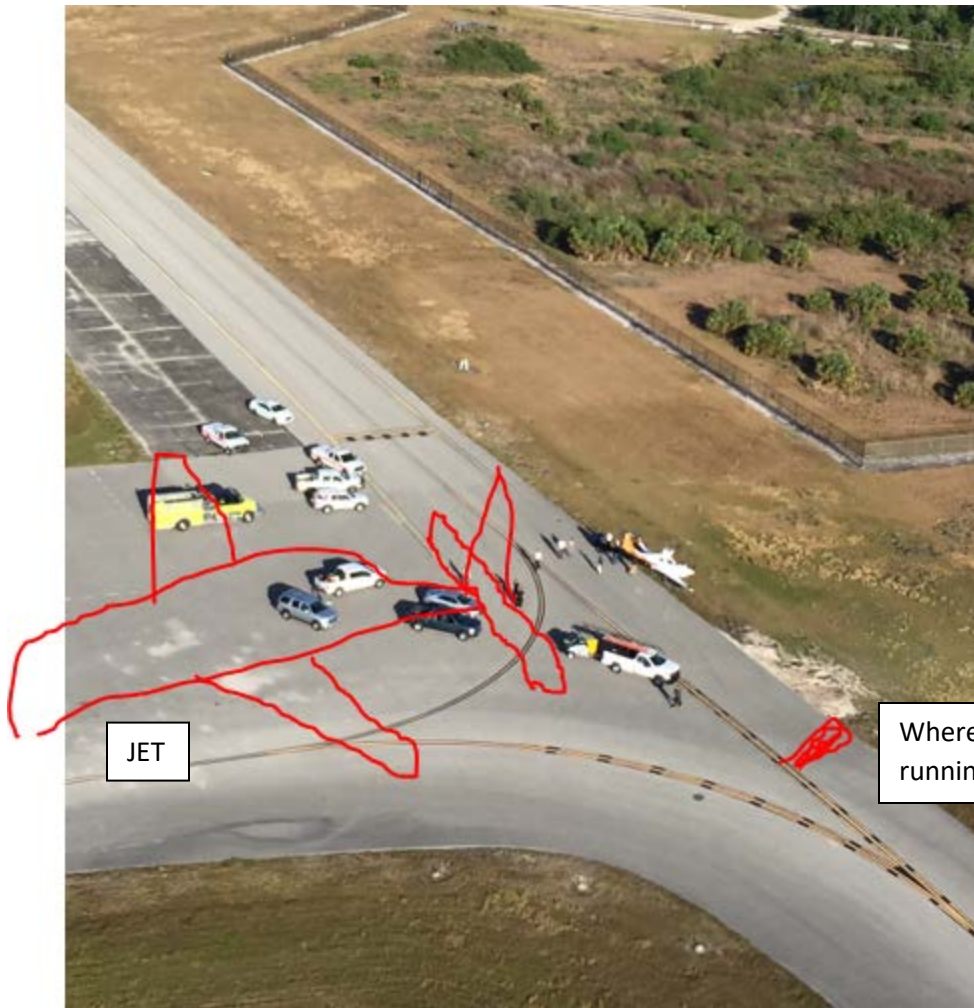
Where I stated "Lancair that jet is running"
