# **NATIONAL TRANSPORTATION SAFETY BOARD**

## **MATERIALS LABORATORY FACTUAL REPORT**

Report No. 19-072

Place : Arecibo, PR  
Date : 6/10/2018  
Vehicle : Cessna 182  
NTSB No. : ERA18LA165  
Investigator : Leah Read

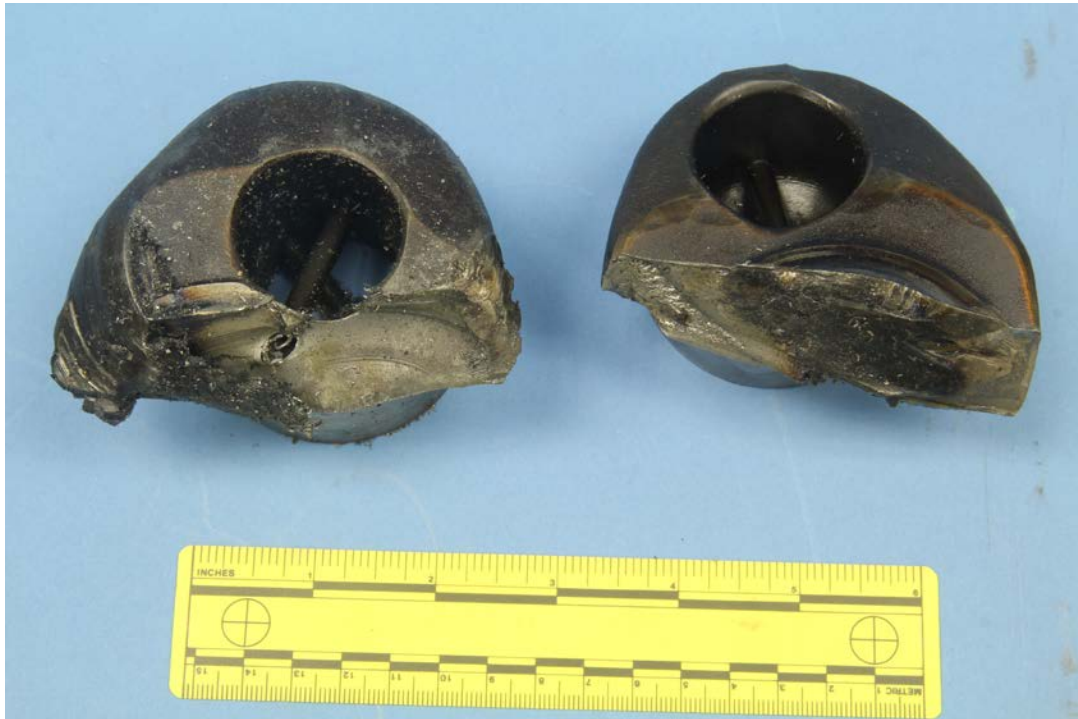
Fractured sections of crankshaft, No. 3 cheek (figure 1).

Figure 1: Fractured sections of crankshaft as received.

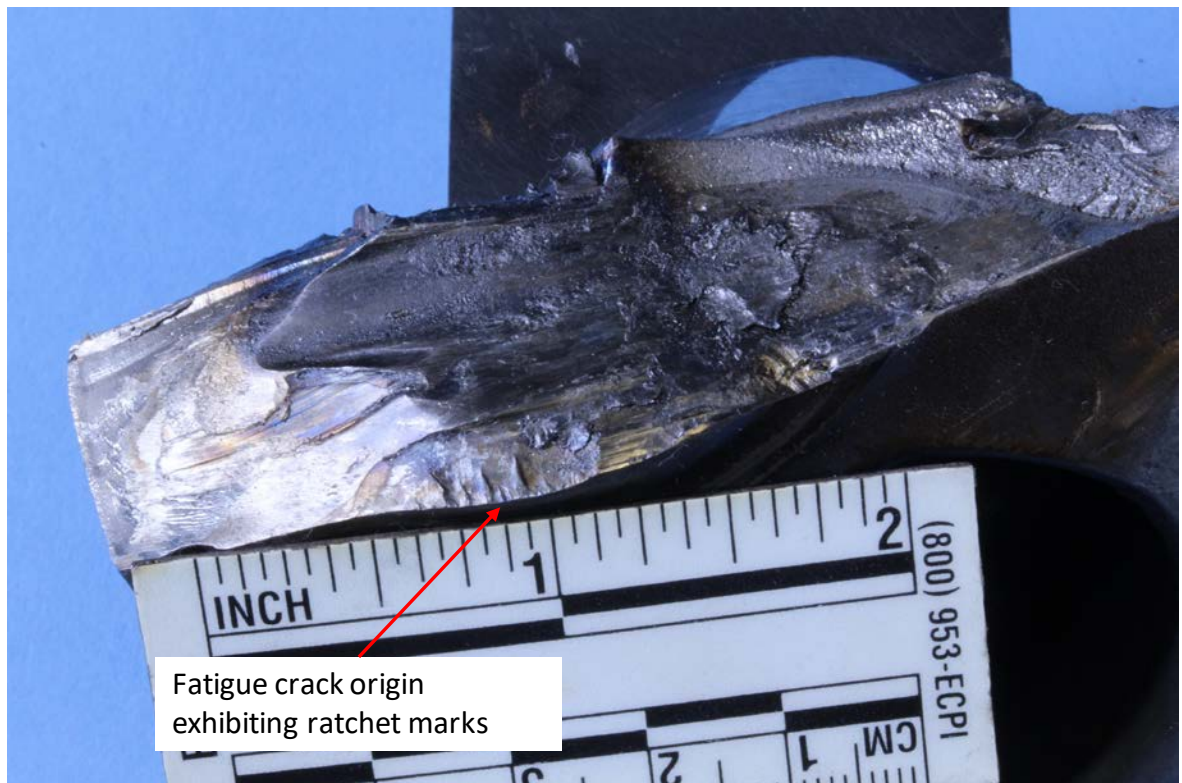
The fractured sections of the crankshaft were degreased and cleaned for inspection using a stereo microscope. Both fracture surfaces of the number 3 cheek of the crankshaft exhibited fracture features consistent with a fatigue crack. Although both fracture surfaces exhibited smearing and recontact damage, the ratchet marks at the crack's origin were visible on both halves (Figures 2, 3). One half of the fracture surface also exhibited very distinct crack arrest marks (Figure 3).

Figure 2: Fracture surface exhibiting ratchet marks at crack origin.

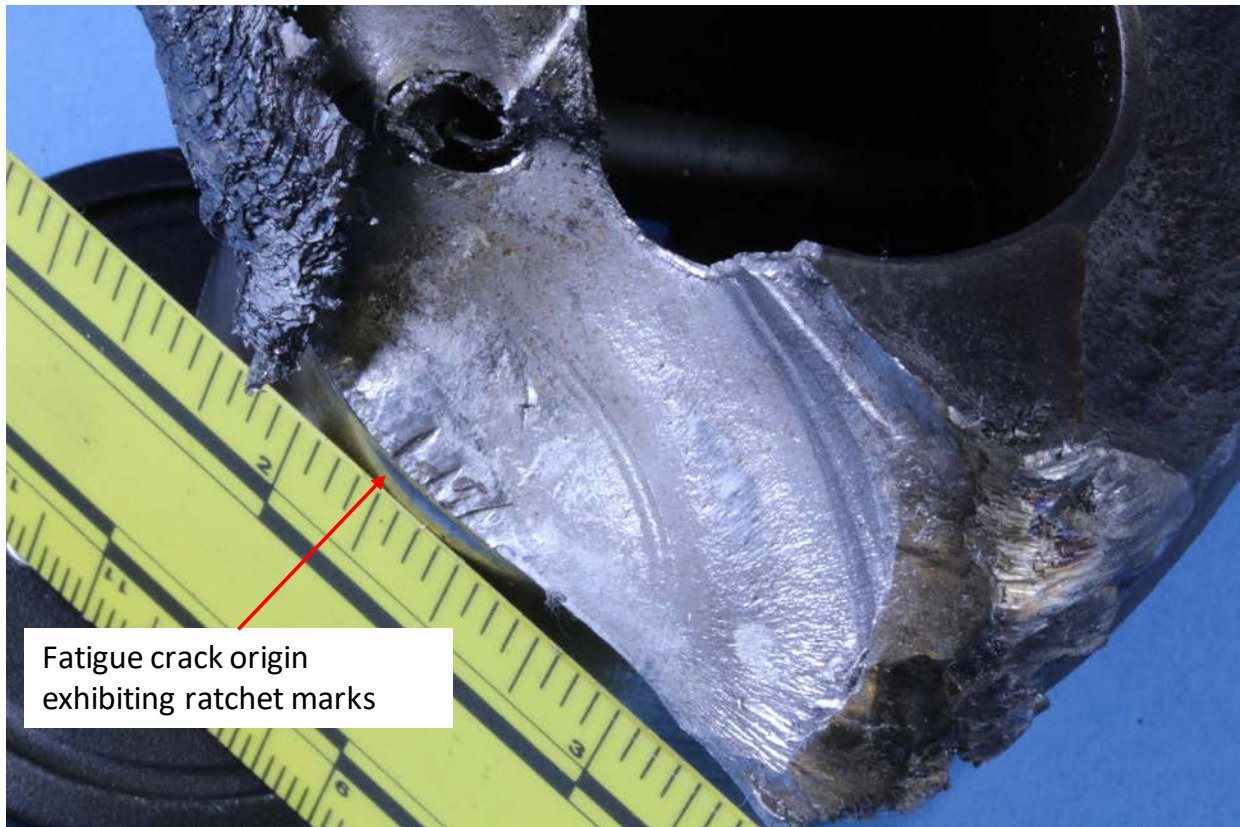
Fatigue crack origin  
exhibiting ratchet marks

Figure 3: Fracture surface exhibiting ratchet marks and crack arrest marks.
