## **MEMORANDUM for RECORD**

**Date: August 14, 2018, 0900-1000 EDT**  
**Airframe Examination (Landing Gear)**  
**NTSB Accident Number: ERA18LA176 – Atlanta, GA**

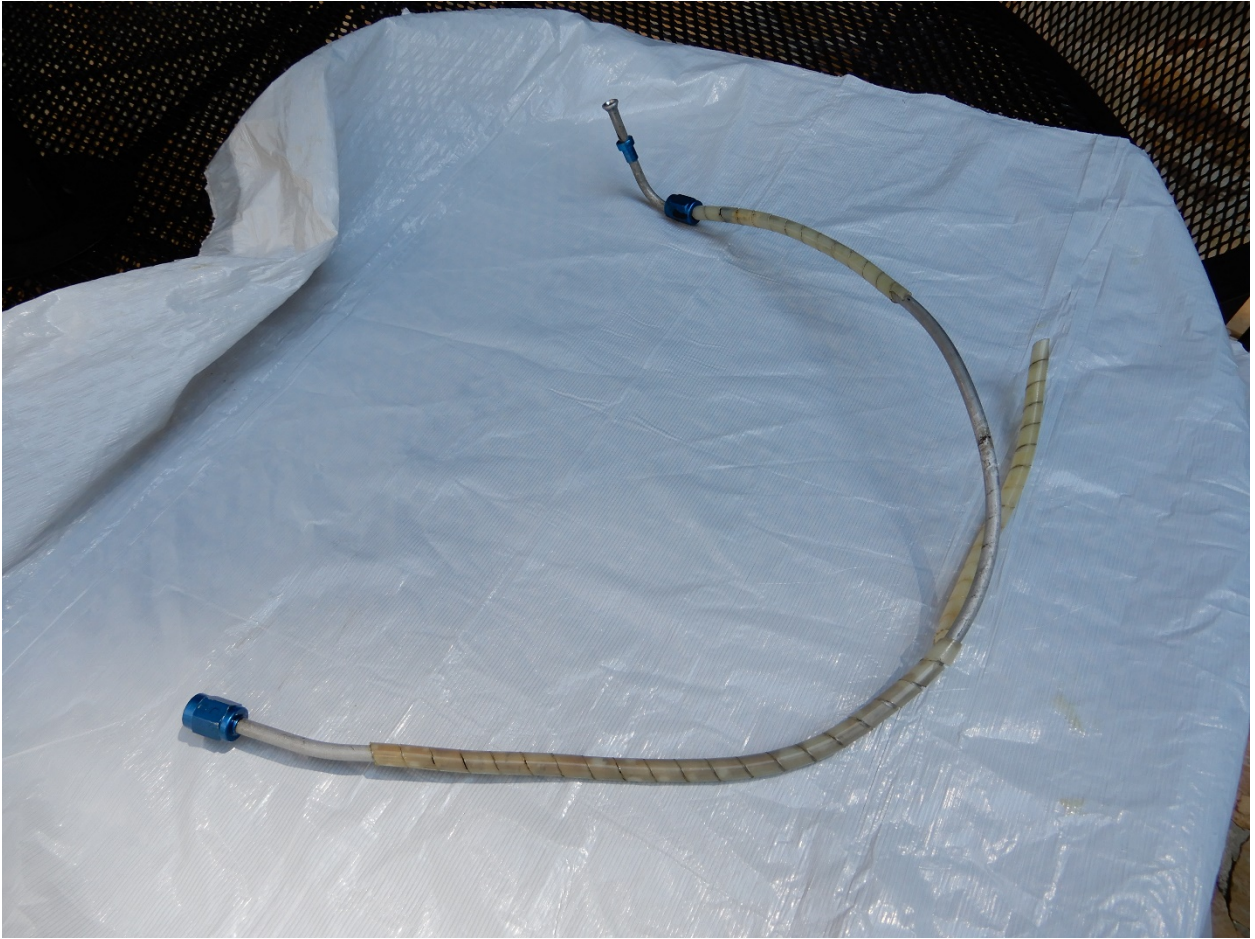
- Further examination revealed that, as the emergency hydraulic handle was activated, a stream of hydraulic fluid sprayed from the surface of the aluminum line connecting the emergency handle/pump to the electric hydraulic pump that was mounted under and behind the instrument panel of the pilot's side. The line was about 23 in long (Figure 1). The plastic sheathing protecting the line was intact; it was partially removed to facilitate examination of the leaking area. There were no areas of line chafing noted on the line and no adjacent structure where chafing would occur. A video was taken of the line leaking fluid.

Figure 1. Hydraulic line between emergency pump and electric hydraulic pump.

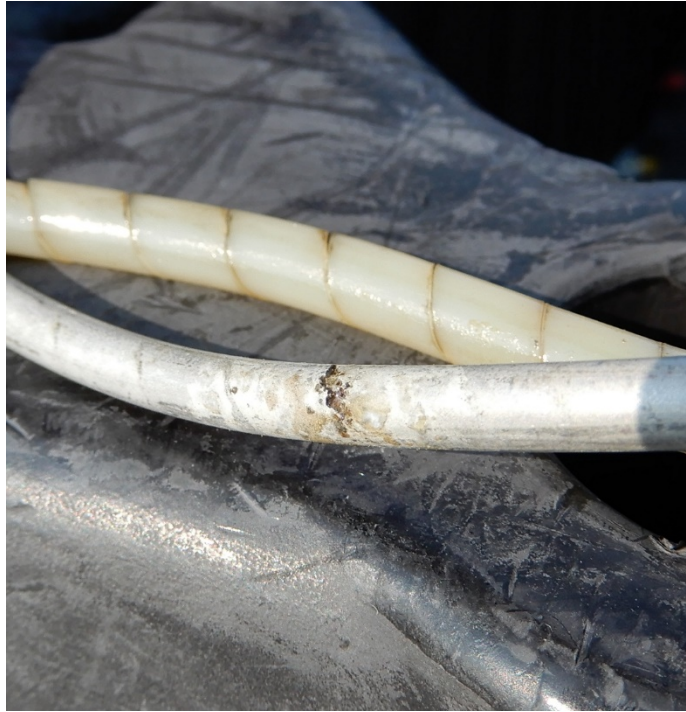
- The leaking hydraulic line was removed and examined. A visual examination using 10X magnification revealed an area of corrosion and pitting on the

aluminum surface. The affected area was about 0.75 in long and covered about  $\frac{1}{2}$  the circumference of the tube (Figure 2).

Figure 2. Pitted area in hydraulic line where fluid leaked.
