**NATIONAL TRANSPORTATION SAFETY BOARD**

**AIRFRAME AND ENGINE EXAMINATION**

**ERA18LA181**

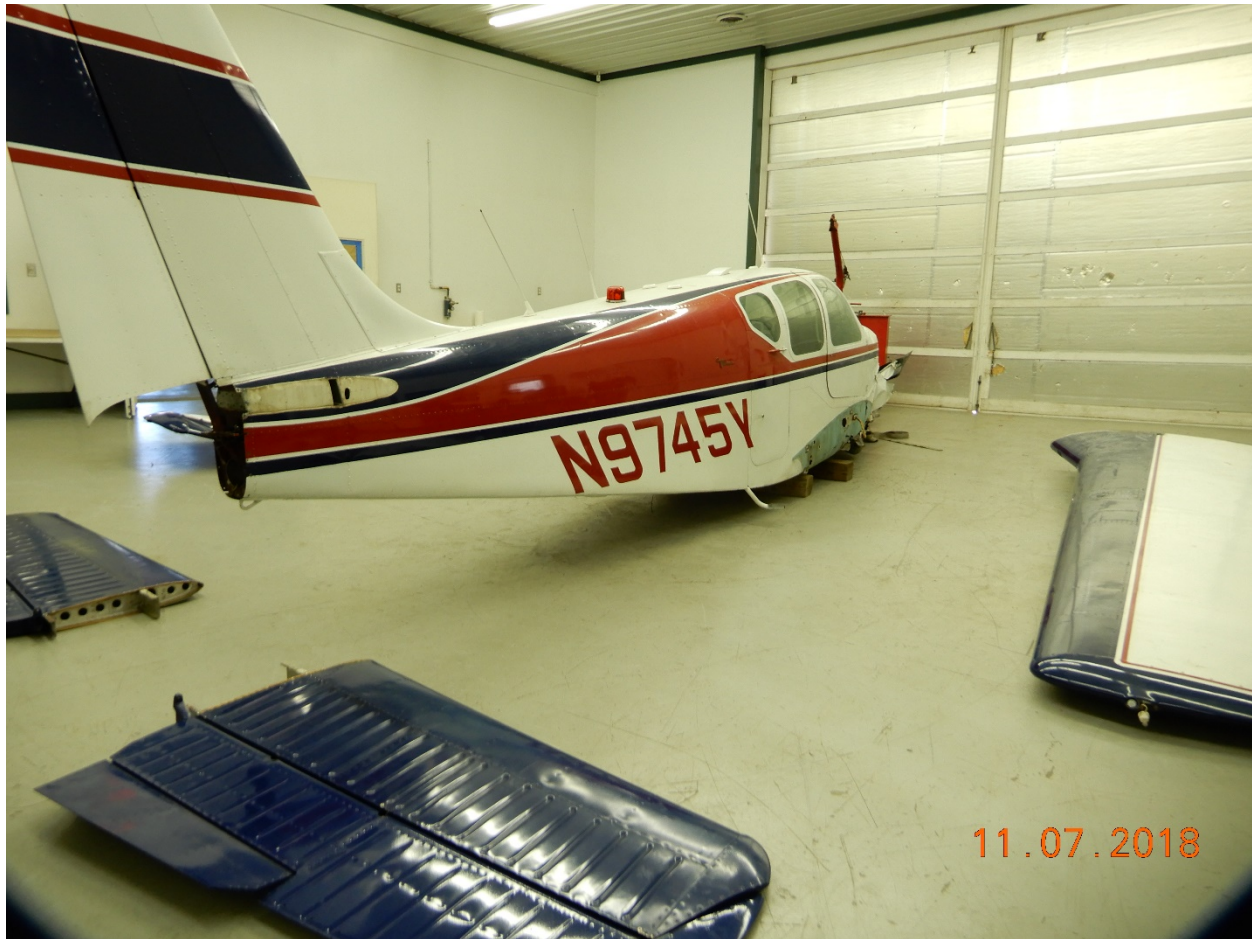
The airplane remained largely intact following the accident; however, both wings and the left and right horizontal stabilizers/elevators were removed for transport. All portions of the airplane were accounted for during the examination. The right wing exhibited upward buckling impact damage. The empennage was intact and the baggage door was operational. The landing gear and wing flaps were in the retracted position. The elevator trim was consistent with a nose-up position. The cabin door was operational.

Figure 1: Airplane as viewed from aft right side

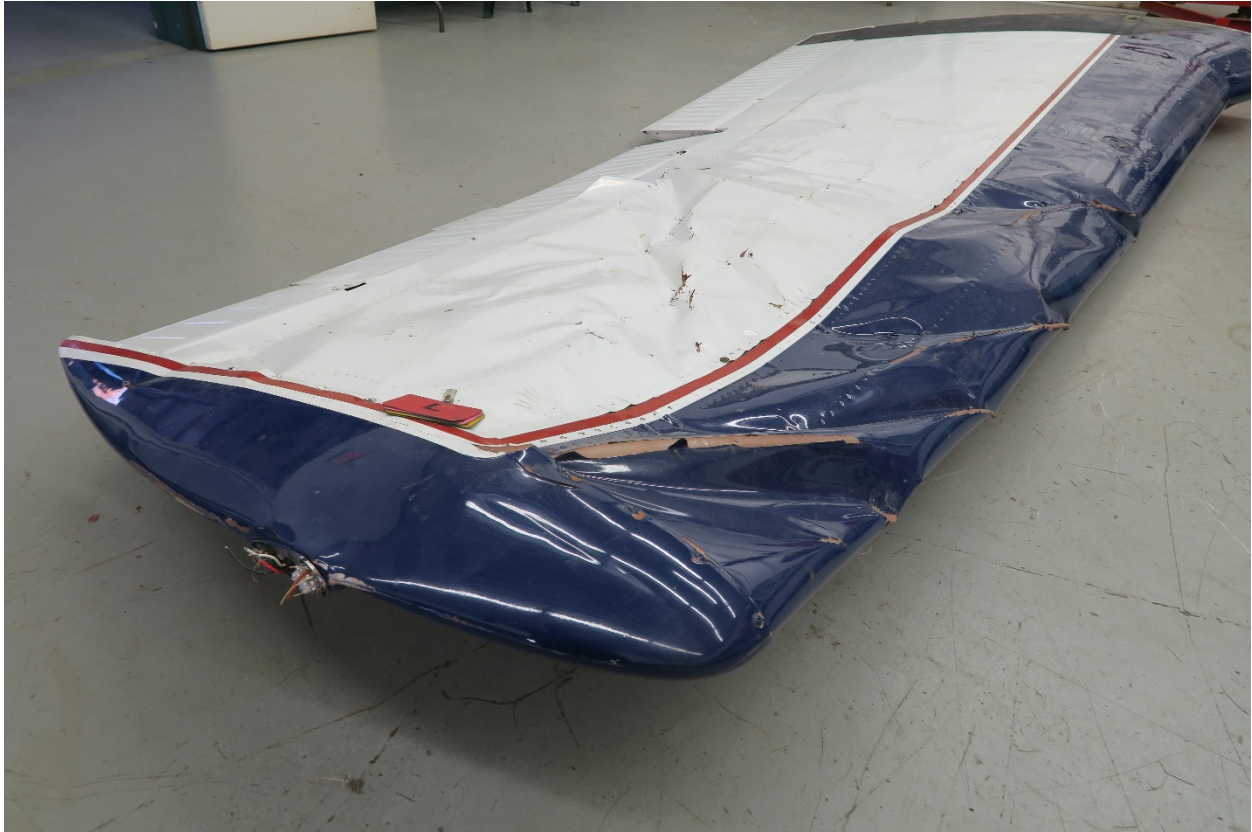
Figure 2: Left wing (Courtesy Textron Aviation)

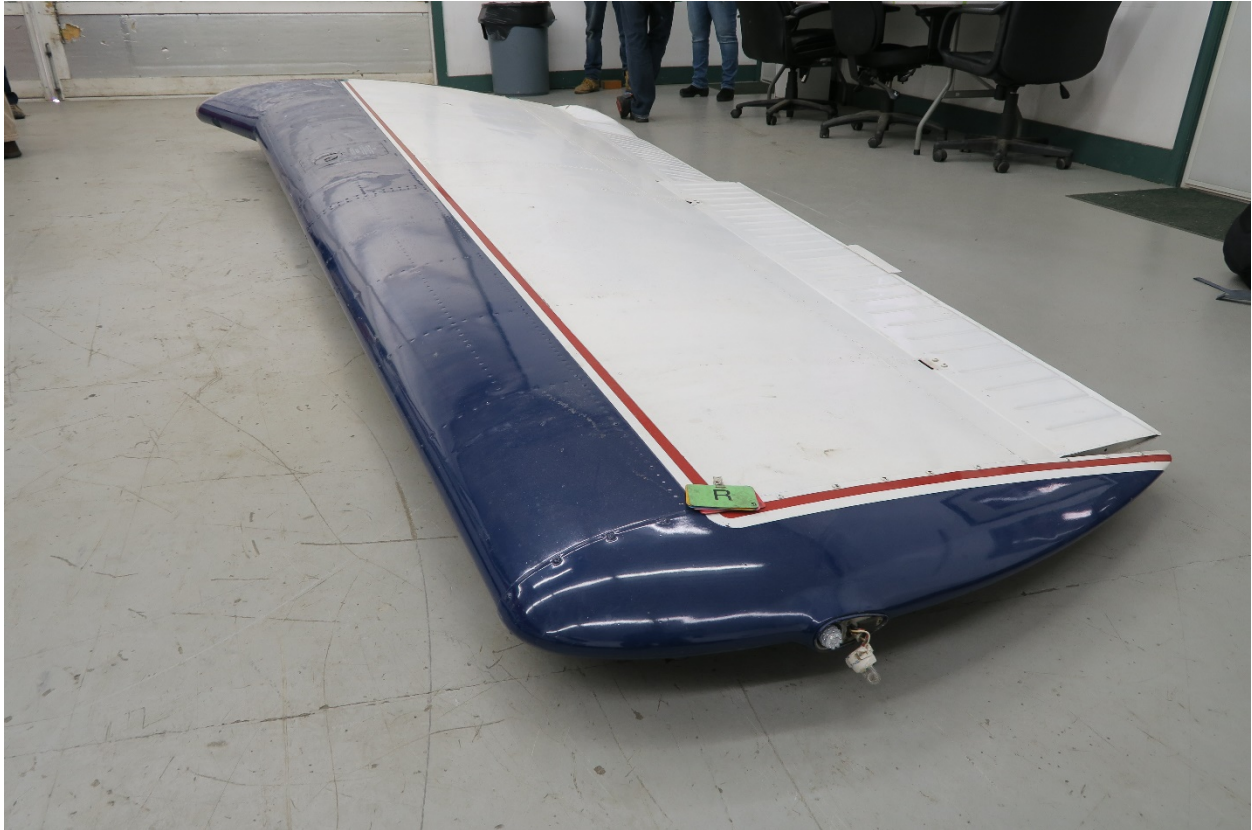
Figure 3: Right wing (Courtesy Textron Aviation)

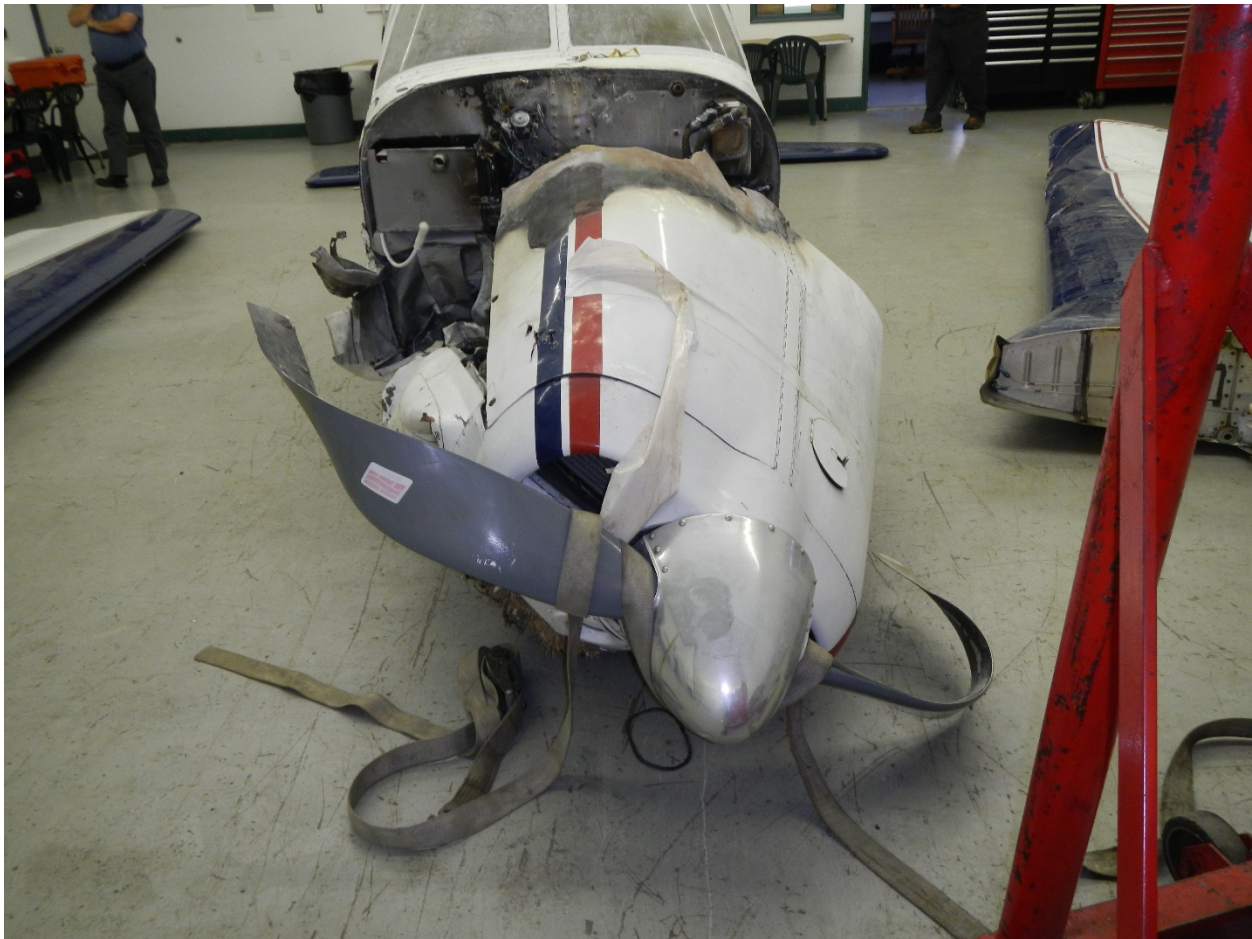
The engine was equipped with a 2-bladed constant speed propeller, which remained attached. The pitch change links were fractured during the accident. Both blades exhibited s-bending; one blade was missing a portion of its tip.

Figure 4: Engine and propeller (Courtesy Continental Motors)

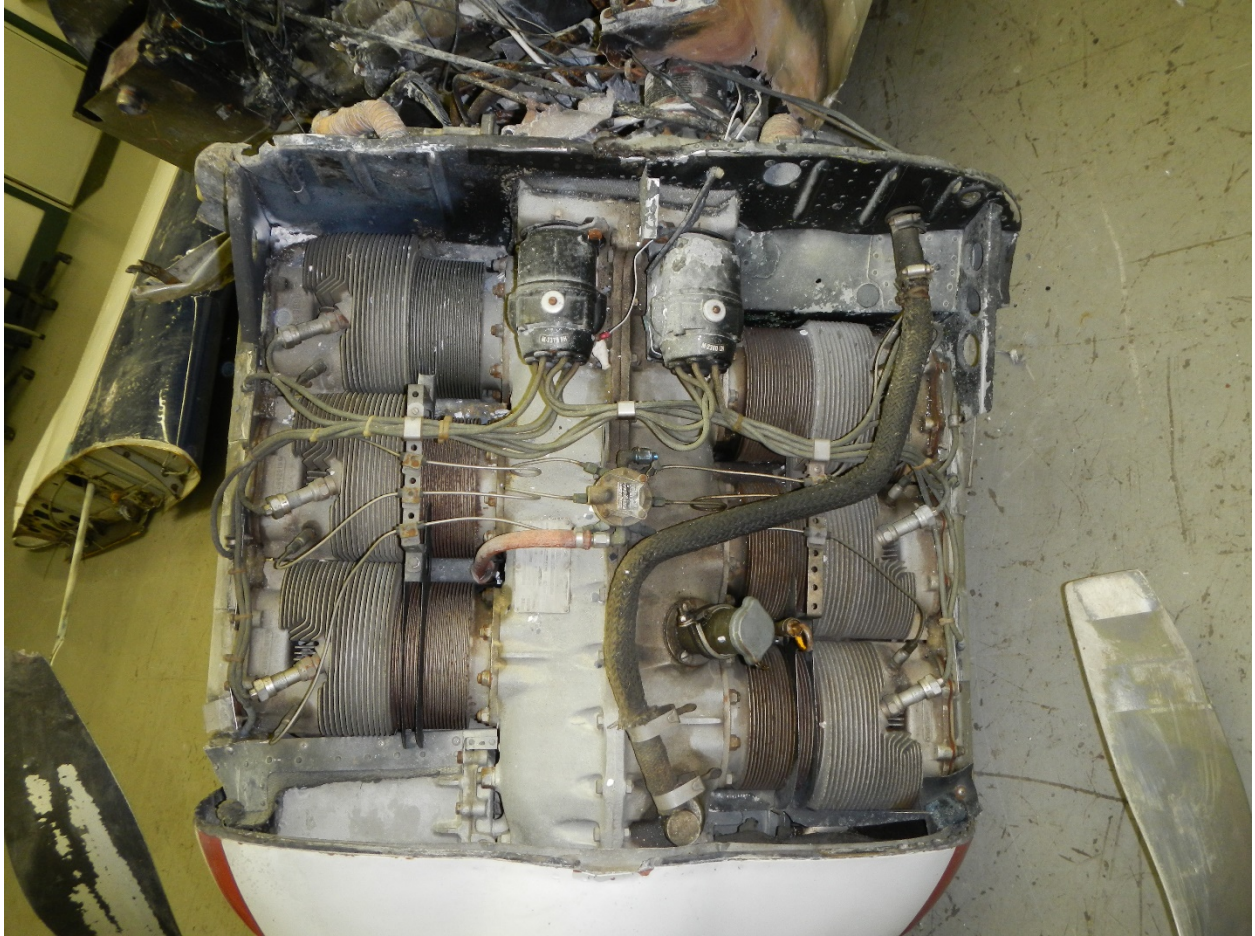
Figure 5: Top of engine with cowling removed (Courtesy Continental Motors)

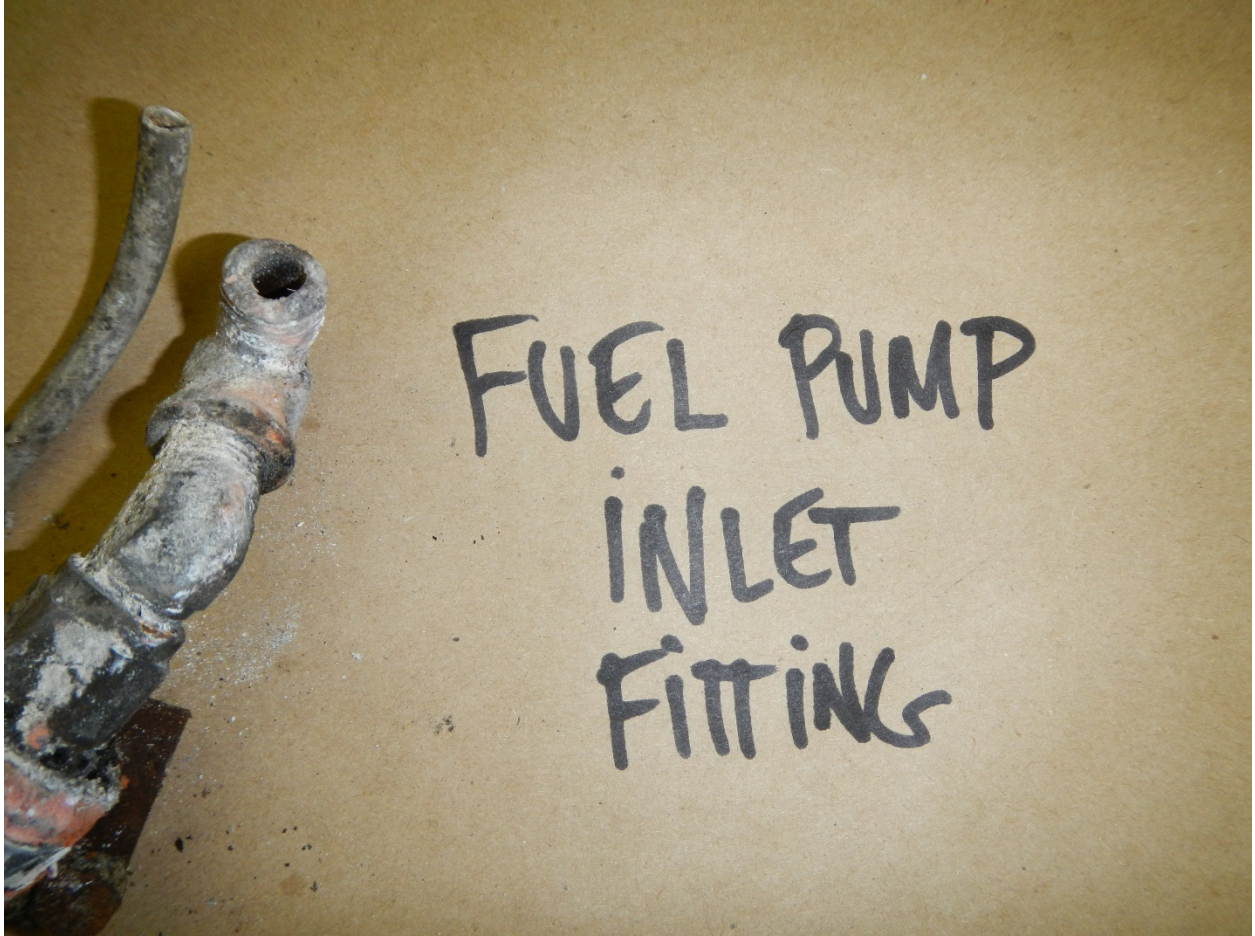
The engine did not exhibit any external anomalies but was fire damaged at its aft end. The fuel line from the firewall to the fuel pump inlet was fracture-separated at the inlet fitting. The pump and the fractured fitting were retained for further examination.

Figure 6: Fuel pump inlet fitting (Courtesy Continental Motors)

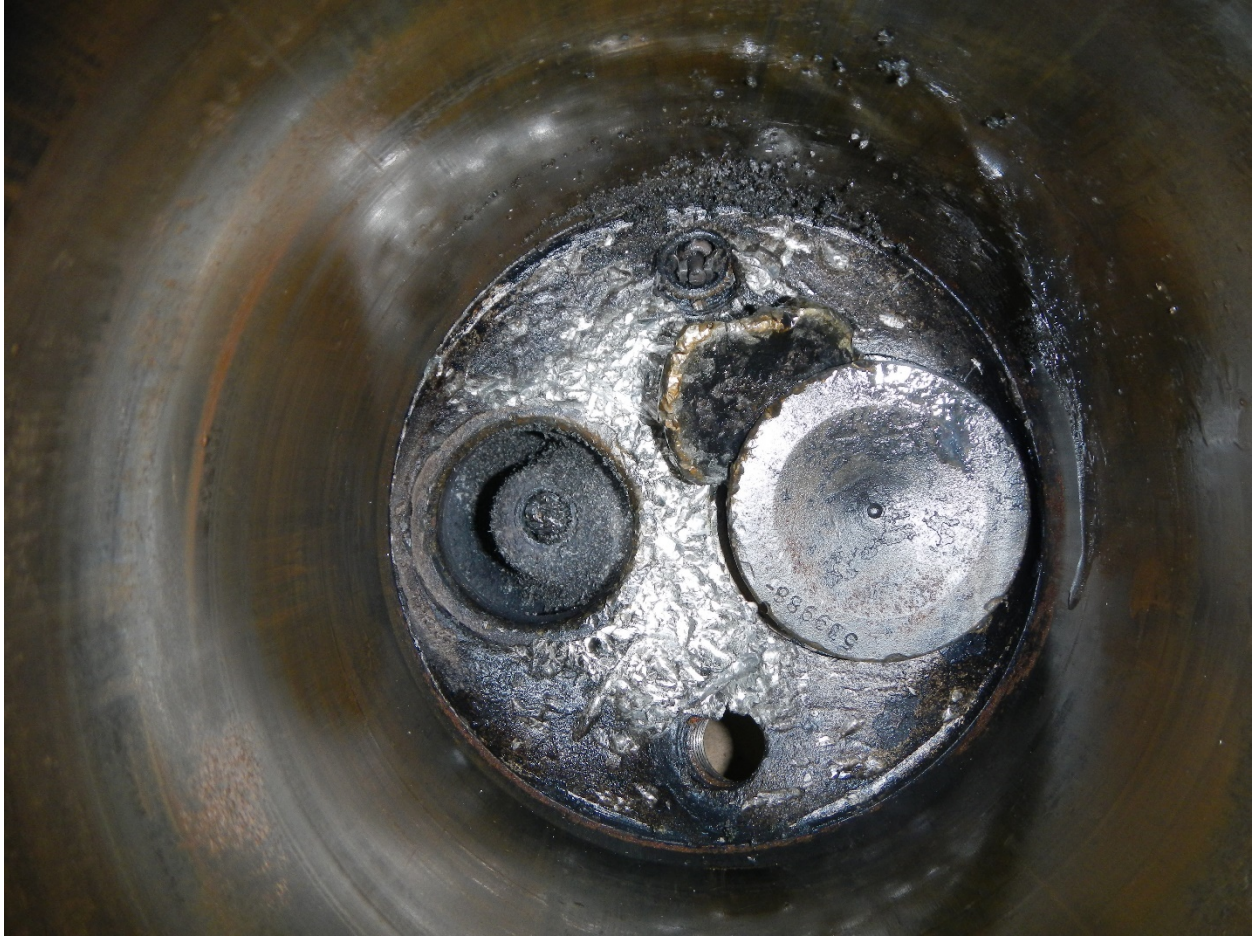
Continuity of the crankshaft and camshaft were confirmed when the propeller was rotated by hand, and thumb compression was obtained on cylinder Nos. 1, 2, 4, 5, and 6. Borescope examination of these cylinders revealed no anomalies that would have precluded operation. Borescope examination of cylinder No. 3 revealed catastrophic damage, including heavy mechanical damage to the piston and separation of the exhaust valve, a portion of which was lodged under the intake valve. The No.

Figure 7: No. 3 cylinder valves (Courtesy Continental Motors)

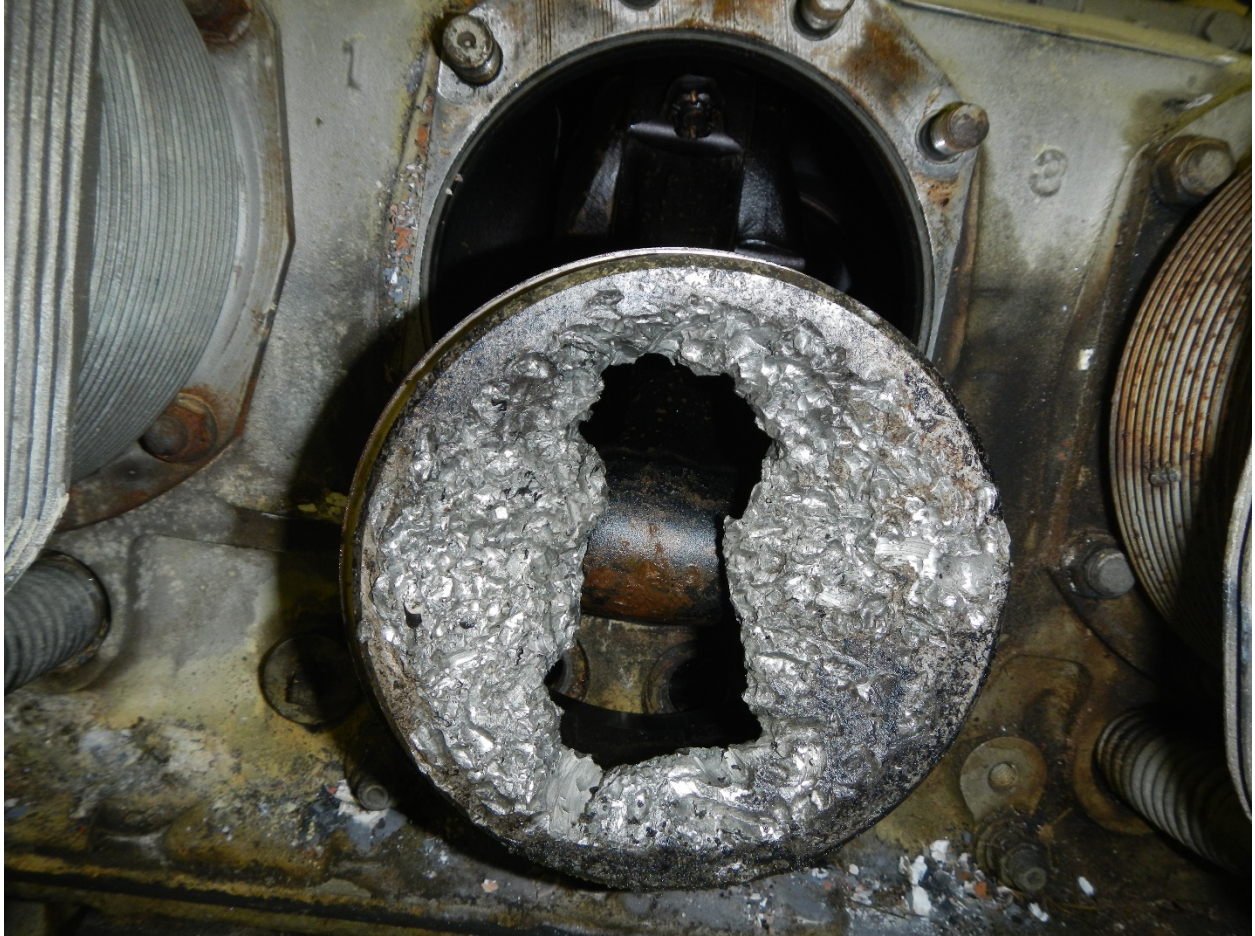
Figure 8: No. 3 cylinder piston (Courtesy Continental Motors)

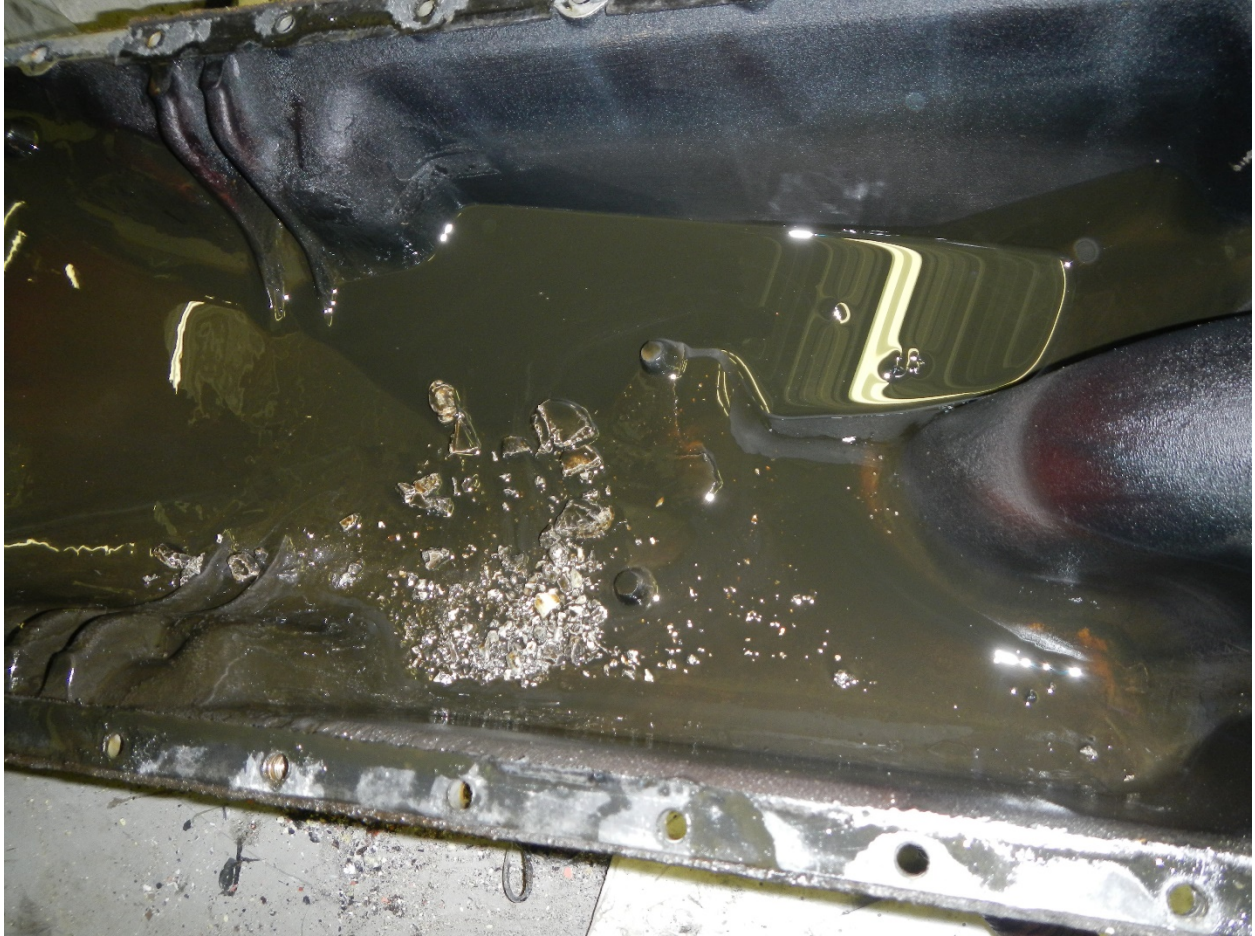
The oil sump was removed and exhibited numerous pieces of metal consistent with material from the No. 3 piston head.

Figure 9: Oil sump contents (Courtesy Continental Motors)
