**NATIONAL TRANSPORTATION SAFETY BOARD**  
Vehicle Recorder Division  
Washington, DC 20594

## **Onboard Image Recorder**

**Specialist's Factual Report**  
**By Sean Payne**

| Aircraft: | Beechcraft 35, N9745Y |

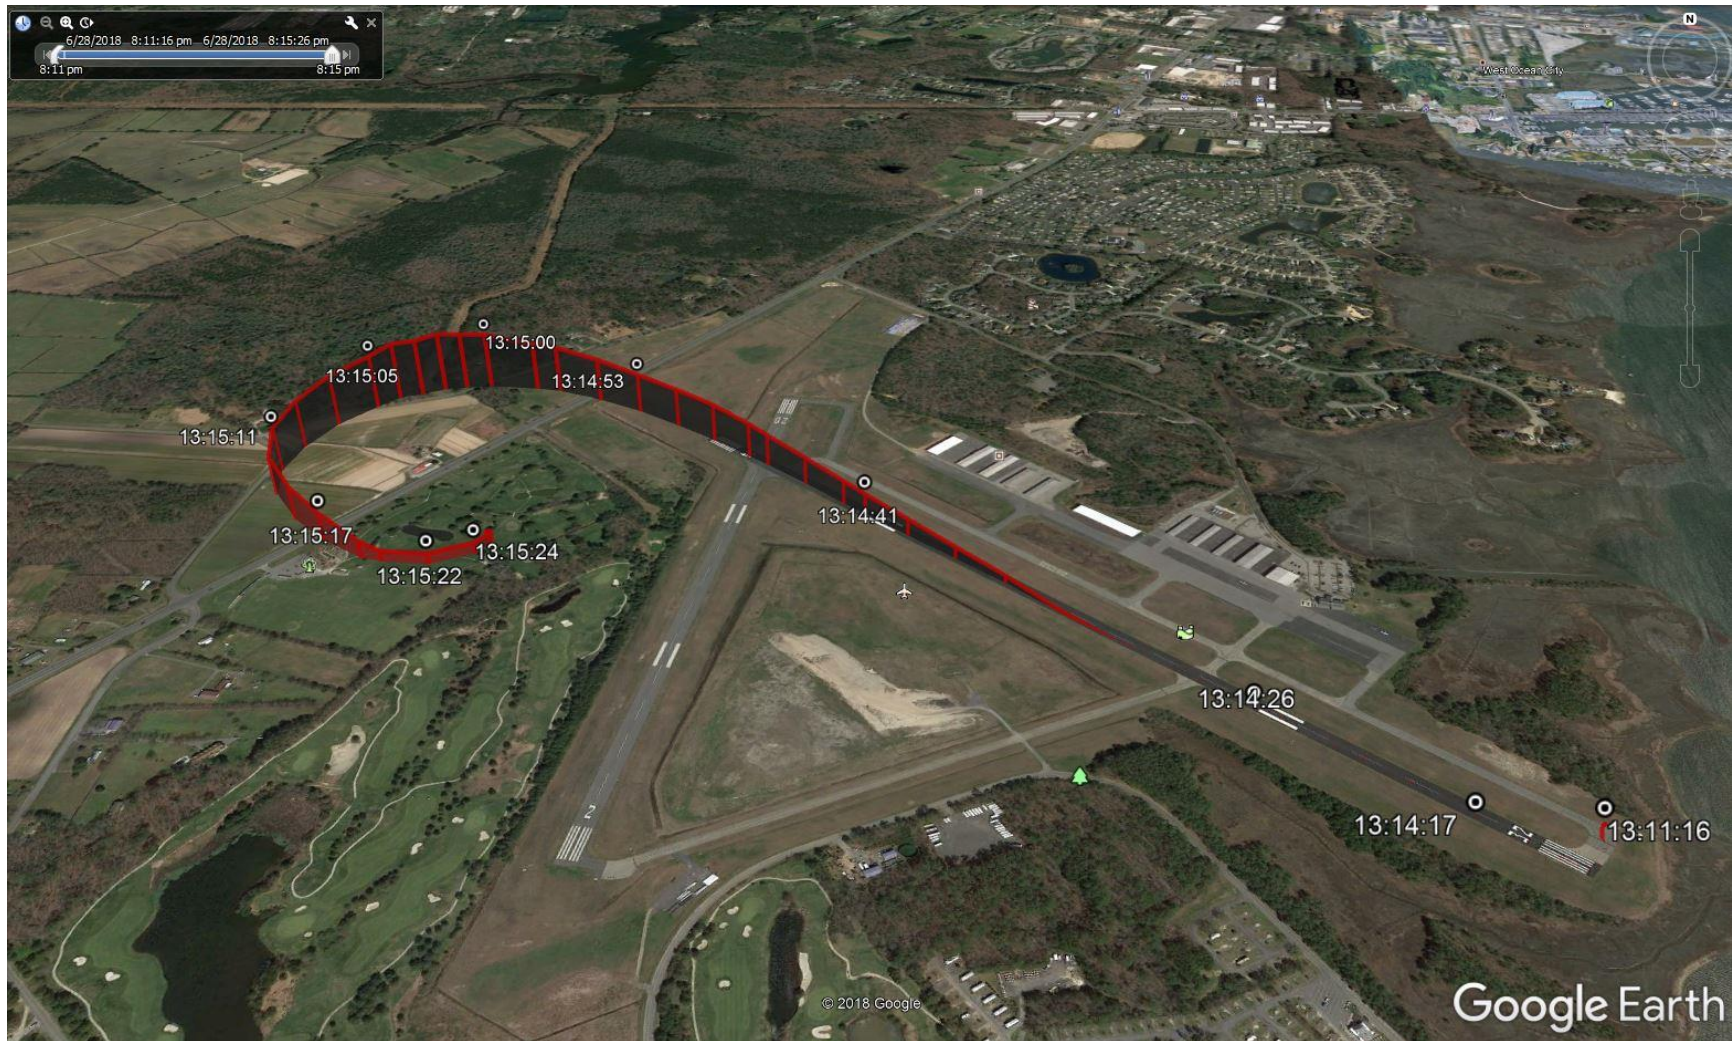
Figure 1 is a north-up oriented view of the aircraft’s location recorded by the Garmin VIRB during the accident flight. The GPS information originated at 13:11:16 near the runup area at runway 32. By 13:14:26, the aircraft had become airborne. The aircraft appeared to turn left from runway heading around 13:14:53. At this time, the GPS data still showed a climb trend. At 13:15:02, the GPS device recorded a maximum altitude of 305 feet. From there, altitude data showed a decreasing trend for the remainder of the recording as the aircraft continued to turn back toward OXB. In comparison to video events, impact with terrain occurred around 13:15:23. GPS data showed the aircraft continued to move northeast and came to a stop. GPS data was clipped after the aircraft came to rest.

Figure 1: A north-up Google Earth overlay of the accident flight.

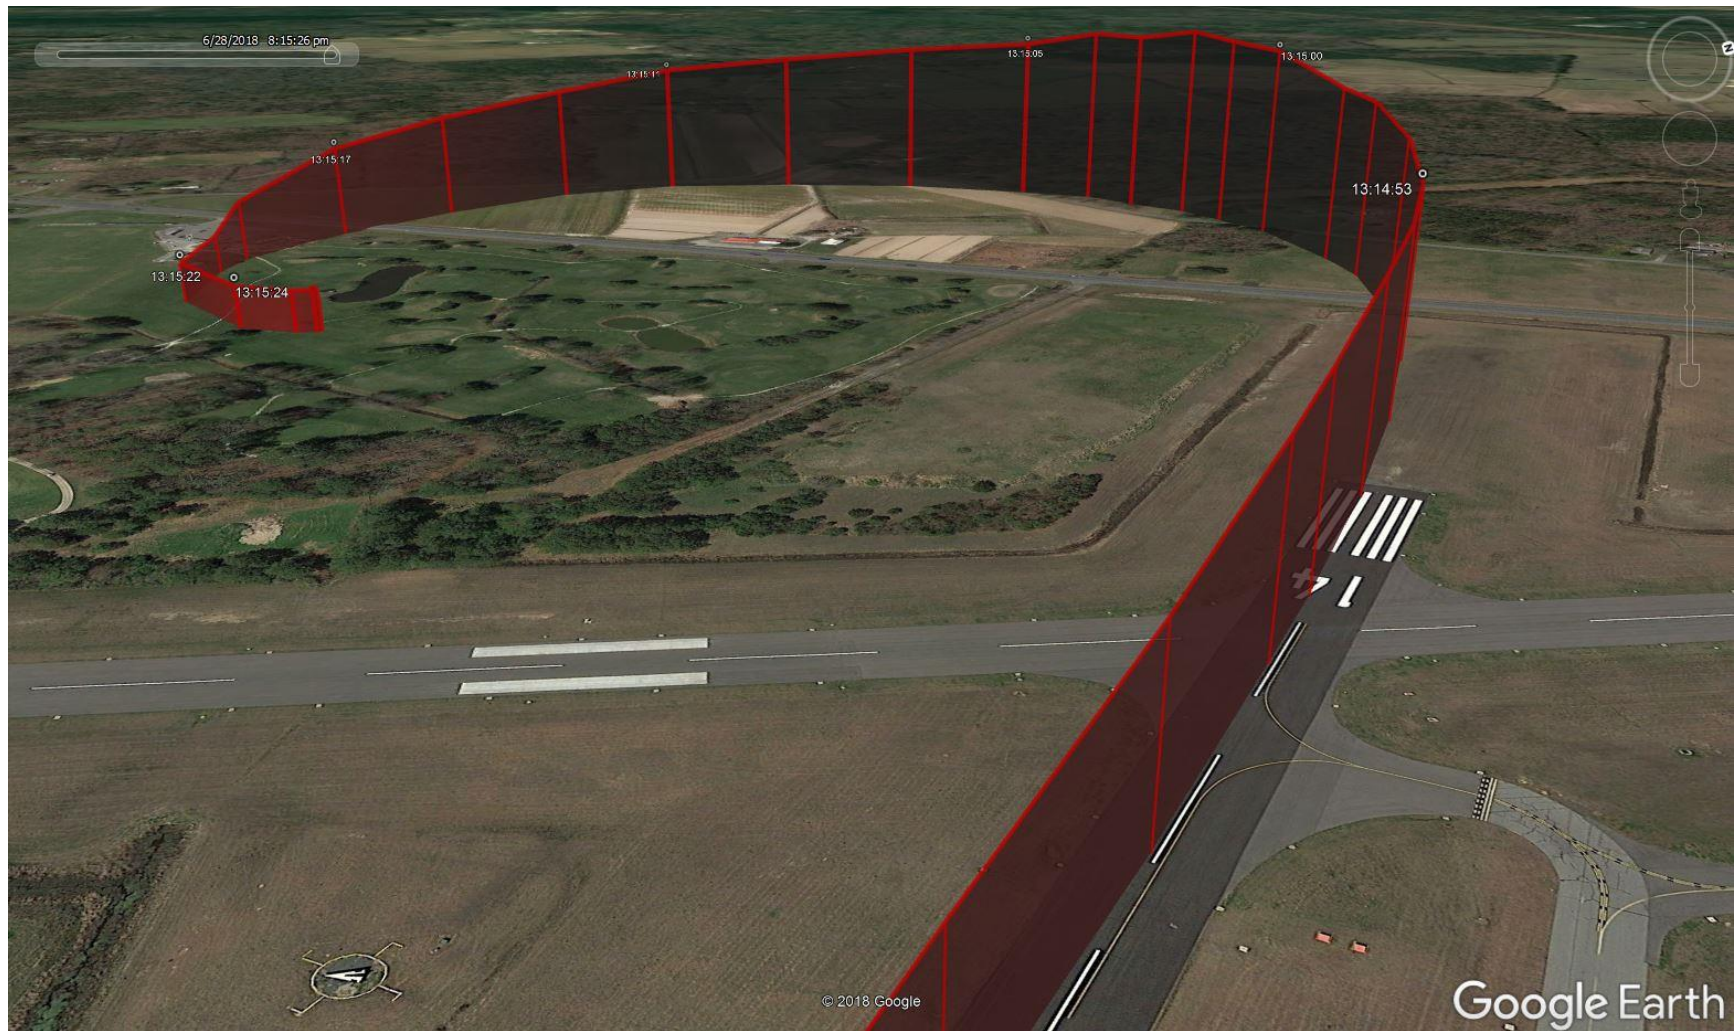
Figure 2 is a Google Earth overlay showing the turn and descent profile of the aircraft after departing runway 32.

Figure 2: A north-up Google Earth overlay of the accident flight showing the turn and descent profile.

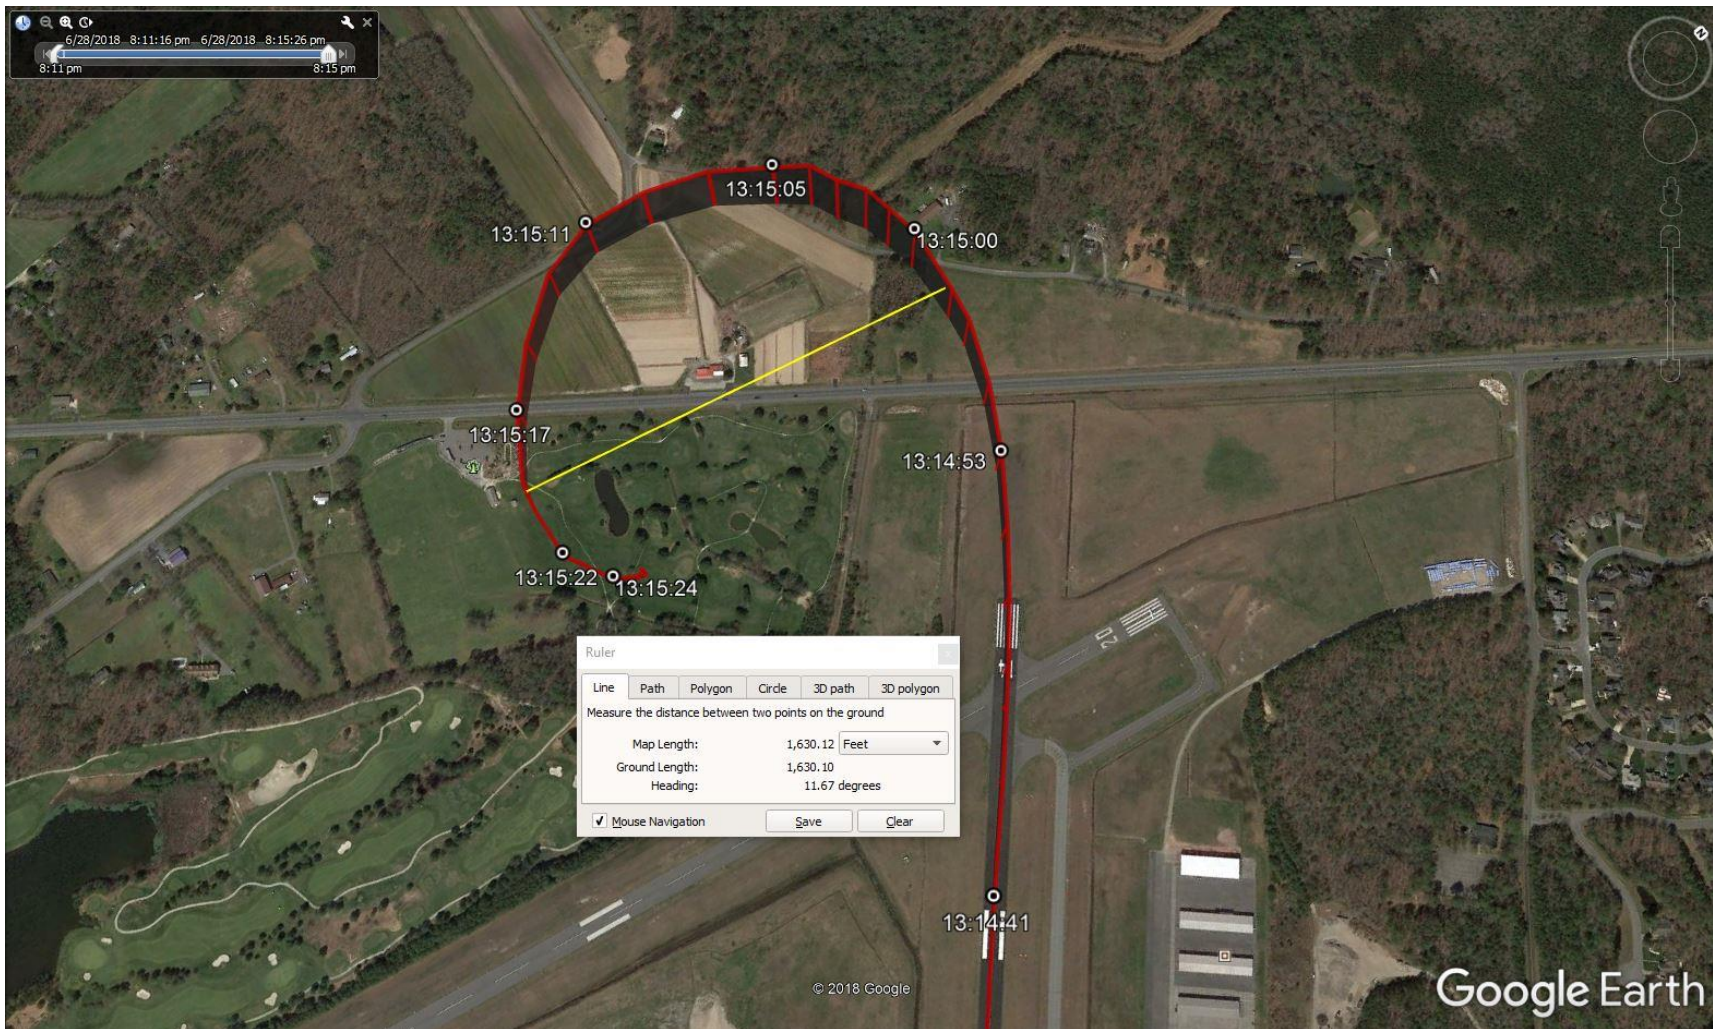
Figure 3 is a Google Earth overlay showing a top down perspective of the final portion of the accident flight. The diameter of the aircraft’s turn was approximately 1630 feet.

Figure 3: A north-up Google Earth overlay of the accident flight showing a top down perspective.
