Air Safety Office  
Parker Hannifin Corporation  
Parker Aerospace  
14300 Alton Parkway  
Irvine, California 92618

**Date:** 2/5/2020

**Examination Location:** Parker Stratoflex, 220 Roberts Cutoff Rd, Ft. Worth, TX

**Subject:** Bell 206B Hose Exam – For NTSB under FAA Witness

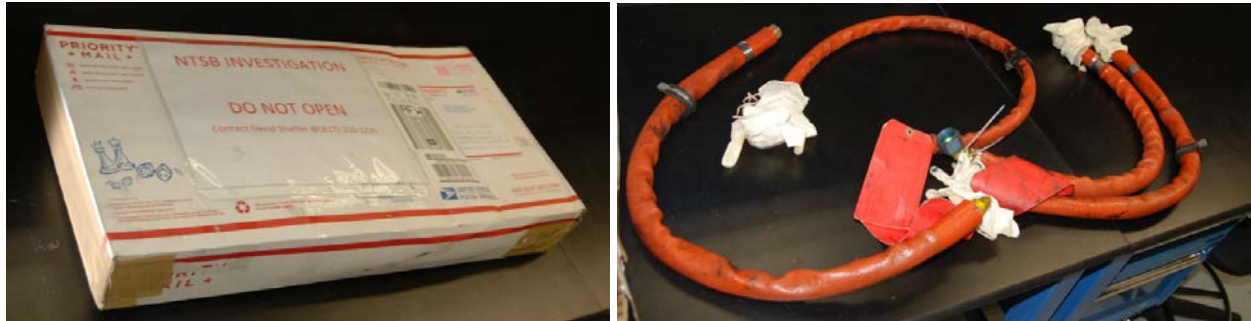
The package containing the four hoses was sent to Parker Stratoflex and quarantined unopened in a locked lab area. The package was opened and contained four hoses, 3 which had red NTSB tags attached.

The general condition of the hoses were good and in a normal in service condition and the fire sleeves weren't damaged. The Oil Out hose, Tank Vent @ Gearbox Hose, and Gearbox Vent Hose were assembled at Parker Stratoflex, and the Oil In hose is a Stratoflex hose assembled by Aviall. Aviall is the distributor who is trained and authorized to assemble for Stratoflex. The Oil Out hose was assembled in October 18, 2004, the Oil In hose assembled on January 4, 2005, the Tank Vent @ Gearbox hose on August 10, 2001, and the Gearbox Vent Tube hose on November 26, 2001.

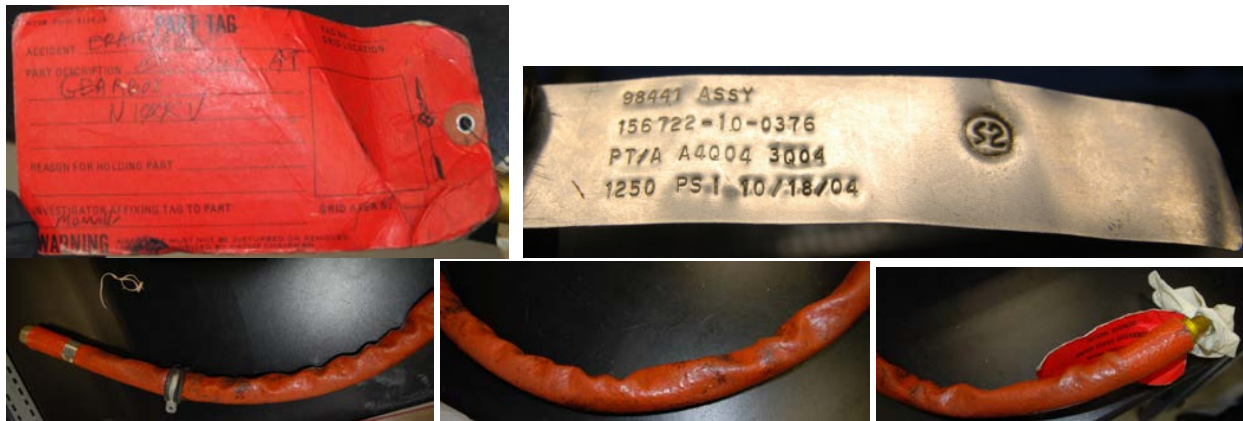
#### Oil Out Hose:

The Oil Out Hose is missing both fire sleeve clamps on each end.

The missing clamps on the Oil Out hose would not affect performance of the hose and is only there to retain the fire sleeve to the hose fitting.

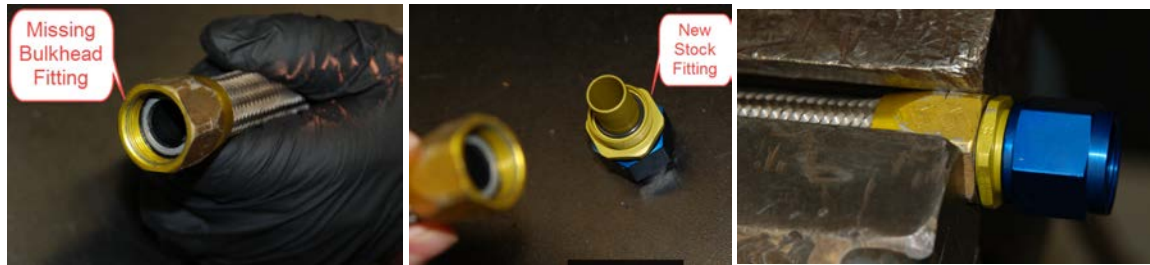
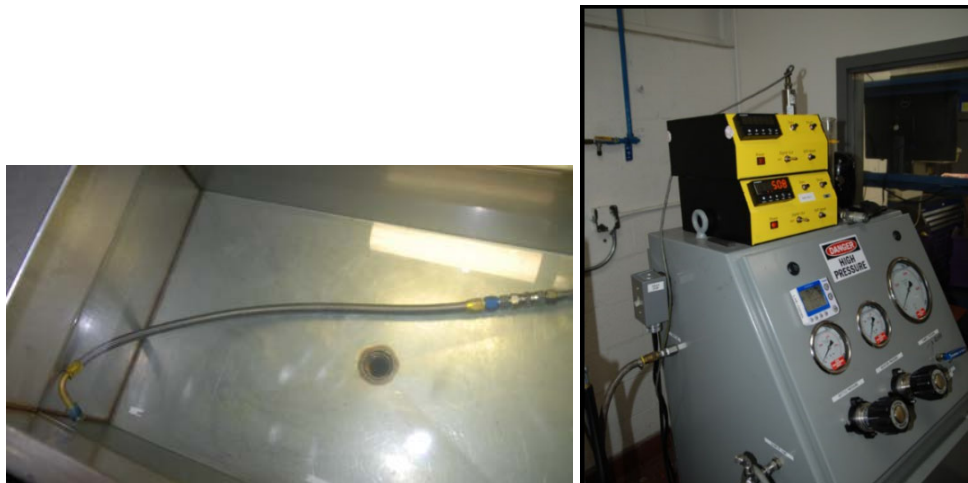
The hose was tested by capping one end and pressurizing with air under water to 500 psi. The hose did not leak as no bubbles were observed.

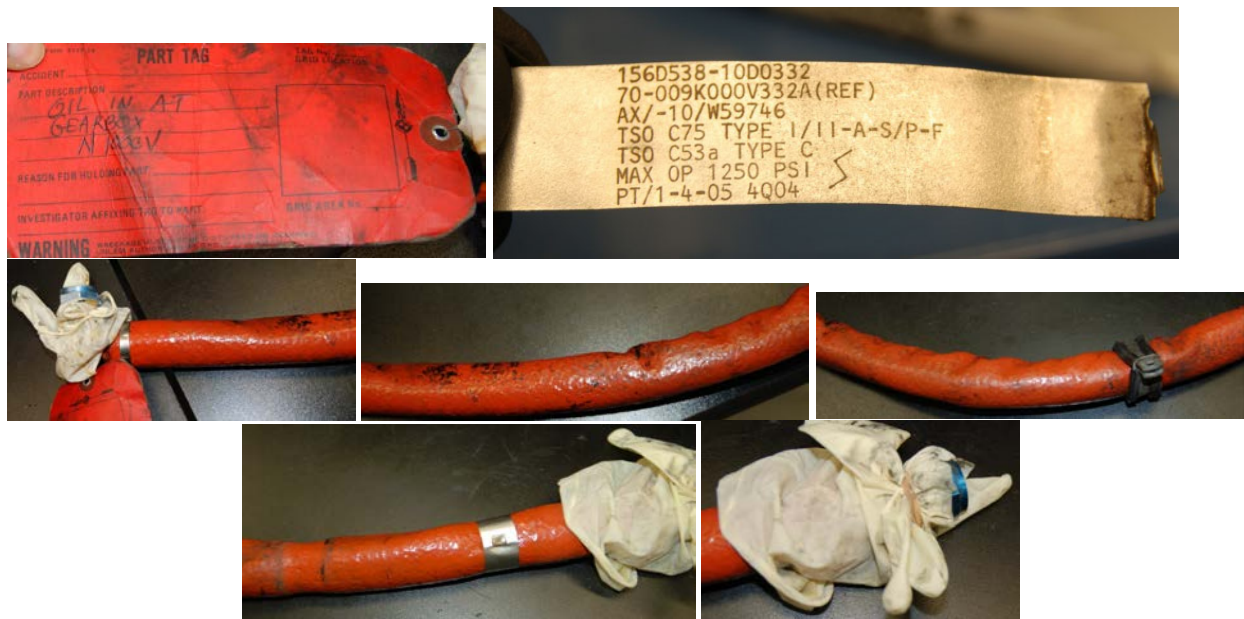
#### Oil In Hose:

The fire sleeve was removed. The hose had a kink and slight bend in the middle.

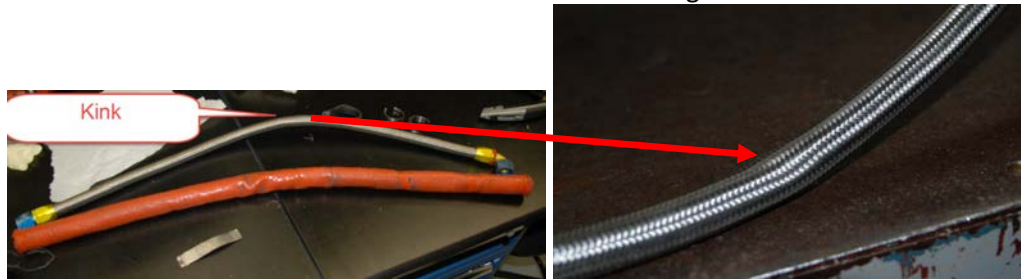
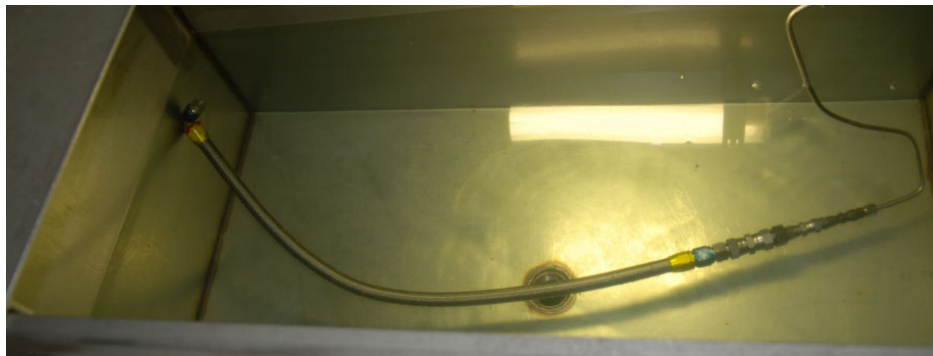
The hose was tested by pressurizing with air under water to 500 psi and the hose did not leak as no bubbles were observed.

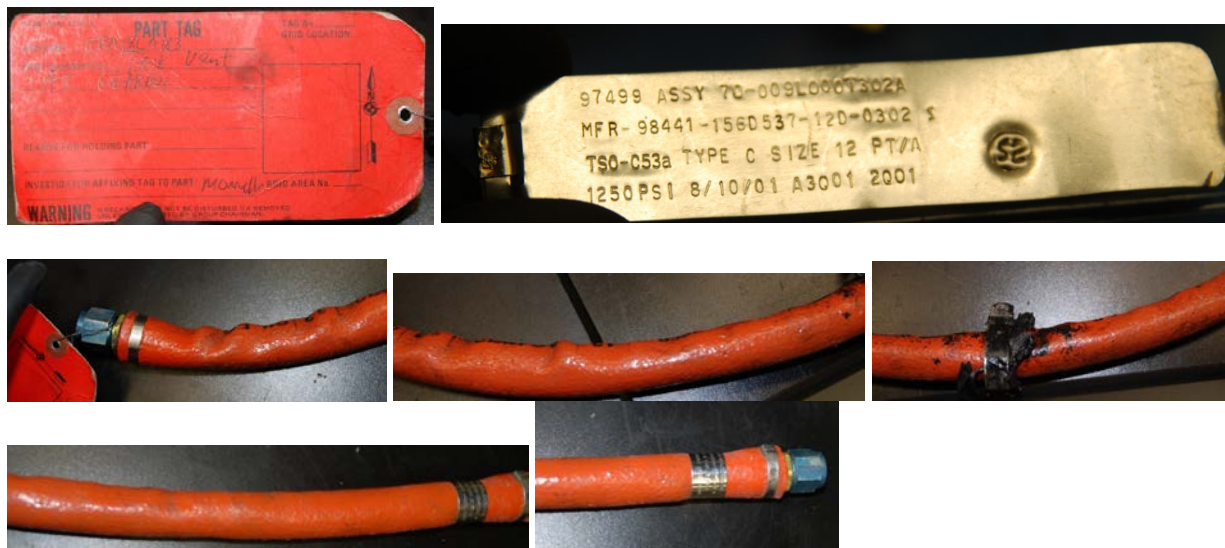
**Tank Vent @ Gearbox Hose:**

RTV had been applied to ends of hose (indicative of being assembled by Aviall as Stratoflex fire sleeve ends are dipped). The hose had a slight kink on the tag end.

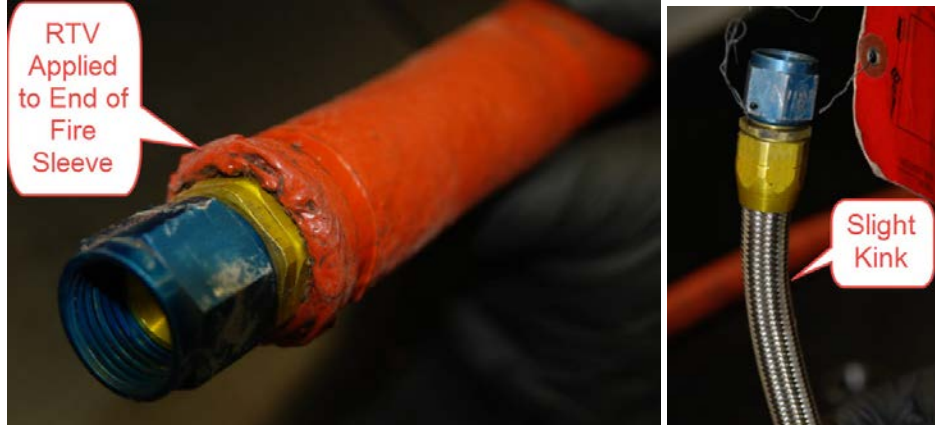
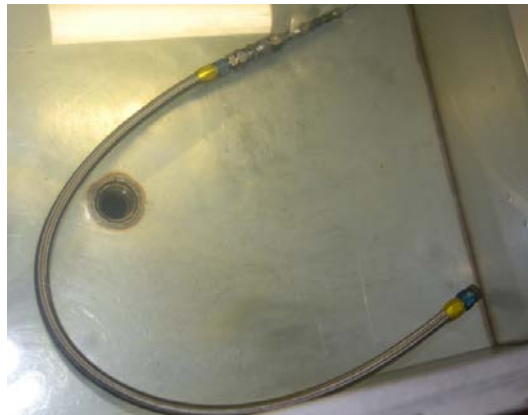
The hose was tested by pressurizing with air under water to 500 psi and the hose did not leak as no bubbles were observed.

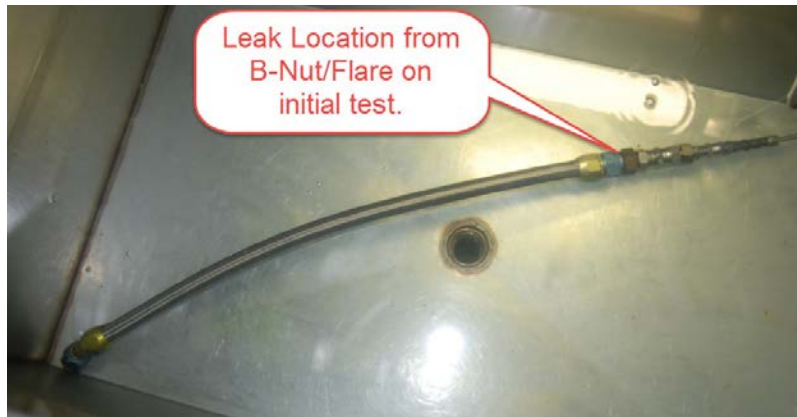
The hose was capped on one end and an adaptor added to connect to the test fixture. The hose was pressurized to 500 psi and a few bubbles were coming from the hose flare indicating a leaking flare to adaptor connection.

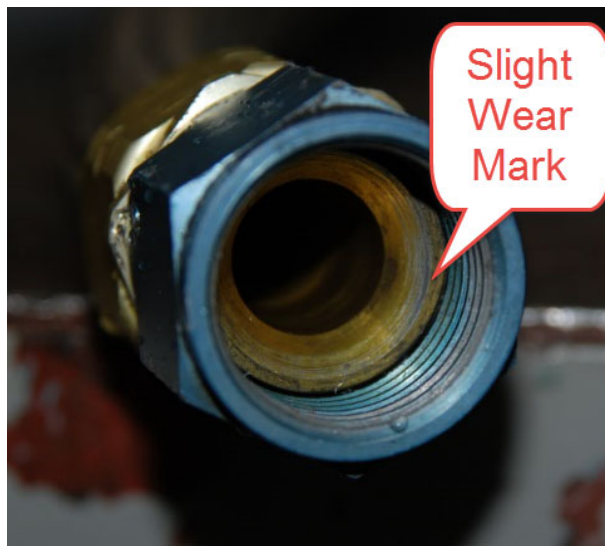
The adaptor was removed and the hose female flare had a slight wear mark on the female flare side.

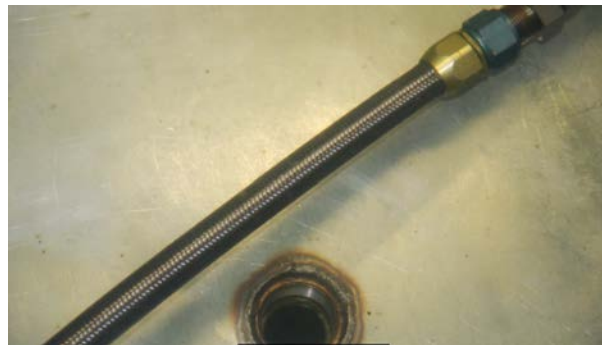
A different newer adaptor was used to attach hose to the test fixture and was pressurized again with air under water and the hose and flare did not leak.

All four hoses were pressure tested with 500 psi of air and submerged in water to visually inspect for bubbles. All four hoses held 500 psi with no leaks observed. The gearbox vent tube hose leaked initially, but did not leak when a newer different adaptor was used to hook the hose to the test fixture.
