# NATIONAL TRANSPORTATION SAFETY BOARD

## MATERIALS LABORATORY FACTUAL REPORT

Report No. 19-027

Place : Passadumkeag, Maine  
Date : July 12, 2018  
Vehicle : Glasair SH-2, N352GL  
NTSB No. : ERA18LA190  
Investigator : Heidi Kemner, AS-ERA

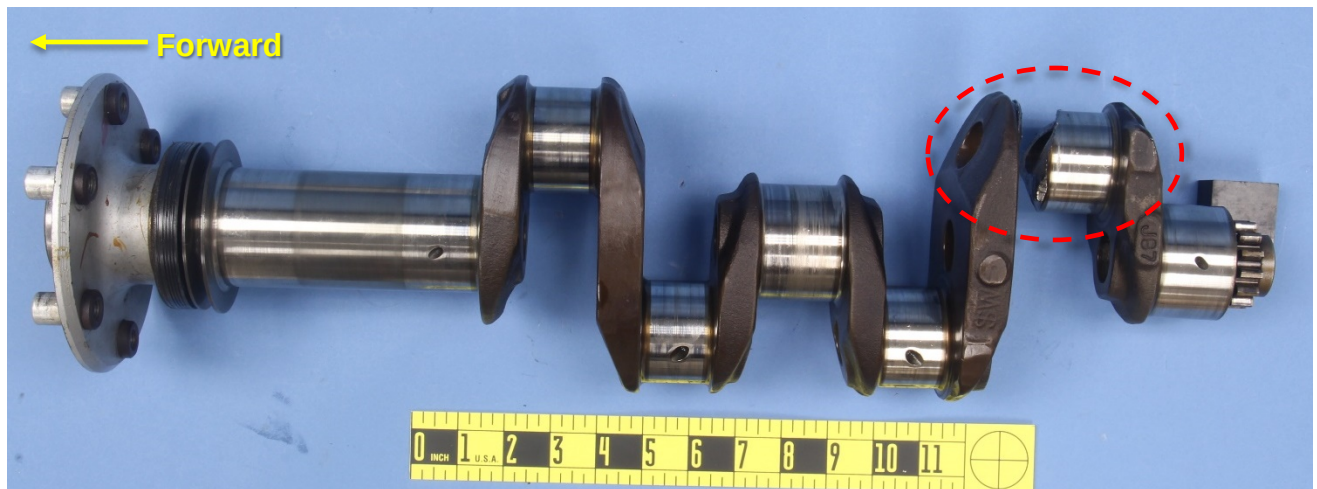
A crankshaft from the accident engine was sent to the NTSB Materials Laboratory, and is shown in Figure 1. According to records supplied to the Materials Laboratory, the engine had undergone a propeller strike in 2013, about 350 flight hours prior to this accident. No engine inspection had been performed after that event.

As shown in Figure 1 and Figure 2, the crankshaft had fractured into two main pieces at the #4 cylinder journal (the aft most cylinder journal). The journal had fractured perpendicular to the crankshaft direction, located along the radius at the web forward of the #4 cylinder journal.

Figure 1 – The fractured pieces of the crankshaft, as received. The fractured #4 cylinder journal is annotated on the figure (red circle).

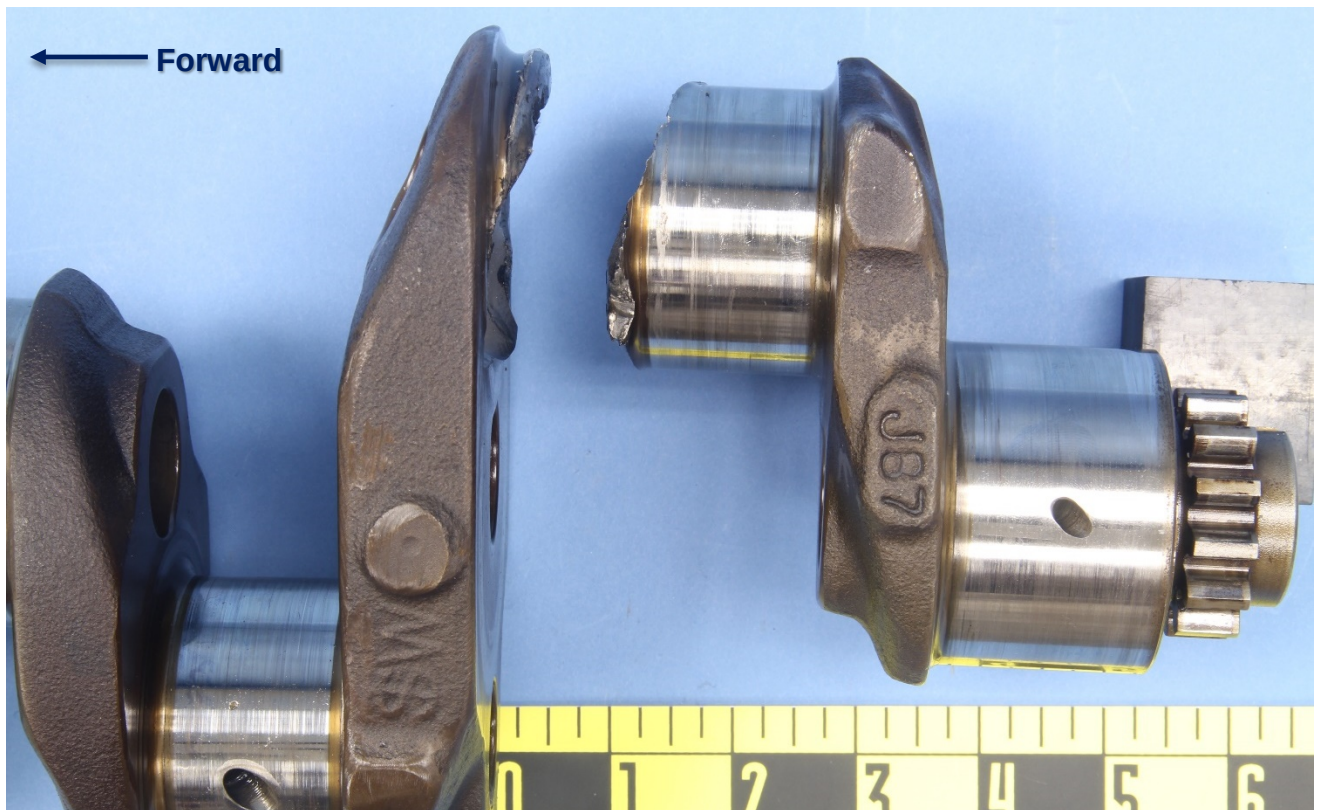
Figure 2 – The mating halves of the fractured #4 cylinder journal of the received crankshaft.

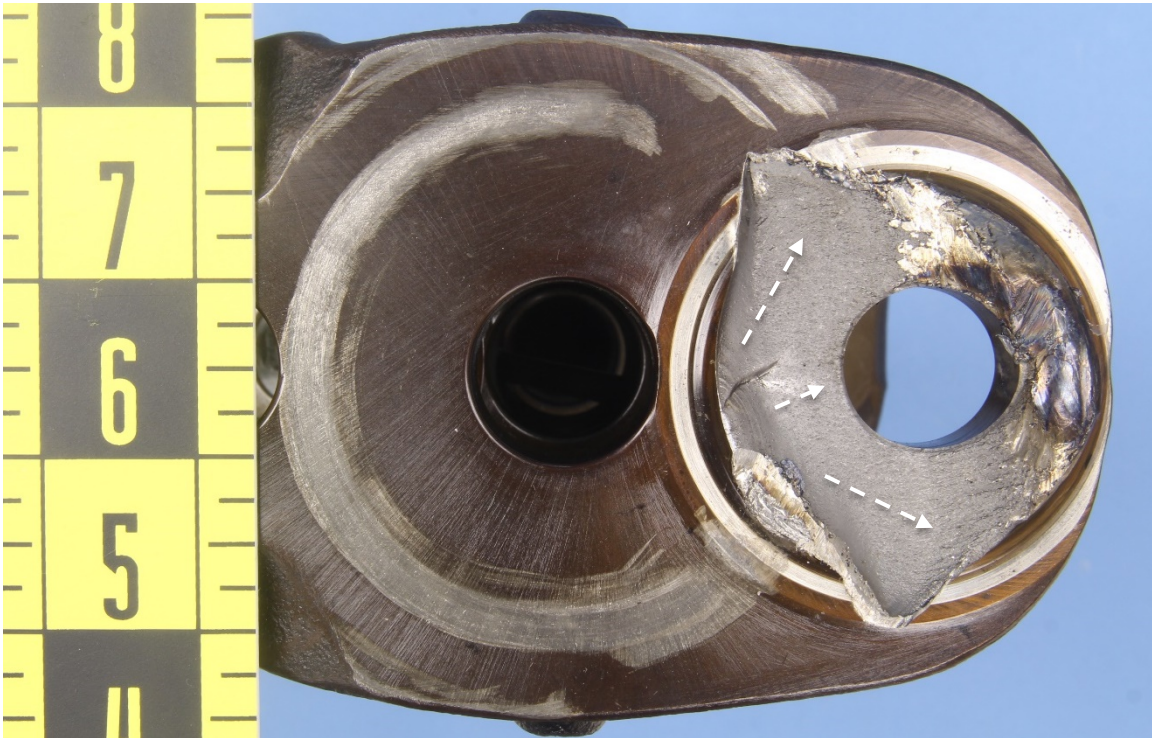
The forward mating fracture surface is shown in Figure 3 and Figure 4. About half of the fracture surface exhibited smearing, consistent with post-fracture damage to the forward surface. The lower half of this fracture surface exhibited crack arrest marks, consistent with progressive crack propagation. As denoted by the arrows in Figure 3, the progressive portion of the fracture surface propagated inward from the journal surface.

Figure 3 – The forward side fracture surface of the #4 cylinder, as received. The arrows denote the crack growth direction.

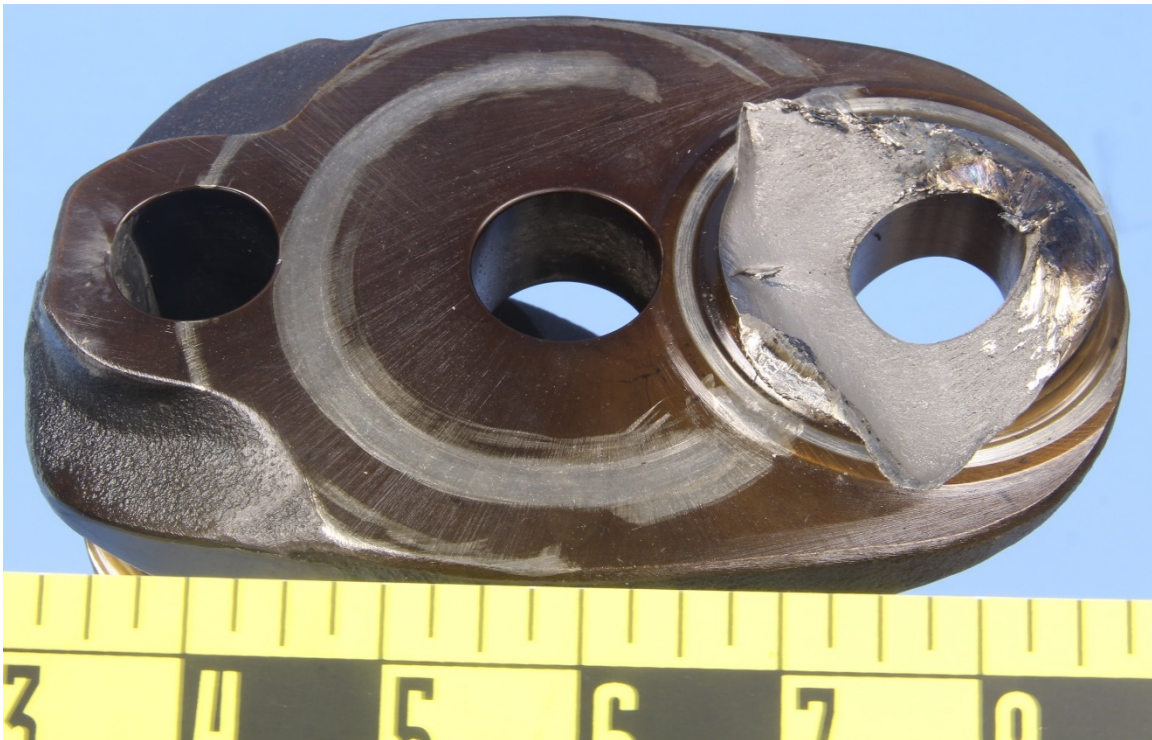
Figure 4 – Angled view of the forward fracture surface.

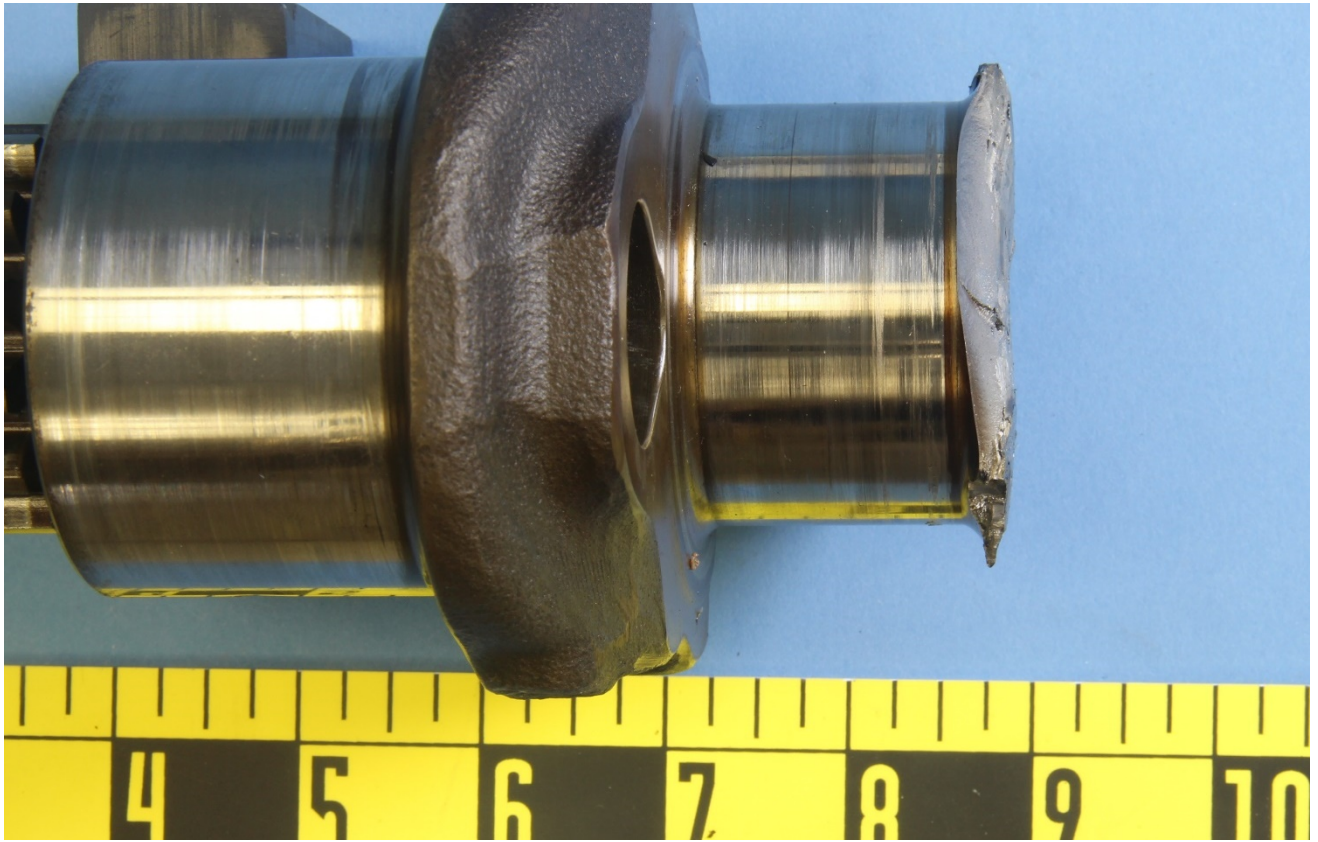
Figure 5 and Figure 6 illustrate of the aft fracture surface. This fracture surface was examined more thoroughly as the progressive fracture regions were less damaged than on the forward side. The crack initiation site was located on the journal surface, denoted by the yellow arrow in Figure 6.

Figure 5 – Normal view of the aft fracture surface from the crack initiation site side.

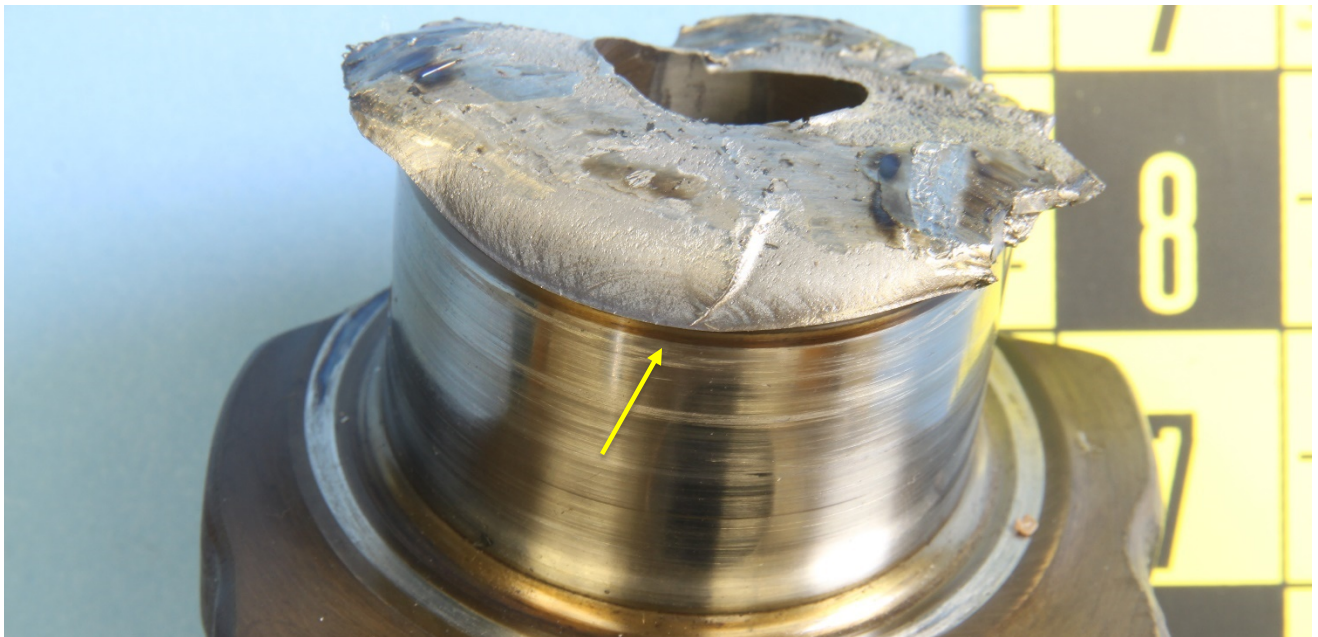
Figure 6 – Angled view of the aft fracture surface, facing the crack initiation area (arrow).

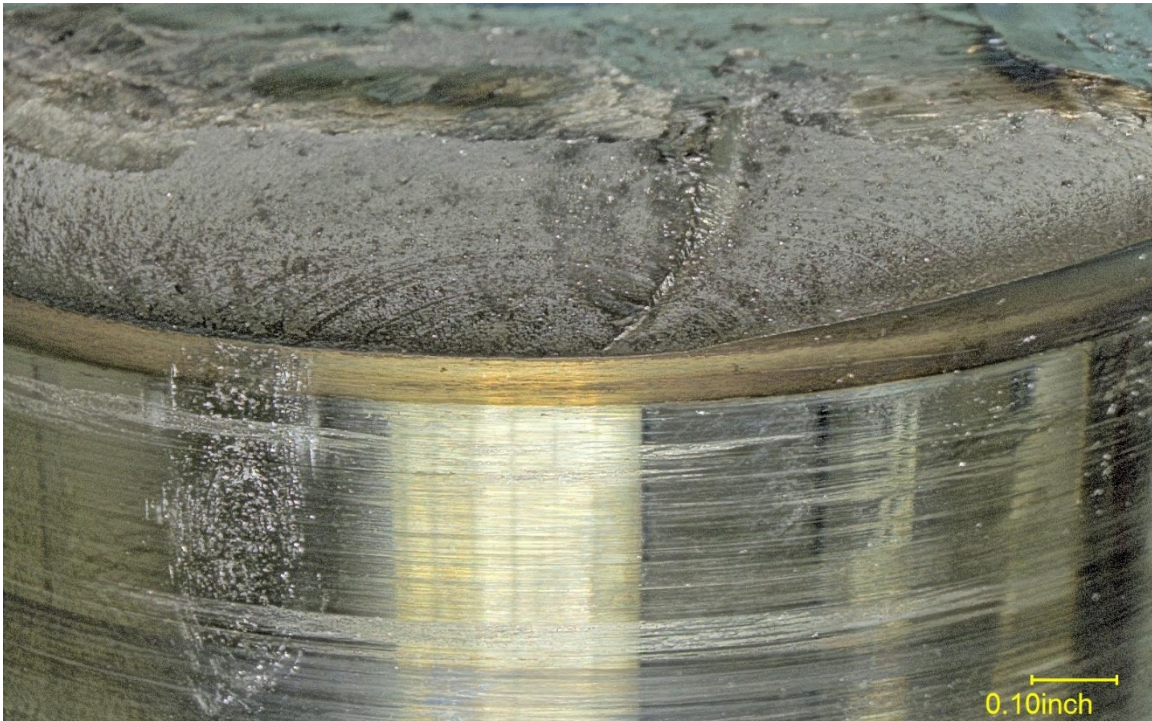
This location corresponded with the forward transition radius of the journal as well as a circumferential gouge with a brownish-colored streak. Closer views of the crack initiation area and the brown circumferential streak are shown in Figure 7. The crack initiation area exhibited ratchet marks, consistent with where two smaller cracks joined and coalesced during the propagation stage (see Figure 8).

Figure 7 – Closer view of the aft fracture crack initiation site, located at a circumferential streak on the journal.

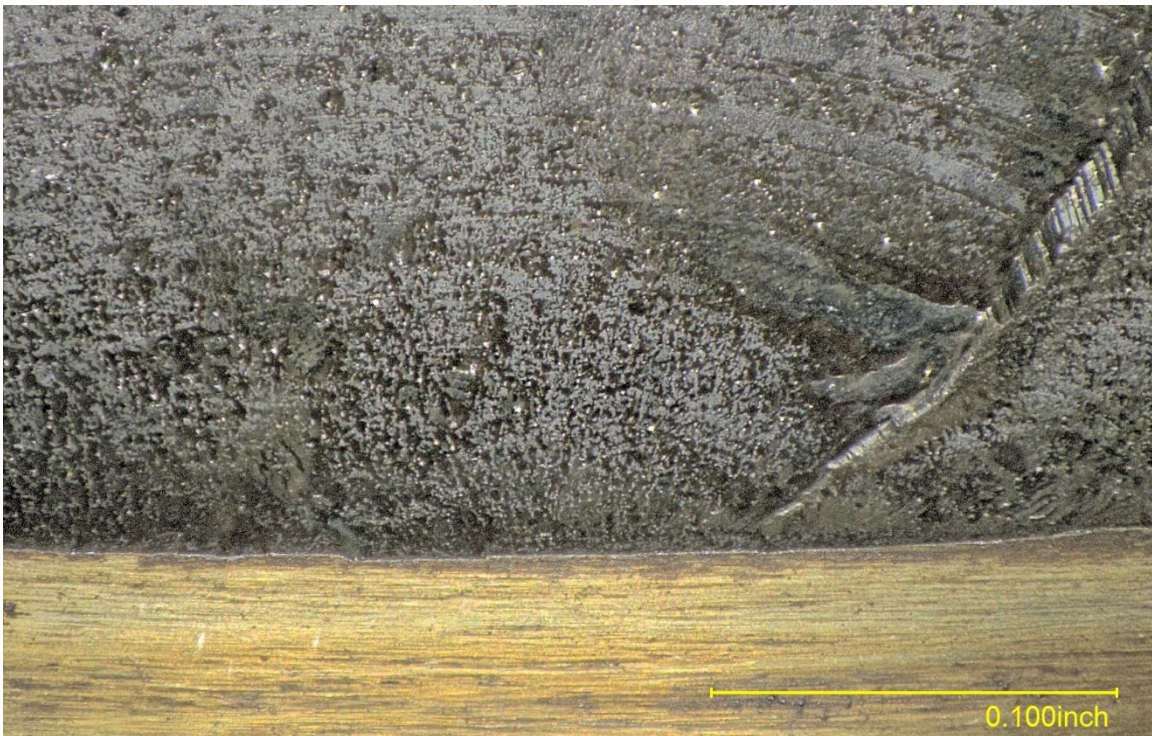
Figure 8 – Closer view of the aft crack initiation sites, with a prominent ratchet mark present on the right.

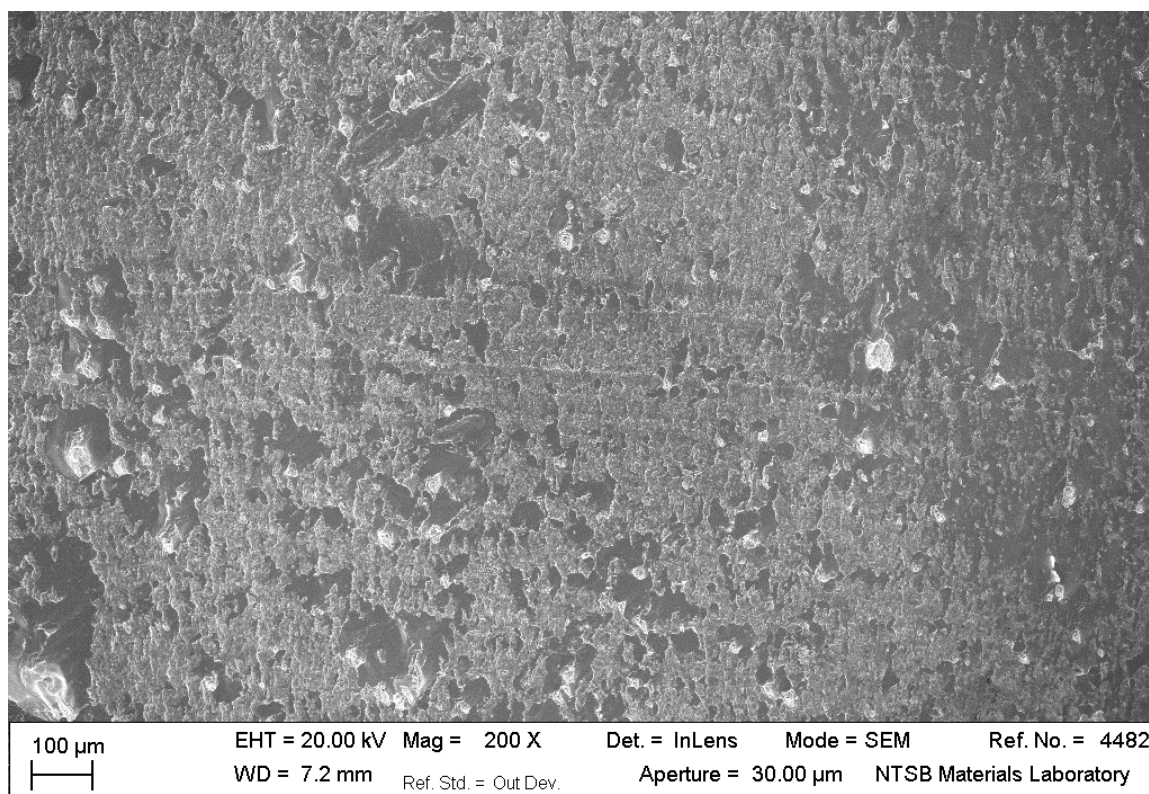
The aft fracture surface was cleaned using acetone and examined using a scanning electron microscope (SEM). A typical area of the end of the fracture surface is displayed in Figure 9. Much of the microscopic features of the fracture surface had been obliterated by post-fracture contact with the mating forward face, as indicated by the darker-colored, smoother areas in Figure 9. However, undamaged areas were able to be examined, such as the crack arrest marks in Figure 9 and Figure 10.

Figure 9 – Secondary electron (SE) micrograph of the end of the aft fracture surface, showing crack arrest marks.

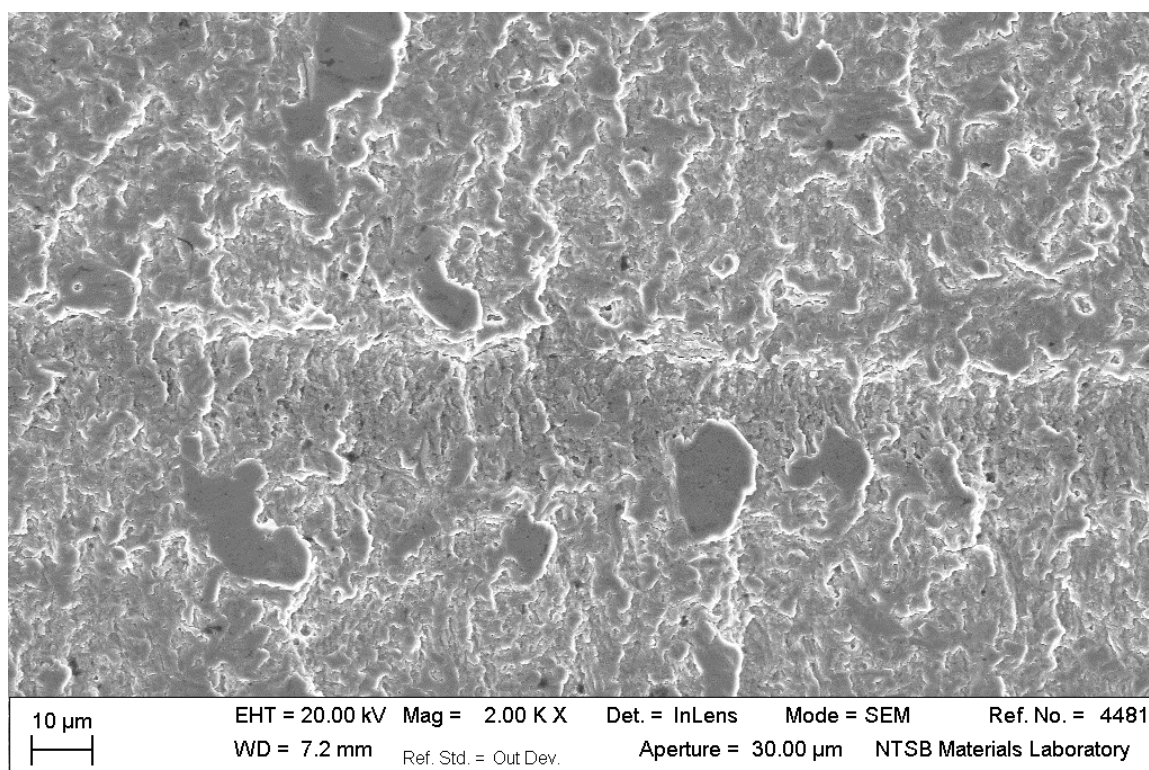
Figure 10 – SE micrograph of one of the crack arrest marks in Figure 9.

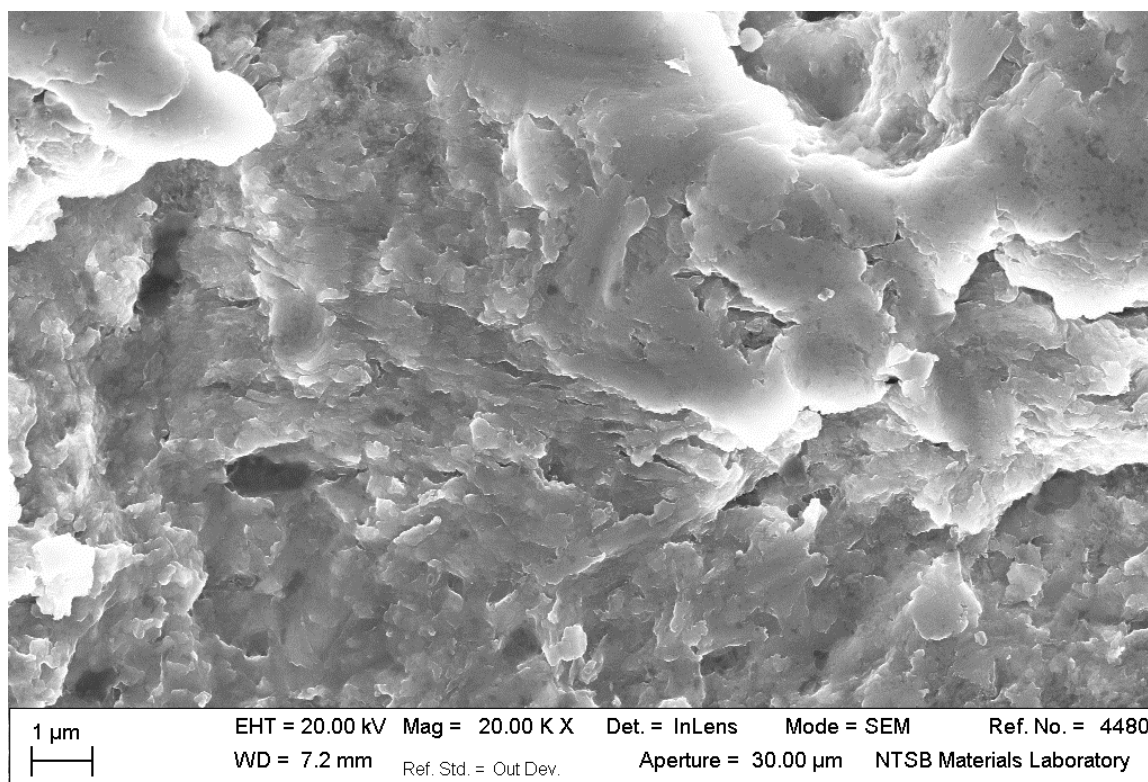
Closer examination of this region of the fracture surface revealed fatigue striations, consistent with fatigue crack propagation (Figure 11 and Figure 12). These striations were finely spaced and exhibited changing or erratic thicknesses on different areas of the fracture surface (Figure 12). These fatigue features were consistent with propagation through high-cycle fatigue. Outside of the fatigue regions only dimple rupture features were found, consistent with subsequent and final overstress fracture of the crankshaft journal.

Figure 11 – SE micrograph of fatigue striations from Figure 10.

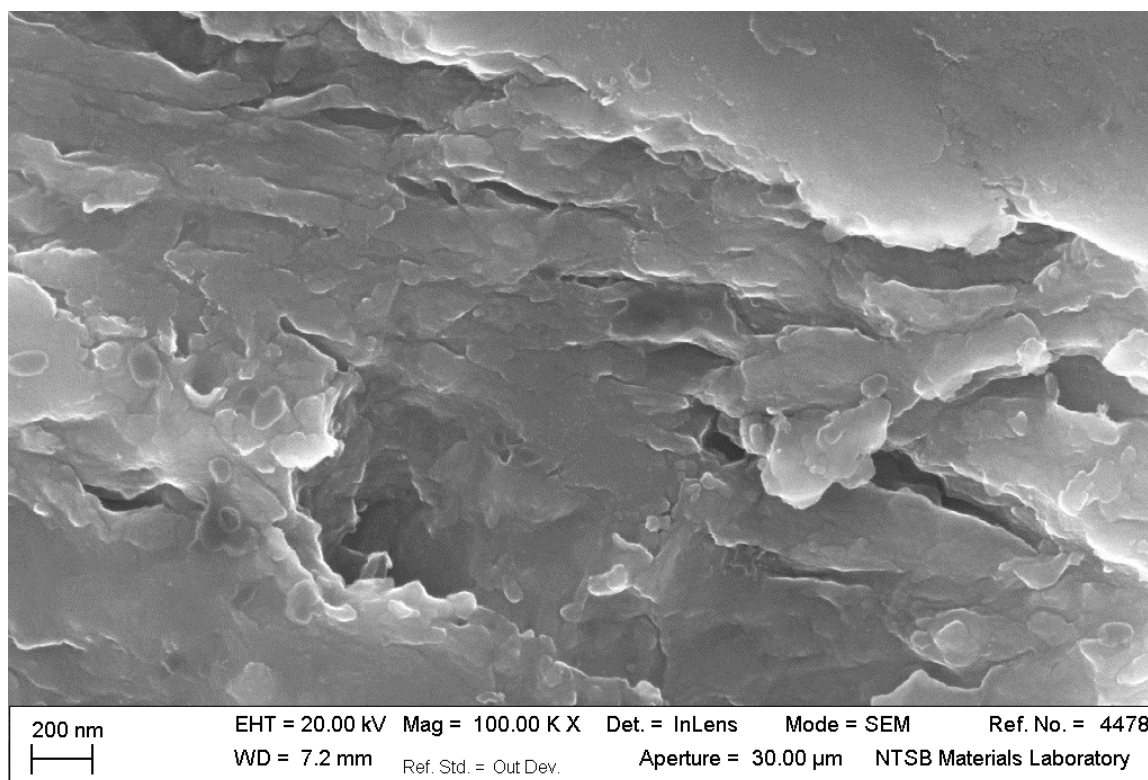
Figure 12 – Closer view of the fatigue striations in Figure 11.

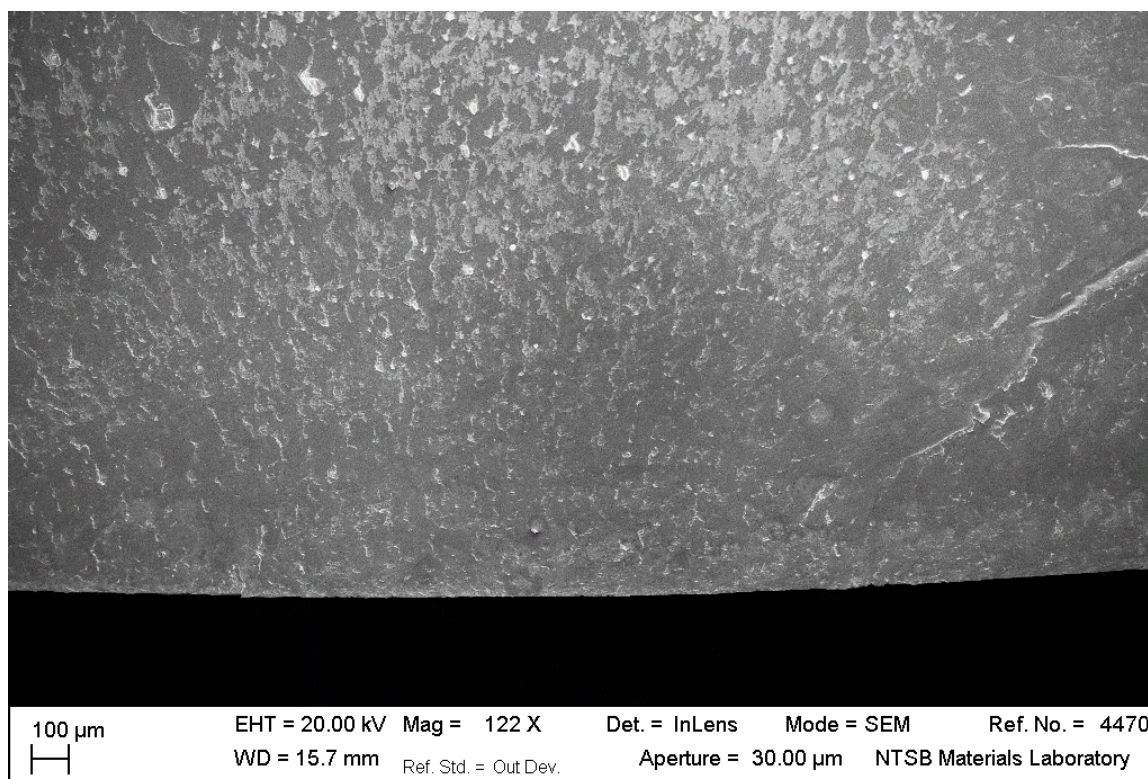
Figure 13 through Figure 15 show closer view of the fatigue crack initiation sites. Examination using a SEM found three primary initiation sites, with possible smaller initiation sites collocated in the area. These initiation sites were all located on the fracture surface edge with the journal surface. There were no material features (such as cracks, pores, or voids) located at these initiation sites. However mechanical defects, such as gouges and streaks, were present at the crack initiation sites.

Figure 13 – SE micrograph of the fatigue crack initiation site on the aft fracture.

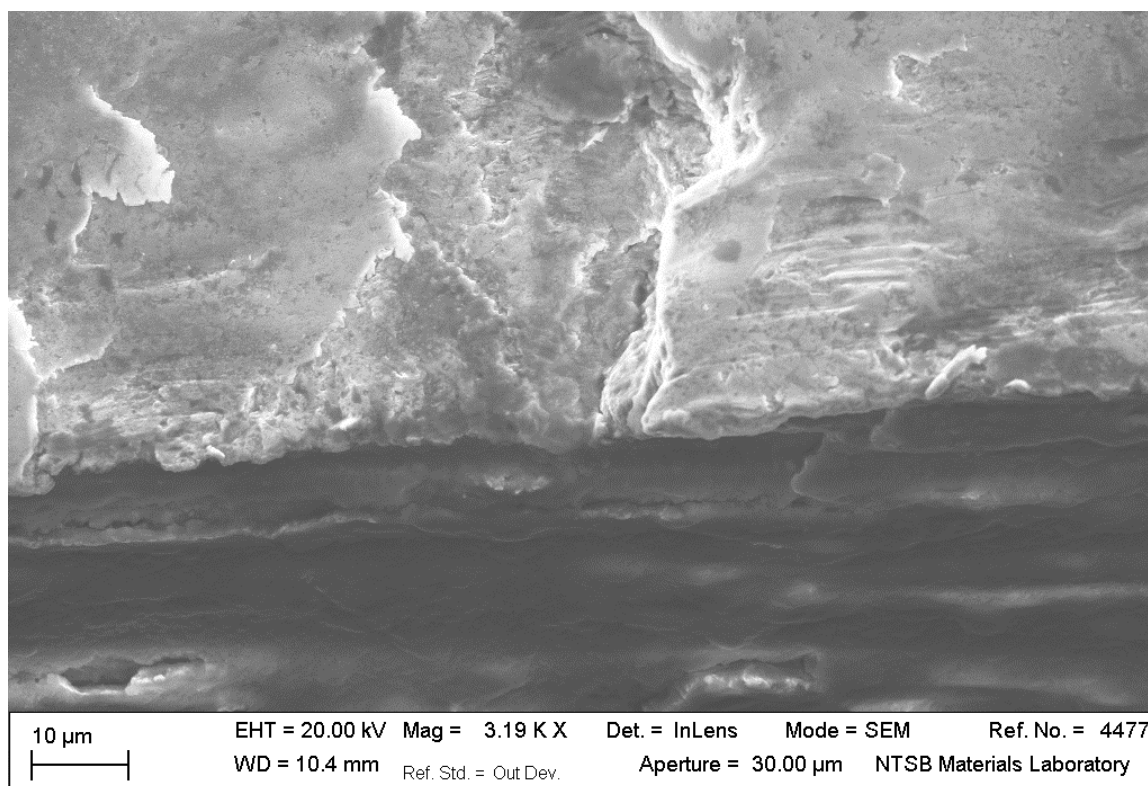
Figure 14 – SE micrograph of the corner of the main crack initiation site in Figure 13.

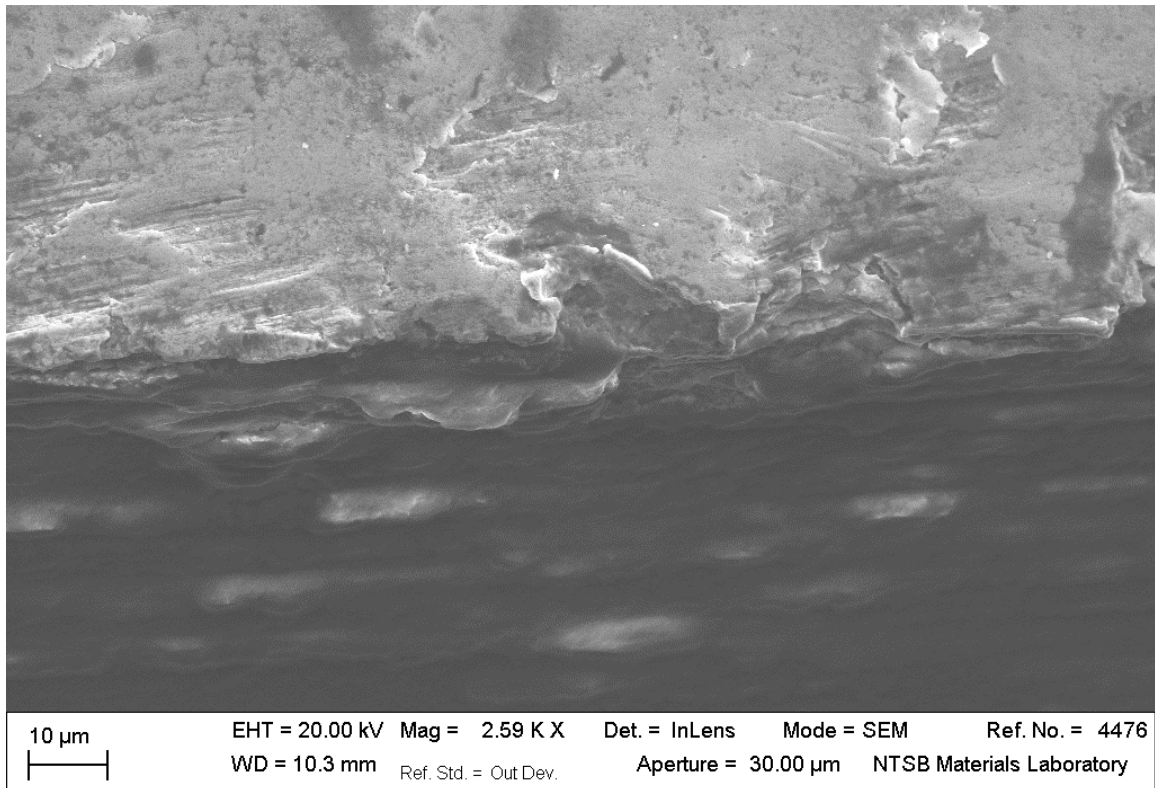
Figure 15 – SE micrograph of a fatigue crack initiation site to the right of the ratchet mark in Figure 8.
