**ERA18LA190**

**Passadumkeag, Maine**

**Glasair SH2 – N352GL**

**NTSB ENGINE EXAMINATION REPORT**

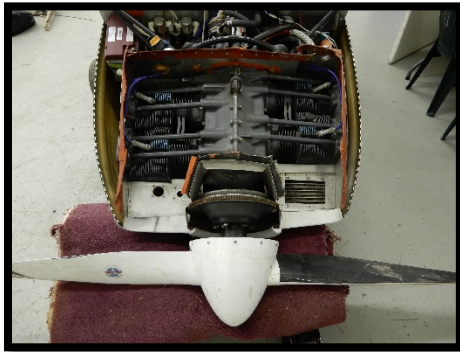
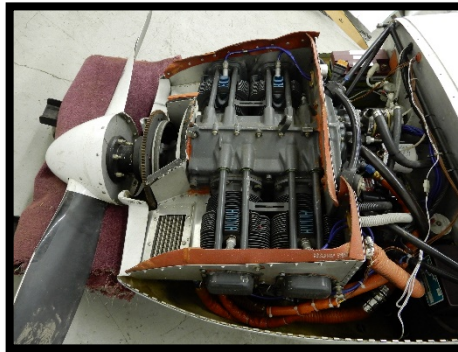
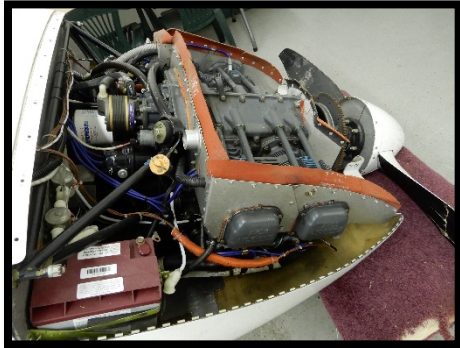
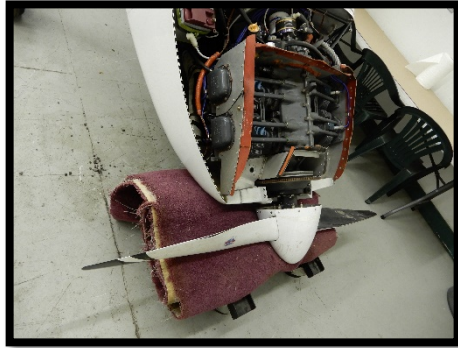
- The engine remained attached to the airframe through all engine mounts.
- The crankcase remained intact.
- The cylinders remained attached to the crankcase.
- An unknown amount of oil was noted in the engine.
- The throttle and mixture cables remained attached to the engine but were cut for the engine examination.
- All components remained attached to the engine.
- The cowling was removed and the propeller would not rotate.
- The engine was removed from the engine mounts to facilitate further examination.

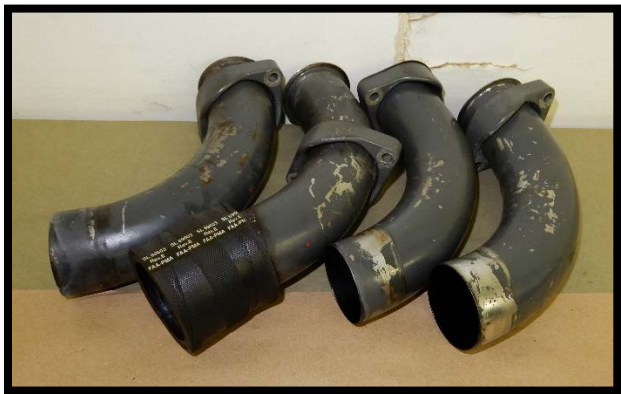
The exhaust piping was removed and no obstructions were noted, except a small amount of metallic debris was noted in the No. 4 exhaust pipe, but it was not obstructed.

The intake piping was removed and no anomalies were noted.

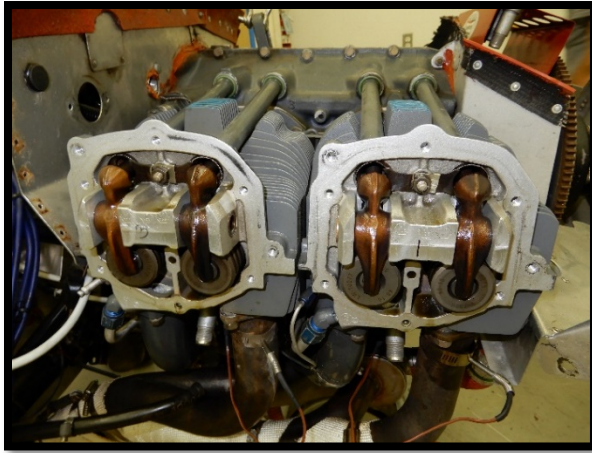
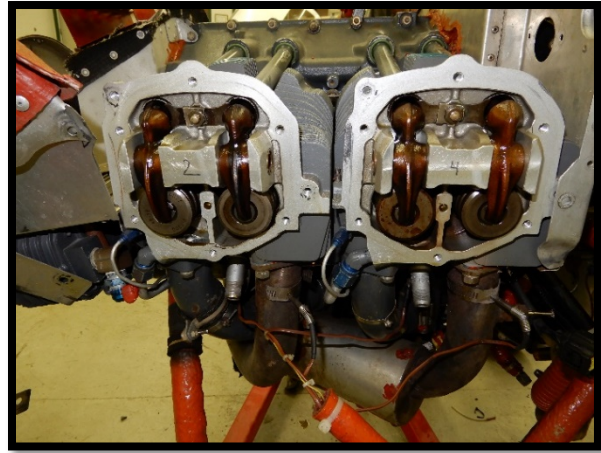
The rocker box covers were removed and no anomalies were noted. All rocker arms, push-rods, and springs remained in place. The cylinders were examined by boroscope and corrosion was noted on the cylinder walls. All cylinders were removed from the engine.

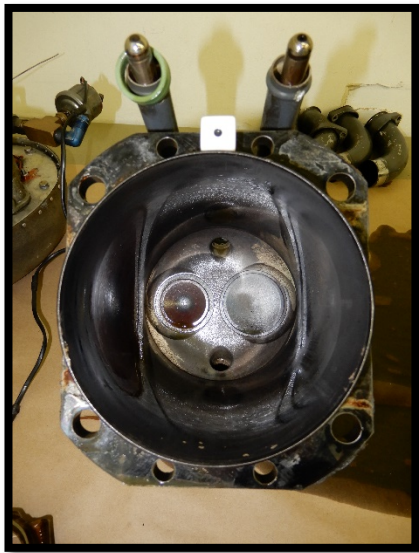
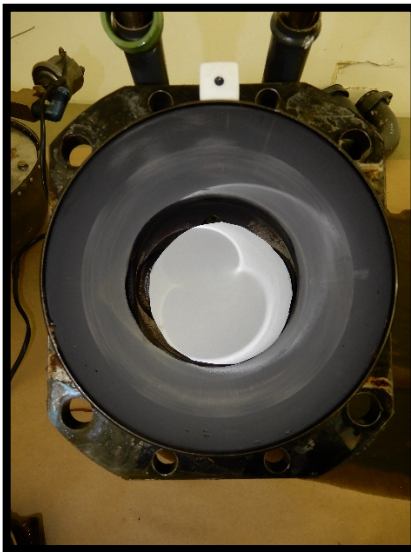
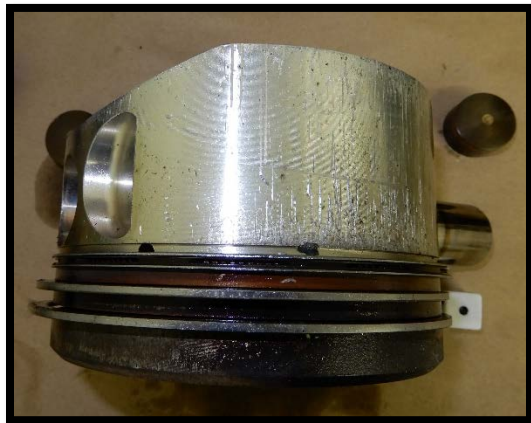
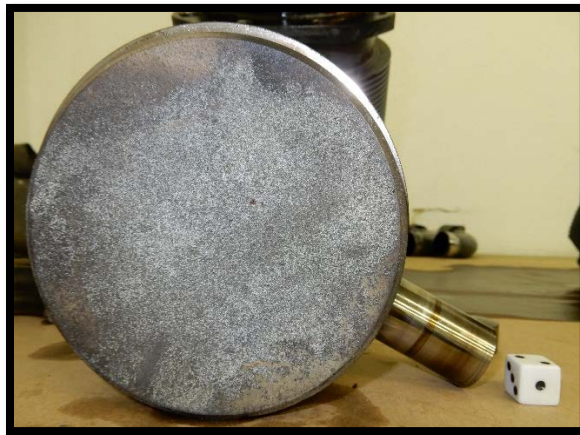
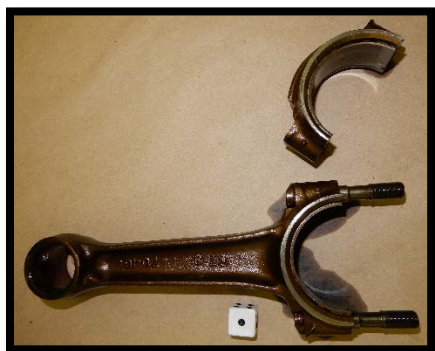
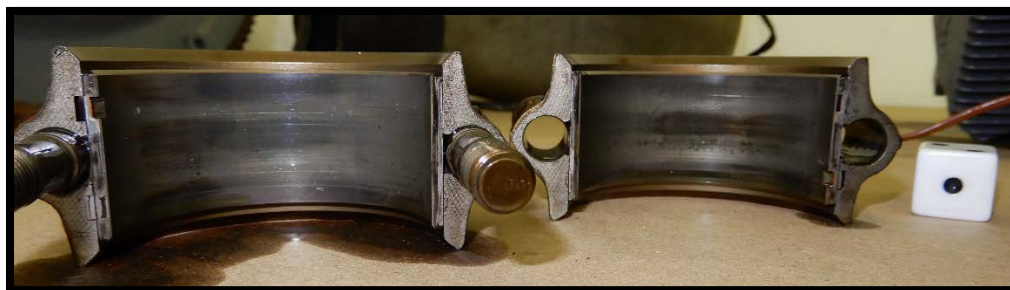
The No. 1 cylinder was removed from the engine. Lead deposits were noted near the valve faces. The intake and exhaust valves remained seated. The piston was removed from the connecting rod and no anomalies were noted with the piston pin. The piston face was examined and lead deposits were noted. The piston rings remained on the piston and the ring gaps were not aligned. The connecting rod was removed from the crankshaft and a small number of light gouges were in the bearing.

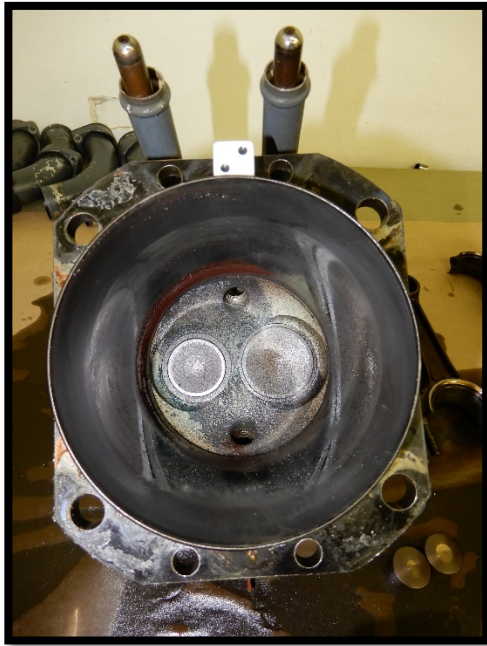
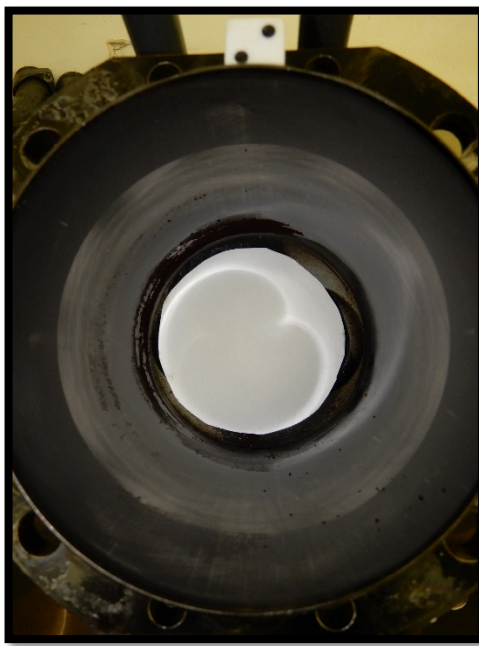
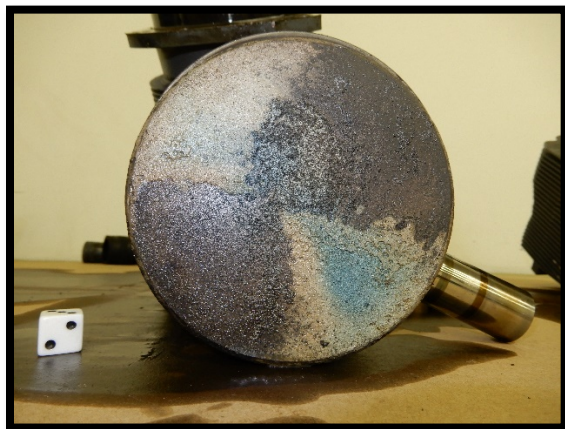
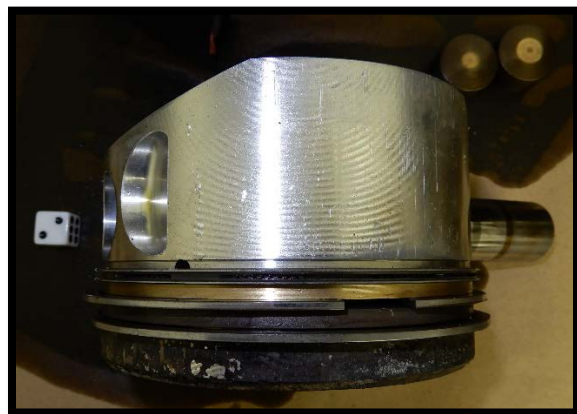
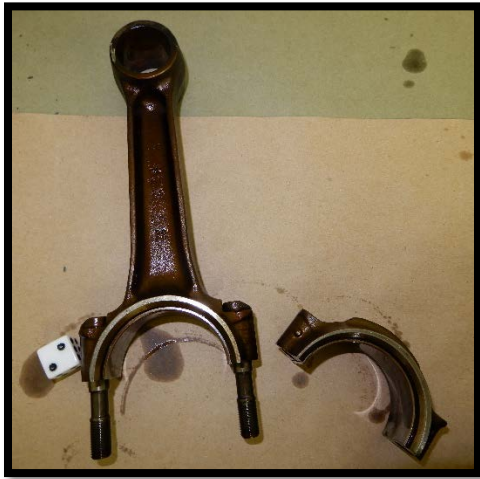
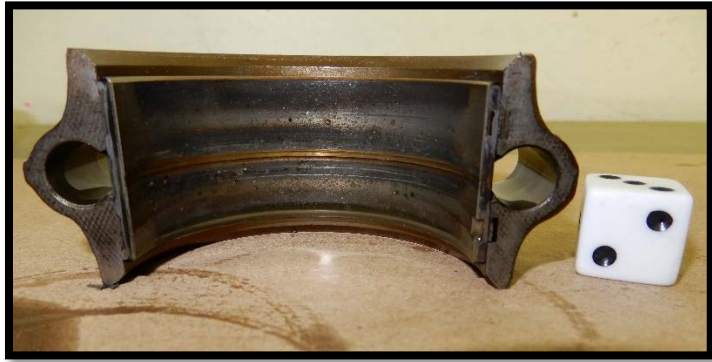
The No. 2 cylinder was removed from the engine. Corrosion was noted on the cylinder walls. The intake and exhaust valves remained seated and no anomalies were noted. The piston was removed from the connecting rod and the piston pin exhibited no anomalies. The face of the piston was examined and lead deposits were noted. In addition, the face of the piston was partially blue in color. The piston rings remained on the piston and the ring gaps were not aligned. The connecting rod was removed from the crankshaft and gouges were noted in the bearing.

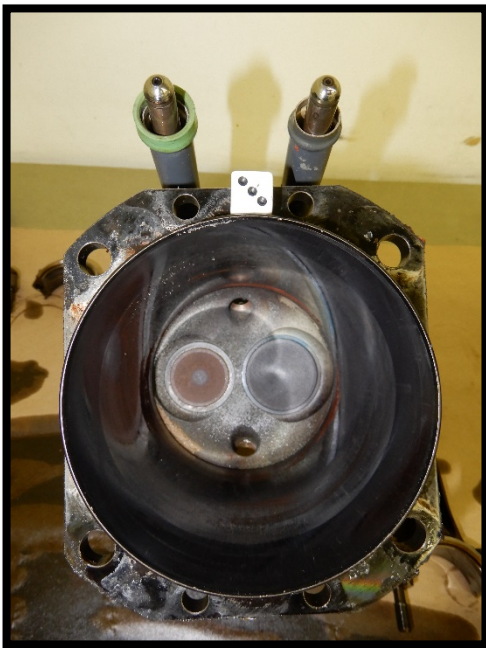
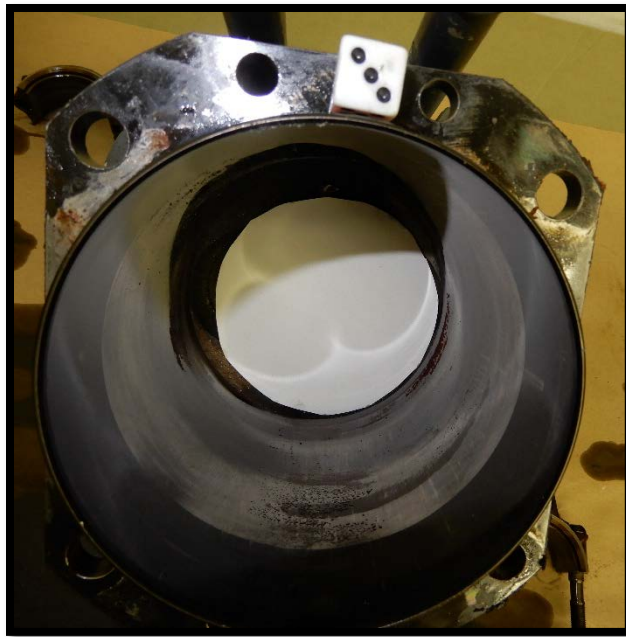
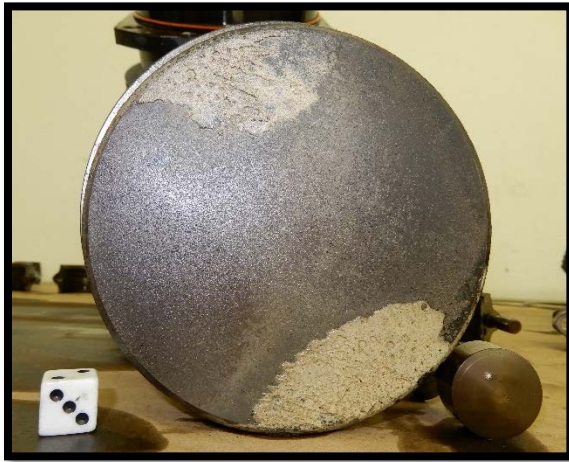
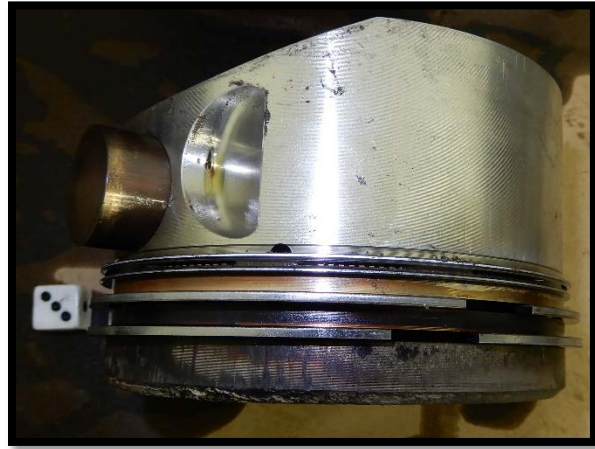
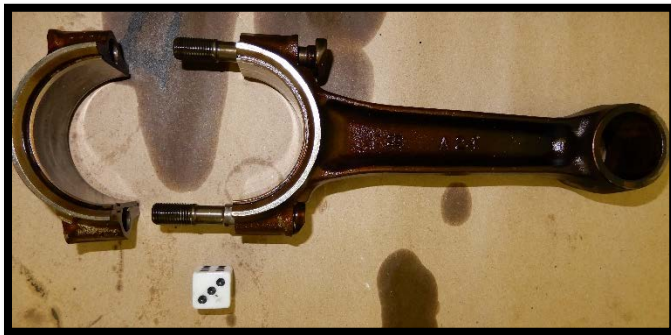
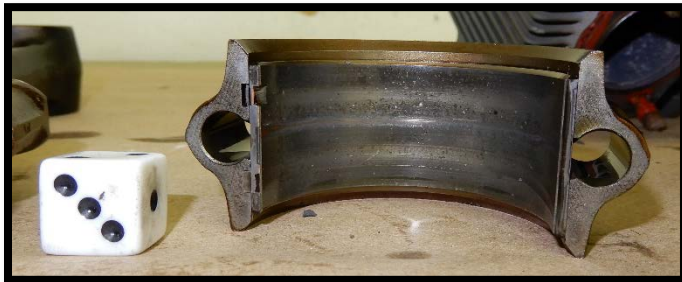
The No. 3 cylinder was removed from the engine and corrosion was noted on the cylinder walls. The intake and exhaust valves remained seated. The piston was removed from the connecting rod and there were no anomalies noted with the piston pin. The piston face was examined and lead deposits were noted on the face. The piston rings remained on the piston and the ring gaps were no aligned. The connecting rod was removed from the crankshaft. A gouge was noted in the No. 3 crankshaft bearing. No other anomalies were noted.

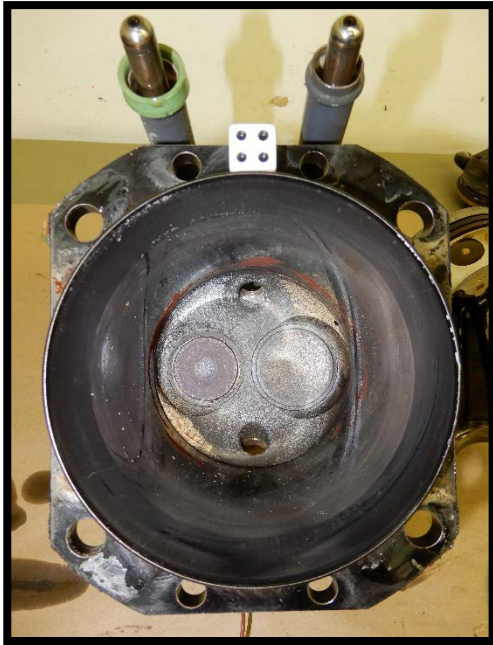
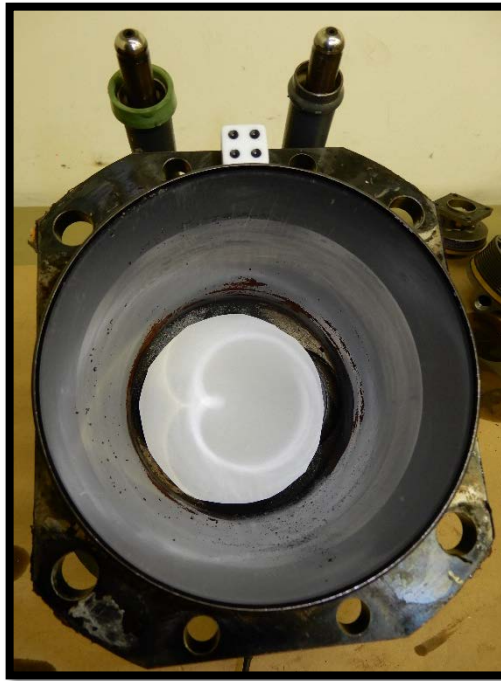
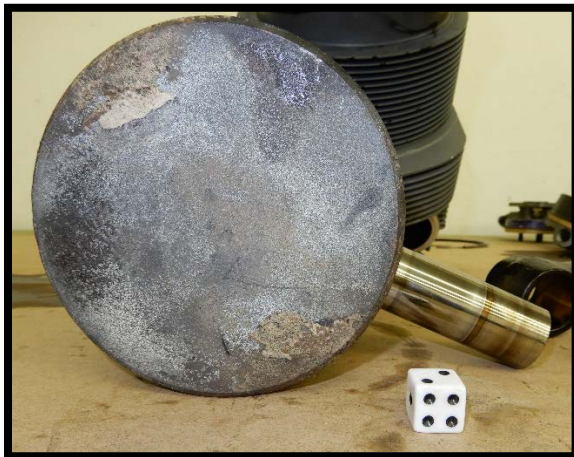
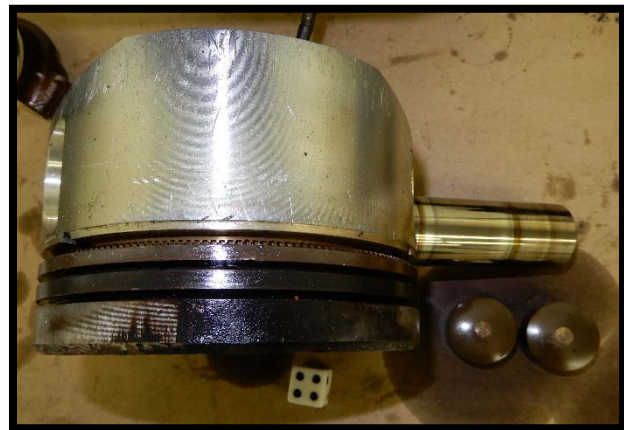
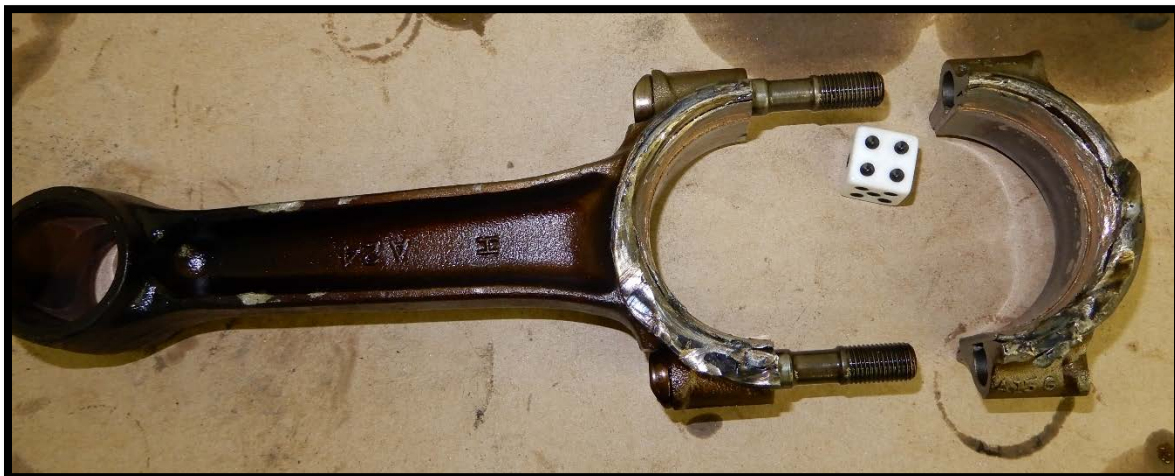
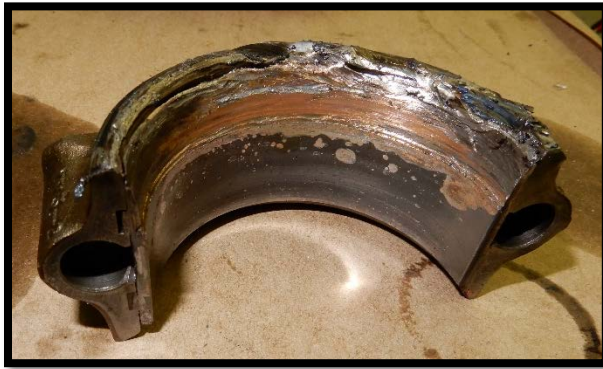
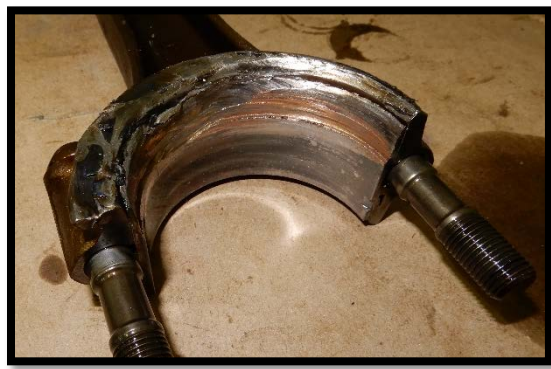
The No. 4 cylinder was removed and examined. The cylinder walls exhibited corrosion. The intake and exhaust valves remained seated and no anomalies were noted. The piston was removed from the connecting rod and no anomalies were noted with the piston pin. The piston rings were removed during engine disassembly, no anomalies were noted, and the piston ring gaps were not aligned. The piston face was examined and no anomalies were noted. The No. 4 connecting rod would not move on the crankshaft. The connecting rod was removed from the crankshaft and the connecting rod bearing exhibited thermal discoloration and impact damage.

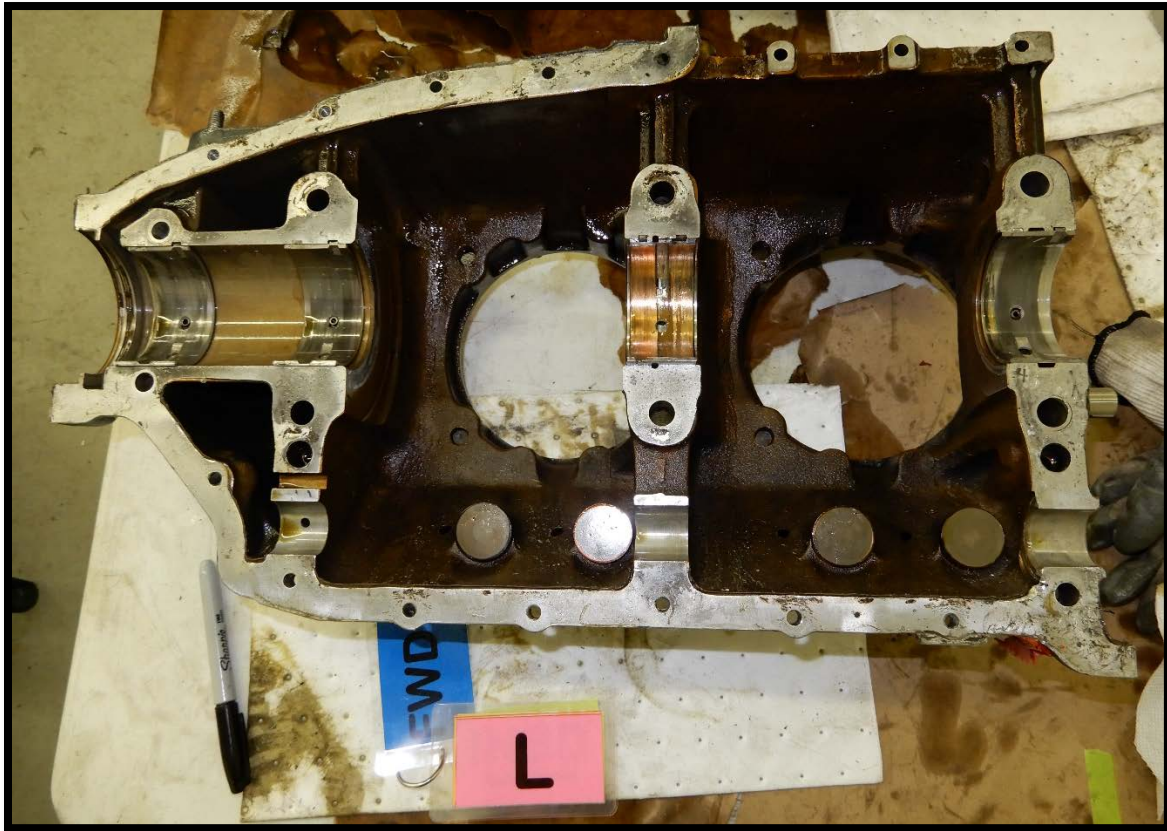
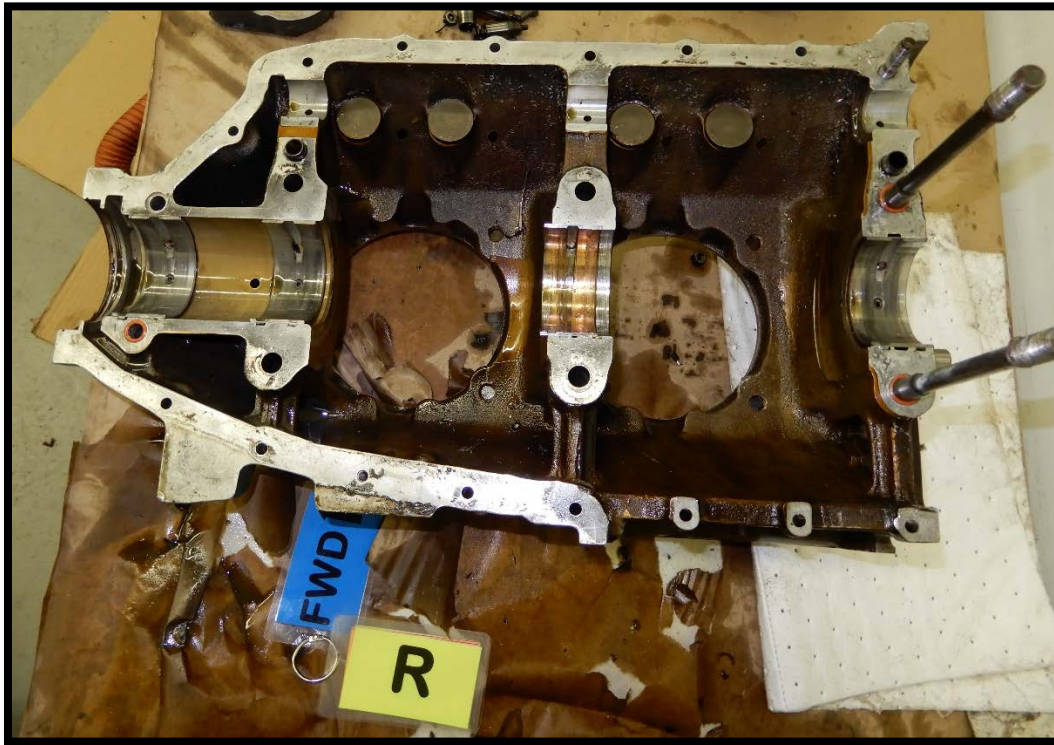
The crankcase was split and metallic debris was noted throughout the walls of the crankcase. There was no fretting noted on the crankcase. The camshaft lifters were examined and no anomalies were noted. In addition, the camshaft bearings were not damaged.

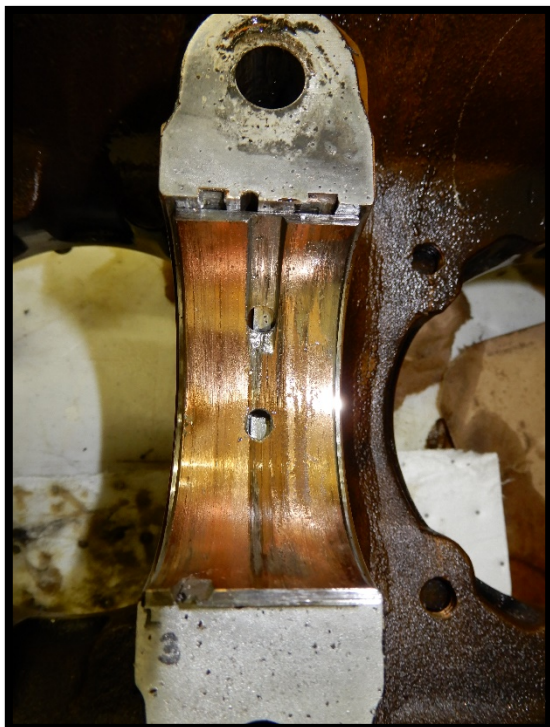
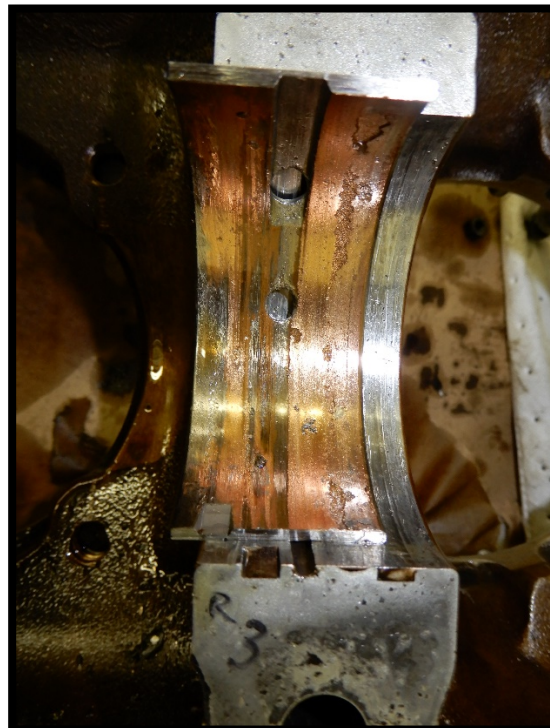
The Nos. 1 and 2 main bearings exhibited initial wear marks but remained in place. The No. 3 main bearing was worn and the top lay of material was worn away so that copper could be seen. The aft section of the No. 3 main bearing was more worn than the front section of the No. 3 main bearing. The No. 4 main bearing exhibited wear on the front section and the left side of the No. 4 main bearing exhibited more damage than the right side of the bearing.

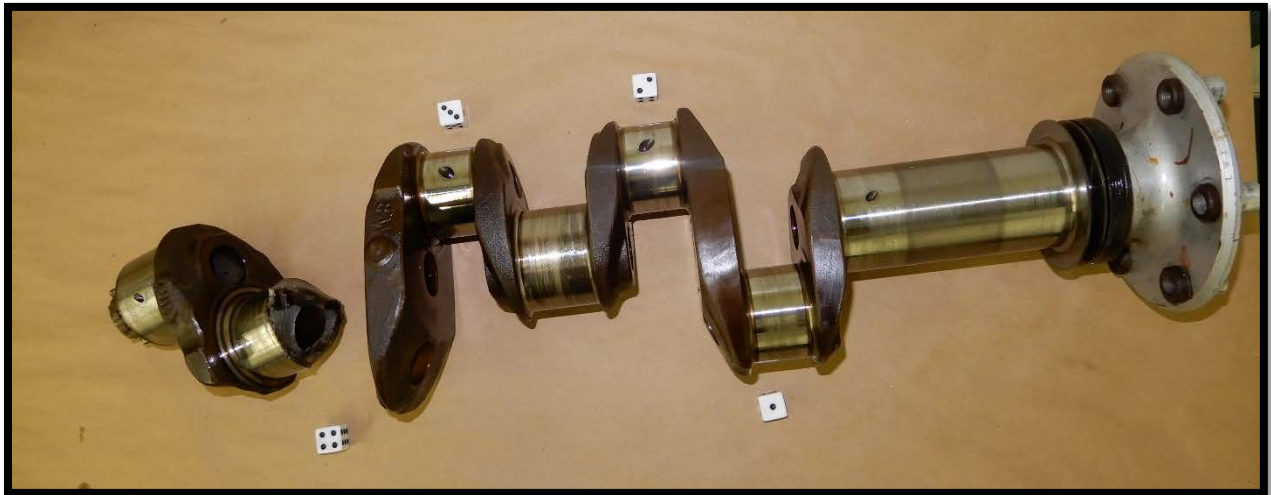
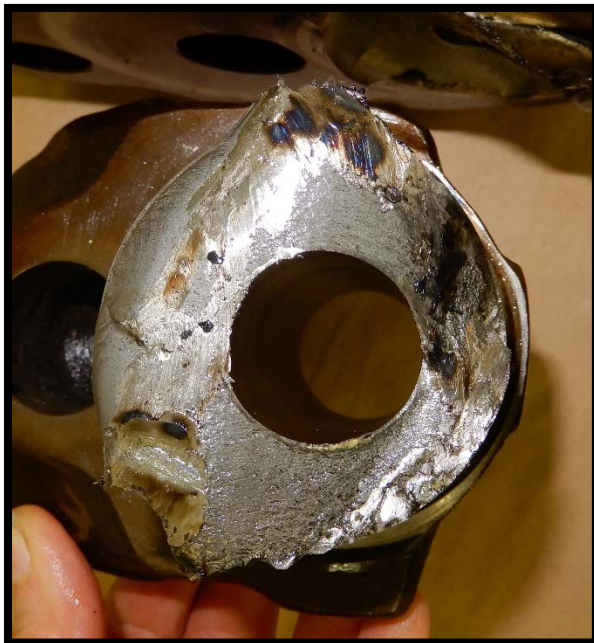
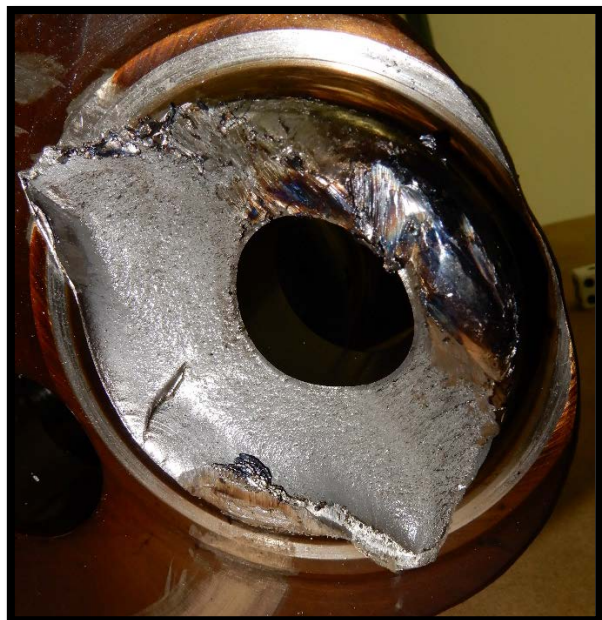
The crankshaft was removed from the engine and was fractured at the forward section of the No. 4 connecting rod journal. The Nos. 1 and 2 main bearing journals were examined and no anomalies were noted. The No. 3 main bearing journal exhibited rotational scoring and wear. The No. 4 main bearing journal exhibited a small amount of wear on the forward section, otherwise, no anomalies were noted. All of the oil passages on the crankshaft were free of debris. The Nos. 1 and 3 connecting rod journals were examined and no anomalies were noted. The No. 2 connecting rod journal exhibited rotational scoring. The No. 4 connecting rod journal was fractured, exhibited thermal discoloration, and rotational scoring. The crankshaft was retained and sent to the NTSB materials laboratory for further examination.

The examination revealed that the crankshaft was fractured at the number 4 crankshaft journal.

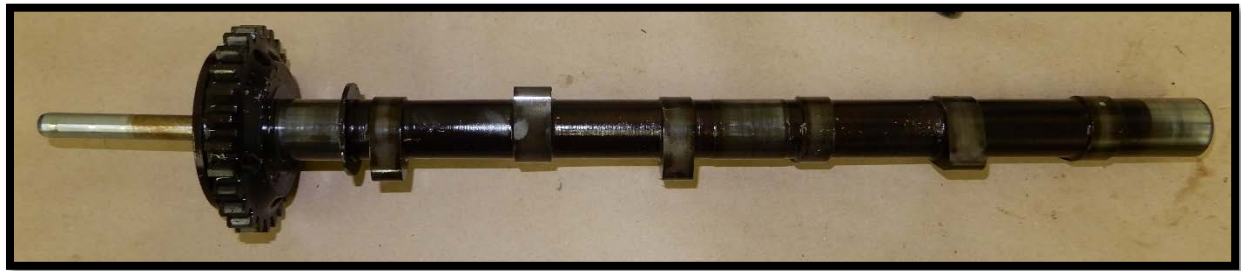
The camshaft was examined and no anomalies were noted. Metallic material was noted on the camshaft. The camshaft lobes were examined and no anomalies were noted.

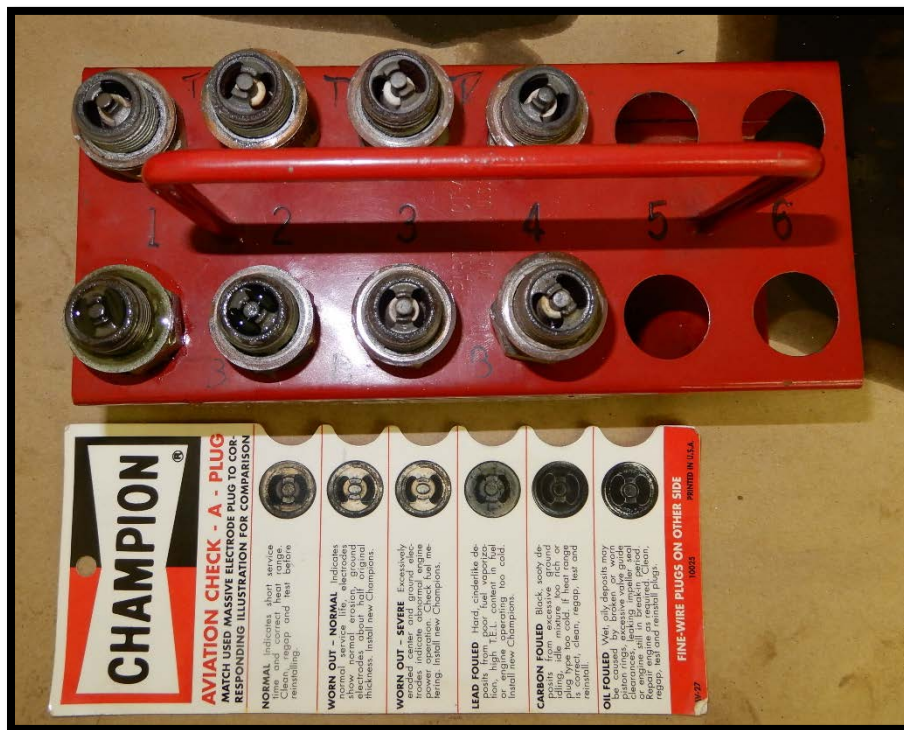
All spark plugs were removed from the engine and they were the massive electrode type. The Nos. 1 and 2 bottom spark plugs were oil soaked. All other spark plugs were light grey in color and exhibited “normal wear” when compared to the Champion Check-A-Plug Chart.

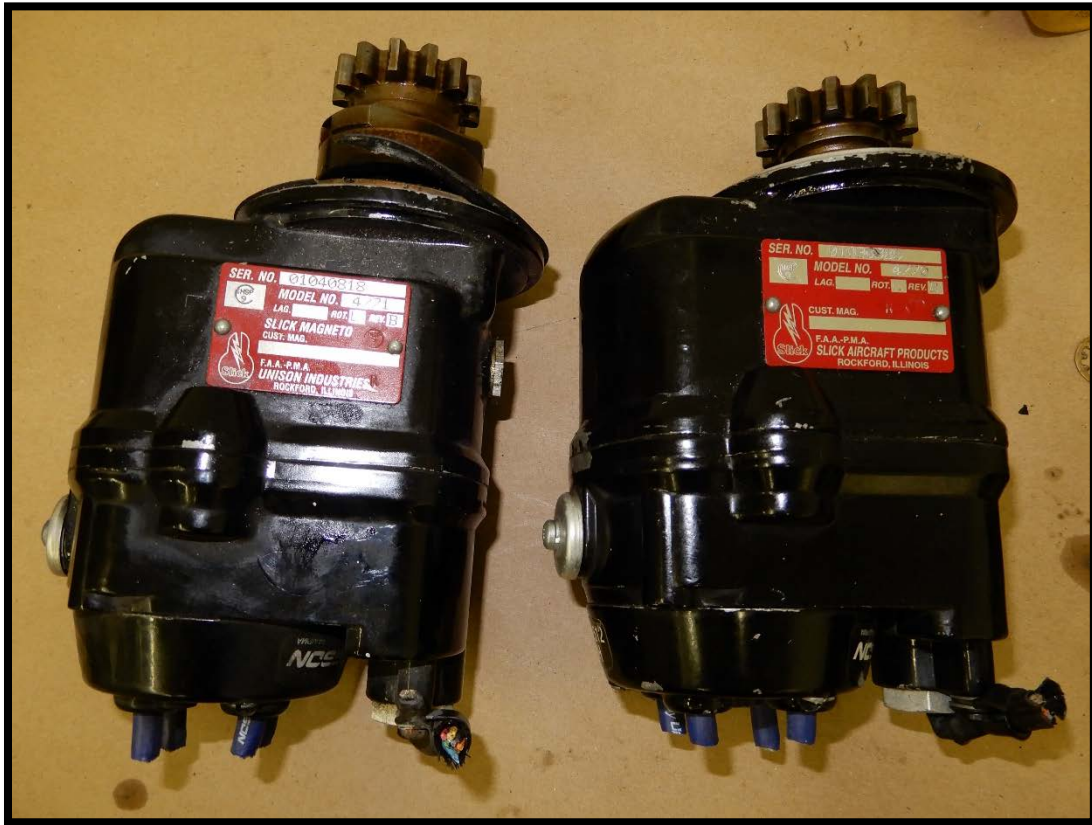
The magnetos remained attached to the engine and were removed. They were rotated by hand, however, spark could not be produced because of the LASAR ignition system.

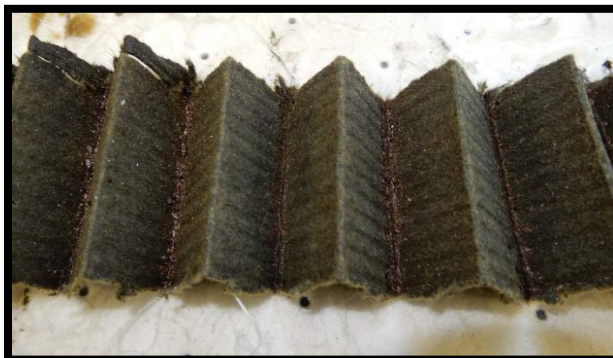
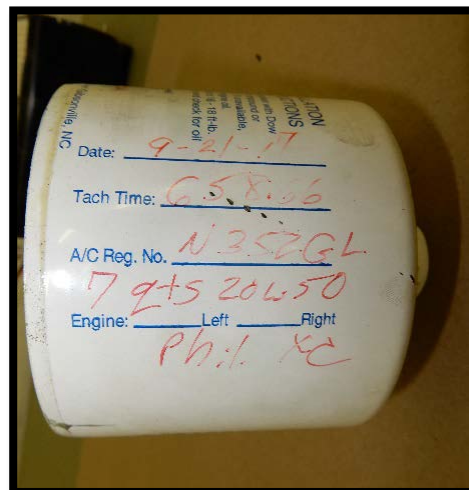
The oil line was detached from the oil cooler and oil drained from it. The oil filter remained attached to the engine, was removed, and disassembled. There was metallic debris noted in the filter.

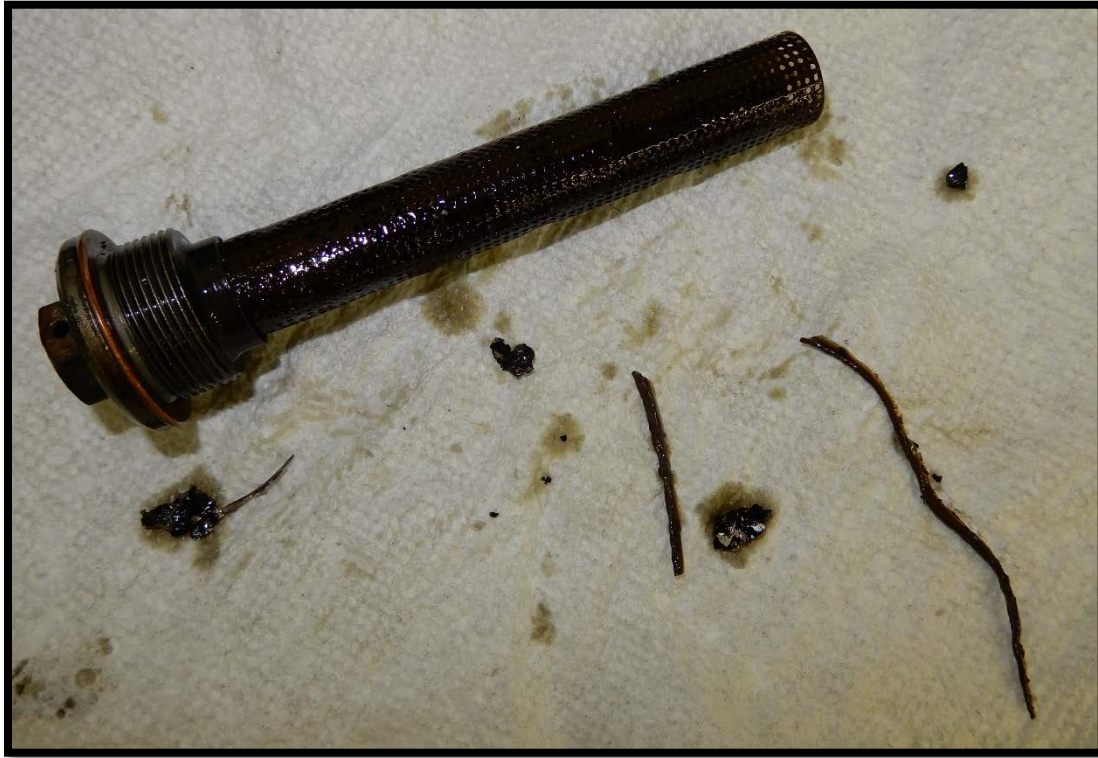
The oil sump was removed from the engine and metallic particles were noted throughout. The oil suction screen was removed from the oil sump and metallic particles were noted in the screen.

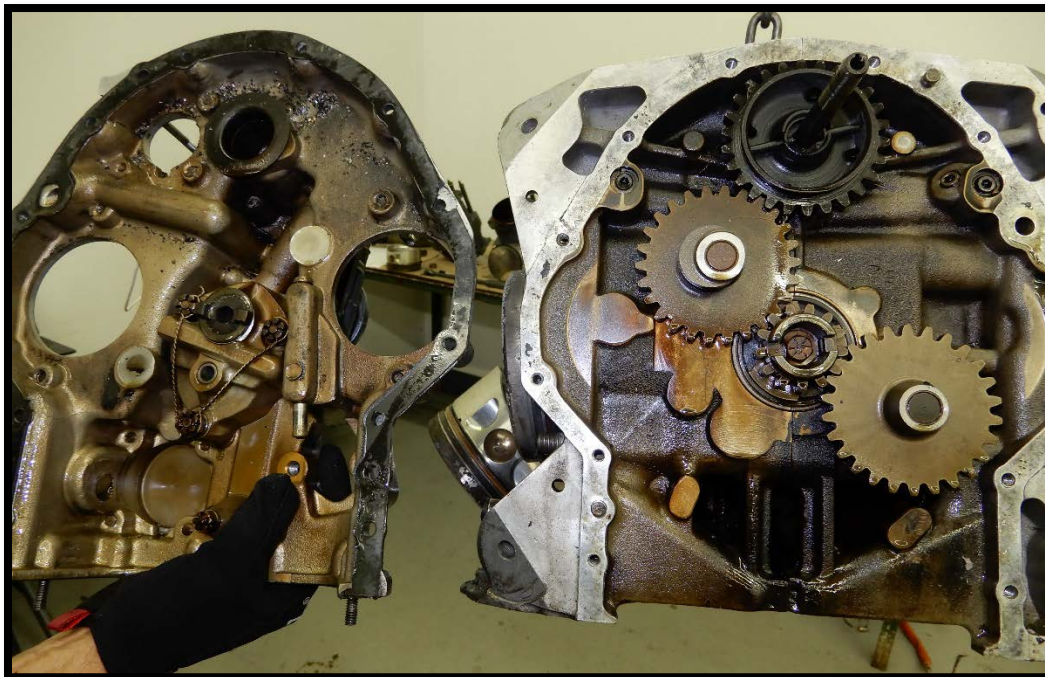
The accessory section of the engine was removed and metallic particles were noted on the gears and along the case.

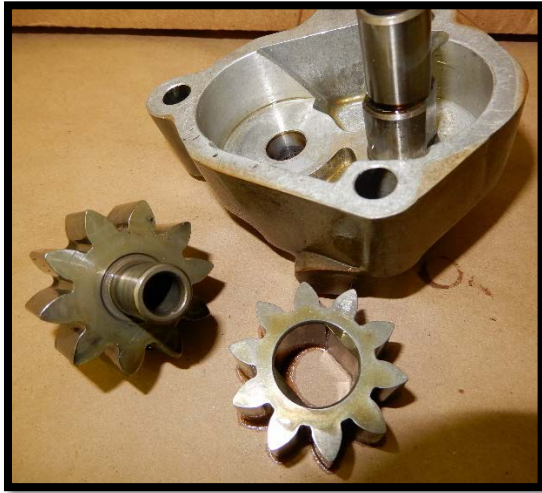
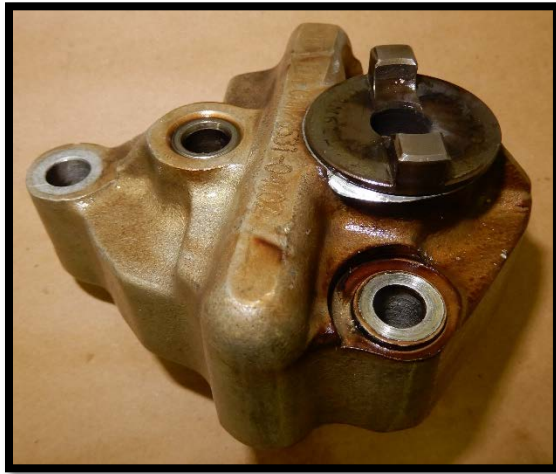
The oil pump was removed from the accessory section of the engine and scoring was noted on the oil pump housing and metallic particles were noted on the gears. The oil pump housing exhibited thermal discoloration near the oil pump drive shaft. In addition, there was a gouge in the oil pump housing near the thermal discoloration.

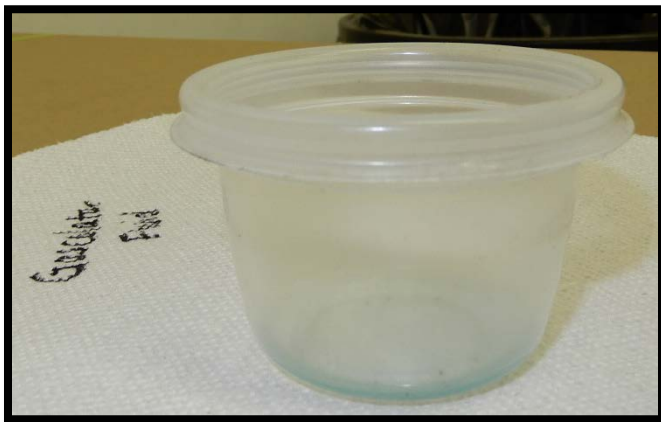
Fuel was drained out of the gascolator and debris was noted in it. The fuel line from the gascolator to the engine driven fuel pump was removed, and there was no fuel in it. The fuel line from the engine driven fuel pump to the carburetor was removed and no fuel was noted in the line.

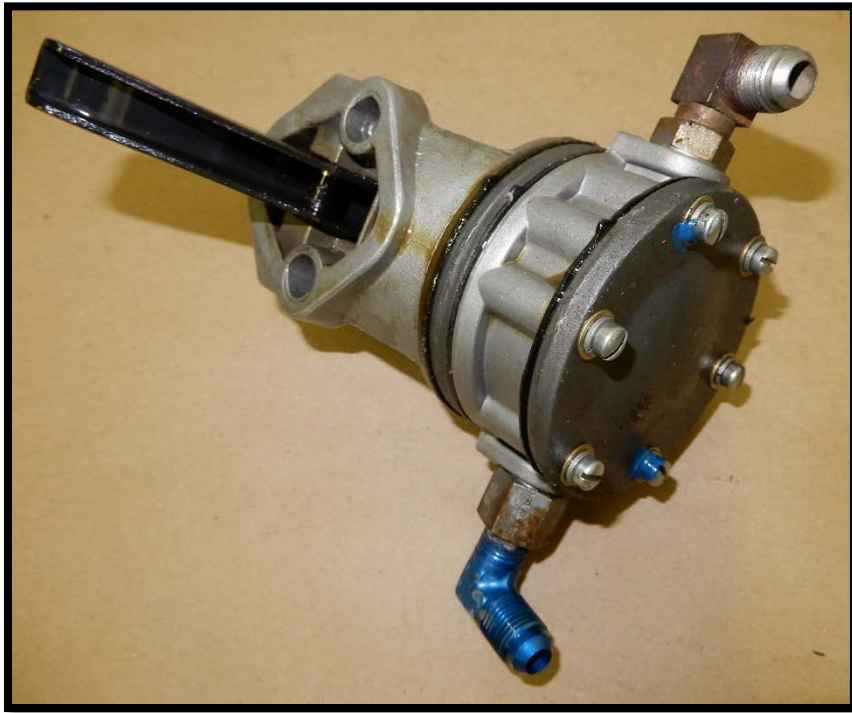
The engine driven fuel pump was removed and a suction and compression test was performed. No anomalies were noted when the pump was actuated by hand.

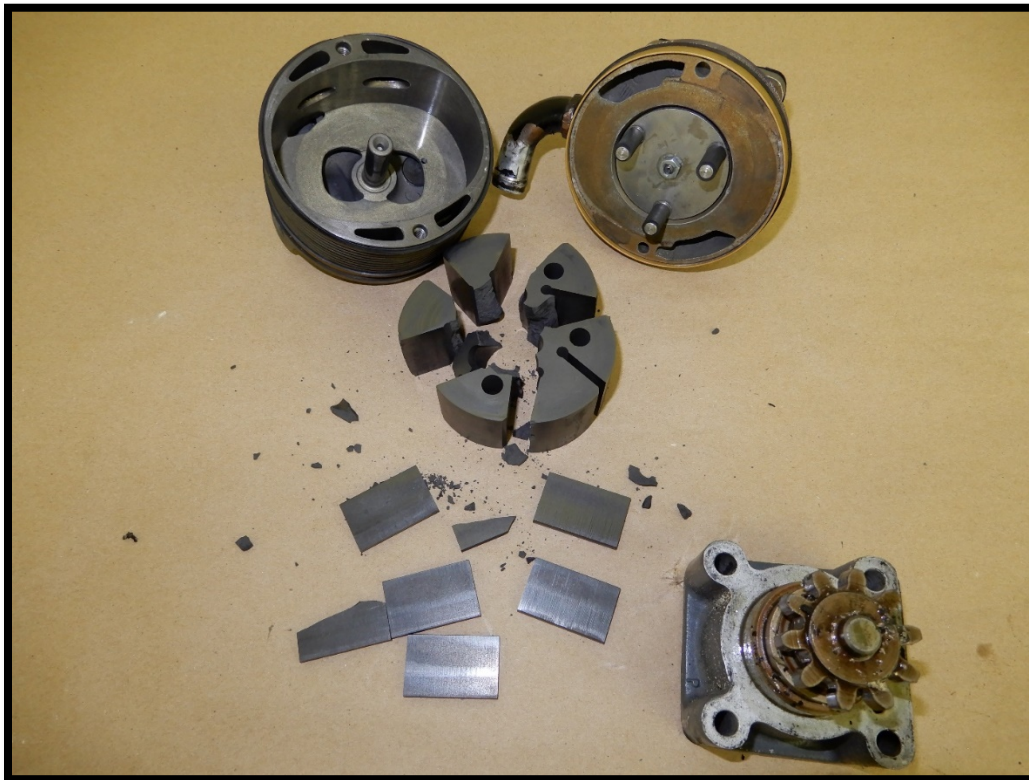
The vacuum pump was removed and metallic material was noted on the drive gear. The vacuum pump rotor and 1 vane were fractured. All other vanes remained intact.
