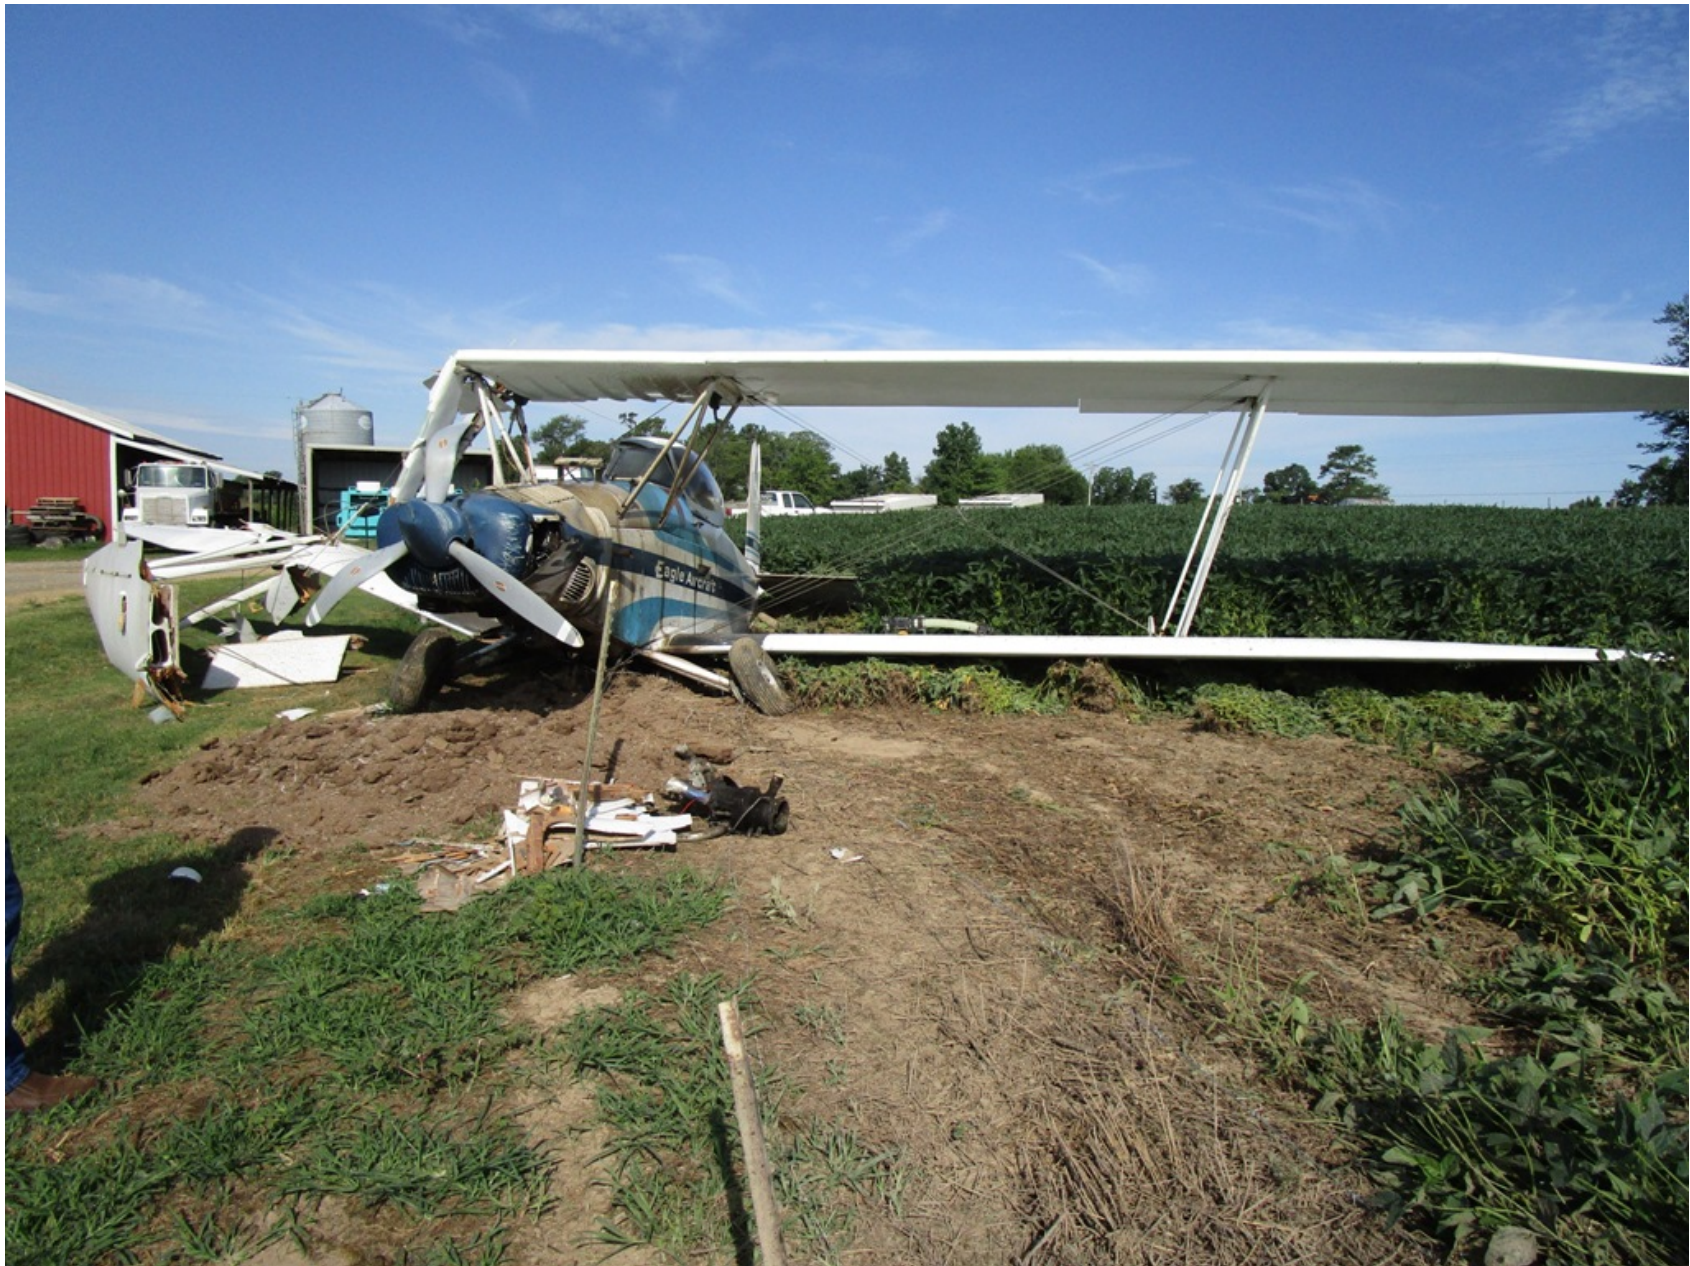
**Photo 1 – Airplane Wreckage (Photo Credit: FAA)**

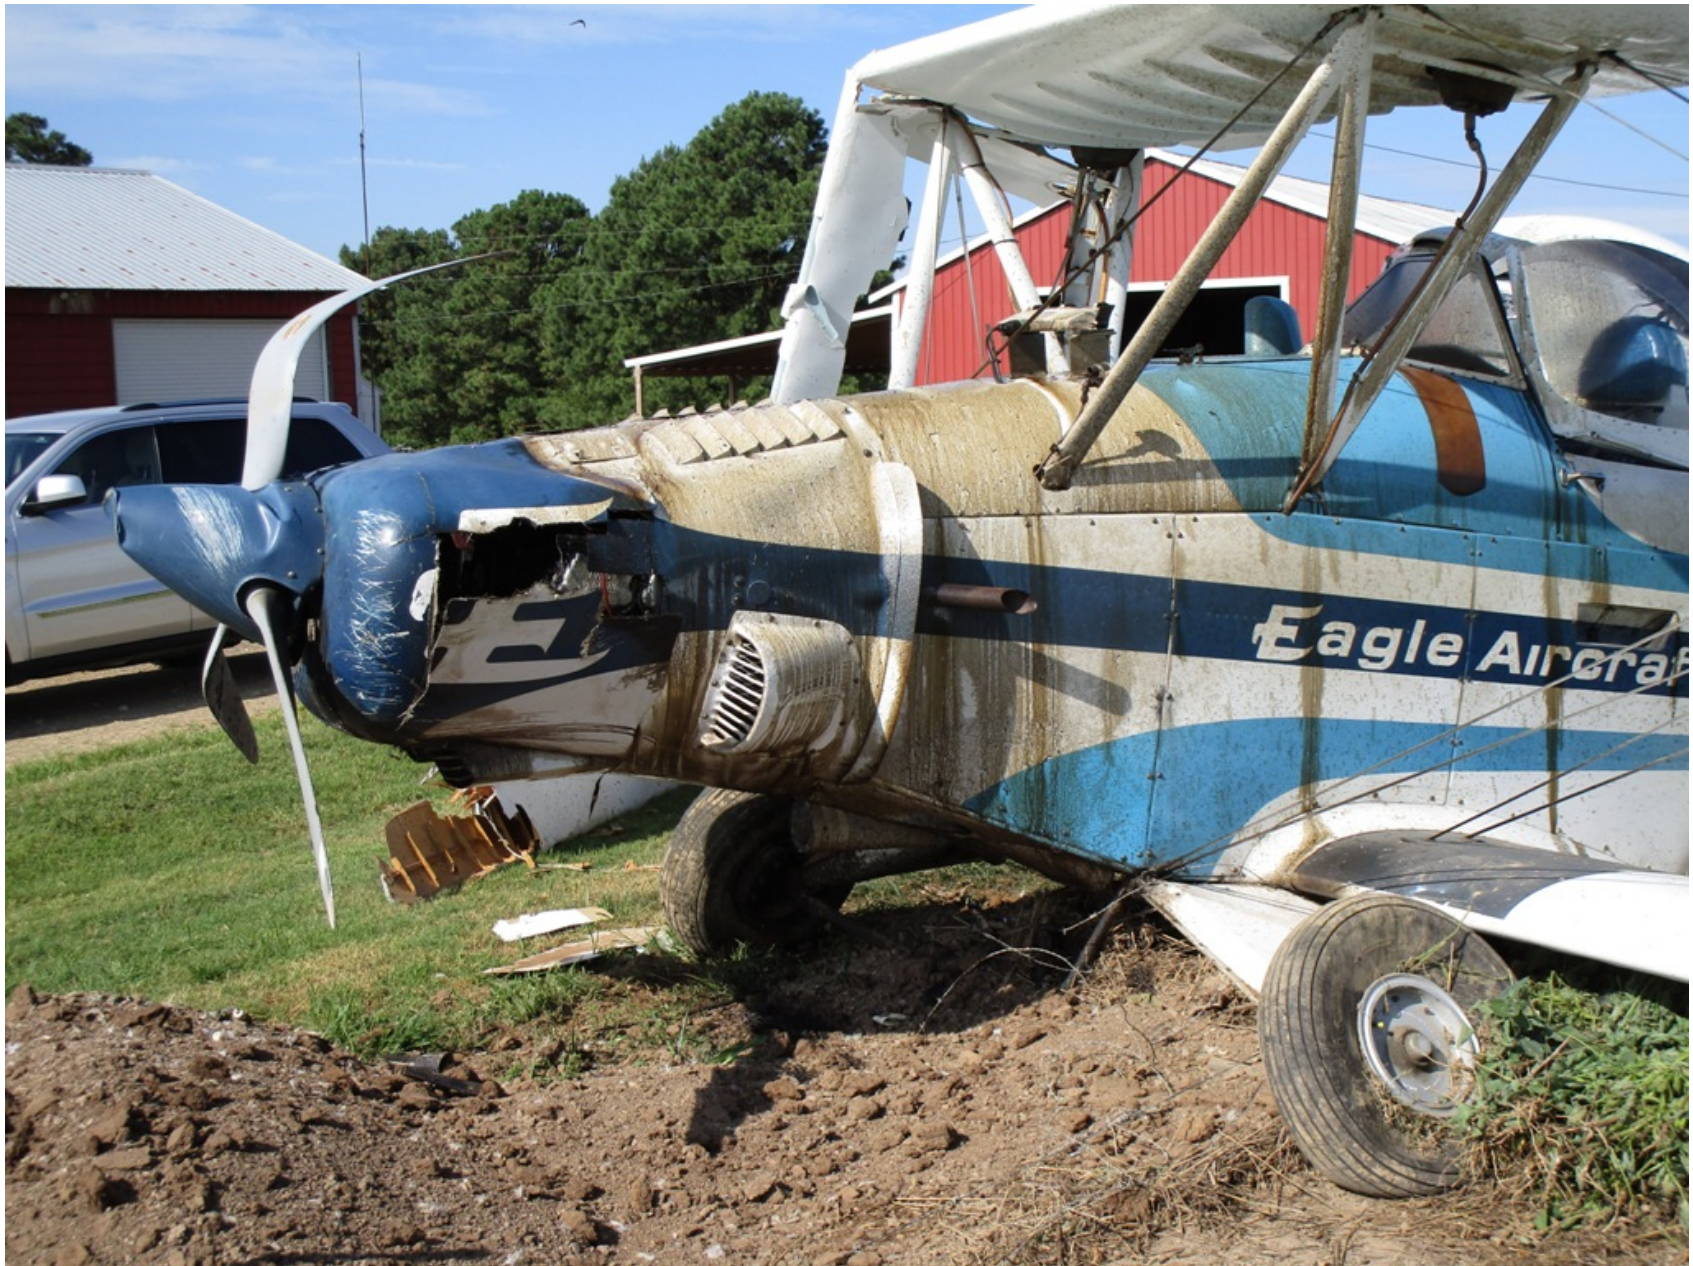
**Photo 2 – Hole in Engine Cowling and Oil Residue (Photo Credit: FAA)**

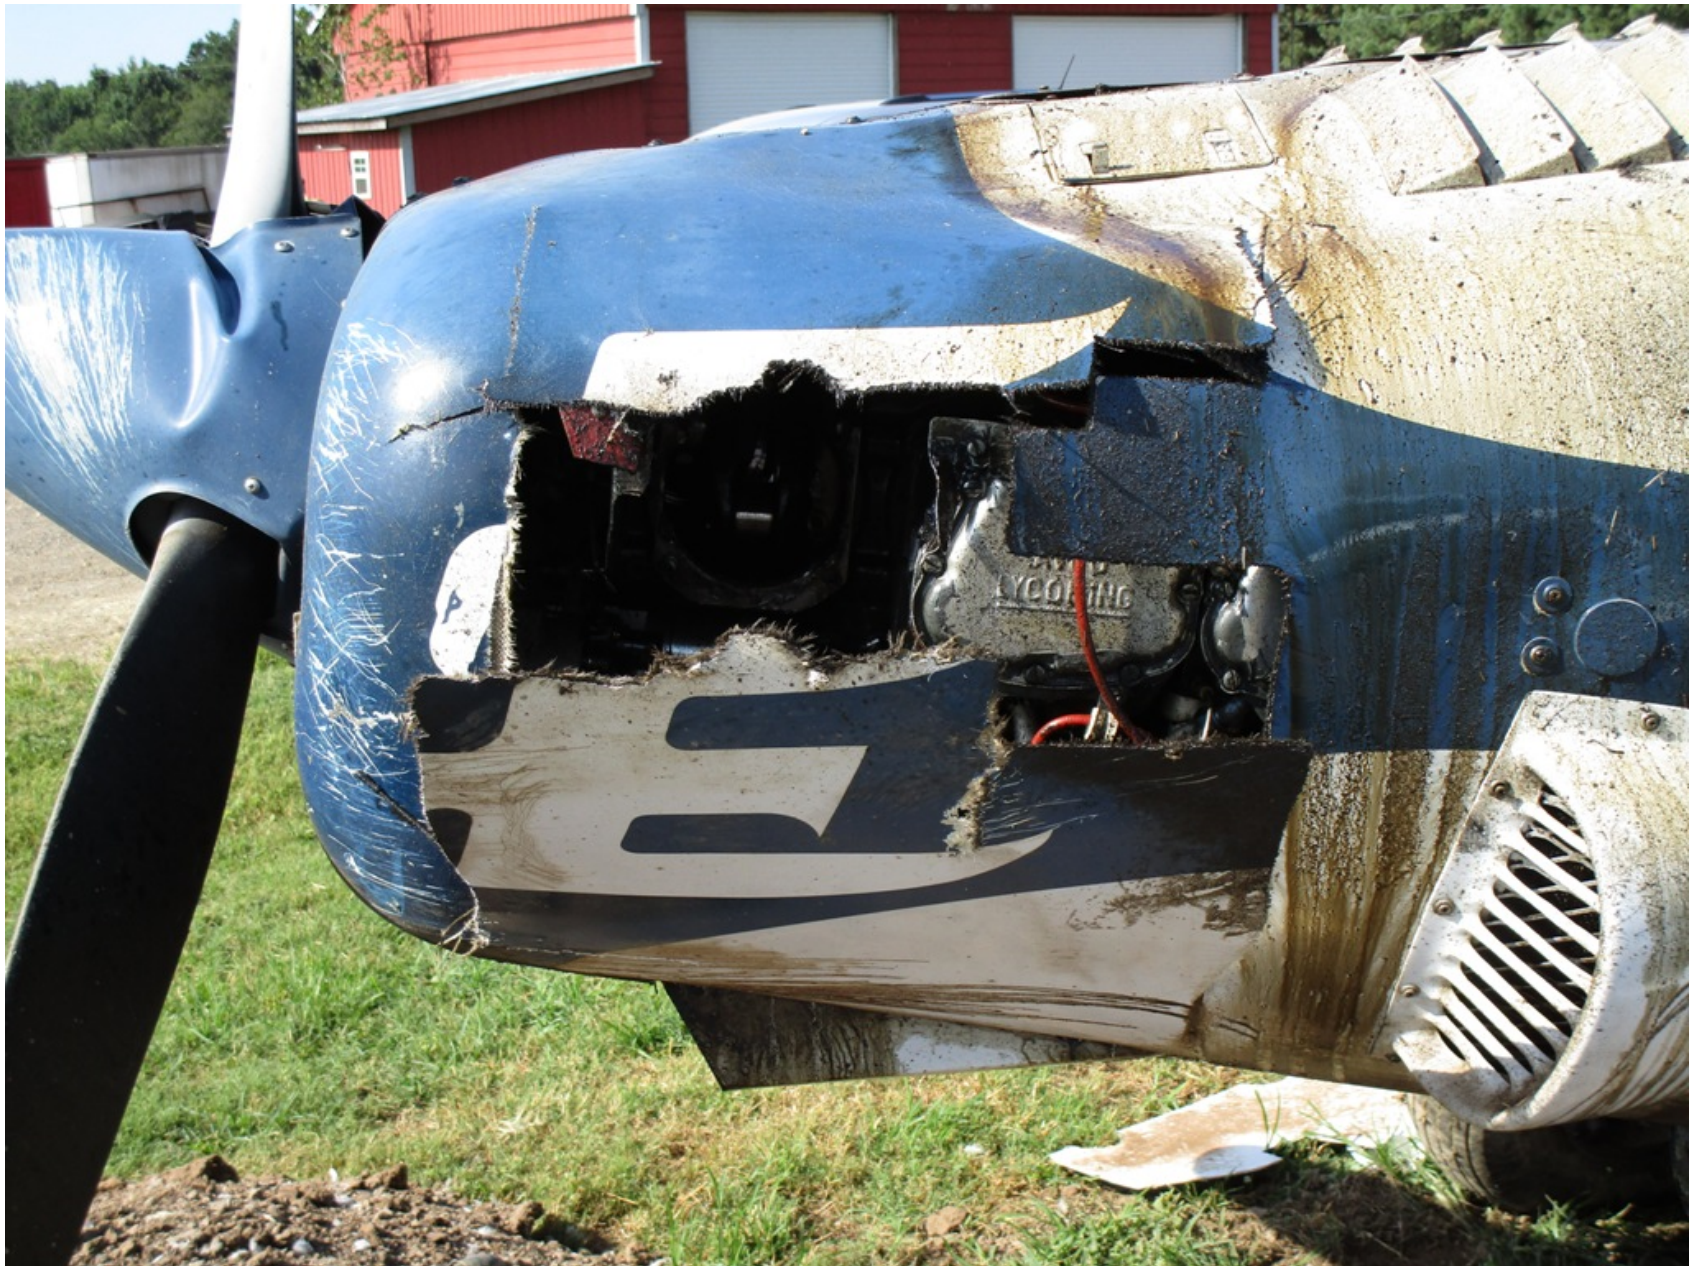
**Photo 3 – Hole in Left Side Engine Cowling (Photo Credit: FAA)**

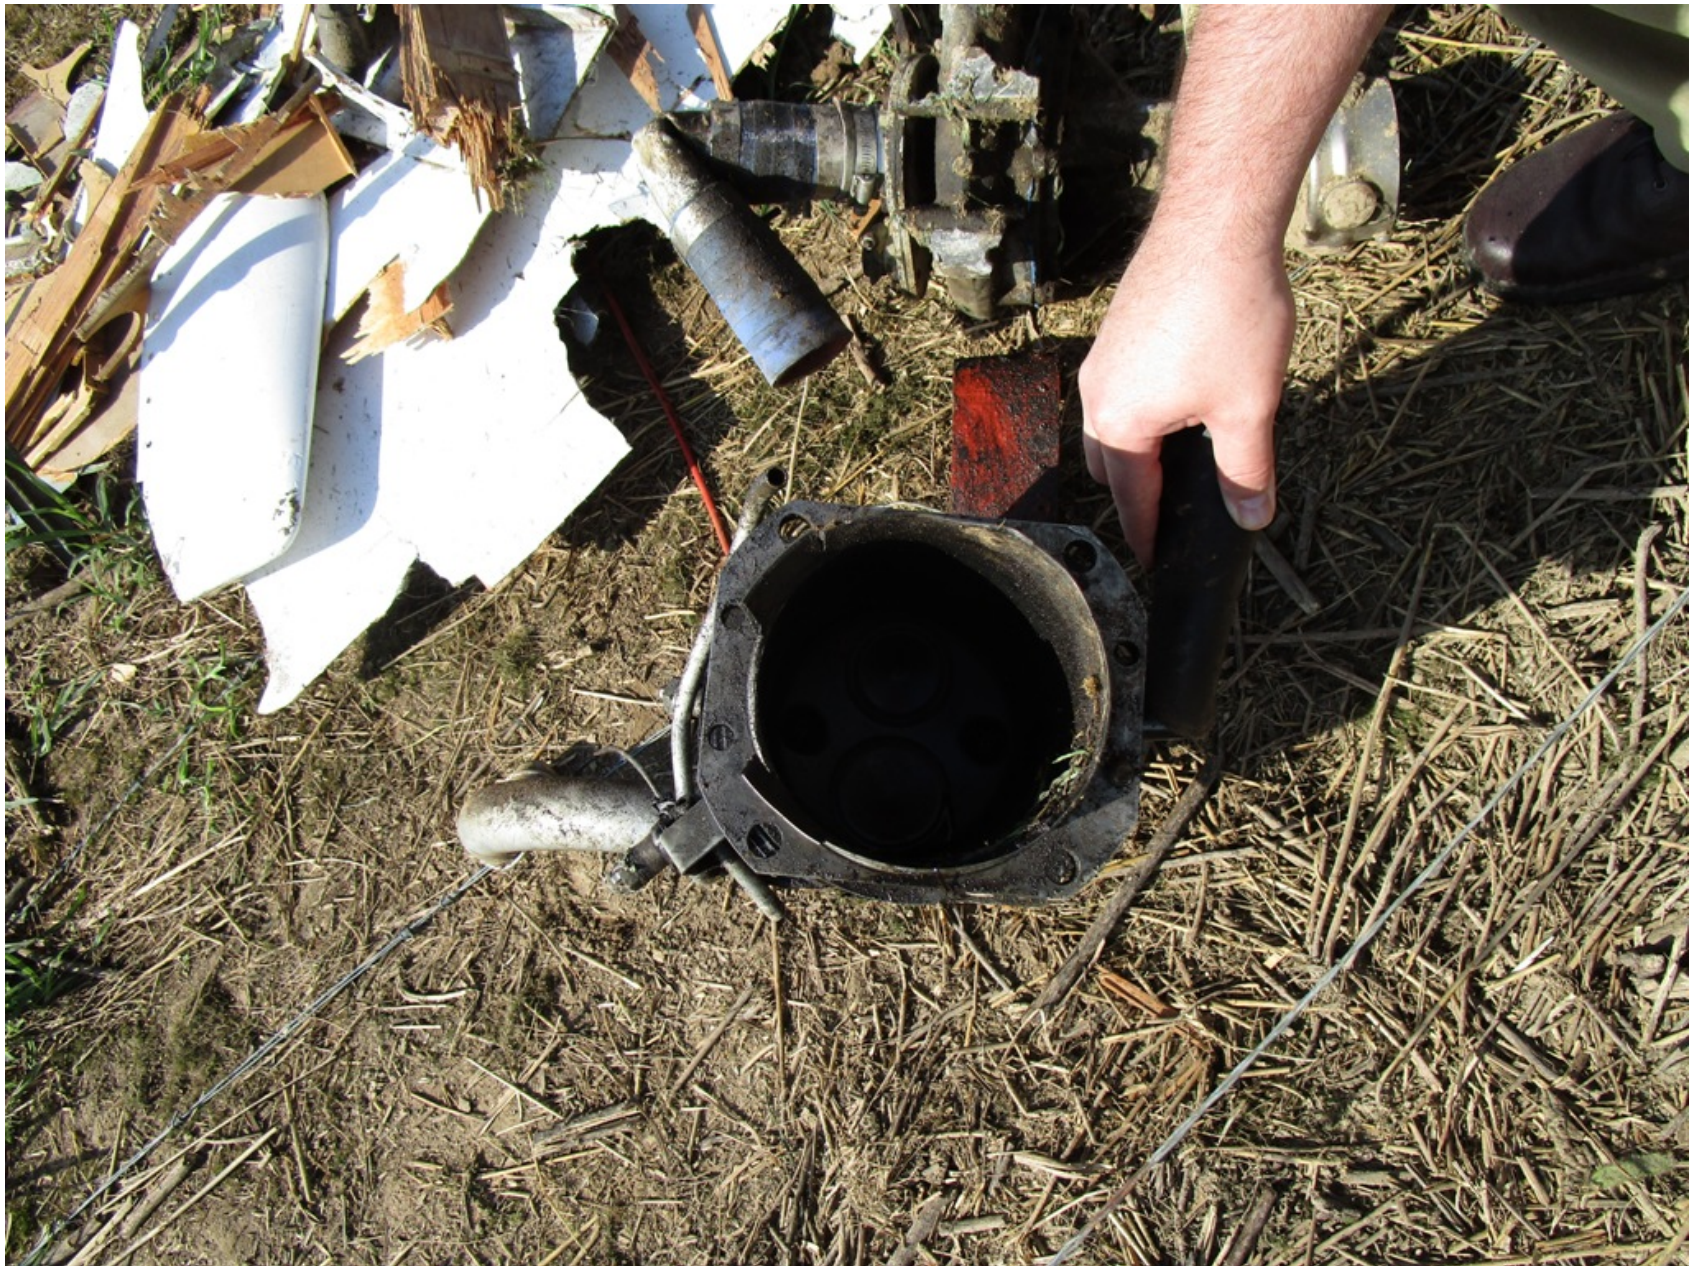
**Photo 4 – No. 2 Cylinder Separated from Engine (Photo Credit: FAA)**

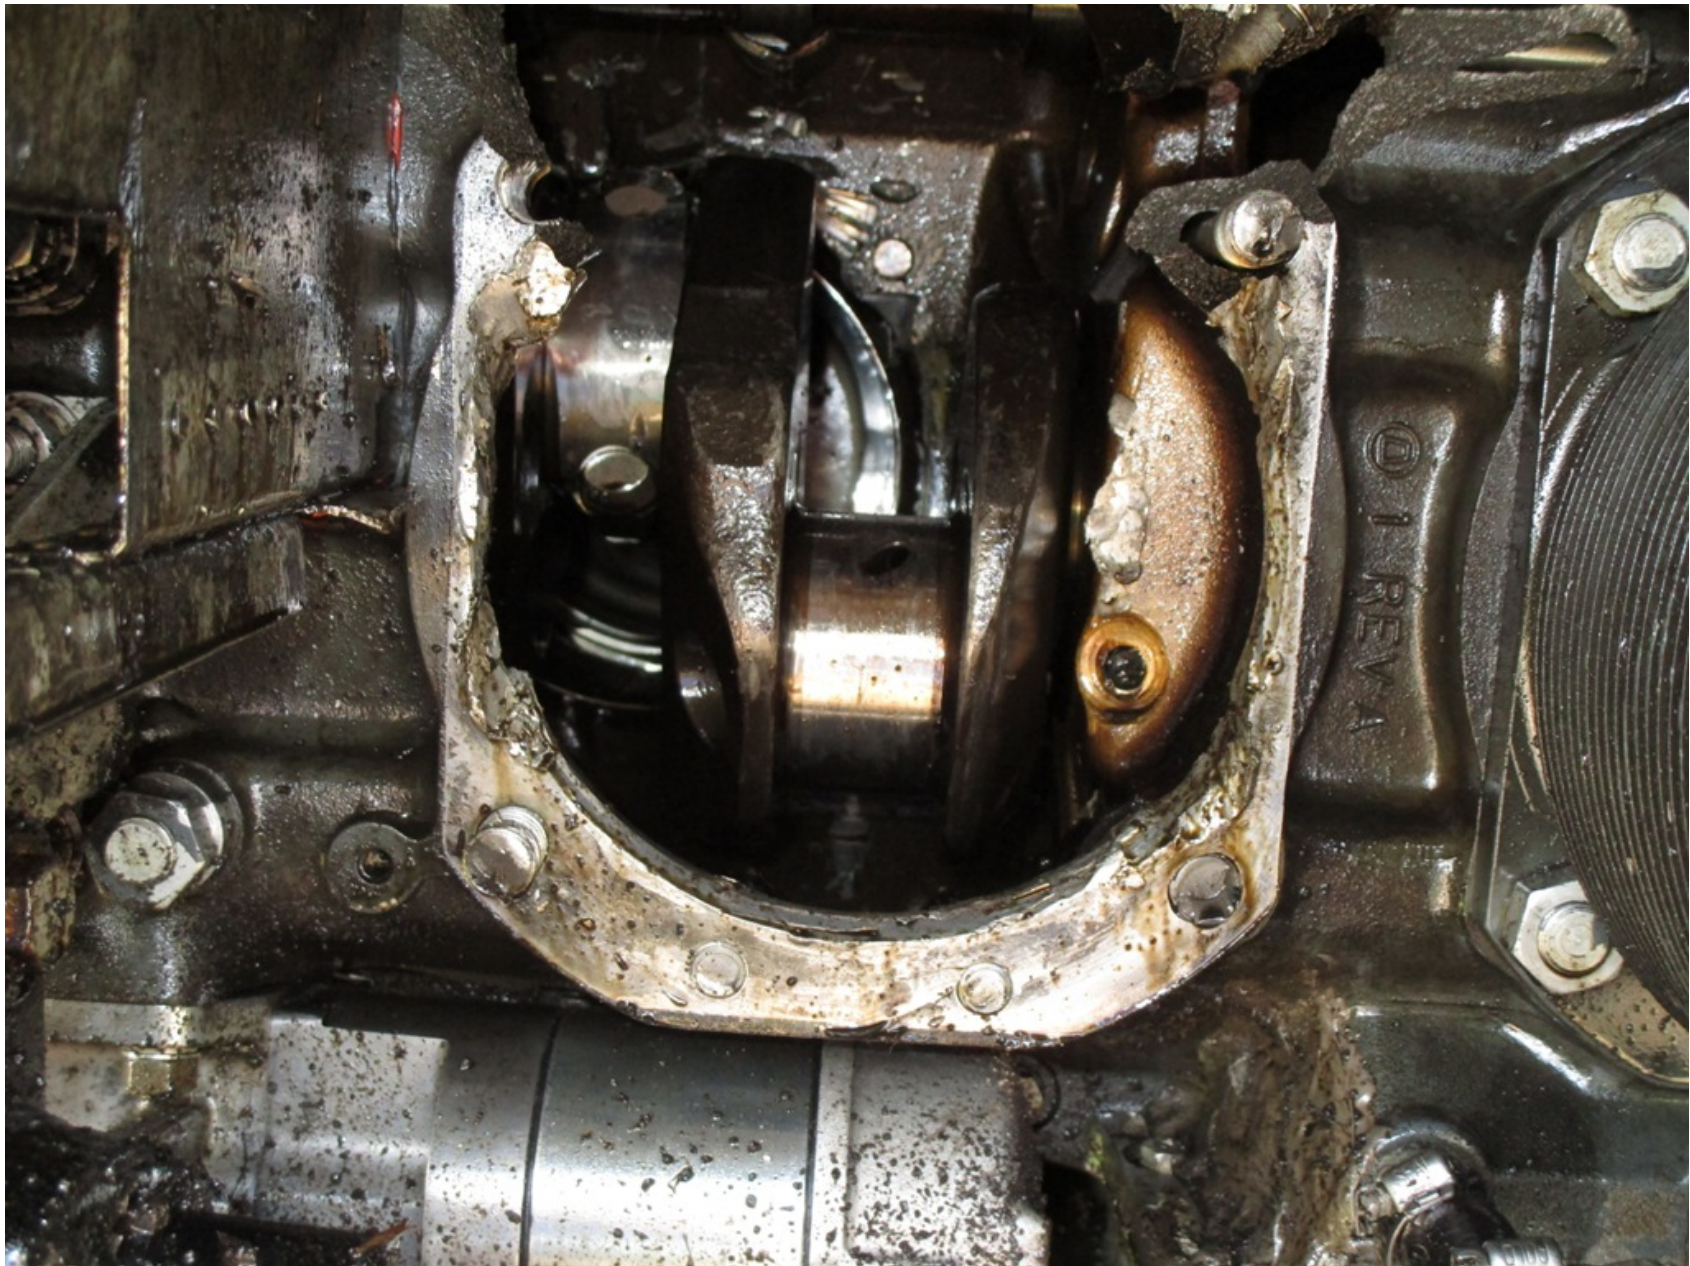
**Photo 5 – No. 2 Cylinder Mounting Deck (Photo Credit: FAA)**

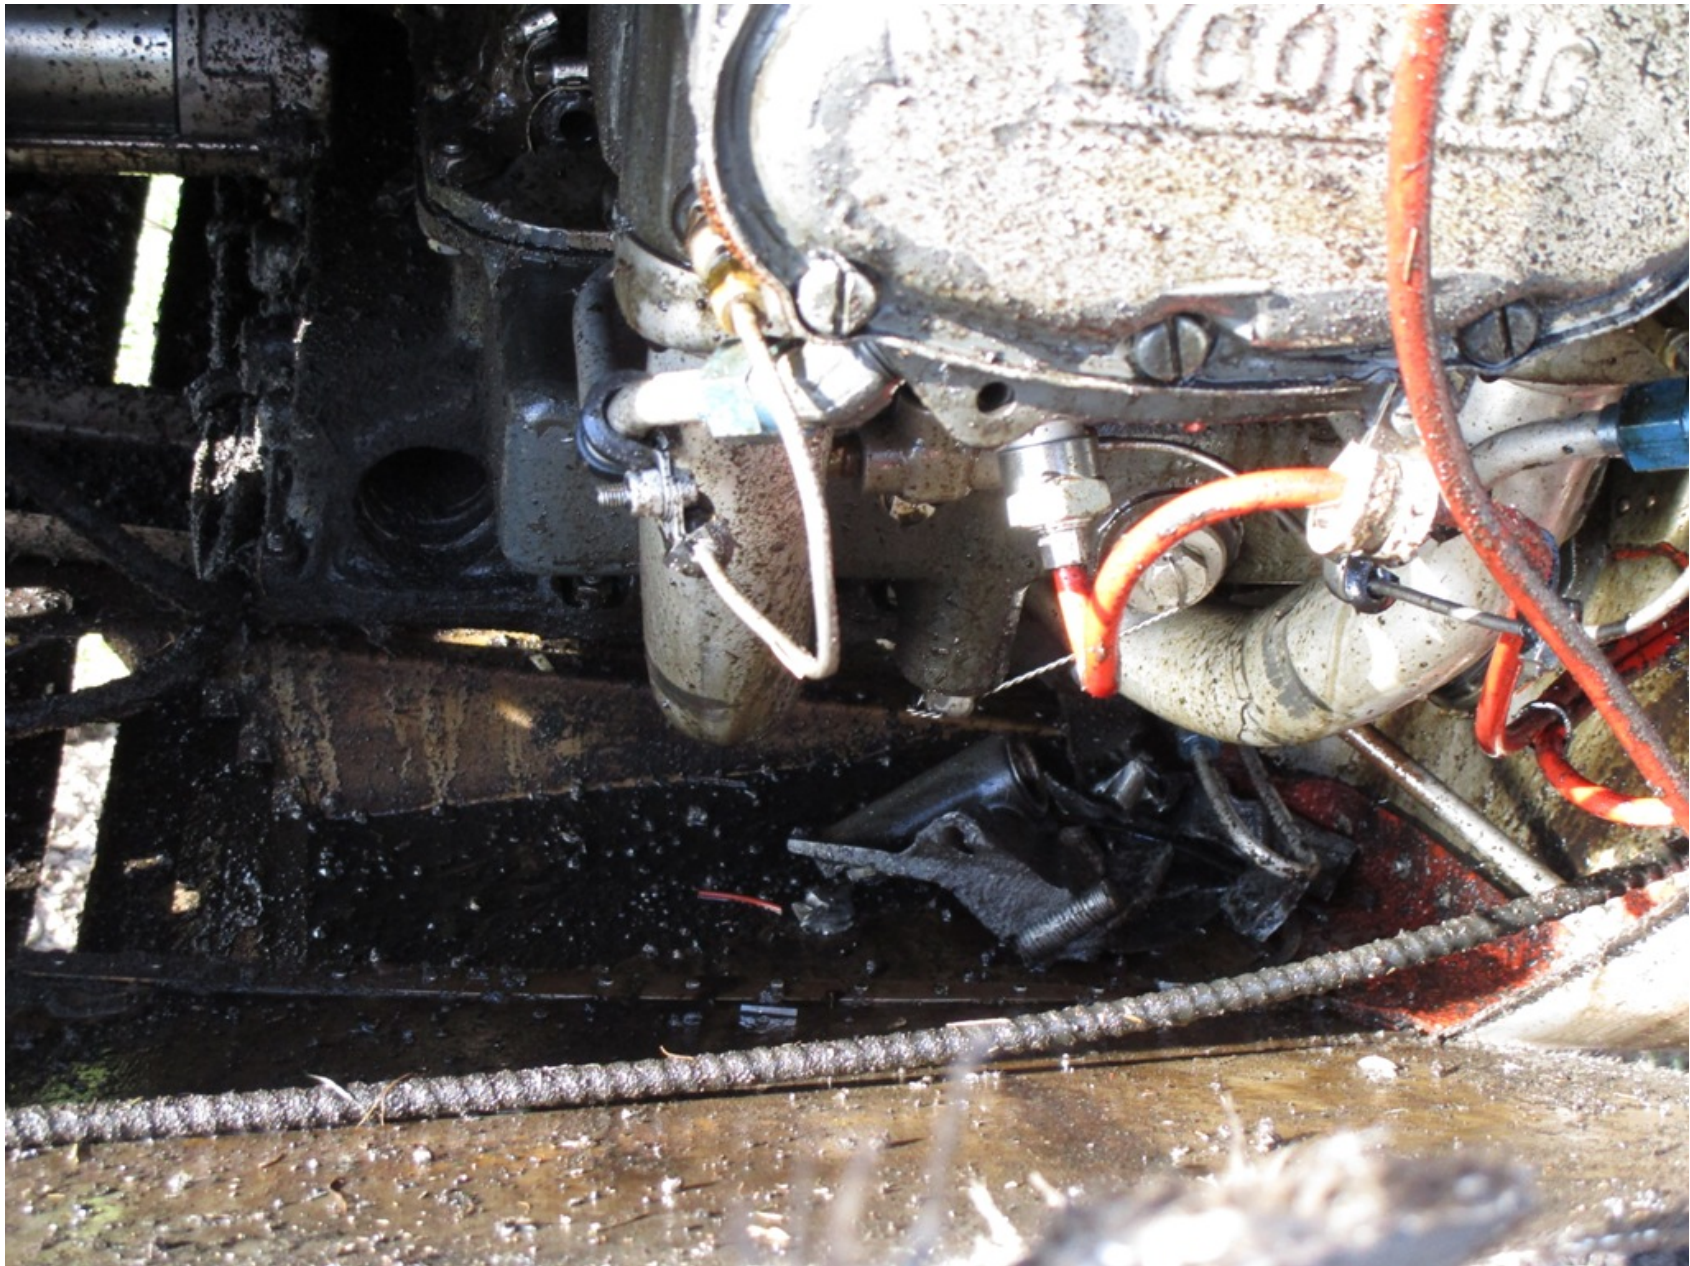
**Photo 6 – Broken Sections of Crank Case in Lower Engine Cowling (Photo Credit: FAA)**
