**From:** Budinski Michael  
**Sent:** Tuesday, October 8, 2019 5:24 PM  
**To:** Read Leah  
**Subject:** ERA18LA195--Materials Laboratory Email Report  
**Attachments:** Number 2 cylinder studs.jpg

Location: Ider, AL  
Accident number: ERA18LA195  
Accident date: 07/18/2018  
Accident vehicle: Eagle DW1 (N8805X)

Component examined: Images of number 2 cylinder separation and associated studs.

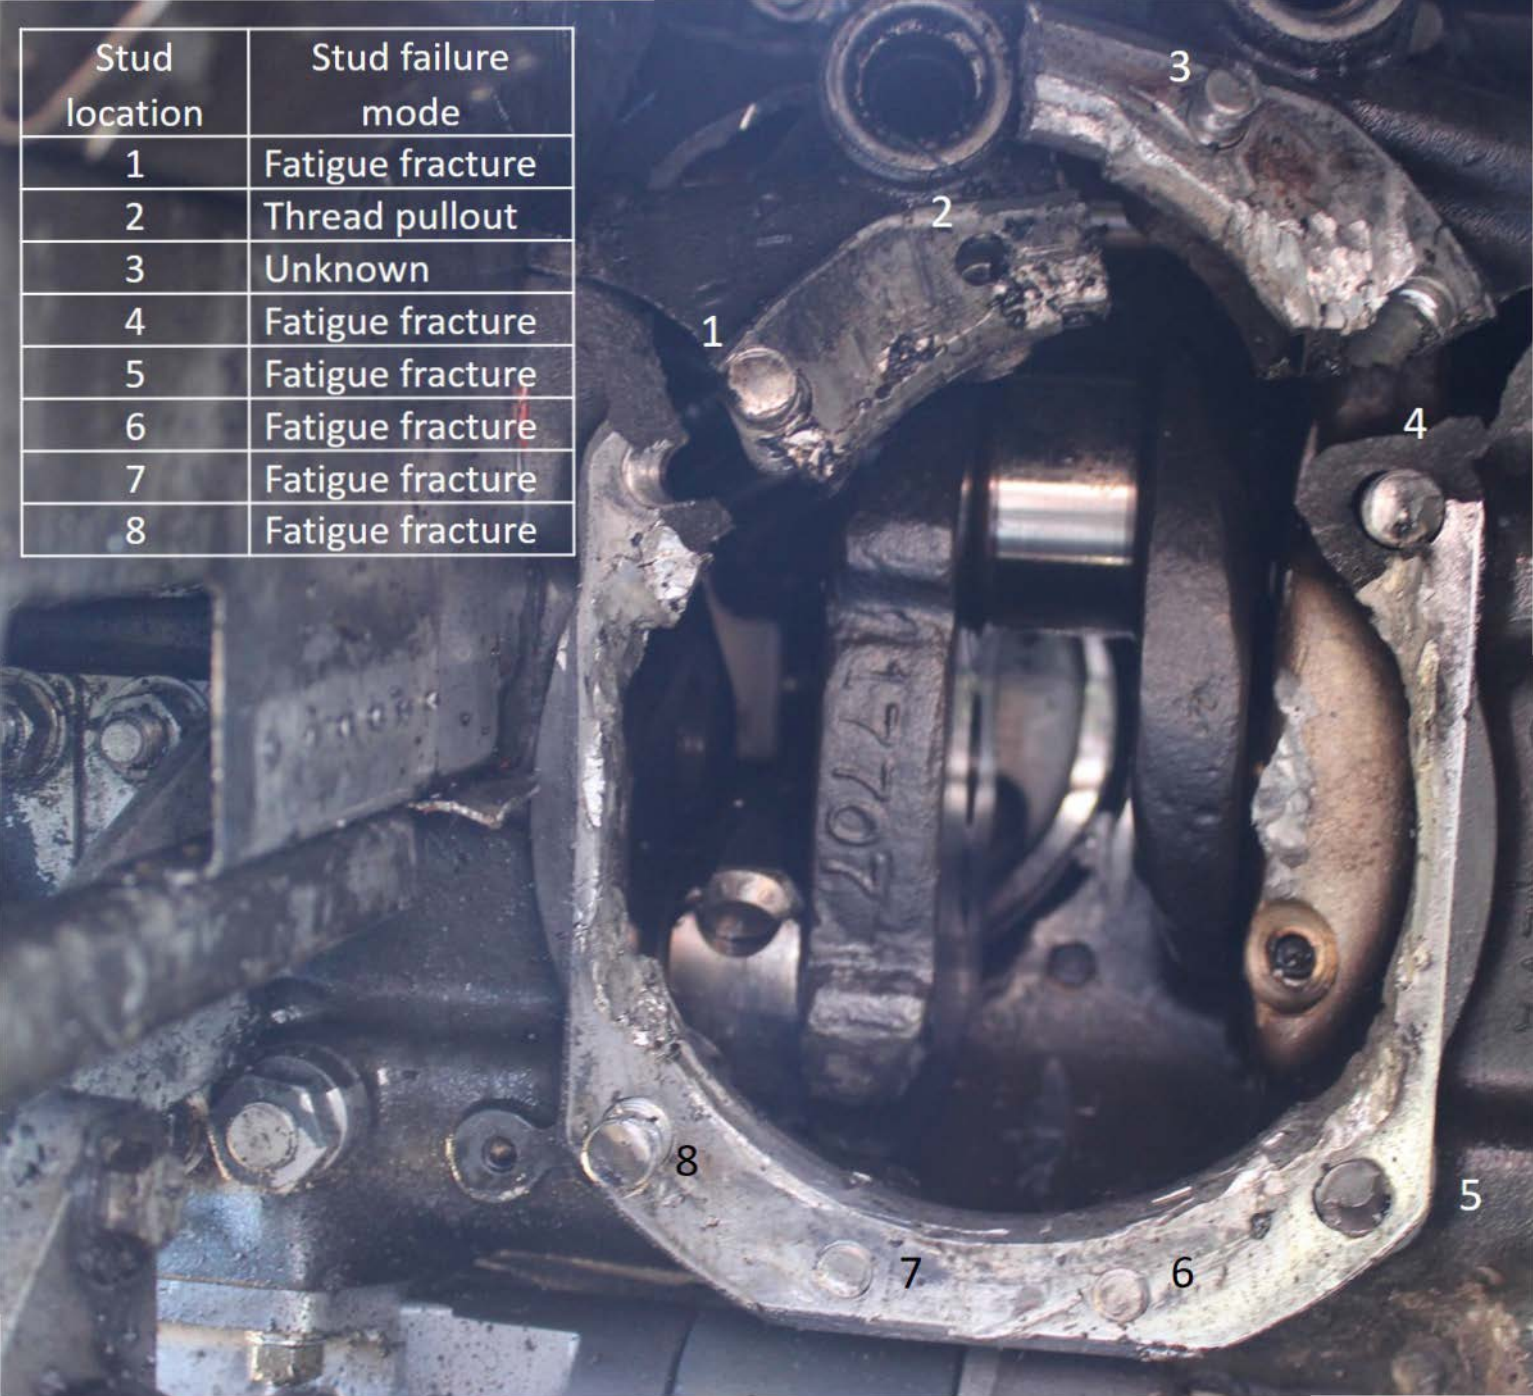
The attached photograph and table below shows the numerical stud location and the mode of failure.

| Stud location | Stud failure mode |
| 1 | Fatigue fracture |
| 2 | Thread pullout |
| 3 | Unknown |
| 4 | Fatigue fracture |
| 5 | Fatigue fracture |
| 6 | Fatigue fracture |
| 7 | Fatigue fracture |
| 8 | Fatigue fracture |
