**MIKE BUSCH**

COMMENTARY / SAVVY AVIATOR

# Cylinder Work: Be Afraid

It is nearly impossible to install a cylinder properly when the engine is on the airplane

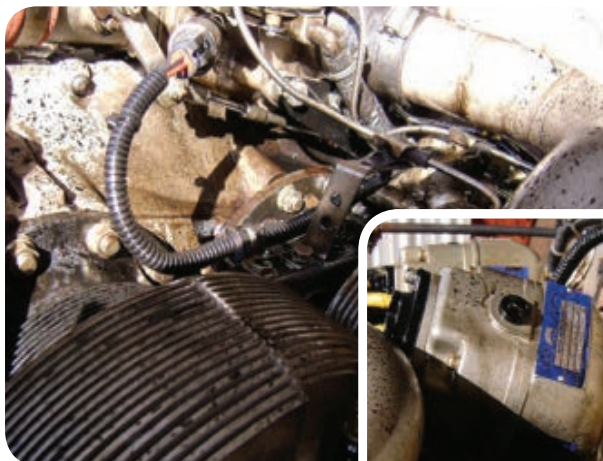
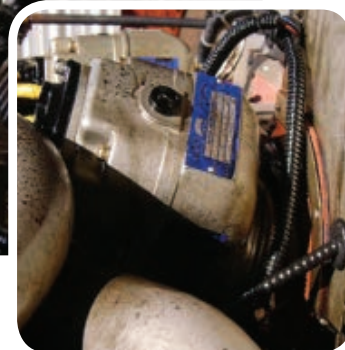
*This Continental IO-550 threw the No. 2 rod through the top of the case less than 10 hours after the No. 2 and No. 4 cylinders were replaced at annual.*

In short, Fuchs contends that there's a significant risk that an engine might come apart after cylinder work (especially a top overhaul) even when the work is performed exactly as directed by the manufacturer. How can that be? According to Fuchs, the root cause of spun bearings, thrown rods, and separated cylinders is simply "failure to achieve sufficient preload in the assembled fasteners."

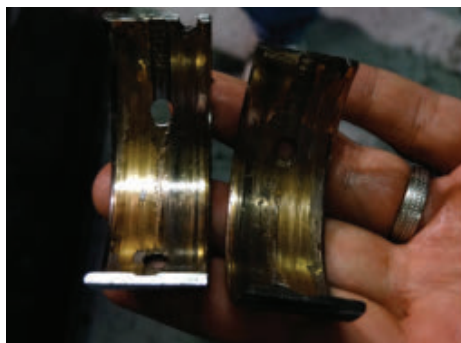
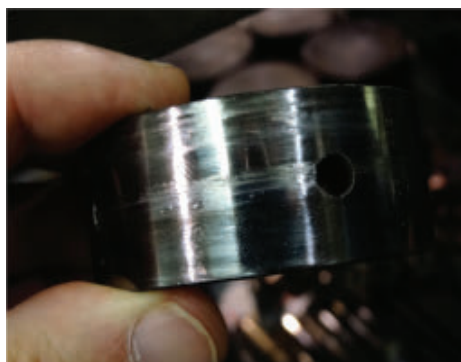
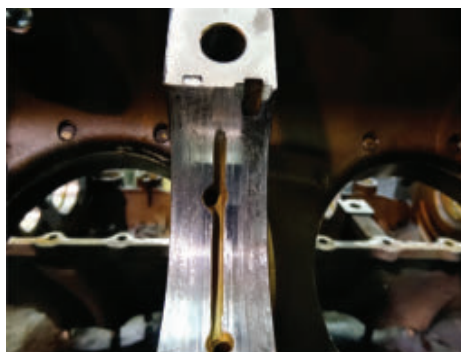
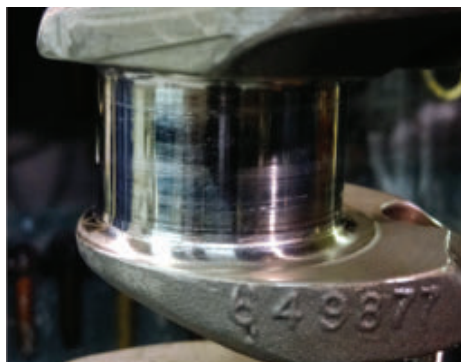
*This Continental IO-360 spun a main bearing after cylinder work. Fortunately, the situation was caught at a routine oil change (where the filter was found to have thousands of flakes of bearing metal) literally an hour or two before the engine would have self-destructed in flight.*

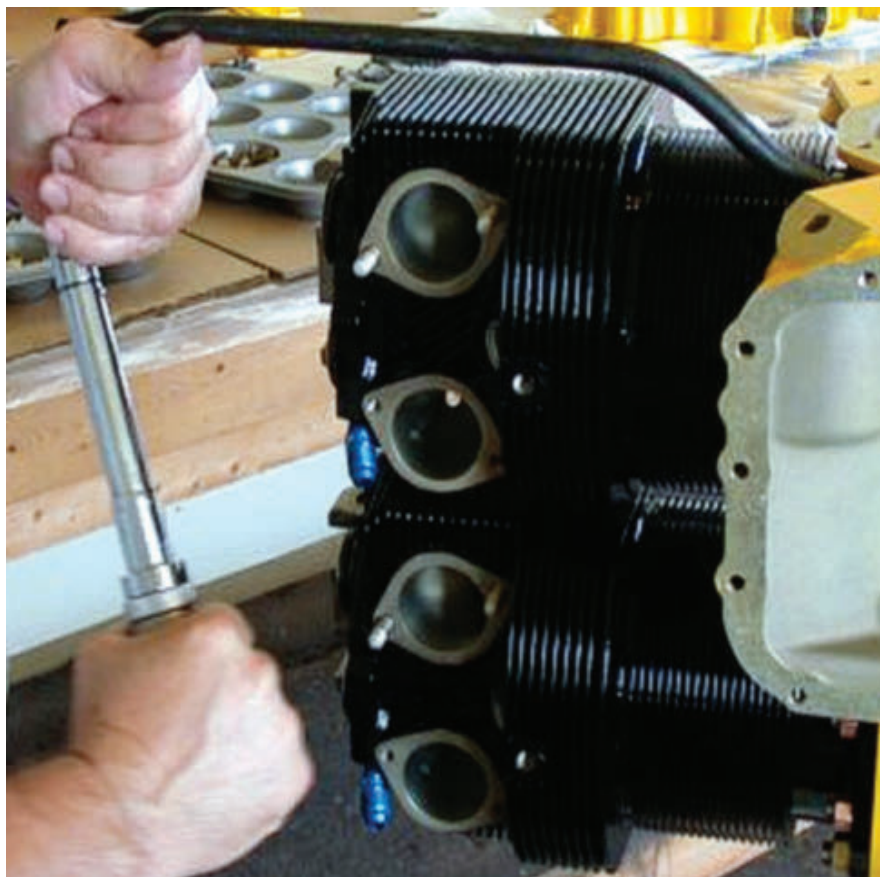
airplane and sitting on an engine stand with unobstructed access, it's almost impossible to do when the engine is mounted in the airplane and various components restrict wrench movement. Frequently, two or three "bites" of the wrench are needed before final torque is achieved, and each adds uncertainty to the final result. "This is particularly true when wrench rotation must be stopped as the nut is approaching the desired 'click' of the wrench—but not there yet," Fuchs says. "Time after time when the wrench is removed before it clicked, the wrench will do so upon attempting to tighten the nut further with no additional rotation of the nut." This deceives the mechanic into believing that proper preload has been achieved when it almost certainly hasn't.

*Achieving final torque needs to be accomplished with one smooth motion of the torque wrench. This is usually possible when the engine is out of the airplane and being assembled on a stand, but it's almost impossible when the engine is in the airplane.*
