# NATIONAL TRANSPORTATION SAFETY BOARD

MATERIALS LABORATORY FACTUAL REPORT

Report No. 18-070

Place : Cleveland, Tennessee  
Date : July 26, 2018  
Vehicle : Cessna 182P, N1311S  
NTSB No. : ERA18LA199  
Investigator : Timothy W. Monville, AS-ERA

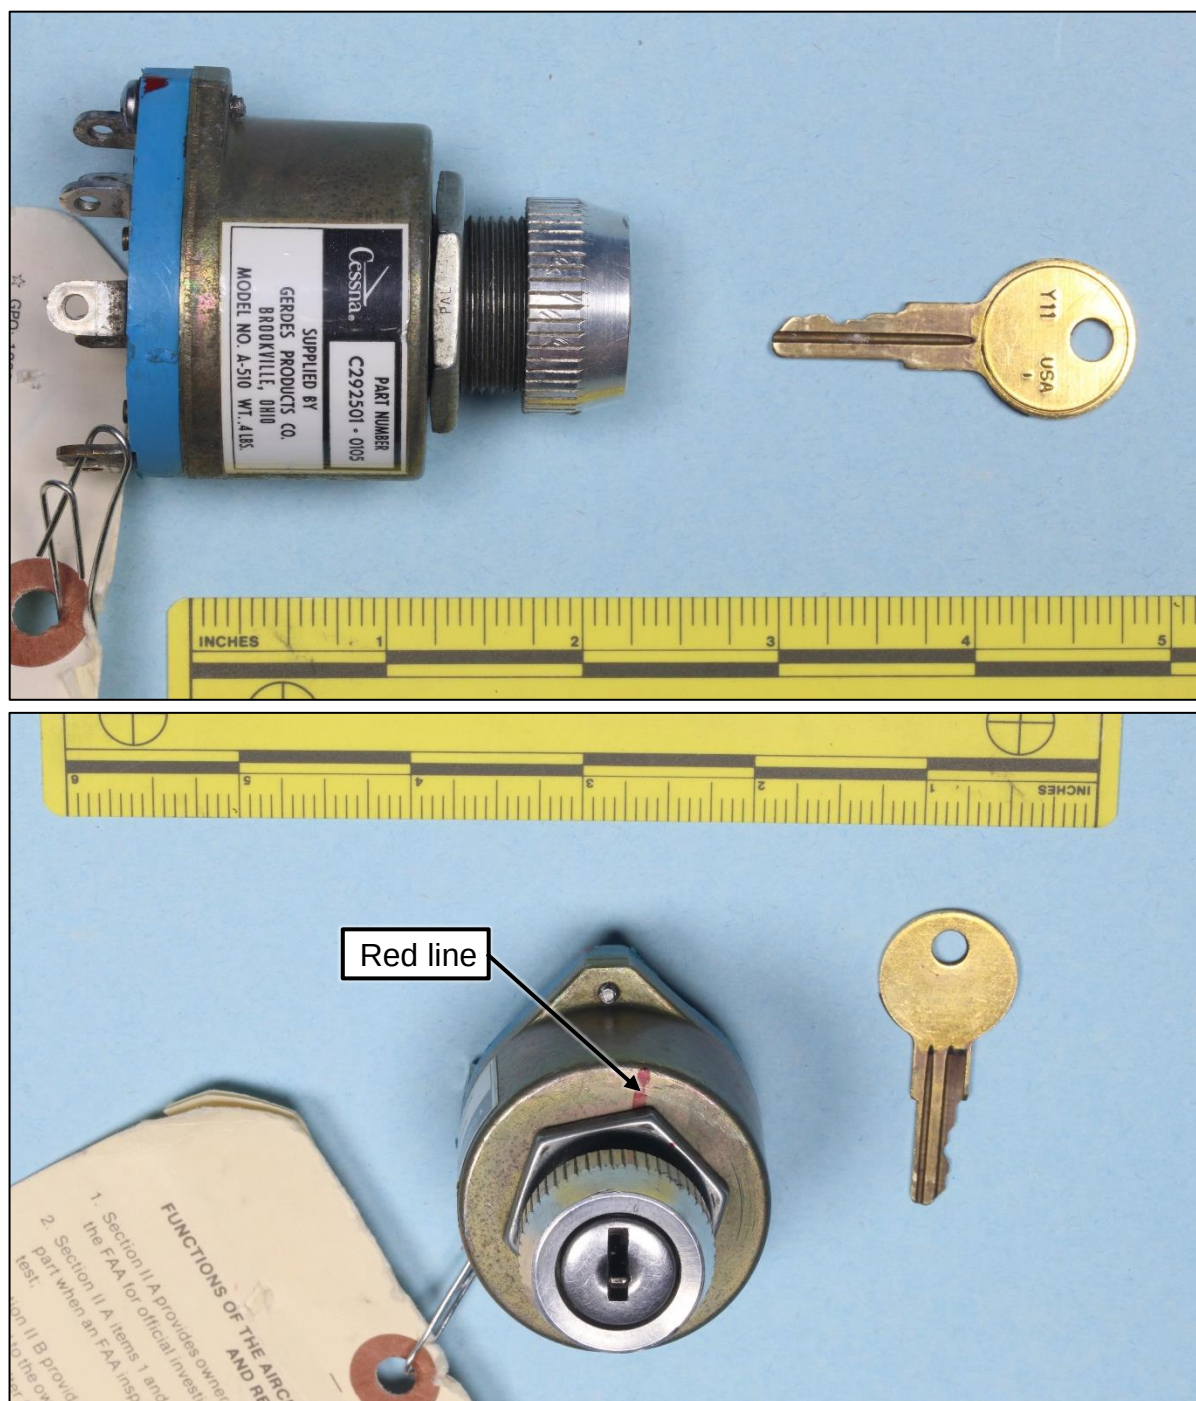
Overall views of the submitted ignition switch assembly and key are shown in figure 1. The ignition switch had a data tag indicating it was Cessna Aircraft part number C292501-0105 made by Gerdes Products Company and a date stamp indicating it was made in 1976. In the lower image, the switch is shown positioned in the off position. A red line marked on the switch body reportedly indicated the position of the key slot as found after the accident, a position rotated slightly clockwise from the off position shown in figure 1. Prior to receipt in the NTSB Materials Laboratory, the switch had been tested and then disassembled at ACS Products Company, Lake Havasu City, Arizona. According to the test report, the right magneto was hot (not grounded) with the key positioned in line with the red mark.

Figure 1. Overall views of the submitted ignition switch and key. The switch in the lower image is positioned in the "OFF" position. The red line indicated in the lower image reportedly marked the switch position as found after the accident.

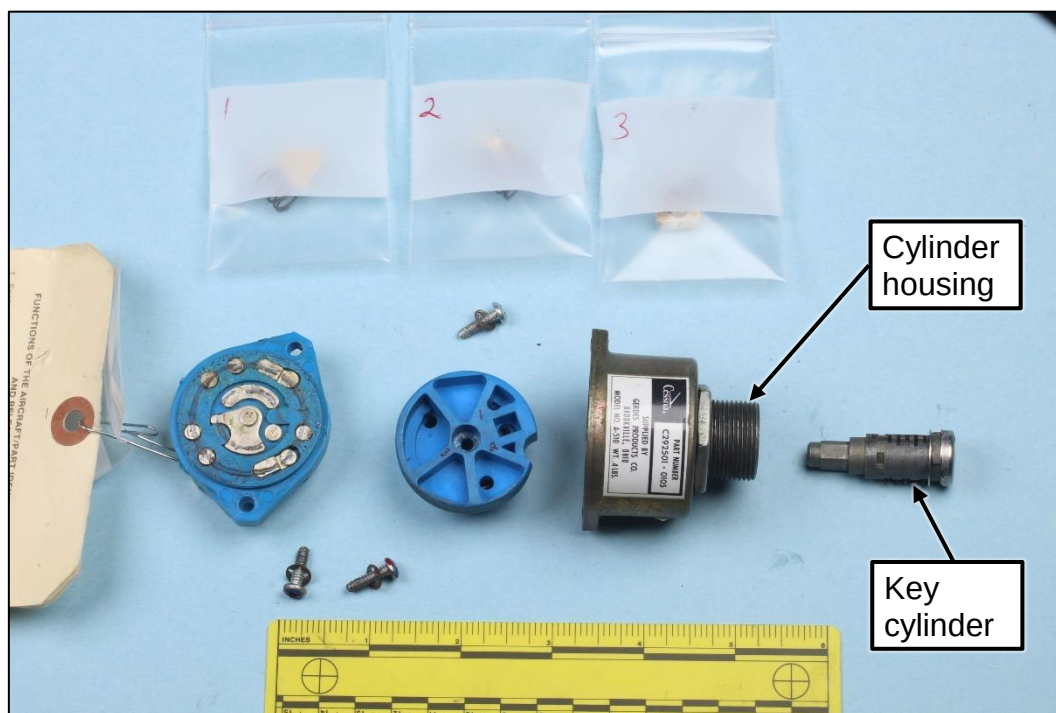
Next the switch assembly was disassembled as shown in figure 2, where the key cylinder and the cylinder housing are shown. In order to operate the switch as designed, the key cylinder rotates within the cylinder housing. Spring-loaded levers in the cylinder (see figure 3) prevent operation of the lock unless a matching key is inserted. In the off position without a key inserted, the levers spring into an axial slot in the cylinder housing wall to prevent rotation of the cylinder within the housing. With the proper key in place,

Figure 2. Components of the ignition switch after disassembly. The key cylinder and cylinder housing components are indicated.

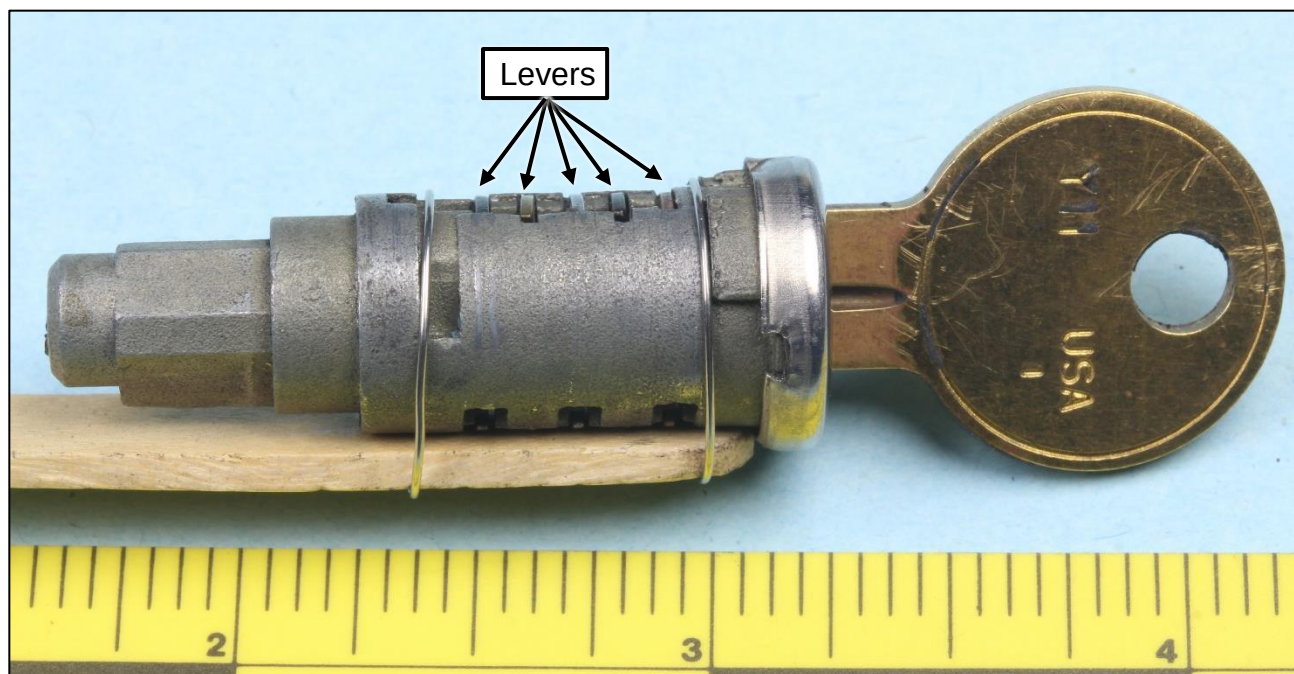
Next the key was manipulated within the cylinder, and movements of the levers were observed. Figure 3 shows the key fully inserted in the cylinder with all levers flush to the outer diameter of the cylinder. Next, the key was removed by pulling the key axially out of the slot. As the key moved, one of the levers identified as the key retention lever raised up as shown in figure 4. The key retention lever was raised by engagement with a ridge on the key identified as the key retention ridge in figure 6. With the lever engaged on the key retention ridge as shown in figure 4, the lever extended beyond the outer diameter of the cylinder, which would only be possible in the cylinder housing if the cylinder was in the "OFF" position.

Figure 3. View of the key inserted in the cylinder. A wood stick was attached to the cylinder as shown to constrain downward lever movement, thereby simulating the interior of the cylinder housing with the key in positions other than "OFF" during testing of the lever action.

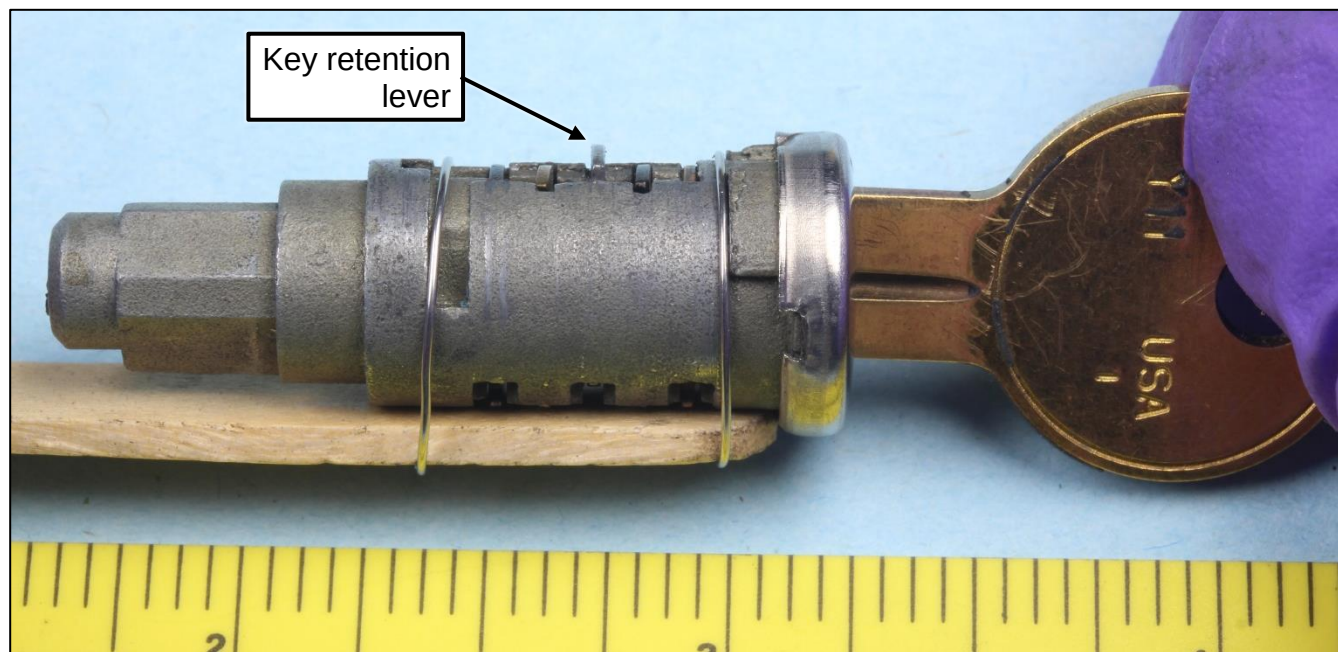
Figure 4. View of the cylinder with the key partially removed axially. The key retention lever raised due to engagement with the retention ridge on the key (see figure 6).

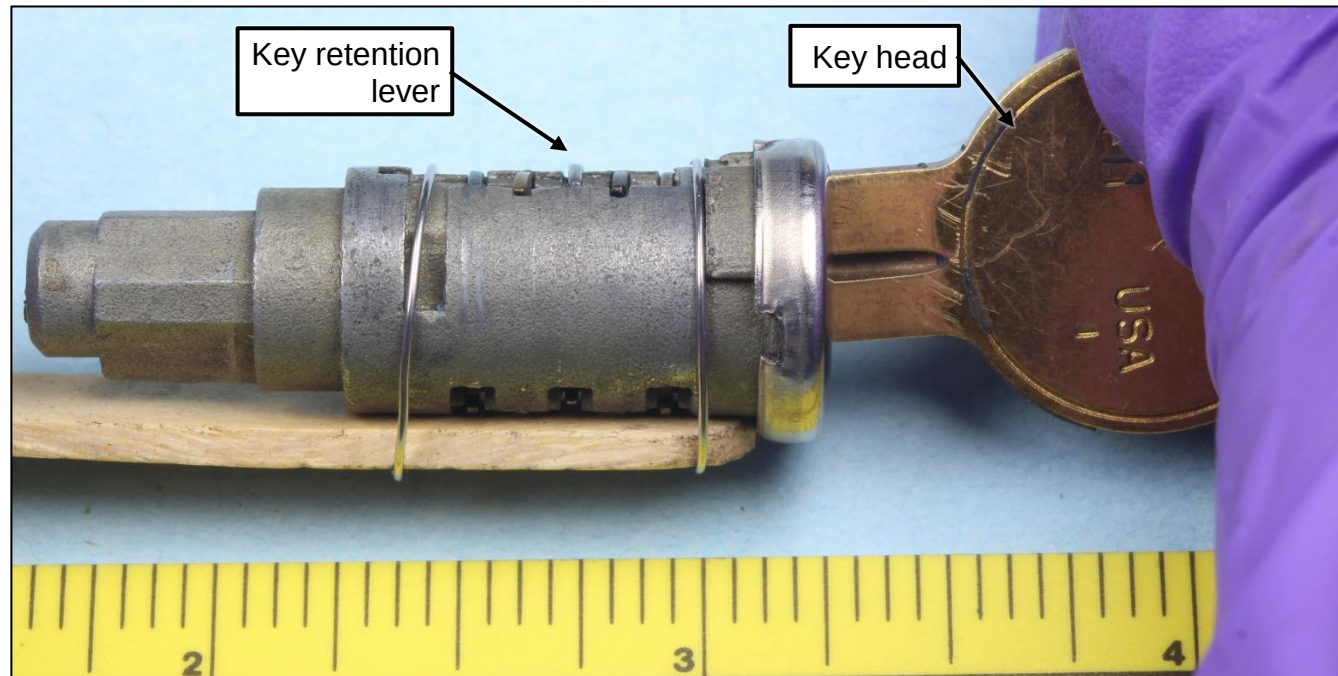
In a separate test, the head of the key was raised upward as the key was removed from the key slot. As the key was removed, minimal movement of the key retention lever was observed. The axial displacements of the key in figures 4 and 5 are similar, but in figure 5 the head of the key was raised upward. In the key position shown in figure 5, the key retention lever was nearly flush with the outer diameter of the cylinder.

Figure 5. View of the cylinder with the key partially removed as in the prior figure but with the head of the key lifted upward. The key could be removed with limited movement of the key retention lever.

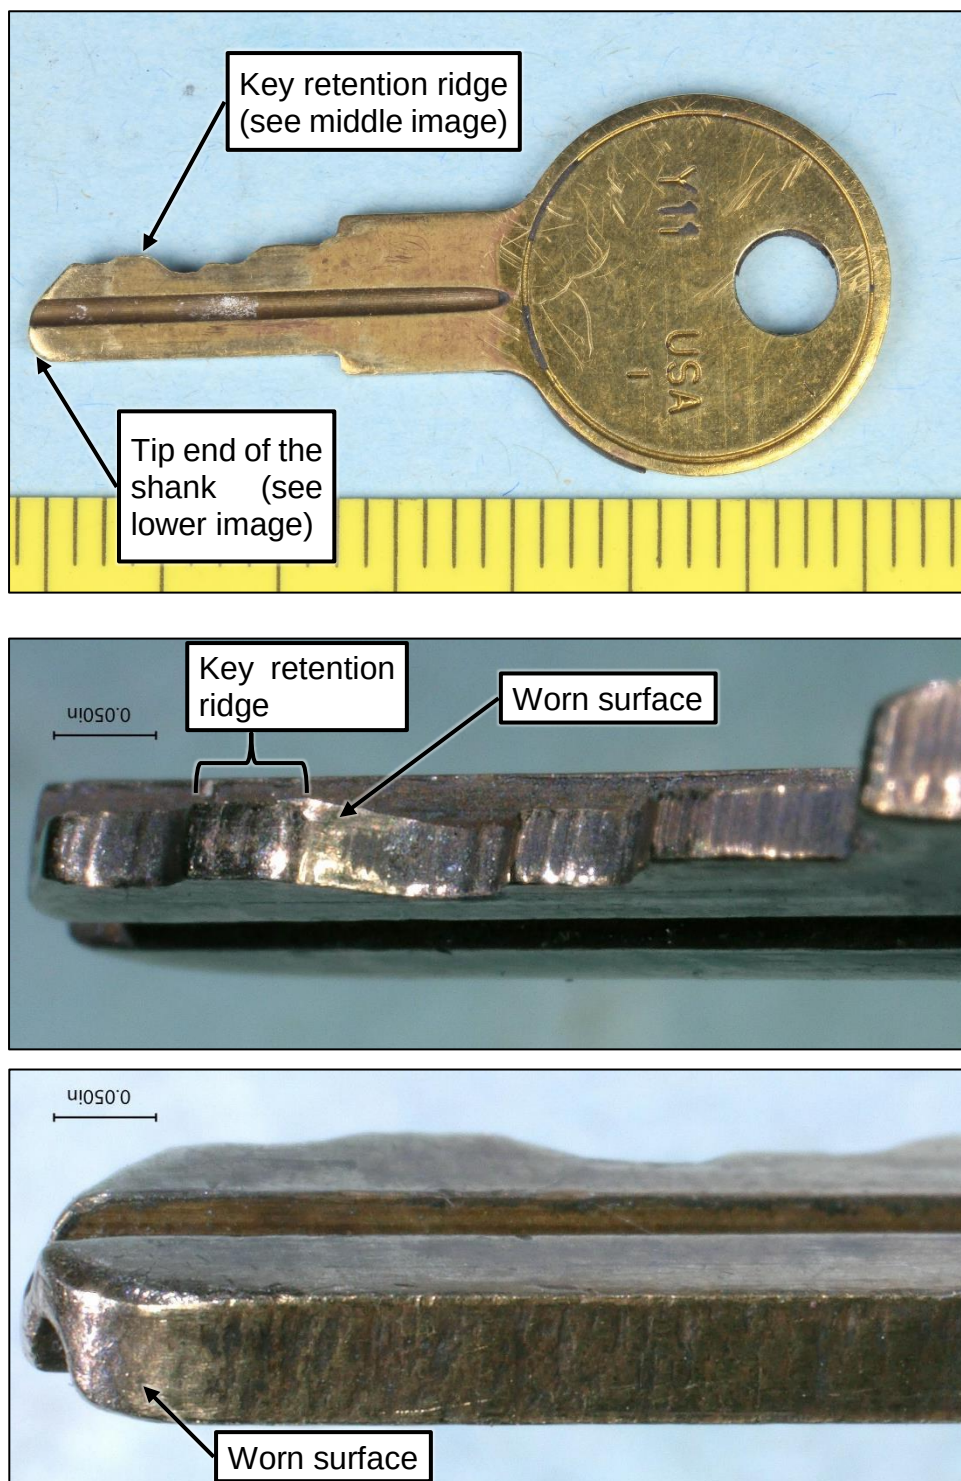
A close view of the key for the ignition switch is shown in figure 6. The ridge associated with movement of the key retention lever as the key was removed from the cylinder is indicated. The cut surfaces of the key notches were examined. Relatively smooth and reflective surface features consistent with a worn surface were observed on the flank of the notch adjacent to the key retention ridge as indicated in the middle image in figure 6. A smooth and reflective surface consistent with wear was also observed on the tip end of the shank opposite the notched side as indicated in the lower image in figure 6. No unused key was available for comparison to determine the extent of wear associated with the worn surfaces.

Figure 6. Views of the key. Worn surfaces on the side of the notch adjacent to the key retention ridge (middle image) and on the lower surface at the tip end of the shank (lower image) are shown.

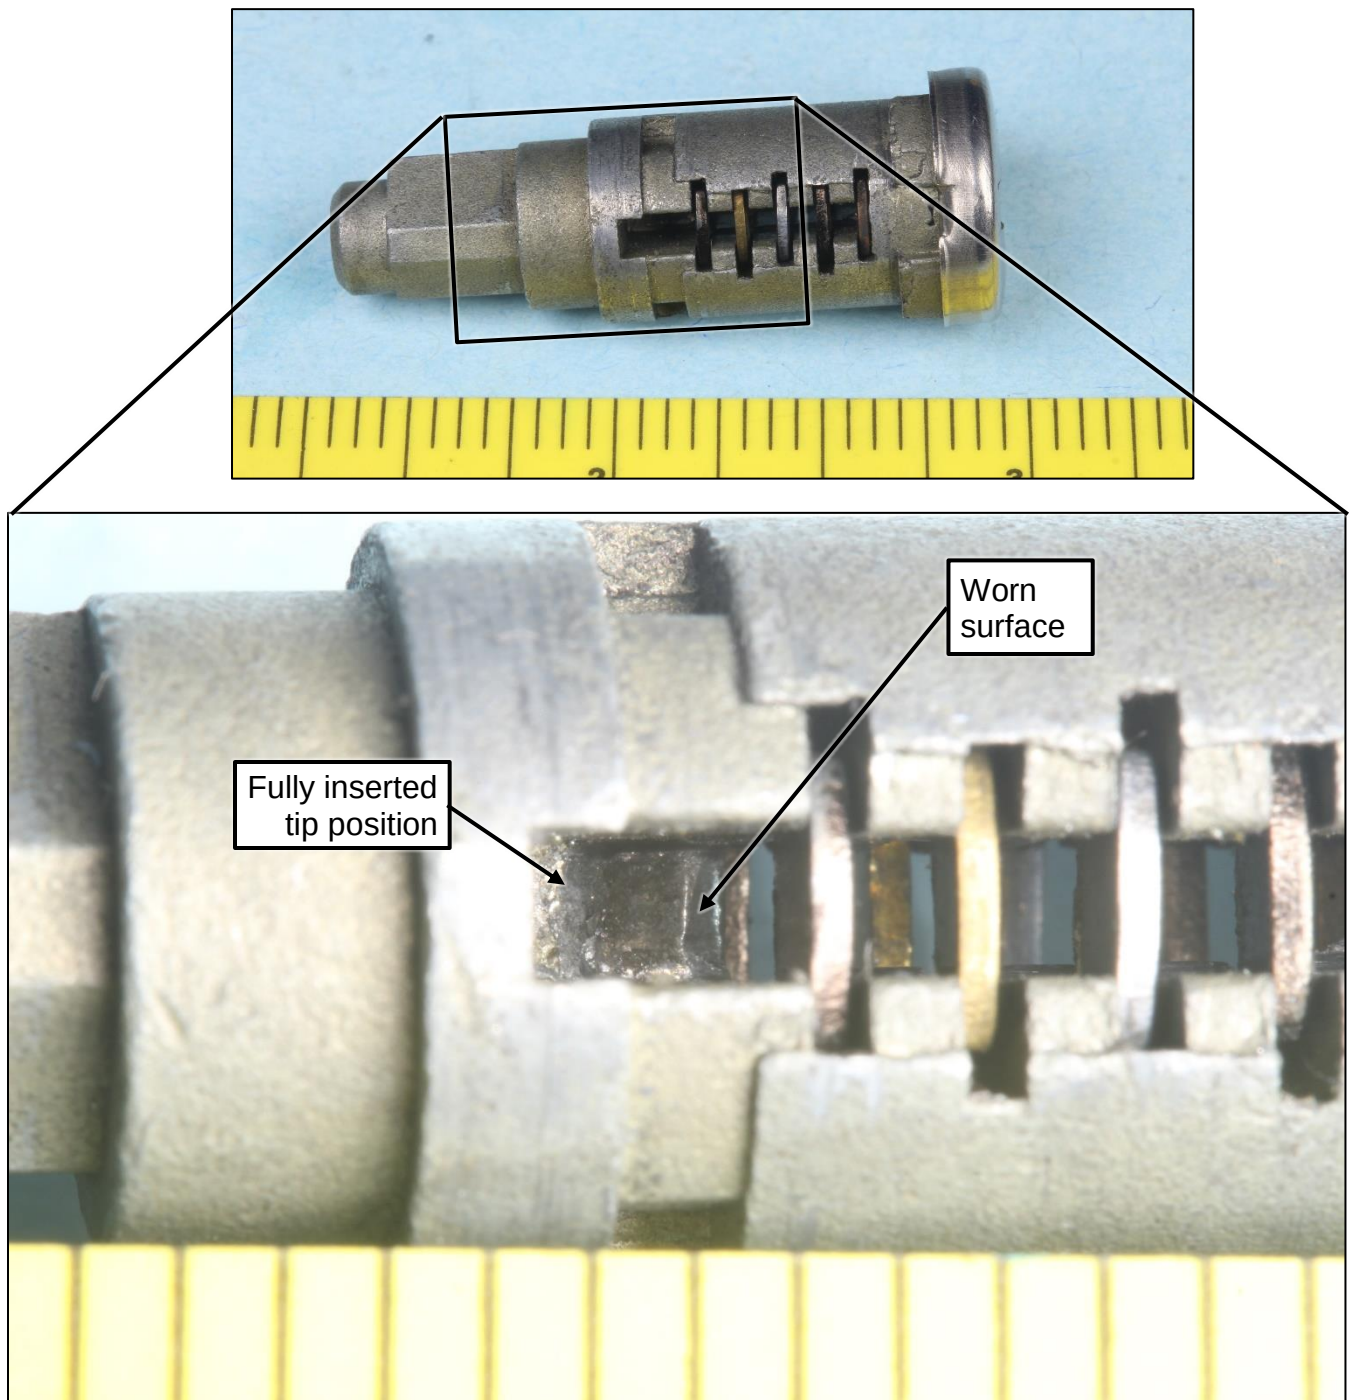
Views of the upper side of the key cylinder are shown in figure 7. A quadrilateral-shaped area with a smooth and reflective surface consistent with wear was observed on the lower side of the key slot as shown in the lower image in figure 7. The location and

shape of the worn area was consistent with wear contact with the tip of the key as it was inserted and removed. With the key inserted fully to the shoulder, the position of the tip of the key was as indicated in the lower image in figure 7.

Figure 7. View of the keyway slot in the cylinder. A worn surface on the lower side of the keyway slot is indicated.
