# NATIONAL TRANSPORTATION SAFETY BOARD

## MATERIALS LABORATORY FACTUAL REPORT

Report No. 18-077

Place : Mayport, Florida  
Date : August 17, 2018  
Vehicle : Beech N35  
NTSB No. : ERA18LA227  
Investigator : Eric Alleyne, AS-ERA

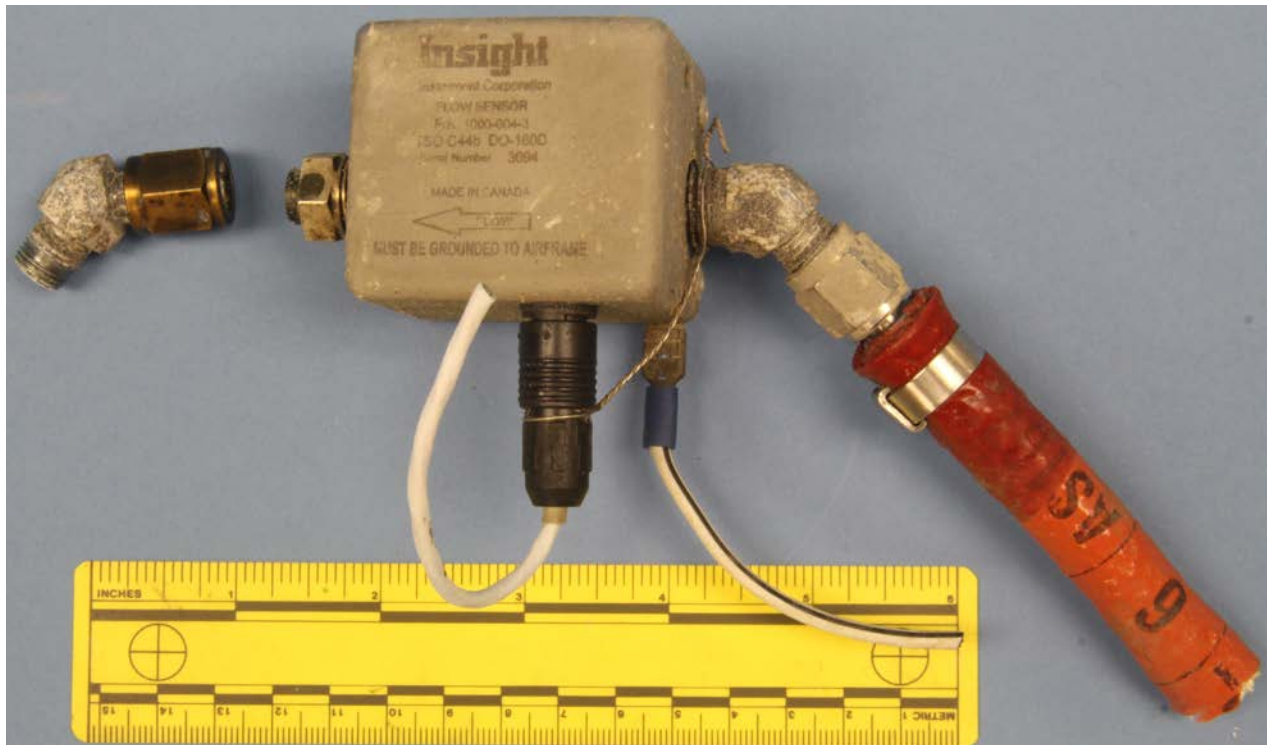
The as-received components are shown in Figure 1 with a portion of AN fitting fractured from the portion of fuel transducer. Both pieces exhibited white salt deposits.

Figure 1 Image of the as-received portion of a fuel transducer and a portion of a fuel line with AN fitting.

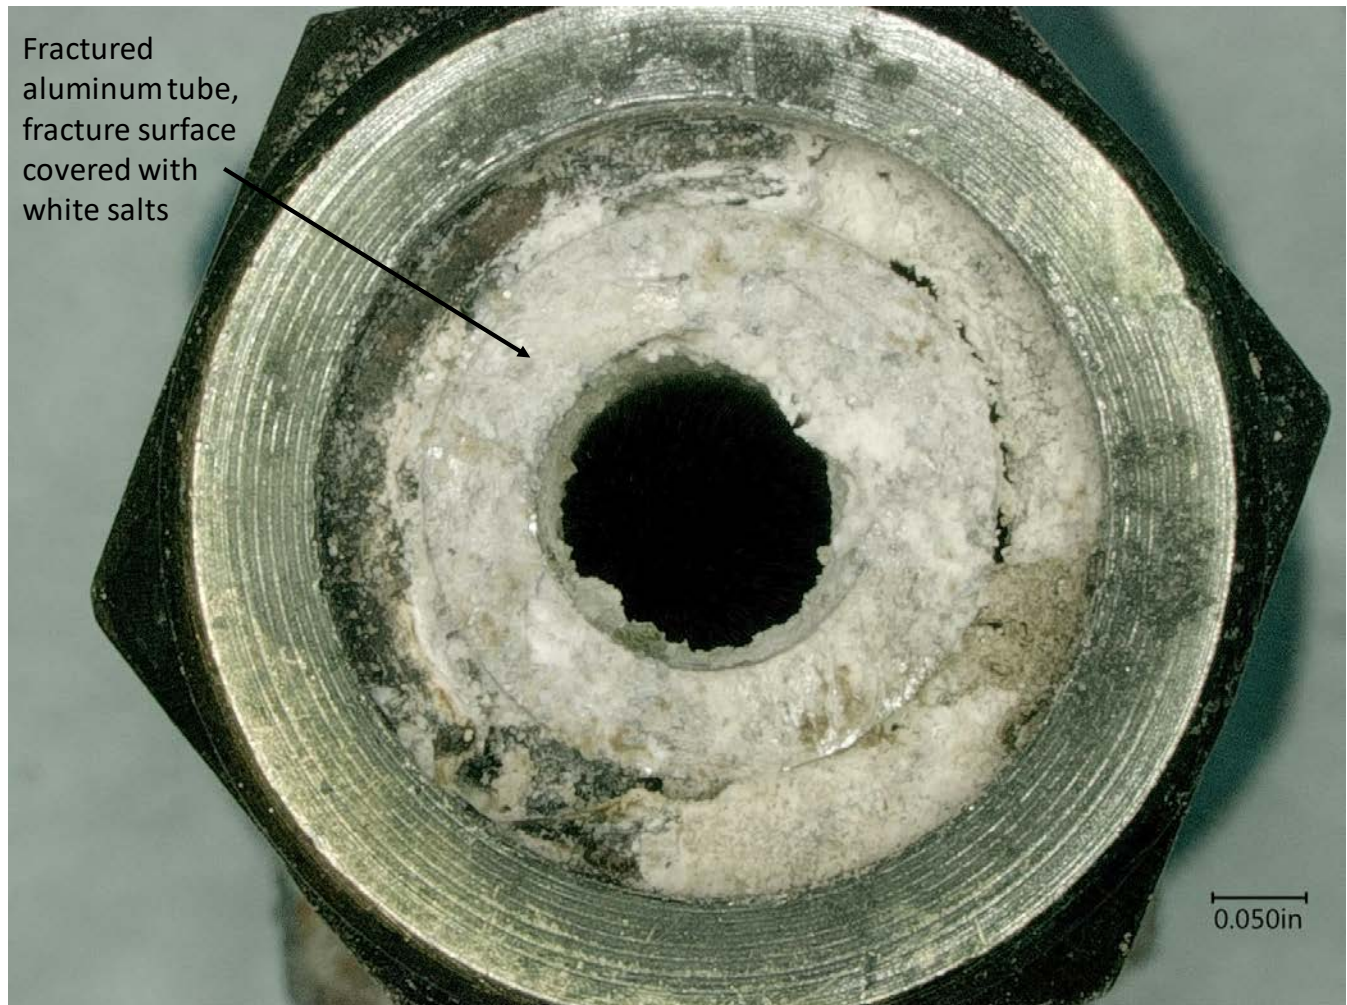
Fractographic analysis was conducted on the portion of fuel line with AN fitting. The aluminum fuel line tube within the fitting was fractured just below the top of the AN nut as shown in Figure 2. As-received, the fracture surface and other surfaces of the AN fitting piece were coated with an adherent white salt deposit, consistent with corrosion product. The fracture surface on the AN fitting piece was cleaned in a mild nonionic detergent using a fine natural-bristle brush and ultrasonic energy. The cleaned fracture surface is shown in Figures 3, 4, and 5. The fracture origin area is identified in the images. The macro-fractographic features are consistent with high-stress, low-cycle fatigue crack propagation, initiating at the outside diameter and progressing through the thickness of the aluminum fuel line and partially along its circumference until final overstress fracture.

Figure 2 Digital microscope image of the as-received fuel line fracture surface, coated with an adherent white salt deposit.

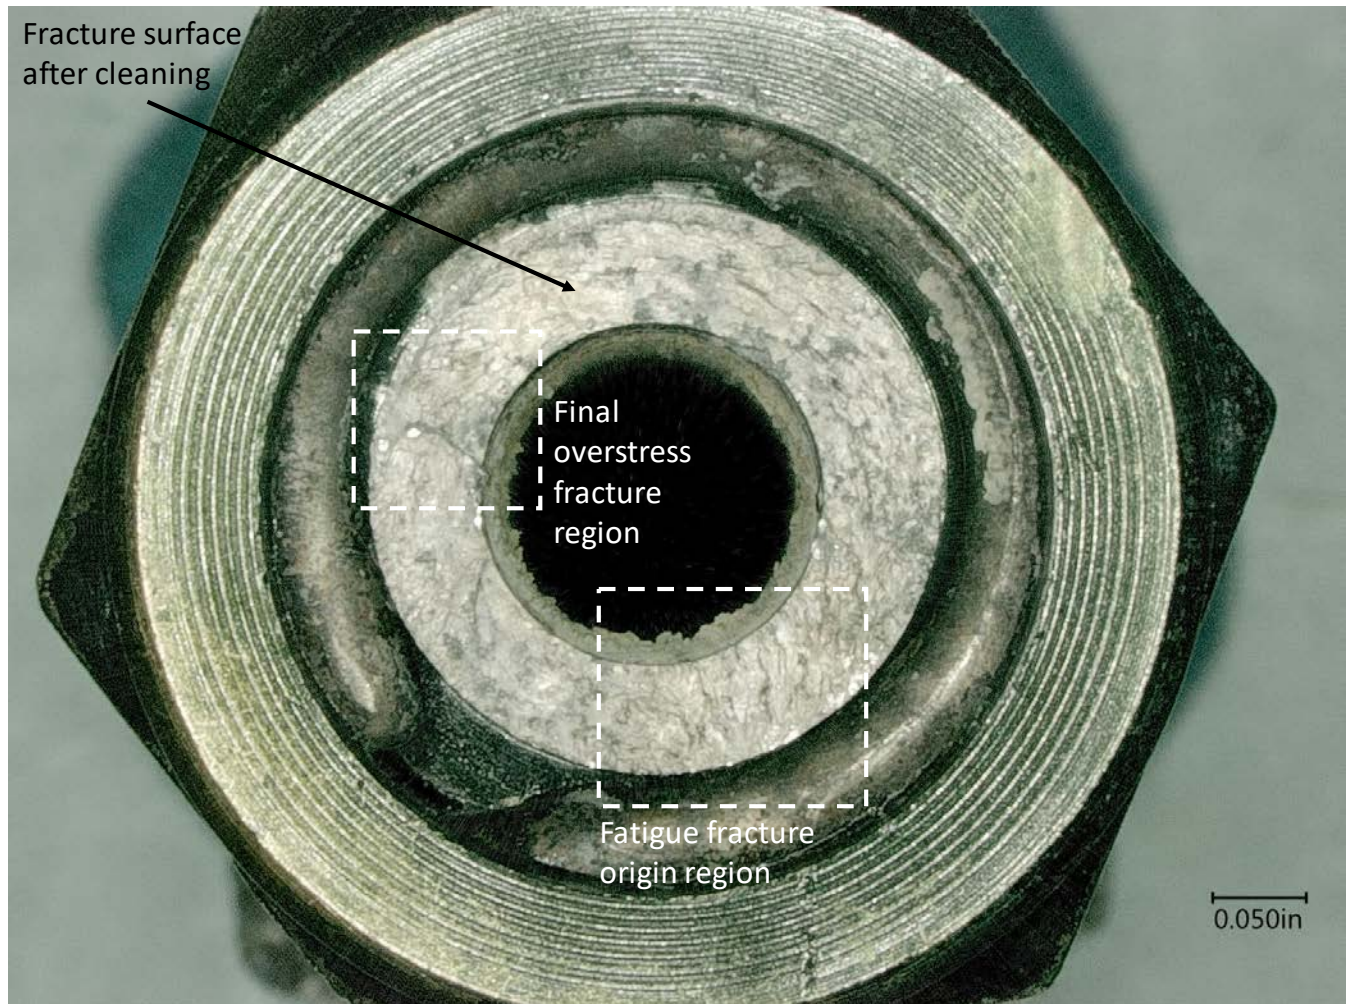
Figure 3 Digital microscope image of the fuel line fracture surface after cleaning. A fracture origin area is identified.

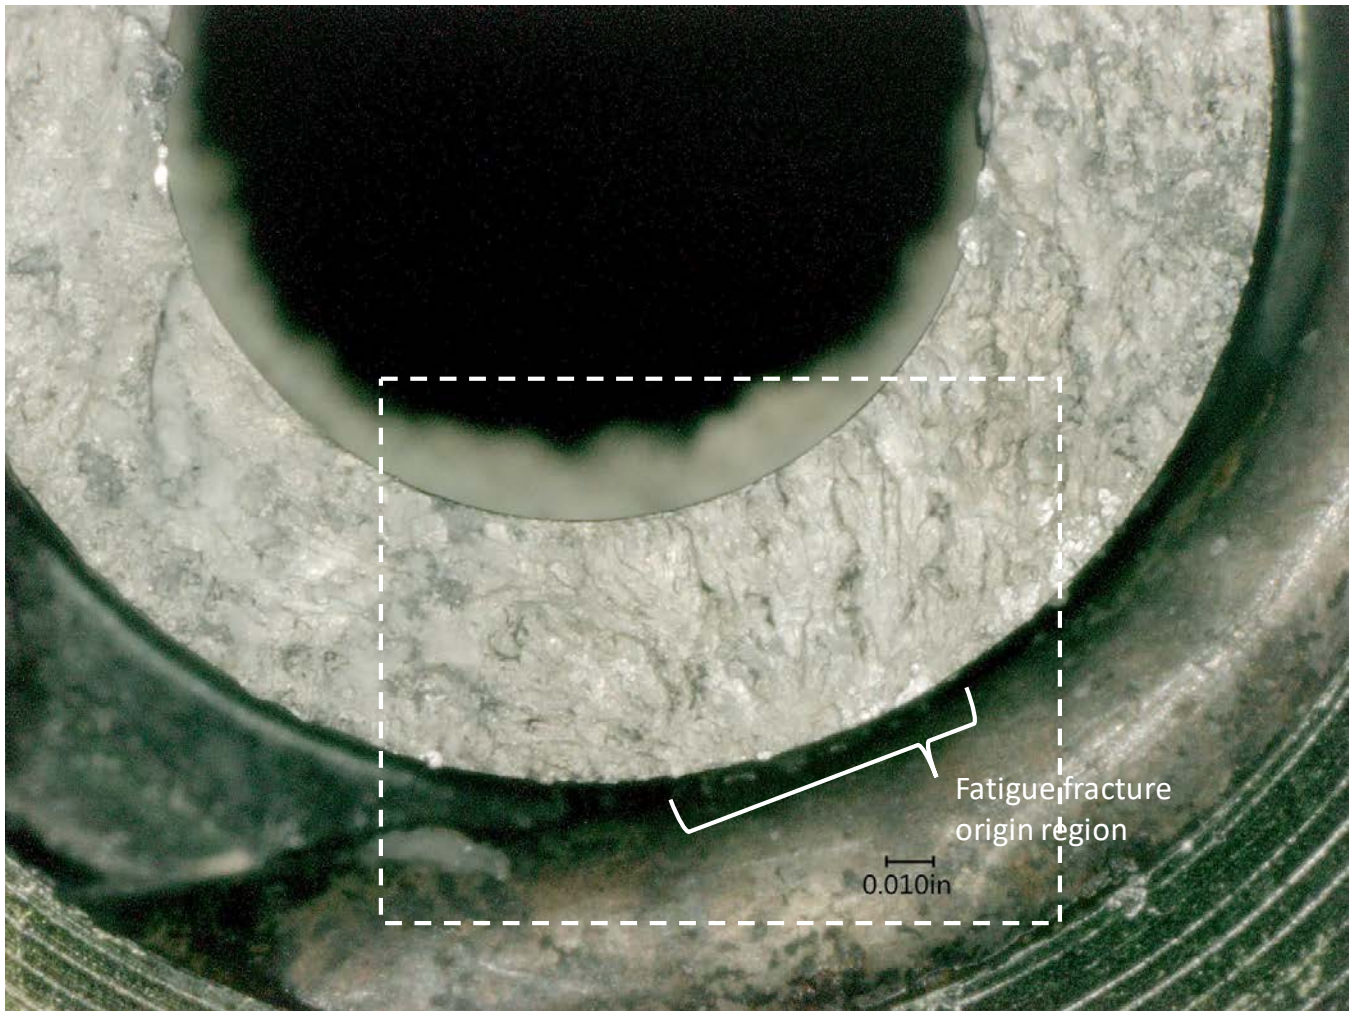
Figure 4 Digital microscope image showing a close view of the origin area identified in Figure 3.

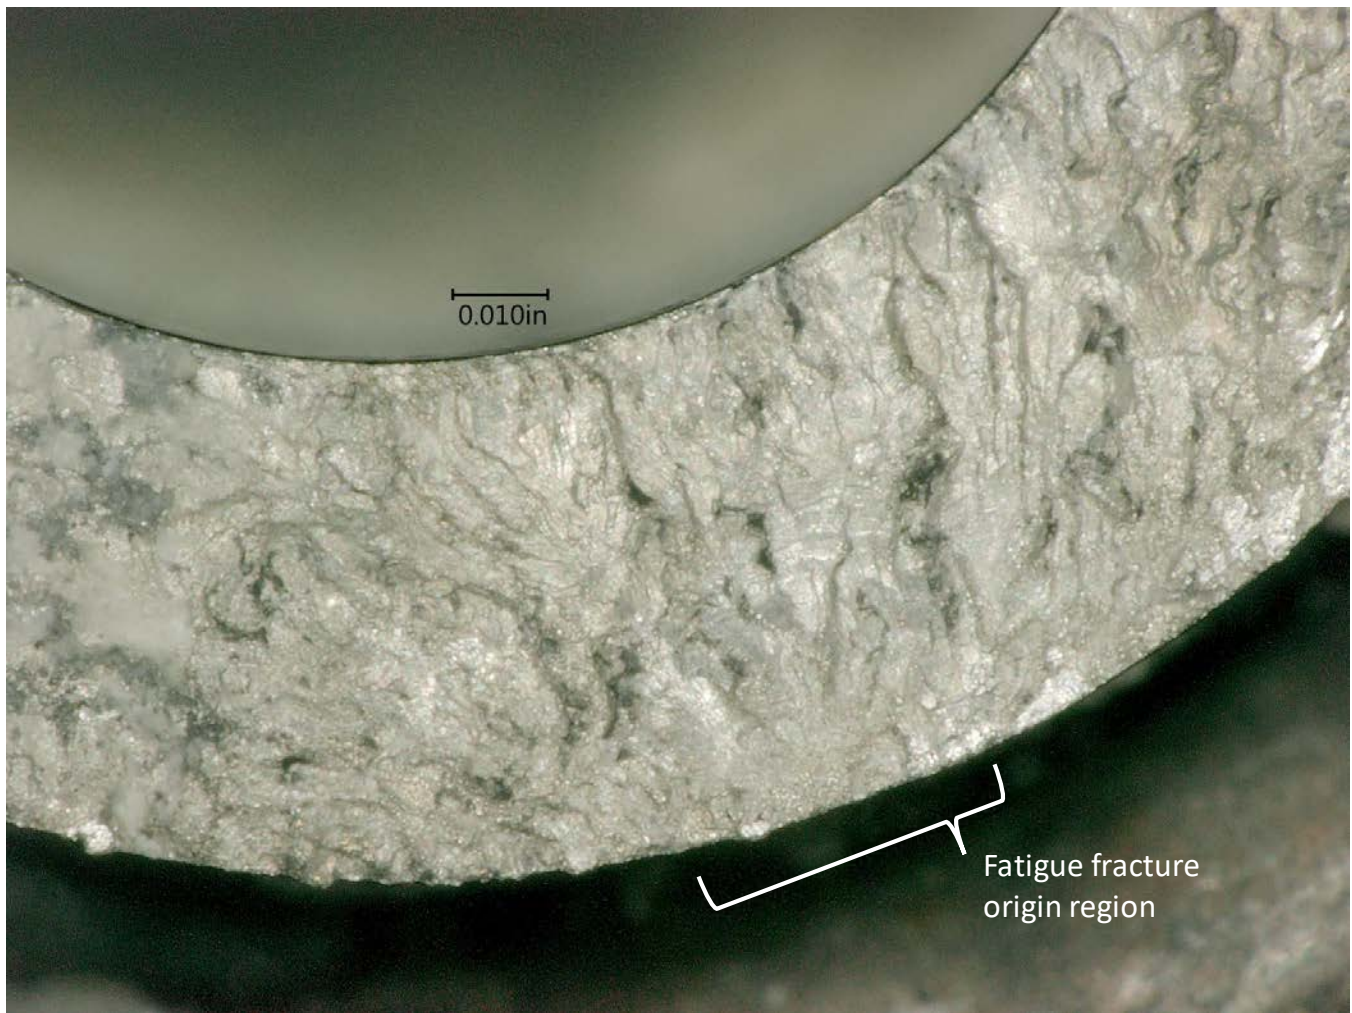
Figure 5 Digital microscope image showing a closer view of the origin area identified in Figure 4.

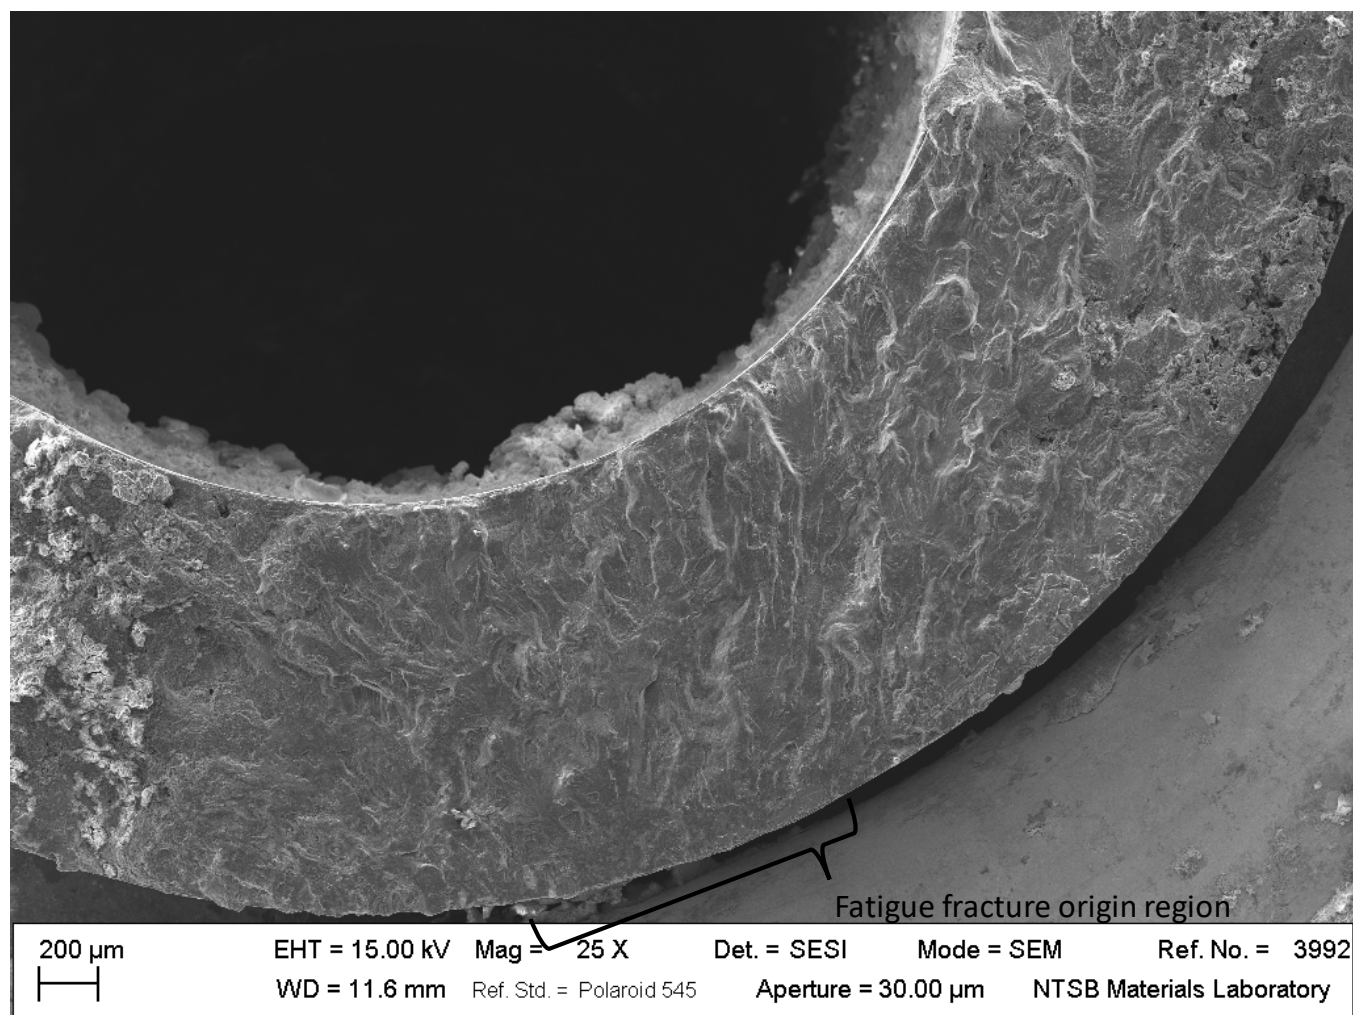
The fracture surface of the fuel line tube within the AN fitting was also analyzed by field emission scanning electron microscope as shown in in Figure 6. Fine fractographic features, such as fatigue crack striations, were not observable at higher magnifications due to the extent of corrosion on the fracture surface. No injurious defects were observed in the region of crack initiation.

Figure 6 Field emission scanning electron microscope image of the fracture origin region as indicated in Figures 3-5.
