## **Lycoming Engines**

Investigation of Fractured Roller Tappet Assembly from Engine TIO-540-AJ1A  
Serial Number L-7625-61E in Support of NTSB Investigation

Report No. LN-18054

### MATERIALS LABORATORY INVESTIGATION REPORT

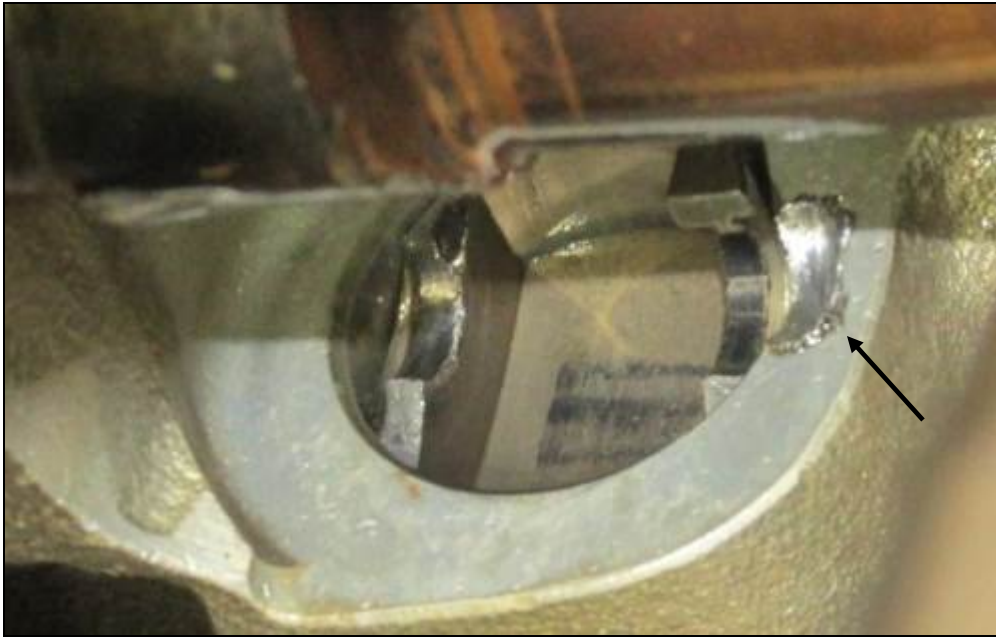
The crankcase, as documented in the teardown report, displayed contact damage in the form of various gouging/contact marks likely from secondary damage following fracture of the roller tappet assembly as debris was moved around the crankcase during continued operation. Shown in Figure 1, the fractured #4 exhaust roller tappet body is visible along with contact damage to the crankcase possibly from the roller and/or the roller shaft. Components of the roller tappet assembly were found and recovered from the sump as shown in Figure 2. Examination in the Materials Lab following initial teardown found additional witness marks, likely from the roller, as shown in Figure 3. The crankcase bore, shown in Figure 4, holding the #4 exhaust roller tappet was found in good condition, with no abnormal scoring or wear. If the roller tappet shaft had shifted laterally during operation while still retained by the body ears, it would be expected to see some scoring on the bore walls. Below the #4 exhaust tappet bore, witness marks were observed on the crankcase from contact with the #4 exhaust roller tappet, as shown in Figure 5, possibly indicating some rocking of the roller tappet inside the crankcase. Dimensional inspection of the crankcase roller tappet bore dimensions which prevent rotation of the roller tappet assembly with respect to the case was performed using go/no-go gages on all six roller tappet bores, which were found conforming.

**Figure 1.** Witness mark in crankcase likely from the roller shaft based on the diameter and position.  
(Photo from SIR image file)

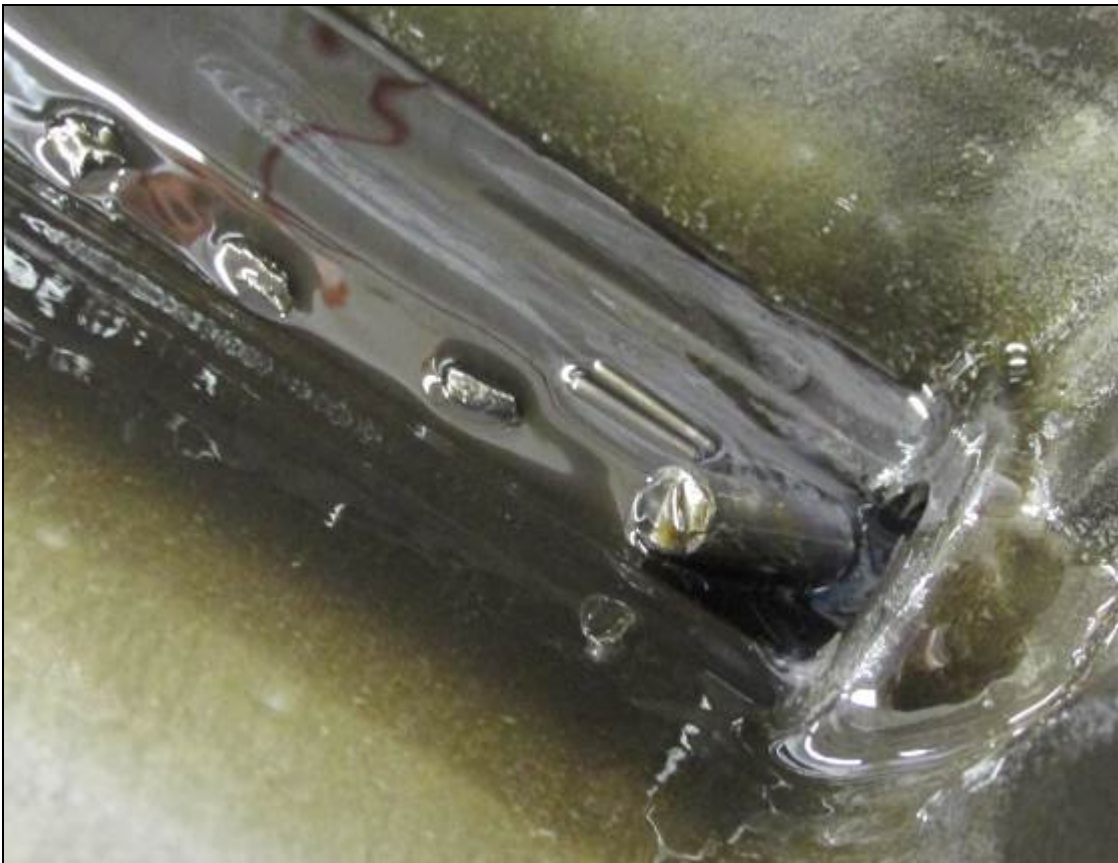
**Figure 2.** Components of the roller tappet were discovered in the sump during teardown. (Photo from SIR image file)

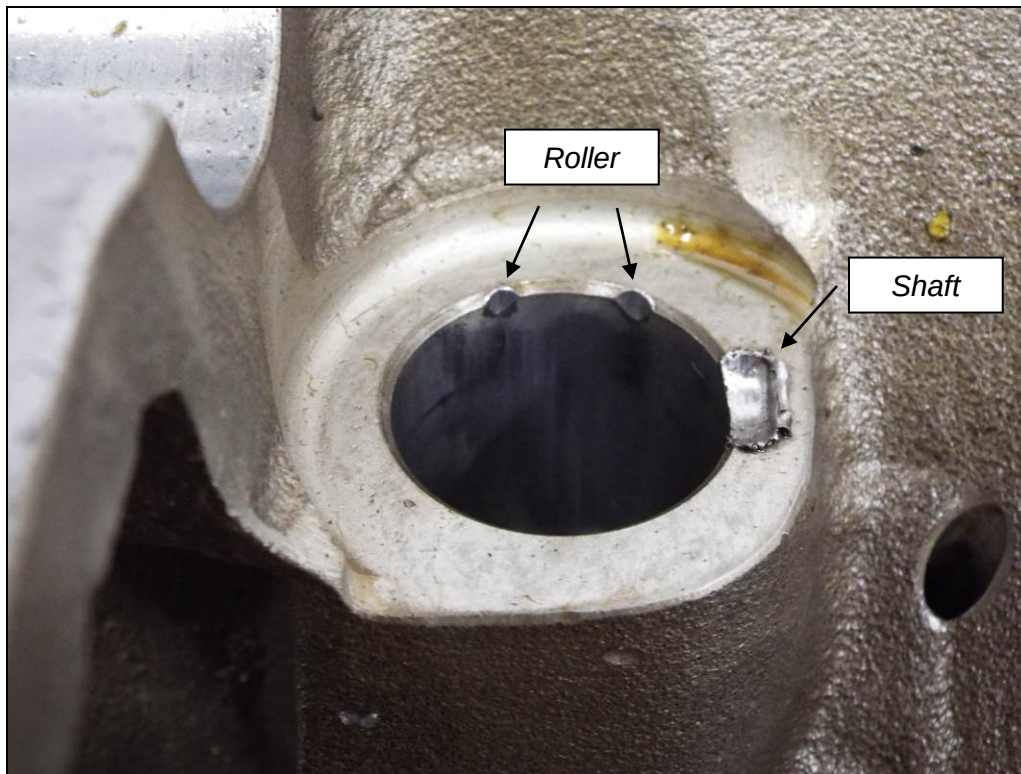
**Figure 3.** Witness marks likely from the tappet roller and shaft.

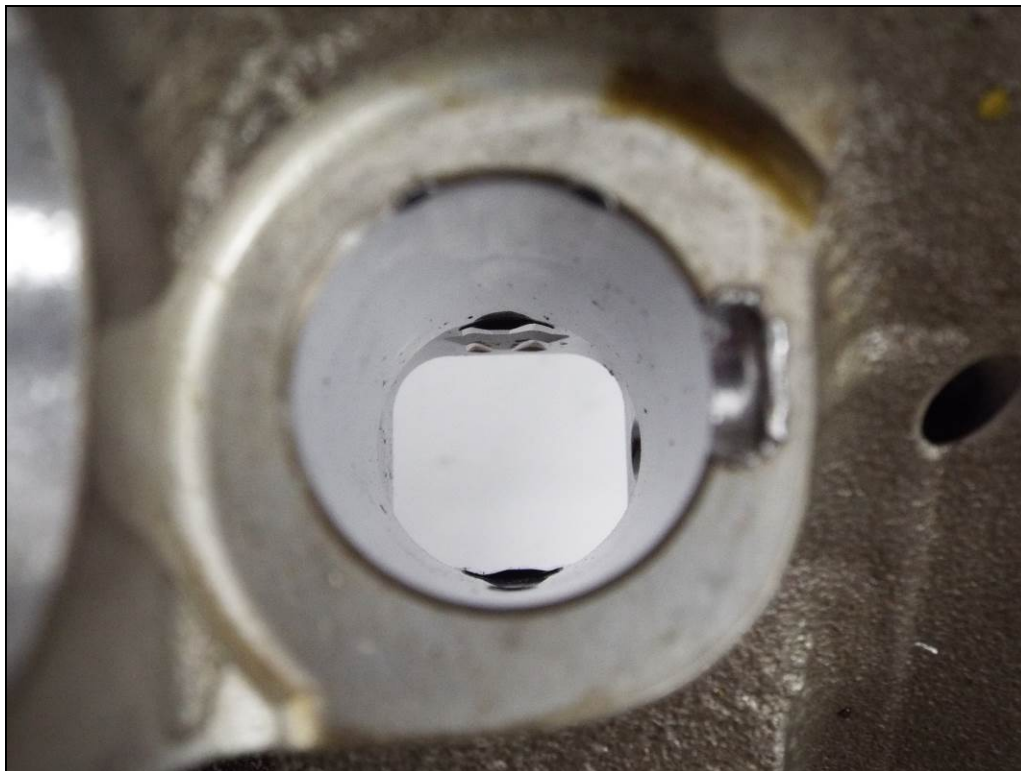
**Figure 4.** Crankcase tappet bore of #4 exhaust roller tappet, viewed from inside of case, with no abnormal wear.

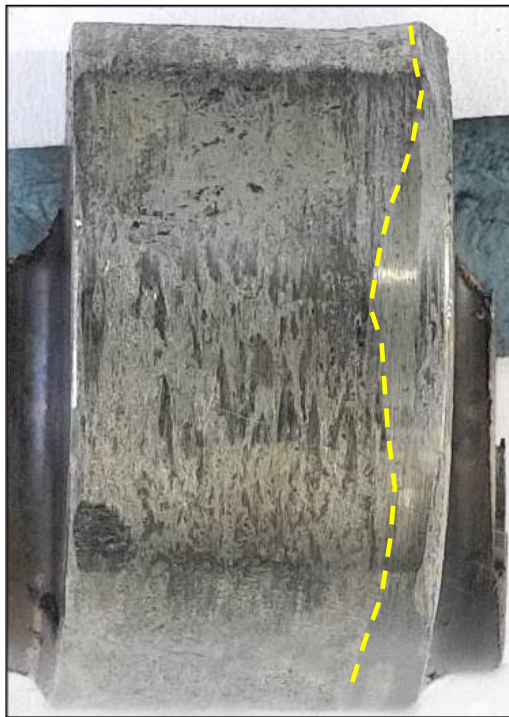
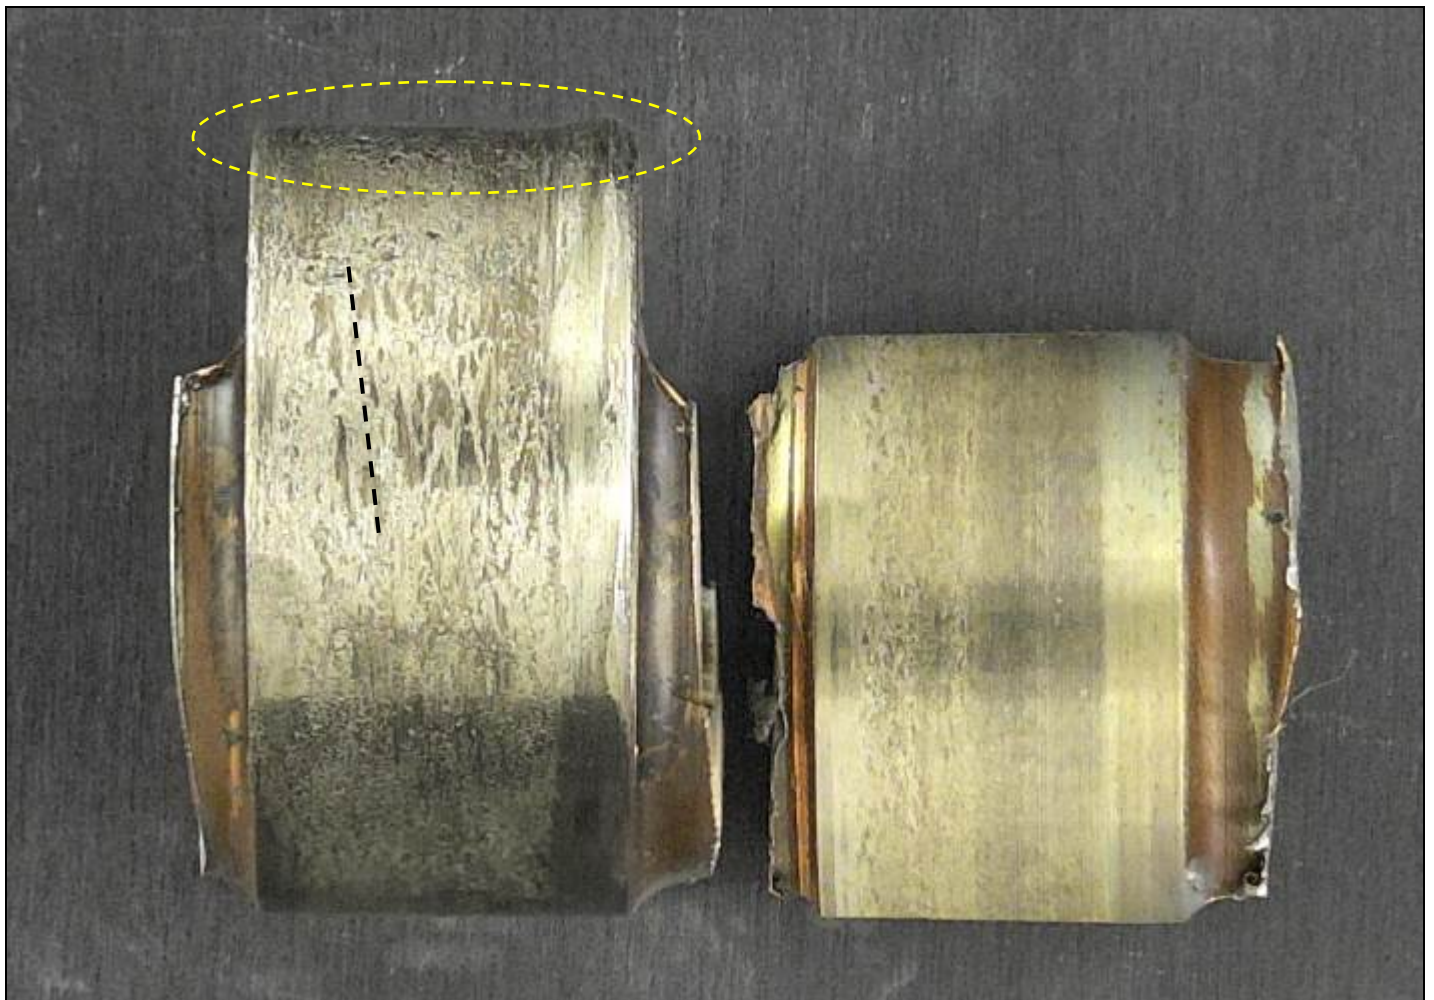
The camshaft displayed severe wear on the #4 exhaust lobe, as shown in Figures 6-7. The #4 exhaust lobe exhibit signs of galling and spalling. Minor damage was observed along the length of the camshaft, appearing as secondary contact marks as material contacted the camshaft during continued operation. The #5 exhaust lobe, shown in Figure 8, also showed some wear damage but was much less severe than the #4 exhaust lobe. The case hardness, case depth, core hardness, and microstructure of the camshaft were conforming. Measurement results of the camshaft are provided in Table 1-2.

**Figure 6.** (Top) Wavy wear pattern on the damaged #4 exhaust cam lobe shown after sectioning. (Bottom Left) Severely damaged region of #4 exhaust lobe. (Bottom Right) Less damaged backside of #4 exhaust lobe.

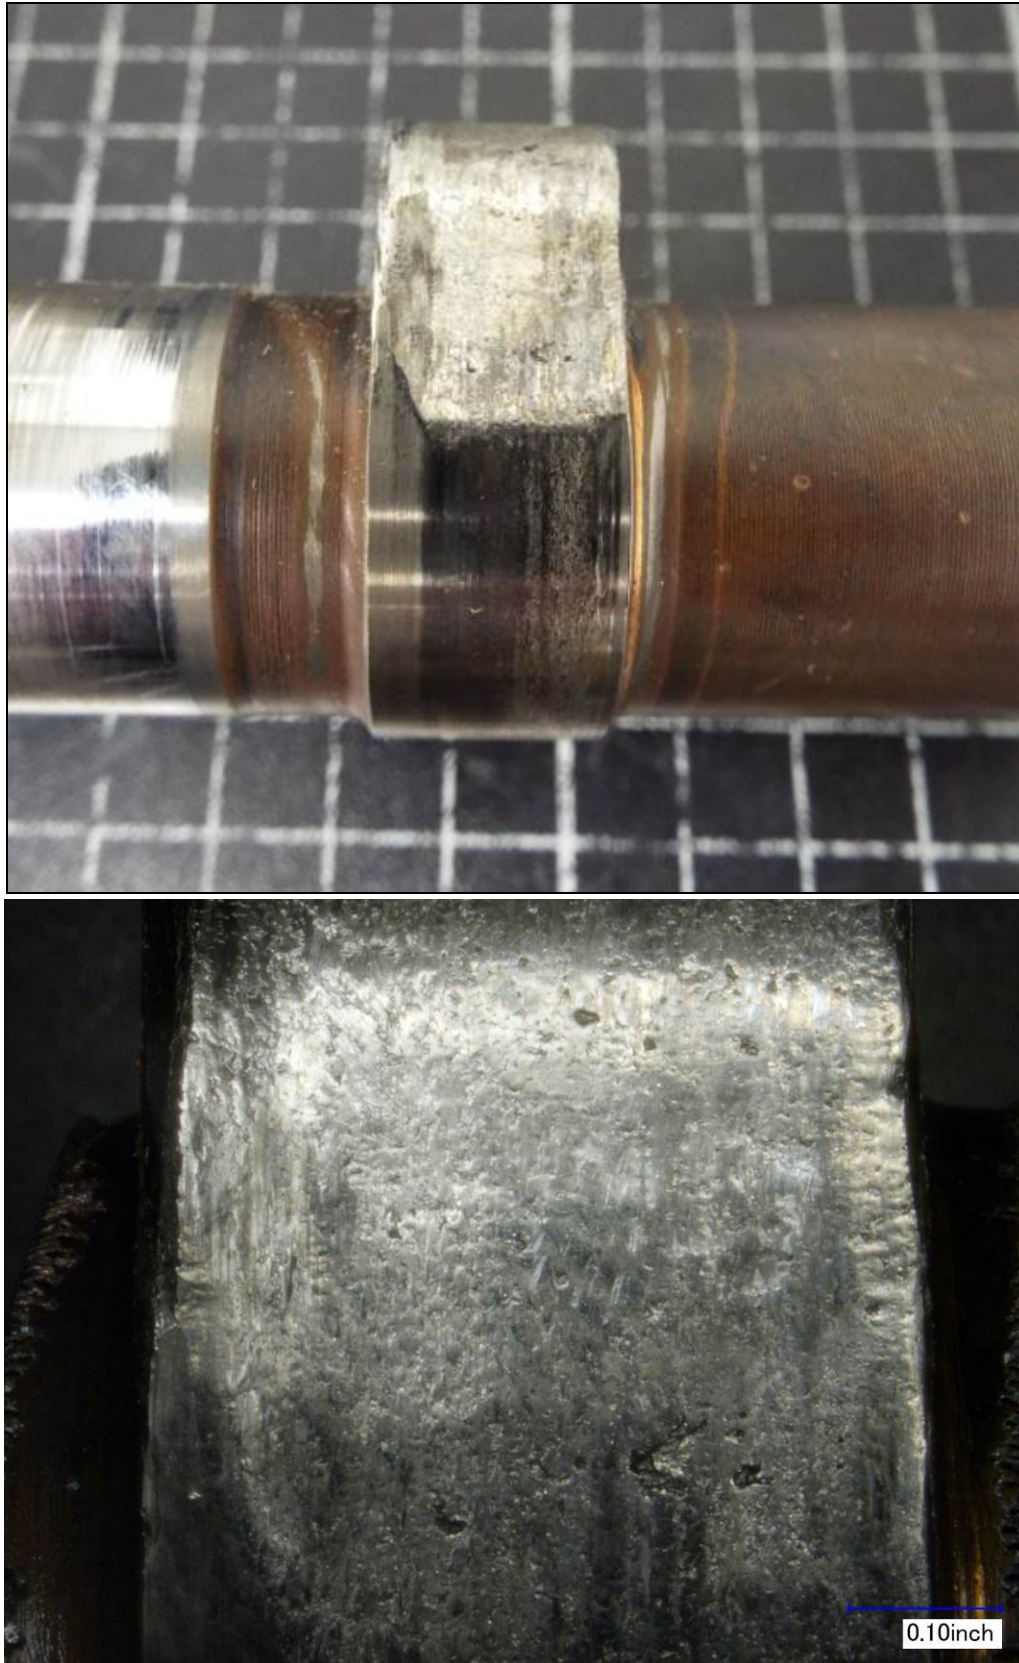
**Figure 7.** Severely damaged #4 exhaust lobe.

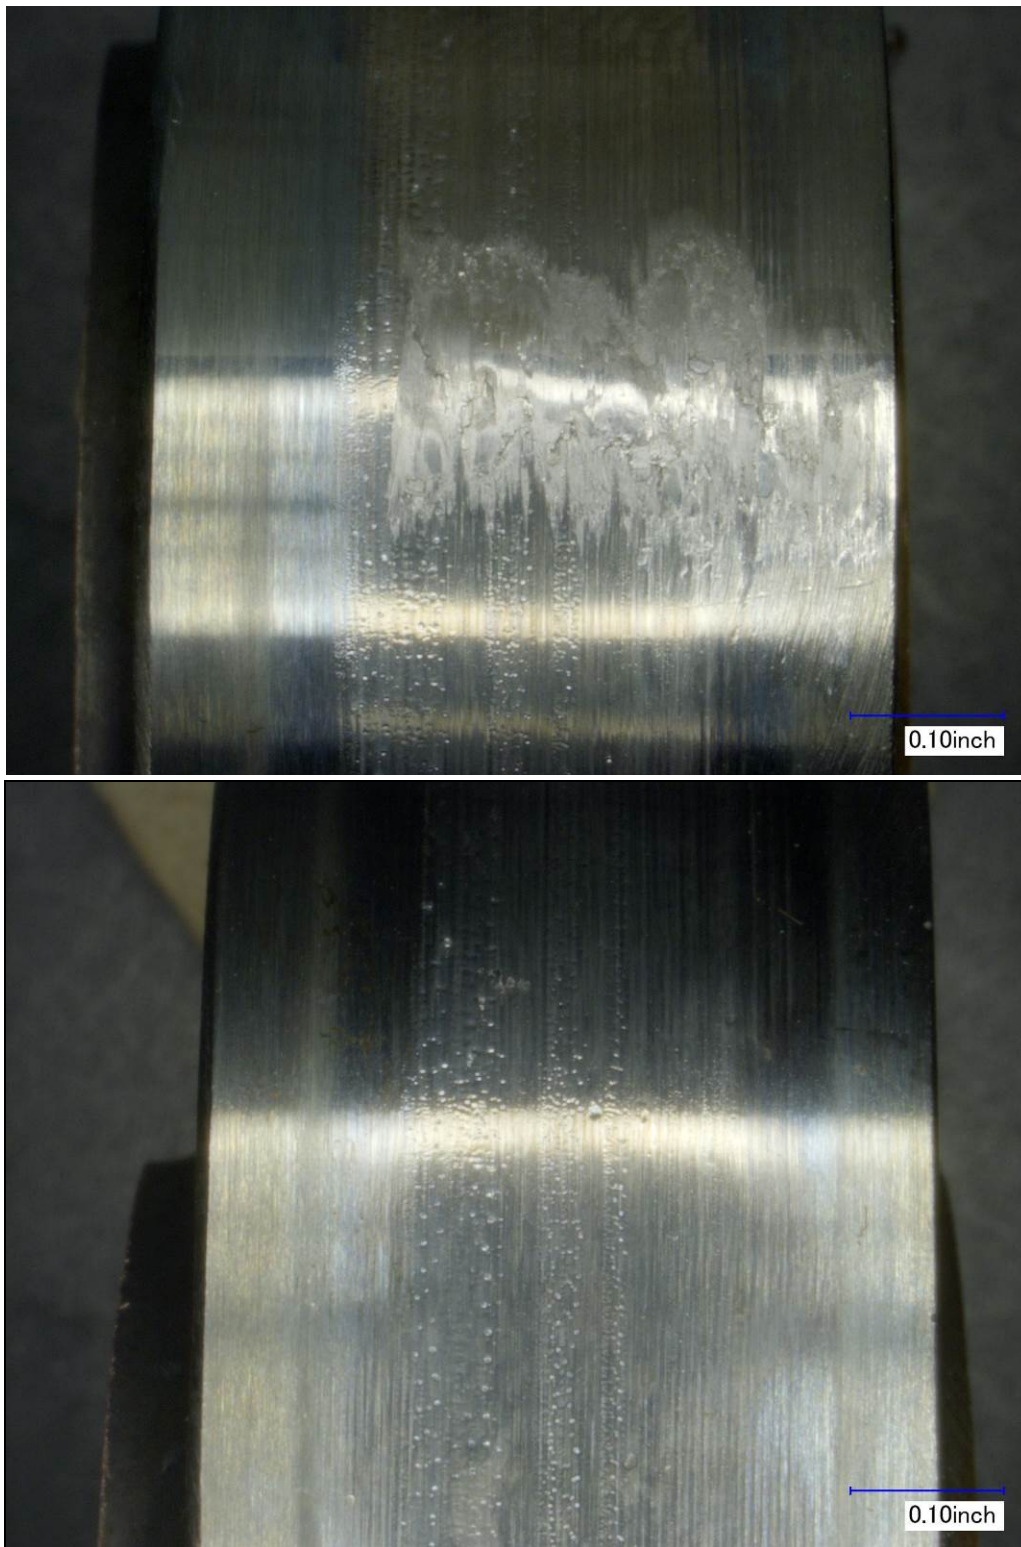
**Figure 8.** #5 Exhaust Lobe of Camshaft with Slight Damage.

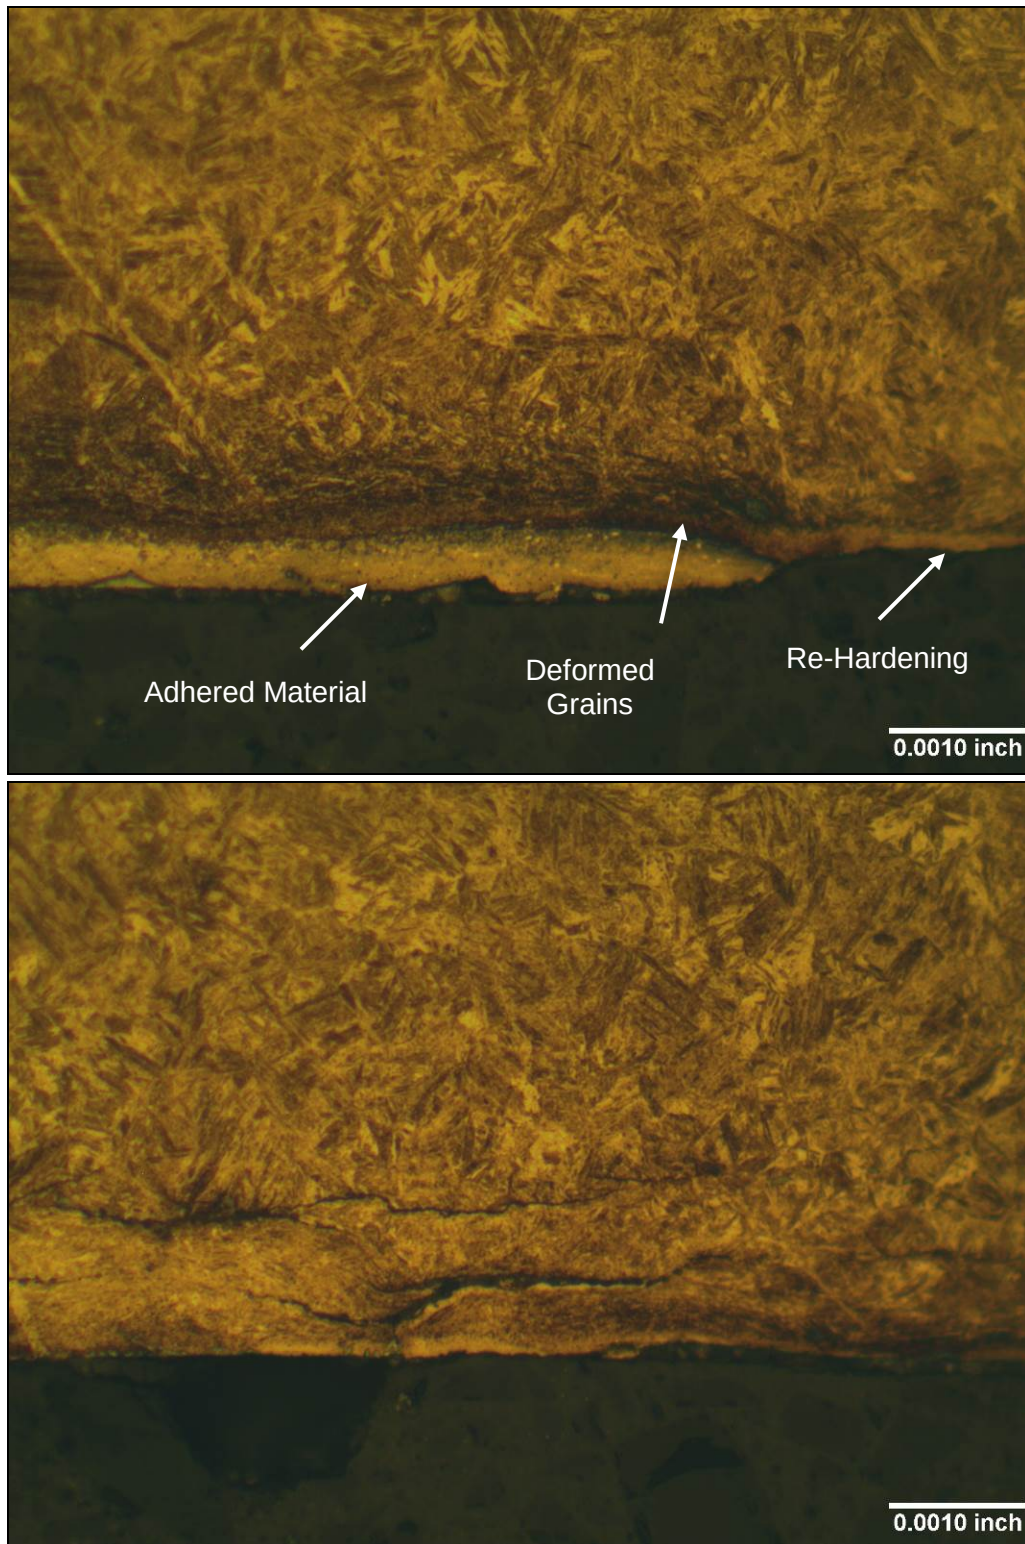
Cross sections of the #4 and #5 exhaust cam lobes were prepared for metallographic evaluation. Shown in Figure 9-10, the severely damaged #4 exhaust cam lobe exhibited re-hardening from the frictional heating, adhered material (likely from the roller based on the Nital etched microstructure), deformed grains due to surface damage, and cracks at the near surface. The #5 exhaust cam lobe, shown in Figure 11, exhibited a conforming case and core microstructure.

**Figure 9.** #4 Exhaust Lobe Severely Damaged Region, Nital etched. (Top) Deformed near surface grains, re-hardening, and adhered material. (Bottom) Cracking along the near surface.

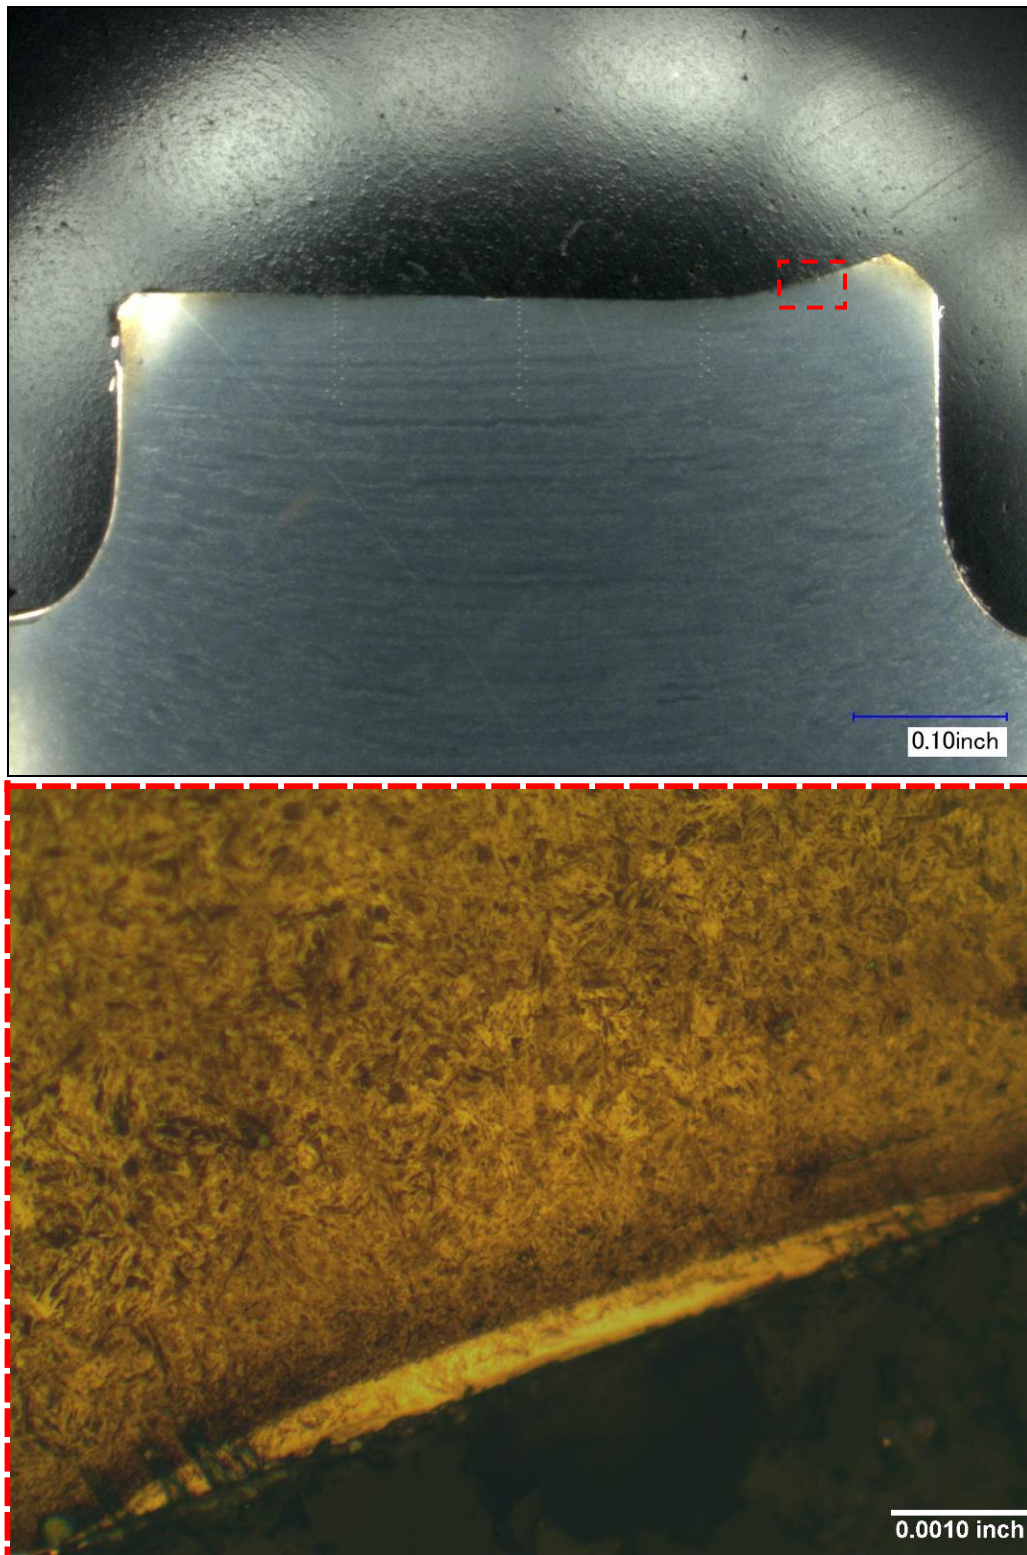
**Figure 10.** (Top) #4 Exhaust Lobe Severely Damaged Region, Nital etched, showing the amount of deformation and wear on the cam lobe. (Bottom) Re-hardening zone from frictional heating.

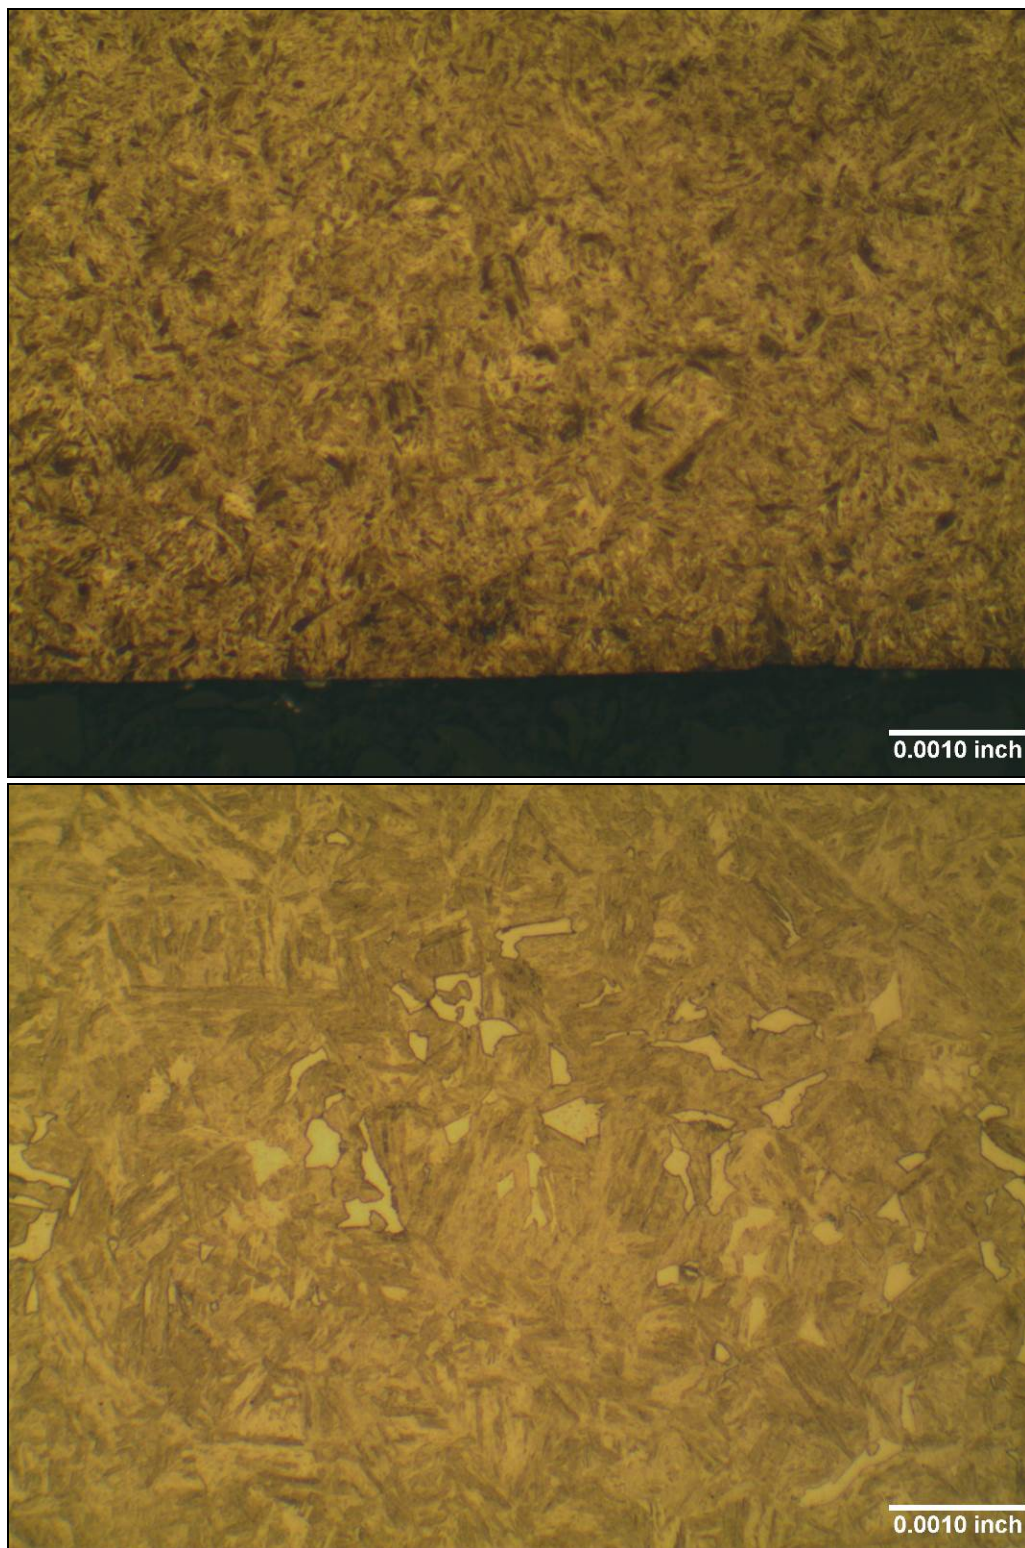
**Figure 11.** (*Top*) Case of tempered martensite and (*Bottom*) Core of tempered martensite and ferrite of #5 Exhaust Cam Lobe

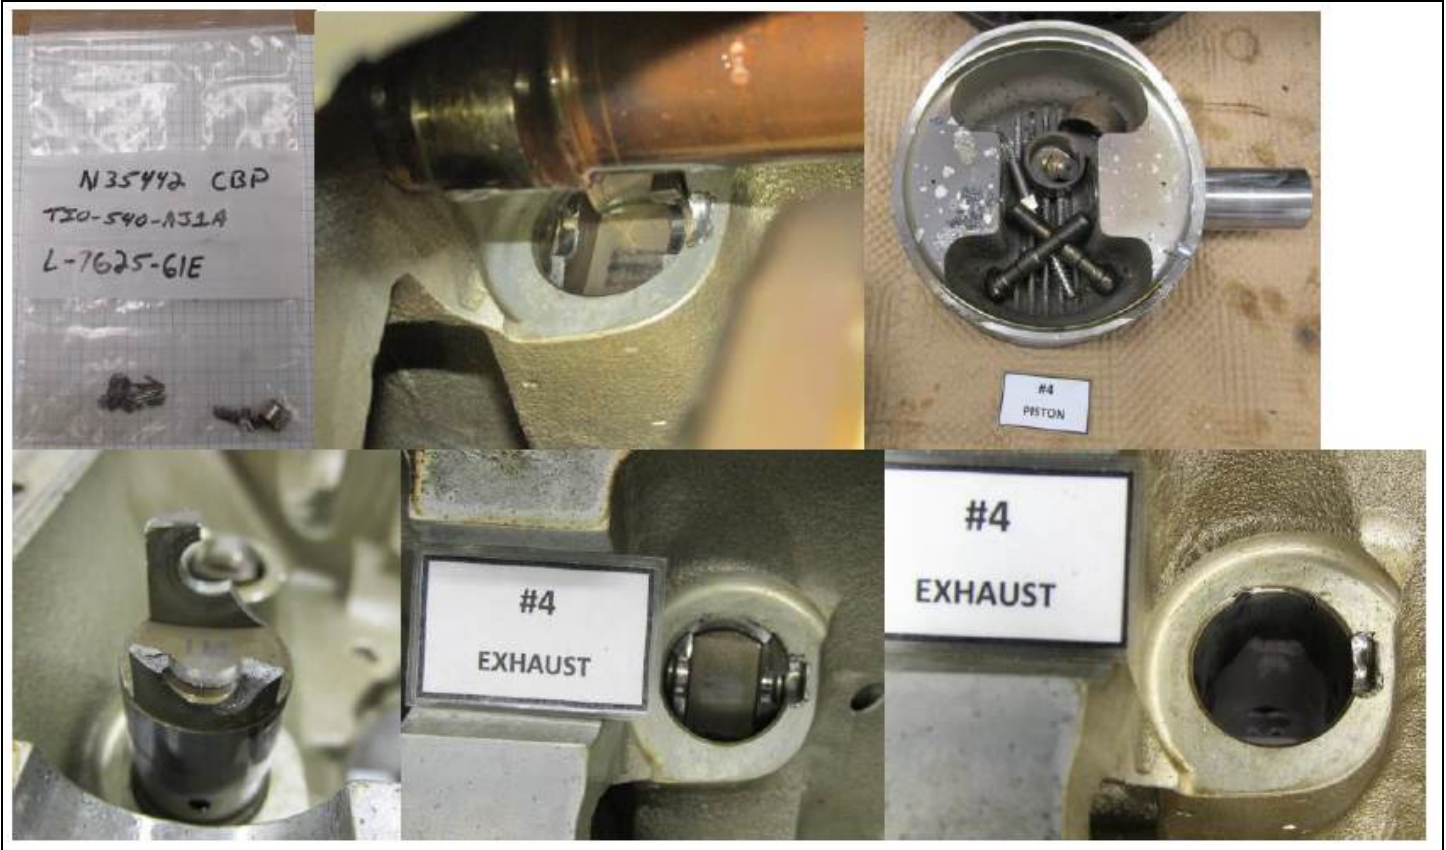
Shown in Figure 12, the #4 exhaust roller tappet was found to be fractured with the roller, needle bearings, and shaft no longer retained by the tappet body. Both ears of the roller body which retain the shaft were fractured. The other 11 roller tappet assemblies were found in overall good condition. Both sides of the shaft were staked on the remaining 11 shafts of the roller tappet assemblies.

**Figure 12.** Fracture #4 Exhaust Roller Tappet documented during SIR Teardown.  
(Photo from SIR image file)

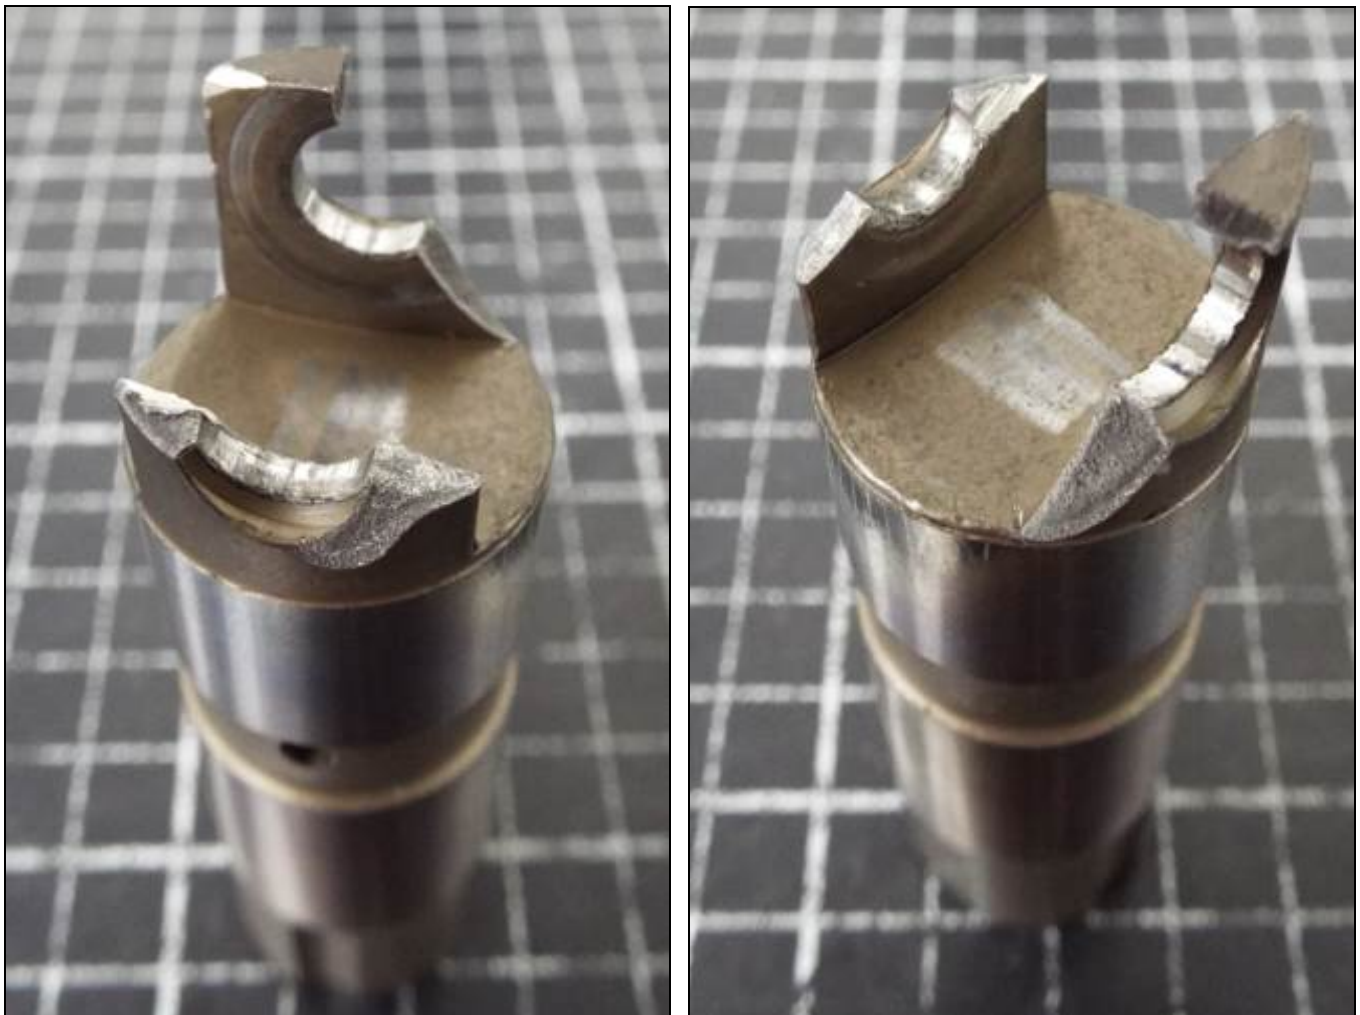
The roller body was found to have both ears fractured, shown in Figure 13. The roller body ear fracture surfaces were examined using stereomicroscopy, digital microscopy, and scanning electron microscopy (SEM). Spalling of the case was observed around the shaft bores on the body along with witness marks from the roller and needle bearings on the inside of the body ears, shown in Figure 14-15. The witness marks from the roller appeared deeper on one ear compared to the other. The microstructure was predominately tempered martensite in the case region of the body ear, but also showed grain deformation on the bore surface, spalled grains at the edge of the ear towards the roller, retained austenite in the case, and a coarse grain structure, as shown in Figure 16. The retained austenite and coarse grain structure are observations only and are not a nonconformance. In Figures 17-19, SEM images show the spalling at the shaft bore edges of the body. The bore surface also showed some plastic deformations on the surface, also visible in Figure 17. The core regions generally exhibited ductile tearing as shown in Figure 20. Figure 21 shows a region of fatigue on one of the body ear fragment fracture surfaces.

**Figure 13.** Macro photos of the fractured #4 exhaust roller tappet assembly.

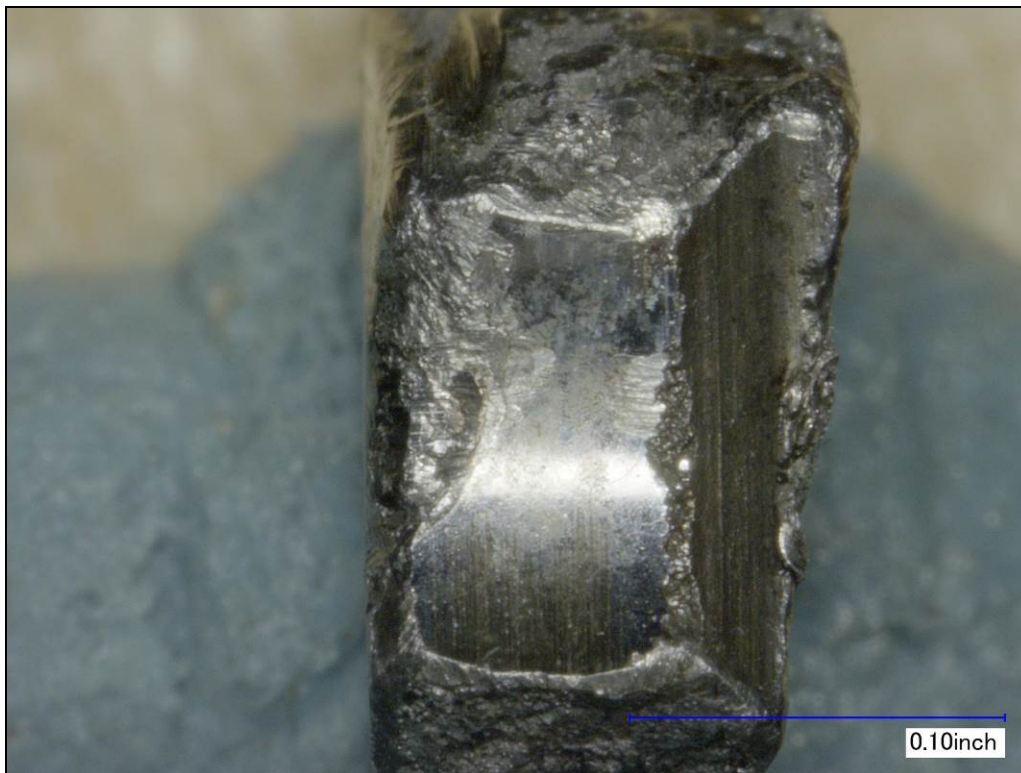
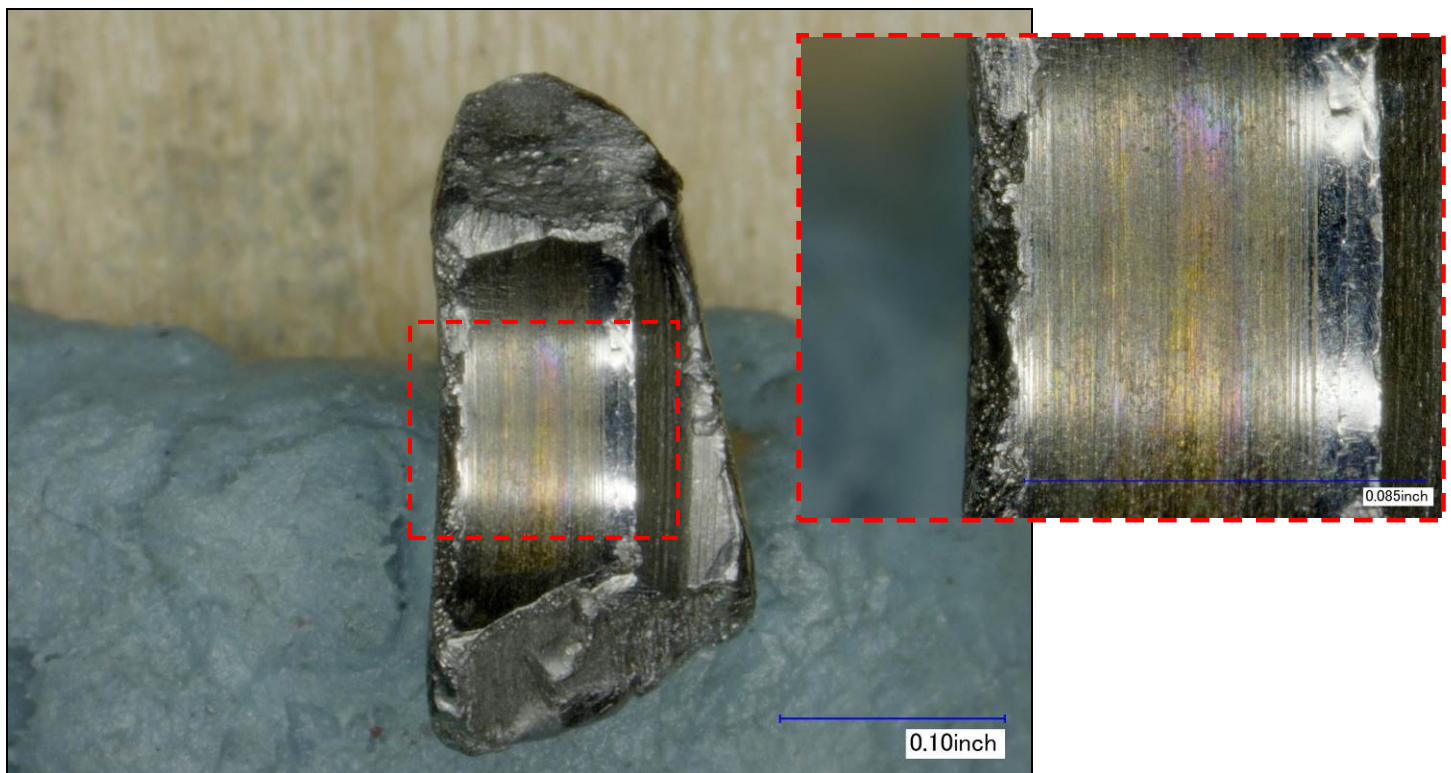
**Figure 14.** Roller body shaft bore with spalling at bore edges.

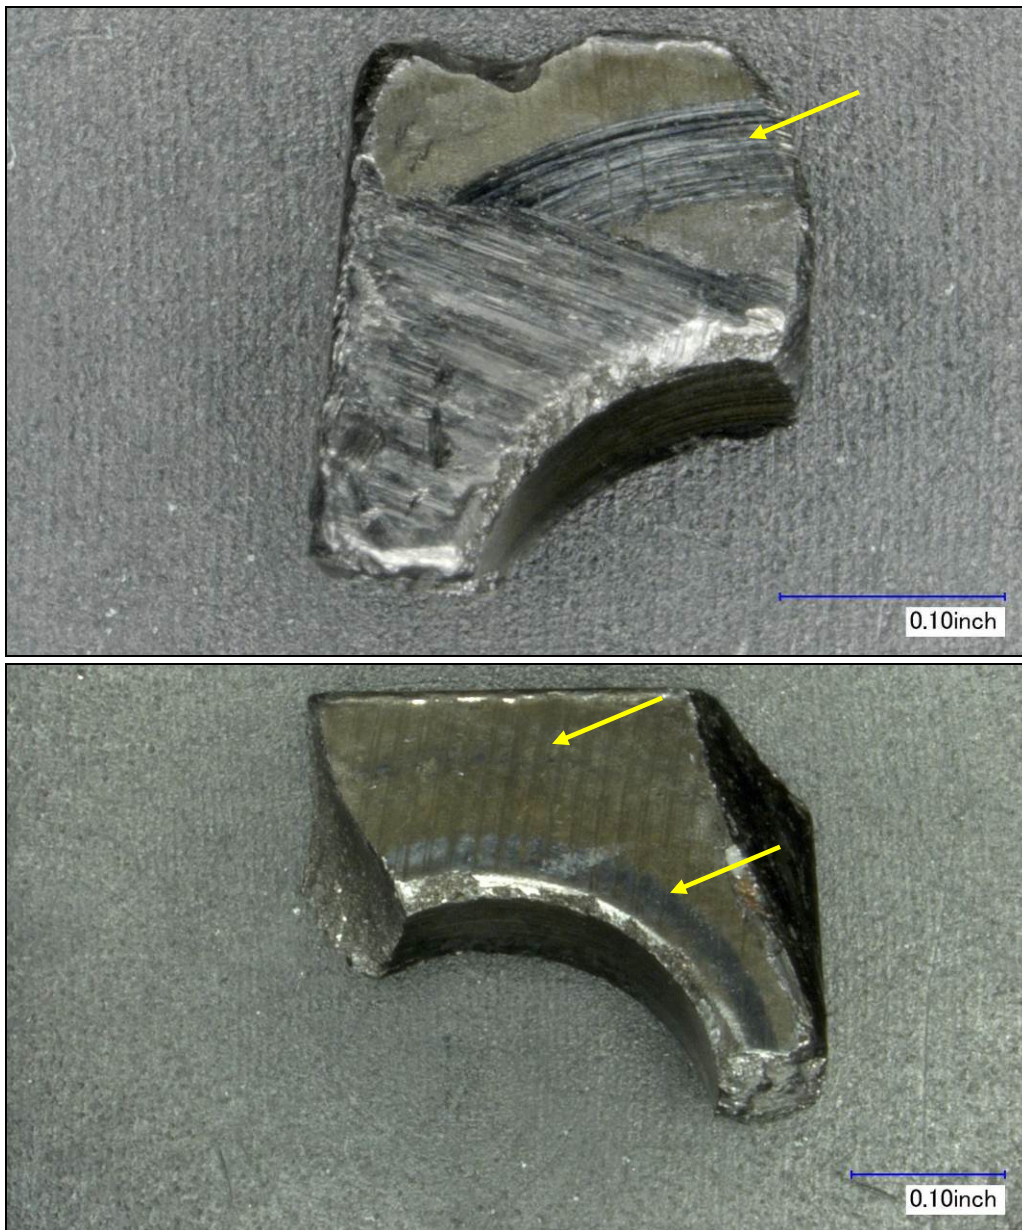
**Figure 15.** Witness marks from the roller and needle bearings.

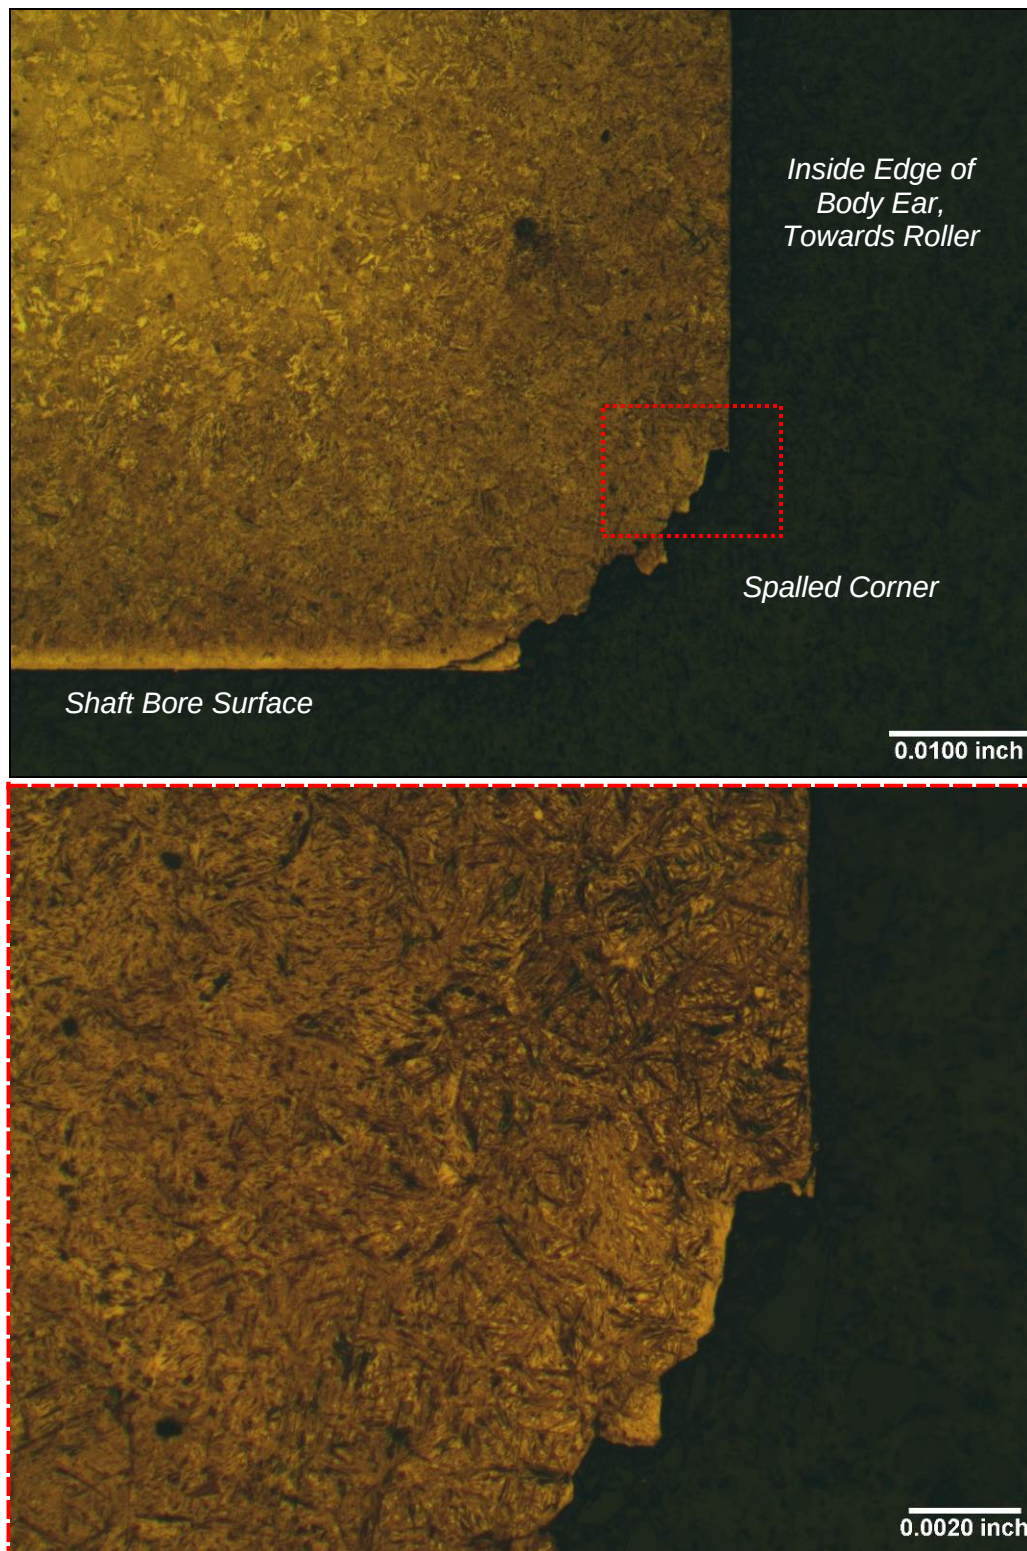
**Figure 16.** Microstructure of roller body ear showing grain deformation at the bore surface, retained austenite, and coarse grain size.

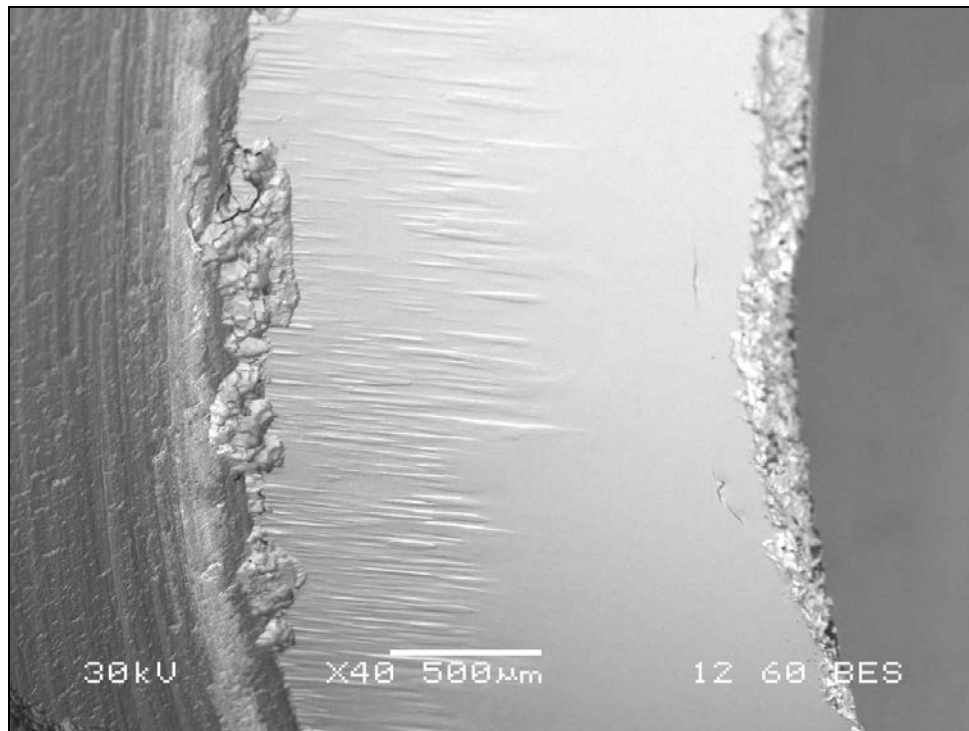
**Figure 17.** SEM image in backscatter mode showing spalling at the edges of the body in contact with the shaft. Also visible are on the bore surface are plastic deformations.
