## **Lycoming Engines**

Investigation of Fractured Roller Tappet Assembly from Engine TIO-540-AJ1A  
Serial Number L-7625-61E in Support of NTSB Investigation

Report No. LN-18054

### MATERIALS LABORATORY INVESTIGATION REPORT

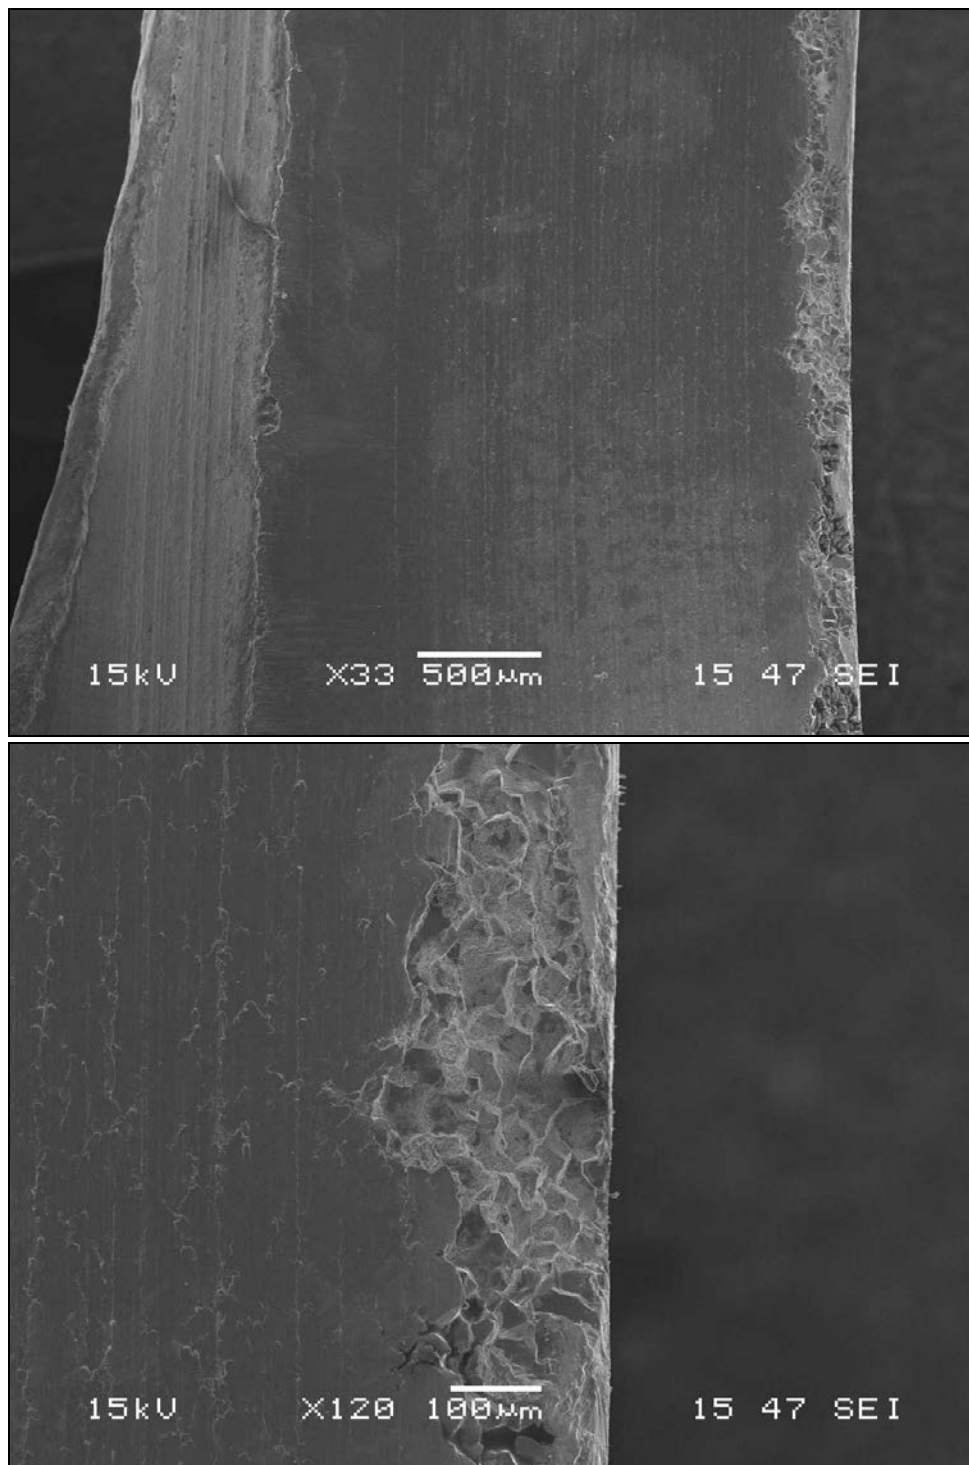
**Figure 18.** (Top) Inside diameter of shaft bore of body. (Bottom) Higher magnification showing spalling at inside edge of shaft ear (side towards roller and needle bearings).

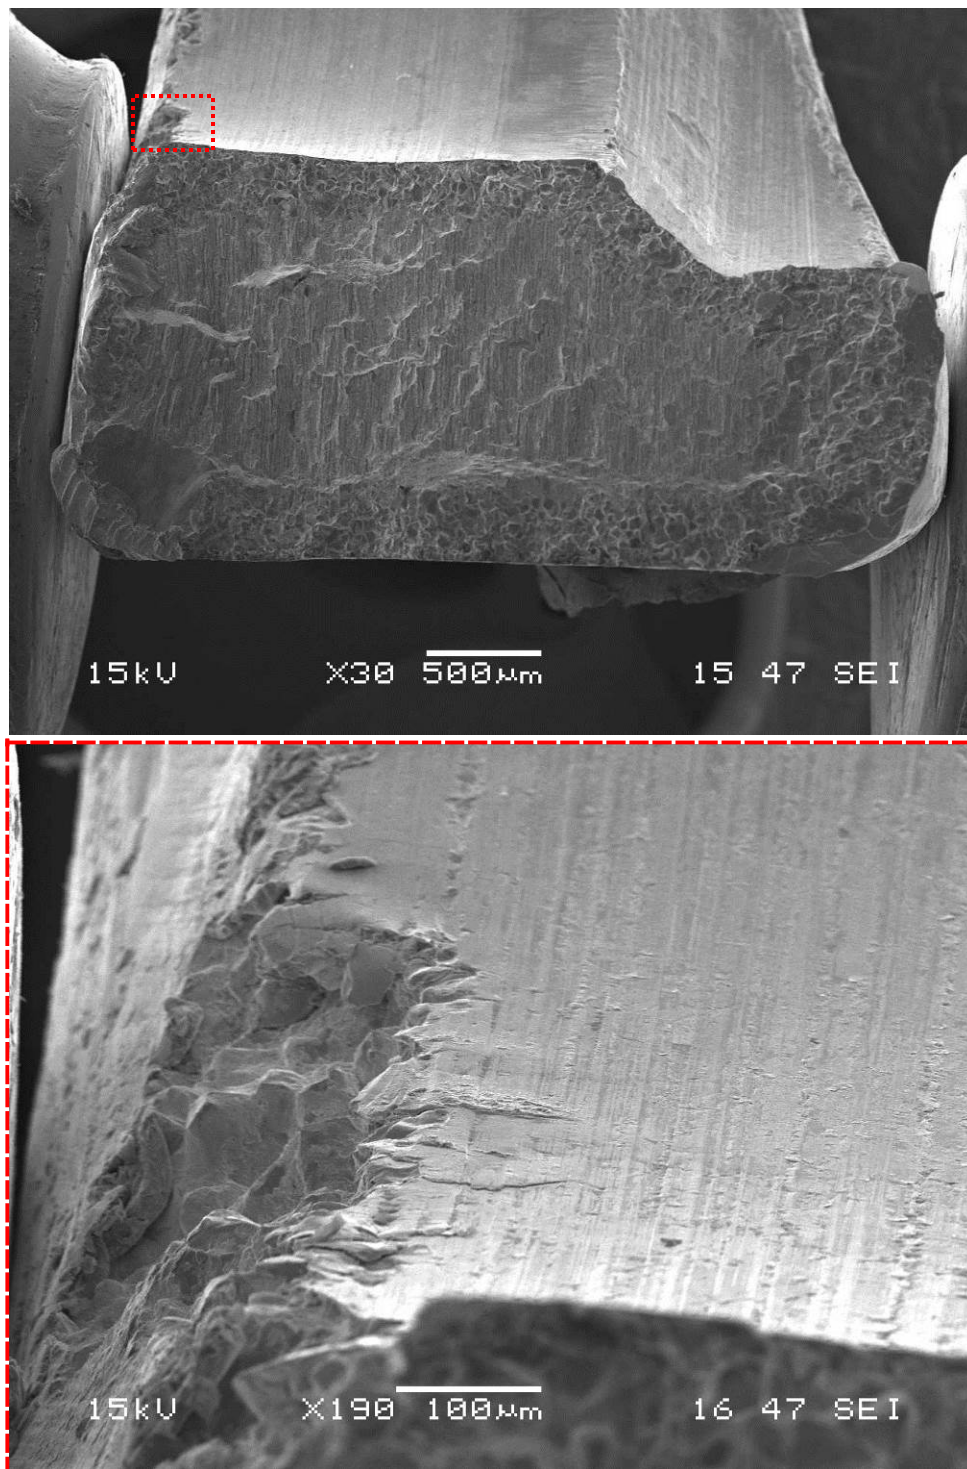
**Figure 19.** (Top) Roller body ear fracture surface. (Bottom) Spalled inside edge towards the roller side of the body ear.

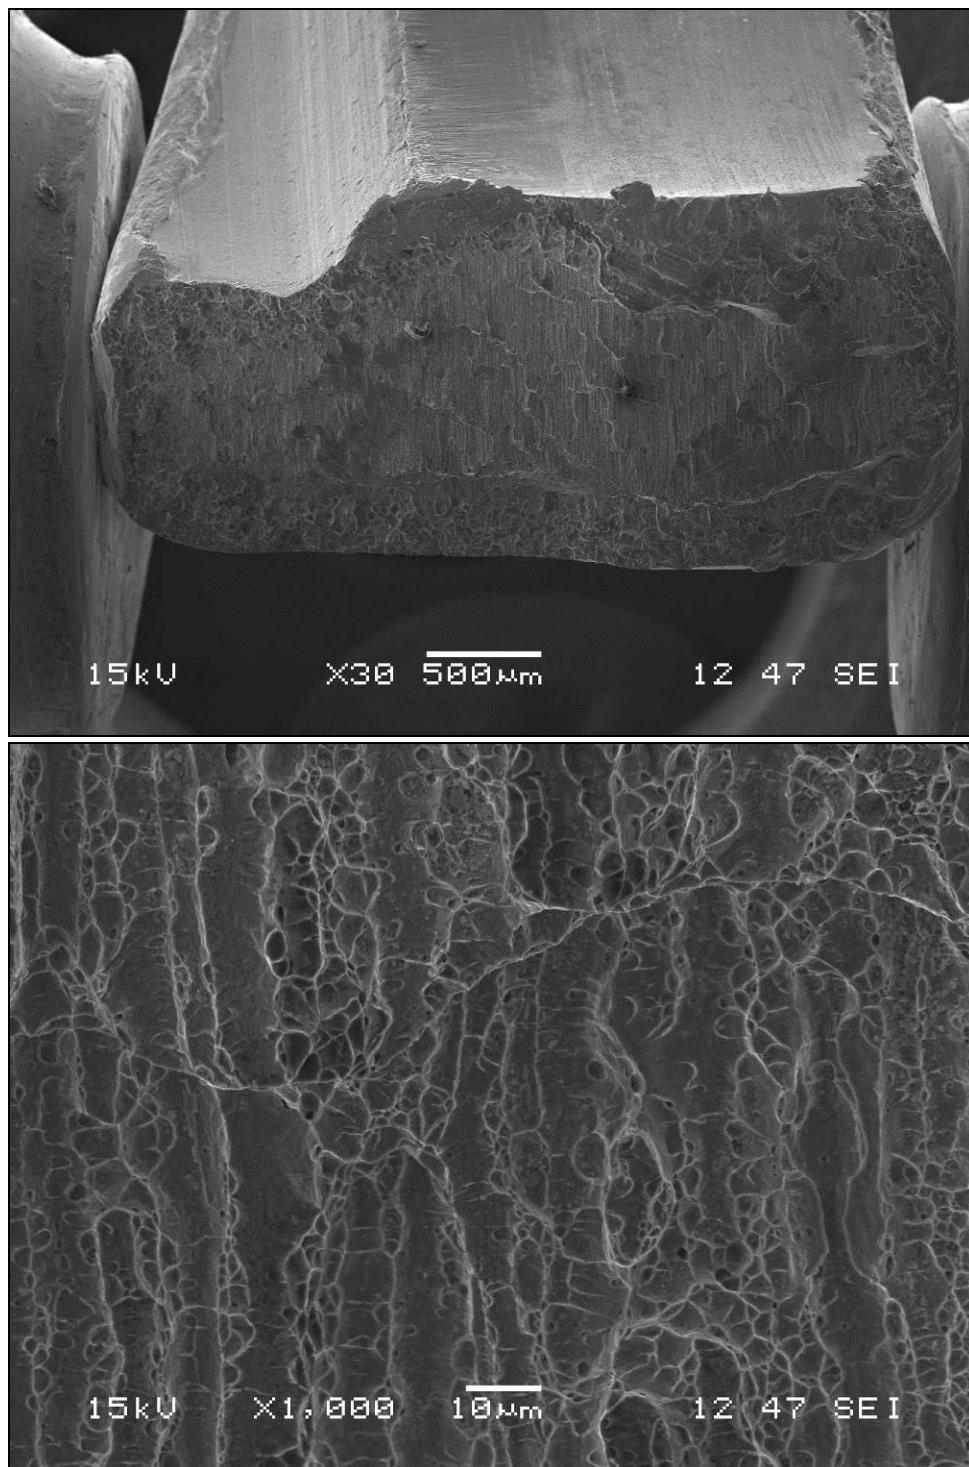
**Figure 20.** (Top) Brittle fracture within the case of the roller body shaft ear and ductile tearing through the core region (Bottom).

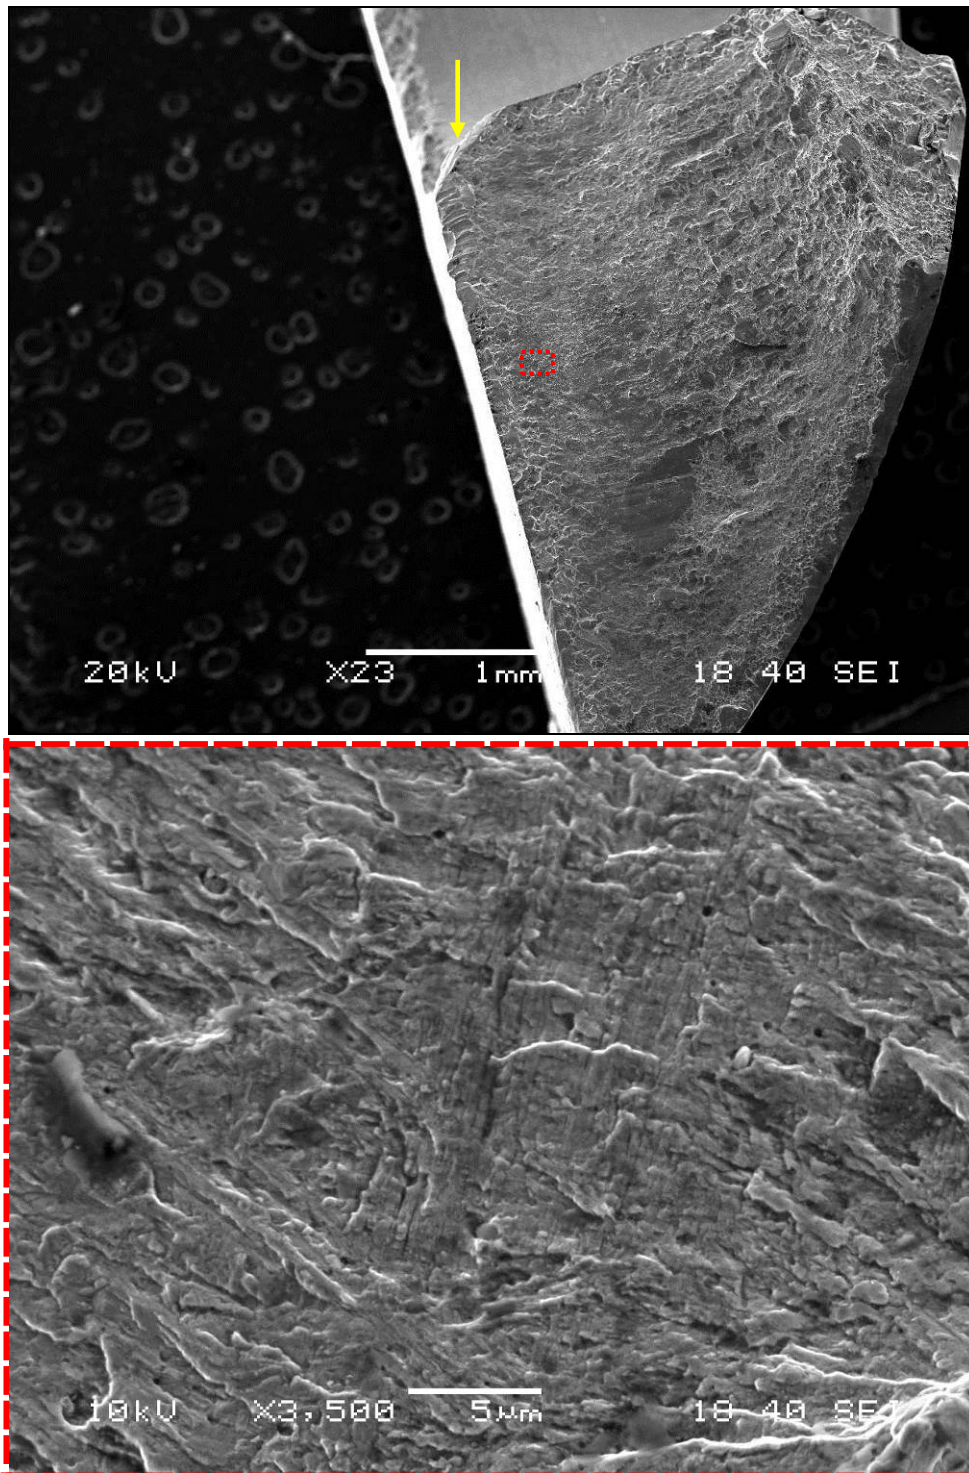
**Figure 21.** One of the roller body shaft ear fracture surfaces showed signs of fatigue, with faint fatigue striations. The yellow arrow indicates the likely fatigue crack origin near the inside corner of the bore.

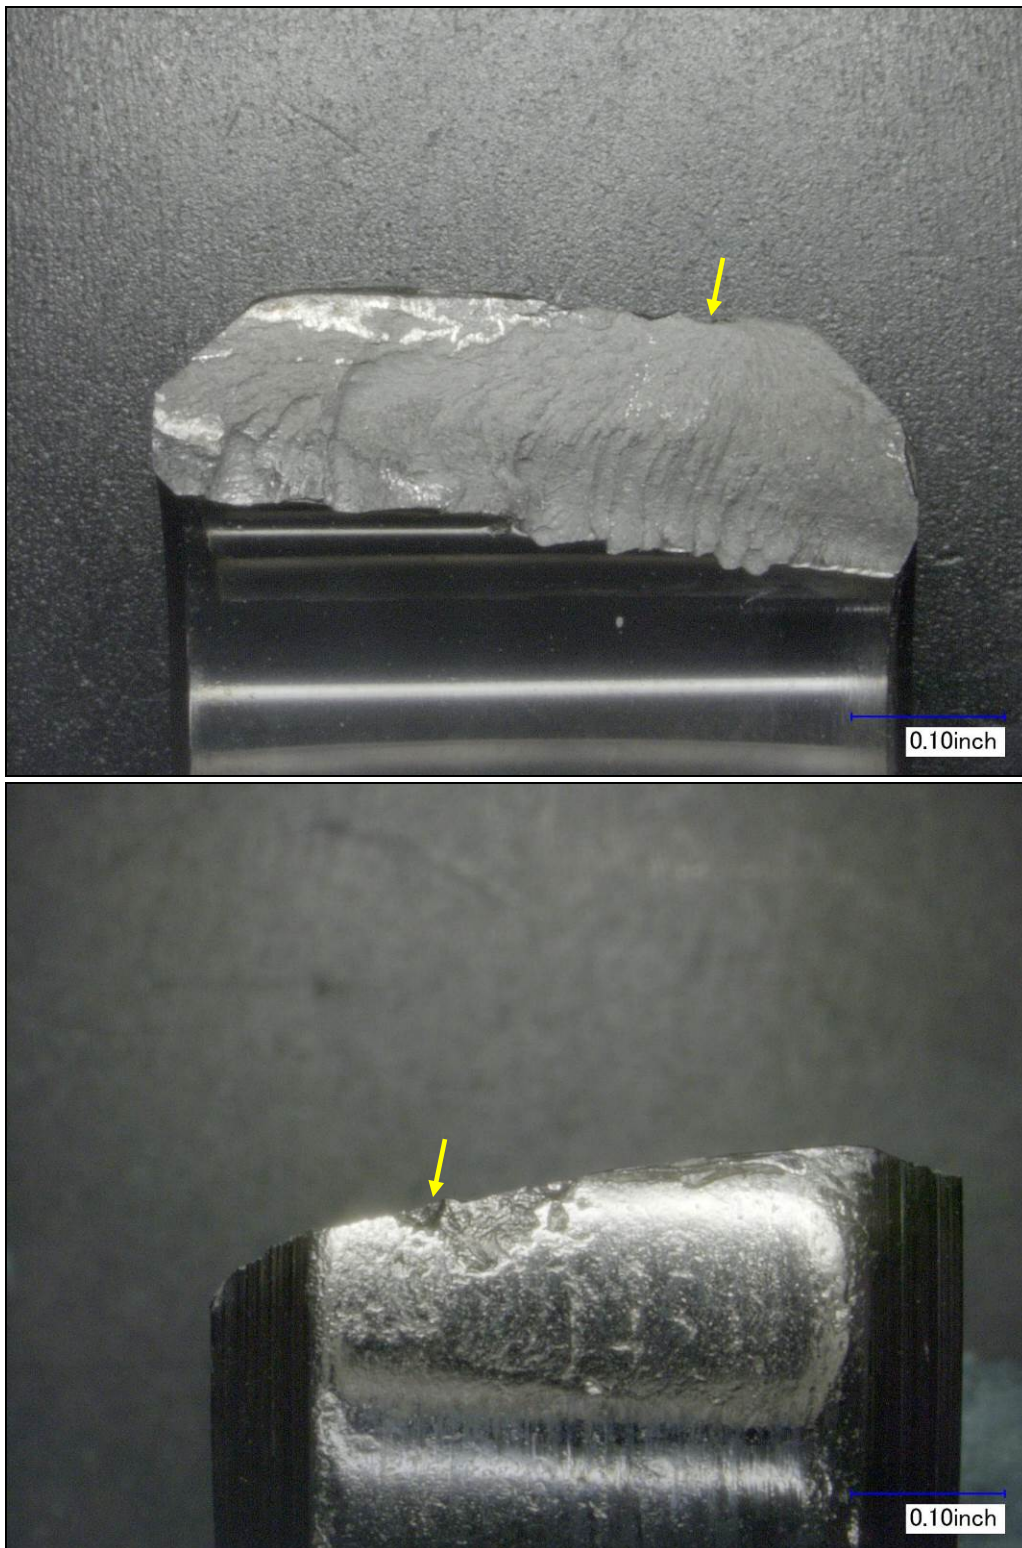
The roller had separated into multiple fragments, showing evidence of brittle fracture originating at the outside diameter in a severely spalled region, shown in Figure 22. Another fragment of the roller showed evidence of fracture origin at the inside diameter, as shown in Figure 23. The roller displayed signs of significant wear and spalling on the OD, consistent with the severe wear observed on the corresponding camshaft lobe. Some areas of the ID were in good condition, as visible in Figure 22, but other regions were galled and/or spalled, shown in Figure 23 and 24.

**Figure 22.** (Top) Fracture surface of roller with possible origin at the outside diameter denoted by the yellow arrow. The inside diameter of this roller segment is in good condition. (Bottom) Outside diameter of the same region had signs of severe spalling.

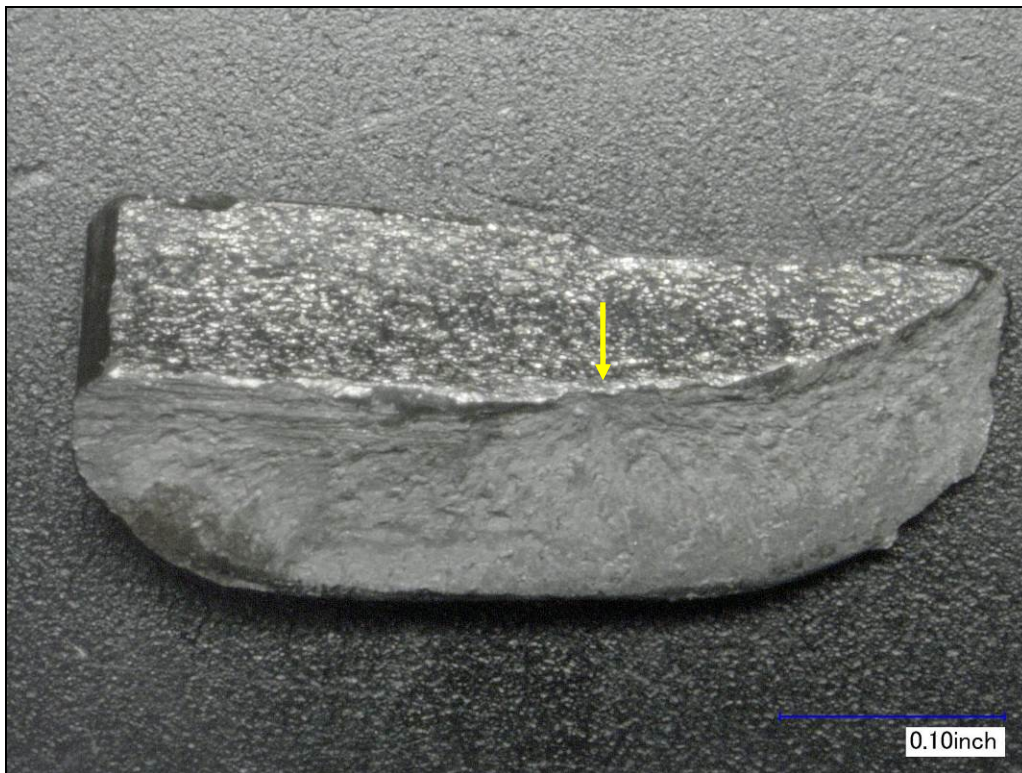
**Figure 23.** Roller ID with a fracture origin at the ID denoted by the yellow arrow.

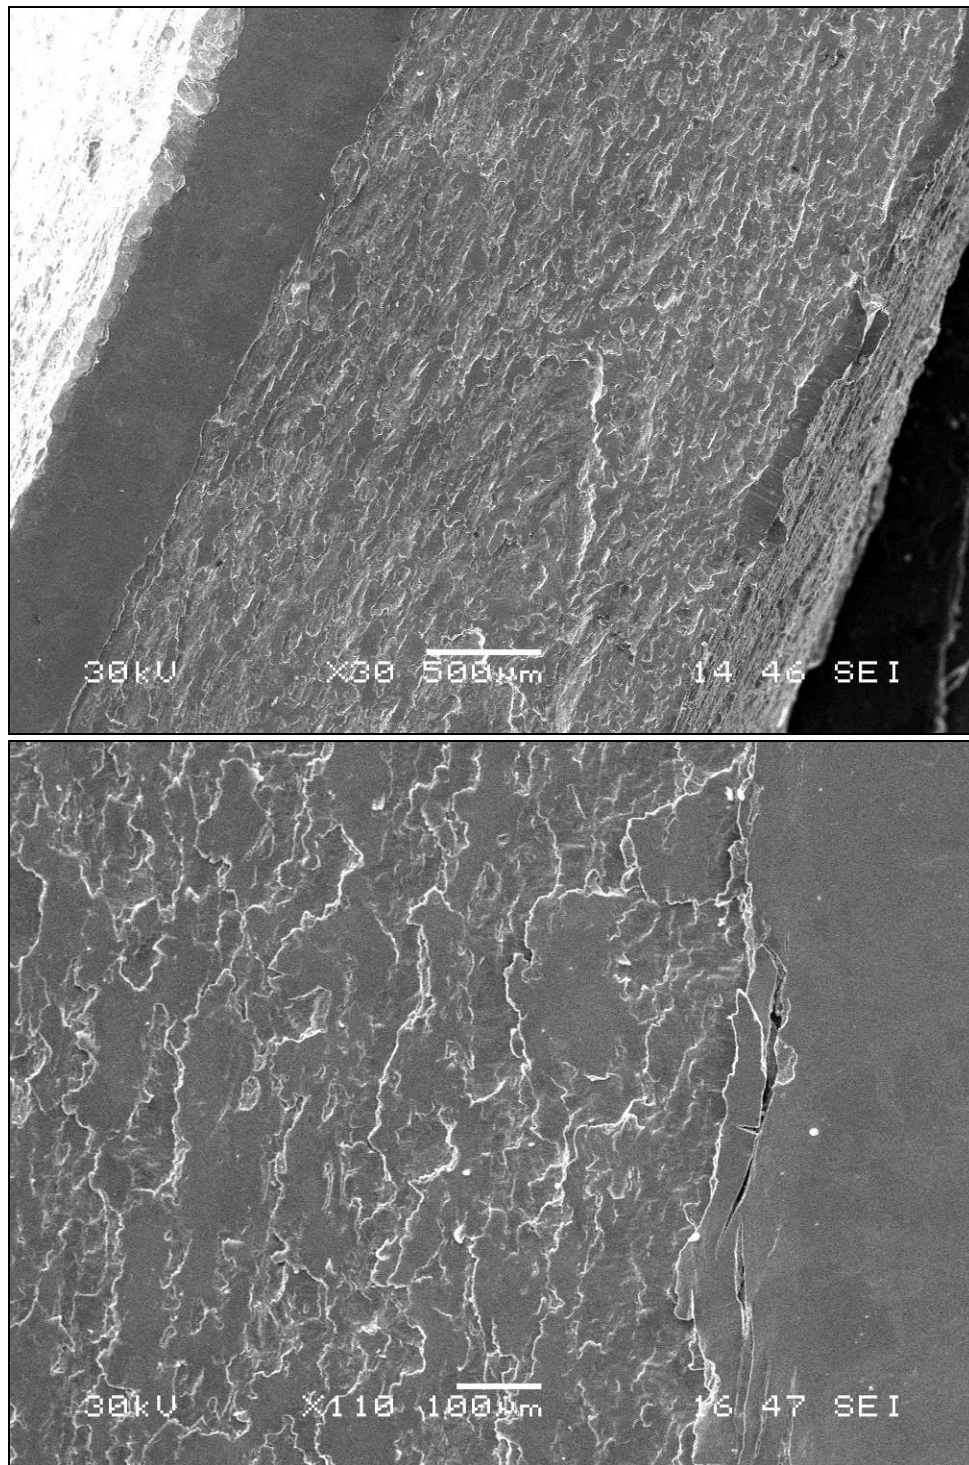
**Figure 24.** (Top) The inside surface of some segments of the roller showed signs of galling/spalling. (Bottom) SEM image of the damaged inside diameter of a roller segment.

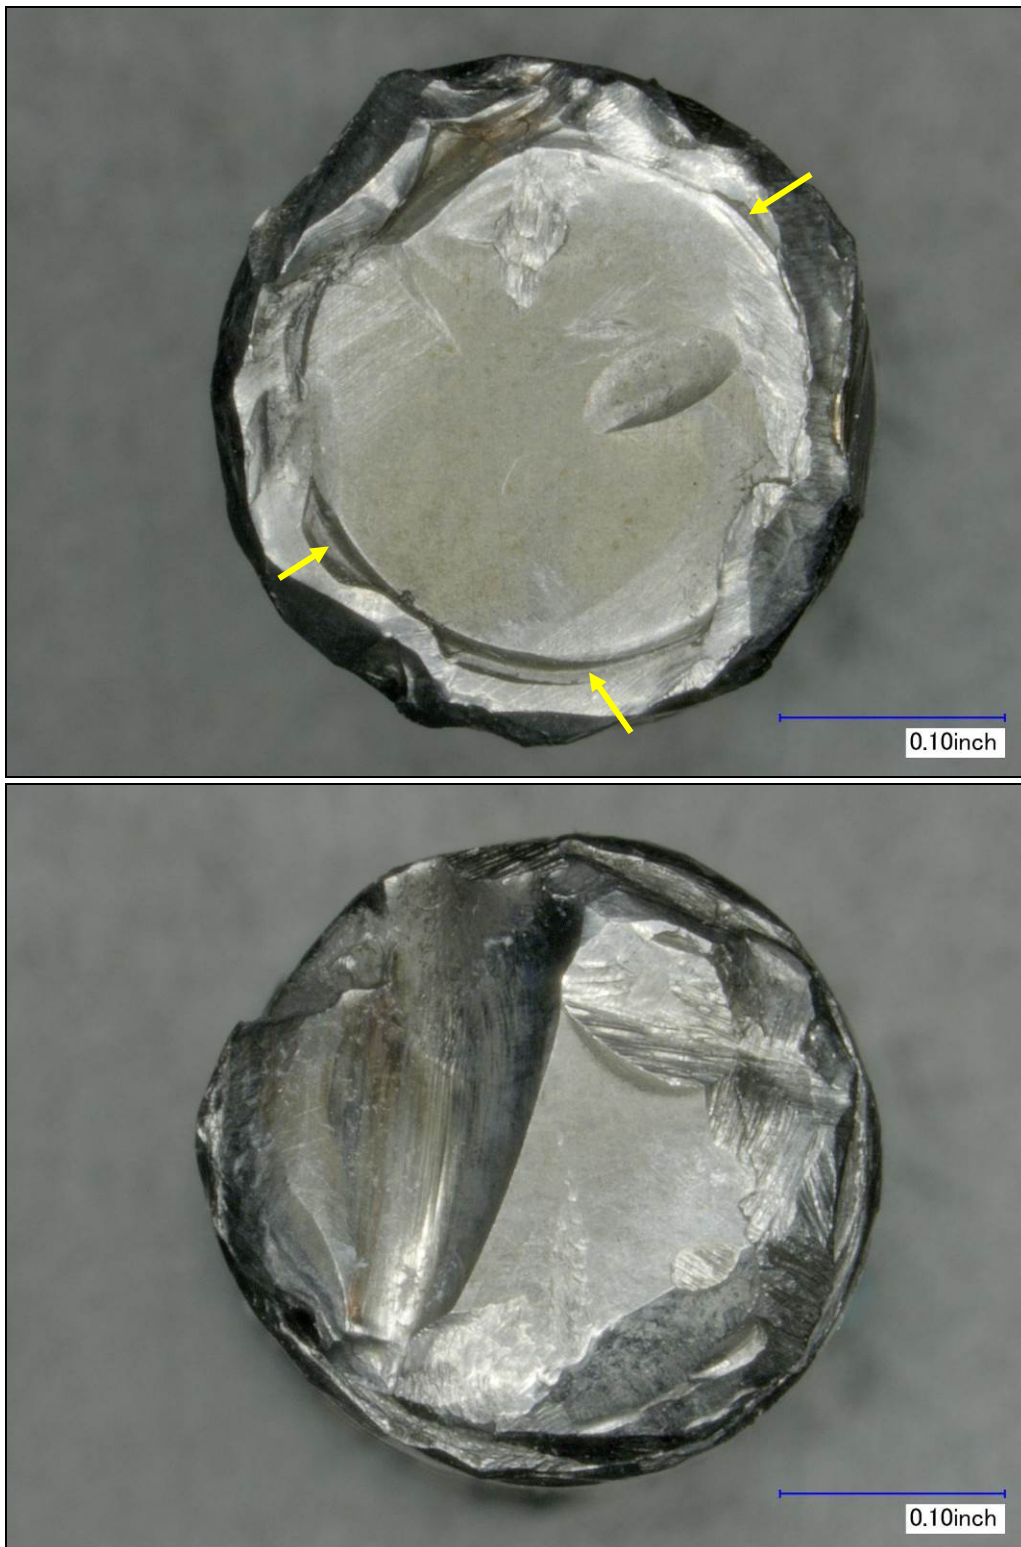
The shaft was damaged mostly on the two ends and some areas of the midsection. One end of the shaft showed the staking indent, while the other end was too badly damaged to retain any evidence of the staking indent as shown in Figure 25.

**Figure 25.** Both ends of the shaft are shown. In the top image, yellow arrows indicate the indent from the staking operation. In the bottom image, the opposite end of the shaft is badly damaged.

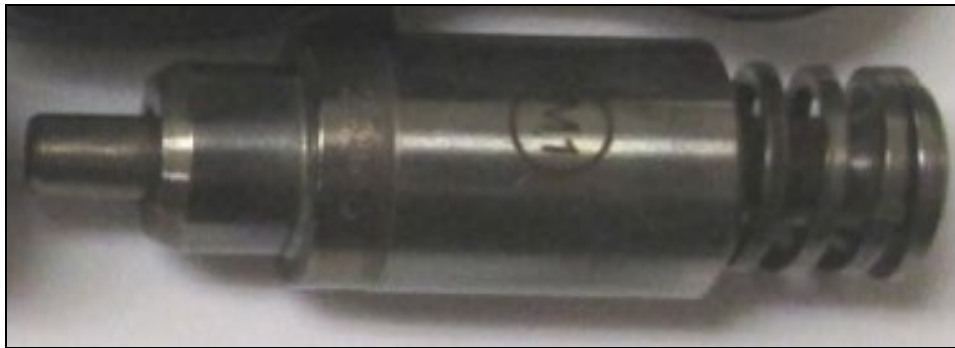
The hydraulic lifter assembly from the #4 exhaust is shown in Figure 26 in the as-received condition in the Materials Lab. The lifter assembly was then tested in accordance with the 15B26066 acceptance standard leakdown test defined in LPS-551 Section V. The leakdown rate was higher than the acceptance criteria of LPS-551 Section V of 10-30 seconds, measuring 41.4 seconds when tested as-received while coated in engine oil. The hydraulic lifter assembly was then purged three times with the Brayco 460 test fluid, and re-run, this time measuring 32.7 seconds. Run a third time, with no additional purging with test fluid, a result of 34.0 seconds was measured. The assembly was then purged three more times, and re-tested, measuring 37.8 seconds. The hydraulic lifter assembly was nonconforming for the leakdown test; however it was within material review board acceptance limits and not considered a contributor to this failure. No additional evaluation of the lifter was performed.

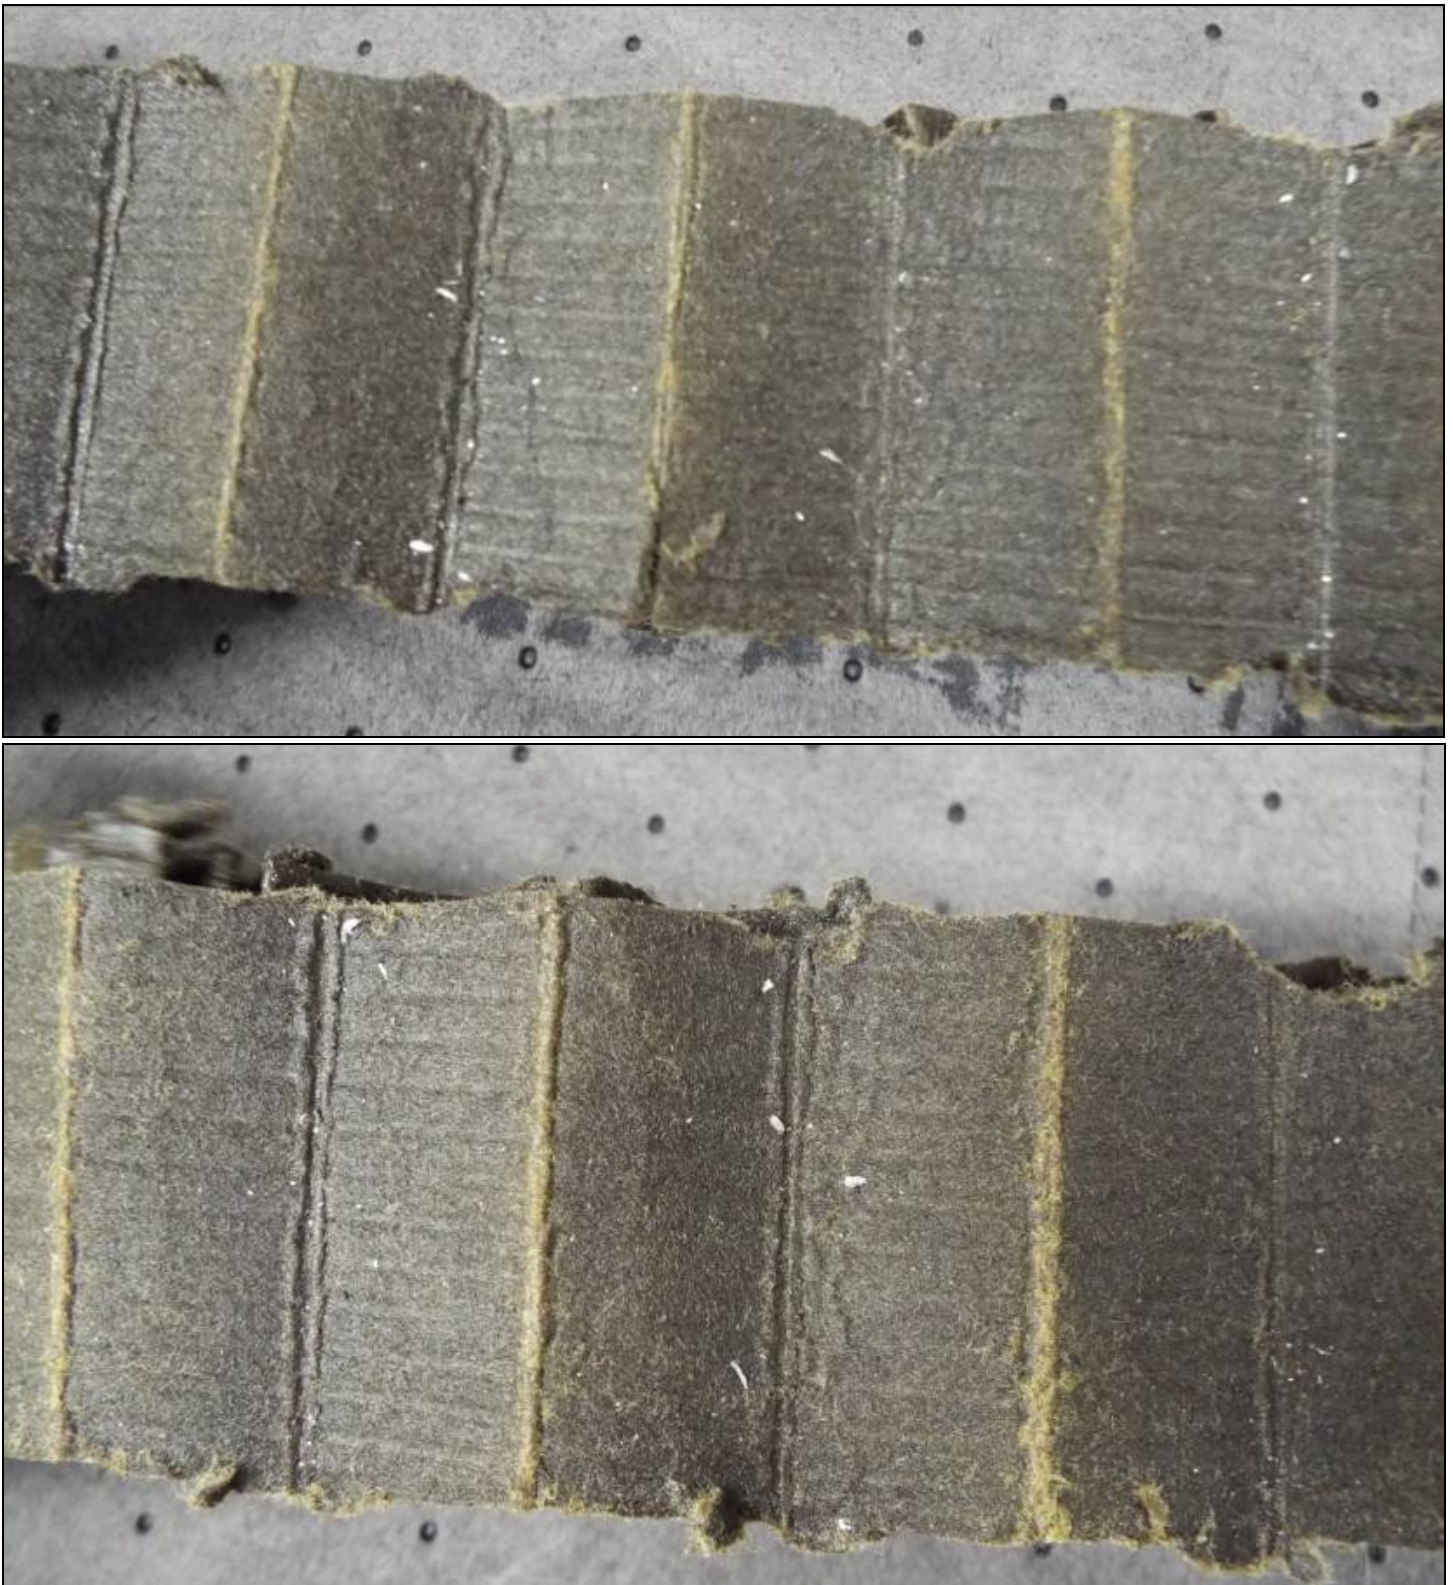
The oil filter was examined and found to contain an expected amount of fine chips based on the engine damage, as shown Figure 27. A representative selection of approximately 18 chips were cleaned in trichloroethylene and examined using energy dispersive x-ray spectroscopy.

Three chips of 52100 steel (likely from the roller tappet assembly roller or shaft), two copper plating chips (camshaft, valve guides, rocker arms, connecting rod bolts), five aluminum alloy chips (likely from pistons or accessory housing), and eight aluminum alloy chips (likely from the crankcase).

**Figure 27.** Typical regions showing the amount of chips found in the oil filter upon examination.
