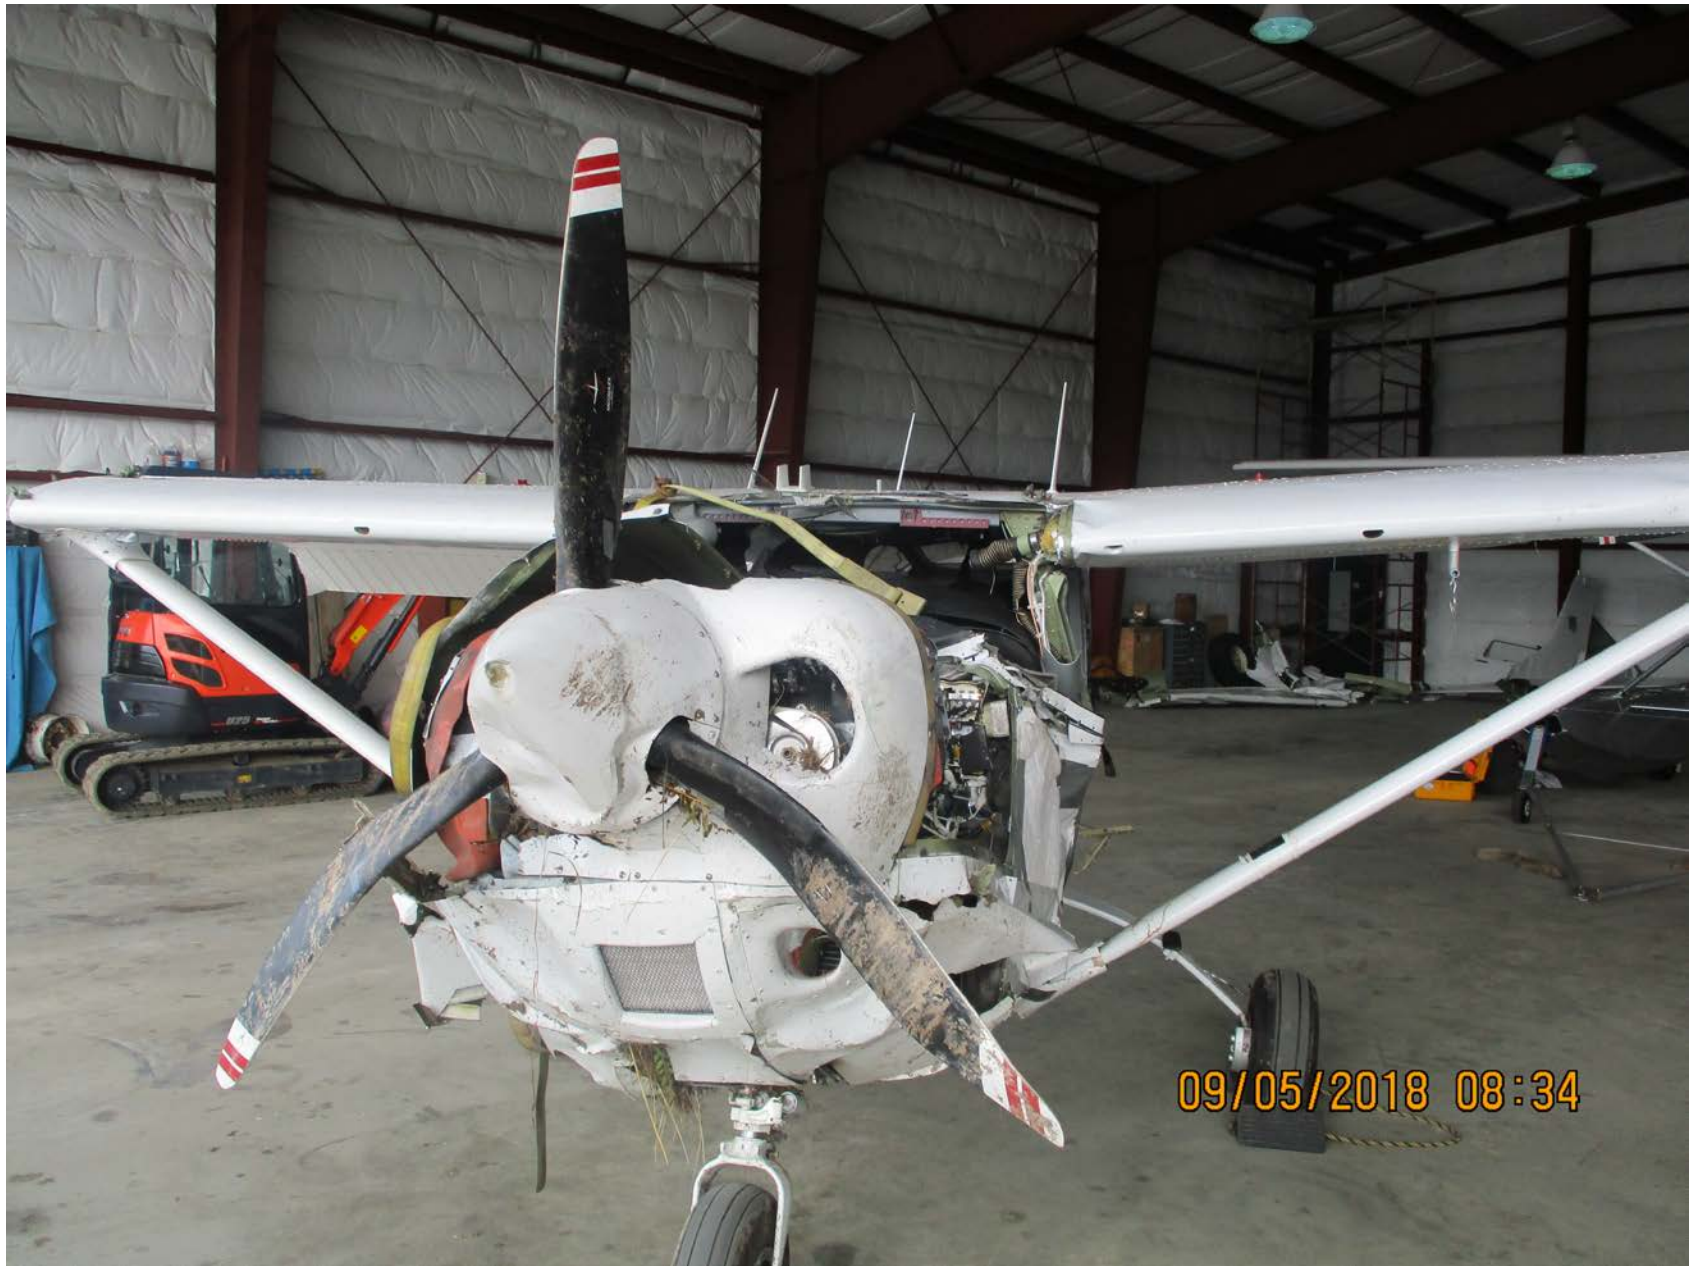
**Photo 1 – Main Wreckage, Front view**

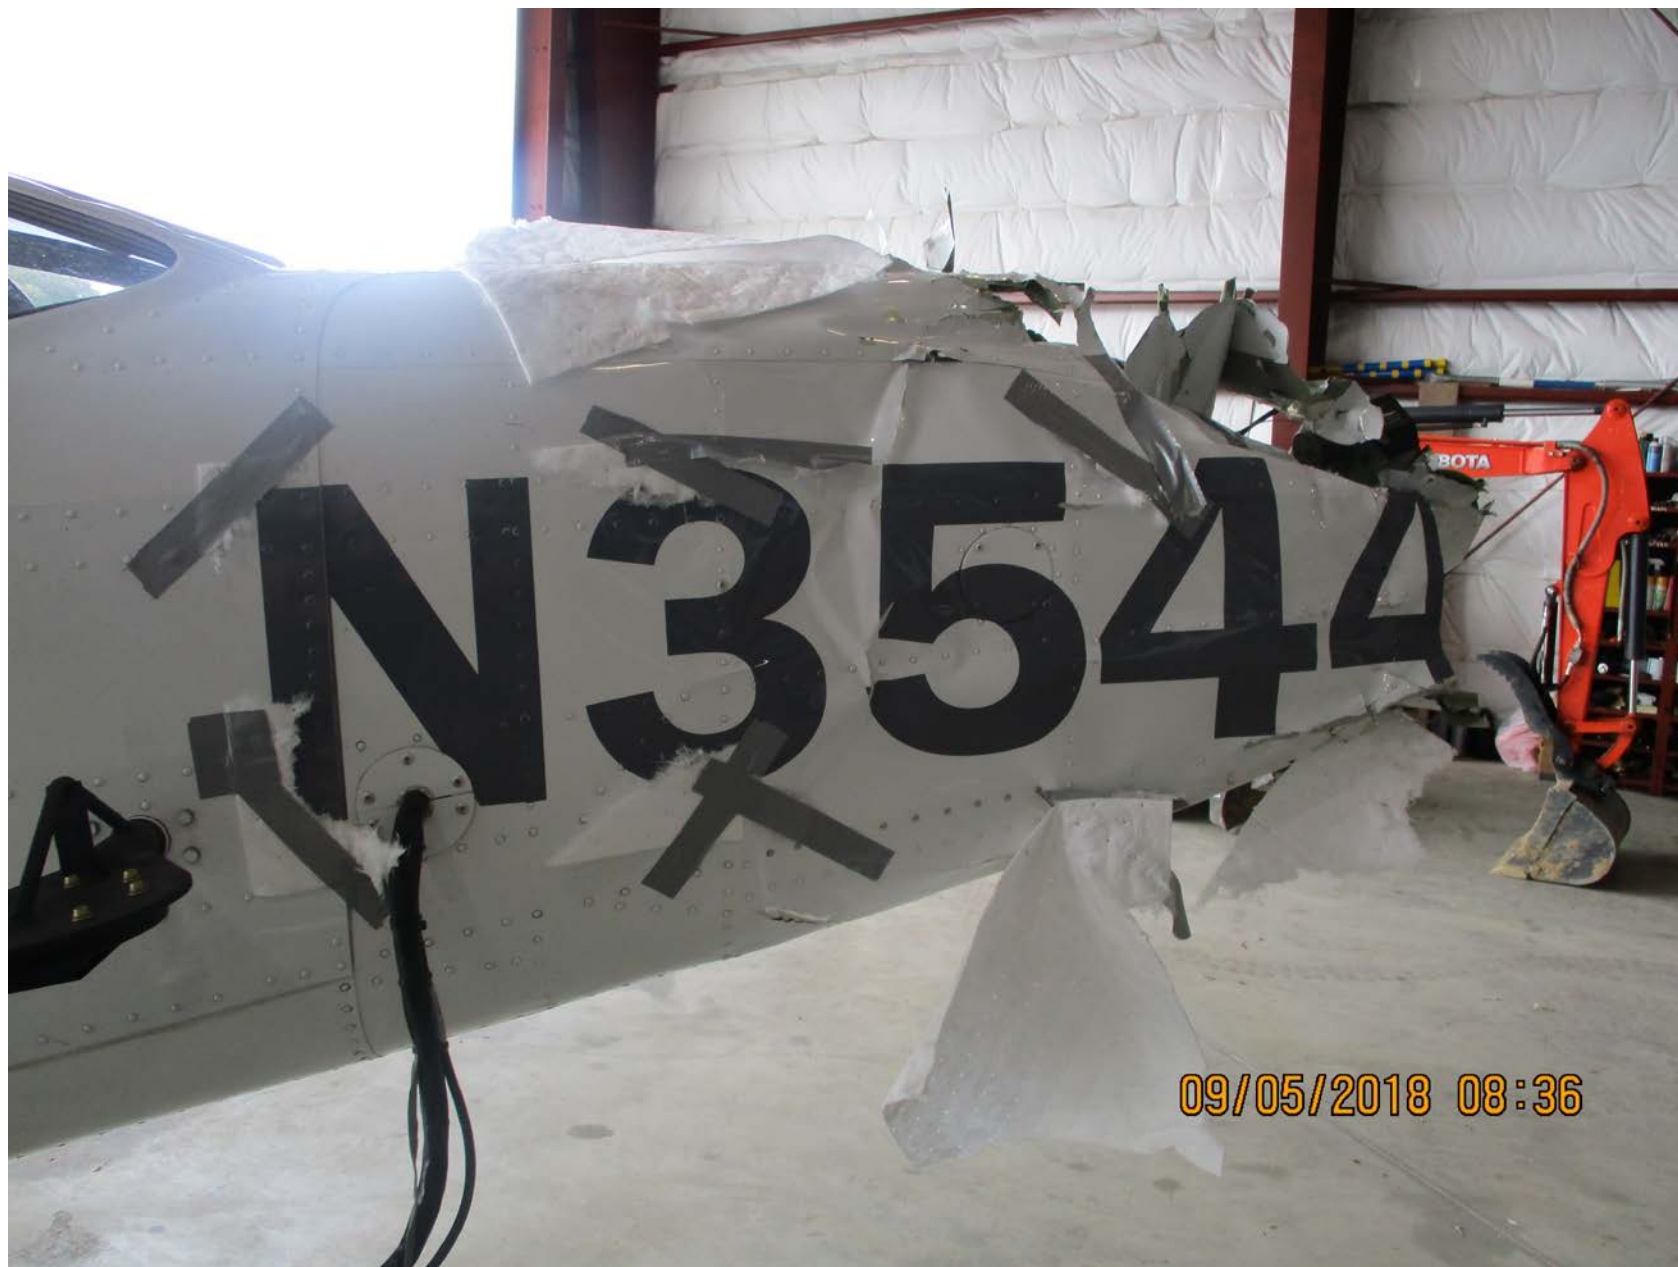
**Photo 2 – Tail number**

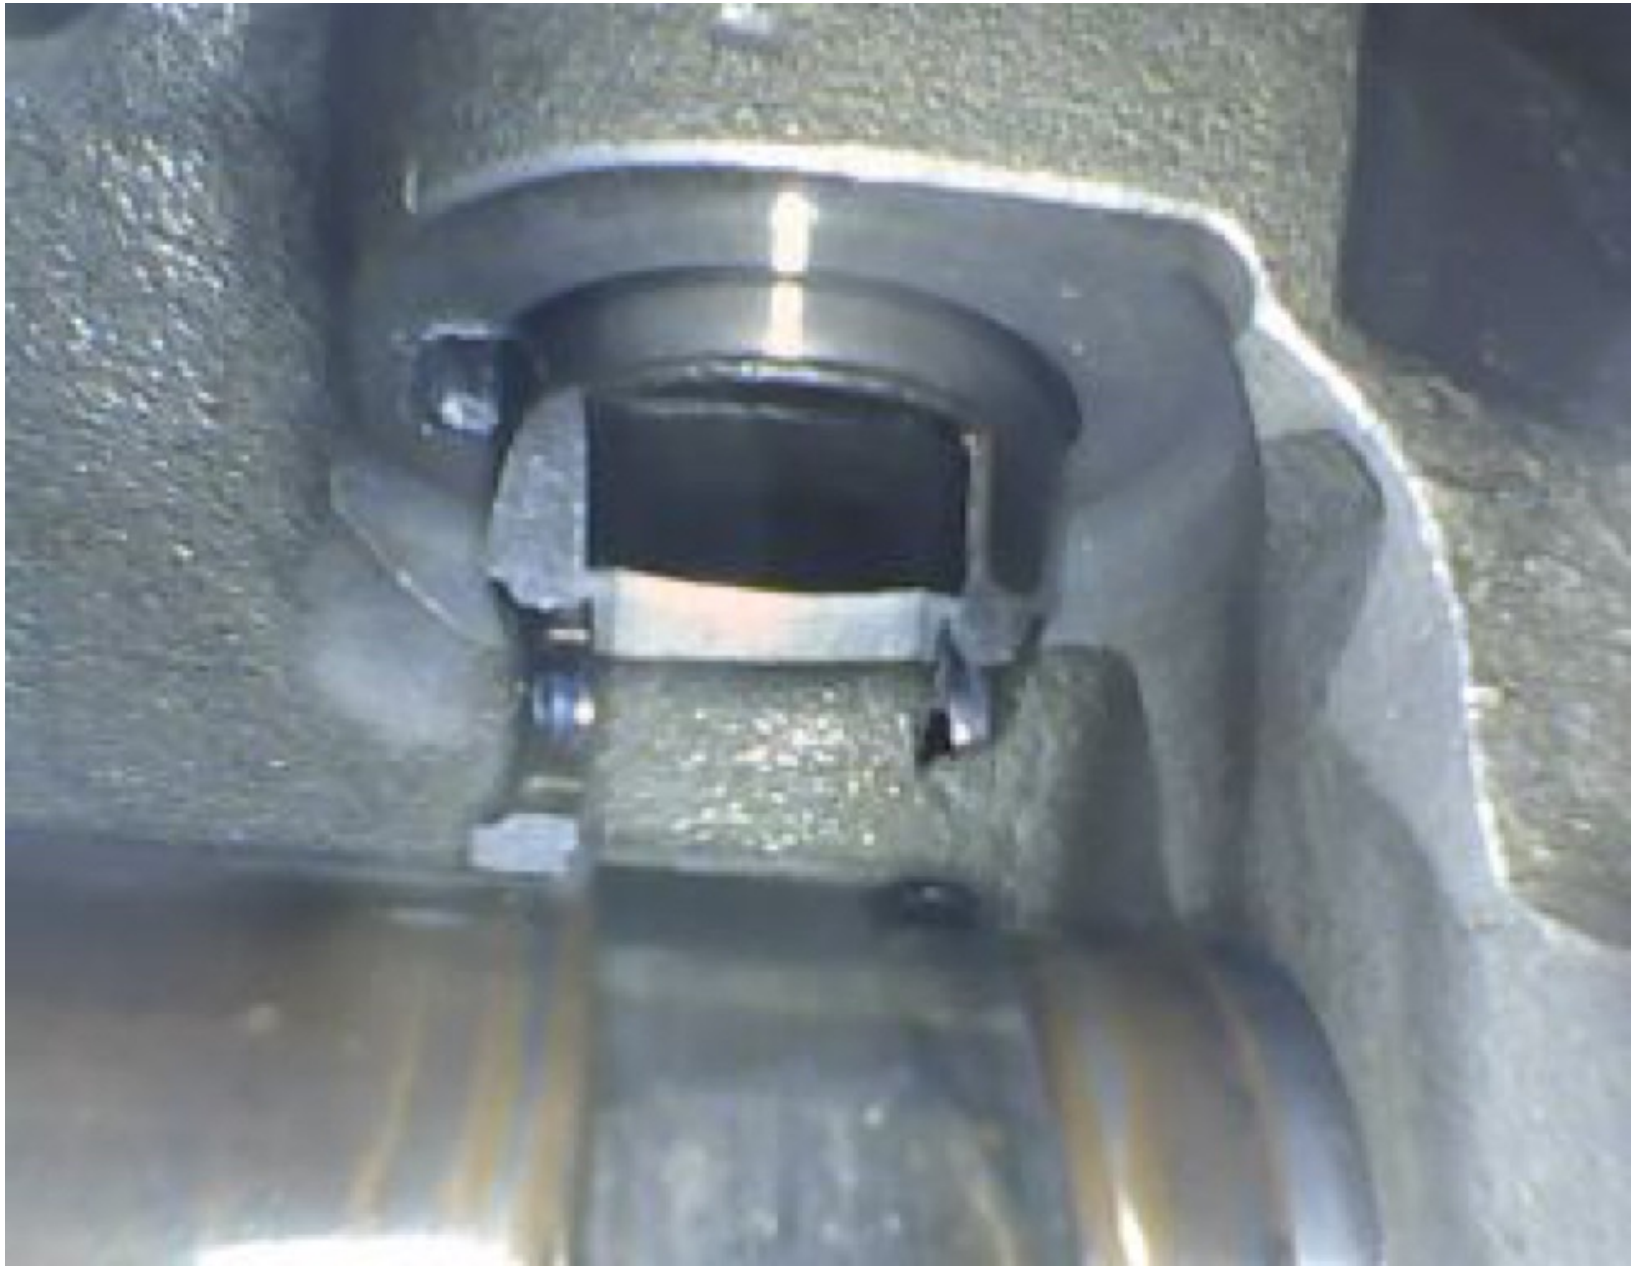
**Photo 3 – Fractured roller tappet**

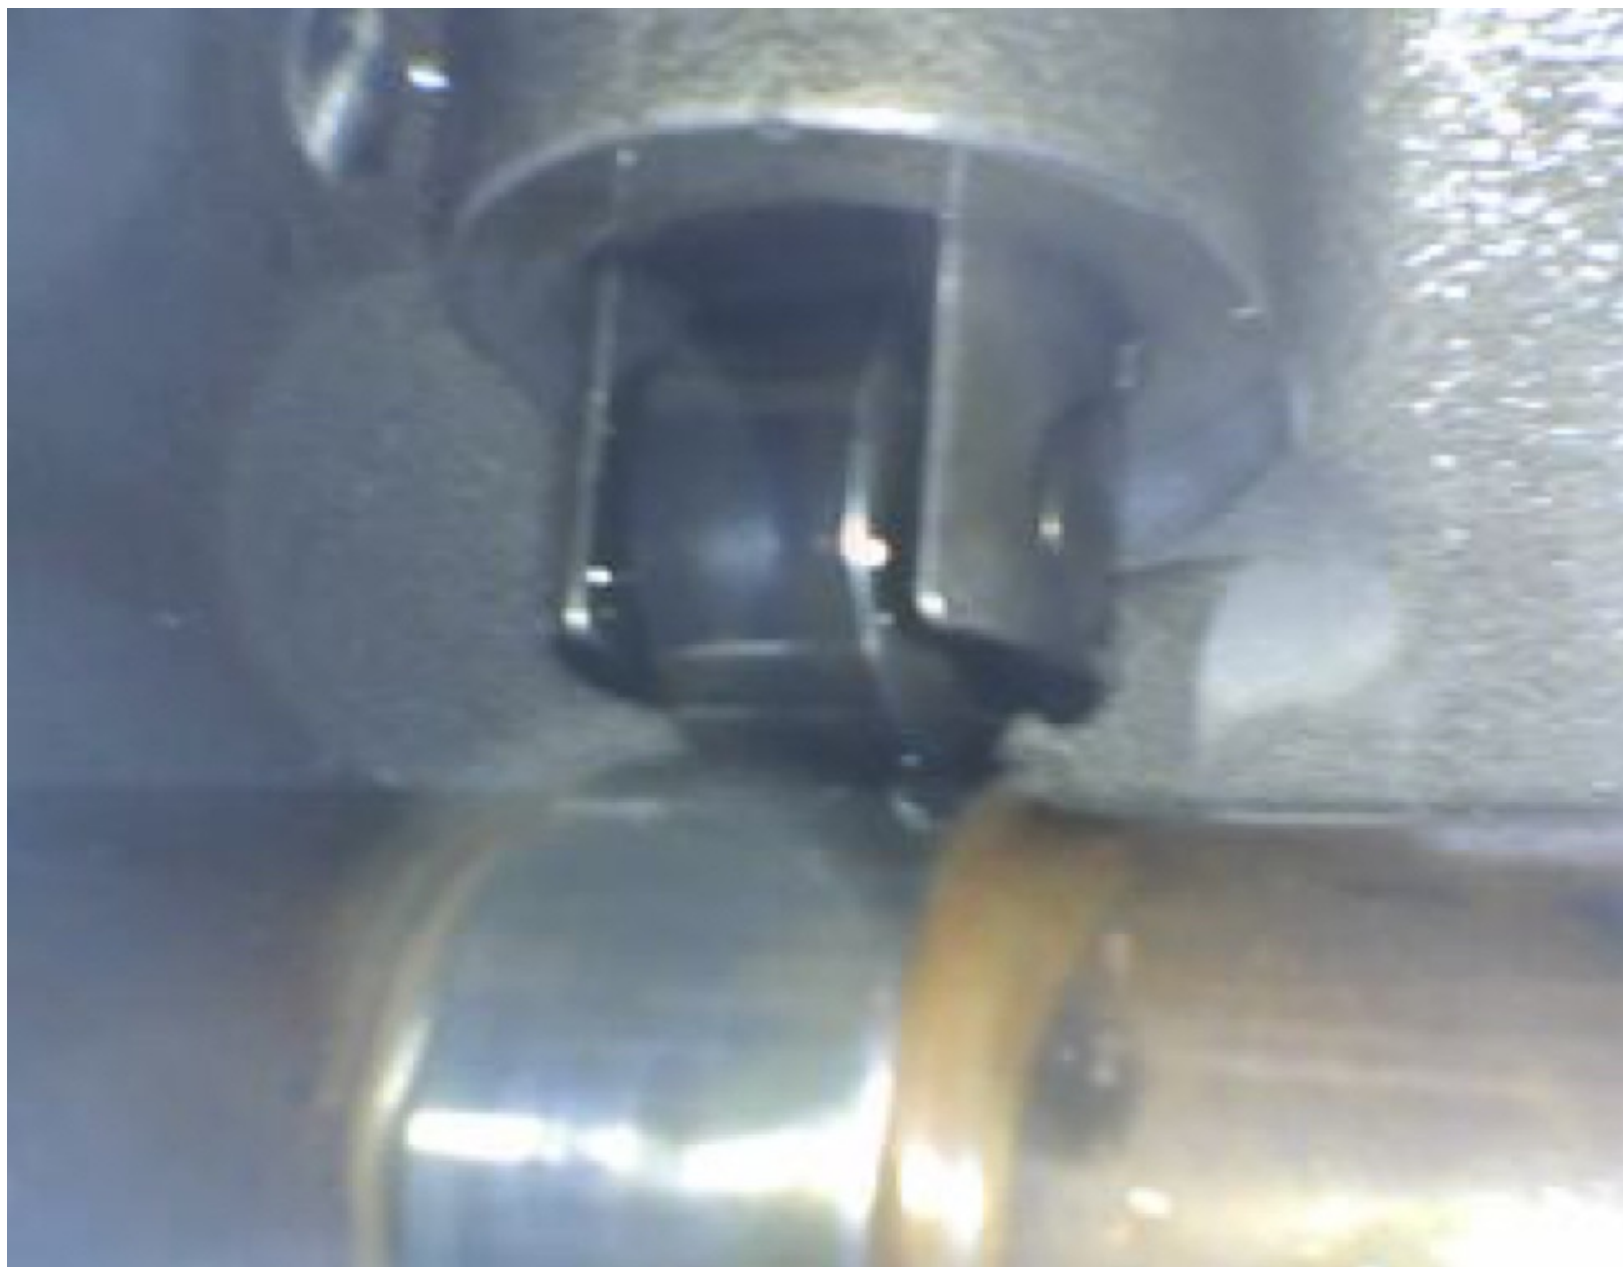
**Photo 4 – exemplar roller tappet**
