# NATIONAL TRANSPORTATION SAFETY BOARD

## MATERIALS LABORATORY FACTUAL REPORT

Report No. 19-018

Place : Quincy, FL  
Date : 8/24/2018  
Vehicle : Beech A36, N773CB  
NTSB No. : ERA18LA229  
Investigator : Timothy W. Monville

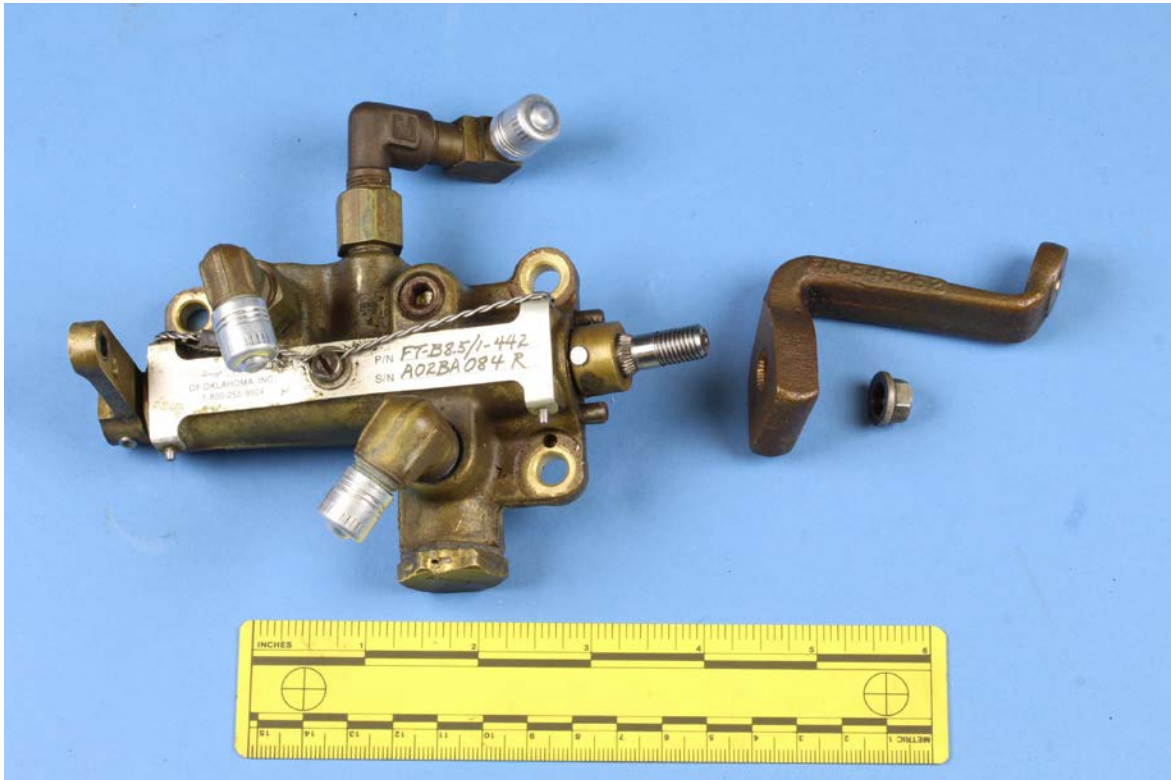
Metered fuel assembly (p/n: FT-B8.5/1-442, s/n: A02BA084R) with mixture control lever (p/n: 646265) and securing nut (figure 1).

Figure 1: Metered fuel assembly with control lever and securing nut as received.

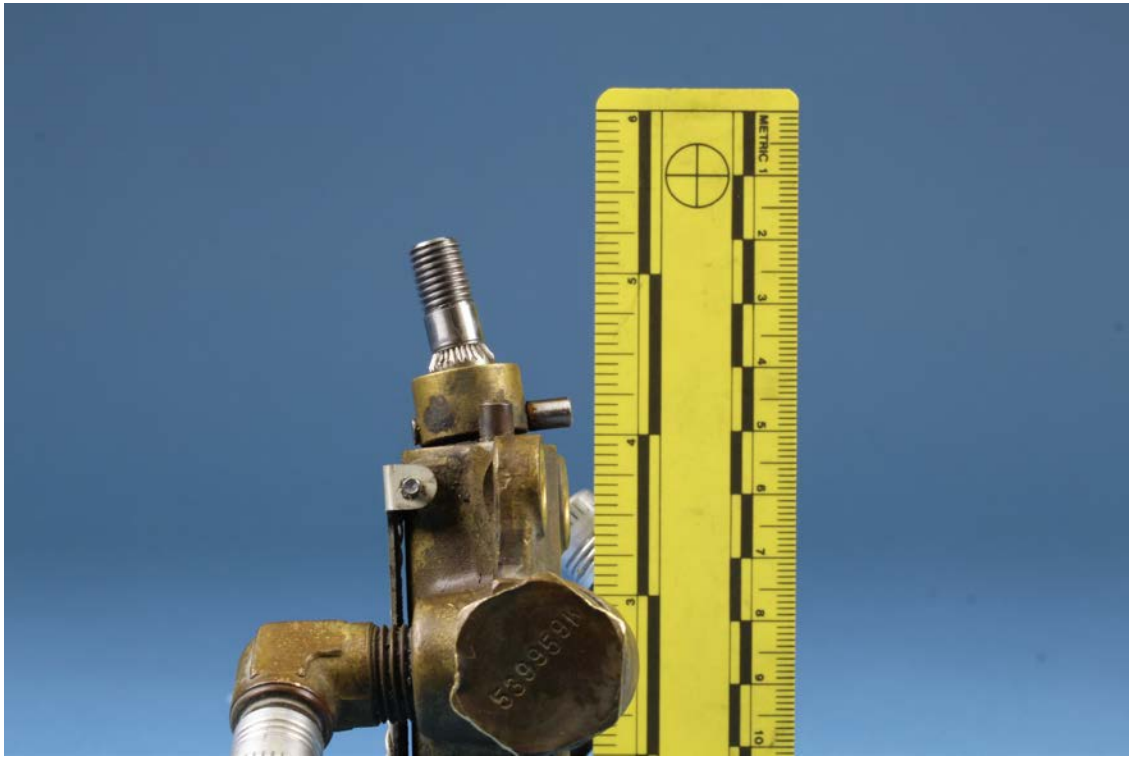
The metered fuel assembly had a stem onto which the control lever would have been attached. The stem was threaded on its end for the securing nut and had a section of tapered splines at the base for engagement with the control lever. This stem had been plastically deformed (figure 2). The threads on the stem were intact with no evidence of deformation. The tapered splines on the stem were also intact.

Figure 2: Bent control stem on metered fuel assembly.

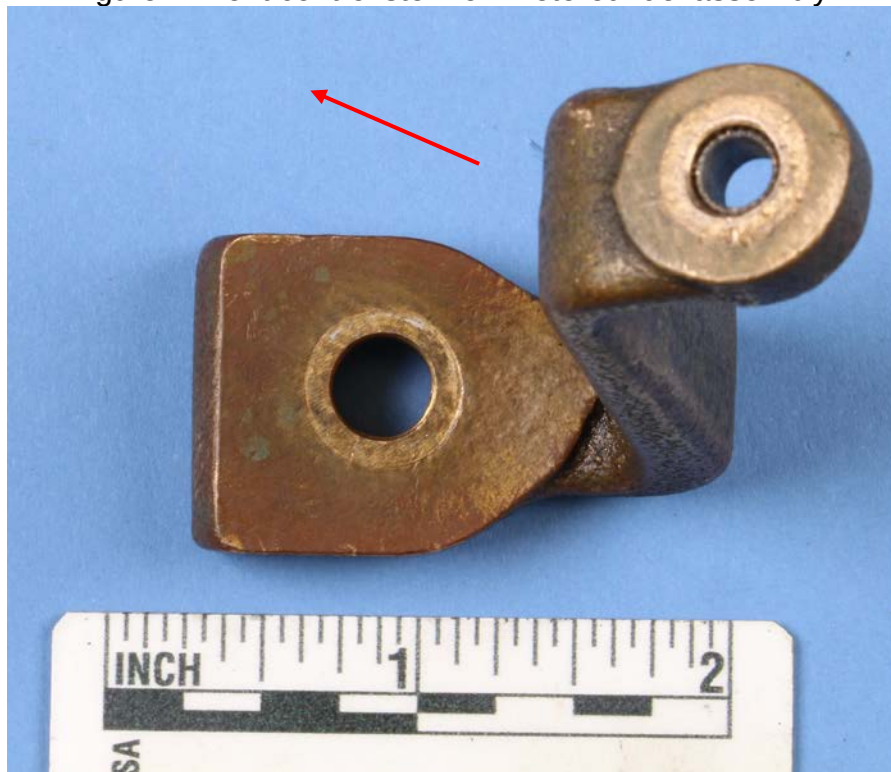
The control lever exhibited plastic deformation. The direction of the deformation is indicated by the arrow in figure 3. The through hole where the metered fuel assembly's stem would pass through the control lever is shown in figures 4 and 5. On the side of the through hole nearest the lever's dog leg (figure 4) indentations from the stem's splines were observed. On the side of the through hole opposite the lever's dog leg (figure 5) there was a smeared contact pattern without distinguishable indentations from the stem's splines. Since the smeared contact pattern did not extend along the entire periphery of the through hole and there was a portion of the periphery with spline indentations that were not smeared it is likely that the control lever and splined shaft were not rotating in relation to each other. Based on the direction of deformation of both the stem and the control lever their relative alignment is shown in figure 6.

Figure 3: Control lever exhibiting plastic deformation. Red arrow shows direction of deformation.

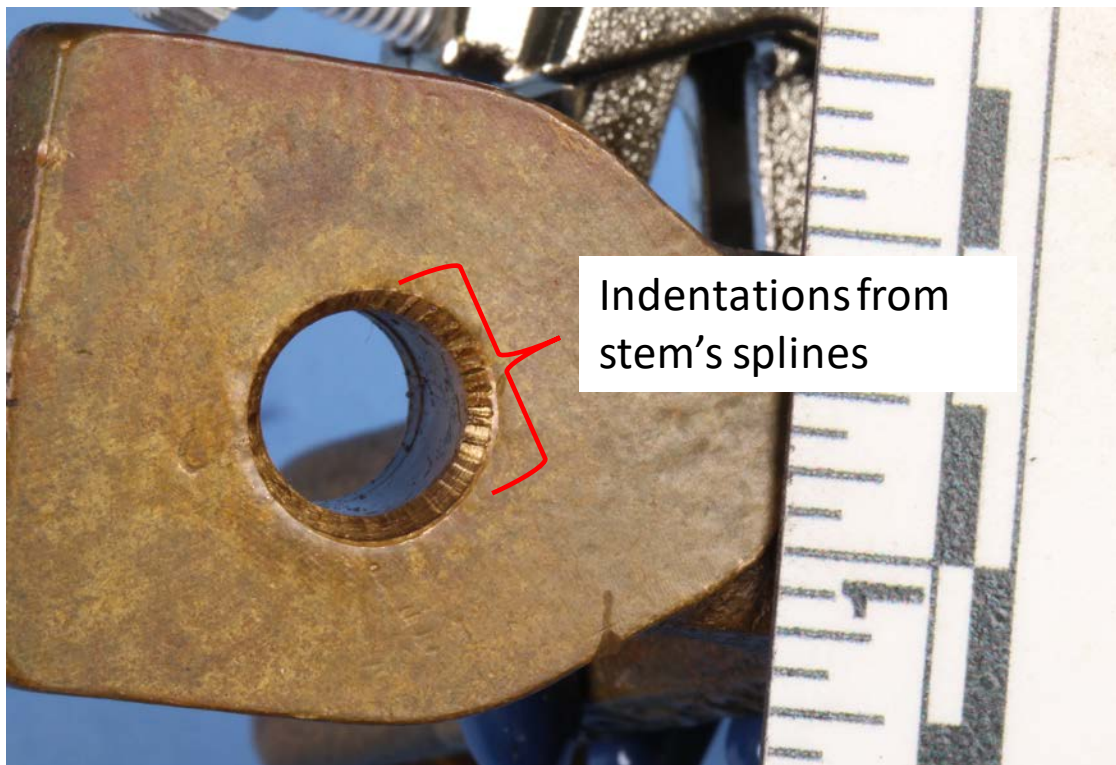
Figure 4: Spline indentations on portion of control lever through hole.

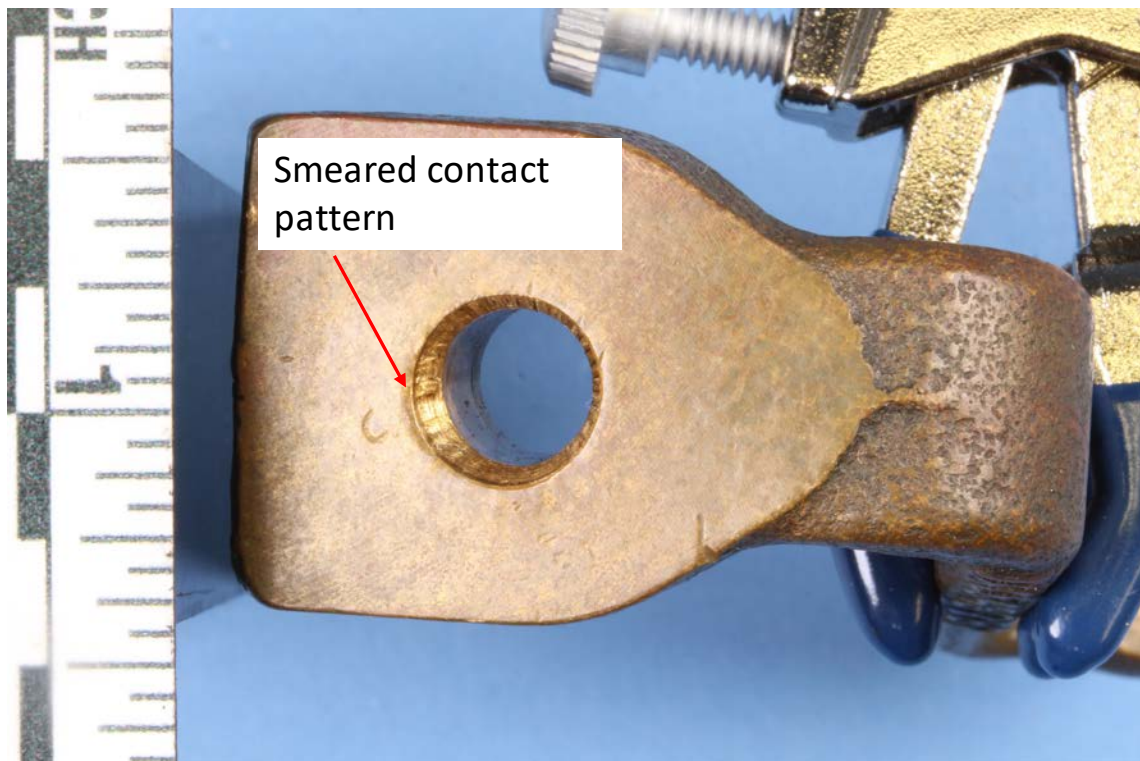
Figure 5: Smeared contact pattern on portion of control lever through hole.

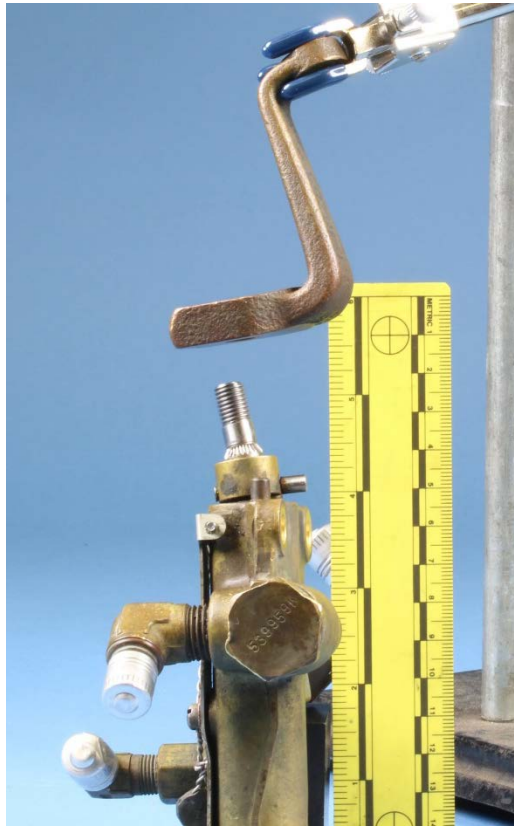
Figure 6: Alignment of metered fuel assembly stem and control lever.

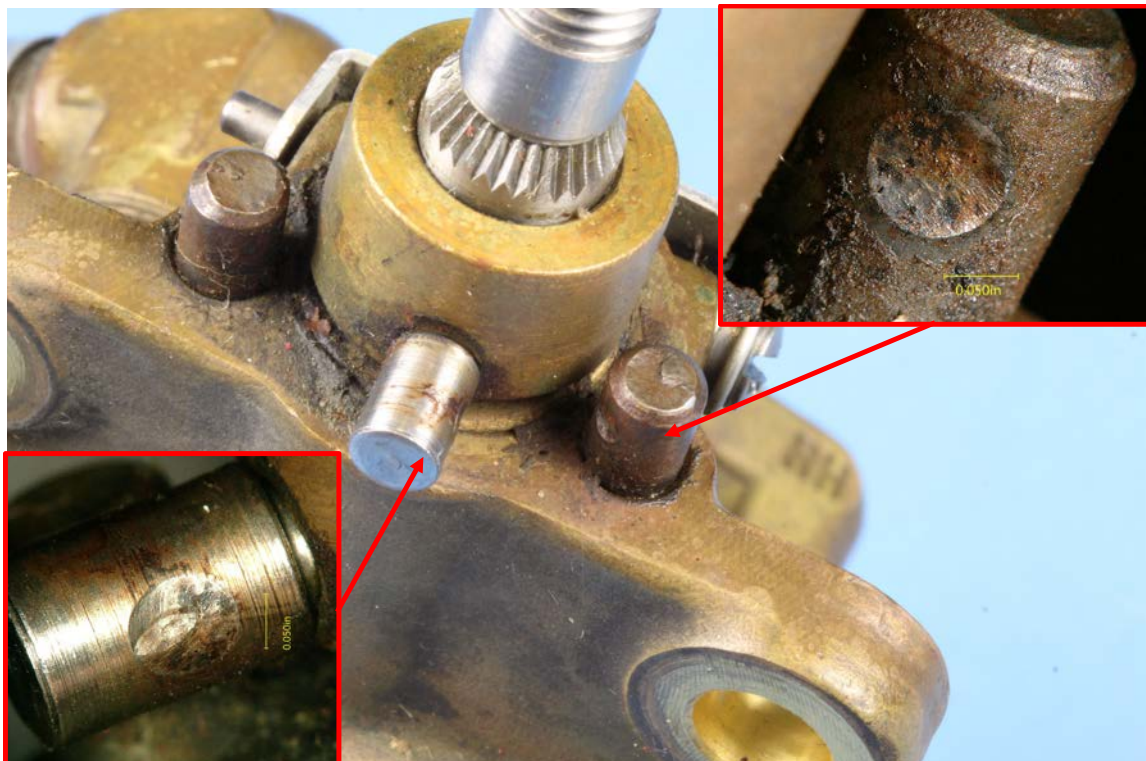
The metered fuel assembly's stem was fitted with a collar and stop pin at the base (figure 7). This stop pin would contact stop pins fixed to the metered fuel assembly's housing. A circular contact pattern was observed between stem's stop pin and one of the stop pins on the assembly housing. Due to the plastic deformation of the stem, this contact pattern between the pins was no longer in alignment.

Figure 7: Contact pattern on stop pins.
