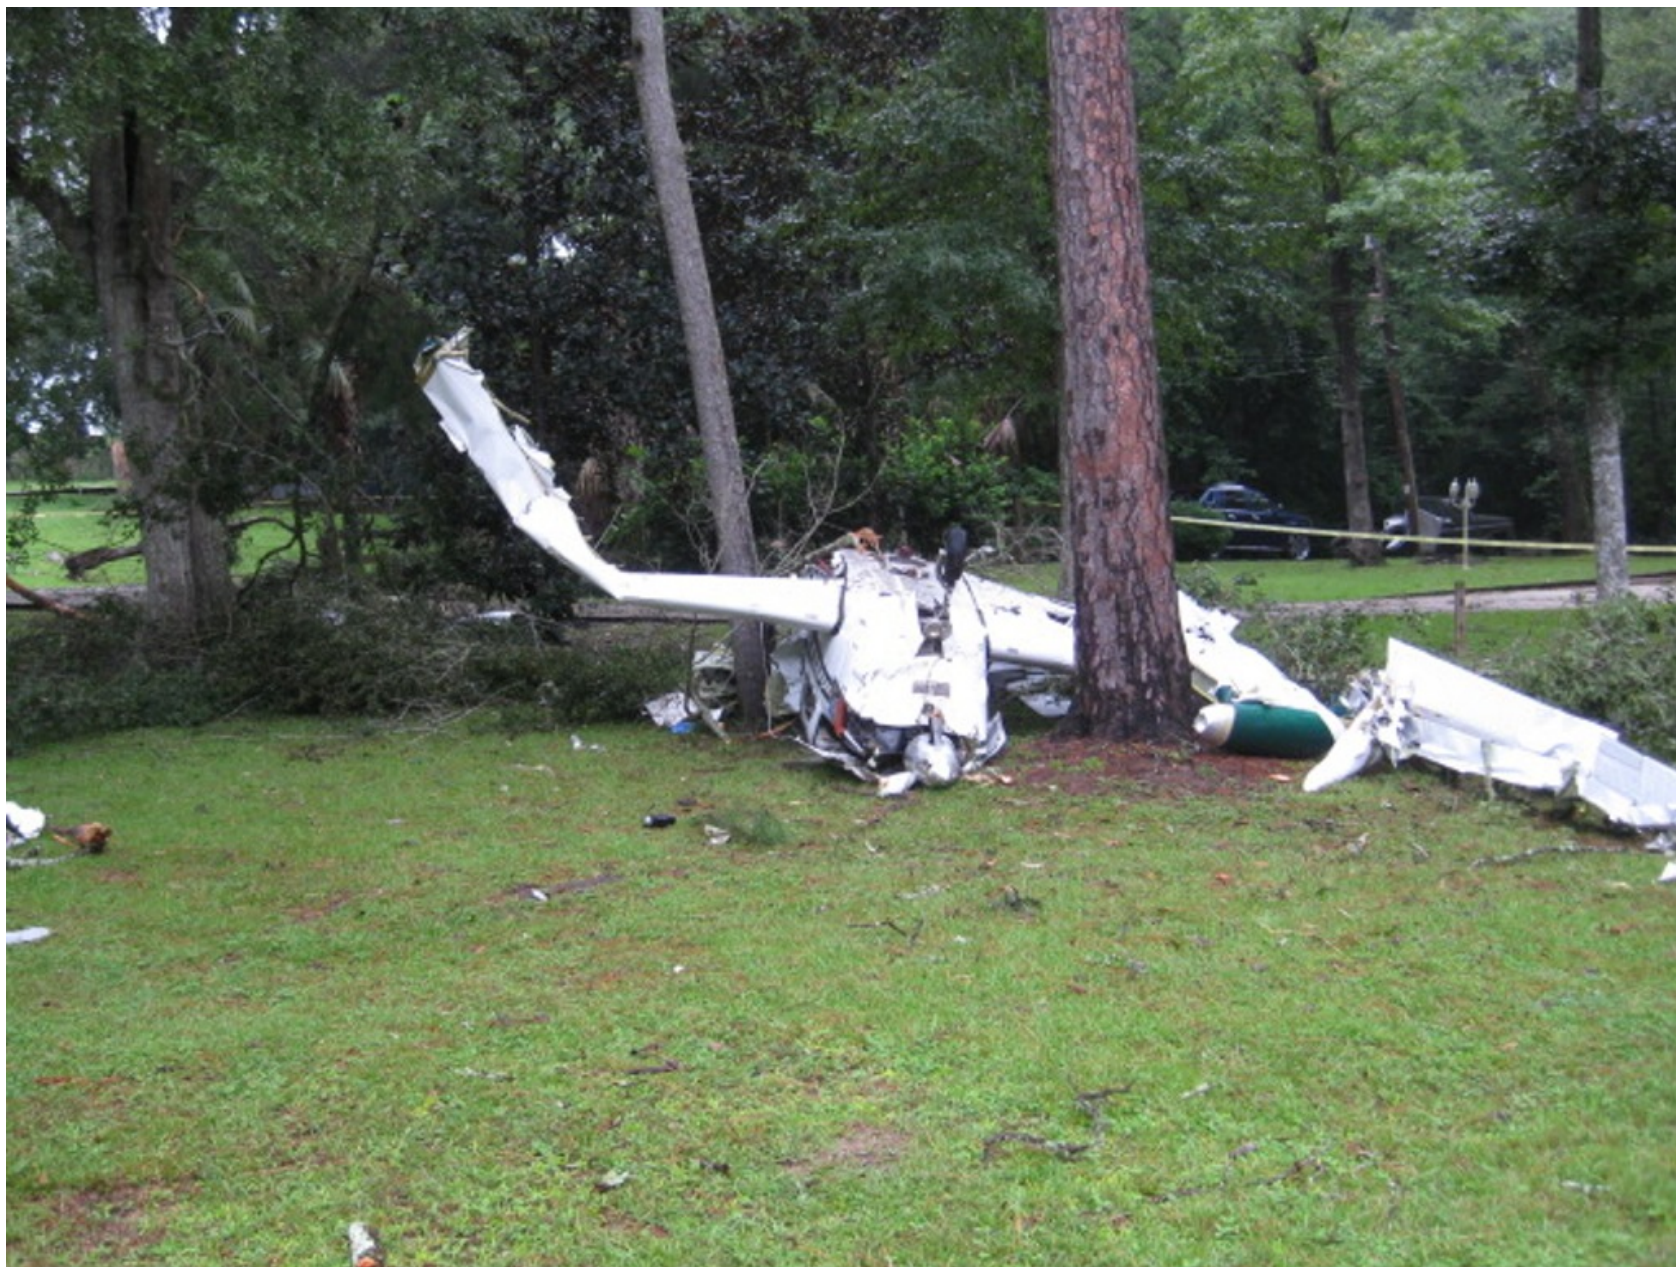
**Photo 1 – FAA Digital Photograph. Frontal View of the Inverted Wreckage at the Accident Site.**

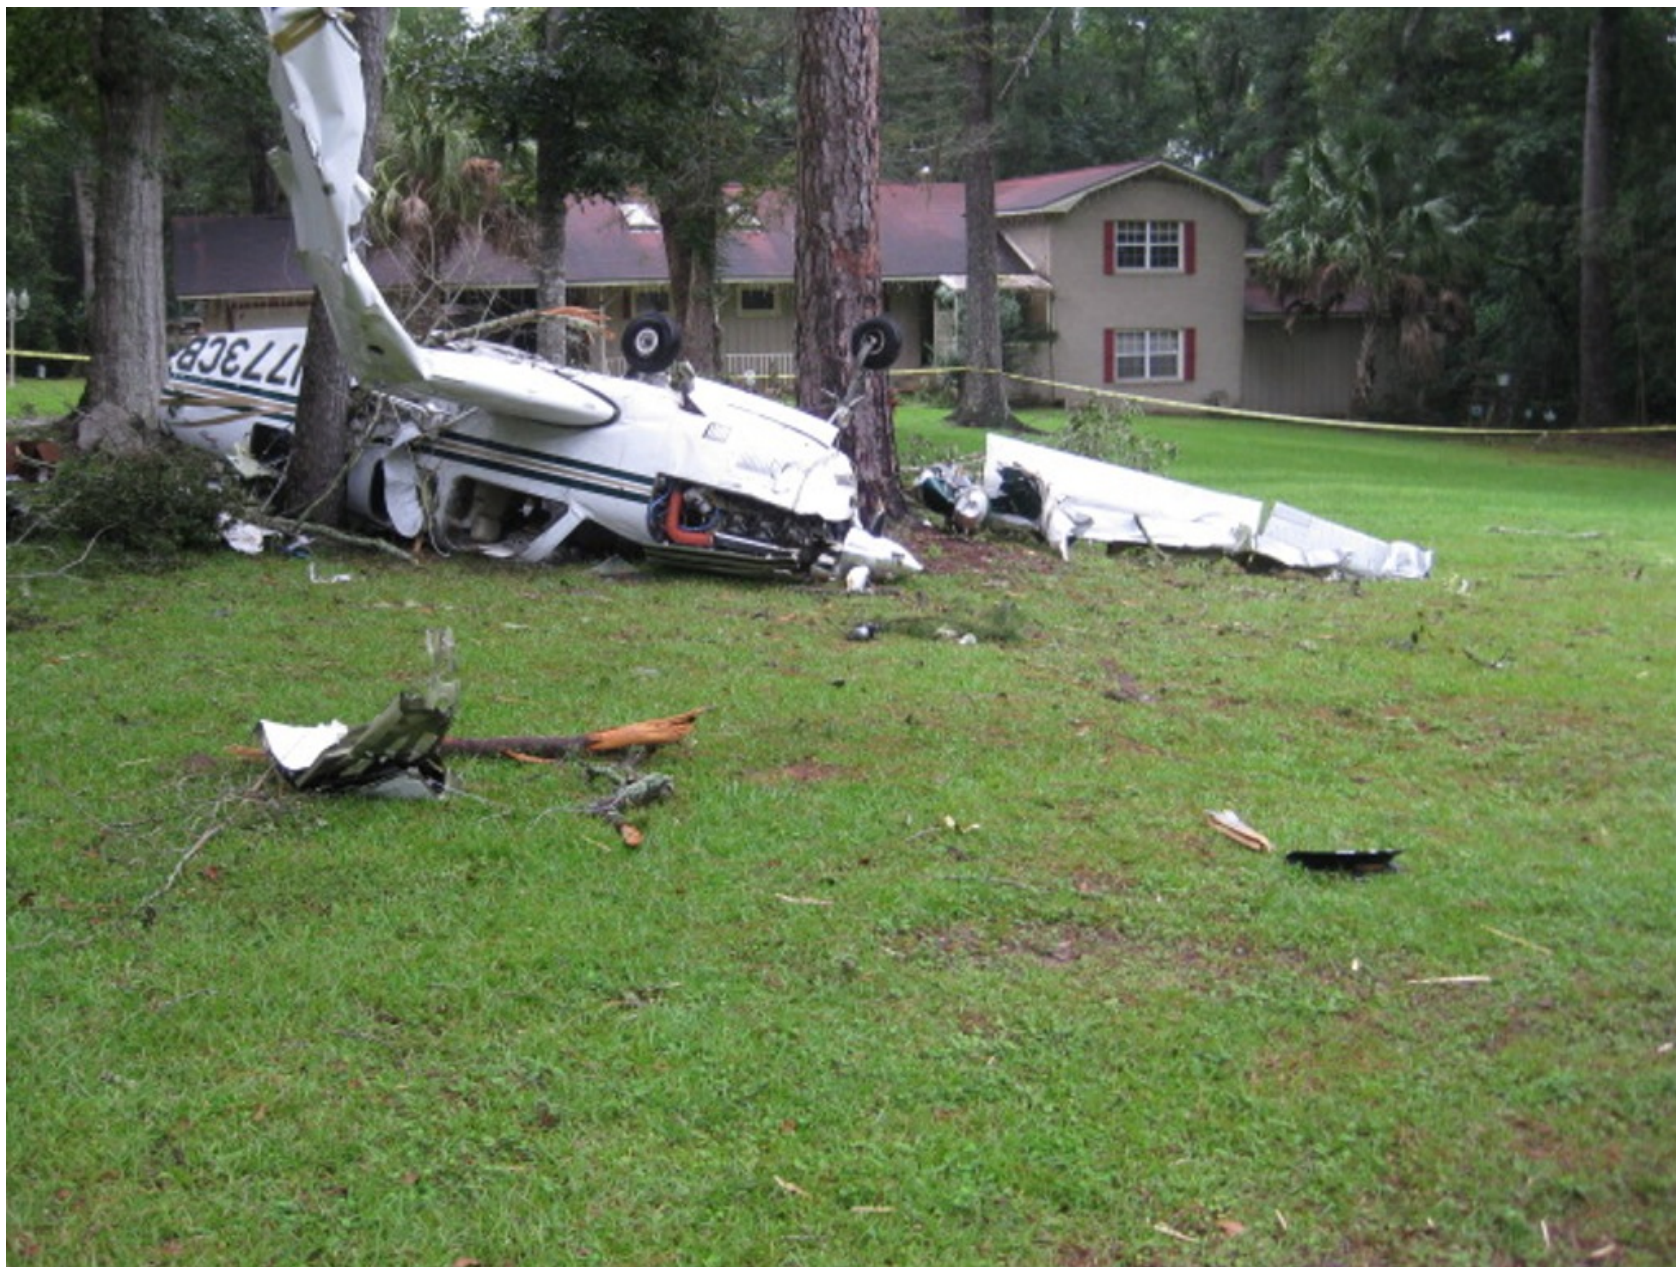
**Photo 2 - FAA Digital Photograph. Left Forward Quartering View of the Inverted Wreckage at the Accident Site.**

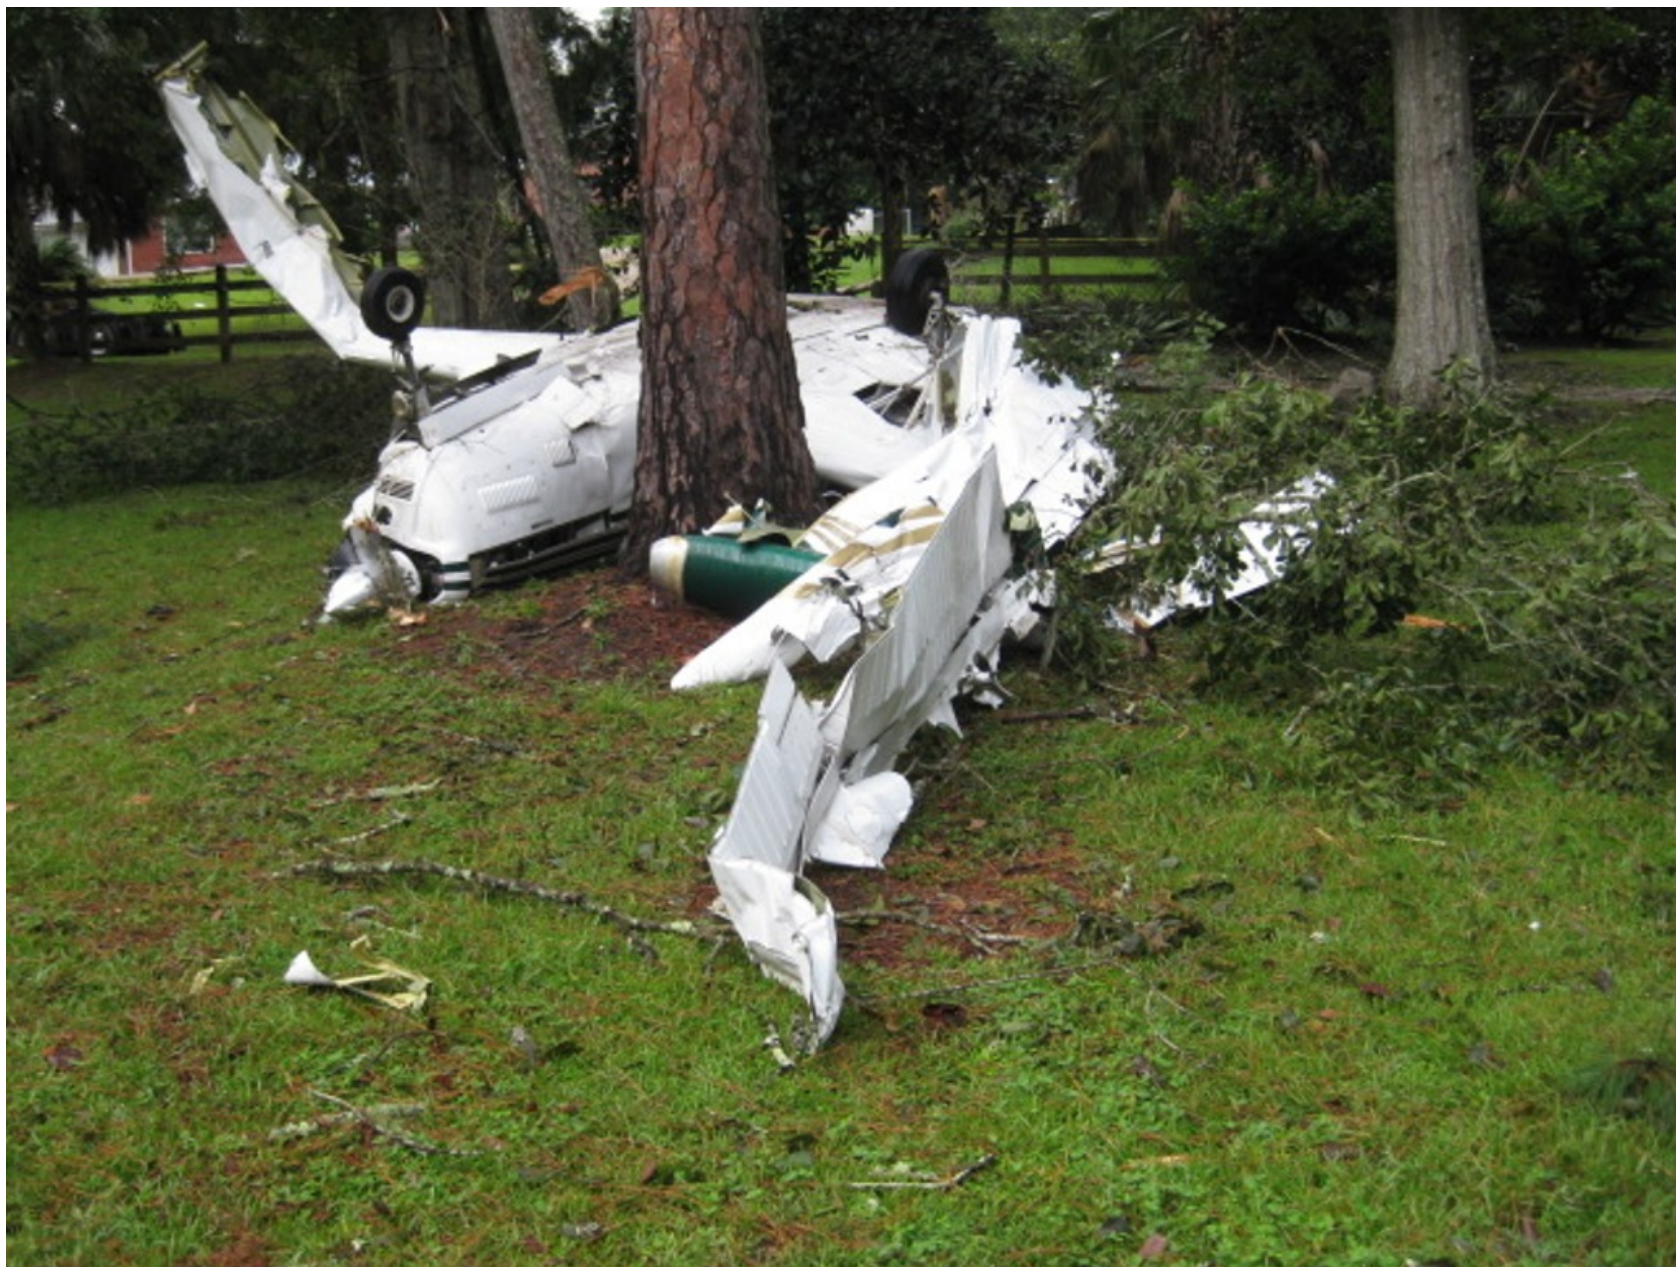
**Photo 3 - FAA Digital Photograph. Right Forward Quartering View of the Inverted Wreckage at the Accident Site.**

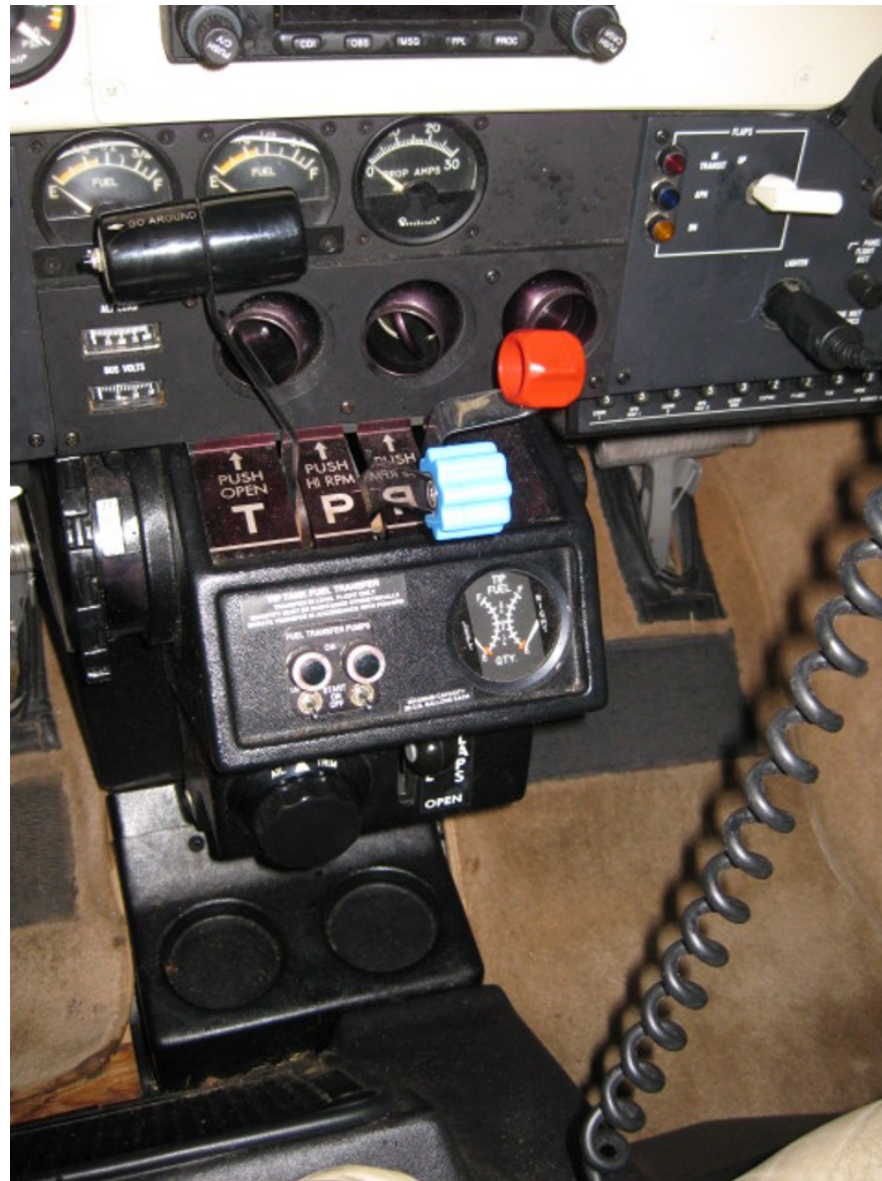
**Photo 4 - FAA Digital Photograph. View of the Throttle Quadrant and Portion of Instrument Panel.**

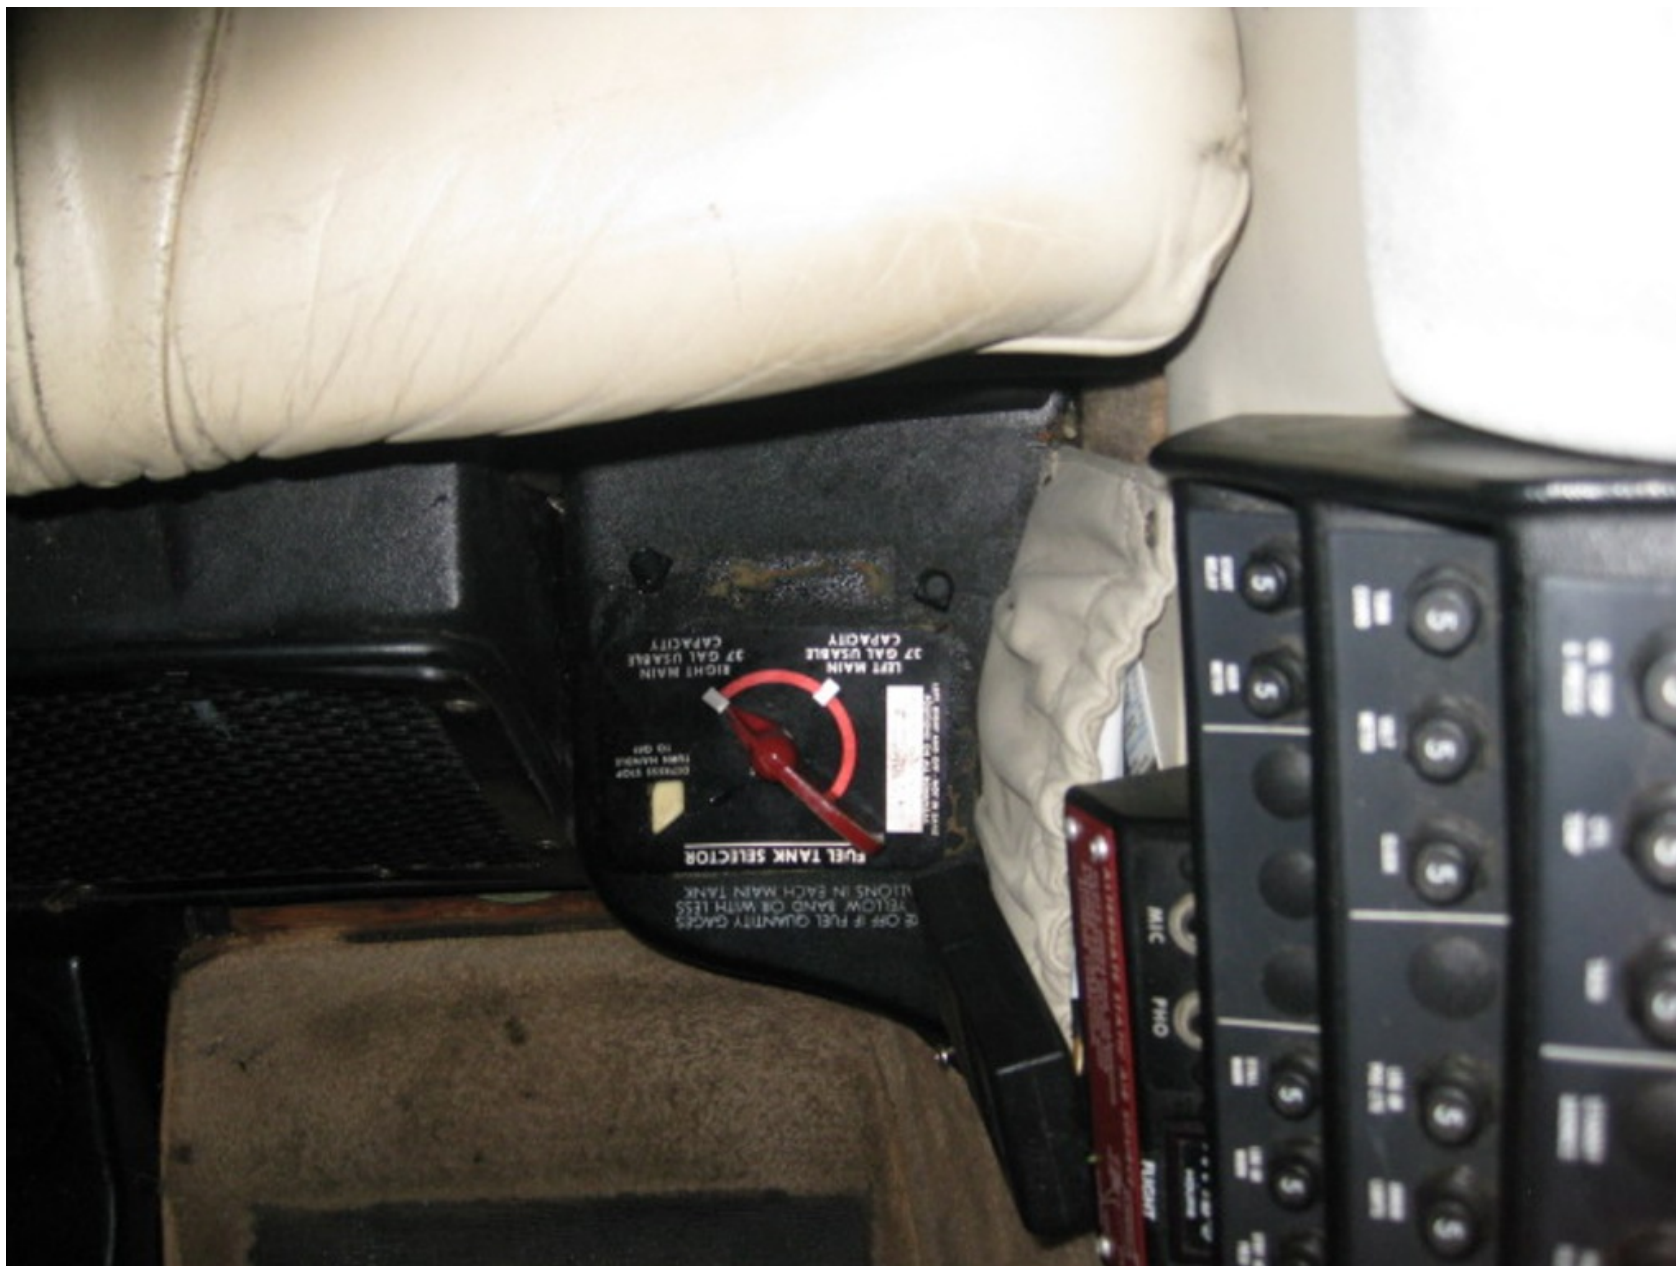
**Photo 5 - FAA Digital Photograph. View of the Fuel Selector Valve in the Right Main Tank Position.**

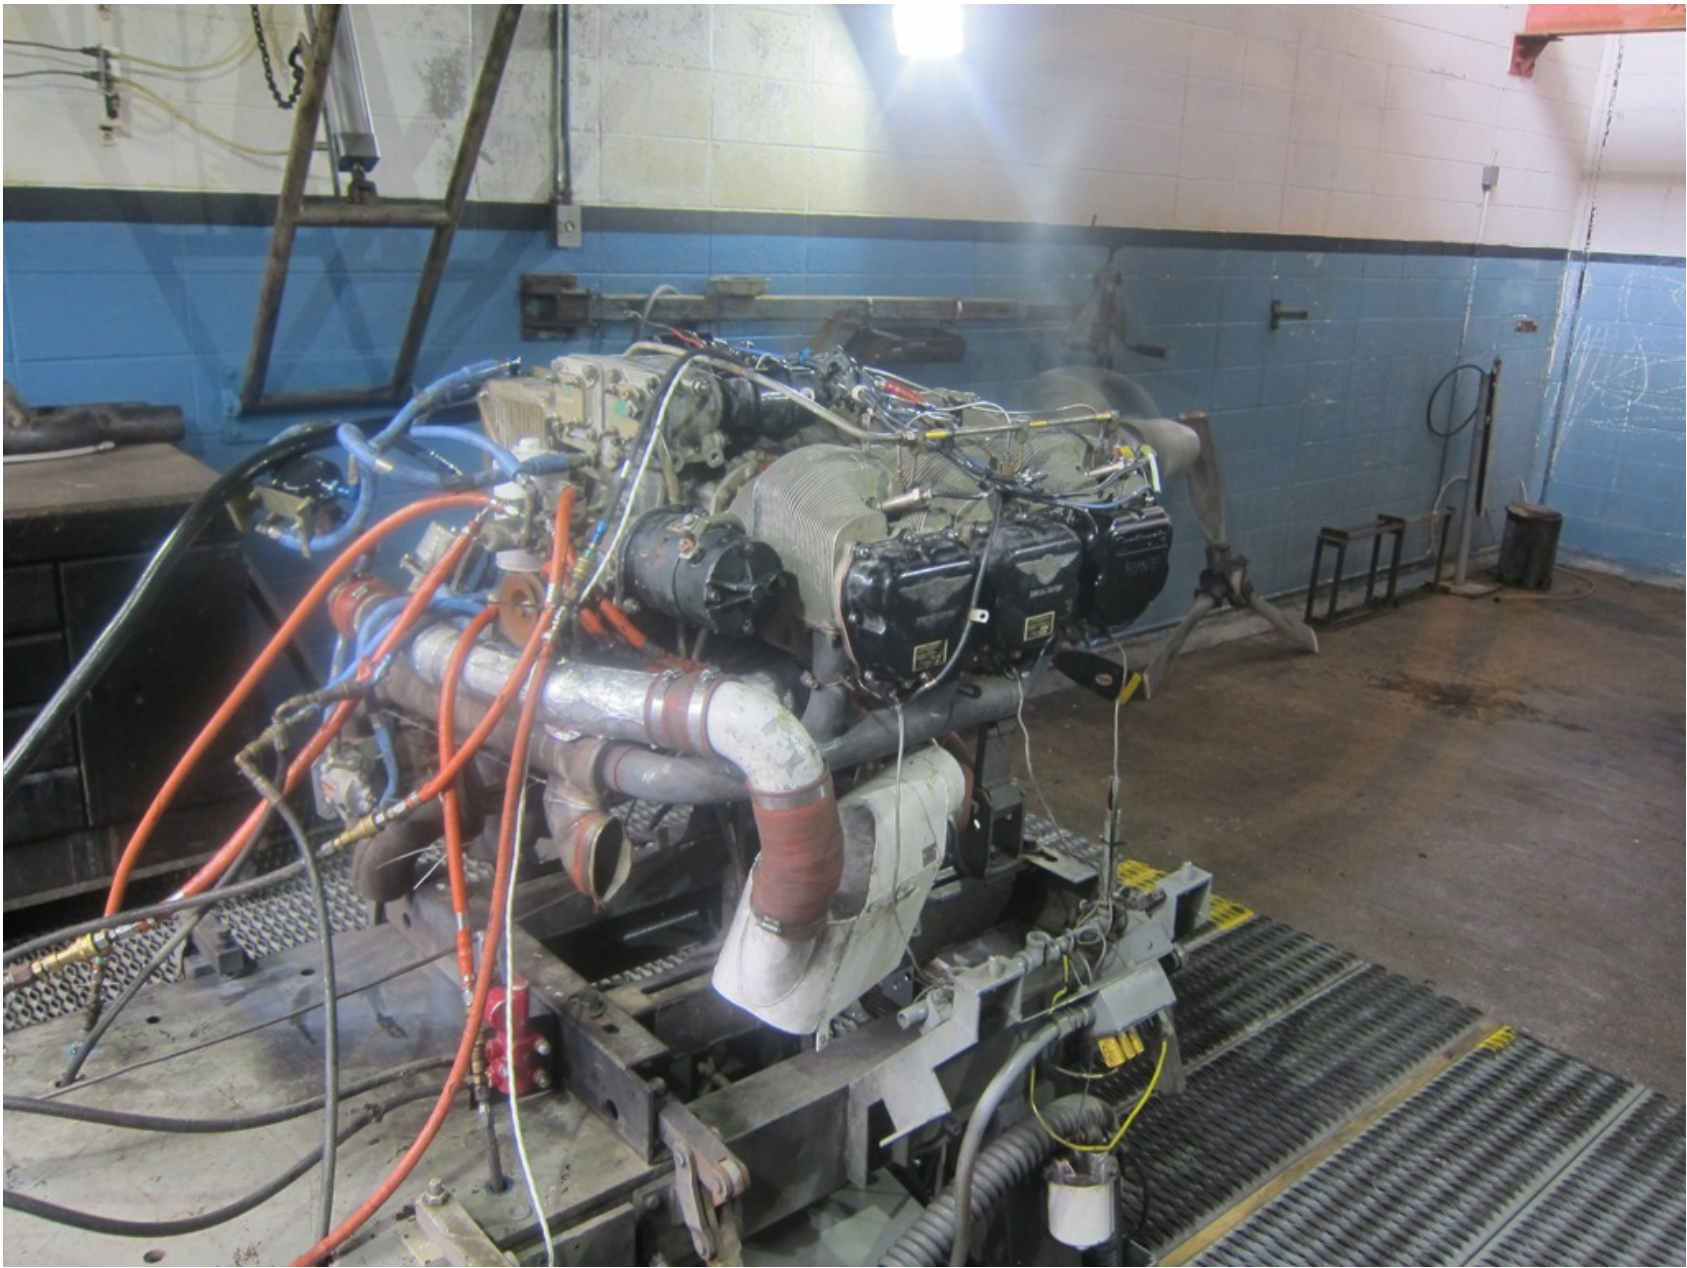
**Photo 6 – Continental Aerospace Technologies Digital Photograph. View During Operational Testing of the Engine in the Test Cell.**
