NATIONAL TRANSPORTATION SAFETY BOARD  
OFFICE OF AVIATION SAFETY  
WASHINGTON, D.C.

# N1537U ENGINE EXAMINATION REPORT

**A. Accident : ERA18LA233**

LOCATION : New Kent County Airport (W96)  
DATE : August 26, 2018  
TIME : 1610 eastern daylight time (EDT)  
AIRCRAFT : Cessna 172 N1537U

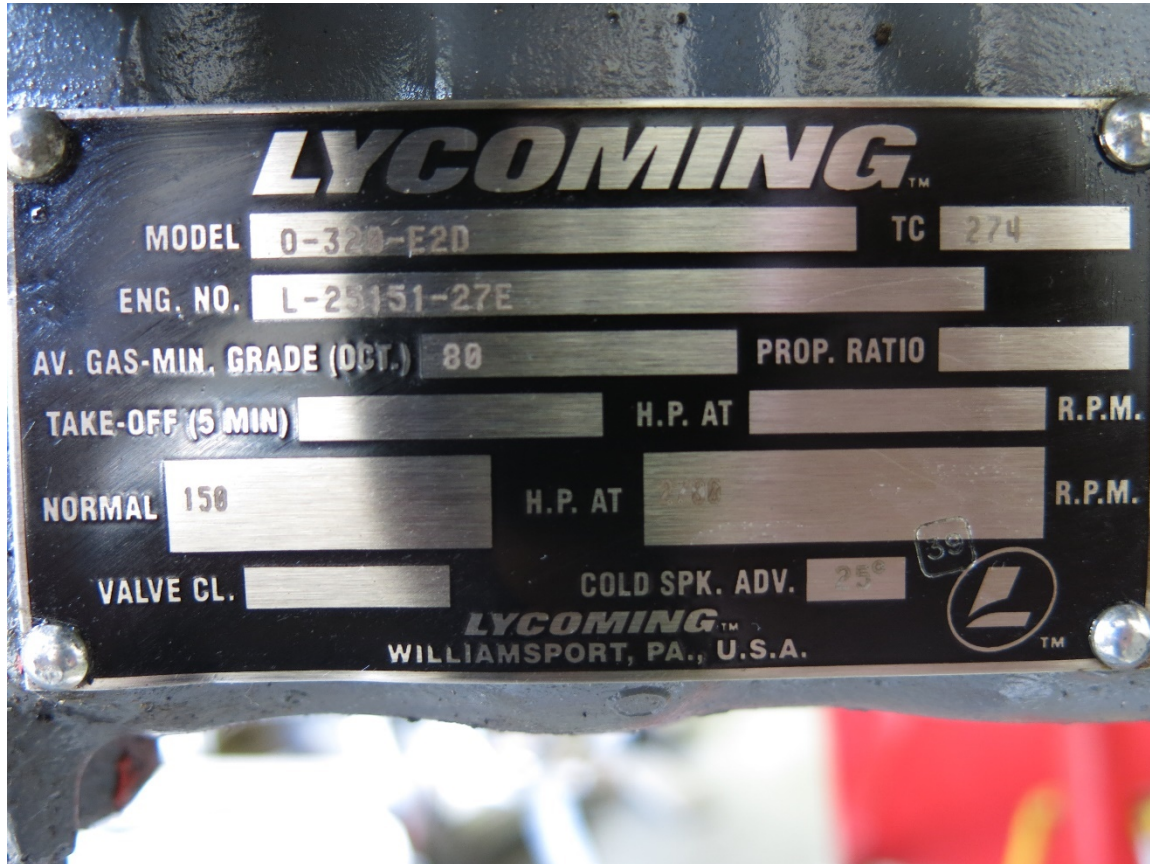
**Photograph 1 – Engine Data Plate**

Engine Manufacturer: Lycoming  
Engine Model Number: O-320-E2D  
Engine Serial Number: L-25151-27E

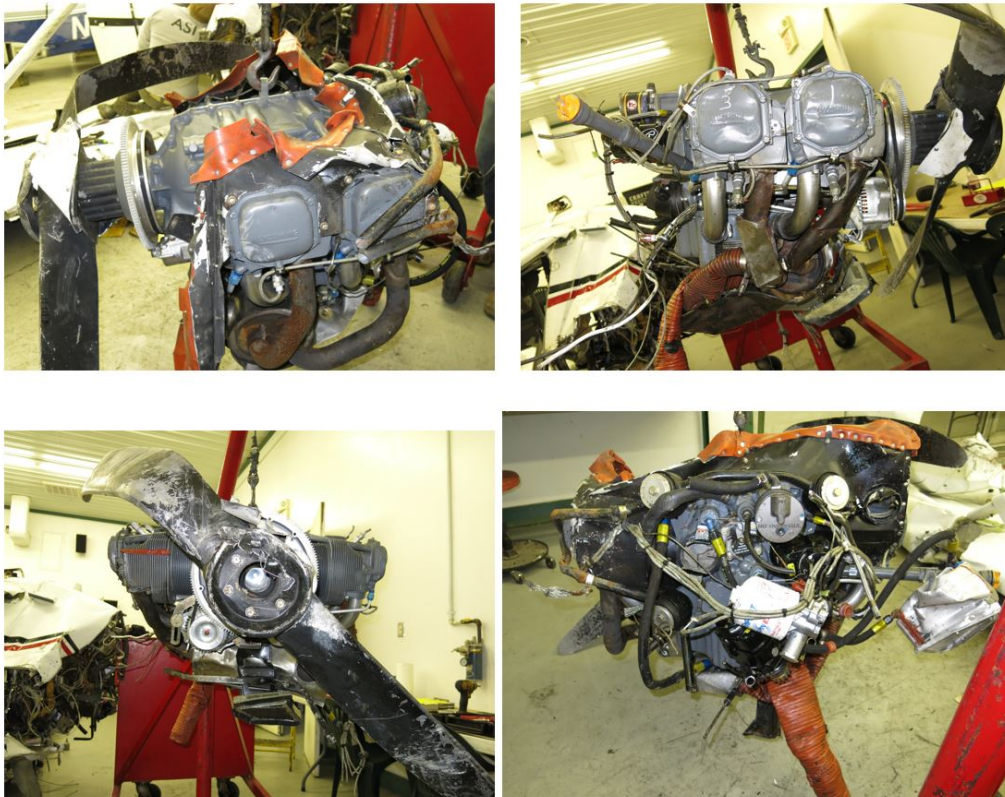
**Photograph 2 – Engine**

The engine remained mounted to the controls and firewall, following was noted:

- The oil filter, oil filter base and dip stick were fractured from the engine.
- The Left magneto was fractured from the engine and hanging from the ignition leads
- All other components remained attached to the engine (photograph 2).

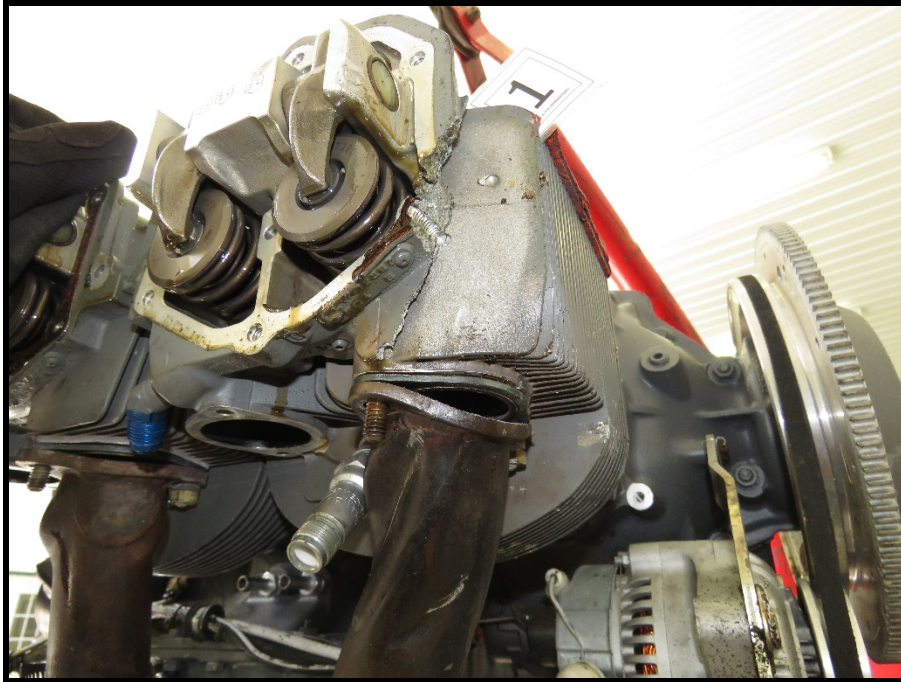
**Photograph 3 – Cylinder No. 1**

The rocker box covers were removed, and no anomalies were noted on cylinders Nos. 2, 3, and 4. Cylinder No. 1 showed signs of impact damage (photograph 3). Crankshaft continuity was confirmed to the accessory section and valvetrain continuity was confirmed by rotating the propeller by hand. The top spark plugs were removed and thumb compression and suction was observed on all cylinders when the crankshaft was rotated. The cylinders were examined by borescope and no anomalies were noted.

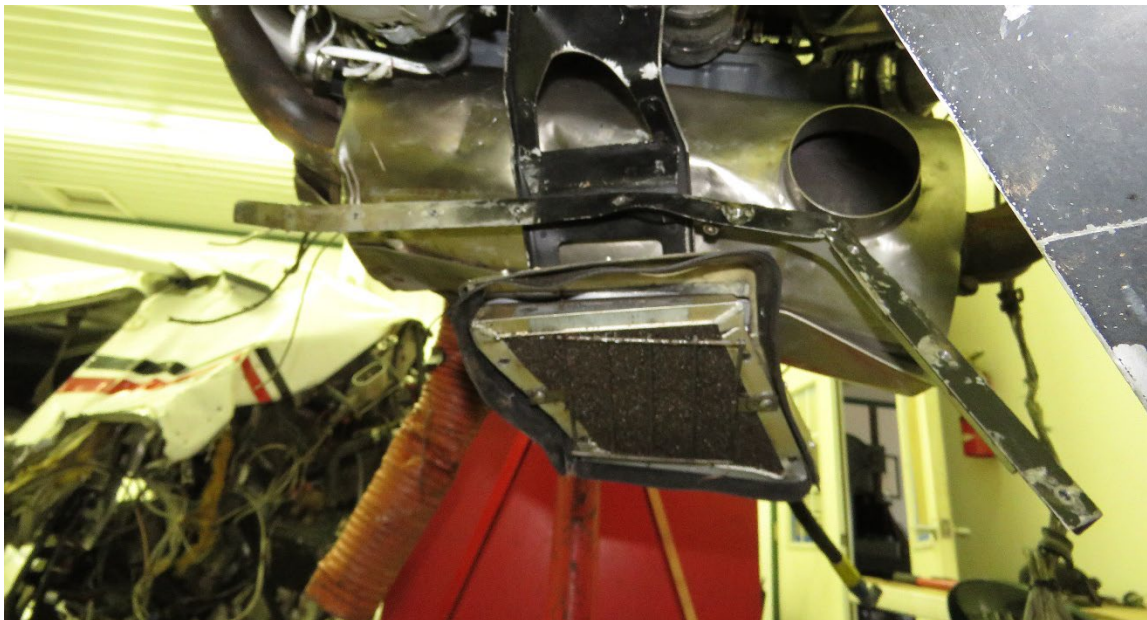
**Photograph 4 – Air Filter**

The air filter box (photograph 4) showed signs of impact damage. The air filter was found clear of debris and free of obstructions.

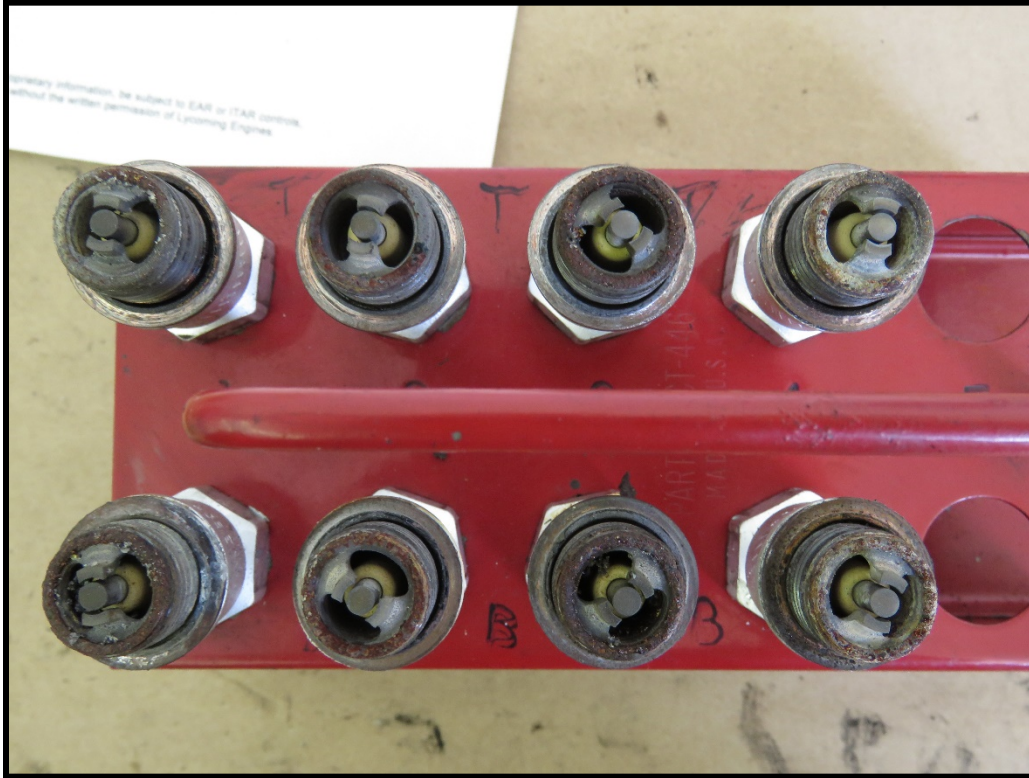
**Photograph 5 – Spark plugs**

All spark plugs were removed from the engine (photograph 5). The spark plugs were massive electrode type plugs. All spark plugs showed coloration consistent with normal engine operation and signs corrosion post accident rust.

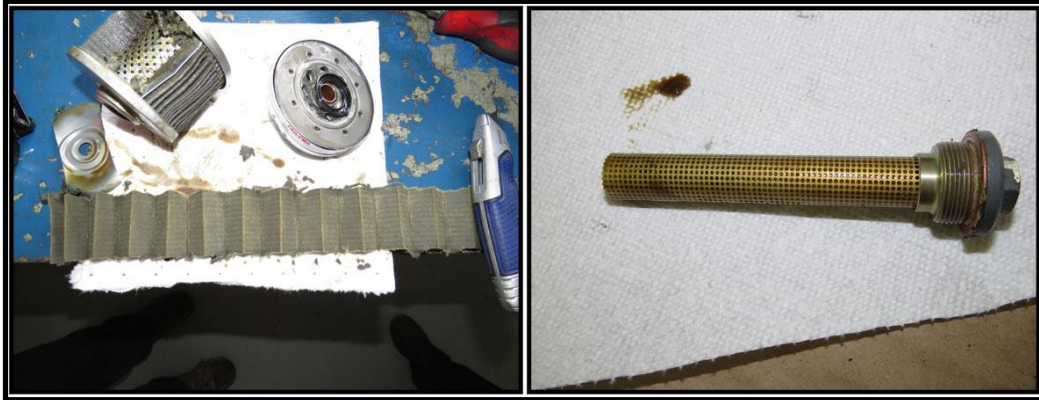
**Photograph 7 – Oil Filter and Oil Suction Screen**

The oil filter, oil filter base and dip stick were fractured from the engine. The oil filter was cut open and filter element was inspected. The filter was found free and clear of metal. (photograph 6). The oil suction screen was removed and found free and clear. The oil cooler unit remained intact and attached to the engine by its inlet and outlet hoses

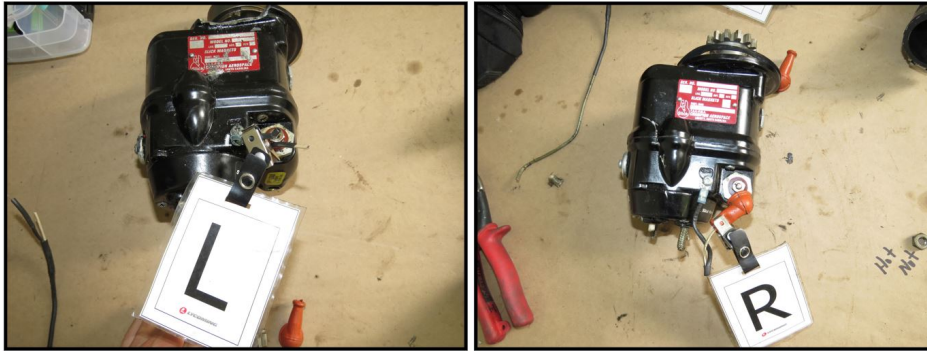
**Photograph 7 – Left and Right Magnetos**

The right magneto remained attached to the engine and was removed. The left magneto was fractured from the engine and hanging from the ignition leads. Both magnetos were rotated by electric drill and spark was observed on all towers, water was observed in both magnetos

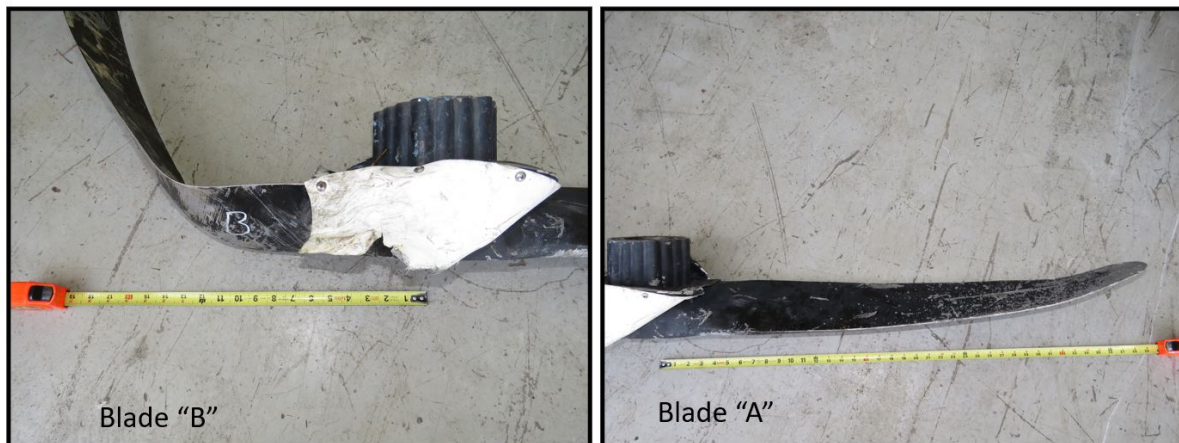
**Photograph 8 – Propeller Blades**

The propeller was labeled as an McCauley identified by P/N # 1C160DTM7553. The propeller showed signs of impact damage to both ends. One blade was bent rearward about 80° (12 inches from the hub) and the other blade bent rearward about 10° (30 inches from the hub). Leading edge polishing, cordwise scratching, and leading edge gouges were observed on both blades.
