# NATIONAL TRANSPORTATION SAFETY BOARD

## MATERIALS LABORATORY FACTUAL REPORT

Report No. 19-081

Place : Georgetown, South Carolina  
Date : September 22, 2018  
Vehicle : Beech V35, N435RB  
NTSB No. : ERA18LA258  
Investigator : Leah Read, AS-ERA

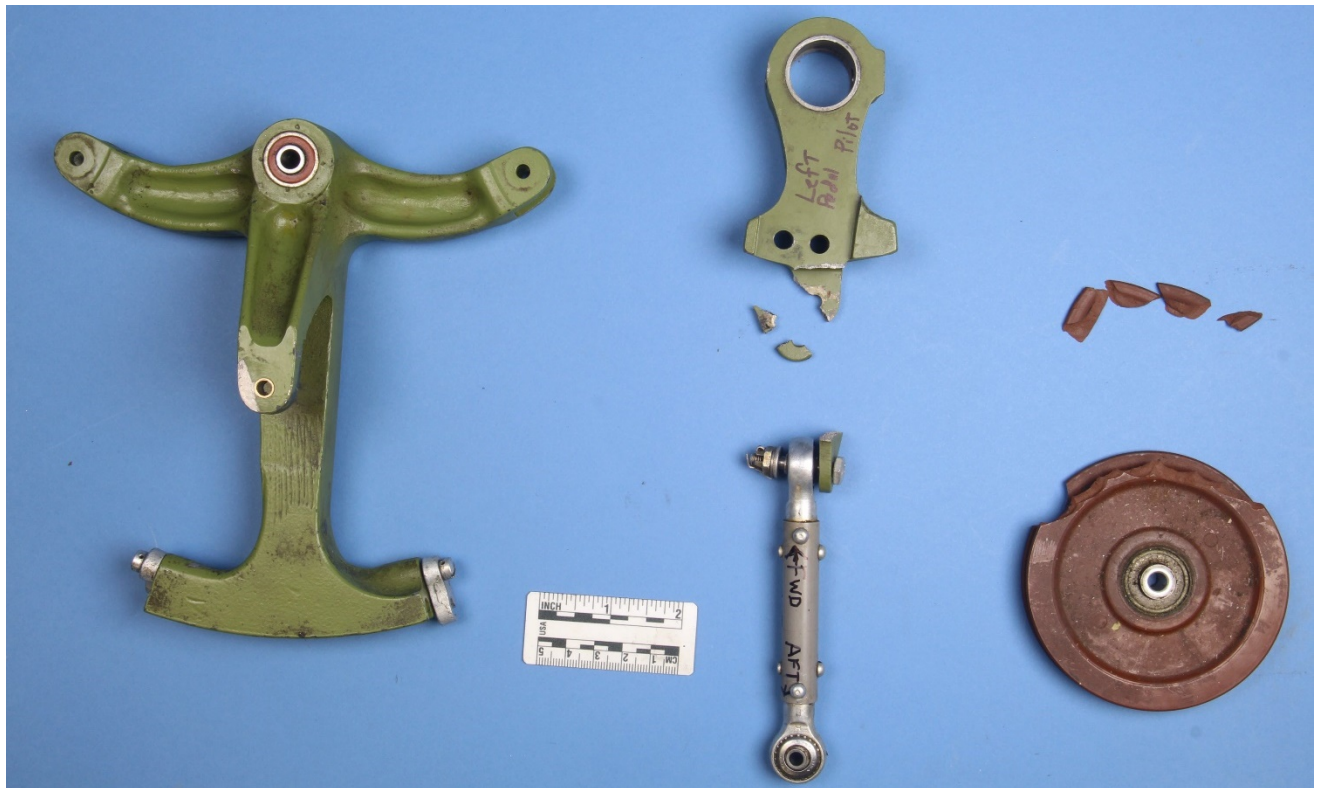
Figure 1 shows the components from the rudder control system, as received by the NTSB Materials Laboratory. The components included a bellcrank, a control pulley, push rod tube, and a lower arm. The pulley and arm assemblies had fractured in multiple

Figure 1 – The components from the pilot rudder system, as received.

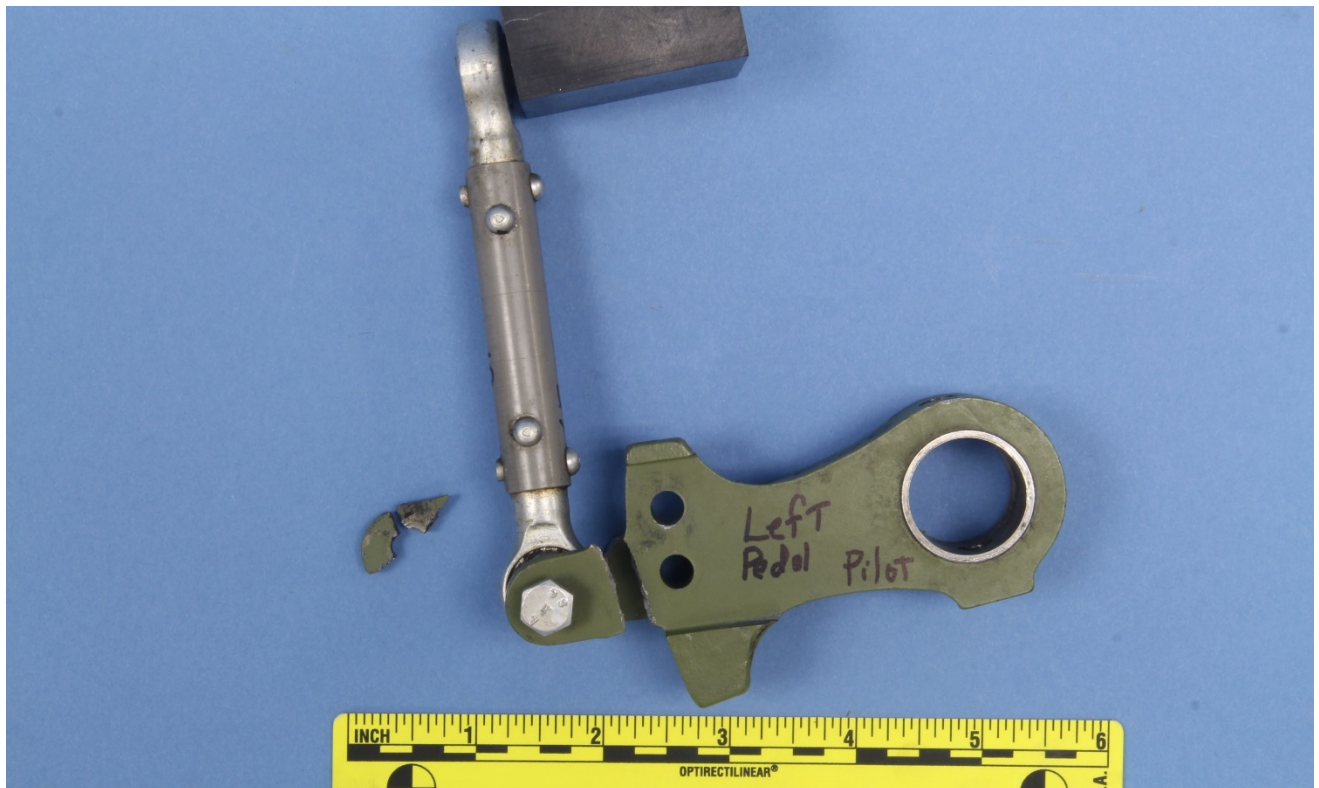
Figure 2 shows a reconstruction of the push rod and the lower arm from the left-hand rudder. The clevis of the lower arm had attached to the forward side of the push rod tube assembly, as shown in Figure 2. The outboard clevis remnant of the arm was still attached with a bolt and nut. The outboard clevis remnant had fractured at the corner. The inboard clevis had fractured in three locations. The push rod tube, as depicted in Figure 3, did not exhibit any indications of damage. The fisheye bearings on both the forward and aft sides of the push rod tube assembly were able to be moved and did not exhibit any contamination or corrosion.

Figure 2 – The pilot left pedal from the outboard side, repositioned with the push rod tube to show placement of the fractured clevis attached to the rod bolt.

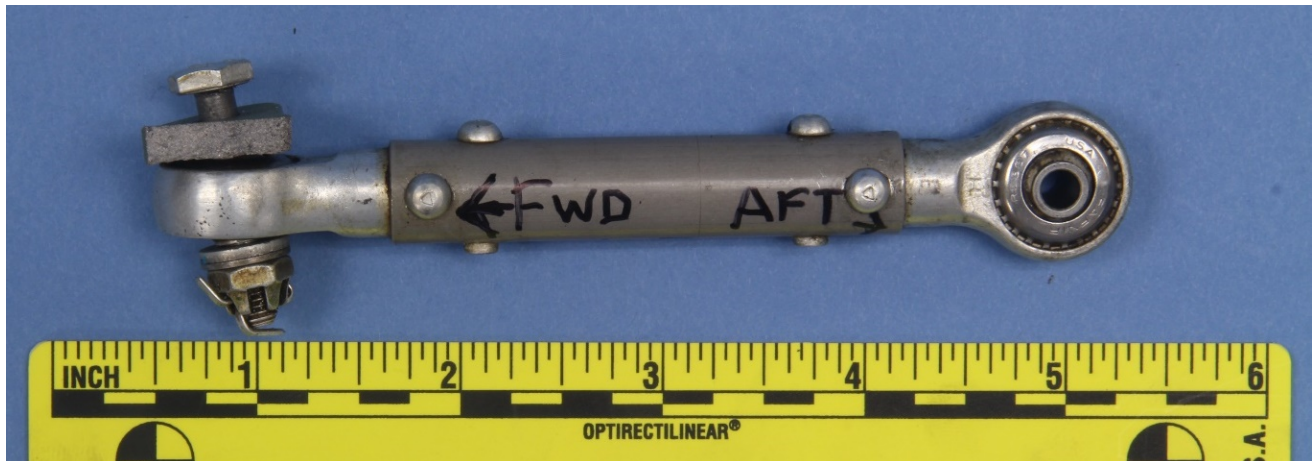
Figure 3 – The push rod tub, viewed showing the fractured clevis from the pedal lower arm.

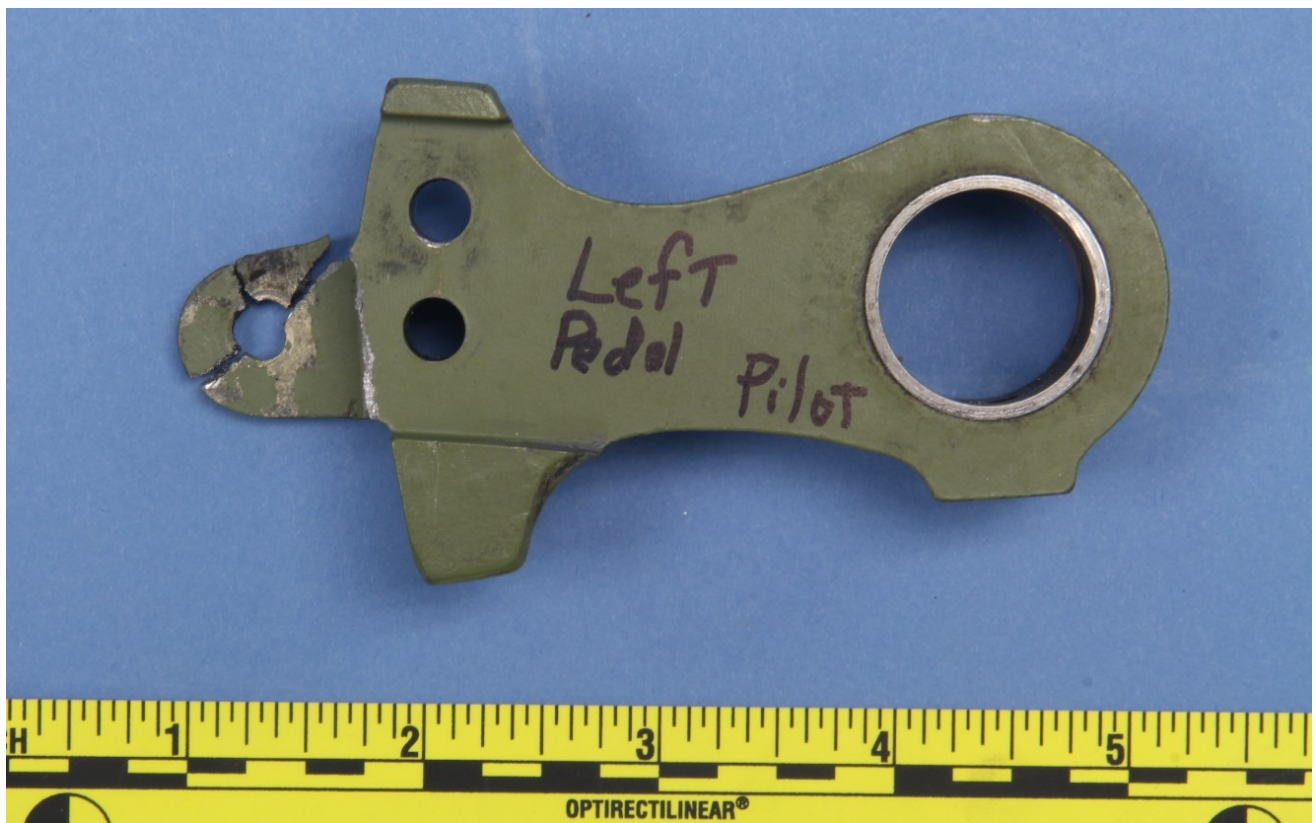
Figure 4 through Figure 7 show the fractured pieces of the clevis fragments that were not attached to the push rod bolt, positioned in their respective places on the pedal arm main remnant. The inboard clevis had fractured radially about the bolt hole in three locations. In contrast, the outboard clevis had fractured at the corner with the pedal body. The inside surfaces of the inboard clevis fragment exhibited missing paint, as shown in Figure 4. The bolt hole surfaces of these pieces also exhibited some wear, consistent with rubbing against the mating bolt shank.

Figure 4 – The left pilot pedal arm from the outboard side, with the pieces of the fractured clevis positioned in their placement at fracture.

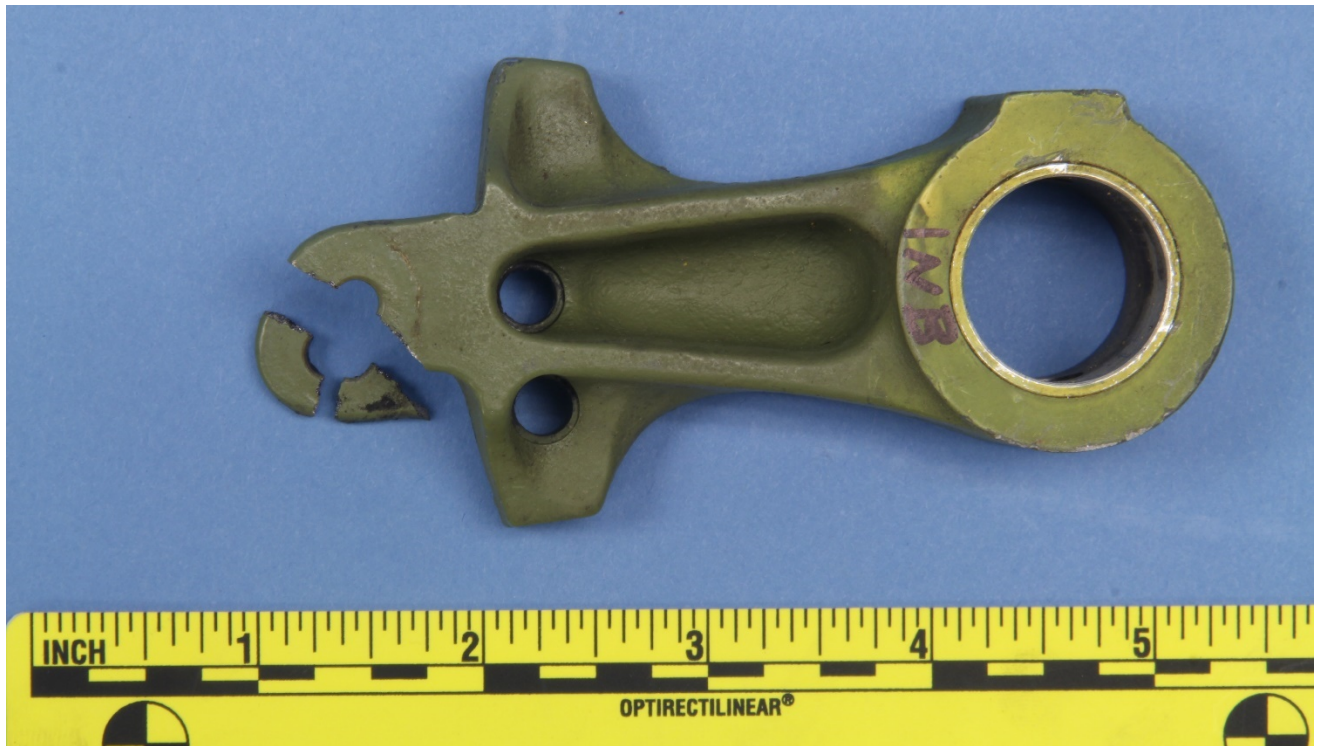
Figure 5 – The fractured pieces of the left pilot pedal arm from the inboard side.

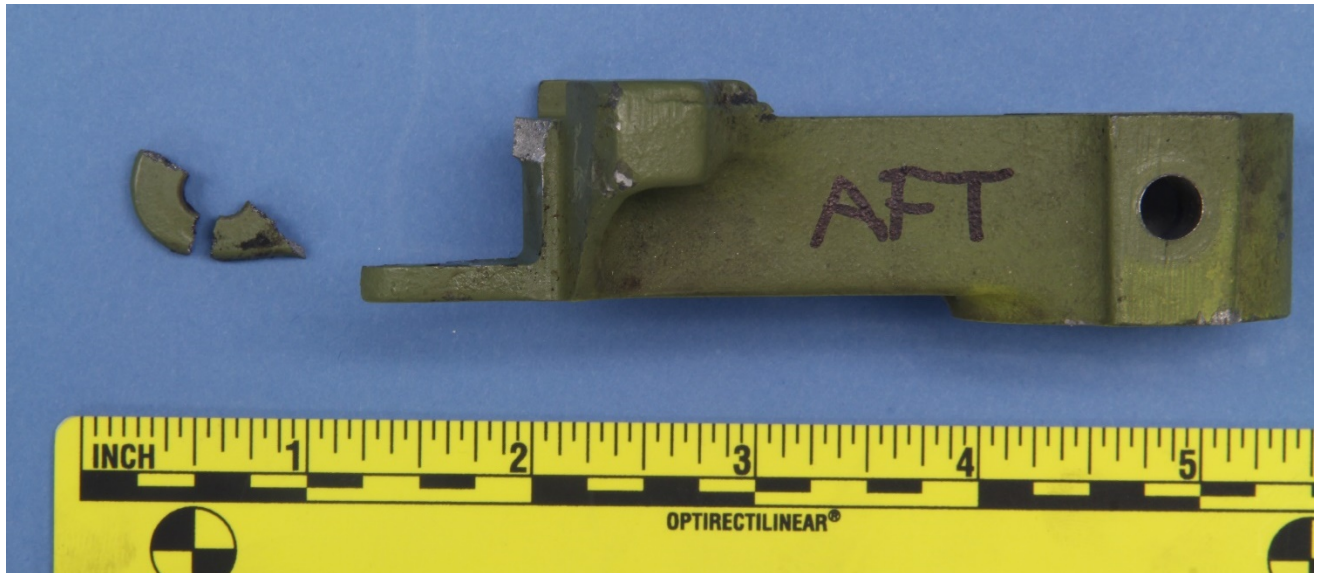
Figure 6 – The fractured pieces of the left pilot pedal arm from the aft side.

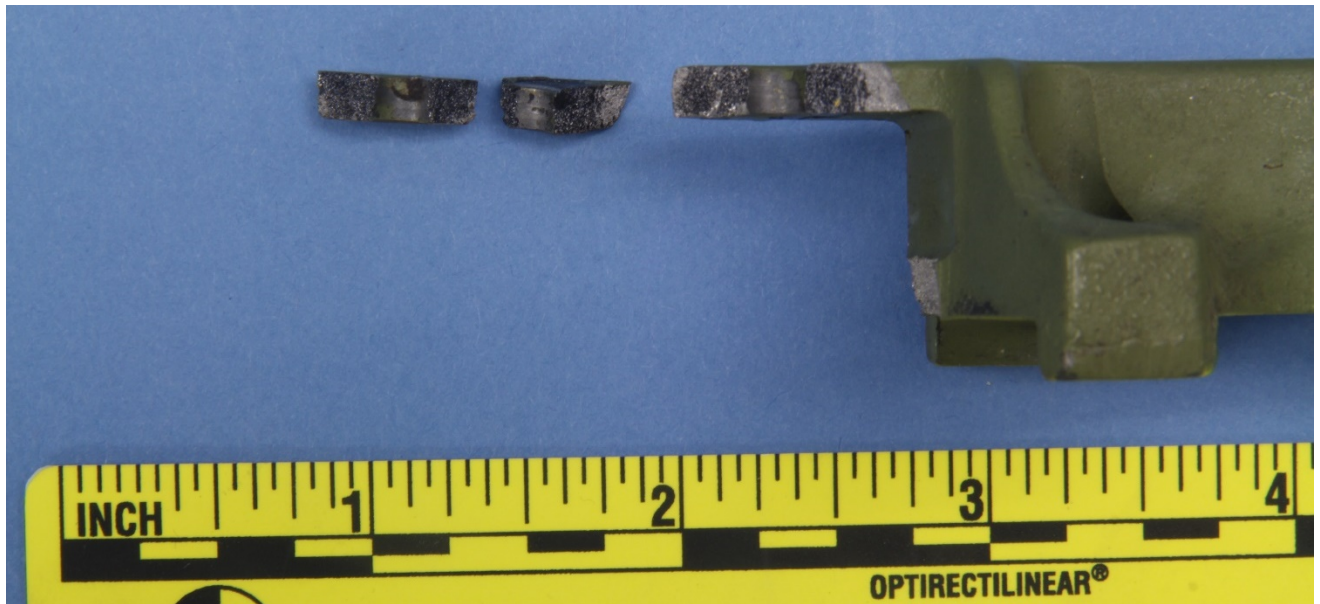
As shown in Figure 7 and Figure 8, the inboard clevis fragment fracture surfaces, and the mating inboard fracture surface on the pedal arm, exhibited a dark color. This was in contrast to the lighter, shiny fracture surfaces of some of the fractures on the pedal arm, and the outboard clevis fragment, shown in Figure 9.

Figure 7 – View of the fractured clevis fracture surfaces, positioned to face the reader.

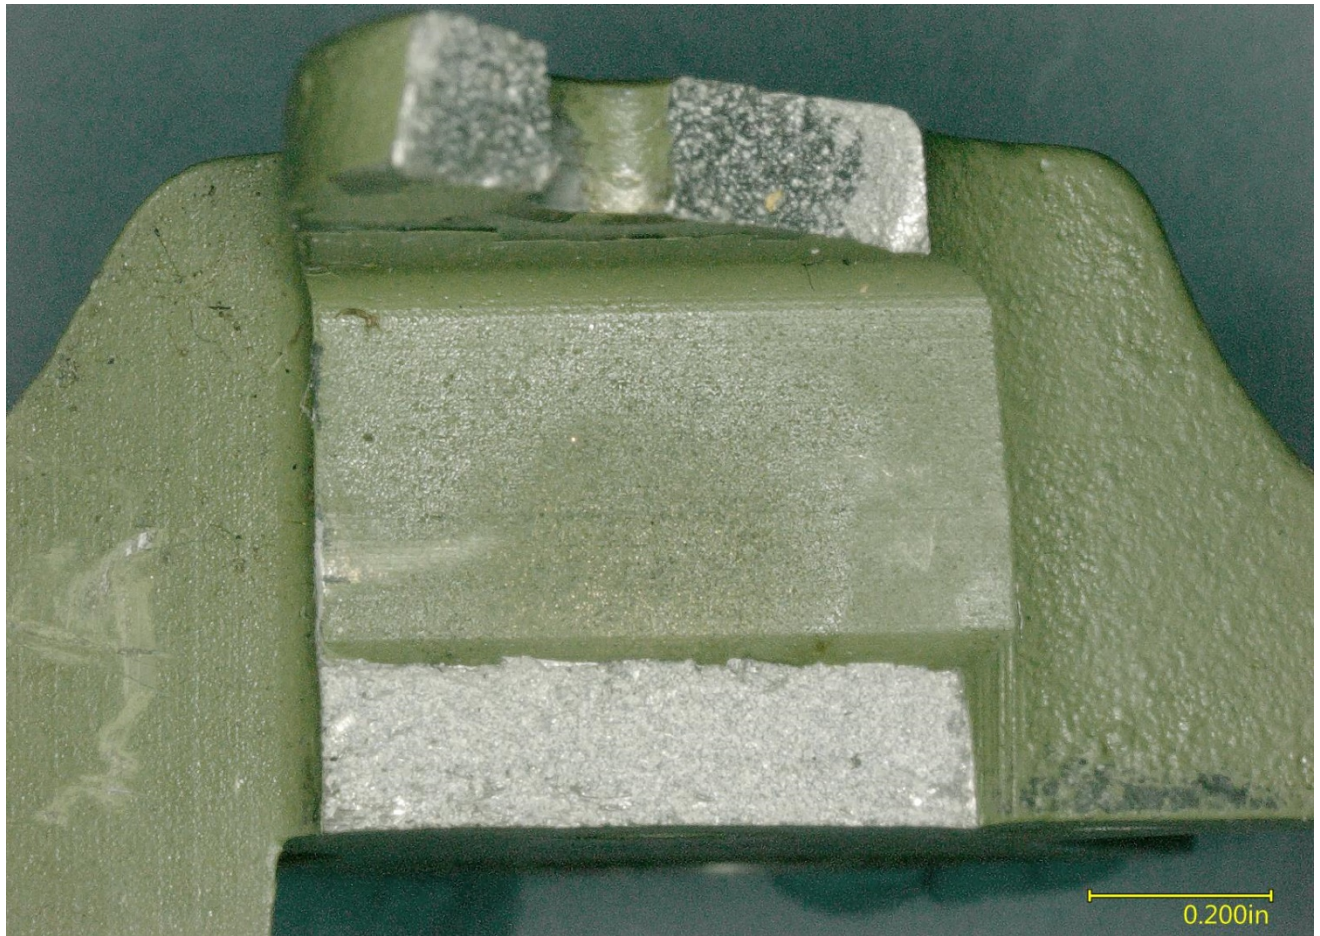
As shown from the slant toward the outboard direction on the outboard clevis fracture on the pedal arm (Figure 8) and the fractured clevis (Figure 9a), the direction of fracture was consistent with bending toward the outboard direction. In examining the fracture surfaces, no indications of plastic deformation or localized ductility were observed. The material adjacent the fracture surfaces was not deformed, consistent with a lack of ductility at fracture of the pedal arm.

Figure 8 – The left pilot pedal arm from the forward side, tilted to show the clevis fracture surfaces.

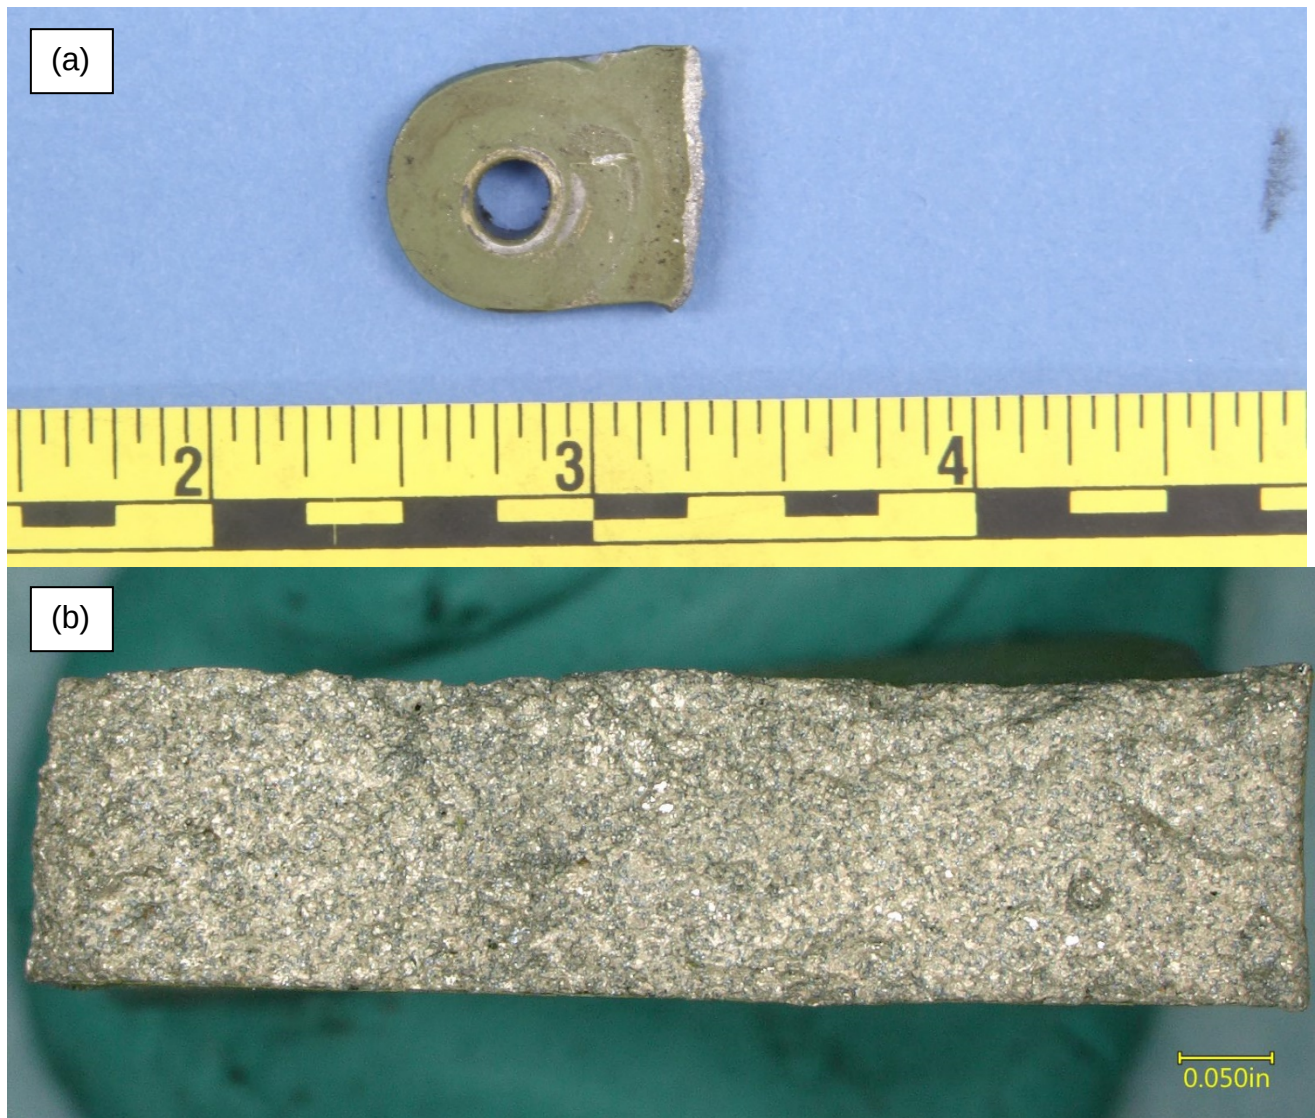
Figure 9 – View of the whole fractured clevis from (a) the side and (b) the fracture surface.

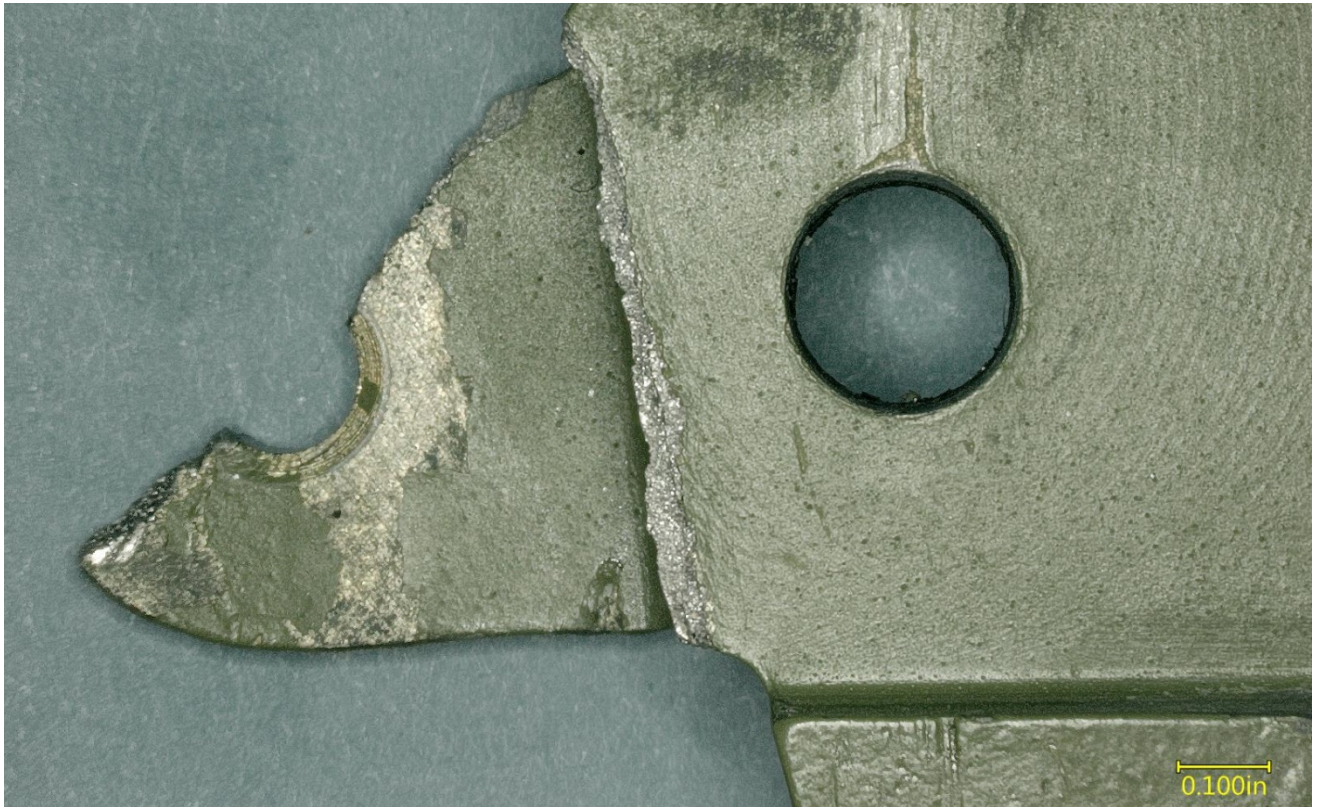
Figure 10 shows the outboard side of the fractured clevis locations. The intact clevis piece that fractured exhibited a slant with the fracture surface facing outboard (see Figures Figure 8 and Figure 10). These features were consistent with the intact clevis piece having fractured in an outboard bending direction.

Figure 10 – Closer view of the fractured clevises from the outboard side.

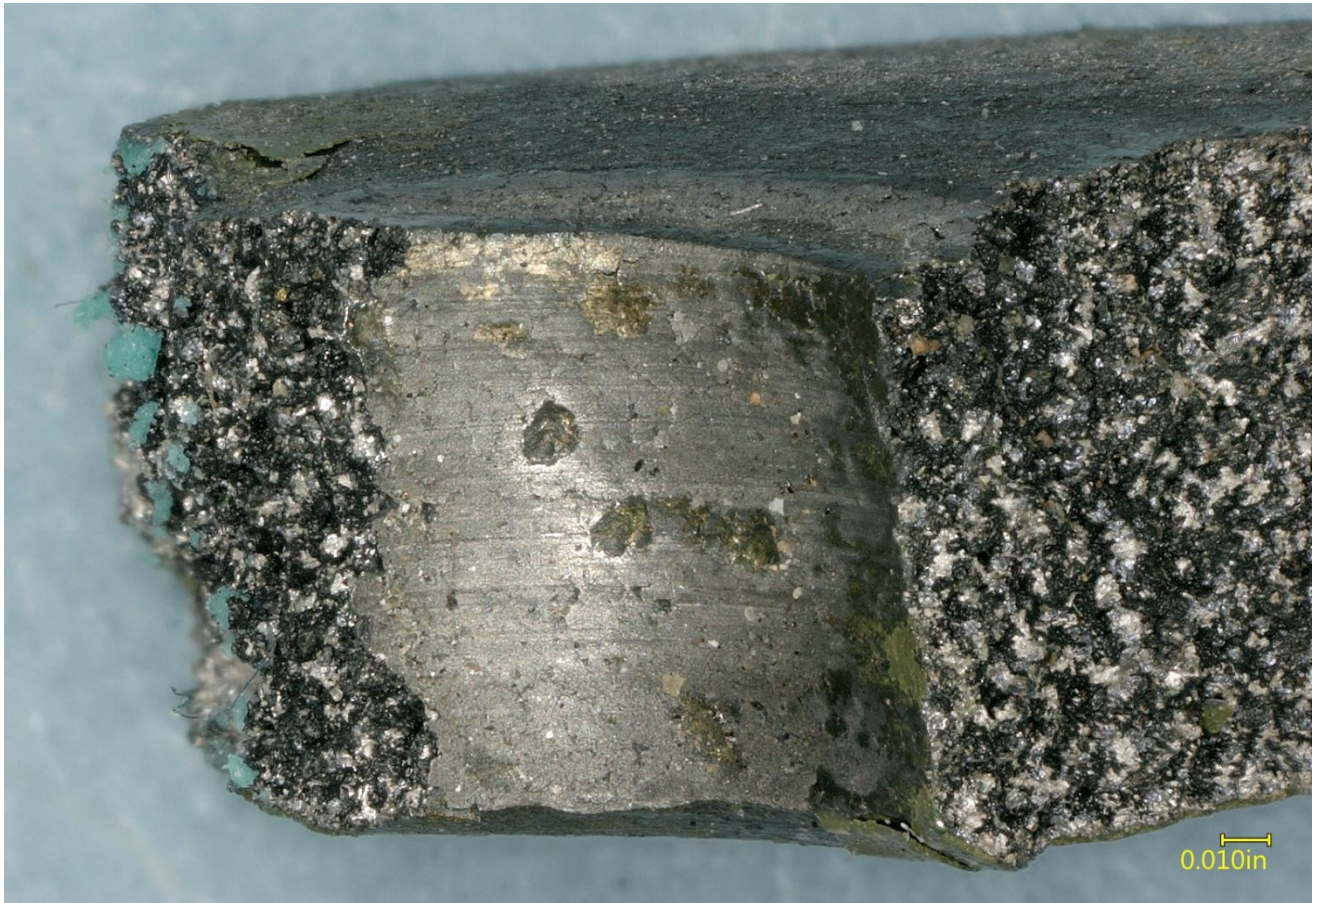
Figure 11 shows the side bore of the smallest fractured clevis fragment from the inboard side. The bore surface exhibited cracking, consistent with the radial orientation of the fracture surfaces on the left and right in the figure. Figure 12 shows one of the fracture surfaces of the fragment. Half of the fracture surface exhibited a shiny appearance, while the other half exhibited a darker color. Figure 13 shows a closer view of the divide on the fracture surface. Both sides were rough with high peaks and valleys. The shiny region of the fracture surface exhibited some flat facets, which were light blue in color.

Figure 11 – View of the bore hole of the smallest clevis fragment, showing cracking and missing material.

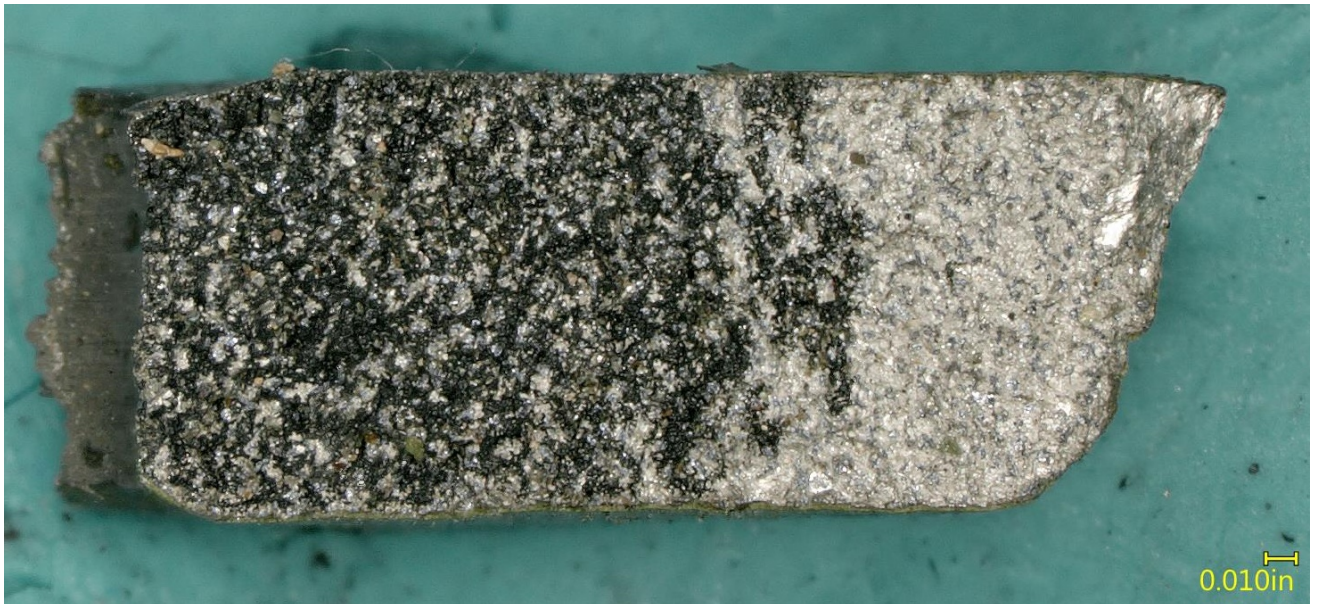
Figure 12 – Flat view of the fracture surface of the clevis fragment in Figure 11, showing dark and light regions.

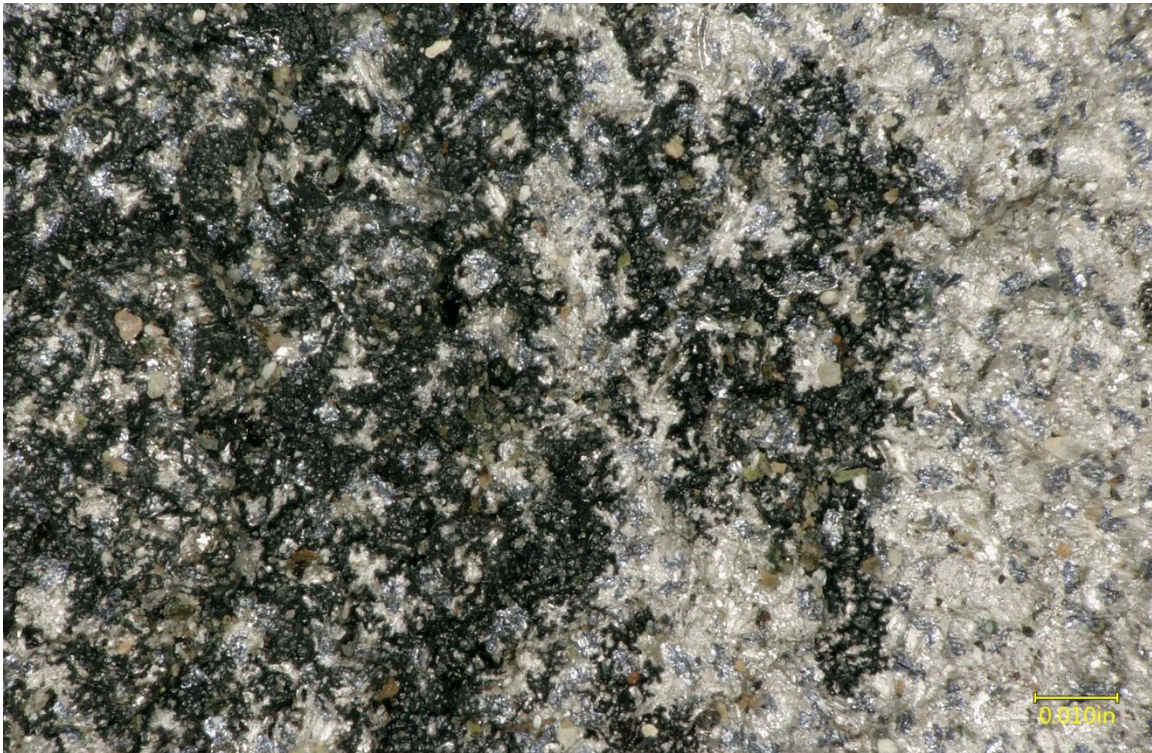
Figure 13 – Closer view of the fragment fracture surface, showing a dark surface material.

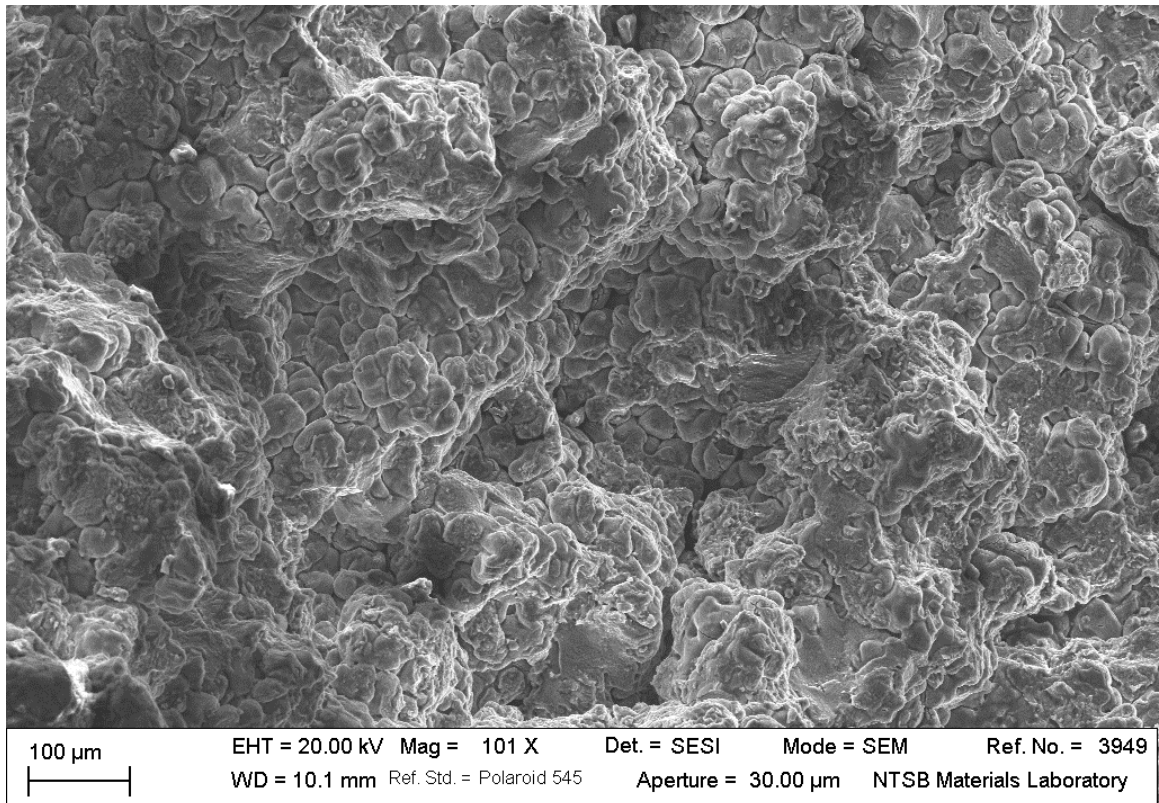
The fracture surfaces of the clevis fragments were examined using a scanning electron microscope (SEM). Figure 14 shows a typical area of one of the fracture surfaces. The surface was tortuous with varied heights. The surface exhibited areas with rounded features and sharper jagged areas.

Figure 14 – Secondary electron (SE) micrograph of a typical area of the pedal arm clevis fracture surface.

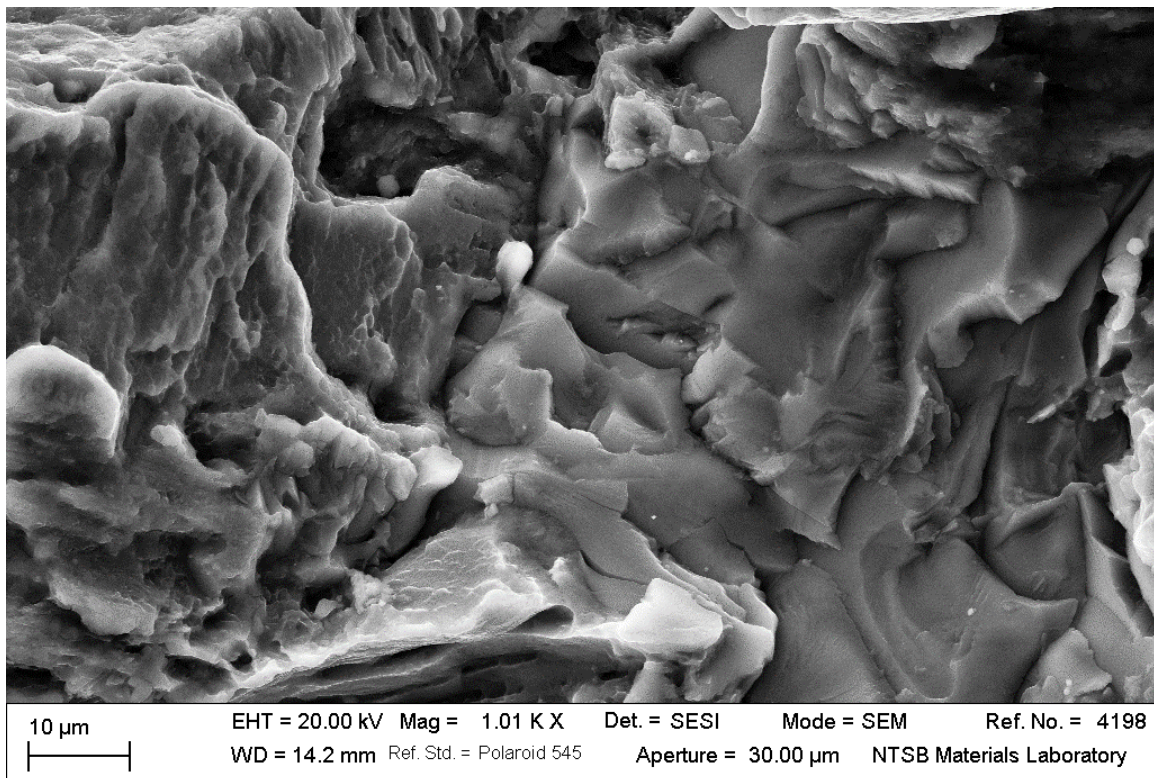
Figure 15 shows some of these sharper features. They consisted of cleavage steps with localized tearing (right side on Figure 15). These features were consistent with fracture of the microscopic precipitates and secondary phases typical of a casting. The fracture surface also exhibited fine dimple rupture features (Figure 16). These features were consistent with ductile overstress fracture of the matrix constituent of the microstructure of the arm.

Figure 15 – SE micrograph of a typical area of the fracture surface exhibiting overstress fracture features.

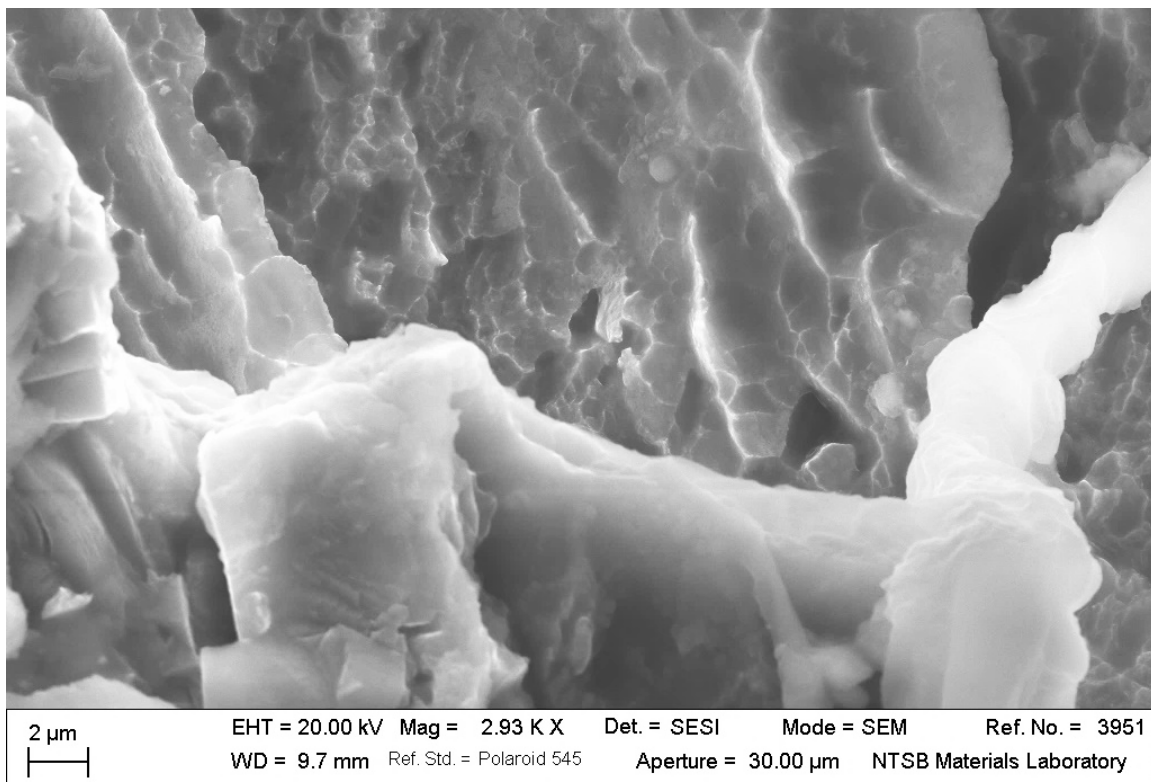
Figure 16 – SE micrograph of dimple rupture on the pedal arm clevis fracture in Figure 15.

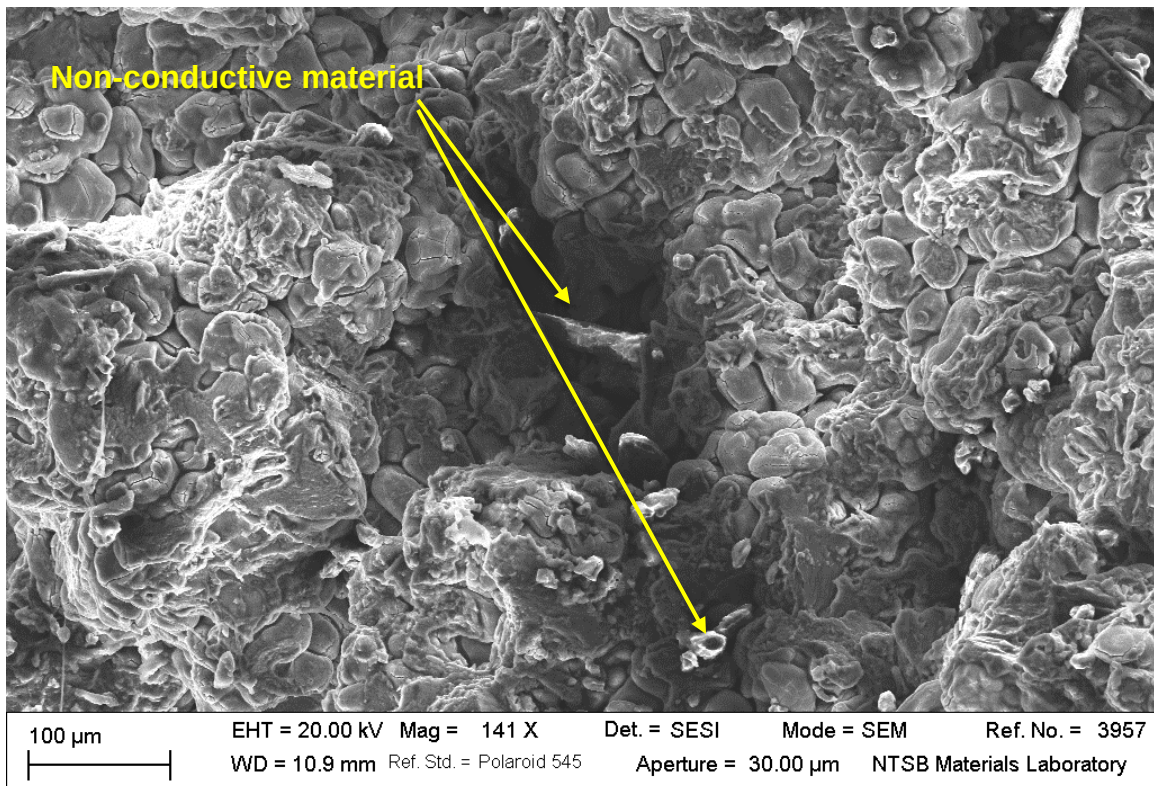
Figure 17 shows a closer view of the rounded features of the fracture surface. These regions typically consisted of deep valleys containing nonconductive material—this material charges in an electron microscope, leaving under- or overexposed areas in micrographs taken with an SEM. Figure 18 shows a closer view of the rounded features. The surfaces typically exhibited a nonconductive (or less conductive) layer. This surface layer exhibited branched microcracking along the surface. The rounded features were consistent with the surfaces of dendrites from the initial casting process. The microcracked surface material on these layers was consistent with surface oxide that formed during the casting process.

Figure 17 – SE micrograph of a rounded area of the clevis fracture, exhibiting non-conductive material.

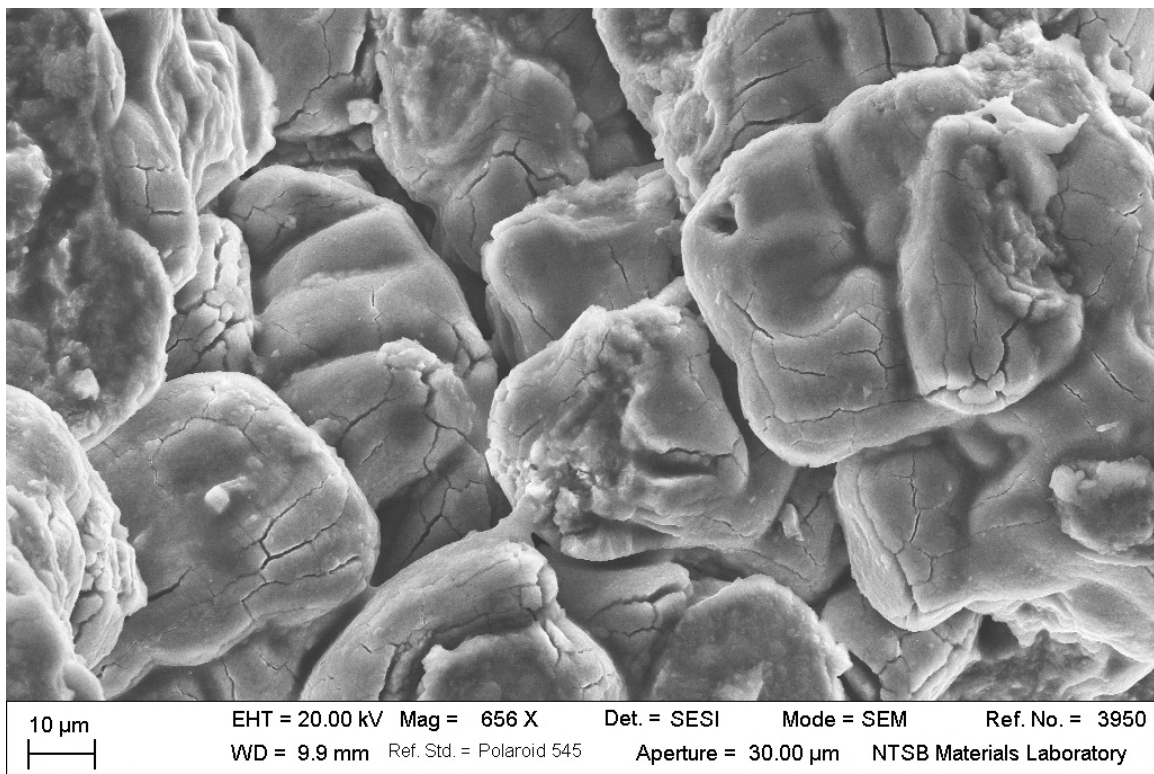
Figure 18 – SE micrograph of the rounded fracture surface areas, showing a microcracked surface layer.

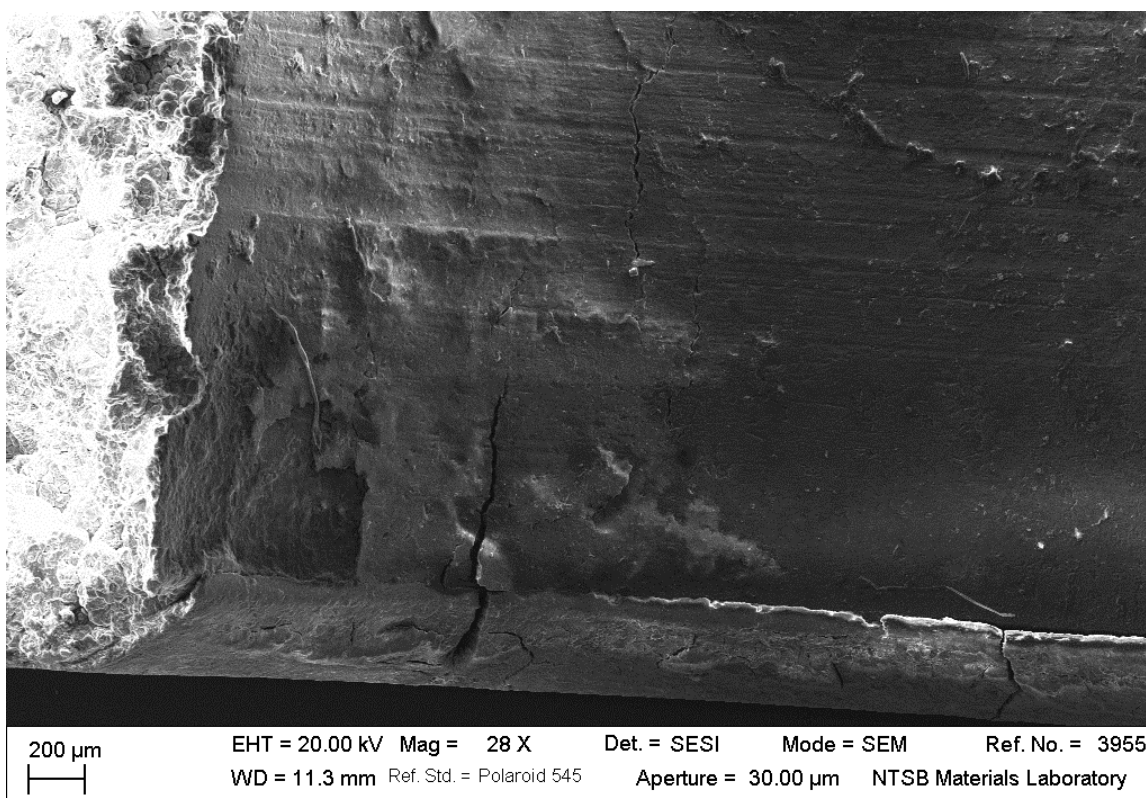
Figure 19 shows the side of one of the fractured clevis fragments, from the inside bore of the bolt hole. As illustrated in the figure, multiple cracks were open to the surface. These cracks were radial in orientation and were parallel to the fracture surface (left in the figure).

Figure 19 – SE micrograph of the side of the fractured clevis piece, showing multiple cracks parallel to the fracture surface.

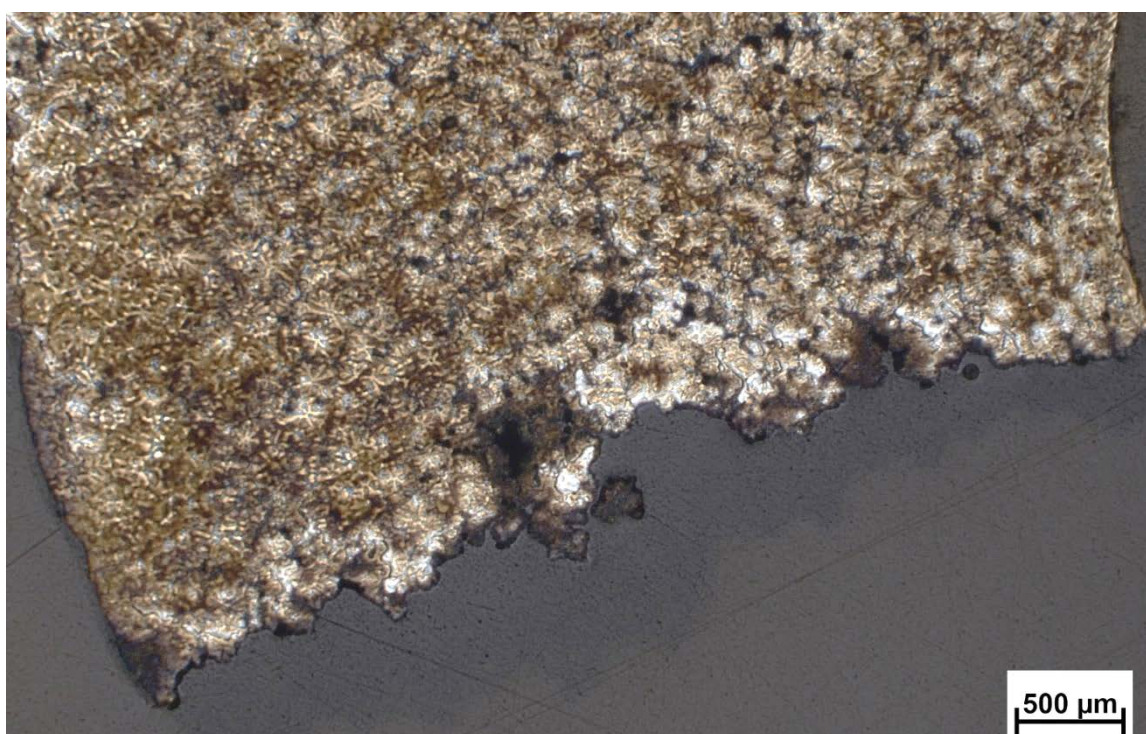
One of the fragments was vacuum mounted, polished, and etched. Figure 20 shows a typical cross section of this fragment, oriented with the fracture surface pointing downward in the figure. The figure shows a tortuous fracture surface. The light and darker colors were consistent with microstructure constituents of the clevis casting. The darker regions were areas with non-conductive material or empty space that had filled with epoxy during the mounting process. Figure 21 shows a closer view of the fracture surface. As shown in the figure, there were large gaps in the interdendritic regions, consistent with shrinkage voids from incomplete casting. Figure 21 also shows cracks emanating from these voids and interdendritic regions.

Figure 20 – Bright-field (BF) optical micrograph of the clevis fracture surface (~25X, etched from tap water).

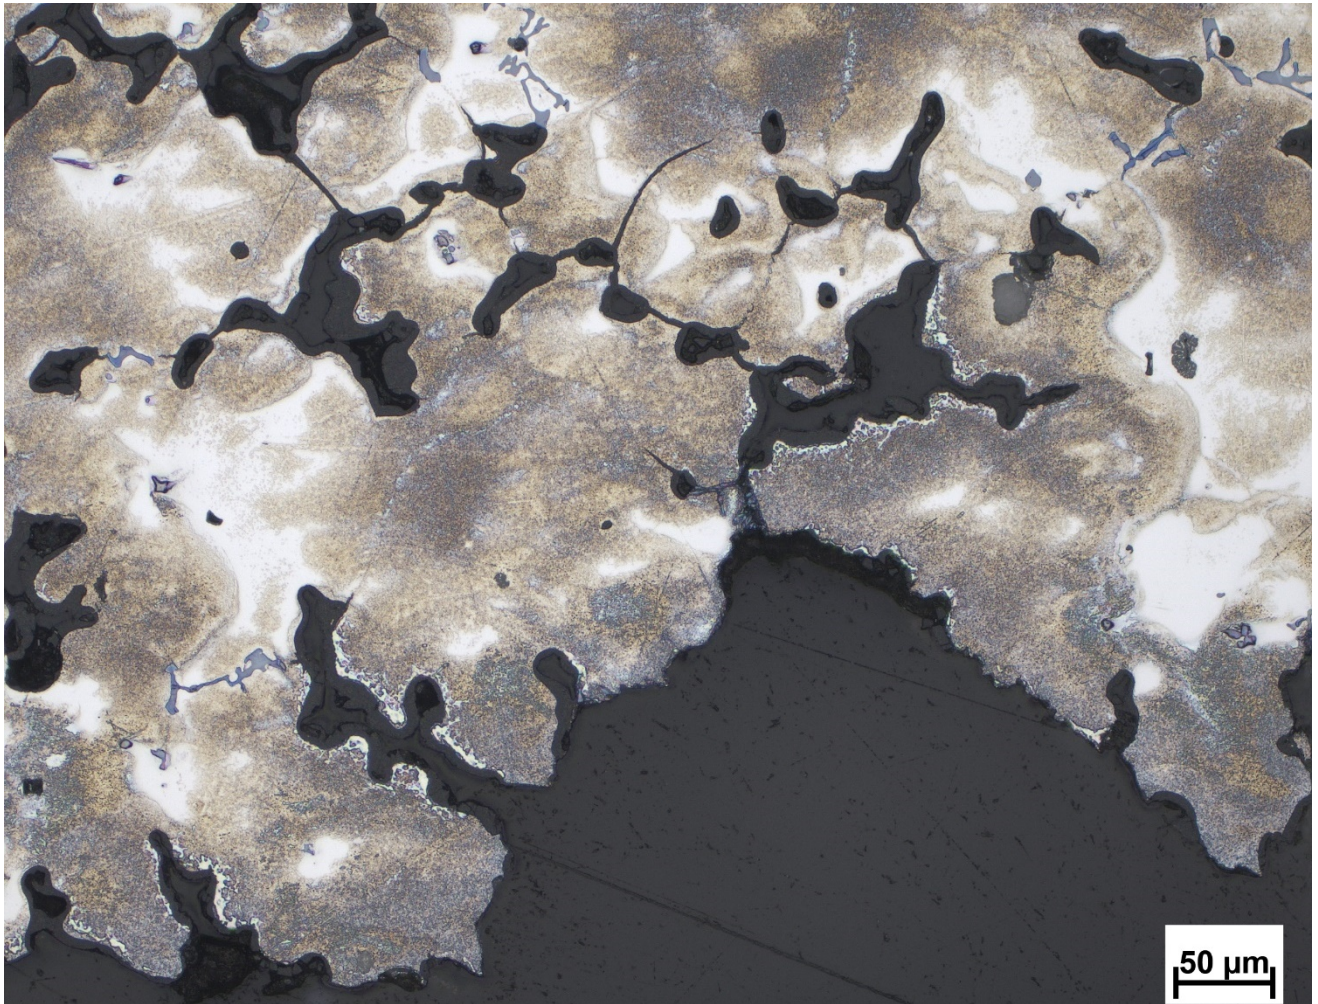
Overall, the fracture features observed were consistent with fracture of the clevis from cracks and voids created during the casting process. The presence of voids, cracks, and oxide layers would reduce the cross-sectional area that could withstand the force applied over the pedal arm clevises. Once a high enough load input was applied to the pedal arm, the remaining material fractured in overstress.

Figure 21 – BF optical micrograph of the fracture surface cross section, showing porosity, internal contamination and subsurface cracking (~200X, etched from tap water).
