# NATIONAL TRANSPORTATION SAFETY BOARD

## MATERIALS LABORATORY FACTUAL REPORT

Report No. 19-081

Place : Georgetown, South Carolina  
Date : September 22, 2018  
Vehicle : Beech V35, N435RB  
NTSB No. : ERA18LA258  
Investigator : Leah Read, AS-ERA

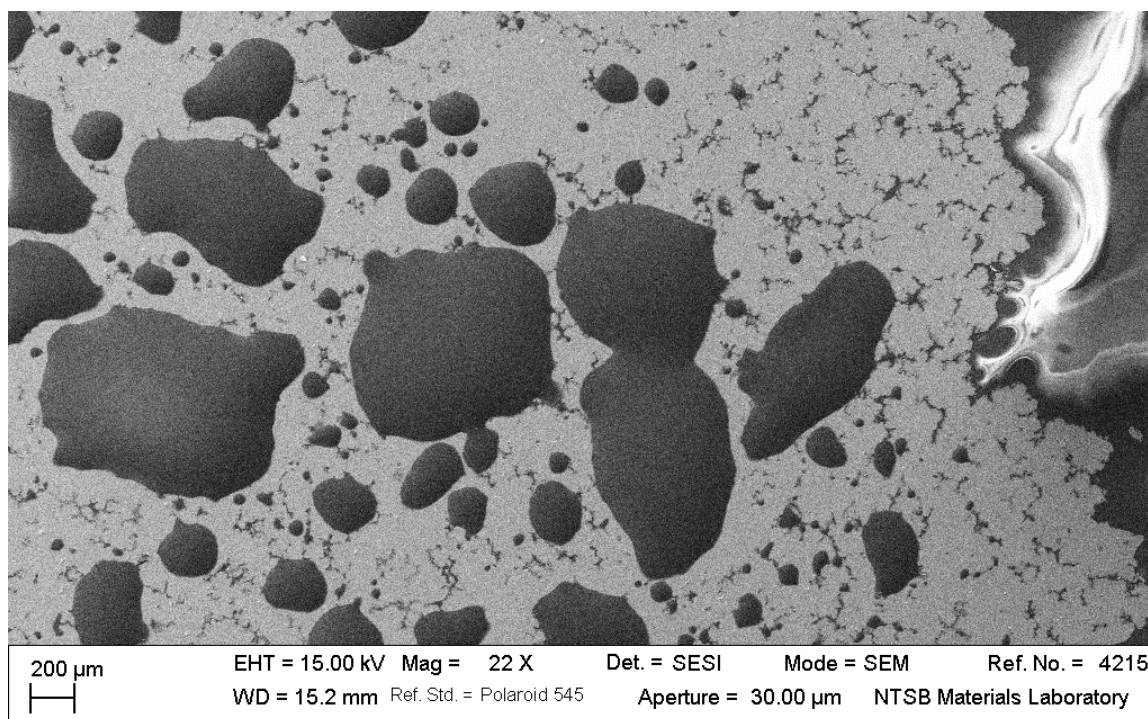
Figure 22 shows the mounted and polished clevis specimen as viewed using a scanning electron microscope at low magnification. This cross section showed voids as large as 1.2 mm (0.05 inches). Figure 23 shows a typical pore in the interdendritic region. This area was examined using energy dispersive x-ray spectroscopy (EDS) in mapping mode (x-ray maps). The composition of the clevis casting was inspected using EDS probes. The composition was consistent with a magnesium casting alloy, such as AZ91.

Figure 22 – SE micrograph of the cross-sectioned clevis fracture surface, showing large subsurface porosity.

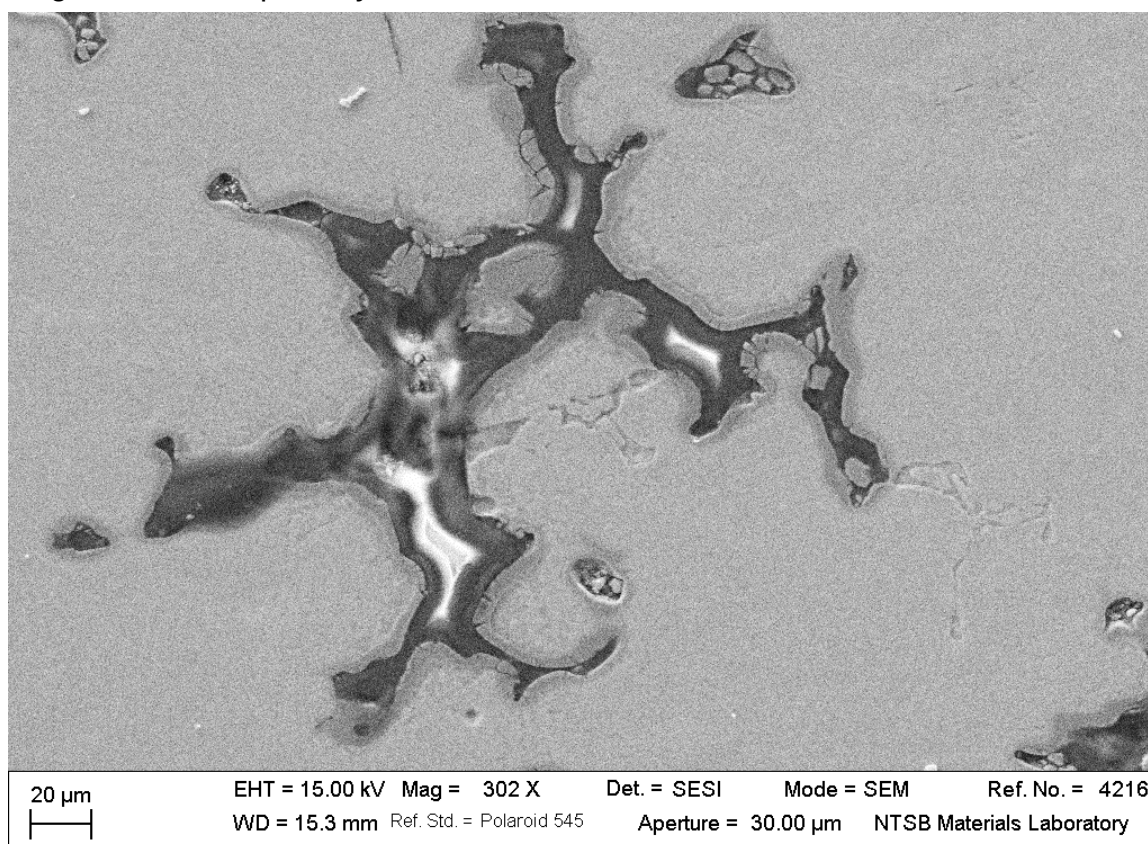
Figure 23 – SE micrograph of one of the interdendritic pores, showing non-conductive material inside.

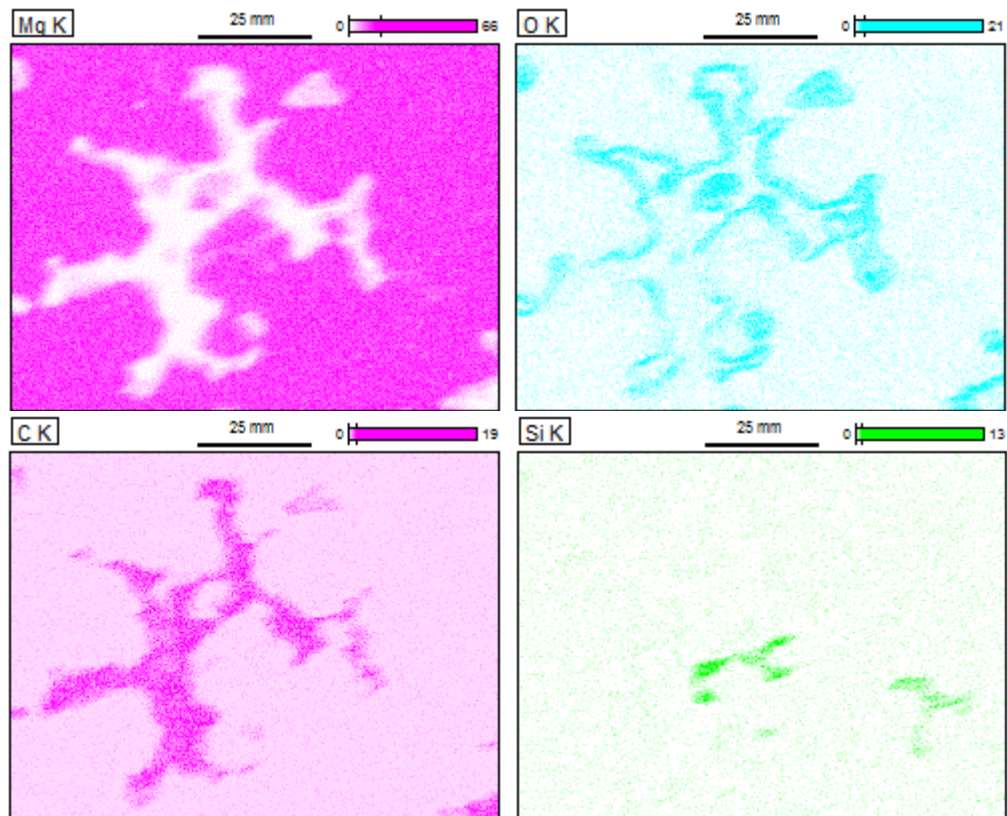
Some of the results of the mapping are depicted in Figure 24. In these figures, areas that are white were absent a particular element and areas that were colored exhibit higher

amounts of that element. As shown in the figures, areas outside the pore were high in magnesium (Mg), and areas inside the pore were high in carbon (C). The areas of the casting surrounding the pore were higher in oxygen (O), consistent with a magnesium oxide (MgO) layer. Figure 25 shows a closer view of the MgO layer surrounding a pore. As shown in the figure, small cracks were present emanating from the pore and surrounding oxide layer.

Figure 24 – X-ray maps of selected elements from Figure 23, highlighting elevated concentrations of Mg, O, C, and Si.

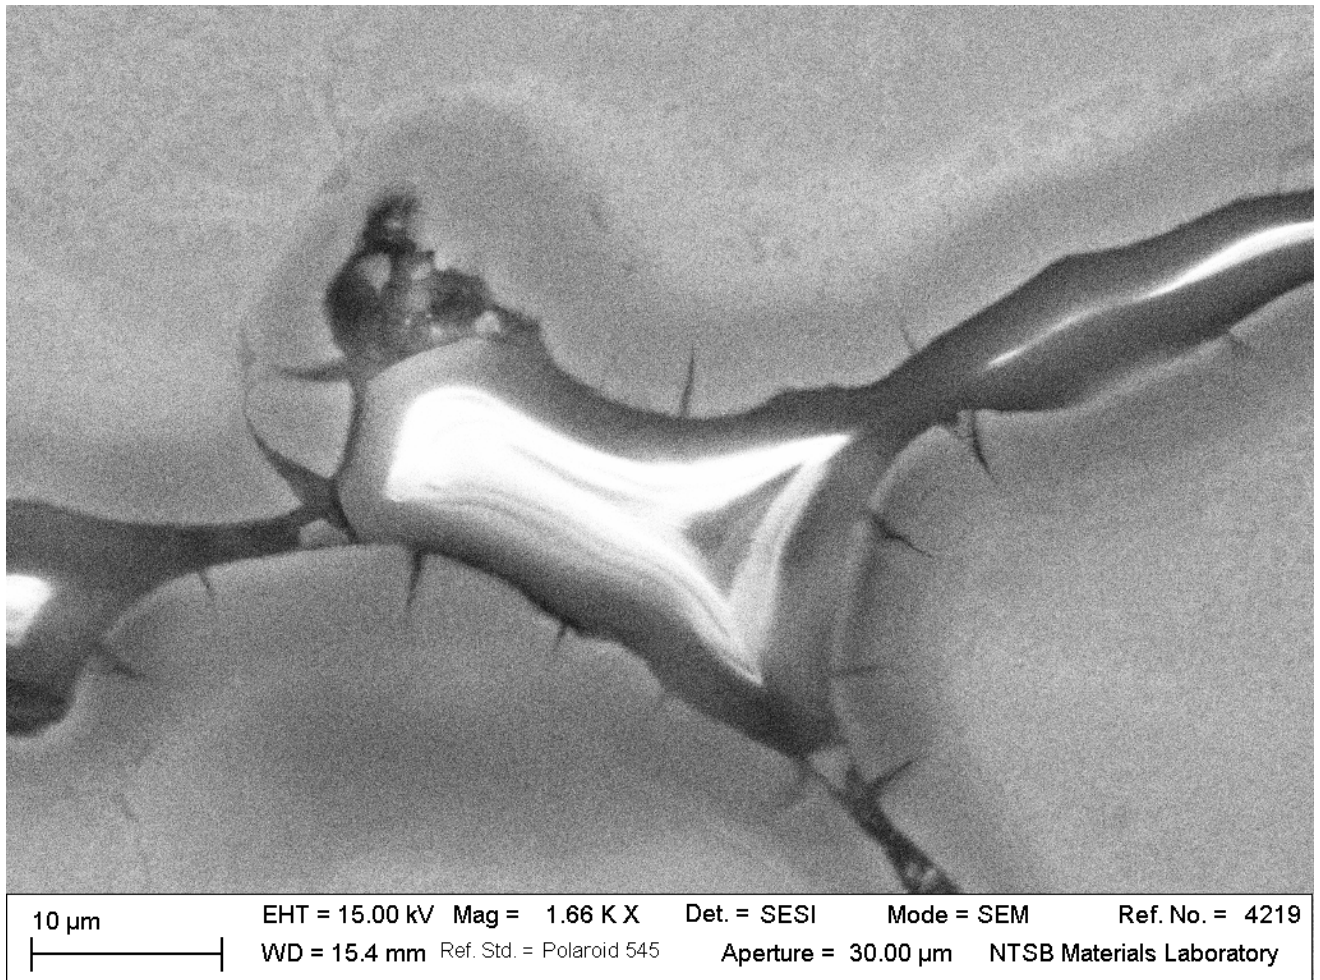
Figure 25 – SE micrograph of a pore, showing cracking in the oxide layer adjacent the pore.

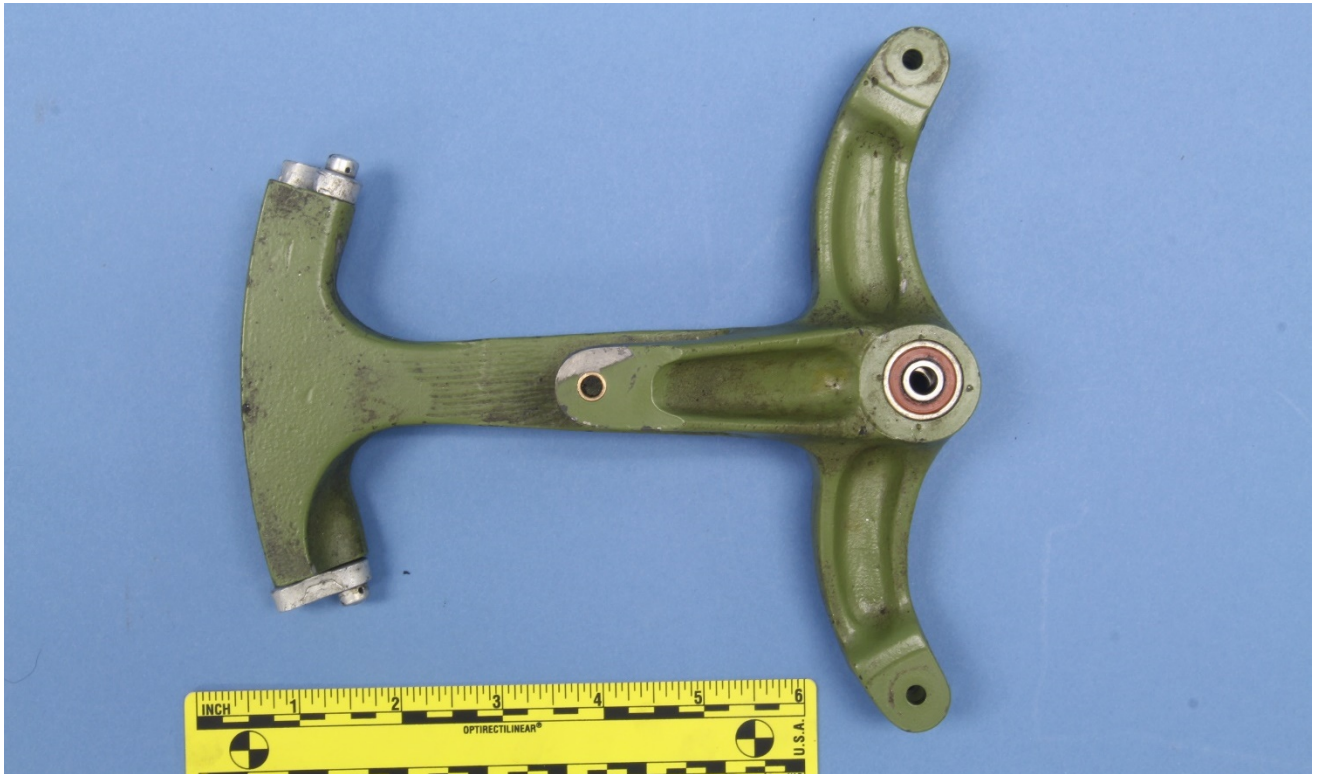
Figure 26 and Figure 27 show the bellcrank assembly, as received. The bellcrank was intact, with no discernible fractures or cracks. Figure 28 shows the rudder cable tracks for the bellcrank. As shown in this figure, there were angled depressions along the cable groove. These were consistent with the adjacent cable being impressed into the groove paint while static (not moving or sliding).

Figure 26 – View of the bellcrank assembly from the arm side, as received.

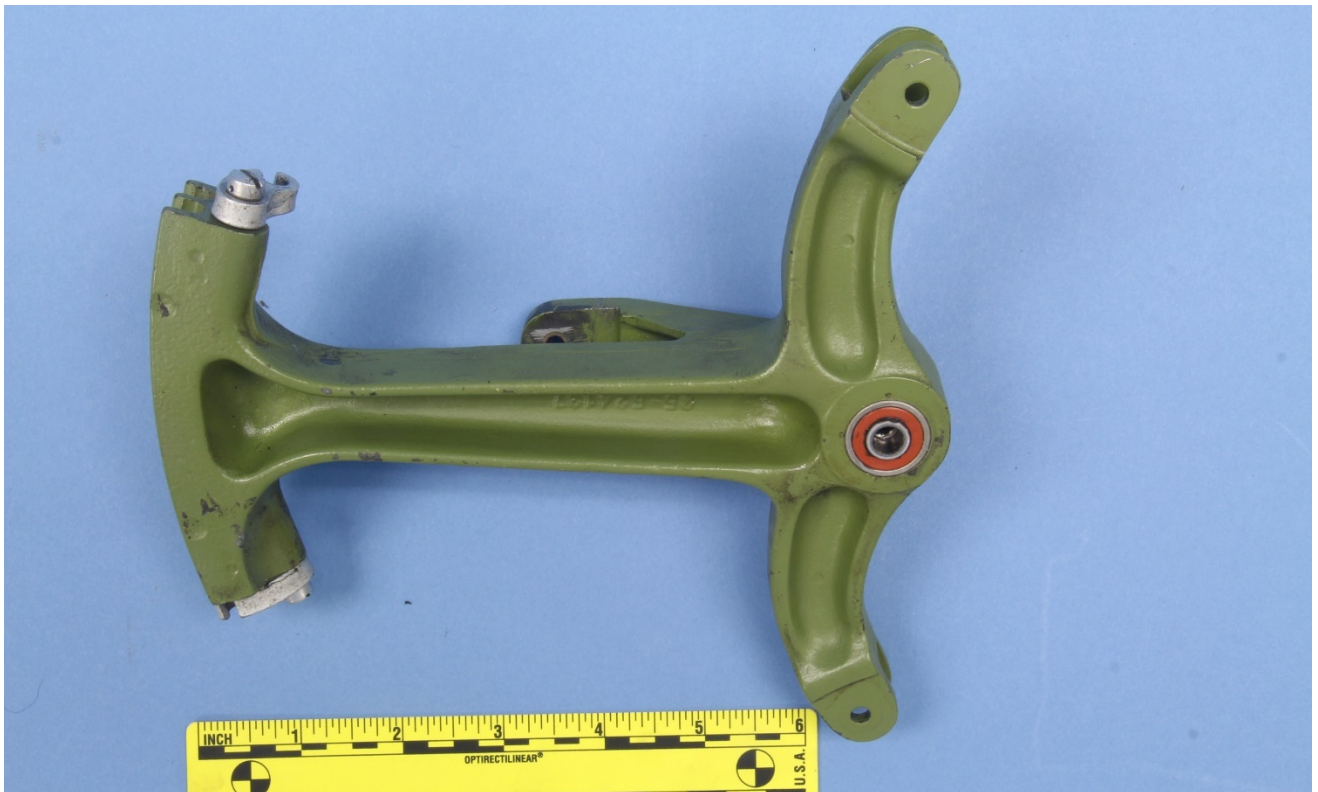
Figure 27 – View of the bellcrank from the side opposite Figure 26.

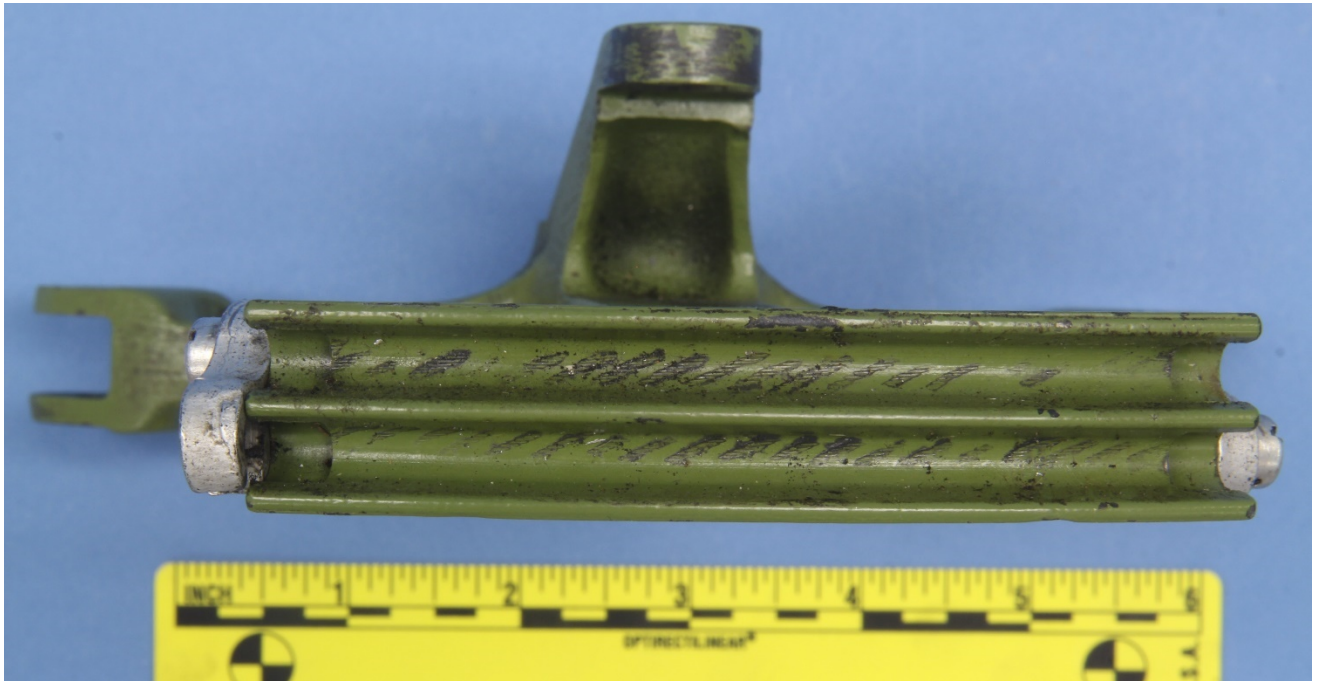
Figure 28 – View of the cable track of the bellcrank, showing impressions.

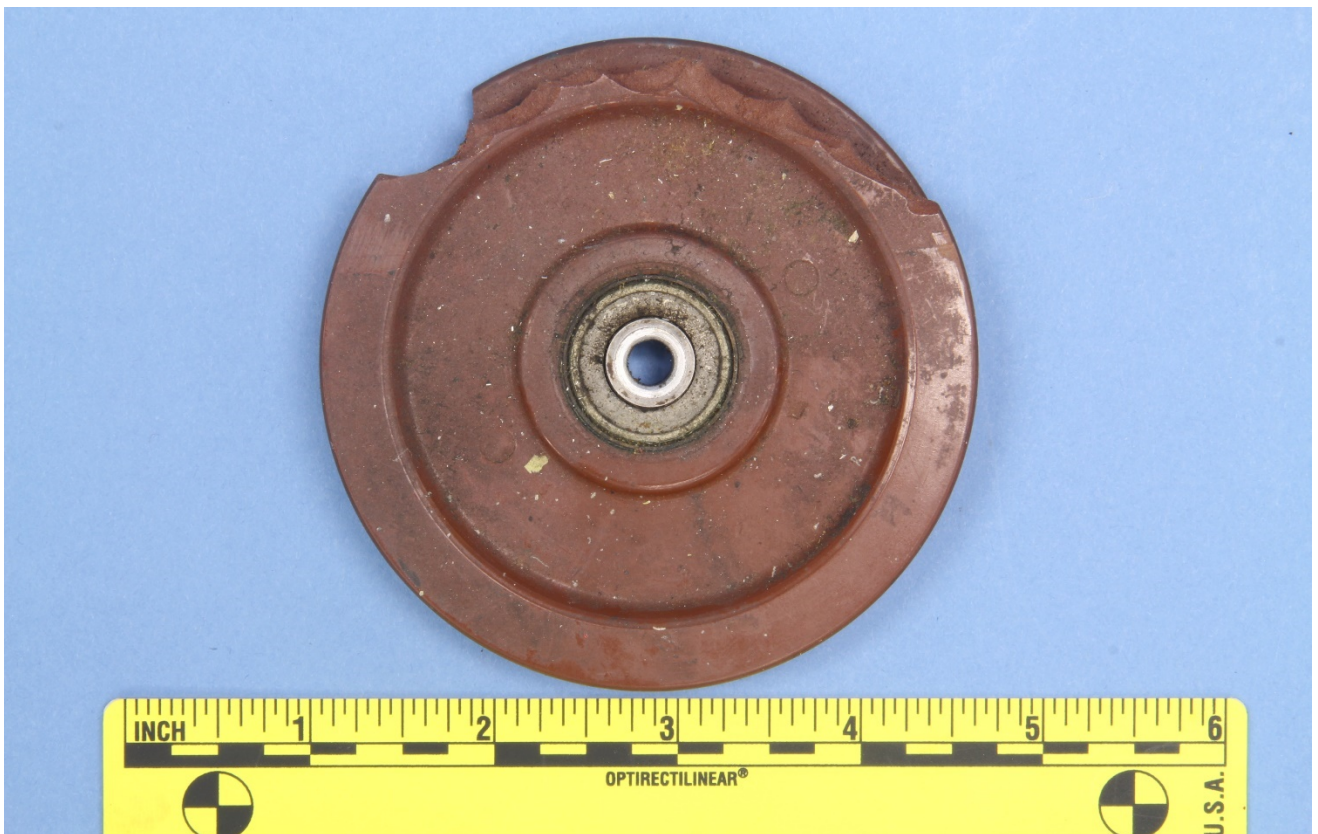
Figure 29 shows the rudder control pulley, viewed from the flange that had fractured in multiple places. These fracture surfaces were slanted downward at an angle, with the fracture surface facing away from the pulley cable groove (Figure 30). The fracture surfaces exhibited river marks and hackles which fanned out away from the cable groove. These features were consistent with the pulley flange being bent outward, and the groove fracturing in multiple locations from overstress.

Figure 29 – The control pulley, as received.

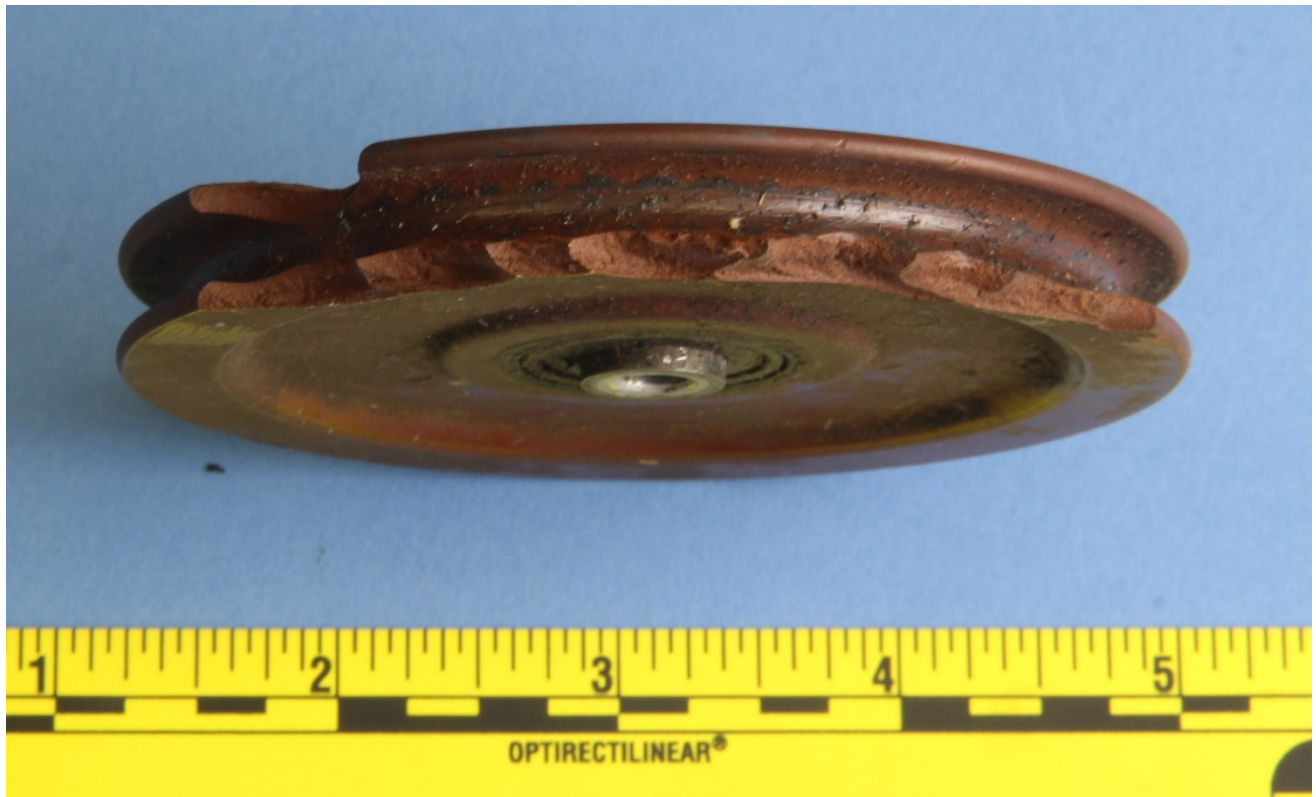
Figure 30 – View of the fracture surfaces of the pulley, as received.
