**From:** [REDACTED]  
**To:** [REDACTED]  
**Subject:** ERA19LA269  
**Date:** Friday, August 23, 2019 4:06:08 PM

After reviewing the information you supplied (Logbook entries, videos and photographs), I would like to point out several issues.

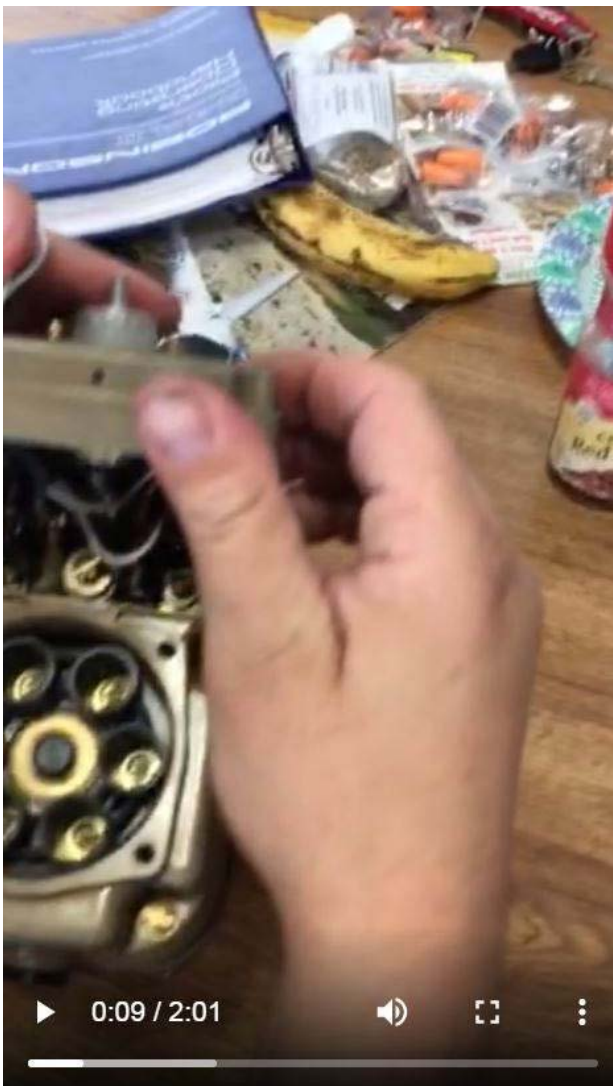
This magneto had 0 hours since overhaul when installed on the accident helicopter. It had approximately 20 hours in service since overhaul. There is no logbook entry indicating that any maintenance was performed on the magneto since installation.

Below is a snapshot of the video, recording the opening of the points cover on the right magneto after the accident. It shows both tach wires were improperly routed. It also shows one wire making contact with the rotating cam screw head.

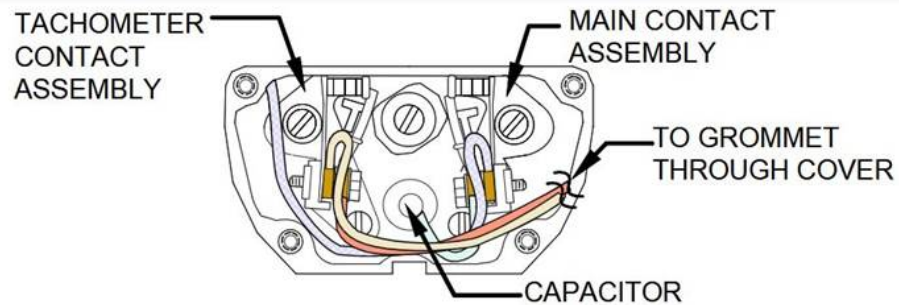
**Figure 9-11. Lead Routing with Tachometer Contacts**

Below is a snapshot from the Continental Ignition Systems Service Support Manual for the S-200 series magnetos showing the proper wire routing. Note that it is viewed upside down when compared with the video snapshot.

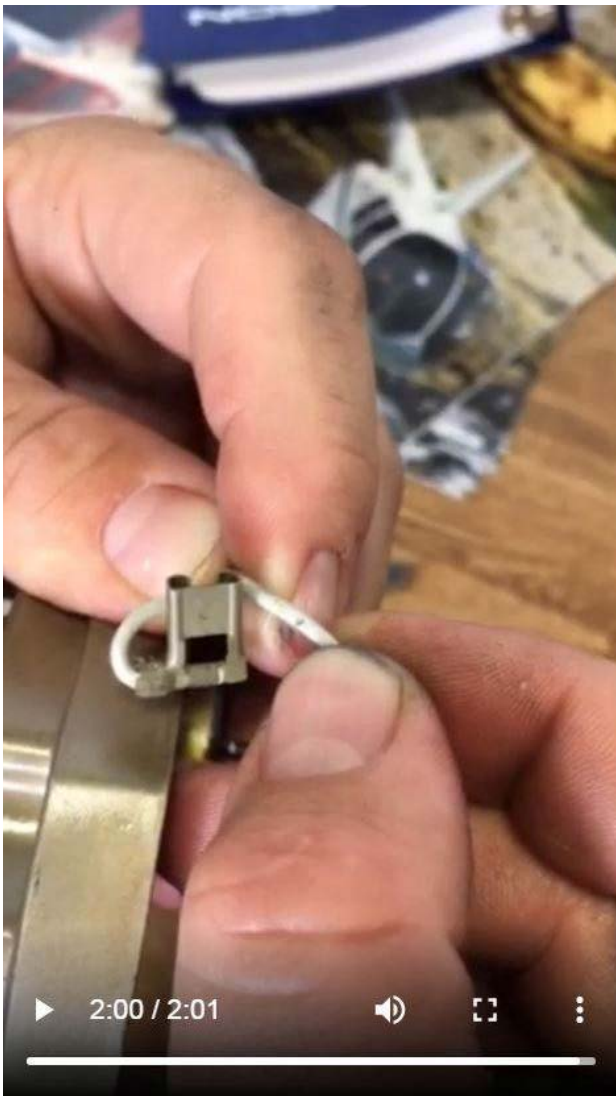
Below is a snapshot of the damaged insulation on the wire that was contacting the screw head.

The damage to the wire insulation will allow contact between the wire and the rotating screw head creating an intermittent short to ground. This will send an errant signal to the governor control unit which in turn will manipulate the throttle accordingly.

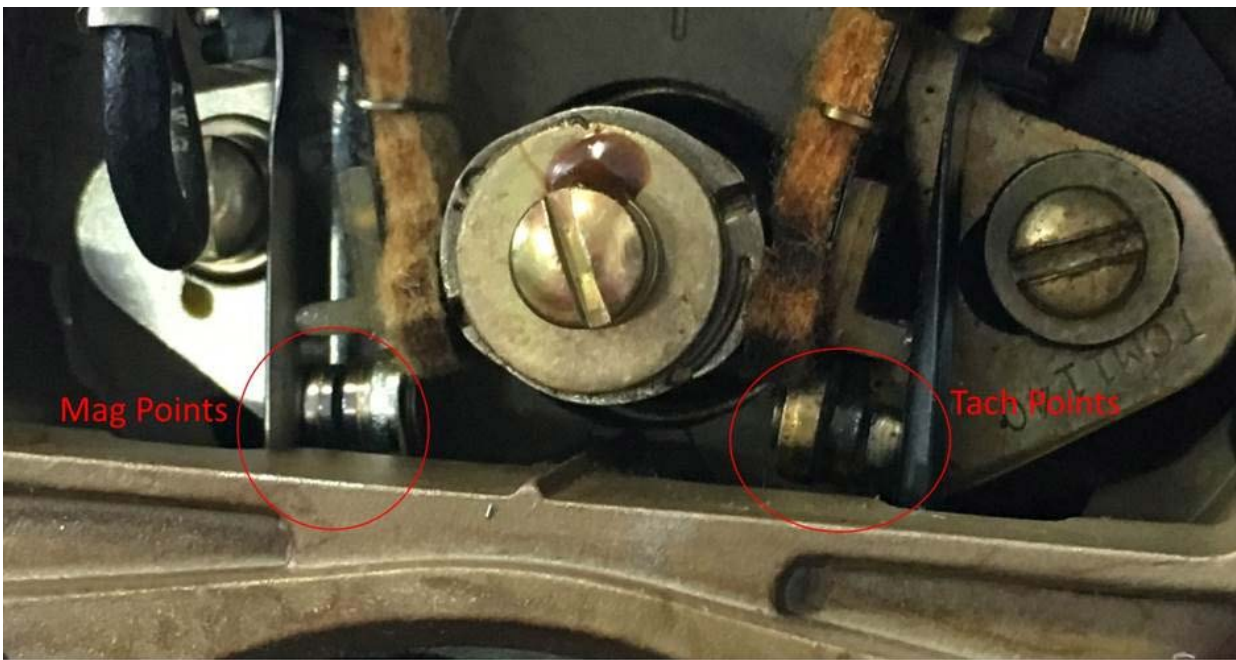
Below is a snapshot of the magneto and tach points. The contact pads on the tach points appear to be misaligned and contaminated when compared to the magneto points. I would not expect to see this in a magneto with only 20 hours in service.
