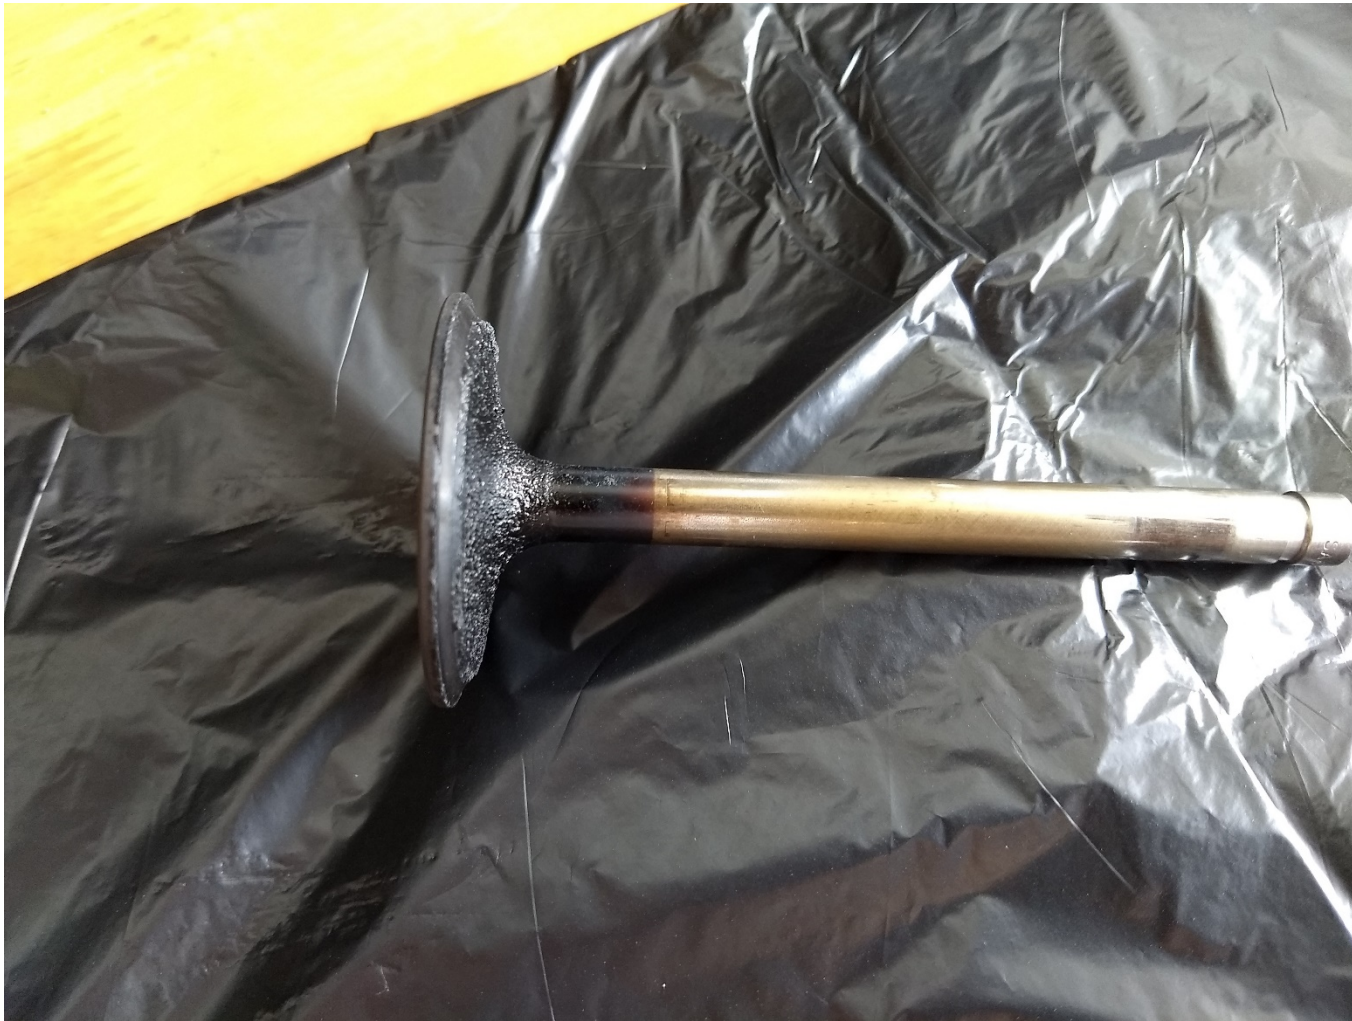
**Photo 1 – Number 3 Cylinder Intake Valve with Carbon Deposit Buildup (Photo Courtesy of Bill Siegel, Mechanic)**

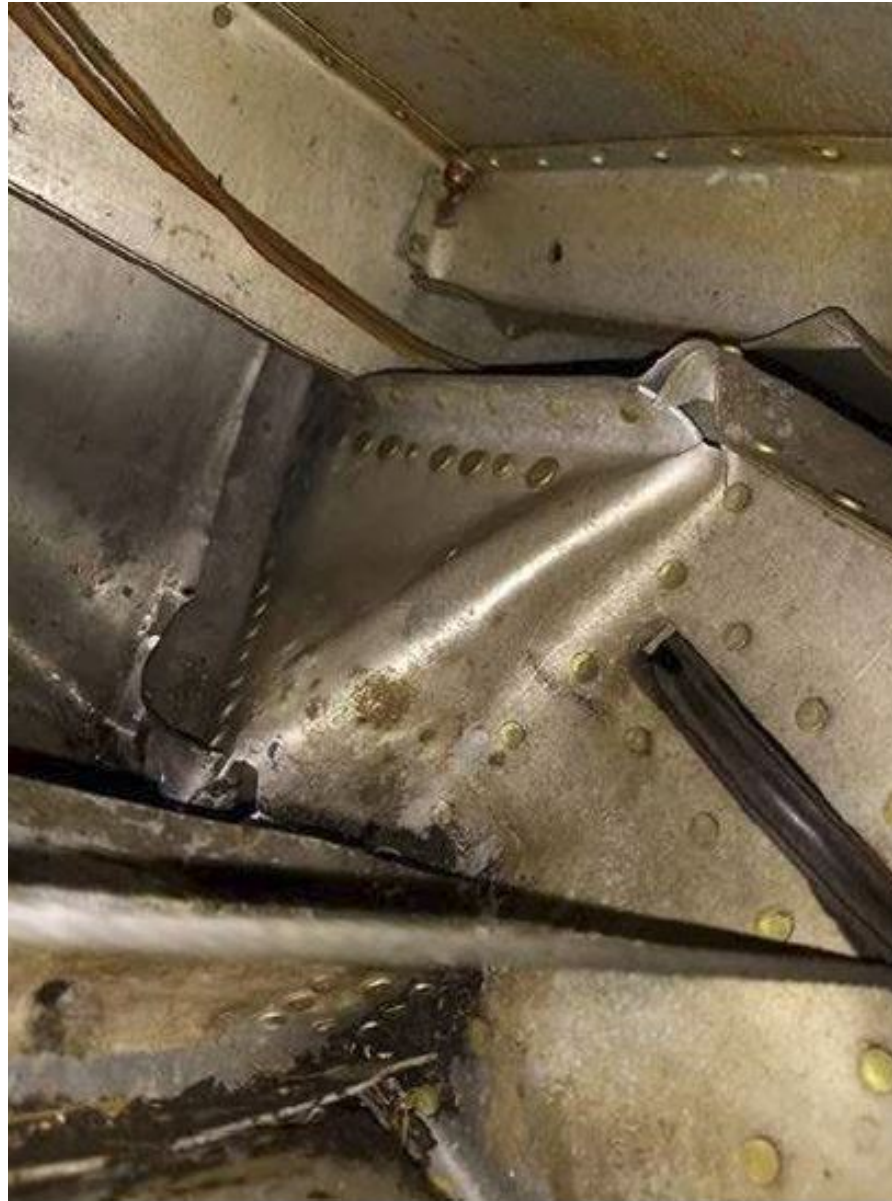
**Photo 2 - Substantially Damaged Wing Spar Carry Through (Photo Courtesy of Bill Siegel, Mechanic)**

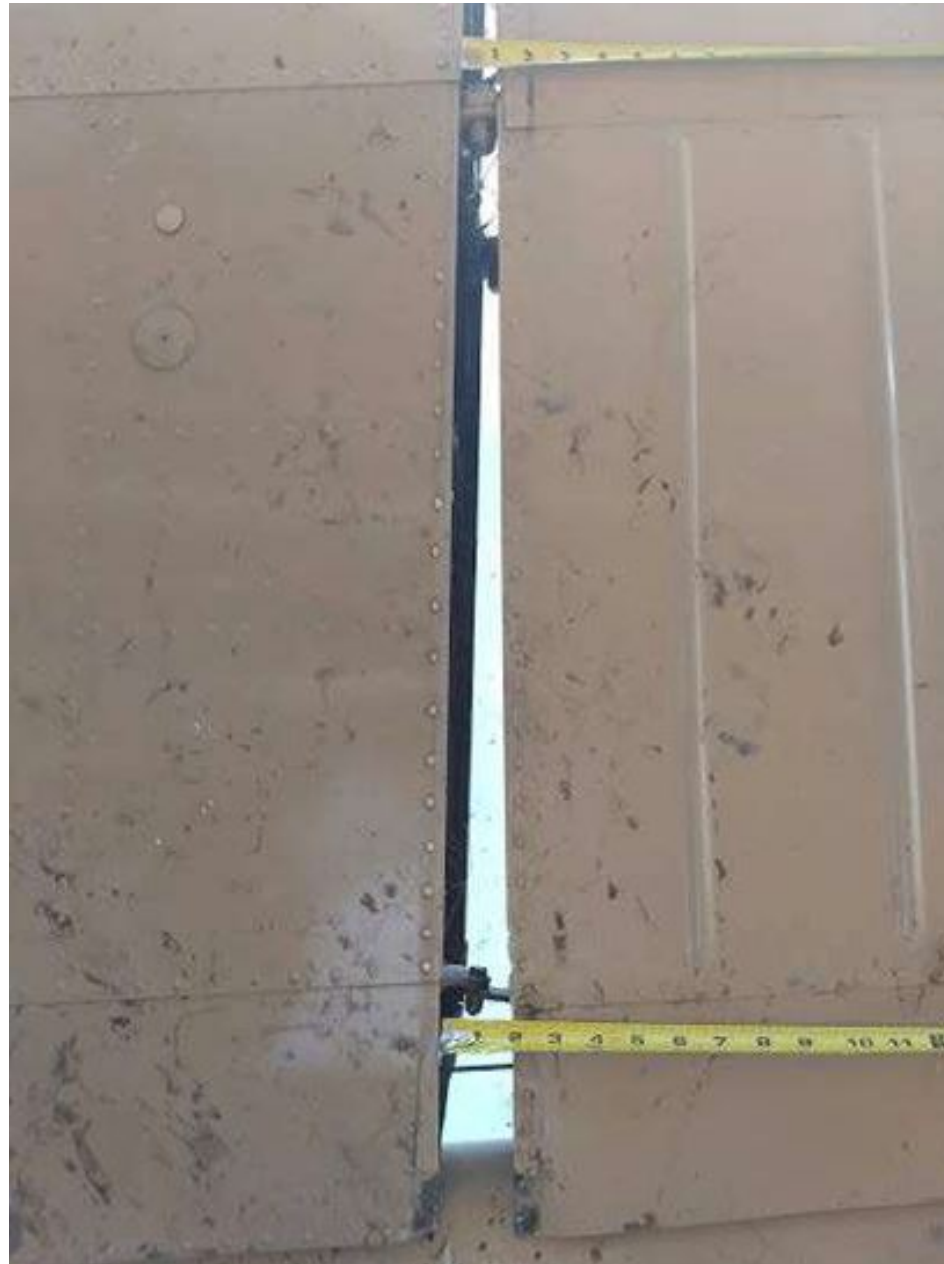
**Photo 3 – Right Aileron Damage (Photo Courtesy of Bill Siegel, Mechanic)**
