# ENGINE EXAMINATION REPORT

## N38811

| ENGINE MODEL | C85-12F |

| <b>EXAMINATION</b> | | <b>ACCIDENT DATA</b> | |
|---|---|---|---|
| <b>DATE</b> | 1-7-2019 | <b>NTSB ACCIDENT #</b> | ERA19FA003 |

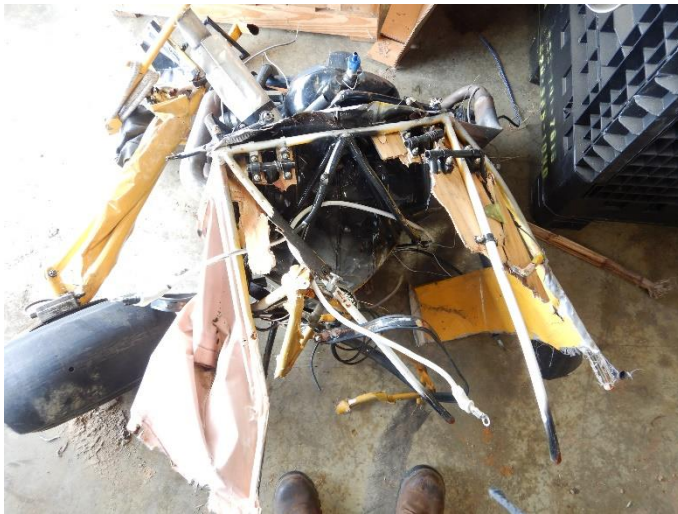
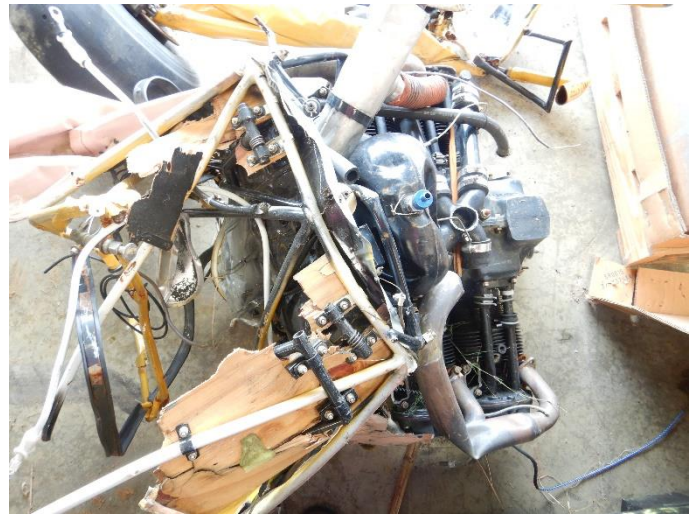
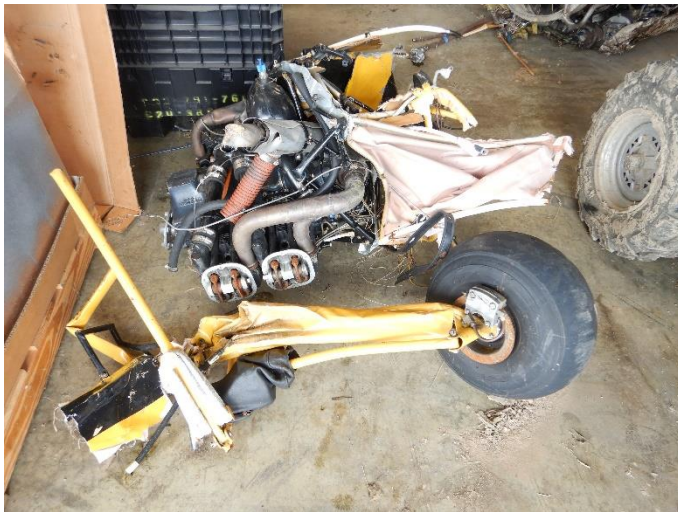
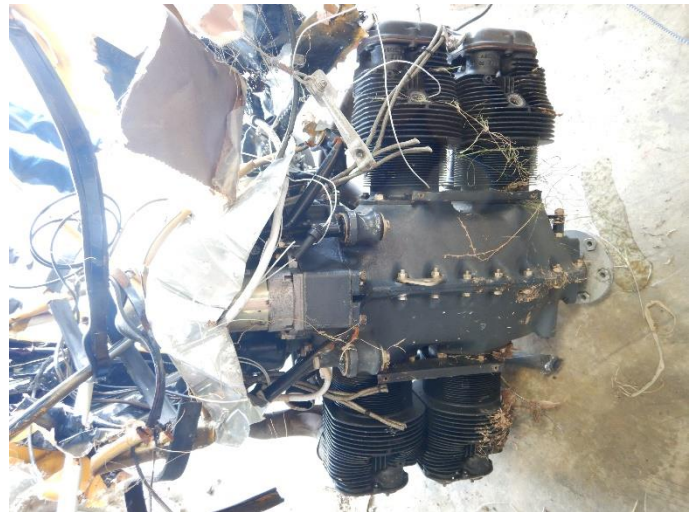
The engine was inverted and partially covered by impact-damaged airframe wreckage (main landing gear). A section of the cockpit floorboard and engine mount remained attached to the engine. The propeller, rocker covers from cylinders 1 and 3 and all sparkplugs had been previously removed by unknown persons. The engine had been in outdoor storage for an undetermined amount of time and the exposed steel parts exhibited rust from exposure to moisture. A lighted borescope inspection of each cylinder indicated water damage from exposure, but all intake and exhaust valves were intact. All valve faces and piston domes exhibited normal combustion deposits and the cylinder wall surfaces exhibited corrosion from exposure to moisture. The crankshaft propeller flange was impact damaged and partially separated. The crankshaft could not be rotated manually. There were no signs of engine internal damage and the crankcase did not exhibit damage from internal rotating components. The oil sump was impact damaged and the carburetor and several induction components separated.
