# NATIONAL TRANSPORTATION SAFETY BOARD

## MATERIALS LABORATORY FACTUAL REPORT

Report No. 18-086

Place : Culpeper, Virginia  
Date : October 12, 2018  
Vehicle : RV-8  
NTSB No. : ERA19FA010  
Investigator : Eric Alleyne (AS-ERA)

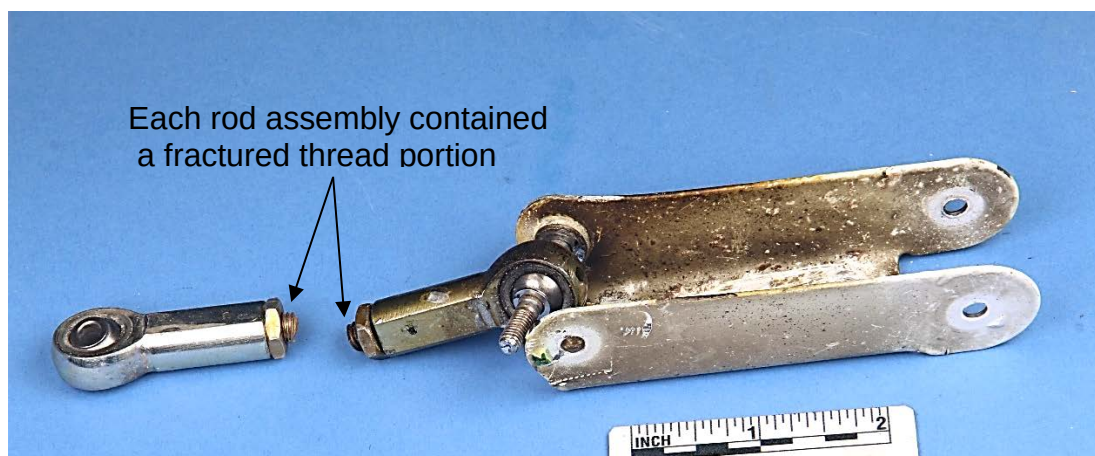
Figure 1 shows a photograph of the as-received left and right aileron control rod end assemblies. The rod end assemblies contained no evidence of a mark to indicate whether they were a left or right aileron control rod end assembly. Each rod end assembly fractured at the thread portion. The fractures were covered with light brown iron oxide (rust). The thread portion was disassembled from each rod end assembly and ultrasonic cleaned with Alconox, a detergent that removes oxide from ferrous metal. The ultrasonic cleaning procedure exposed the fracture features. Scanning electron microscope examination of the thread portion from each rod end assembly revealed the fracture face contained evidence of micro-void coalescence features with an isolated portion at the core containing quasi-cleavage fracture features, both typical of overstress separation. Each fracture face showed no evidence of crack arrest marks, such as fatigue cracking. Figure 2 shows a fracture at the thread portion of a rod end. Figure 3 shows an SEM photograph of typical fracture features found on the fracture face of a thread portion.

Figure 1. As-received left and right aileron control rod end assemblies.

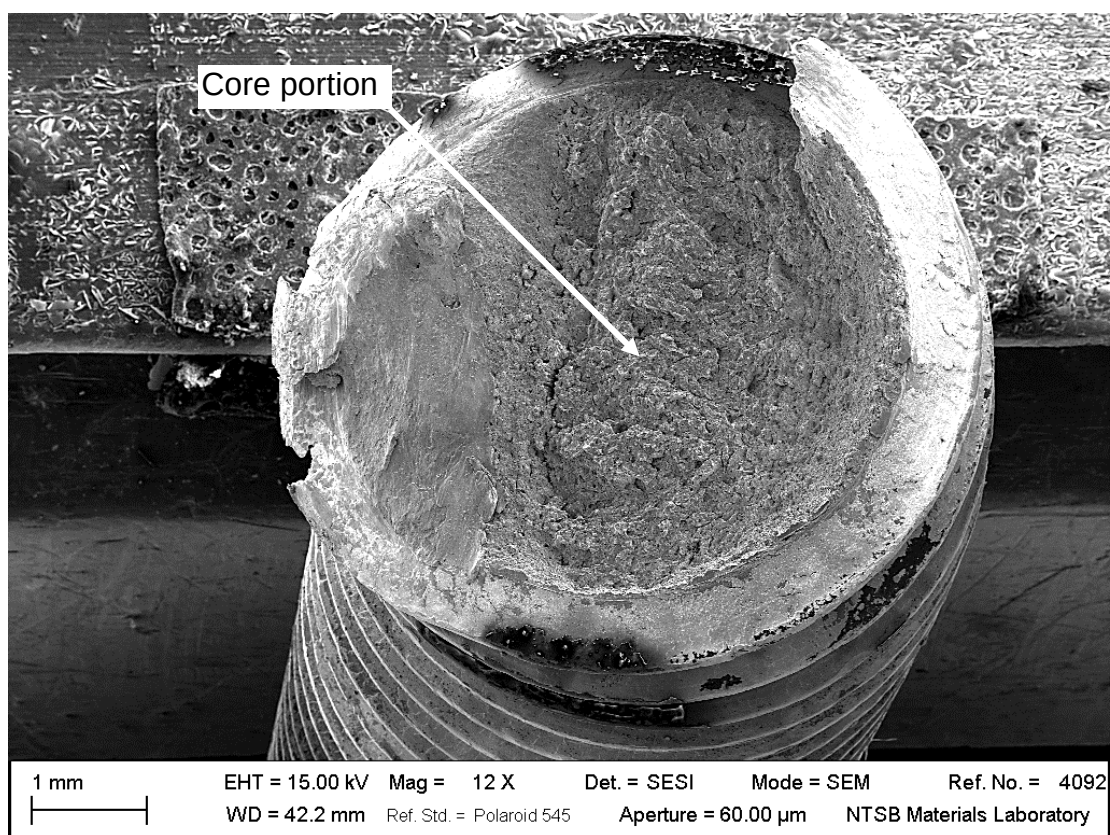
Figure 2. Scanning electron microscope (SEM) photograph showing a fracture at the thread portion of a rod end.

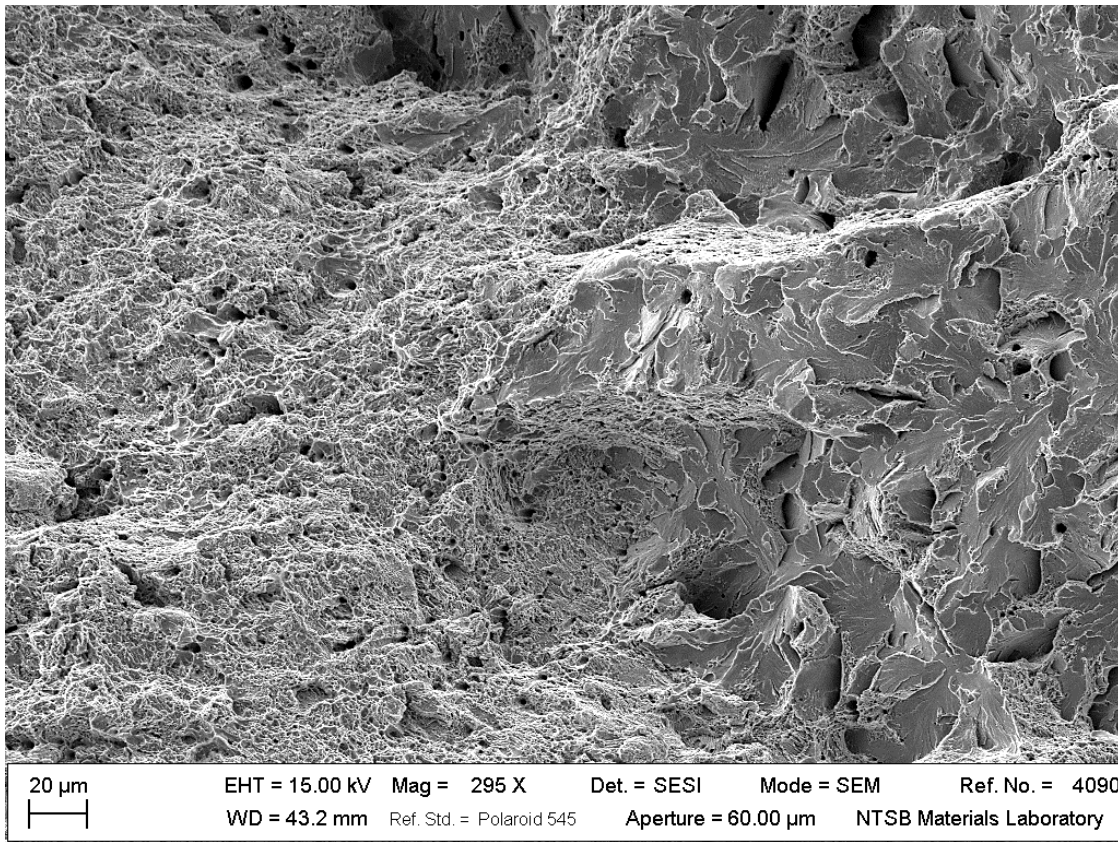
Figure 3. SEM photograph of a portion of the thread fracture face showing the transition region between the quasi-cleavage fracture features at the core (right side of page) and micro-void coalescence features (left side of page), both typical of overstress separation.
