# NATIONAL TRANSPORTATION SAFETY BOARD

## MATERIALS LABORATORY FACTUAL REPORT

Report No. 19-087

Place : Sebring, FL  
Date : 10/30/2018  
Vehicle : Gyrocopter  
NTSB No. : ERA19FA034  
Investigator : Brian Rayner

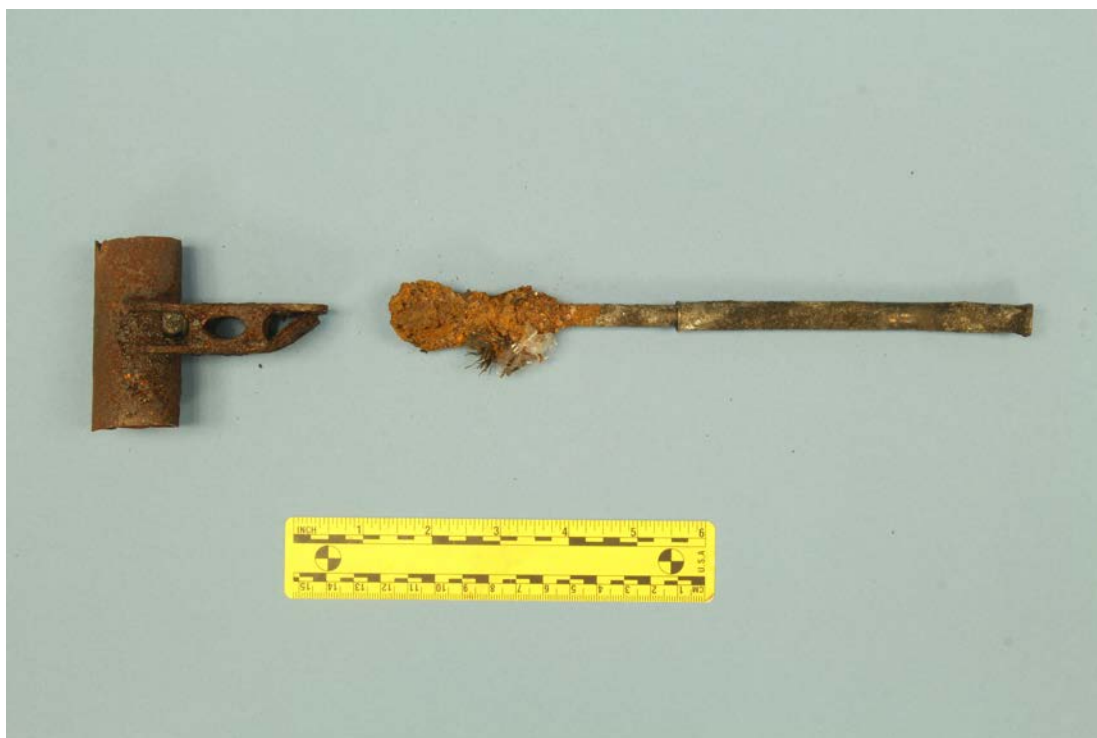
A pitch horn clevis and its associated rod end were submitted for examination. Both components exhibited corroded surfaces throughout (Figure 1). The clevis exhibited one of its ears deformed in an inward direction (Figure 2). The holes for the clevis pin were corroded but did not exhibit any deformation or signs that the rod end had been pulled from the clevis (Figure 3). The damage is consistent with the rod end not having been attached to the clevis at the time of the accident.

Figure 1: Pitch horn clevis and rod end as received.

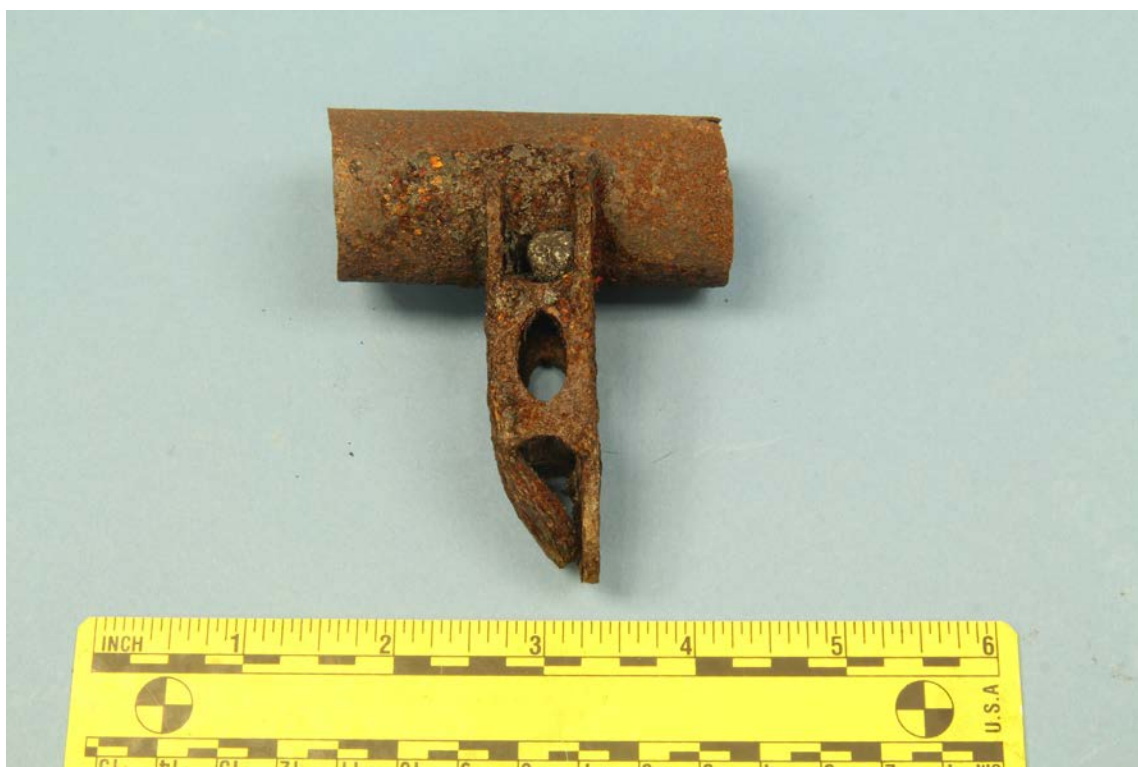
Figure 2: Pitch horn clevis with ear bent inwards.

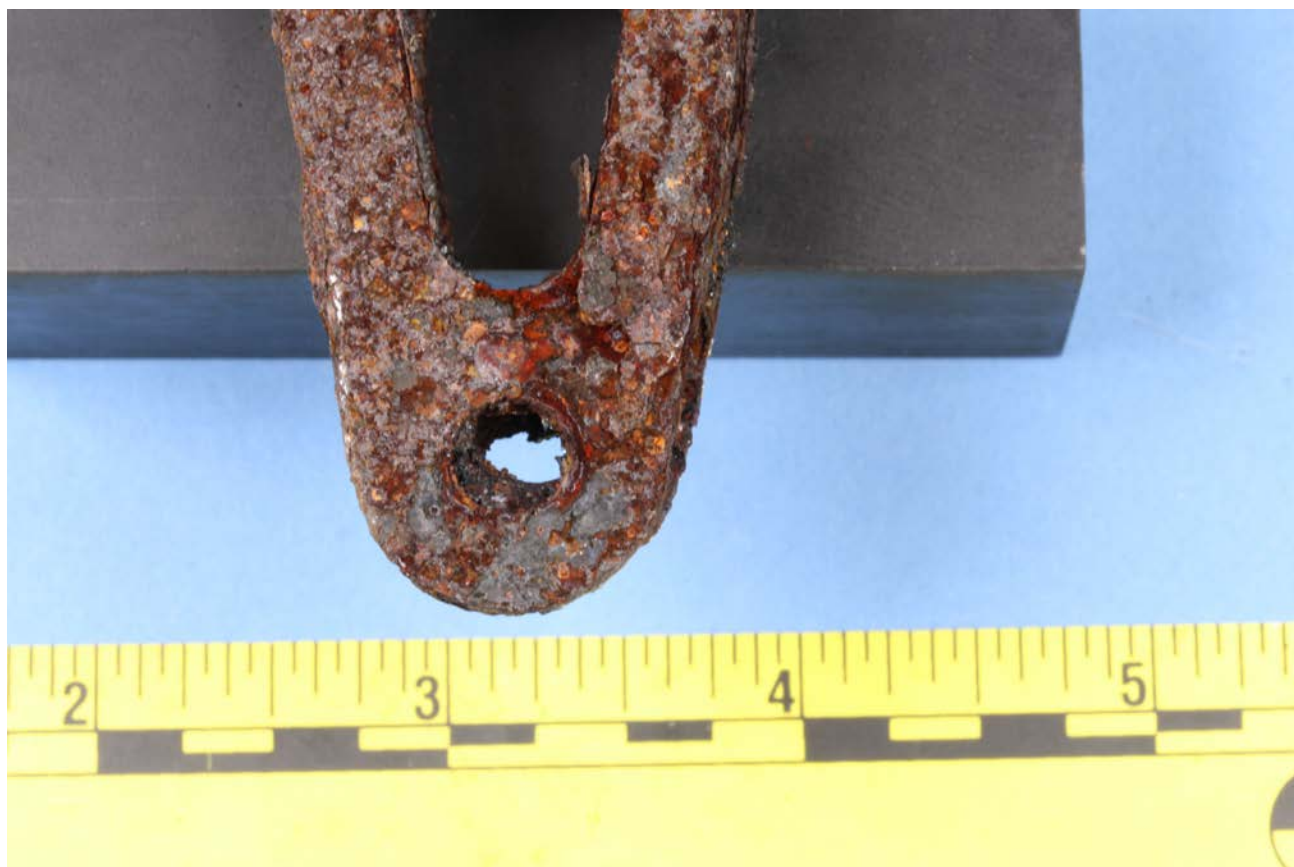
Figure 3: Clevis pin hole corroded but not deformed.
