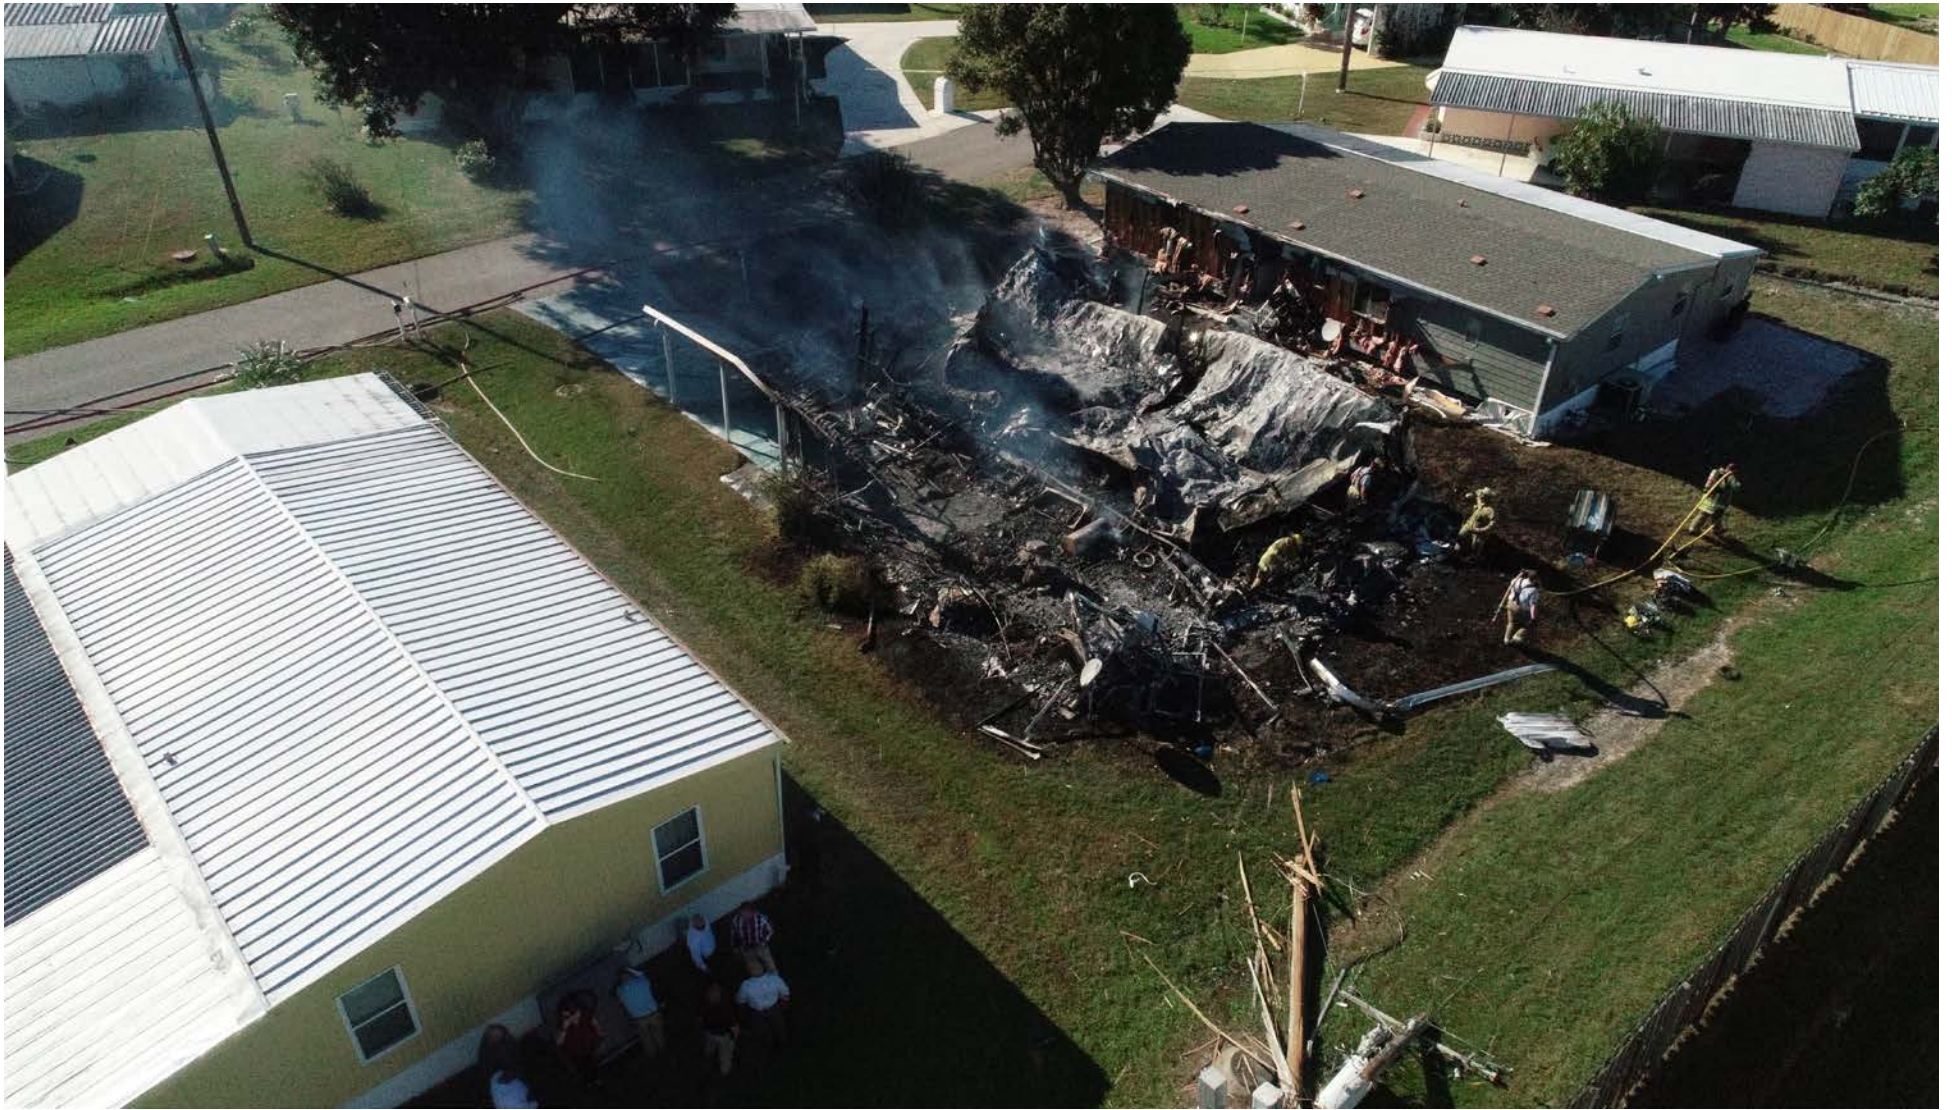
**Photo 1 – View of Crash Site Facing Direction of Travel (Sebring FD)**

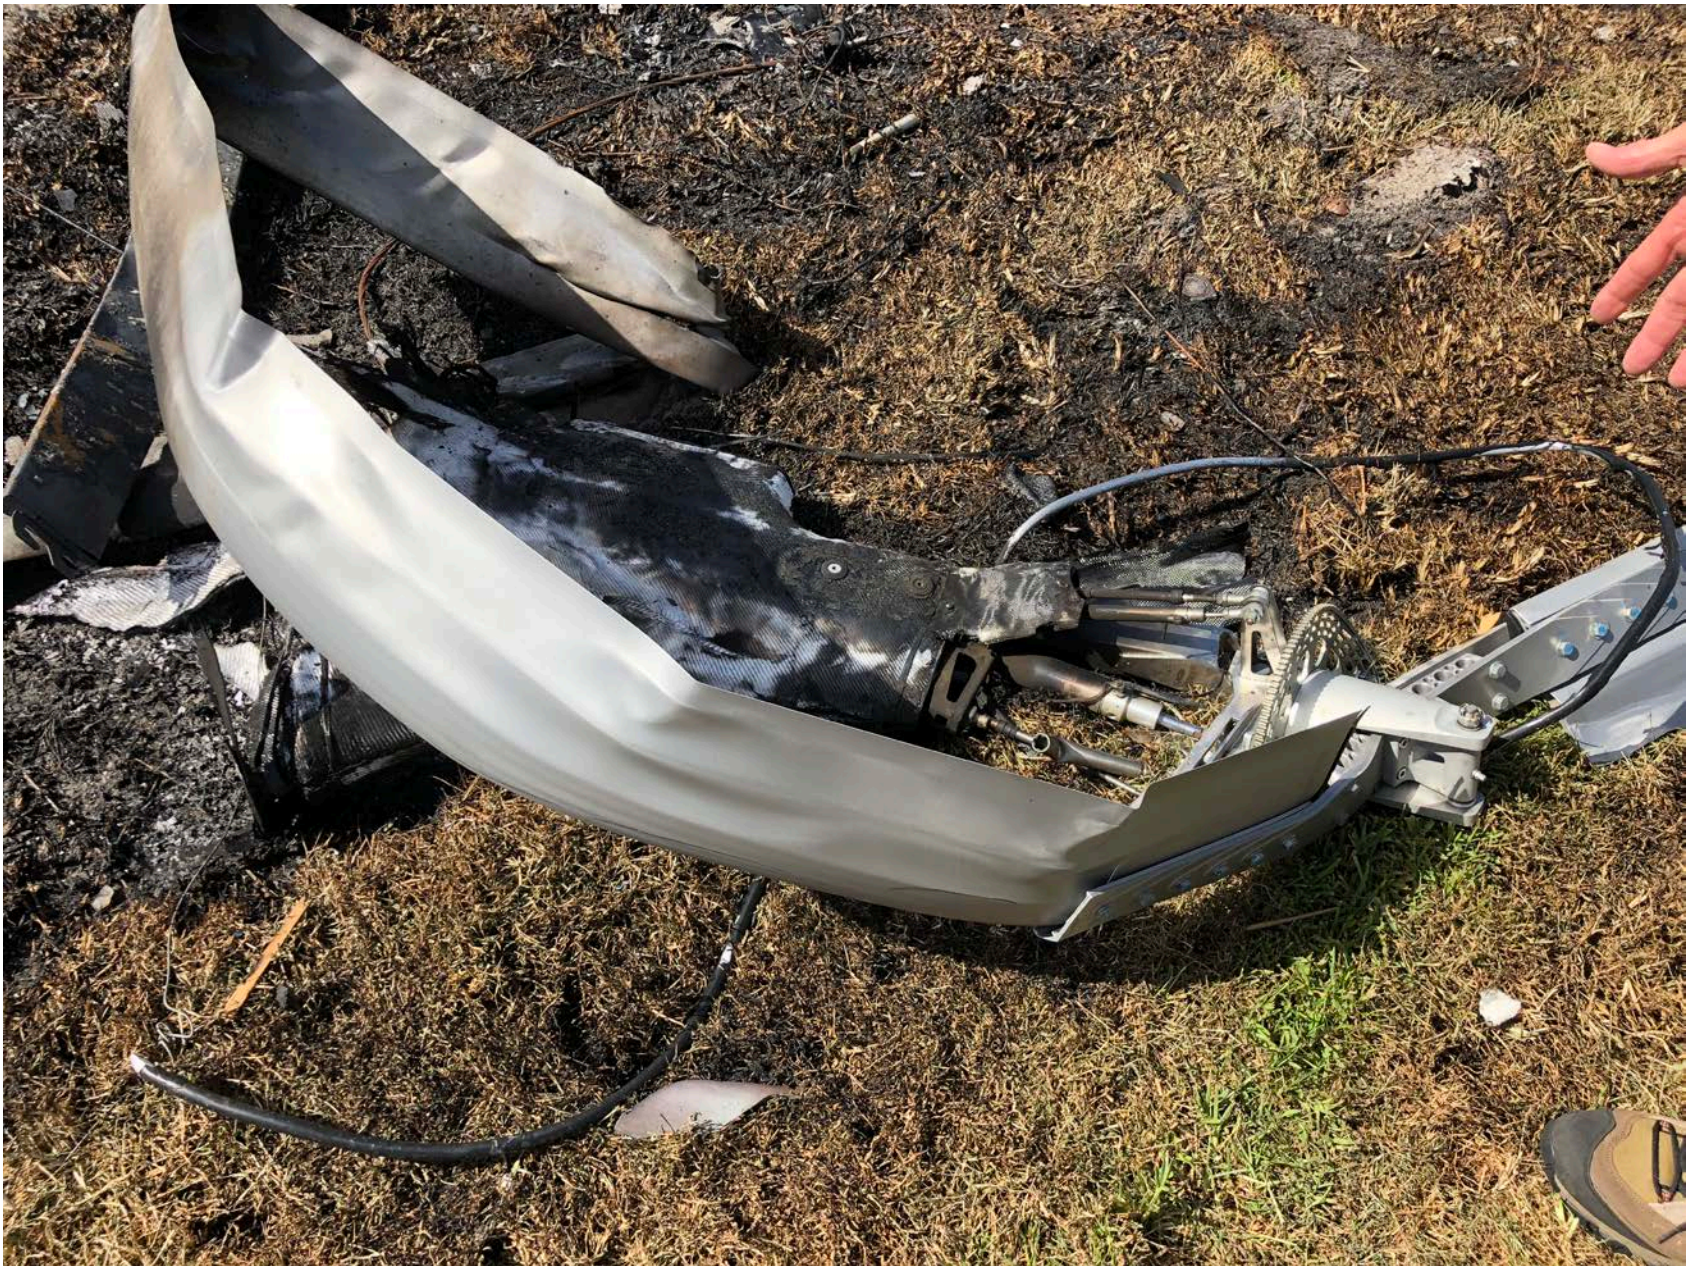
**Photo 2 – View of Main Rotor Head, Blades, and Pylon**

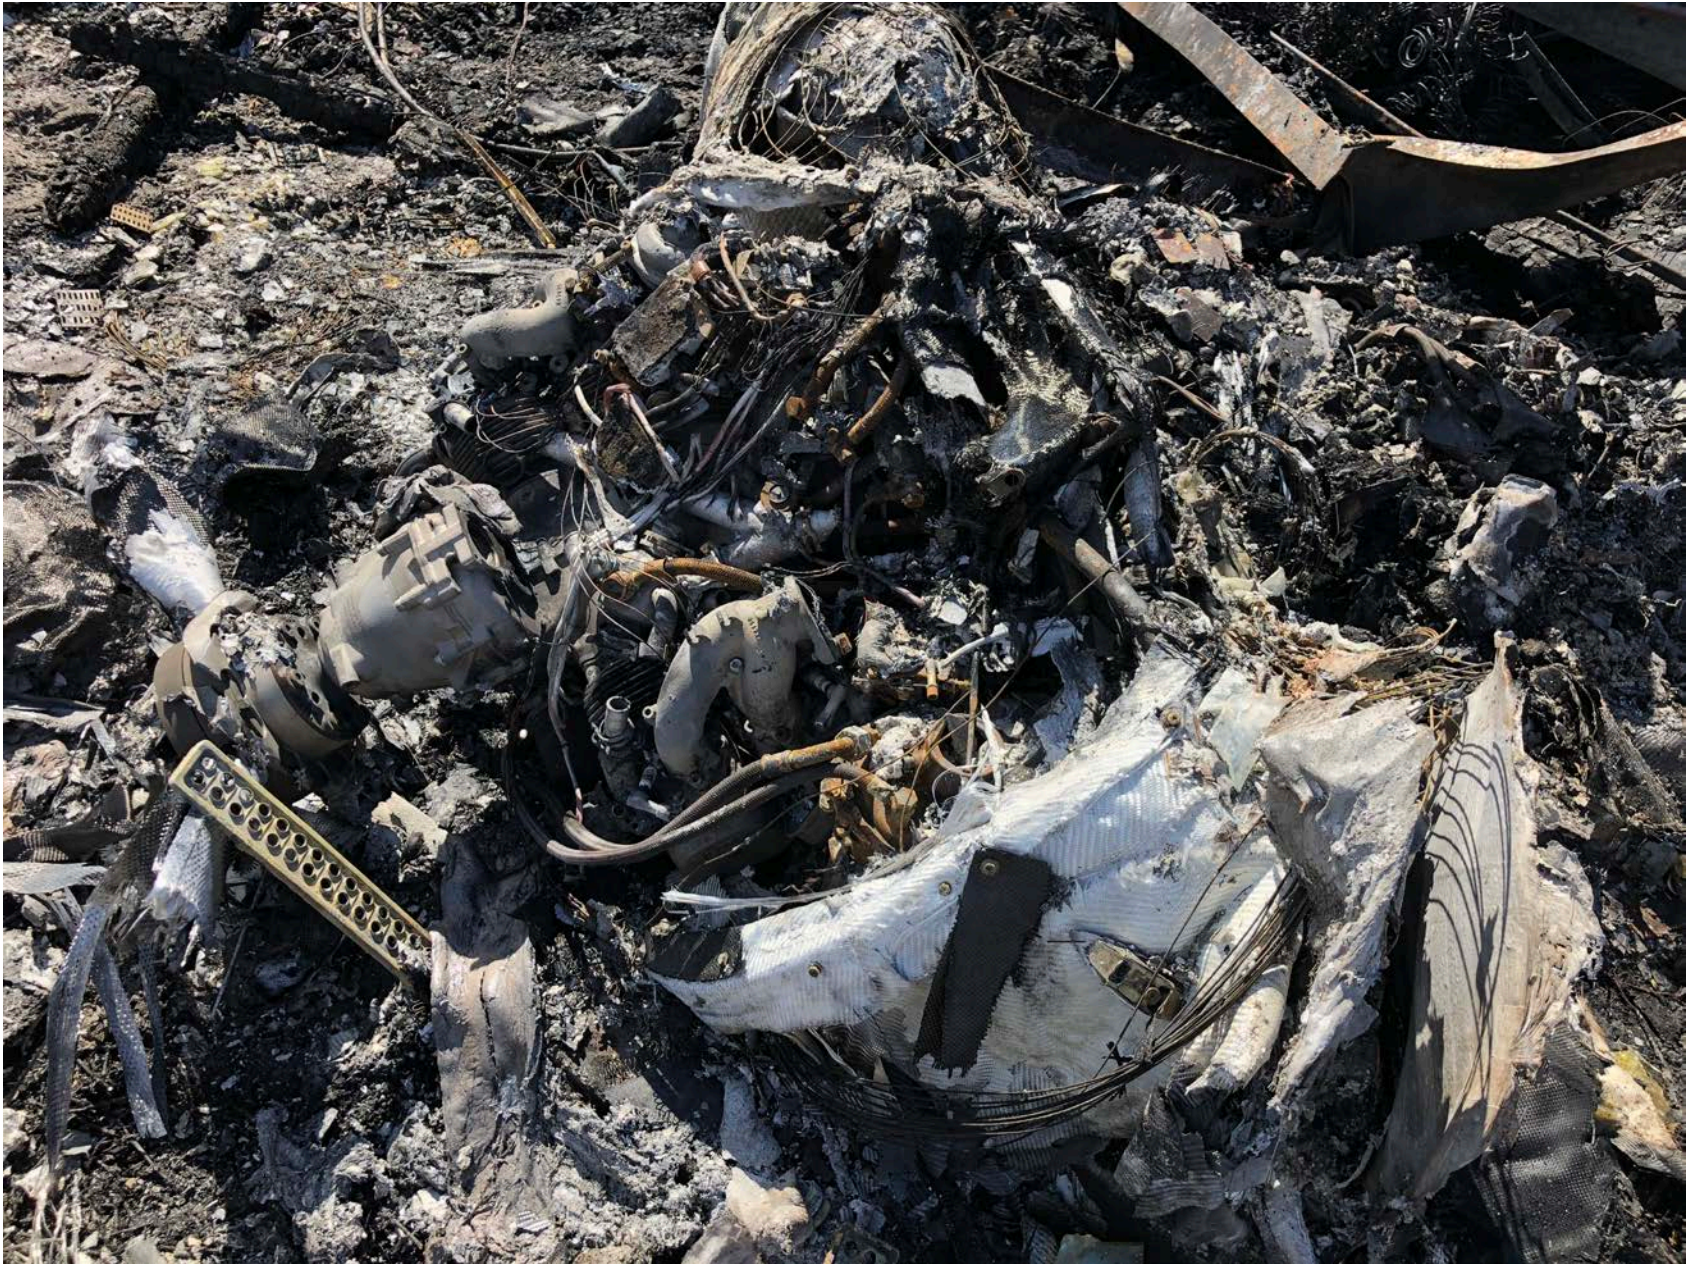
**Photo 3 – View of Engine, Propeller Gearbox, and Propeller Hub**

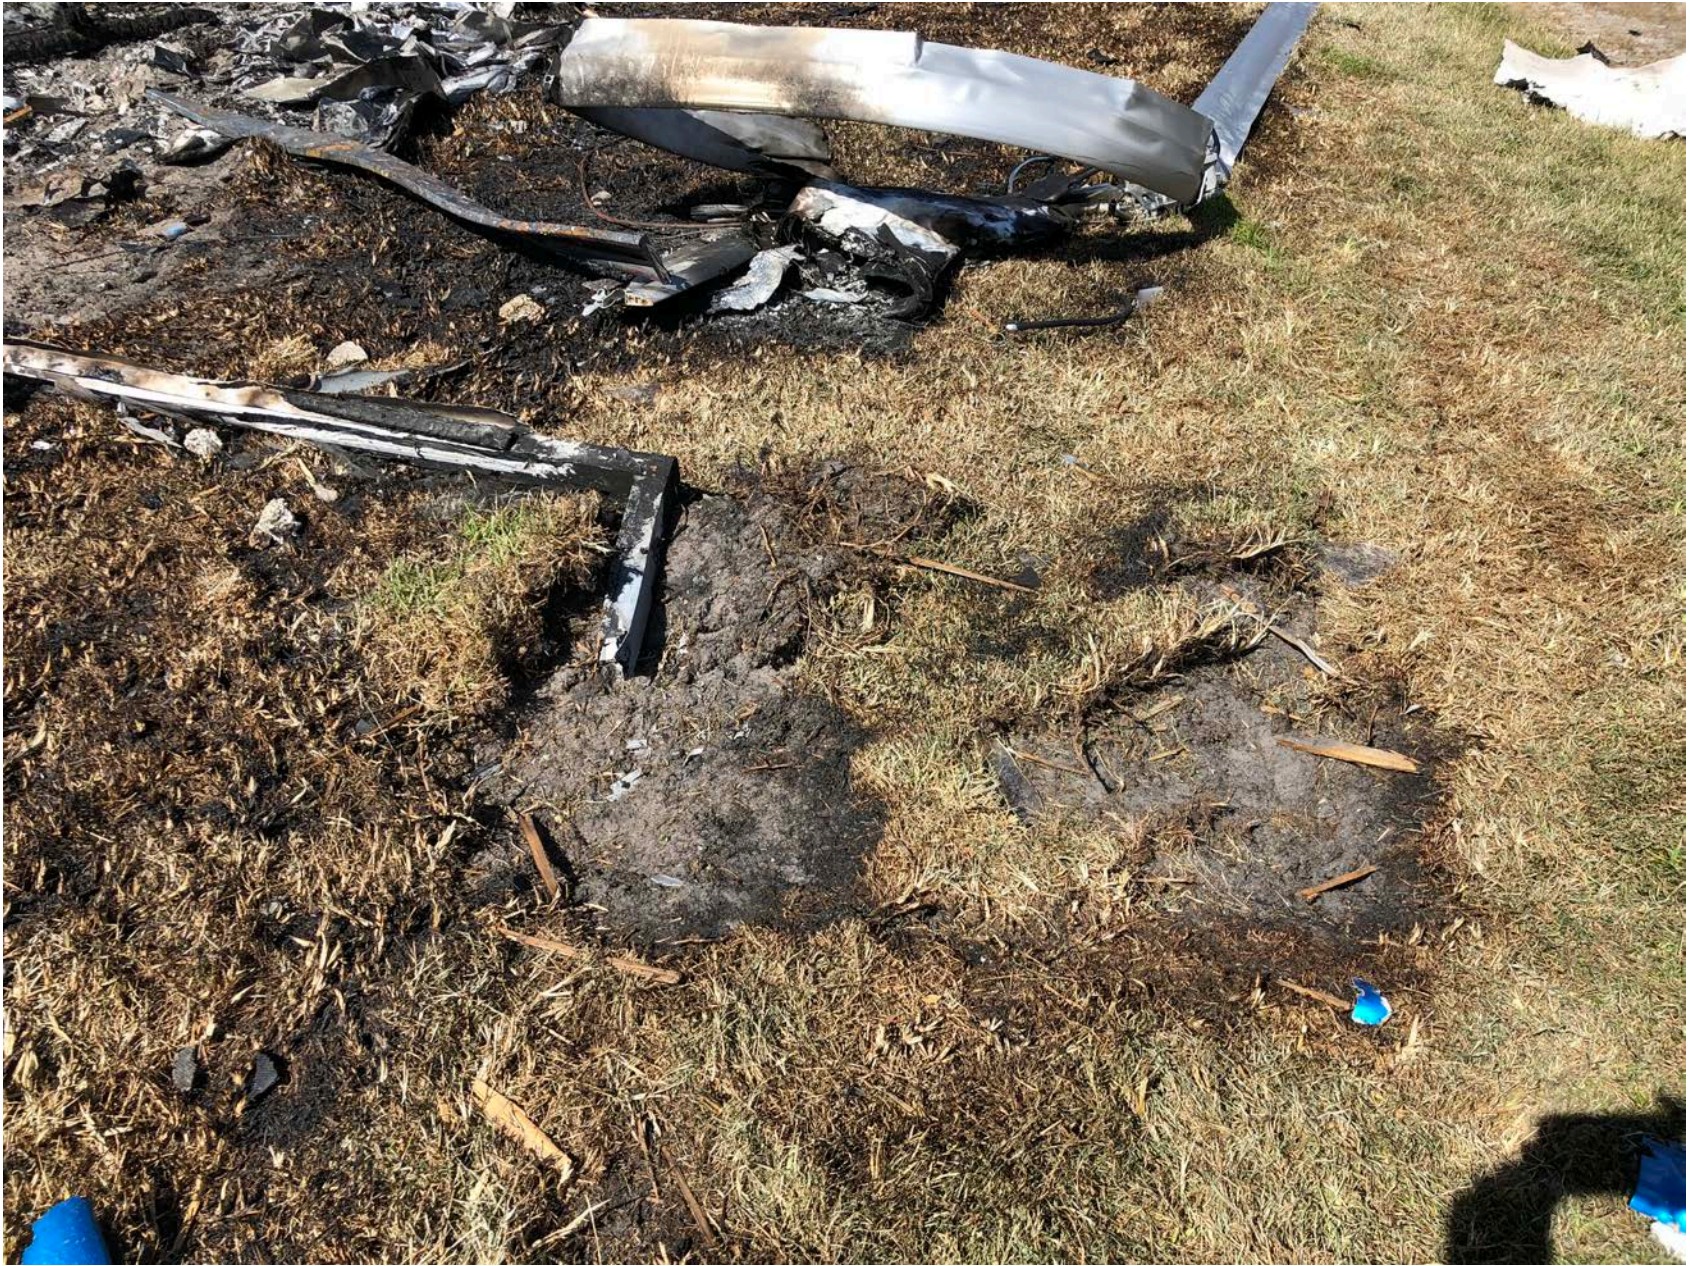
**Photo 4 – View of Initial Ground Scar**

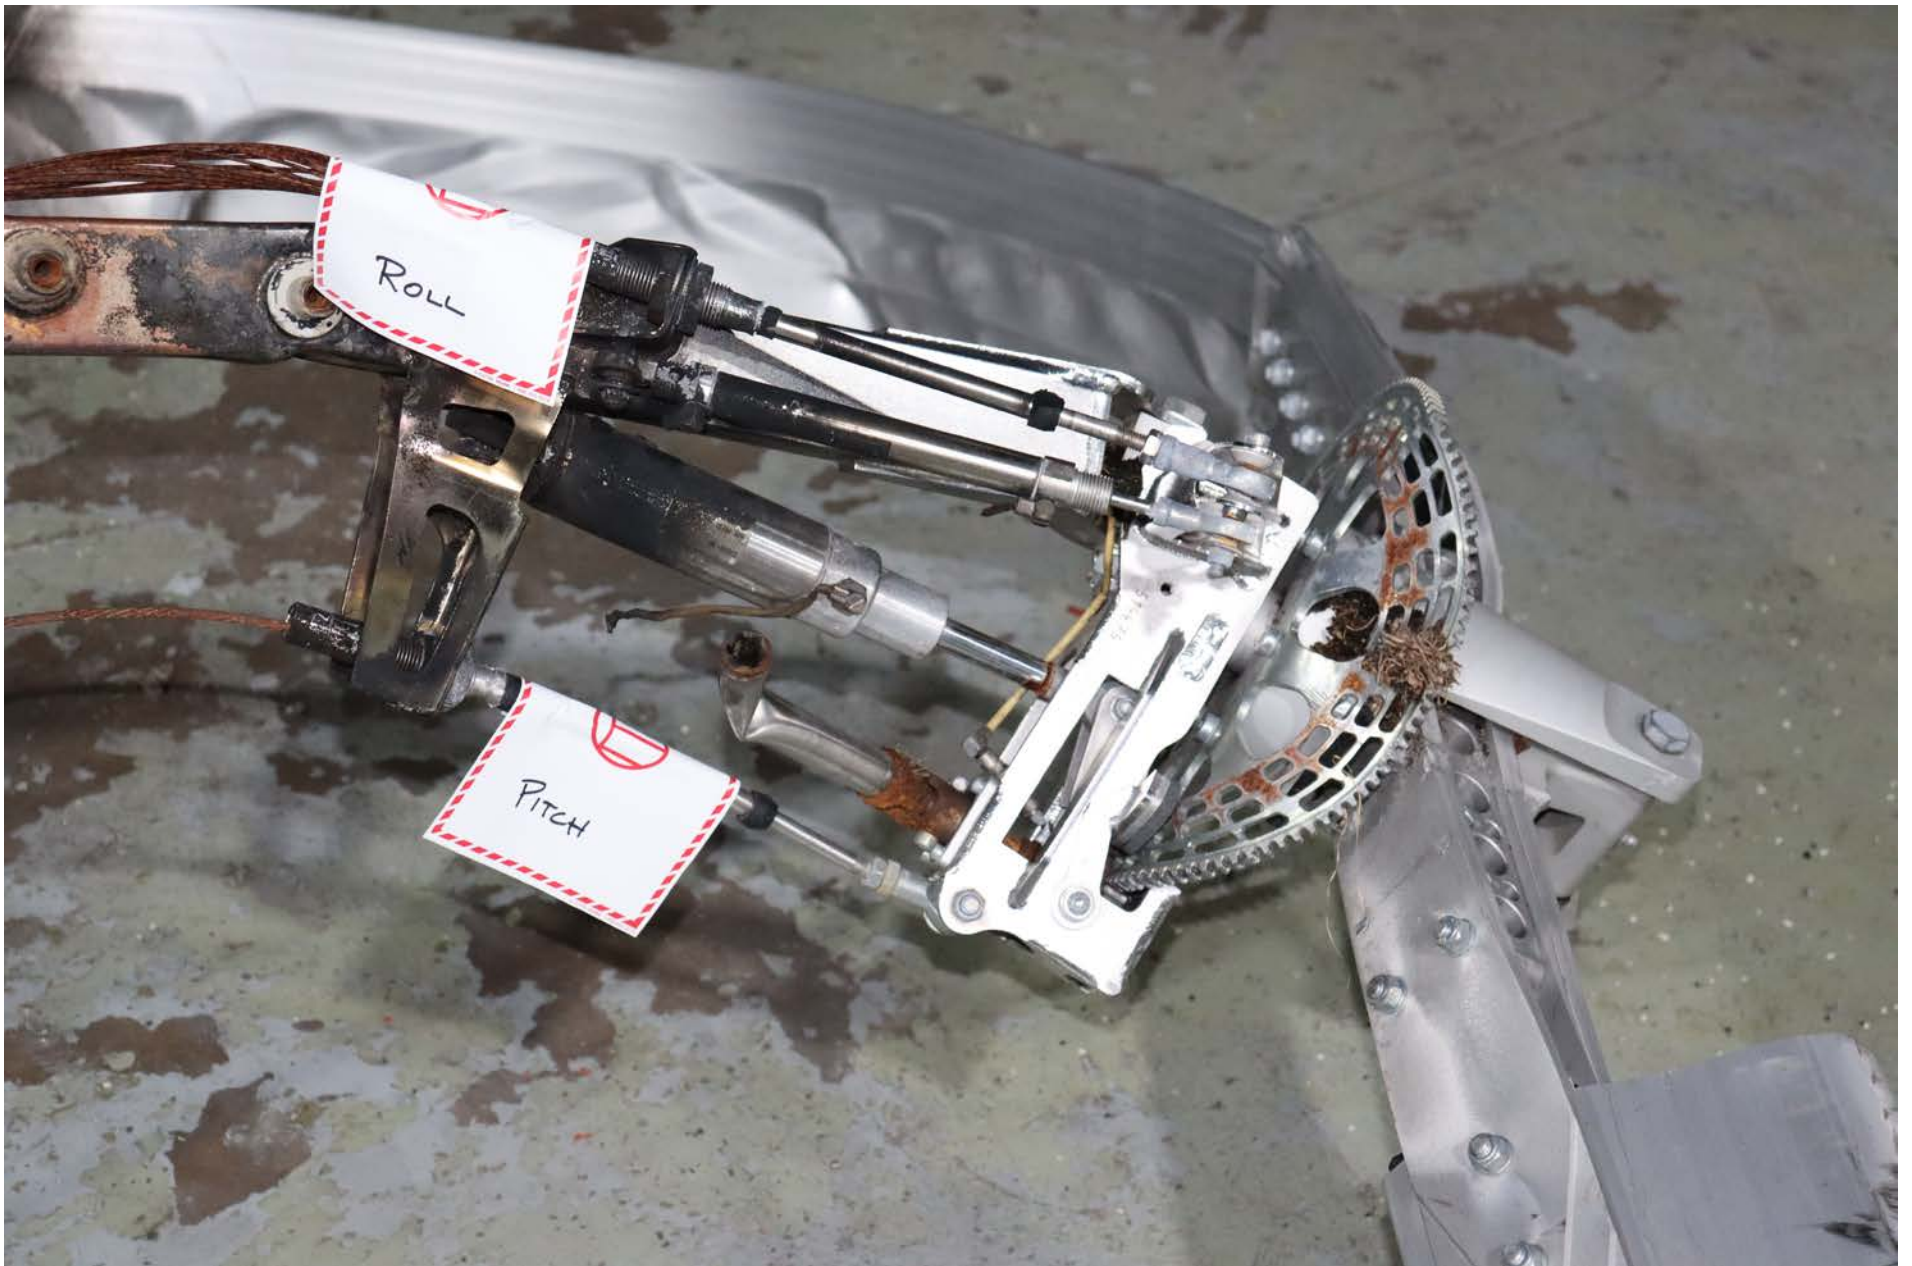
**Photo 5 – View of Upper Flight Controls (AutoGyro USA)**

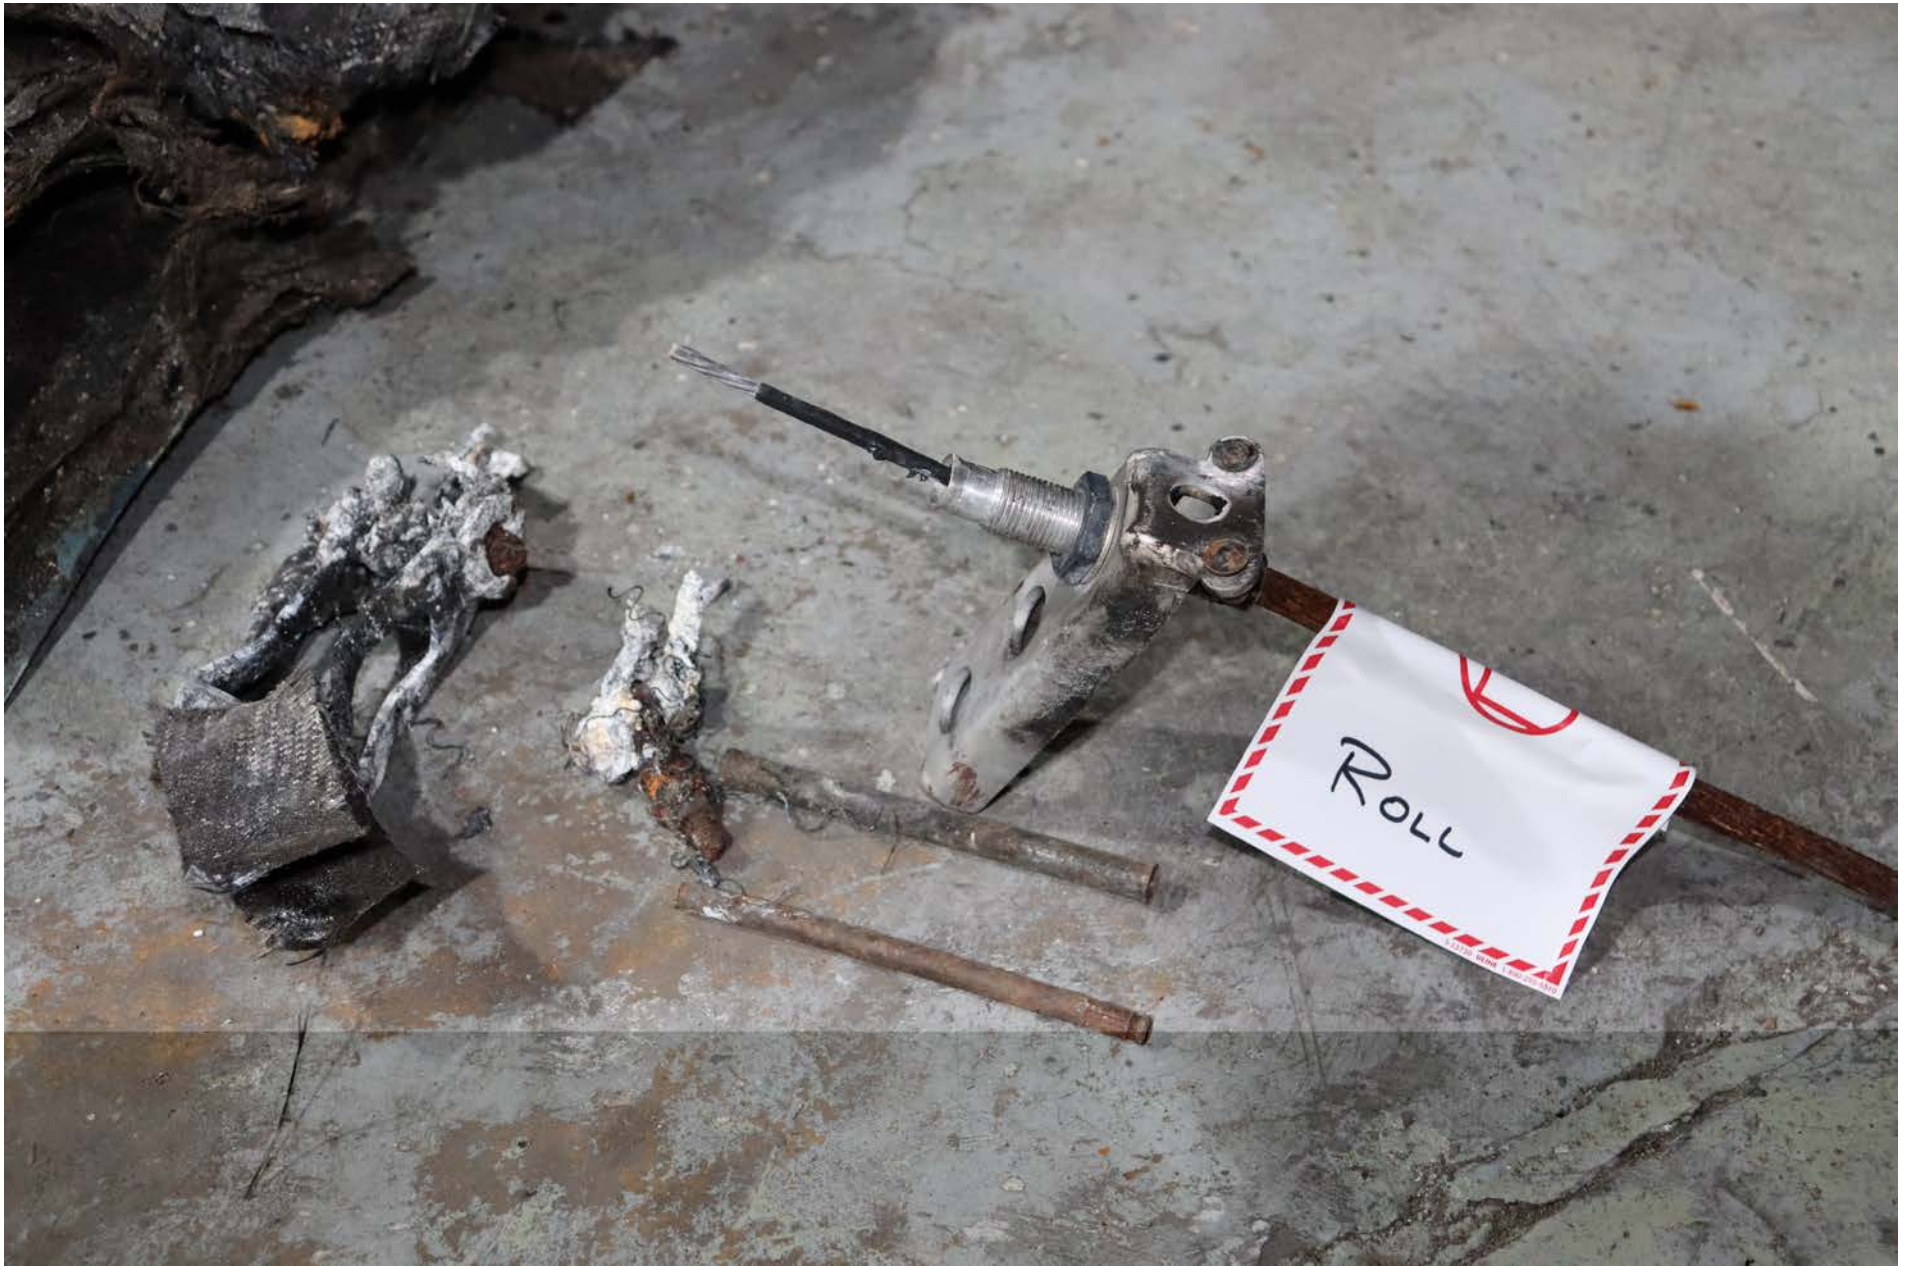
**Photo 6 – View of Roll Cable, Sheath, Roll Control Clevis (AutoGyro USA)**

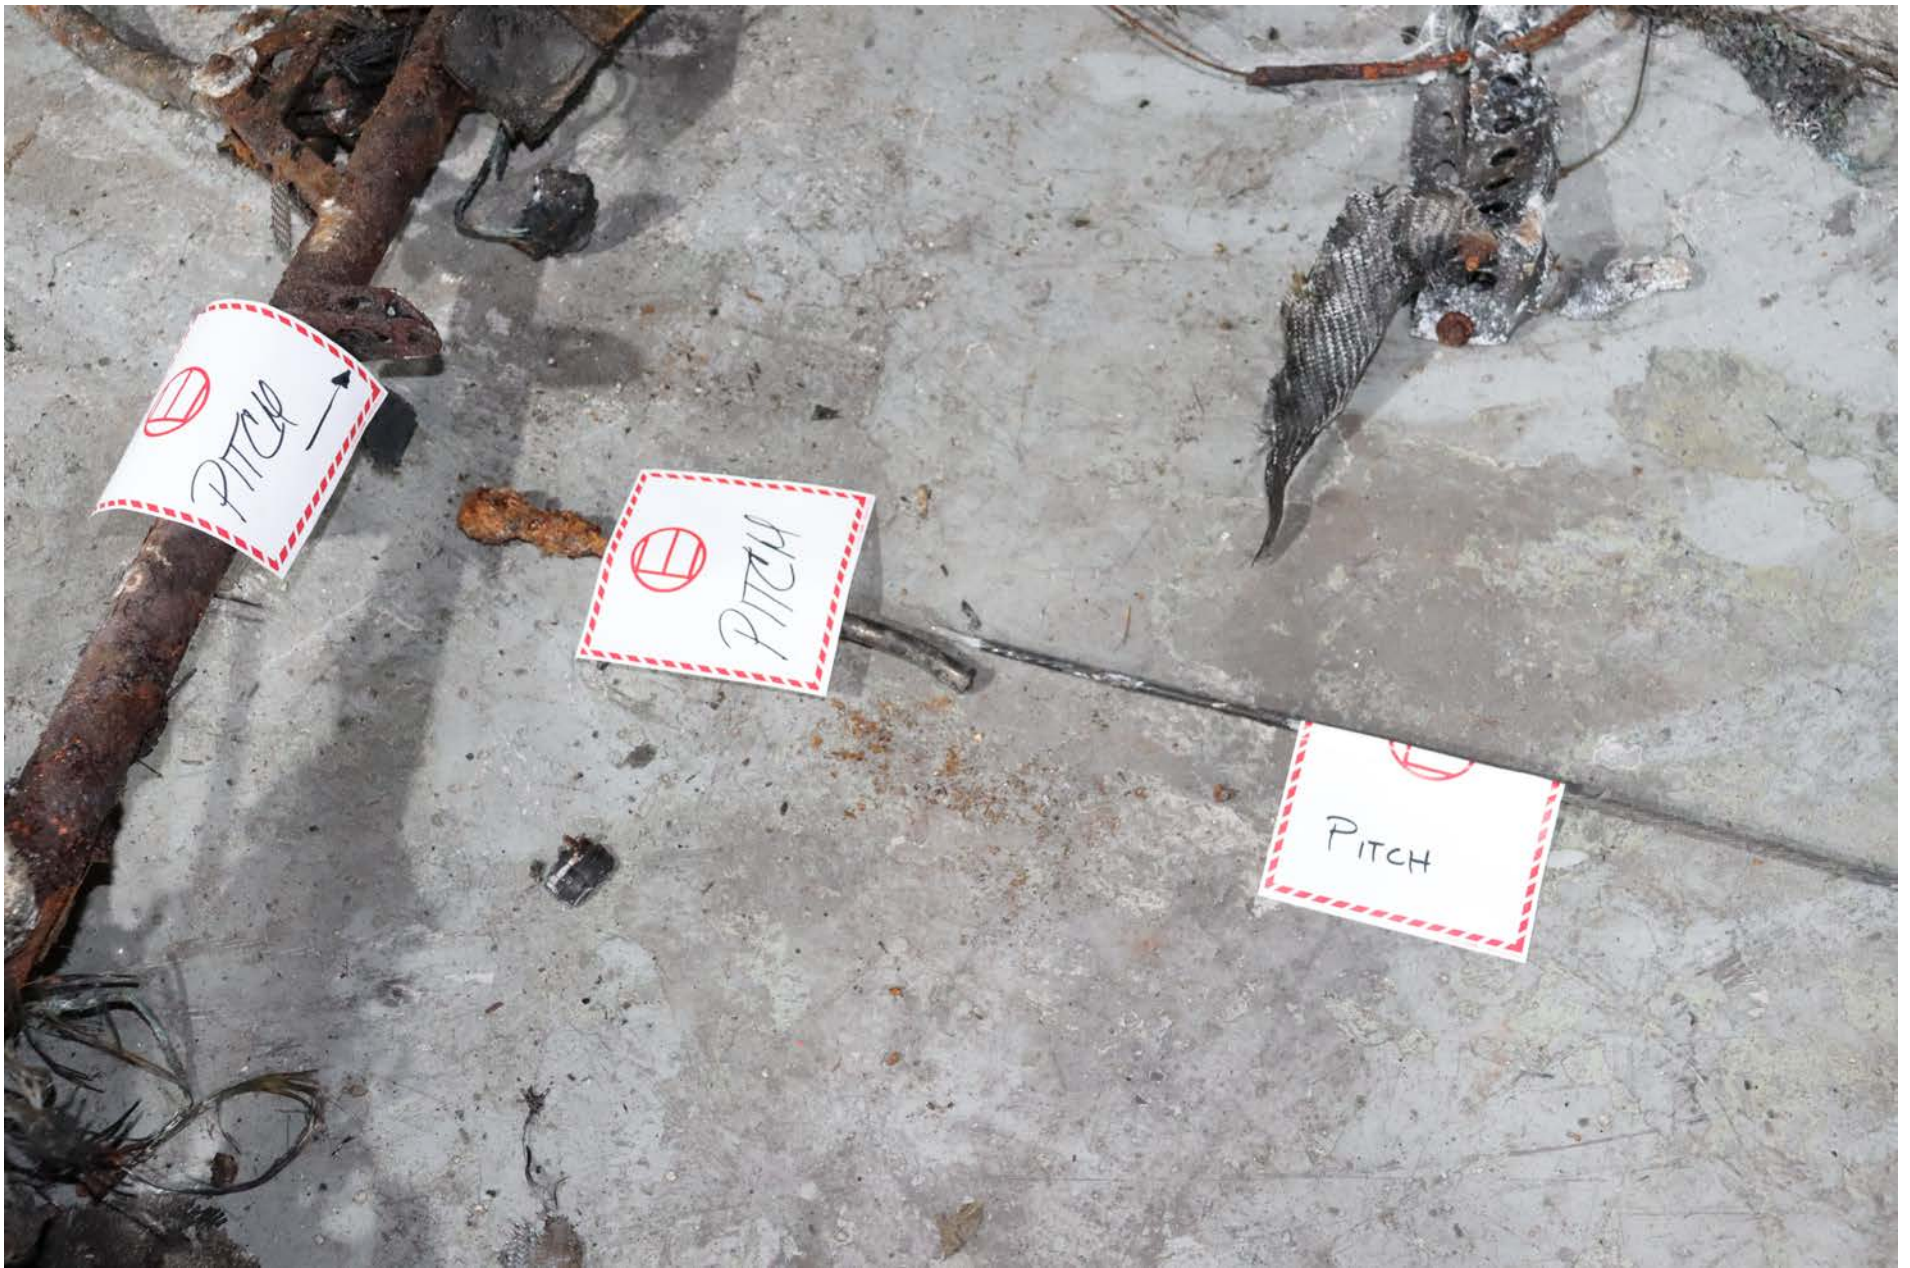
**Photo 7 – View of Pitch Control Cable, Sheath, Rod-End Clevis, and Control Tube Pitch Horn (AutoGyro USA)**

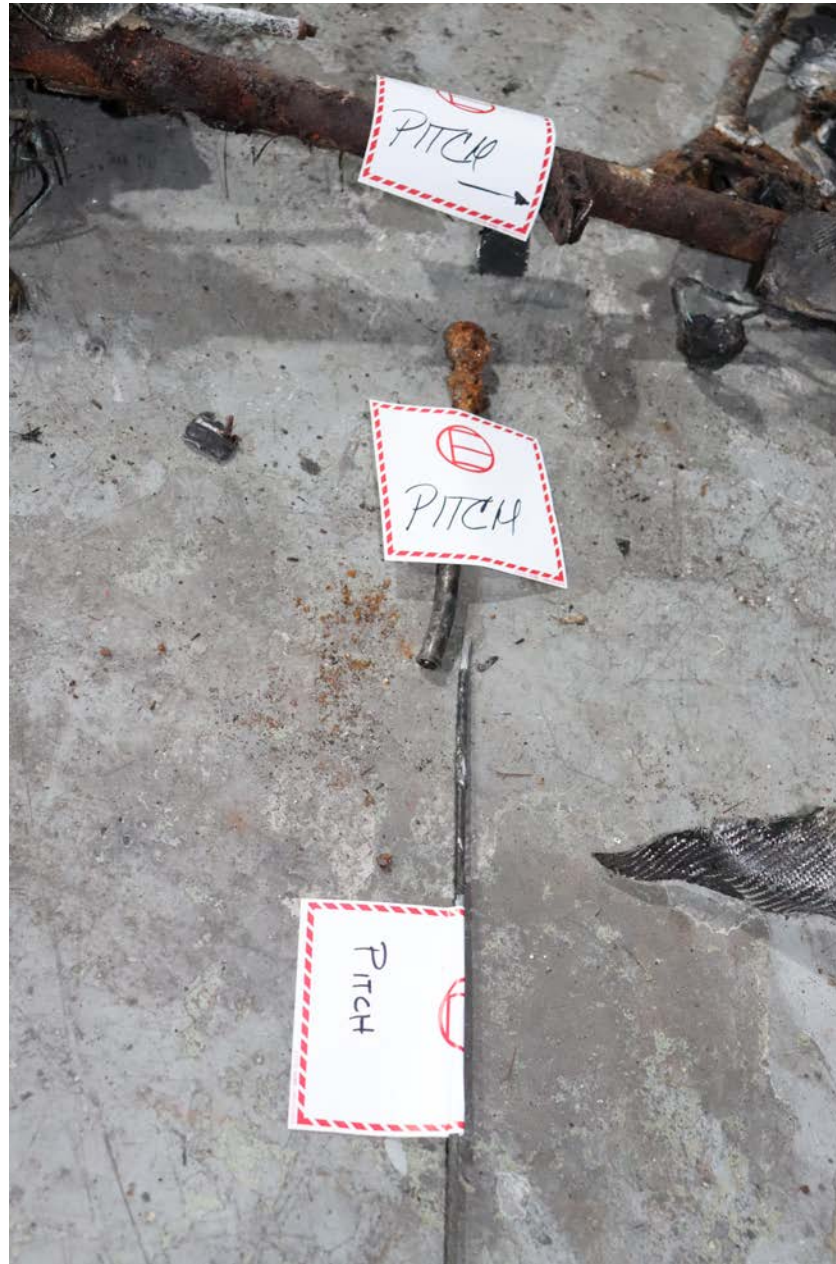
**Photo 8 - View of Pitch Control Cable, Sheath, Rod-End Clevis, and Control Tube Pitch Horn (AutoGyro USA)**
