# NTSB RECORD OF CONVERSATION

**Date: 7/31/2019**  
**Person Contacted: Terry Bryant (FAA Inspector)**  
**NTSB Accident Number: ERA19FA039**

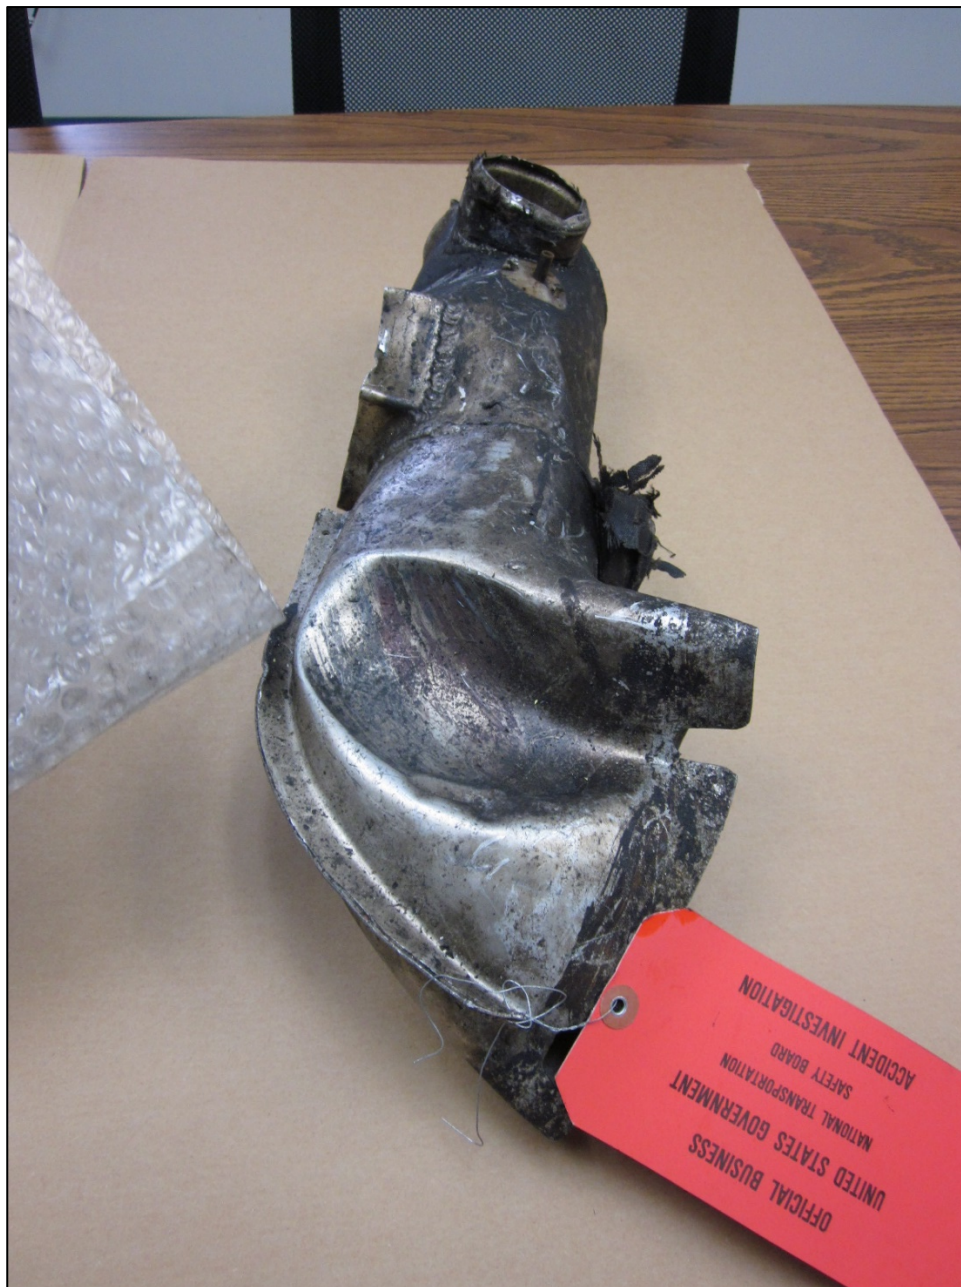
*Photo 1: Overview of Heater Condition*

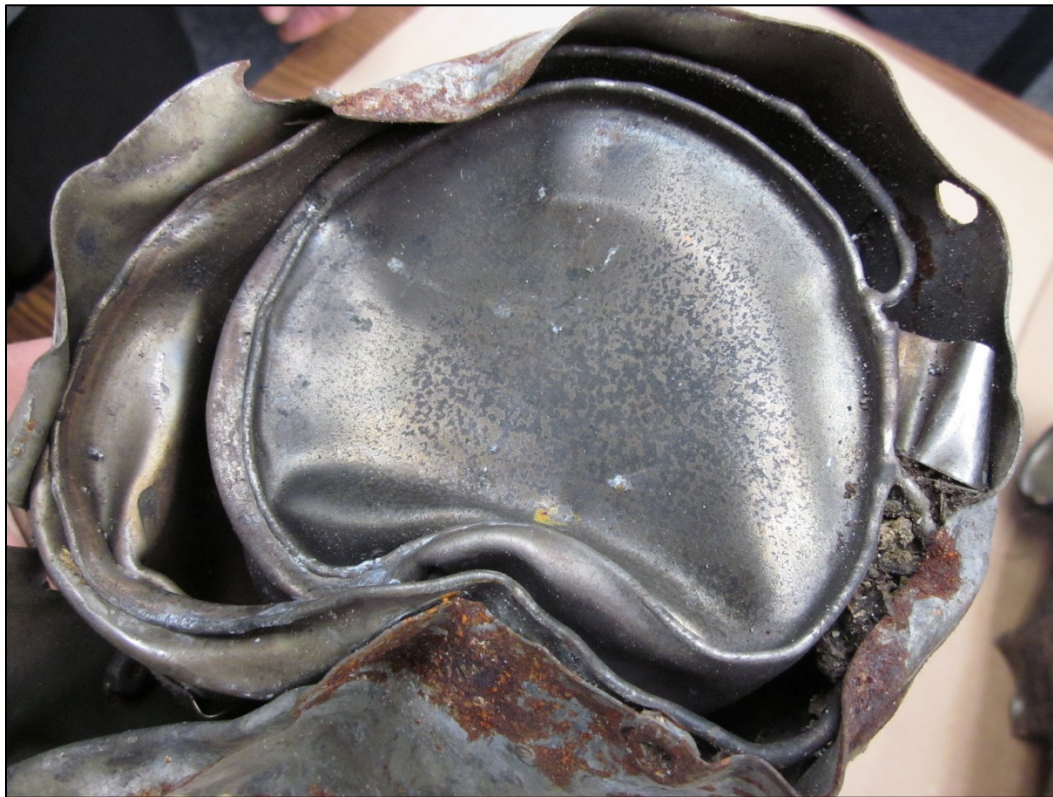
*Photo 2: View of Welding Ends of Heater*

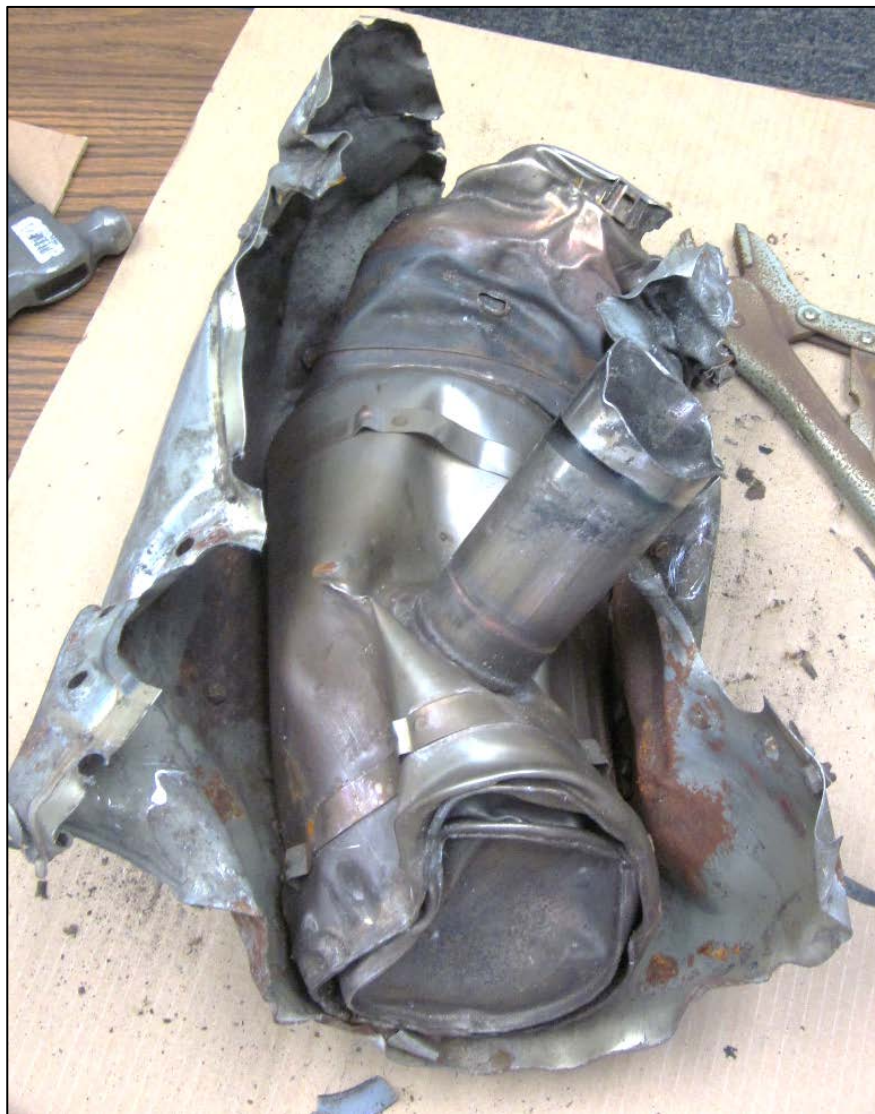
*Photo 3: View of Heater with Outer Shroud Peeled Back*
