# NATIONAL TRANSPORTATION SAFETY BOARD

## MATERIALS LABORATORY FIRE FACTUAL REPORT

Report No. 19-062

Place : Walton, New York  
Date : November 9, 2018  
Vehicle : Cessna 310R, N5044J  
NTSB No. : ERA19FA039  
Investigator : Adam Gerhardt  
AS-ERA

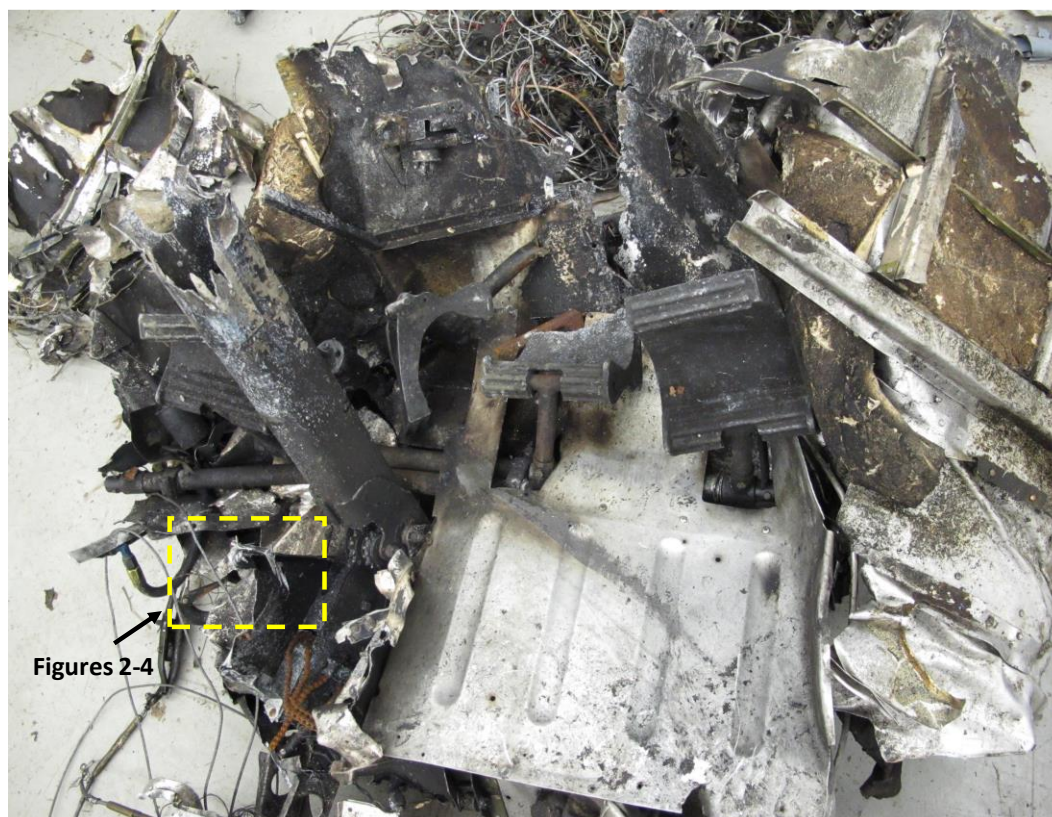
Most of the cockpit section was missing except for the floor section from the forward part of the cockpit as shown in Figure 1. This section exhibits heavy sooting and varying levels of thermal damage. Two small sections of broomstrawing<sup>1,2</sup> on sections of the pedestal wall were observed as shown in Figures 2, 3 and 4. There was also some evidence of thermal-related tearing of the pedestal structure as shown in Figure 5.

Figure 1. Recovered section of cockpit floor

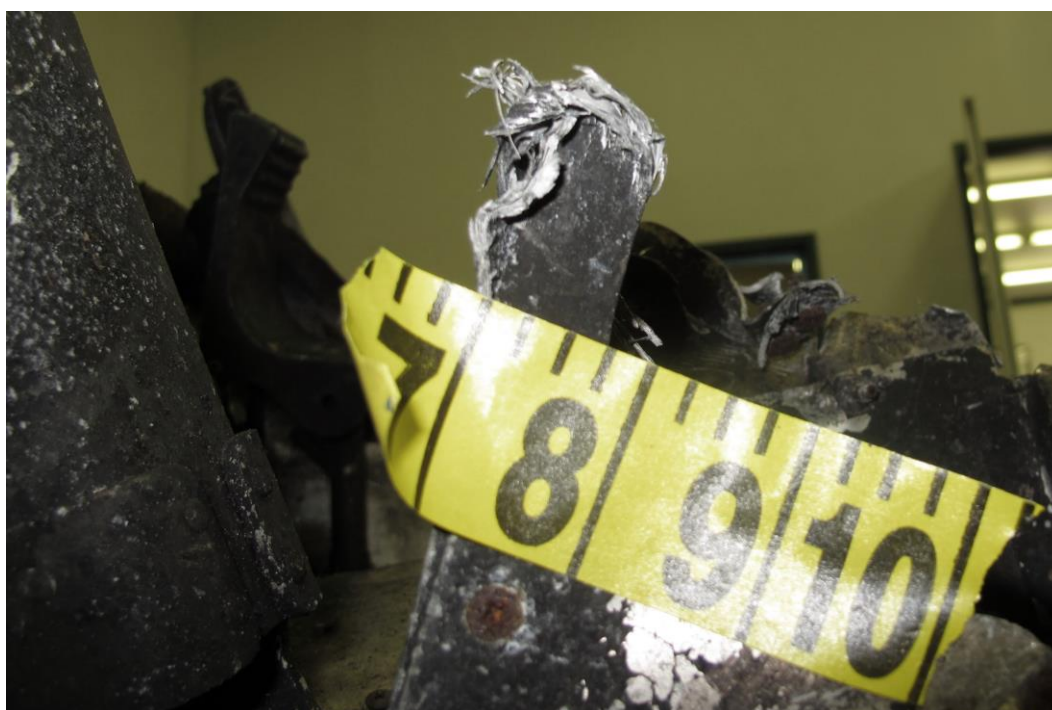
Figure 2. Area of broomstrawing on pedestal structure (side view).

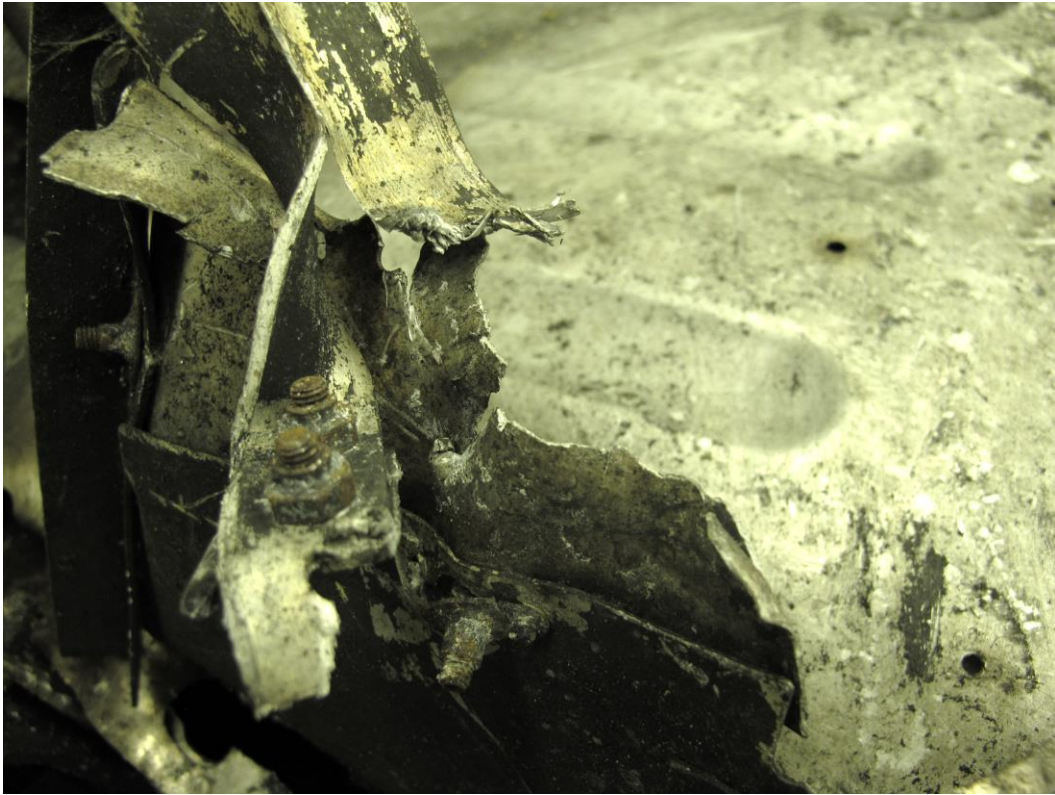
Figure 3. Second area of broomstrawing on pedestal structure.

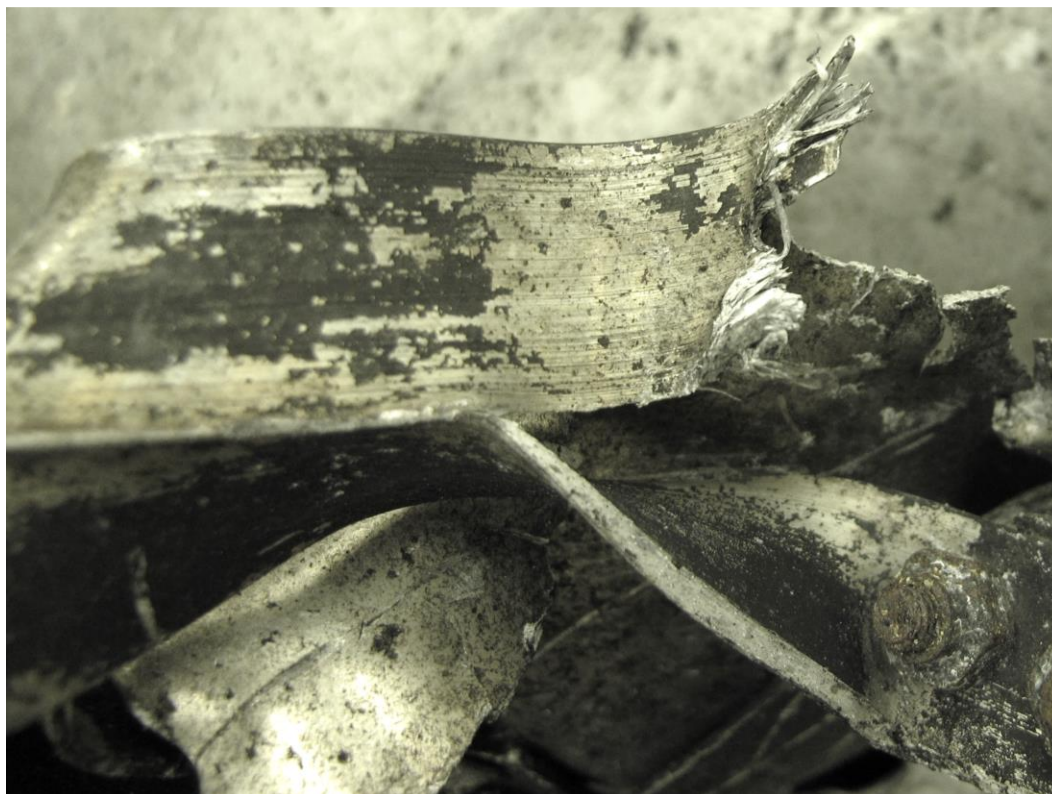
Figure 4. Close-up photograph of second area of broomstrawing.

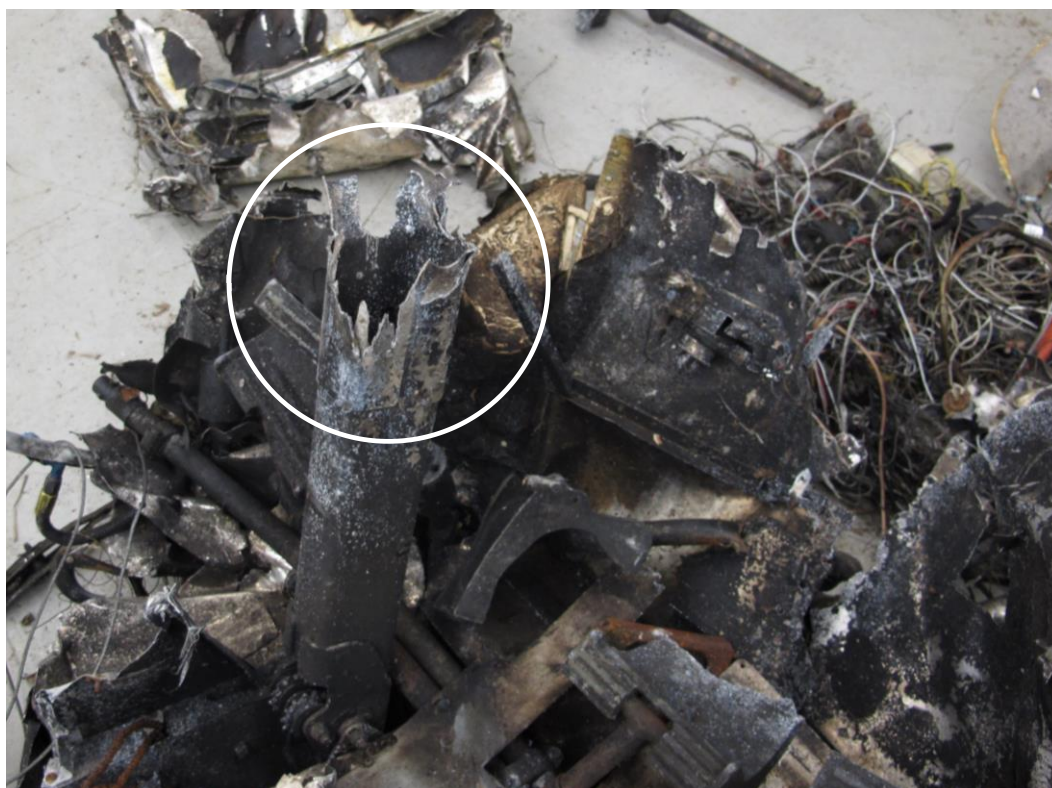
Figure 5. Thermal tearing of pedestal (highlighted in white circle).

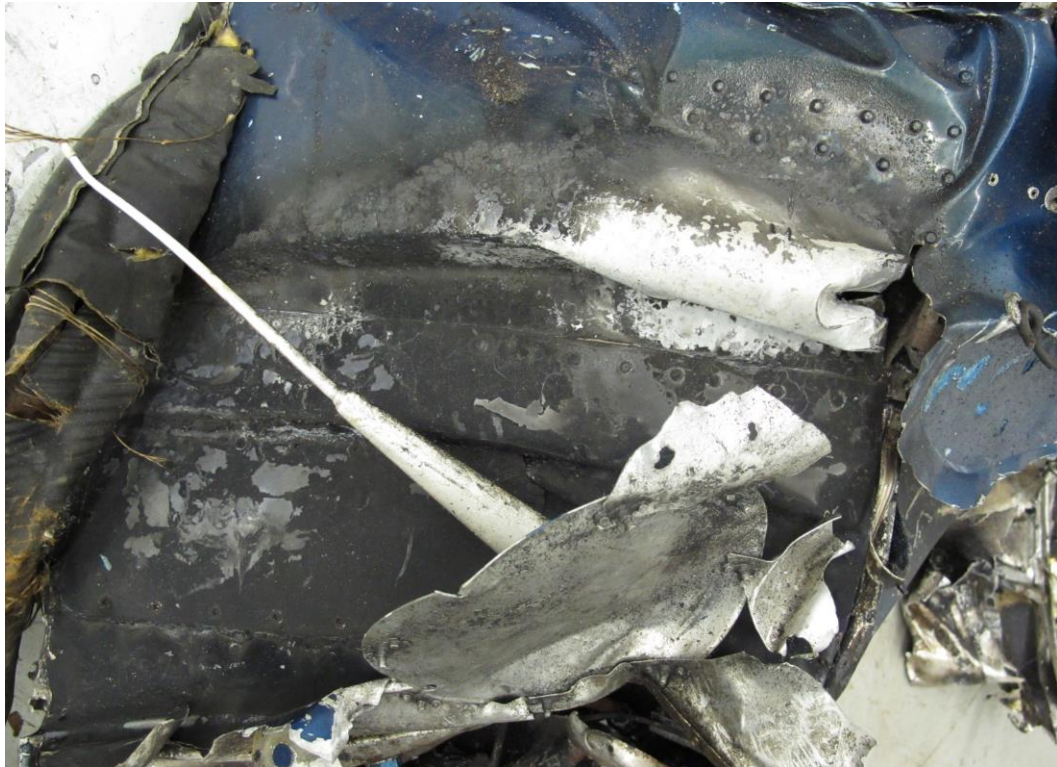
The exterior skin directly beneath the cockpit exhibited a localized area of thermal damage as shown in Figure 6. In this area, the exterior paint was missing, and the primer was discolored white and had powdery appearance. There were other smaller areas of localized areas of paint damage on the exterior surface. In these areas, the paint was discolored black with some localized bubbling of the paint. There were no other areas on the exterior that exhibited thermal damage.

Figure 6. Exterior fuselage surface located under cockpit floor.

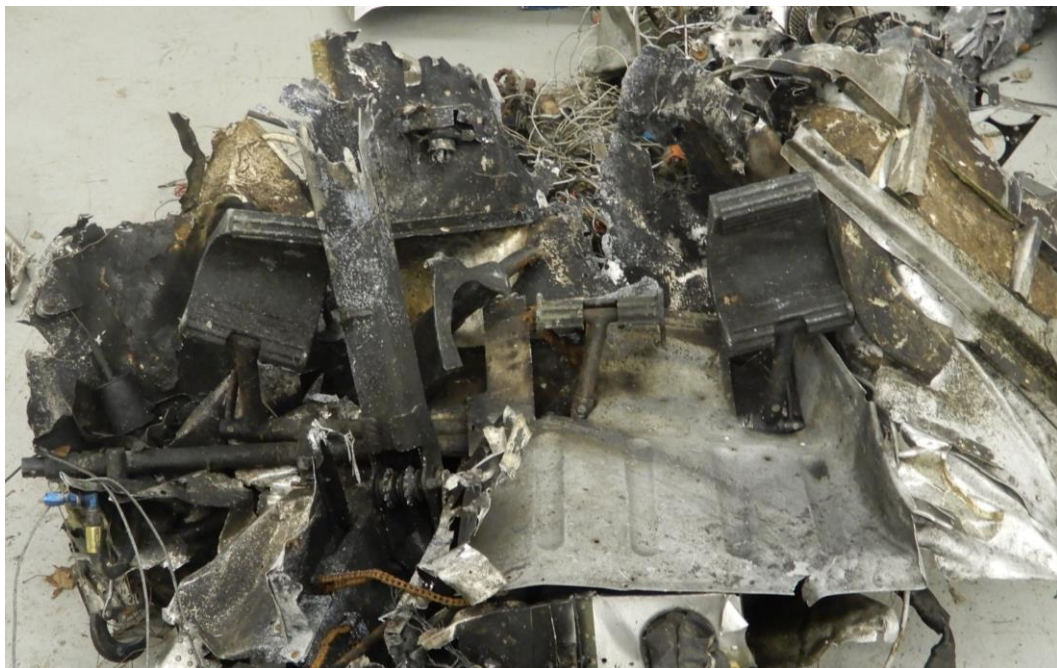
The rudder pedals were recovered. Three pedals were completely intact and displayed no significant damage. The fourth pedal exhibited a fracture at the top. The pedals are shown in Figure 7. The fractured section was not recovered. A small section of flooring and side wall carpeting of the side wall of the airplane was recovered. No significant thermal damage was found in this area.

Figure 7. Rudder pedals.

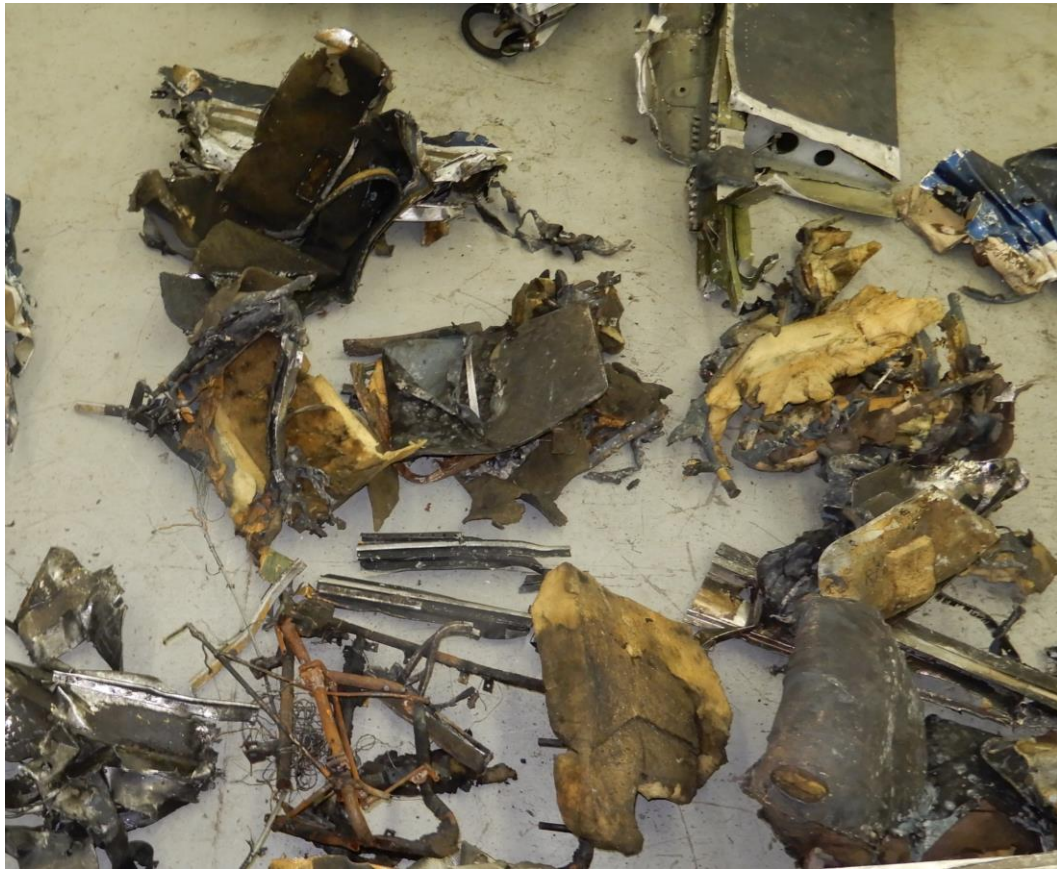
All four seats were recovered. The four seat frames were intact and exhibited varying levels of mechanical damage. Three seats still had some cushion material present. One seat still had the vinyl seat cover intact. Several sections of polyurethane foam were recovered. These sections exhibited varying levels of thermal damage and sooting. A photograph of two seats is shown in Figure 8.

Figure 8. Seat frames with sections of padding. Intact seat is in the lower right corner.

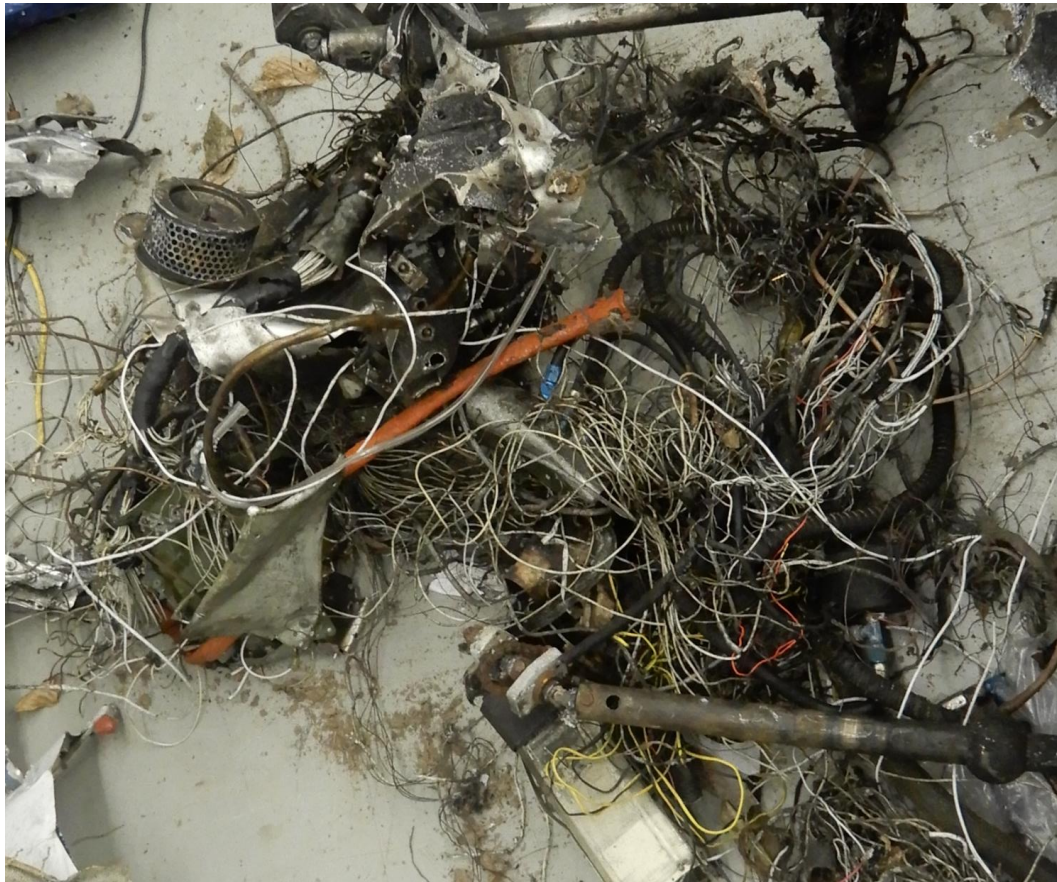
A large portion of the avionics wiring was recovered. No signs of electrical arcing (beading, pitting, or fused wire conductors) were observed. Several wire bundles remained intact, with undamaged insulation as shown in Figure 9. There were some wire bundles missing outer insulation or exhibited discoloration to the insulation, but no damage to the underlying wire conductors was observed. The damage to wire bundles in this area was consistent with mechanical damage.

Figure 9. Recovered instrument panel wiring.

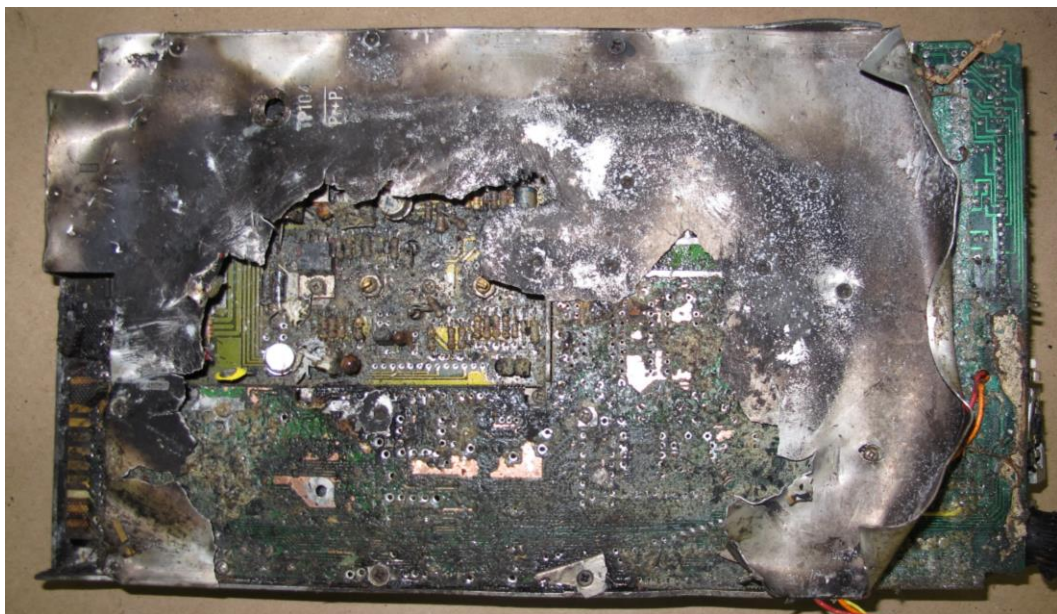
When examined a localized burn pattern on the bottom of instrument was observed as shown in Figure 10. Sooting and light to moderate thermal damage to the circuit board was observed, but the thermal damage did not appear to extend beyond this localized area.

Figure 10. Lower surface of lower navigation unit.

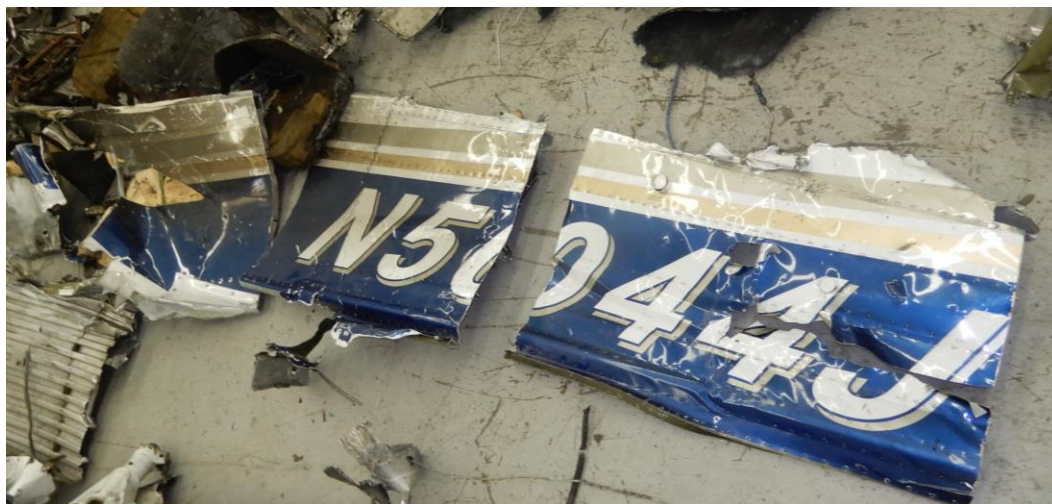
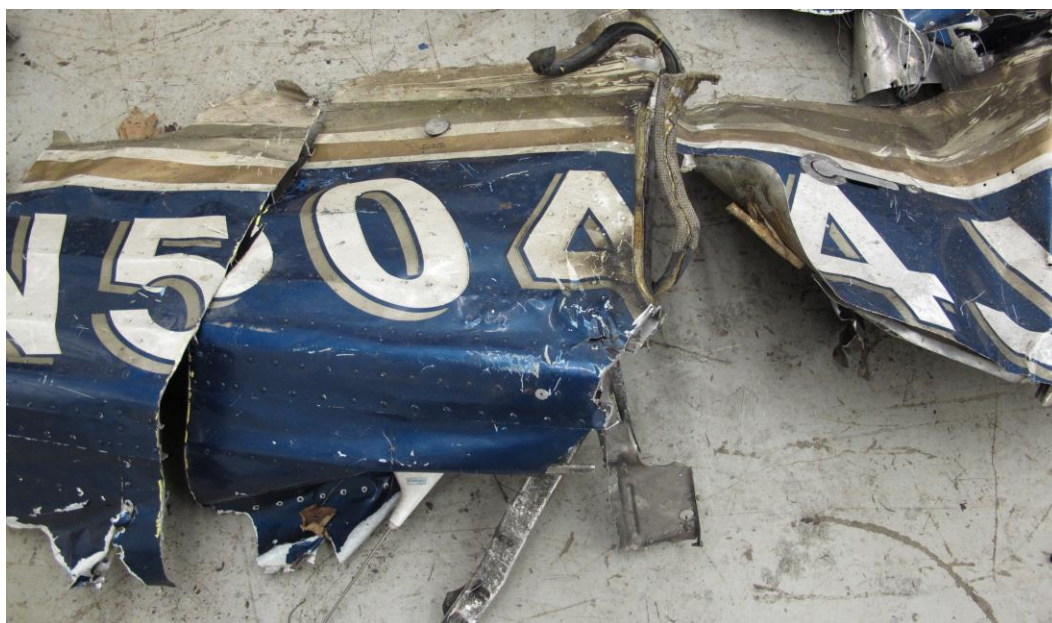
Two sections of the fuselage were recovered, which displayed the registration number on both sides of the airplane as shown in Figures 11 and 12. Each section was cut for recovery purposes. The left section exhibited general mechanical damage and was heavily sooted with varying levels of soot tailing along the rivet lines as shown in Figure 13. The right side exhibited similar damage, with less soot tailing. No other thermal damage was found on these sections. Fragments of the fuel system components exhibited no significant thermal damage.

Figure 11. Section of fuselage (left side).

Figure 12. Section of fuselage (right side).

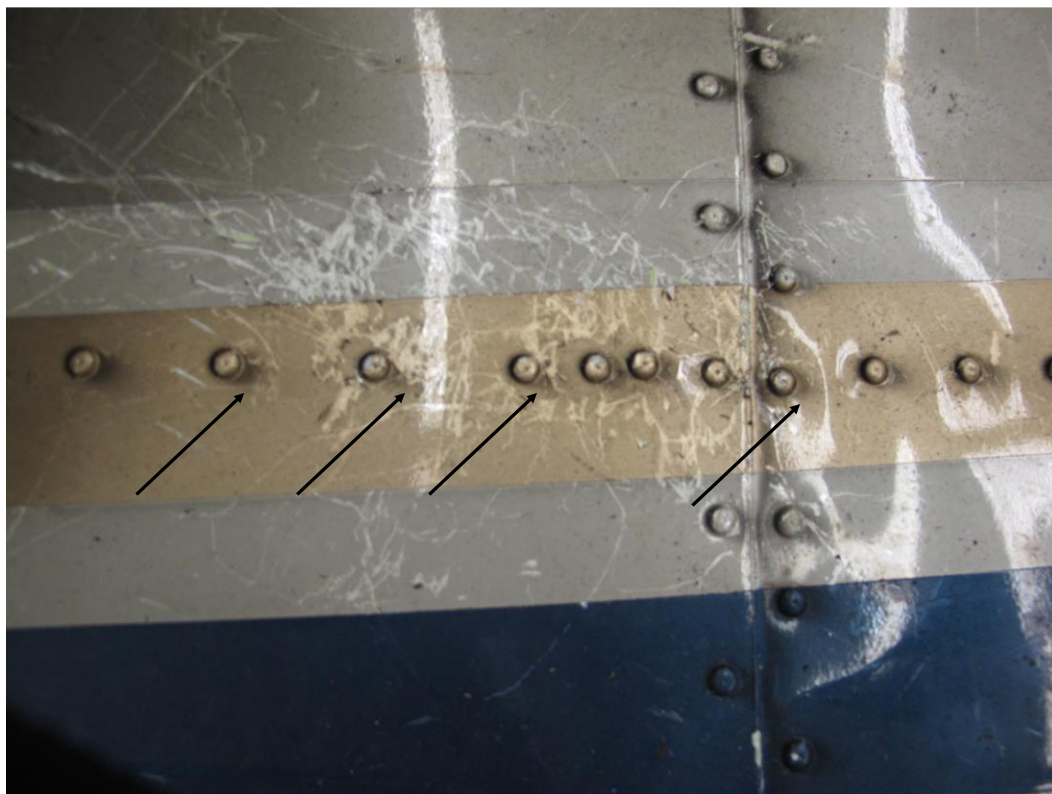
Figure 13. Soot tailing on rivets (highlighted with black arrows).

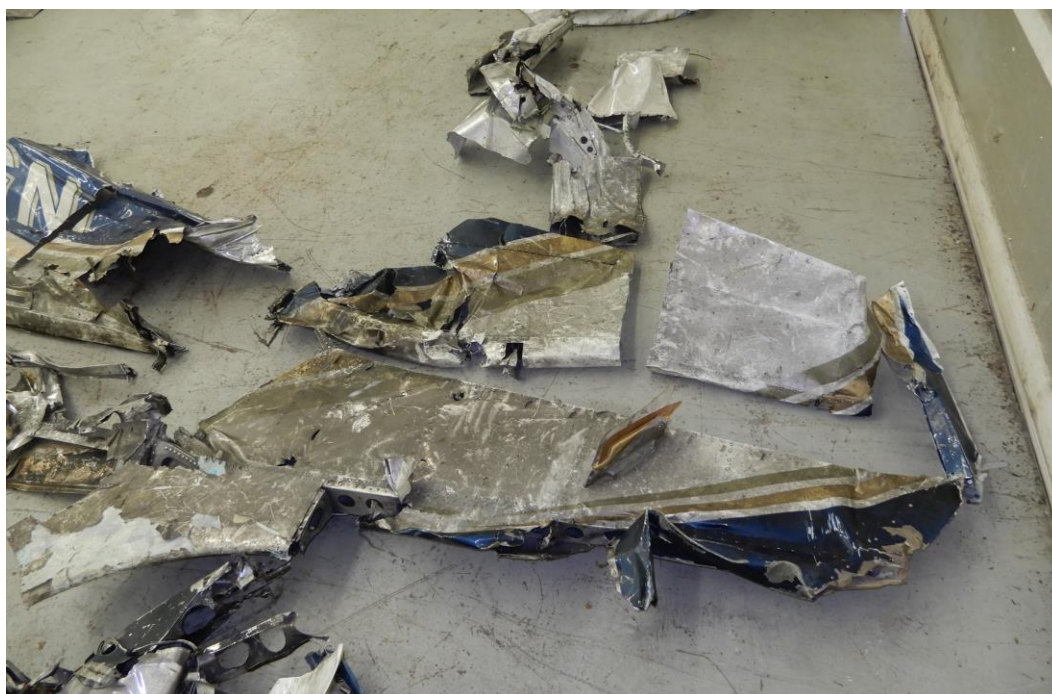
The recovered sections of empennage exhibited significant mechanical damage with varying degrees of soot was found across all exterior surfaces as shown in Figure 14. No other thermal damage was observed.

Figure 14. Recovered sections of empennage.

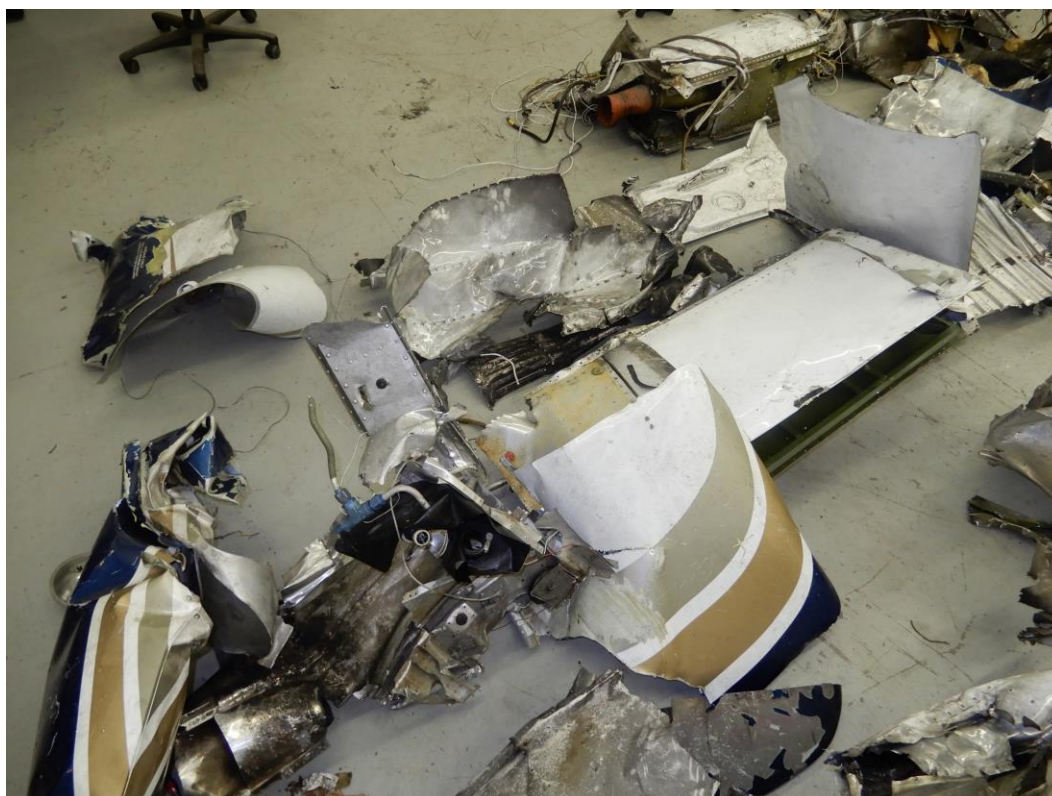
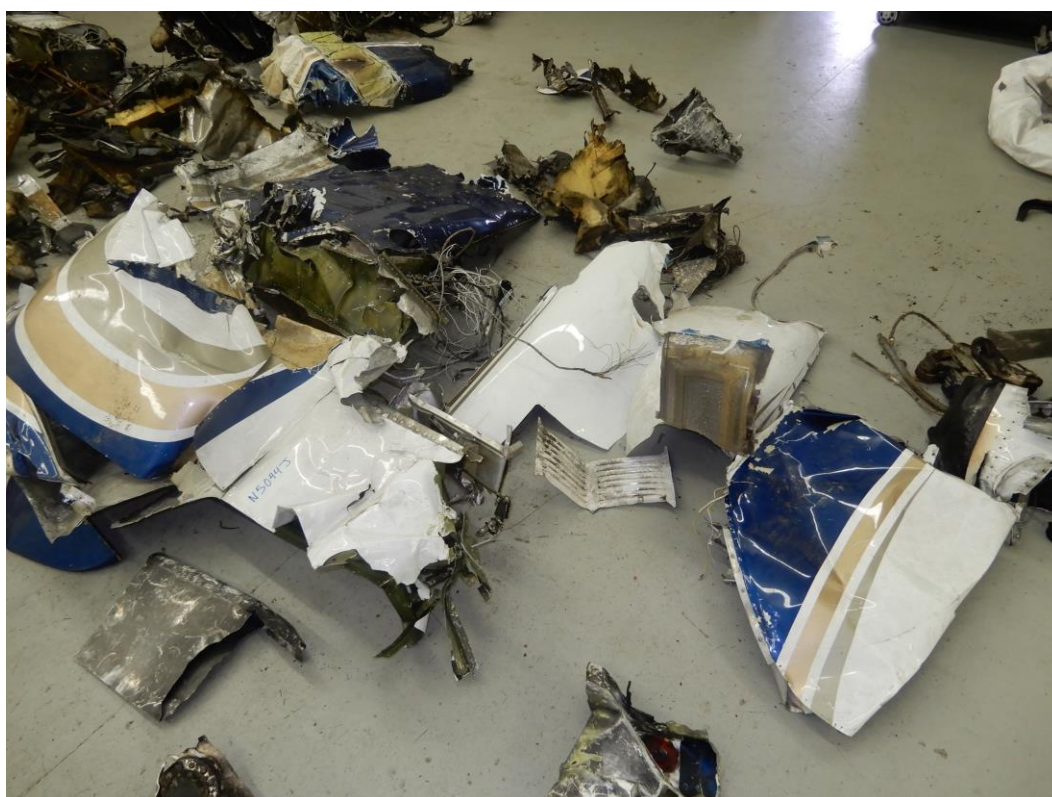
Both wings exhibited significant mechanical damage and fragmentation as shown in Figures 15 and 16. Fragments of the left wing exhibited heavy sooting over its outboard surfaces, with localized areas of thermal damage. The right wing exhibited less sooting and no observable thermal damage. The recovered fragments of the tip tanks did not exhibit significant sooting. The recovered sections of the cowling displayed no thermal damage. The inboard fragments of the wings exhibited no thermal damage and little sooting. Small sections of the fuel bladders exhibited no sign of thermal damage.

Figure 15. Recovered sections of left wing.

Figure 16. Recovered sections of right wing.

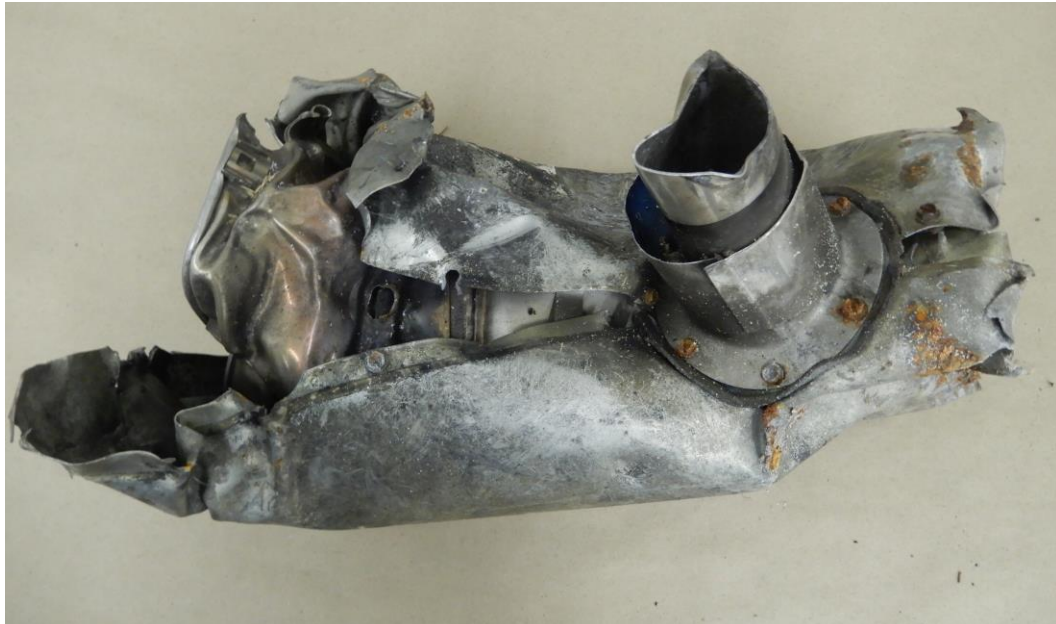
The cabin heater exhibited mechanical-related damage and some localized thermal discoloration with some light sooting on the outer casing as shown in Figure 17. No internal thermal damage was observed. Polymeric materials on the flapper valve and thermostat

Figure 17. Aircraft cabin heater.

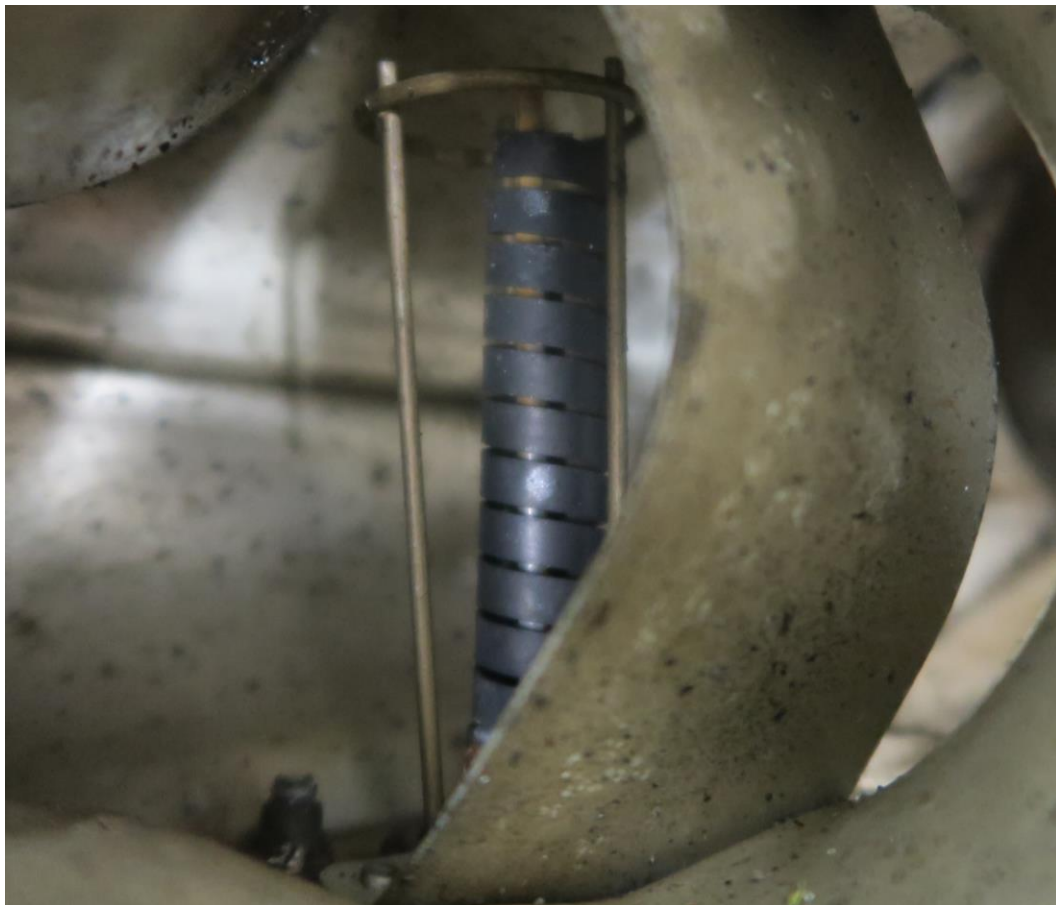
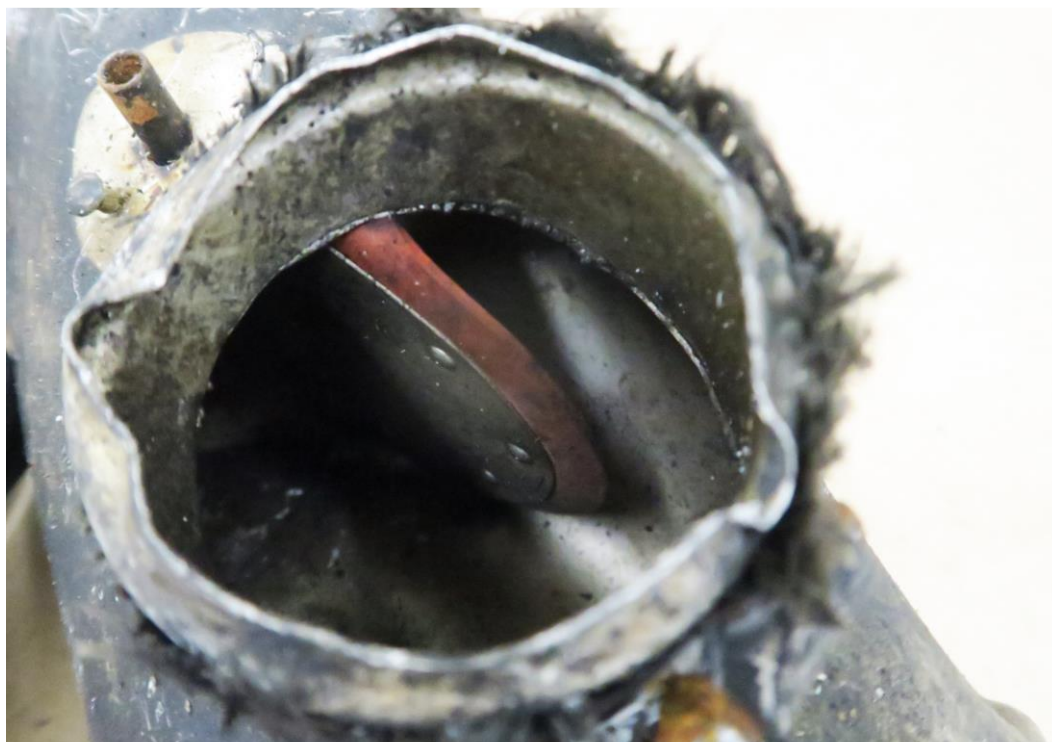
inside the exhaust duct were located, and no evidence of thermal damage/melting or sooting internal to the recovered exhaust ducting was observed as shown in Figures 18 and 19.

Figure 18. Interior of cabin heater.

Figure 19. Air control flapper valve inside the cabin heater.
