# Continental Motors

## ENGINE EXAMINATION REPORT

| ENGINE MODEL | IO-550-A3B |
| FILE NUMBER | 18-286 |

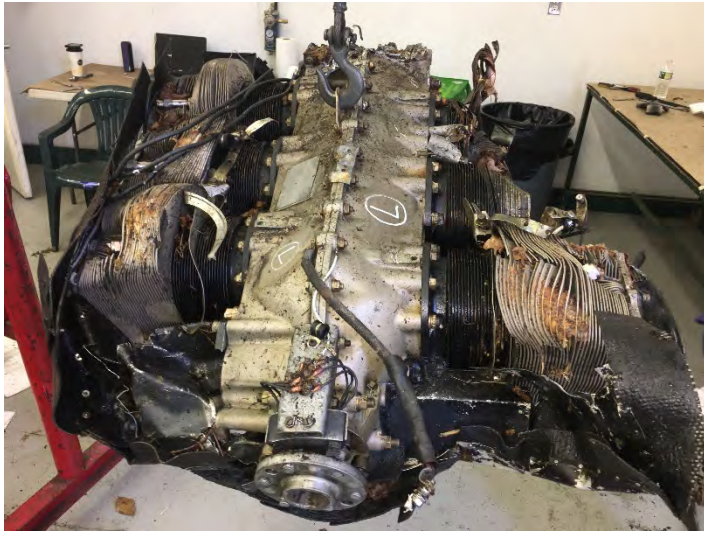
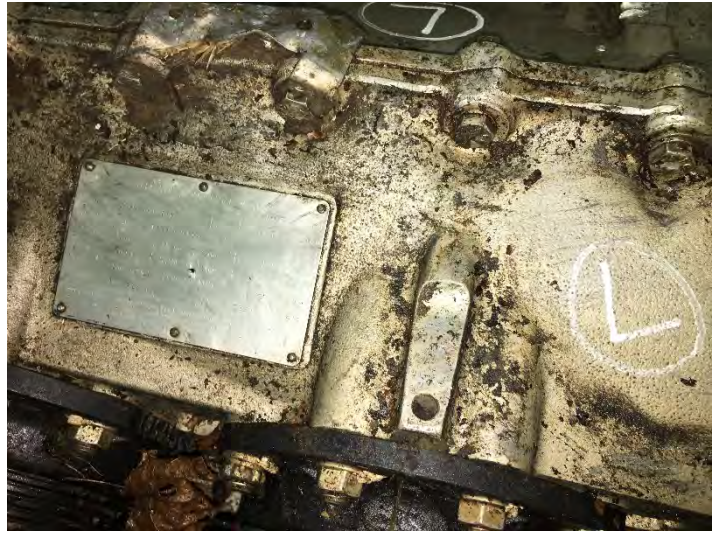
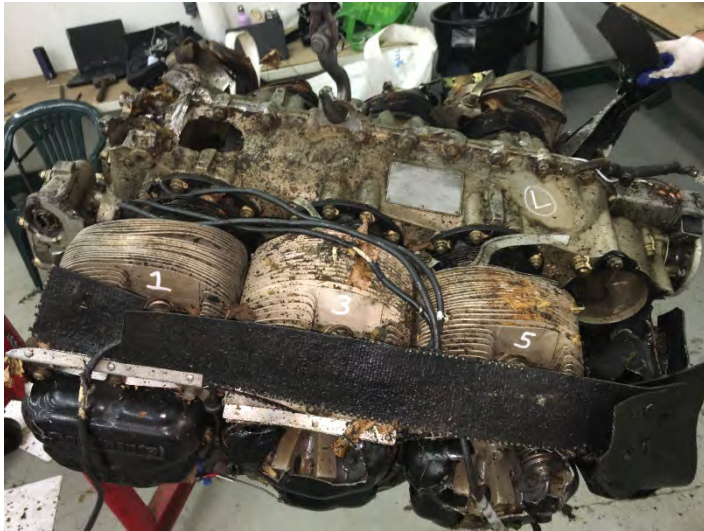
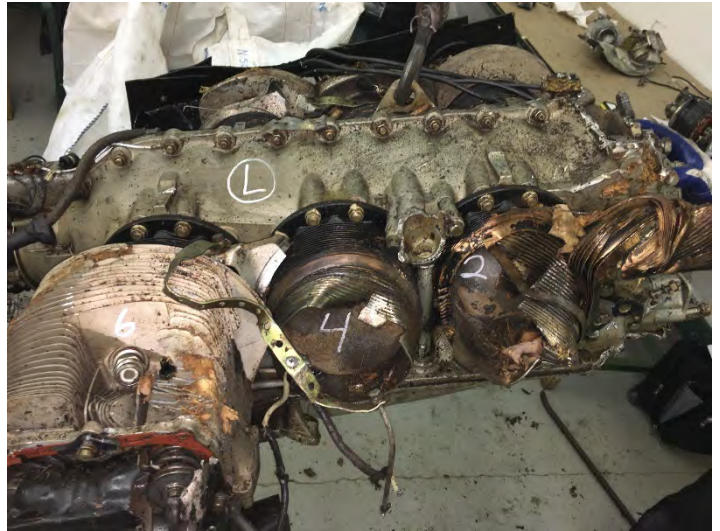
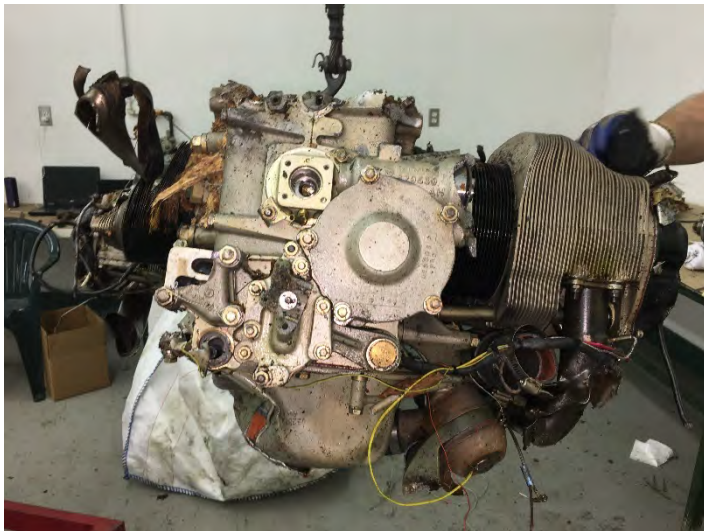
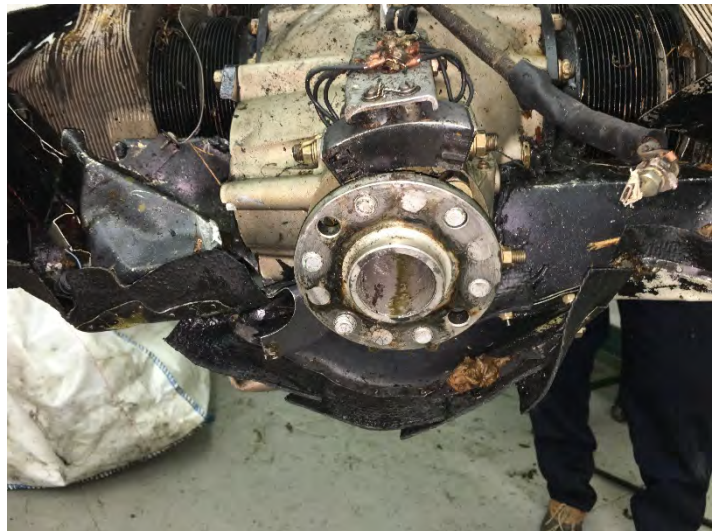
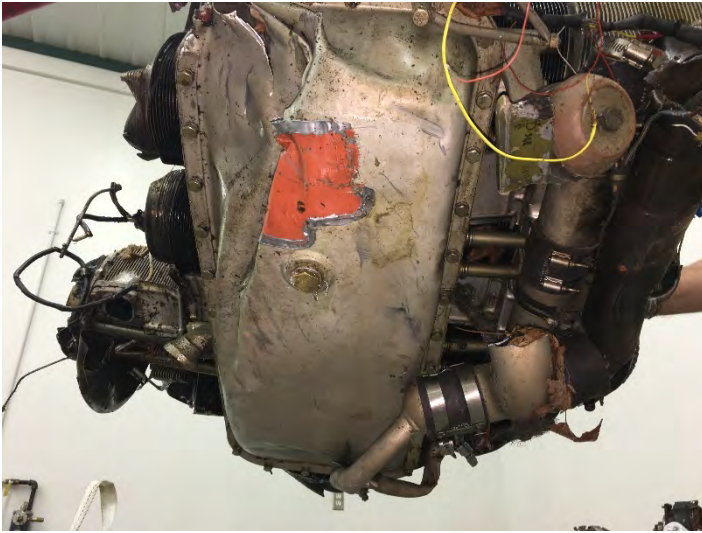
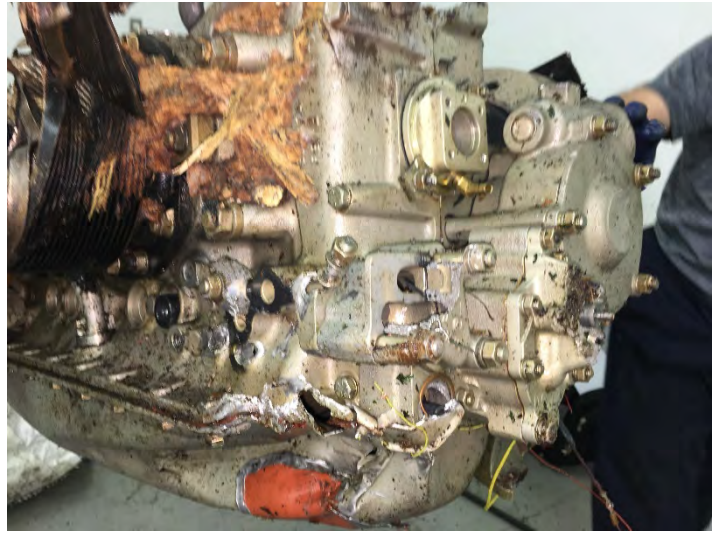
The engine was separated from the aircraft and was lying on the floor of the aircraft recovery facility in a bag. The alternator and propeller were separated, the left aft side of the oil sump was torn and displaced to the right. The top side of the accessory end of the engine was fractured and all of the accessories were separated with the exception of the starter adapter and oil pump. The intake filter, throttle body, and left side intake tubes were separated from the induction system. The #2 and #4 exhaust risers were separated from the engine. The #2 and #4 cylinder heads were fractured and separated from the barrels, both of which sustained tearing and bending deformation damage. The remaining cylinders sustained impact related damage of varying degrees. The magneto mounting pads were separated from the engine and the magnetos were separated. A hole was observed in the crankcase over the #1 cylinder; however, the edges of the hole were deformed inward. Though the engine sustained significant impact-related damage, there was no sign of operational discoloration or pre-accident operational distress.

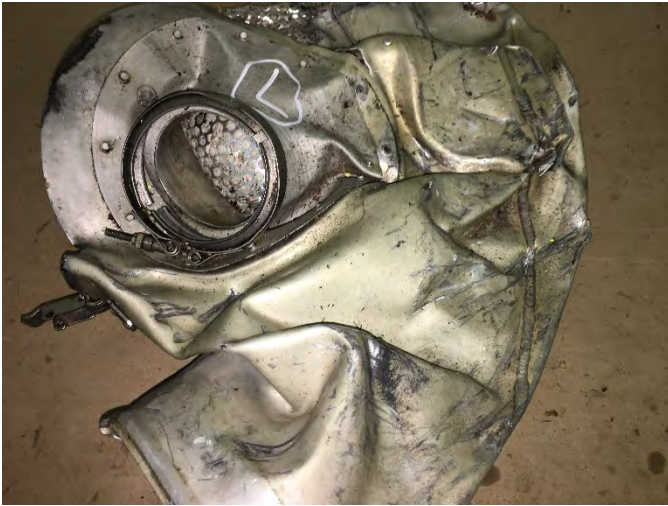
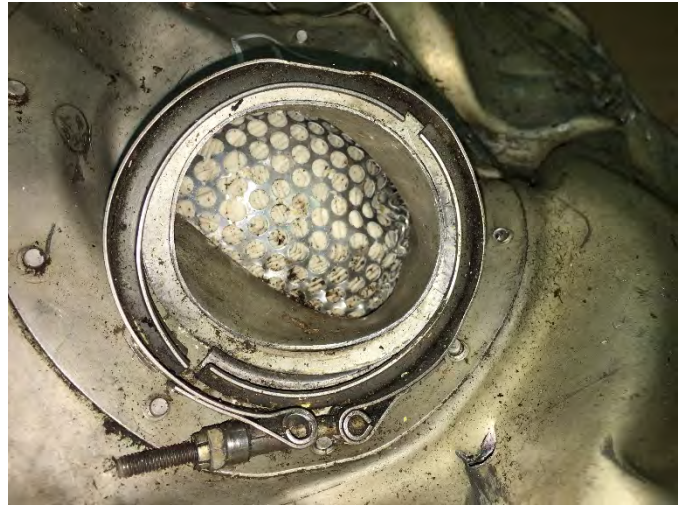
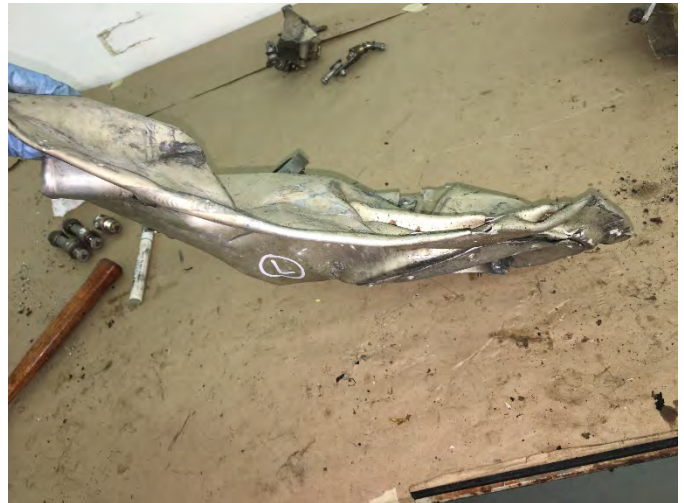
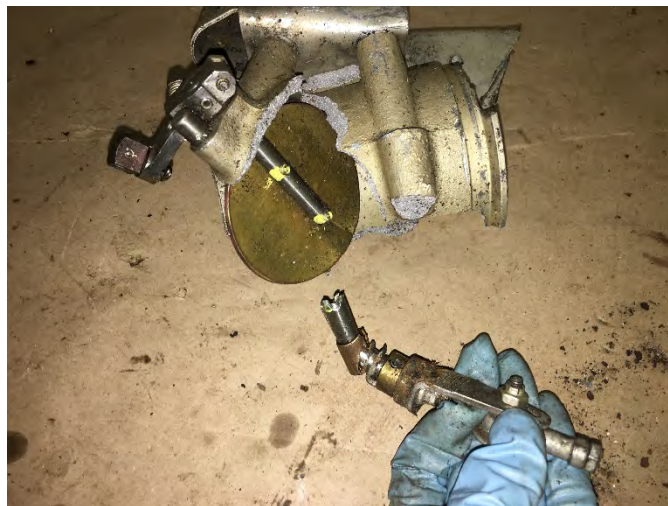
## INDUCTION SYSTEM

The intake shroud and filter were flattened, but remained intact with no obstructions noted with the intake filter. The throttle body and the throttle shaft were fractured.

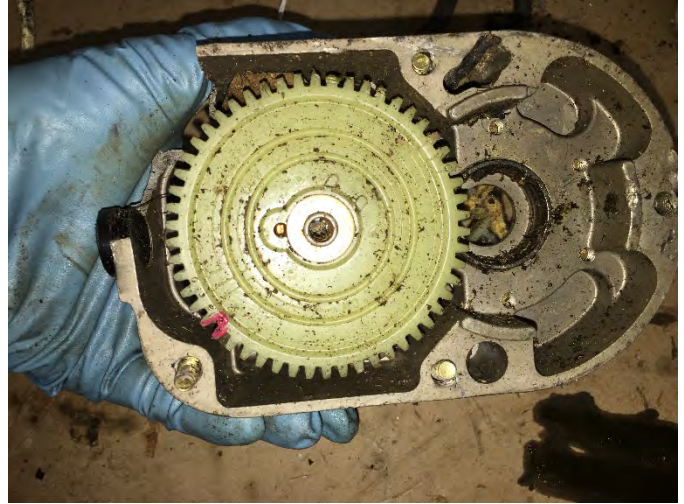
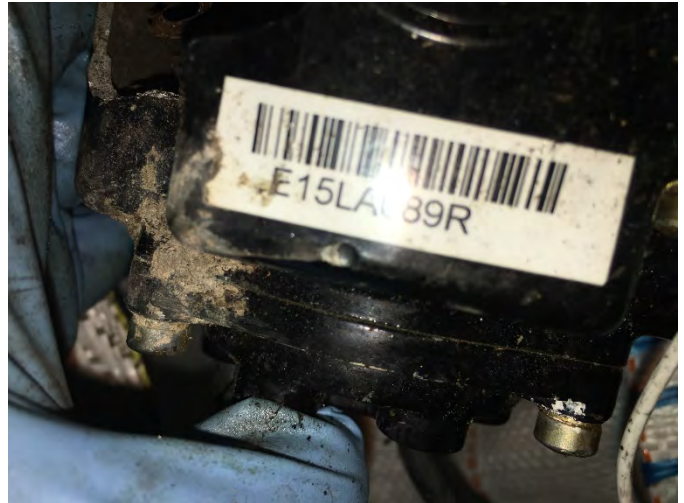
### LEFT MAGNETO

The magnetos were separated from their mounts and the mounting area was separated from the engine. Remnants of fractured magnetos were located in the debris. The top half of the left magneto was observed. The distributor gear remained intact and the teeth were undamaged. The drive shaft/magnet and windings were not observed. Remnants of ignition leads remained attached to the distributor cap. Only the capacitor and points portion of the right magneto was observed. The #1, #3, #5, and #6 top sparkplugs were removed from their respective cylinders. The #5 and #6 top sparkplug barrels were fractured. Examination of the observed electrodes revealed no evidence of carbon or lead fouling with normal wear conditions.

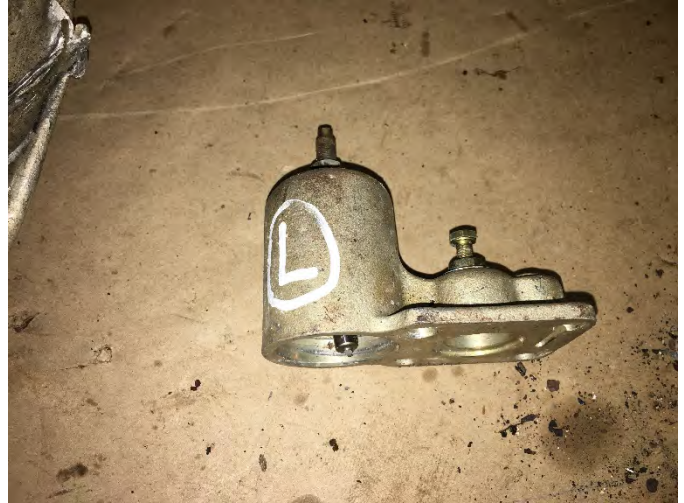
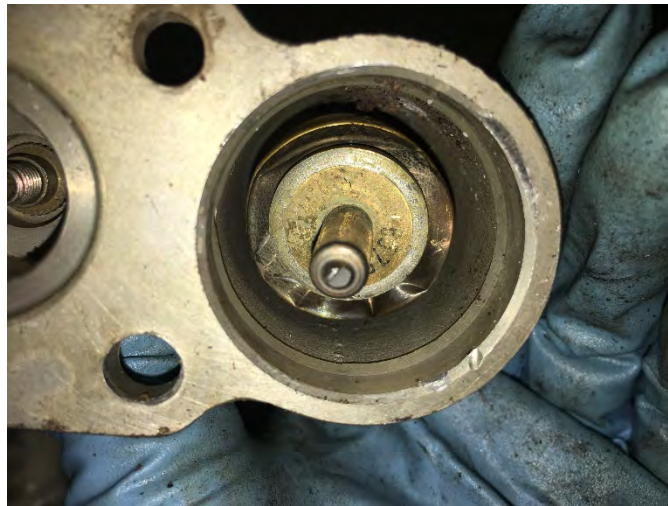
#### FUEL PUMP

The fuel injection system was separated from the engine. The engine-driven fuel pump was separated from the backside of the engine, but its deformed drive coupling remained inserted into the crankshaft gear and pump adapter. Only the engine-driven fuel pump cap (aneroid bellows and low pressure relief valve set screw) were observed. The throttle body was fractured and the fuel metering unit was separated. The throttle and mixture control levers were deformed and a portion of the mixture shaft was pulled from the housing and bent. The fuel fittings were fractured. Removal of the inlet screen revealed it was clear with no obstructions observed. The fuel manifold valve was not

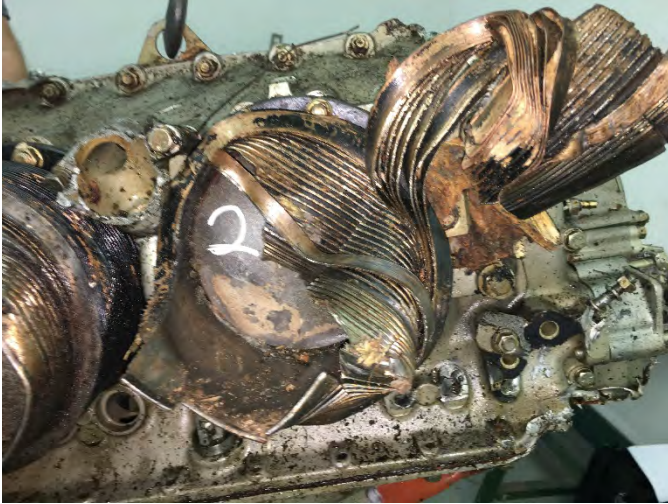
## CYLINDER #2

The cylinder barrels remained attached to the crankcase. All of the cylinder heads sustained impact-related fracture damage with the left side sustaining the most damage. The #2 and #4 cylinder heads were fractured and separated from their respective barrels, and the barrels were torn and bent over the piston. The top sparkplugs were removed from the #1, #3, #5, and #6 cylinders and a borescope was used to examine/document the internal components. No pre-accident anomalies were noted with any of the pistons, barrels, cylinder heads, valves or valve seats.

Cylinder Head Not Observed

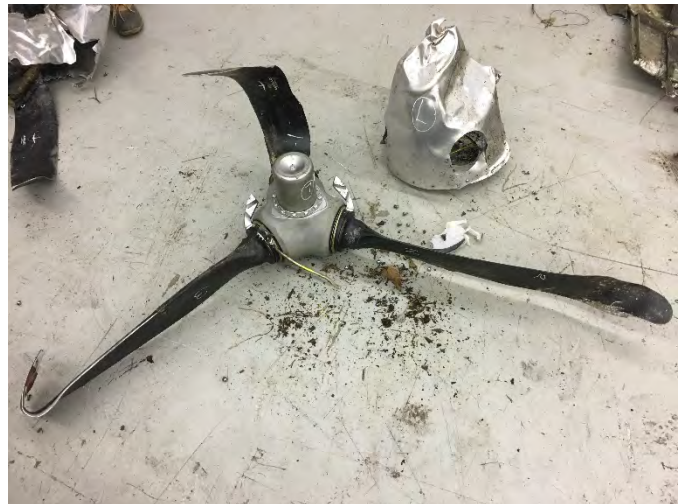
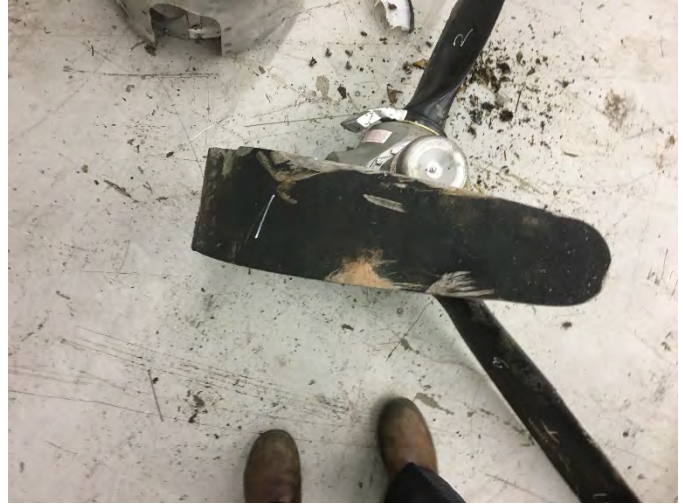
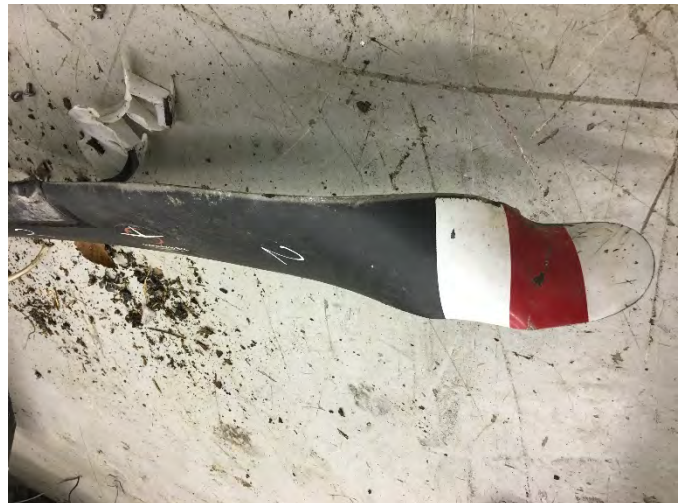
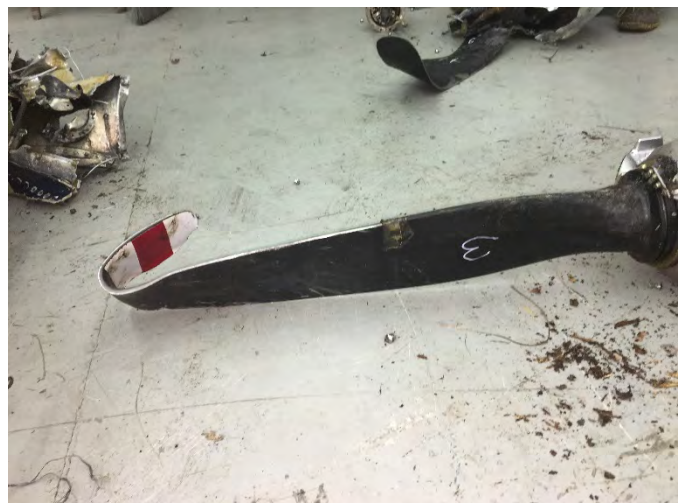
#### PROPELLER

The propeller was separated from the crankshaft and the stripped propeller bolts remained with the crankshaft flange. All three blades remained attached to the hub, but all could rotate freely within the hub indicative of pitch change link fractures. Blade #1 was bent forward almost 180° with some chord-wise paint burnishing near the tip. Blade #2 was twisted 180° toward low pitch at the tip. Blade #3 was bent forward 180° at the tip.
