# Continental Motors

## ENGINE EXAMINATION REPORT

| ENGINE MODEL | IO-550-A3B |
| FILE NUMBER | 18-286 |

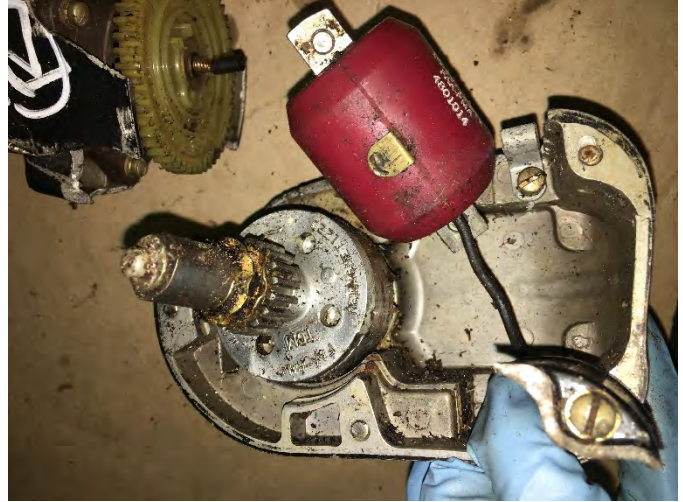
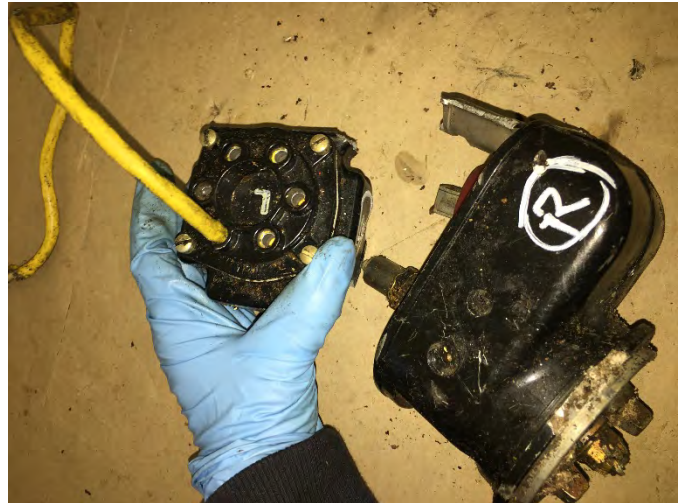
### LEFT MAGNETO

examination of the cylinders. There was no sign of carbon or lead fouling with any of the sparkplug electrodes. Both magnetos were located within the debris. The left magneto housing was fractured. The drive shaft was bent, the windings remained attached to the housing, and the distributor gear remained intact with no pre-accident anomalies noted with the gear teeth (some impact-related deformation damage was noted on a few teeth, but no abnormal wear). The right magneto remained intact but sustained significant impact-related damage that fractured the housing and prevented rotation of the drive shaft. The points were intact, and no pre-accident anomalies were noted through the vent hole for the distributor gear teeth.

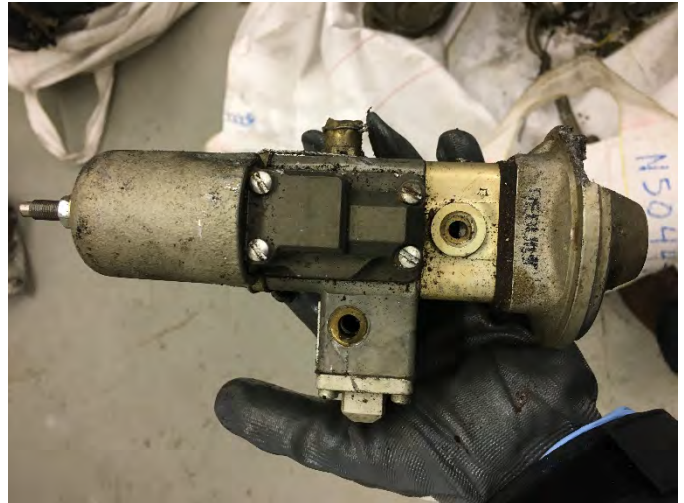
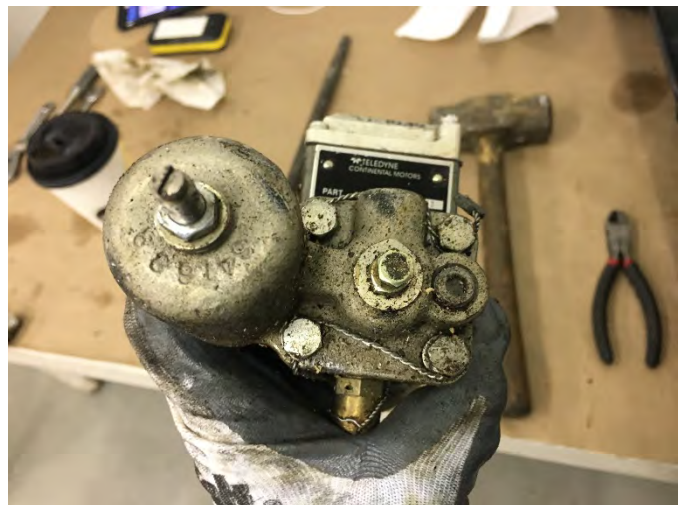
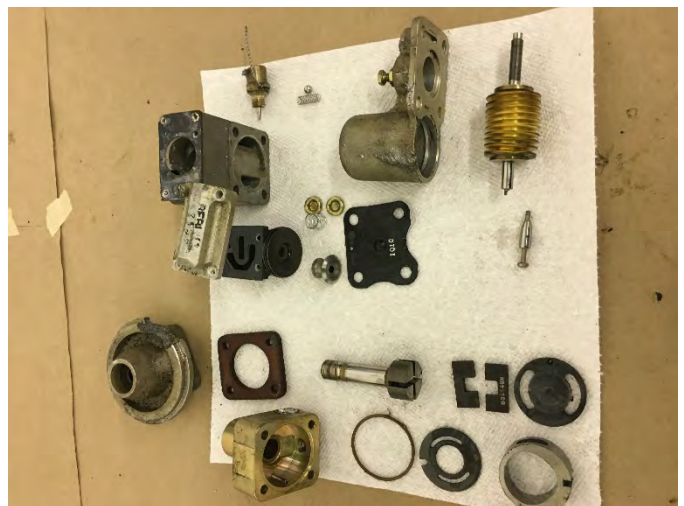
### FUEL PUMP

The fuel injection system was separated from the engine with the exception of the fuel manifold valve, which was separated from its mount but remained attached to the engine via two of its fuel injection lines (the #4 and #6). The engine-driven fuel pump was separated from the backside of the engine and its drive coupling was missing. The fittings were fractured and the pump sustained impact-related damage to the mounting flange, the bellows housing, and the low pressure relief valve cap. A screwdriver was used to check pump shaft rotation which was obtained with no binding noted. Disassembly of the pump revealed that the pump vanes were intact and there were no pre-accident anomalies noted with the internal components. The altitude compensating bellow was deformed and its shaft was fractured, but the fracture surfaces contained shear lips consistent with a side load and impact damage sustained by the bellows housing.

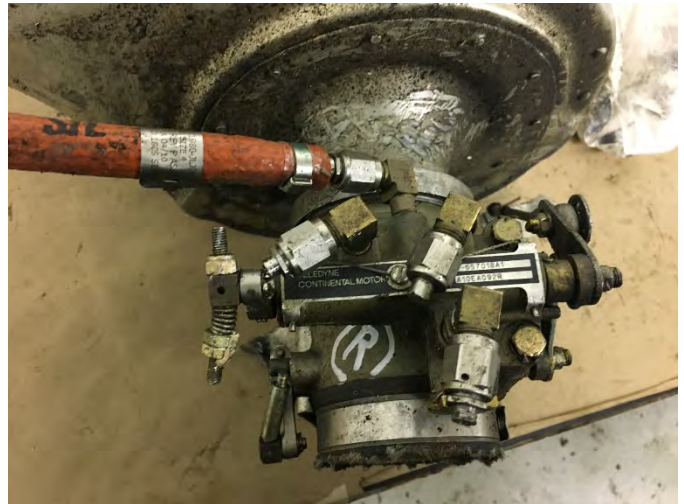
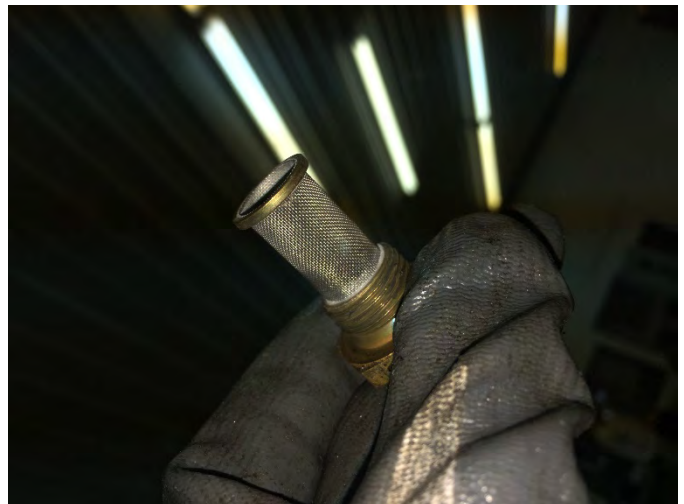
THROTTLE  
BODY  
METERING UNIT

The throttle body/fuel metering unit remained attached to the intake filter housing. The throttle and mixture control rod ends remained attached to their respective throttle and mixture control levers on the throttle body/fuel metering unit. The interconnect between the throttle shaft and the throttle cam was bent and fractured. Manual manipulation of the metering cams revealed no internal binding. The inlet fuel screen was removed and found to be clear.

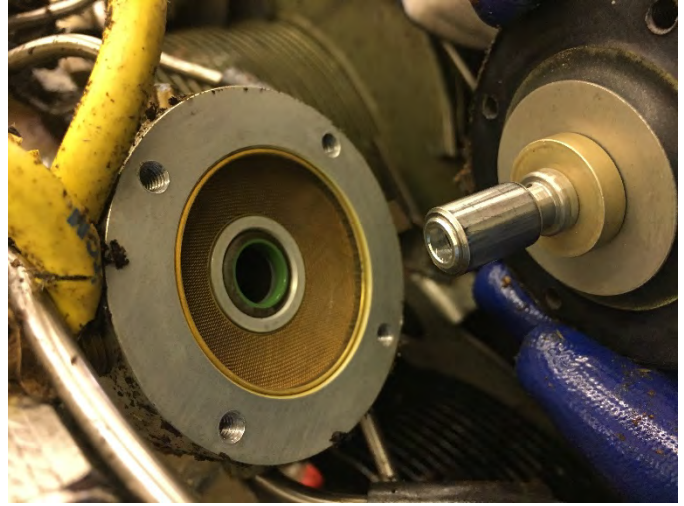
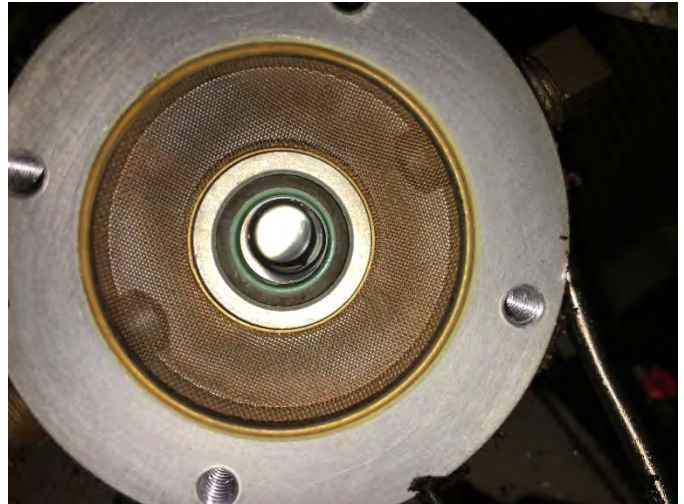
## FUEL MANIFOLD VALVE

The fuel manifold valve cap was removed and residual fuel was found in the housing. The screen was clear and the plunger remained attached to the diaphragm. No pre-accident anomalies were noted.

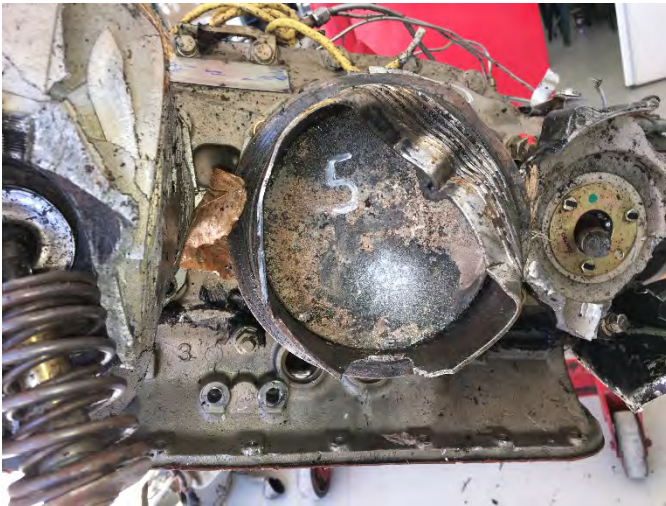
CYLINDER #5

The cylinders remained attached to the crankcase. All of the cylinder heads sustained impact-related fracture damage with the right side sustaining the most damage. The #5 cylinder head was fractured and separated from the barrel, and the barrel was torn in one area and bent over the piston. The #3 cylinder head was fractured and the rockers were separated. The top sparkplugs were removed from their respective cylinders and a borescope was used to examine/document the internal components. No pre-accident anomalies were noted with any of the pistons, barrels, cylinder heads, valves or valve seats.

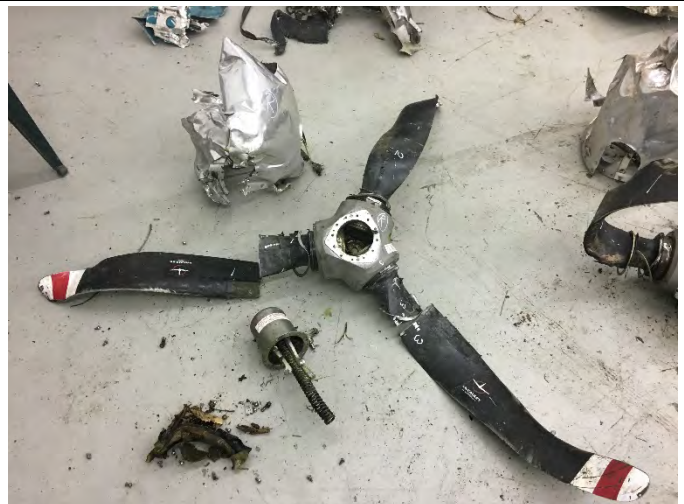
#### PROPELLER

The propeller was separated from the crankshaft and the stripped propeller bolts remained with the crankshaft flange. Two of the three propeller blades were cut by aircraft recovery personnel. The propeller piston was separated from the hub and the blade pitch change links blades were separated.
