## Air Safety Investigations Aircraft Incident/Accident Technical Report

| <b>Aircraft Incident/<br/>Accident Information</b> | Year: 1975 | Make: Cessna | Model: 310R |
| | Serial number: 310R0164 | | Registration: N5044J |
| Location: Walton, NY | | Date: 11-09-18 | Time: 1502 EST |

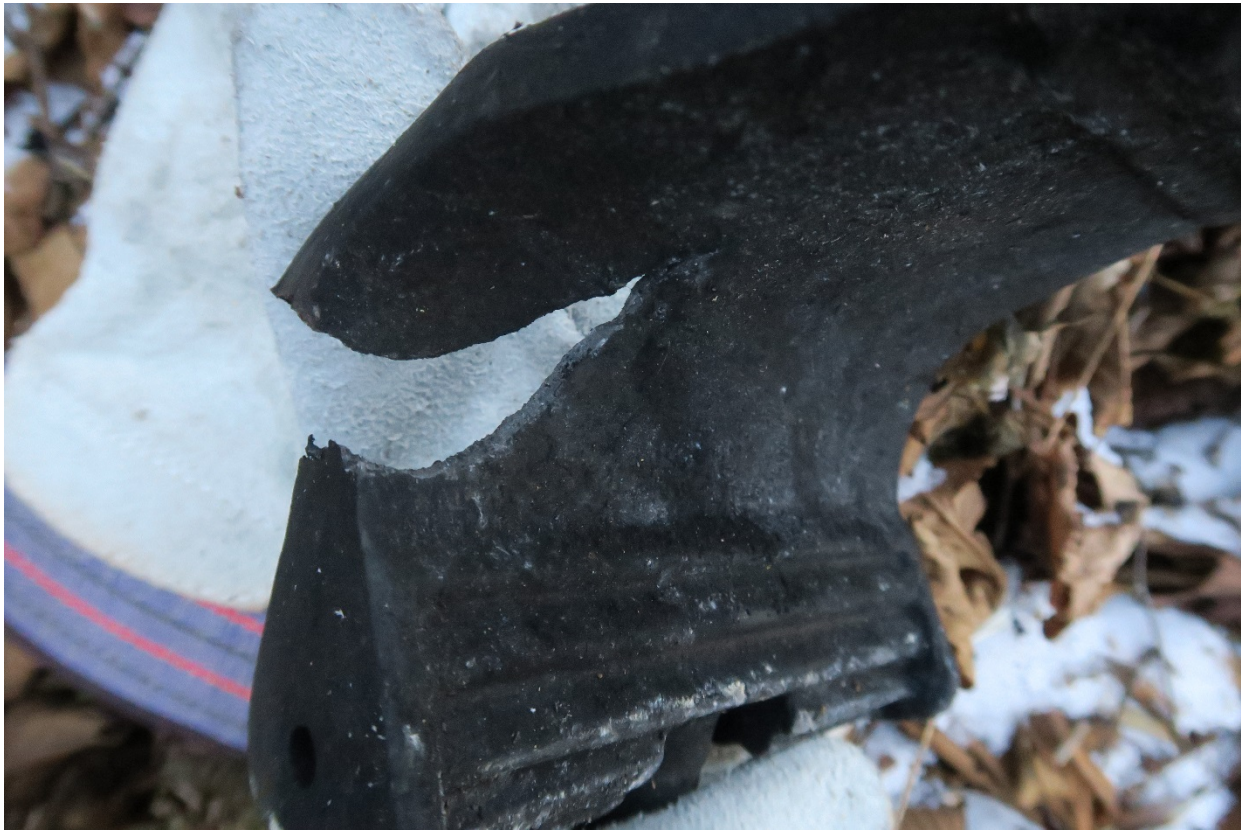
Three of the rudder pedals remained attached to the torque tube. The pilot's side left rudder pedal separated from the airframe and was observed with heavy soot. The pedal was fractured outboard mid-pedal, and the fracture surface was clean with very little soot. The co-pilot's left pedal was also fractured; the surface was clean with very little soot.

Pilot left rudder pedal, TAI On-site ASI-DK-194

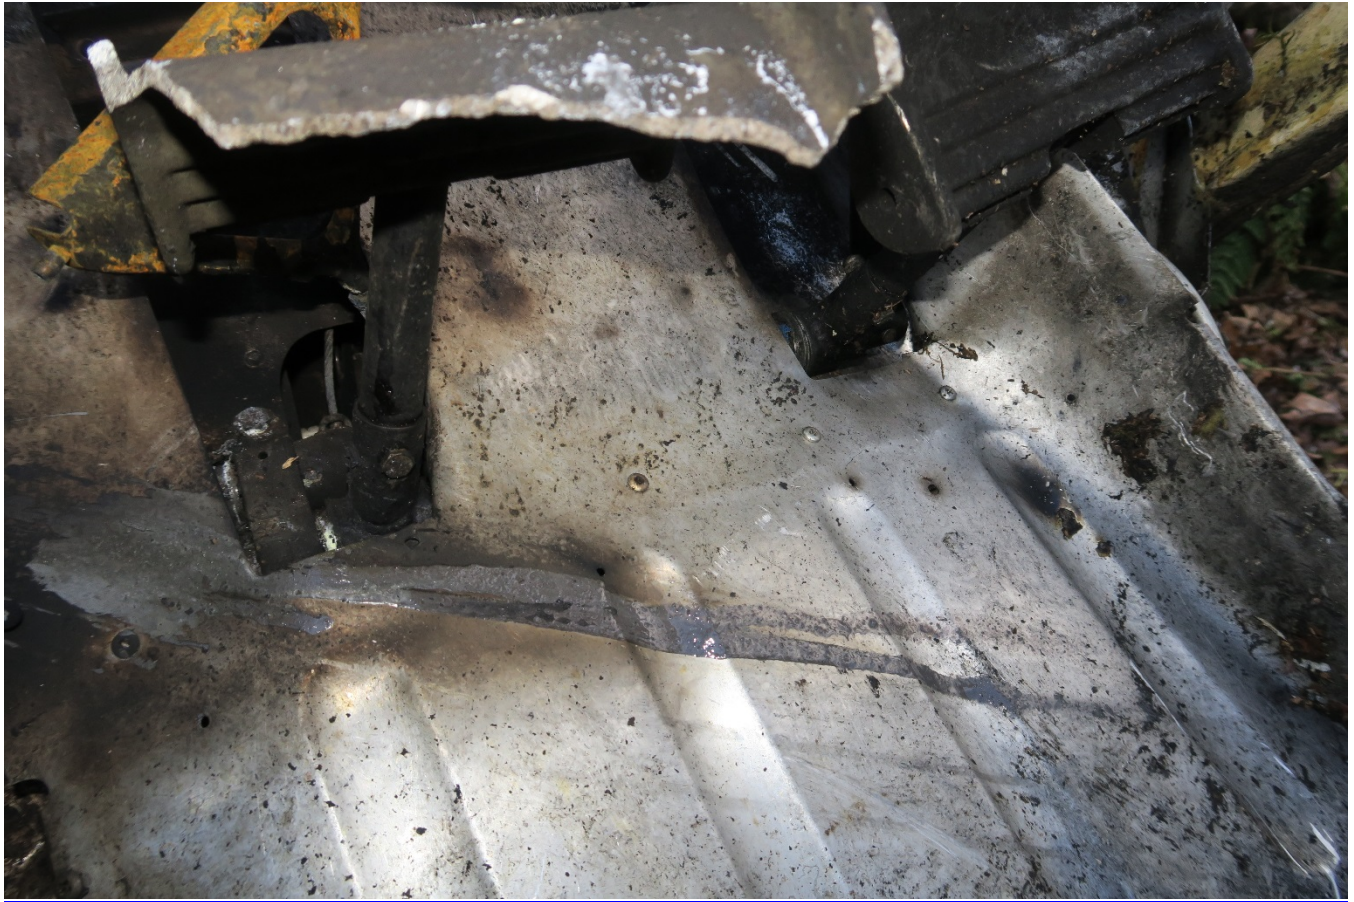
Co-pilot LH rudder pedal, TAI On-site ASI-DK-154

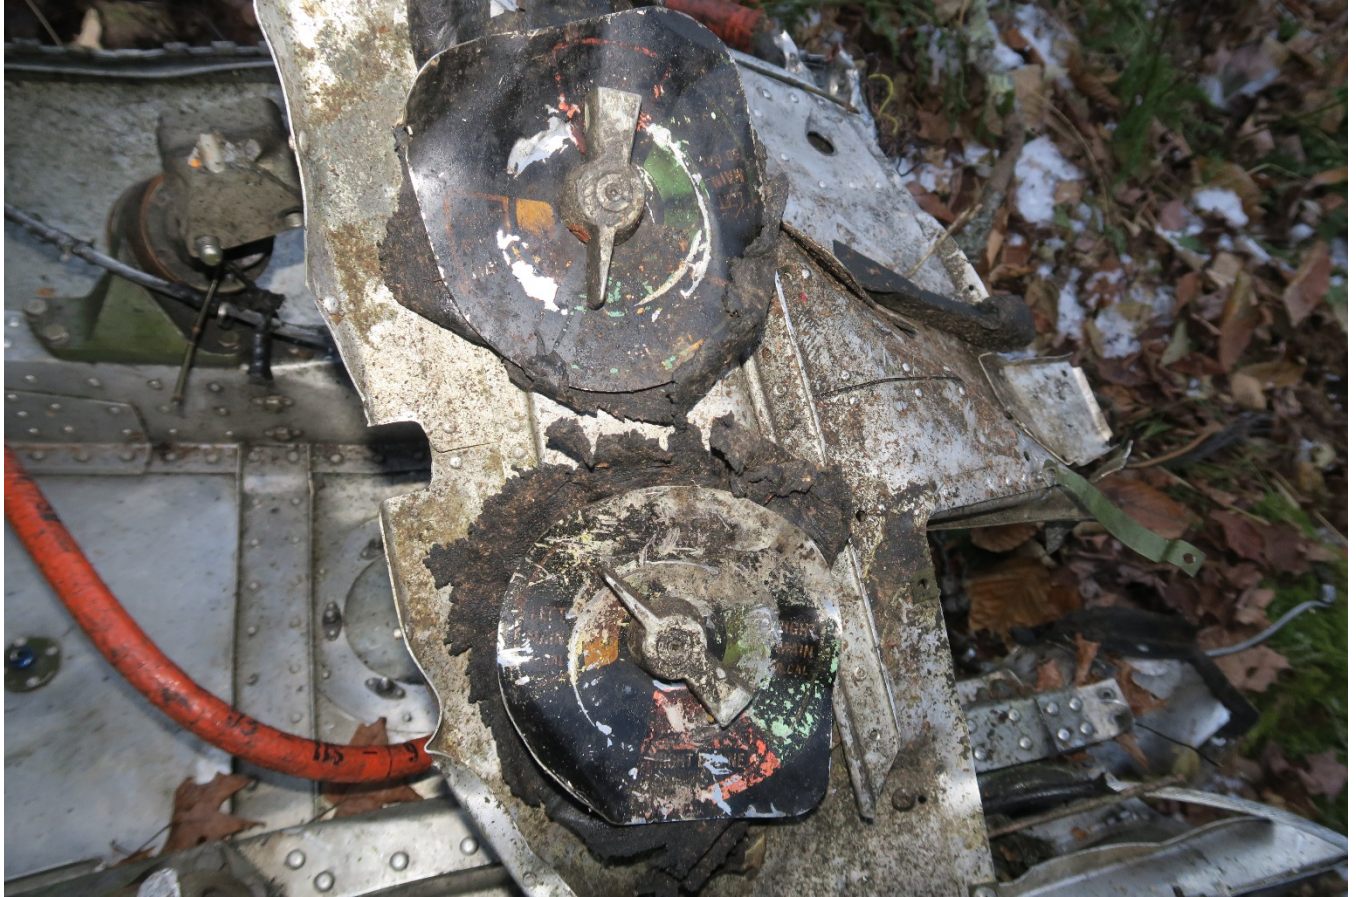
Both fuel selector handles were observed in the right main position. The selector handles were separated from the fuel selector valves and the valves were not located. Due to the condition of the wreckage, the position was unreliable.

Fuel selector handles, TAI On-site ASI-DK-164

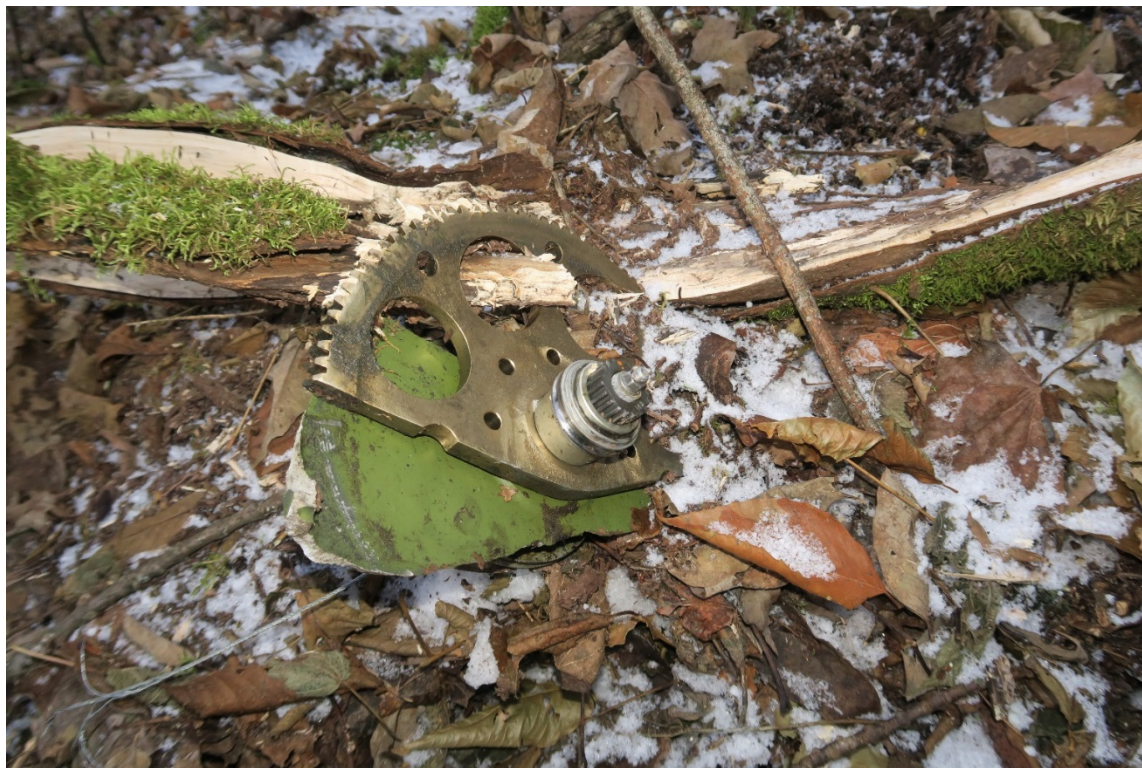
All 3 landing gear struts were located approximately halfway through the wreckage path. Portions of the landing gear control rods, the manual extension system and the gearbox were observed. The ELT was observed highly fragmented.

Portion of landing gear gearbox, TAI On-site ASI-DK-055

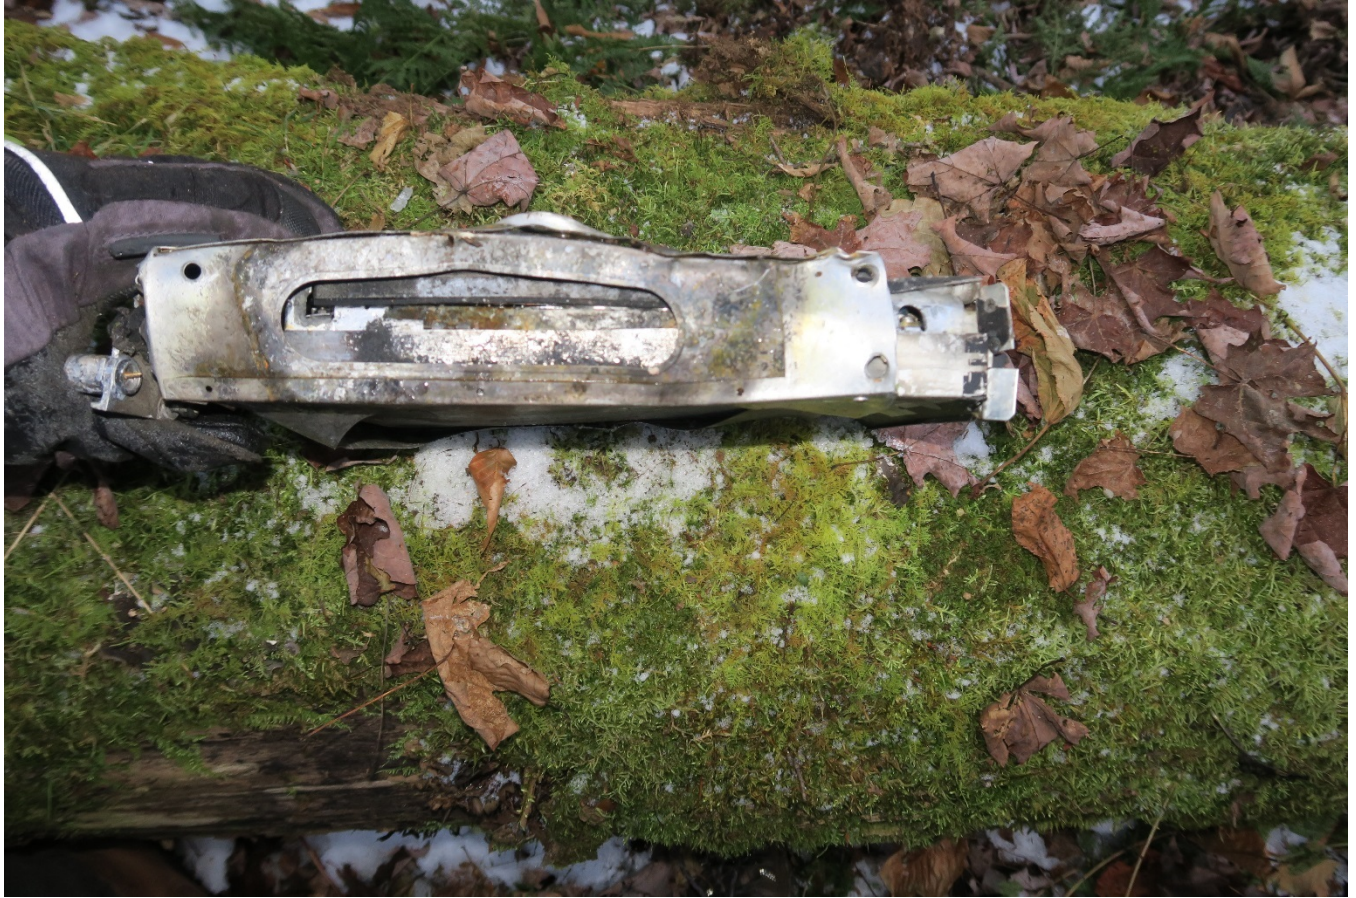
A radio was observed with thermal damage and soot on the left side.

Radio, TAI On-site ASI-18-DK-177

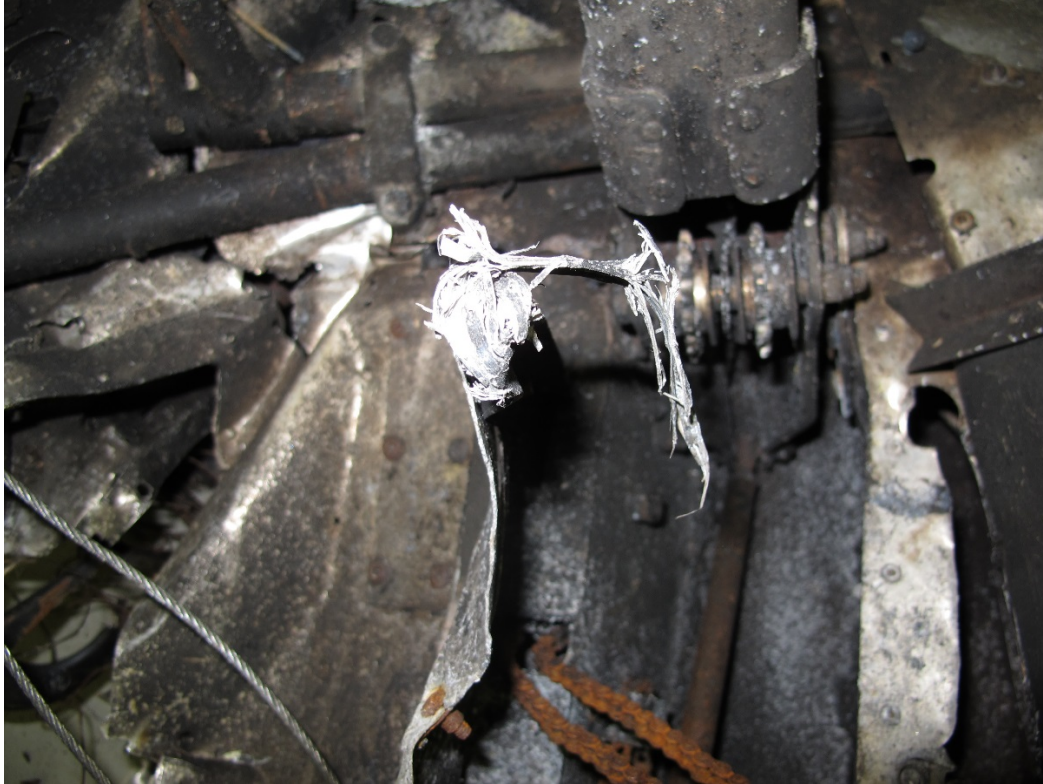
Broomstrawing, NTSB photo

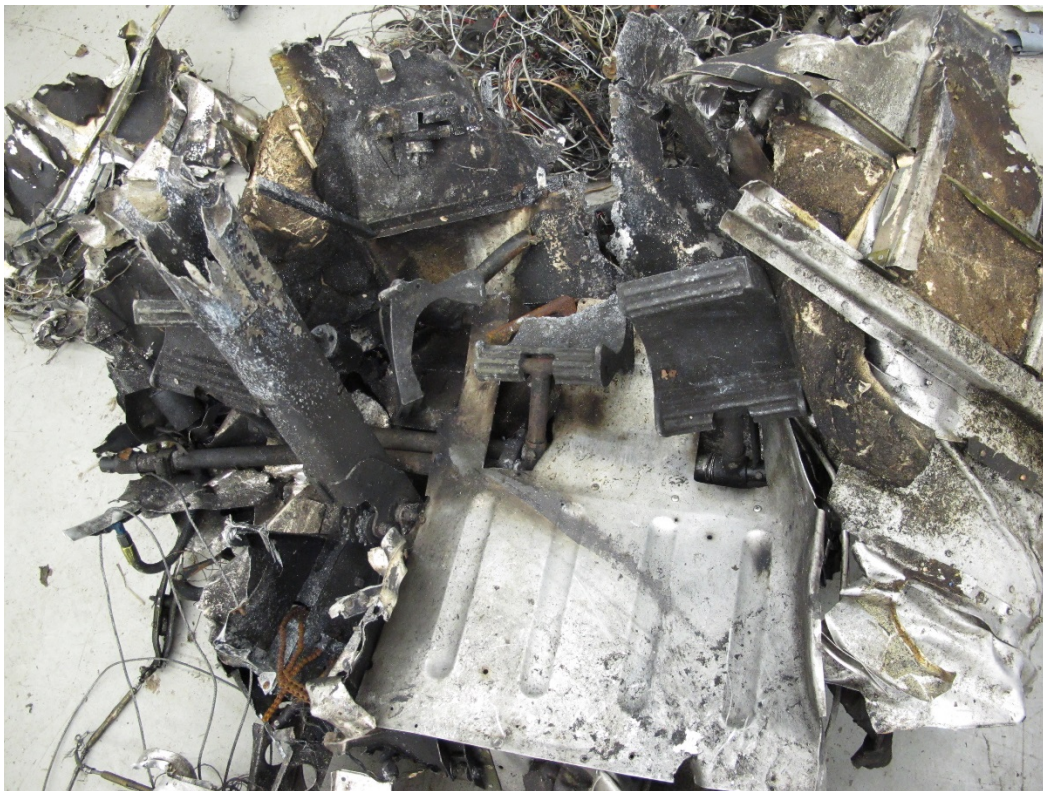
A wreckage layout and review was conducted on 03-19-19 and 03-20-19 that included an NTSB Fire and Explosions investigator. The majority of the cockpit section was not observed, the cockpit floor section exhibited heavy soot and varying levels of thermal damage. Two small sections of broomstrawing were evident on the walls of the pedestal. The majority of the carpet was recovered and exhibited light thermal damage, but the damage did not extend through the thickness of the carpet. The cockpit avionics wiring exhibited no signs of electrical arcing, beading, pitting or fused wire conductors. The only damage to wire bundles in the cockpit area was consistent with mechanical damage. The recovered avionics and instruments exhibited limited thermal damage and soot, mainly to the exterior. None of the instruments exhibited obvious signs of arcing. One Comm/Nav unit exhibited a localized burn pattern on the bottom of the unit. Soot and light to moderate thermal damage to the circuit board was observed, but the thermal damage did not appear to extend beyond the localized area. Small fragments of the circuit breaker panel face plate and surrounding panel were recovered. It displayed heavy thermal damage and delamination; no identifiable circuit breakers were recovered.

Cockpit floor, NTSB photo

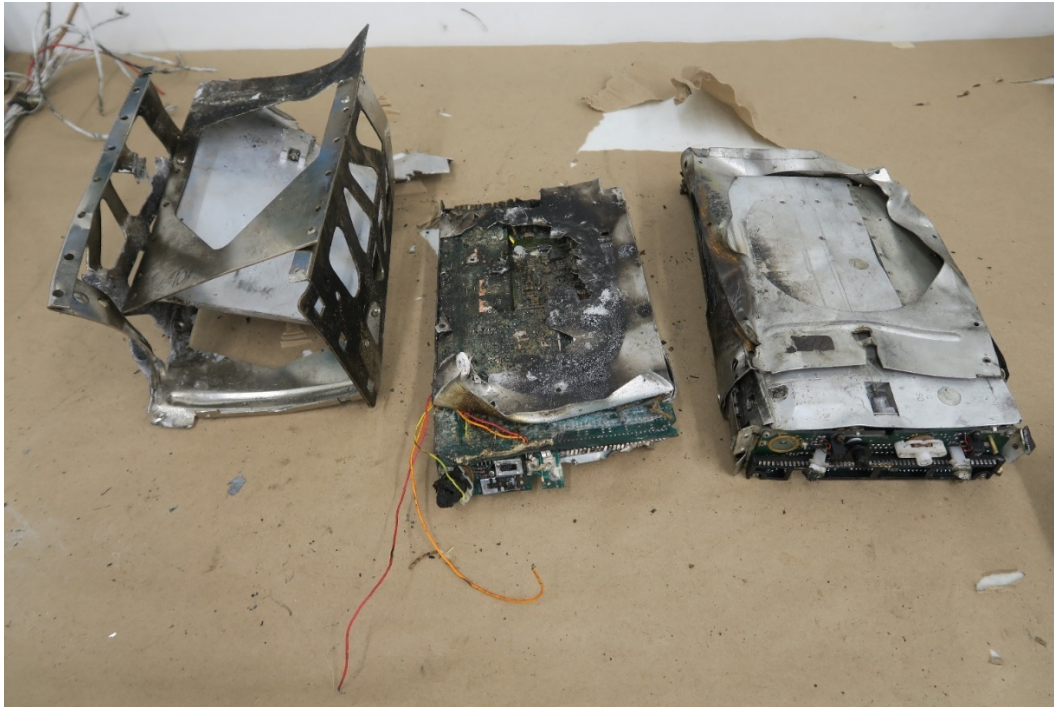
Comm/Nav unit with localized thermal damage, TAI Wreckage Review, ASI-18-DK-032

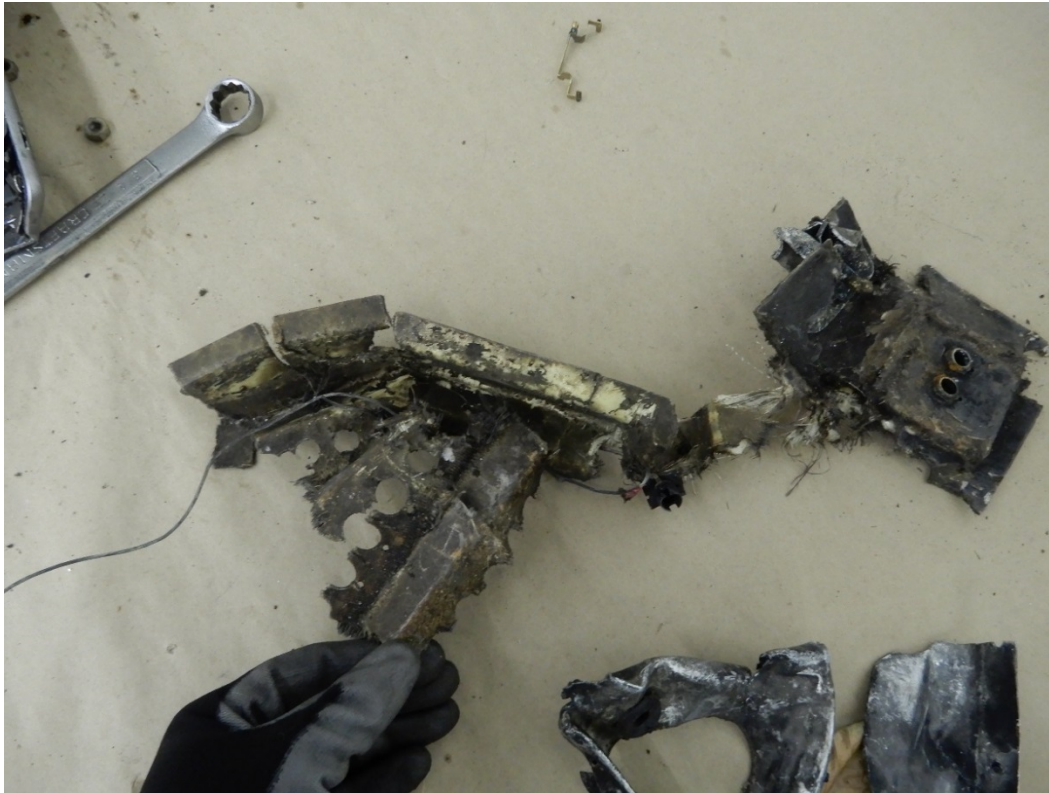
Remnants of circuit breaker panel, NTSB photo

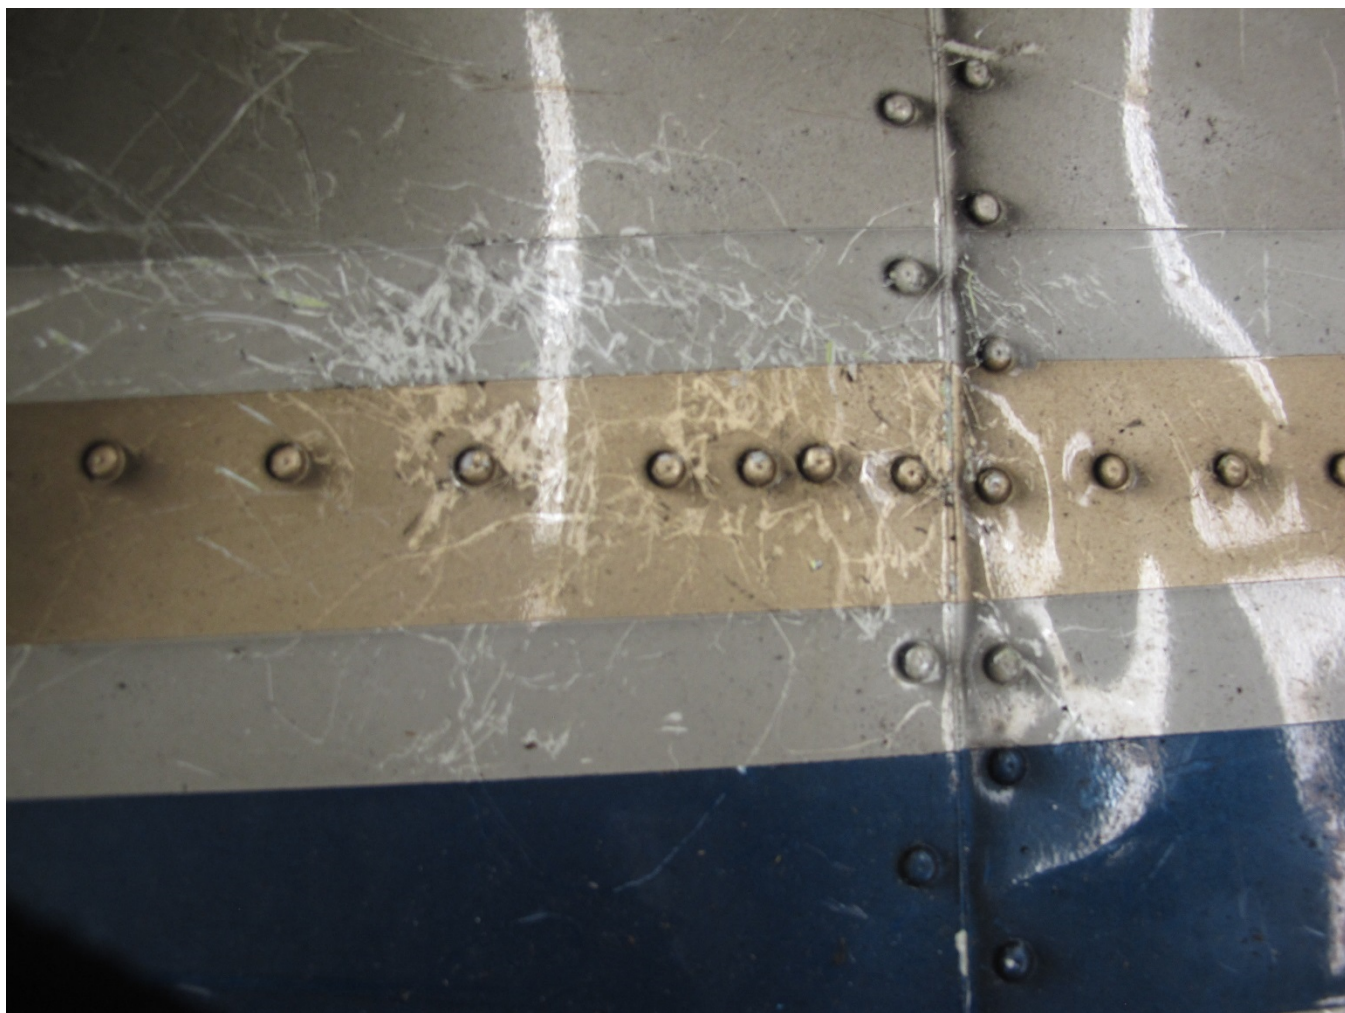
Two sections of the fuselage were recovered which displayed the registration number on both sides of the airplane. The left section exhibited impact damage and heavy soot with varying levels of soot trailing along the rivet lines. The right side exhibited similar impact damage with slightly less soot trailing. No other thermal damage was observed on these sections. The empennage sustained significant impact damage with varying degrees of soot on all surfaces, no other thermal damage was observed. Both wings exhibited significant impact damage and fragmentation. Fragments of the left wing exhibited heavy soot over the outboard surfaces with localized areas of thermal damage. The right wing exhibited less soot and no observable thermal damage. However, fragments of the tip tanks did not exhibit significant soot. The recovered sections of the engine cowlings displayed no thermal damage. The inboard fragments of the wings exhibited no thermal damage and little soot. Fragments of the fuel system components exhibited no significant thermal damage. Small sections of the fuel bladders exhibited no sign of thermal damage.

Soot trailing along rivets, left fuselage, NTSB photo

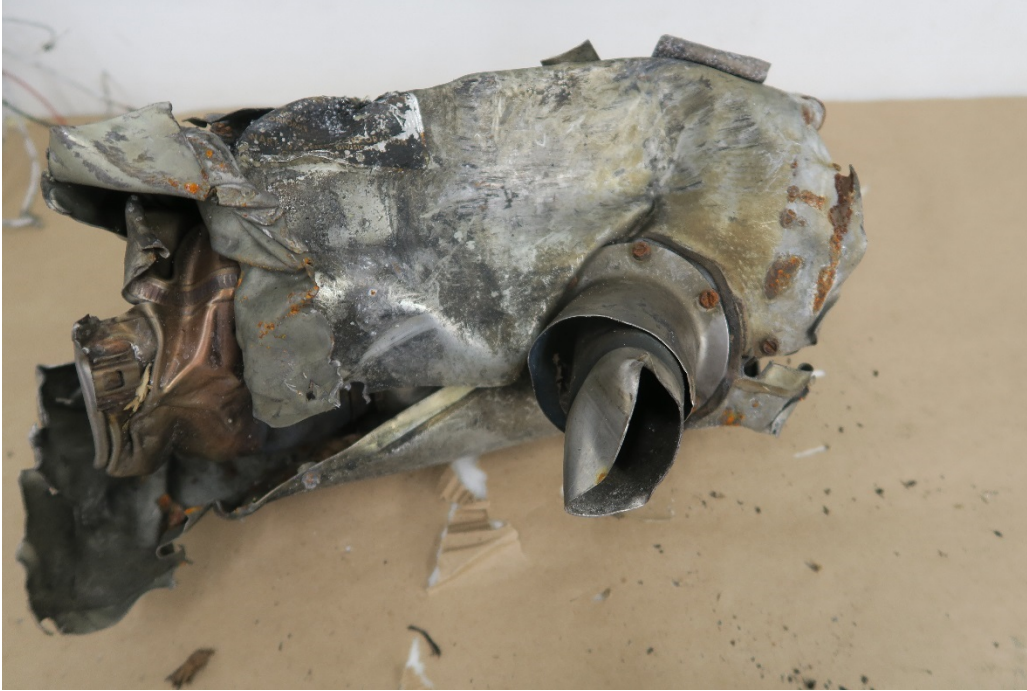
The cabin heater exhibited impact damage, some localized thermal discoloration and light soot on the outer case. No internal thermal damage was observed. Polymeric materials on the flapper valve and thermostat inside the exhaust duct were located, and no evidence of elevated temperatures or soot internal to the recovered exhaust ducting was observed.

Cabin Heater, TAI Wreckage Review, ASI-18-DK-027

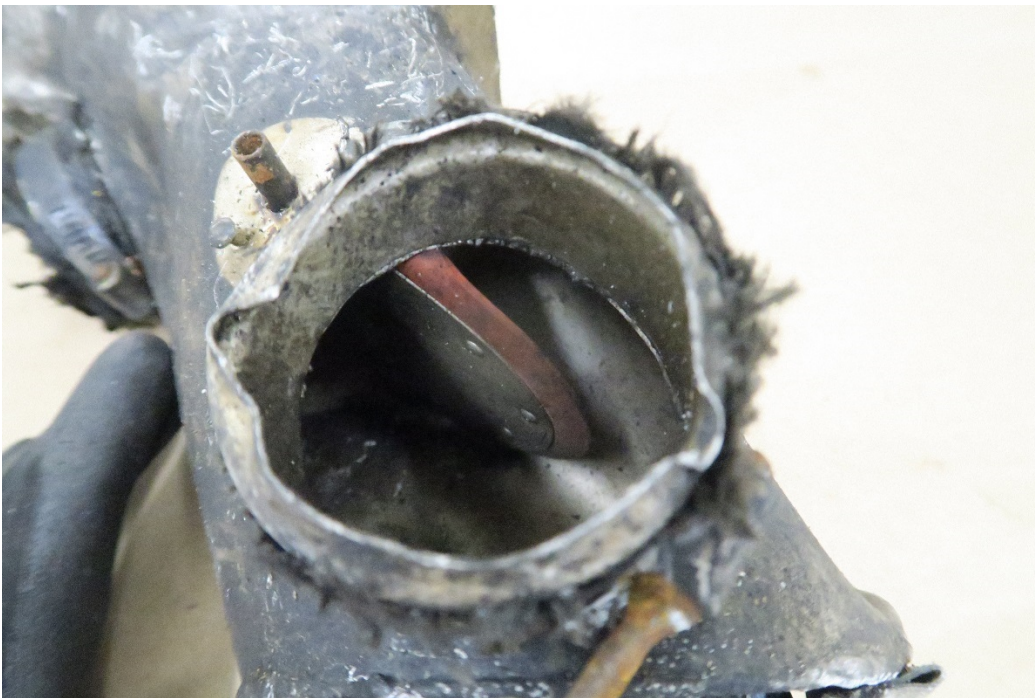
Heater internal flapper valve, TAI Wreckage Exam, ADI-18-DK-029
