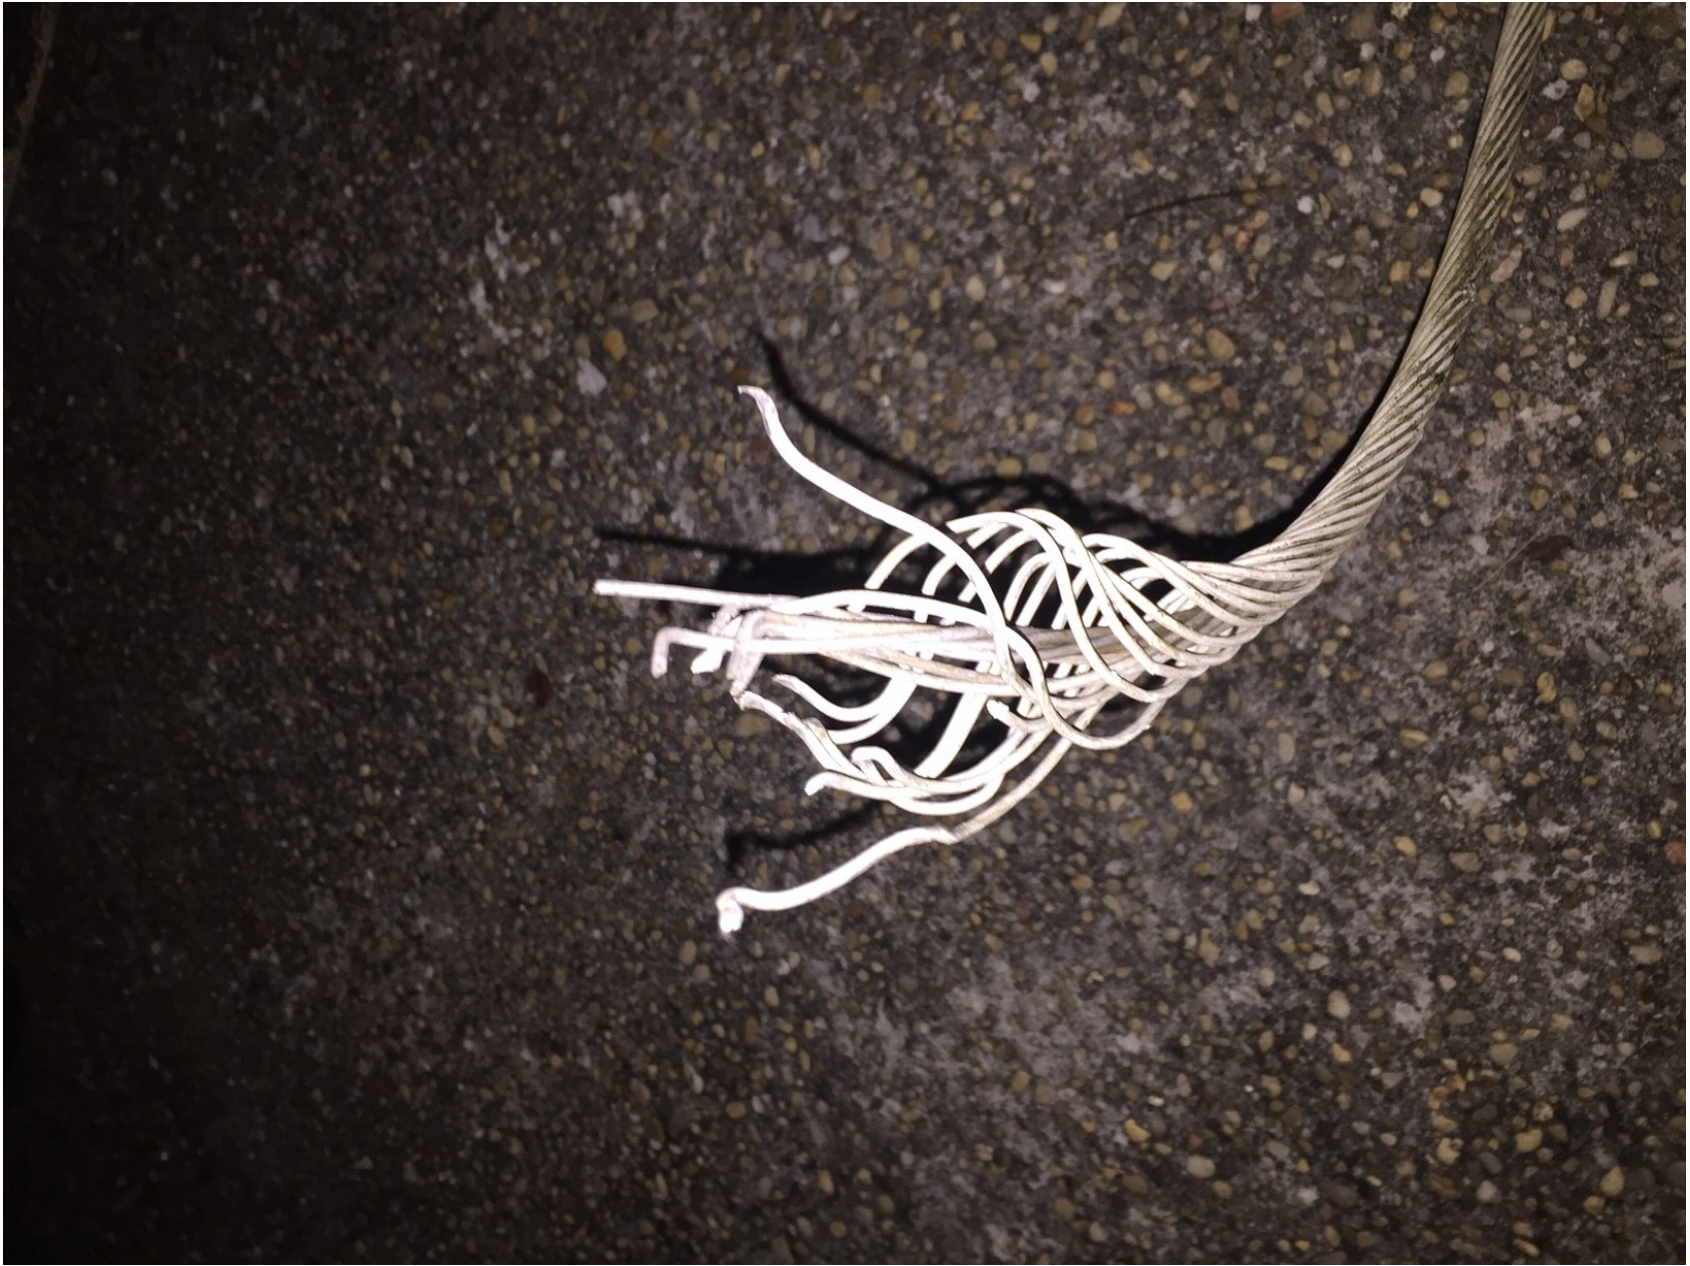
**Photo 1 – View of the severed power lines.**

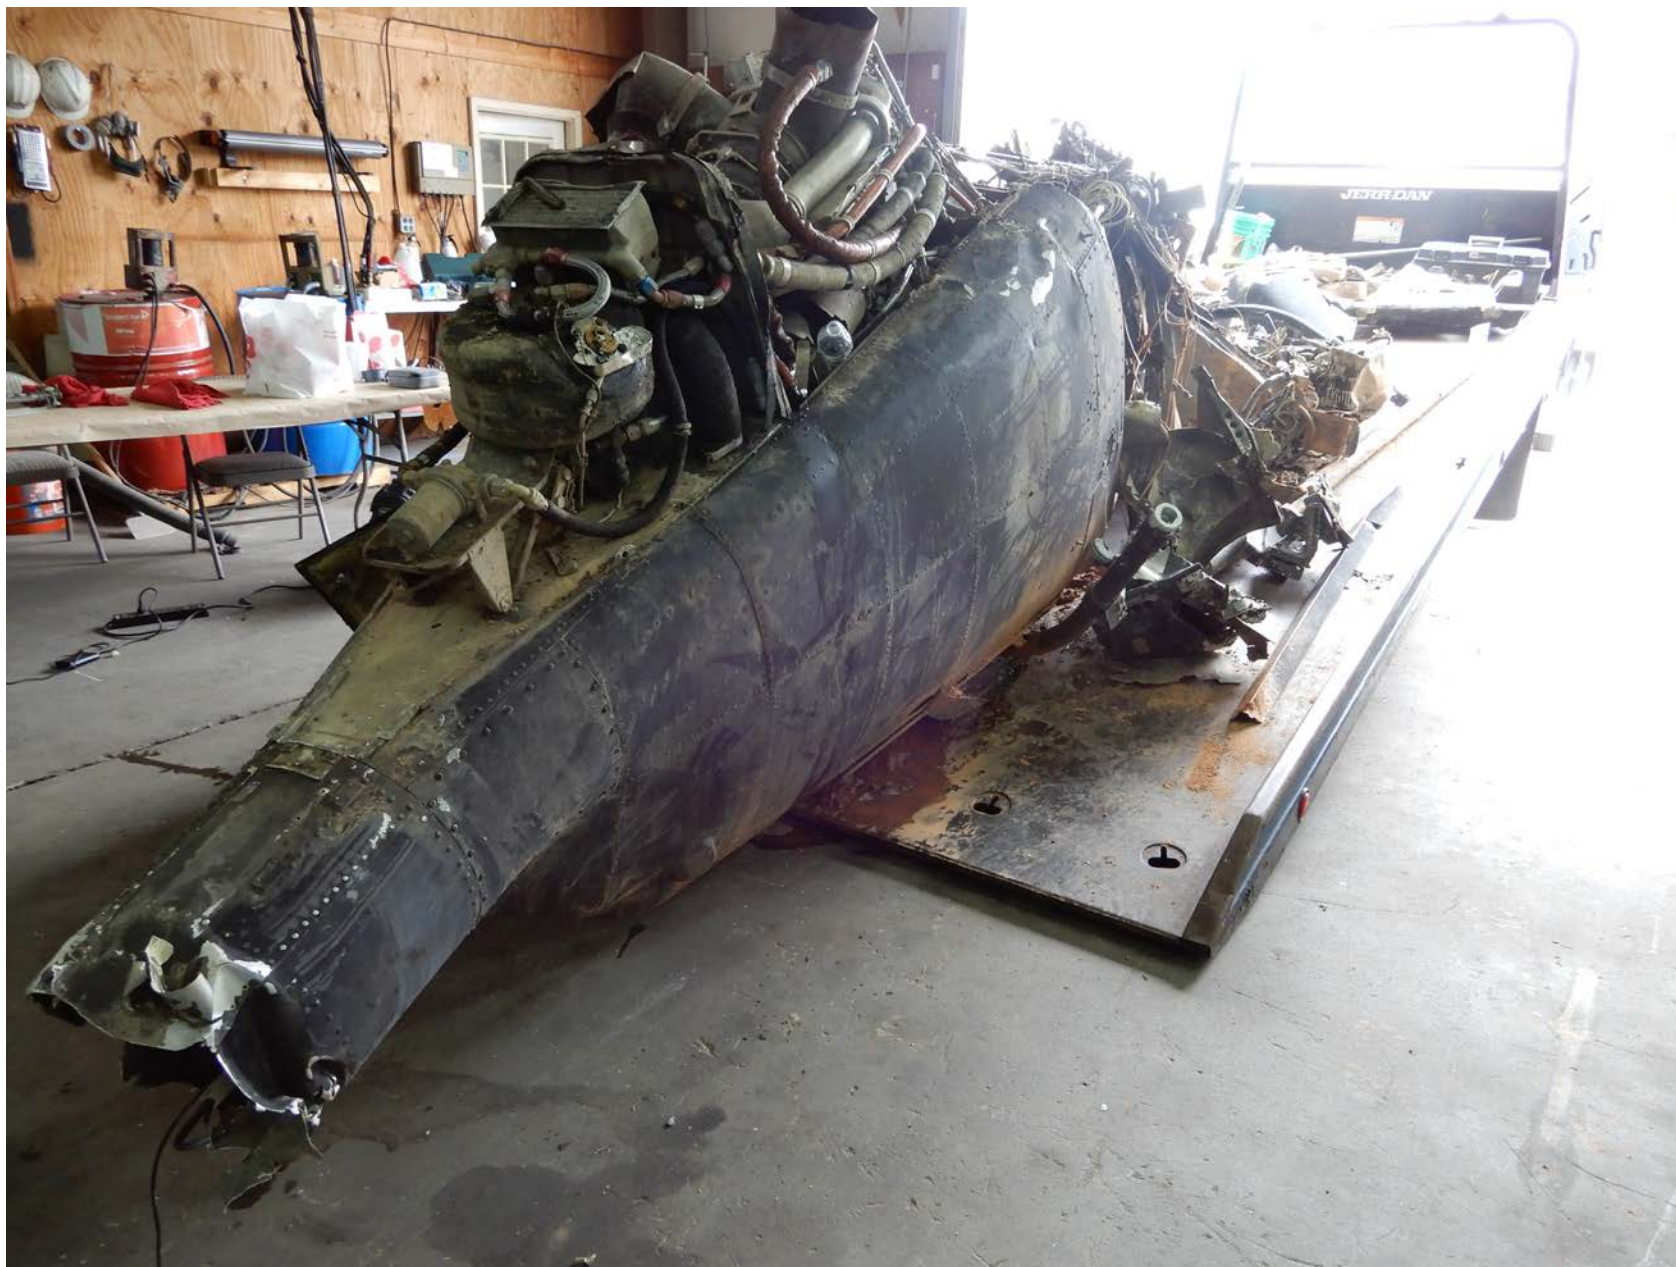
**Photo 2 – Right side view of the wreckage.**

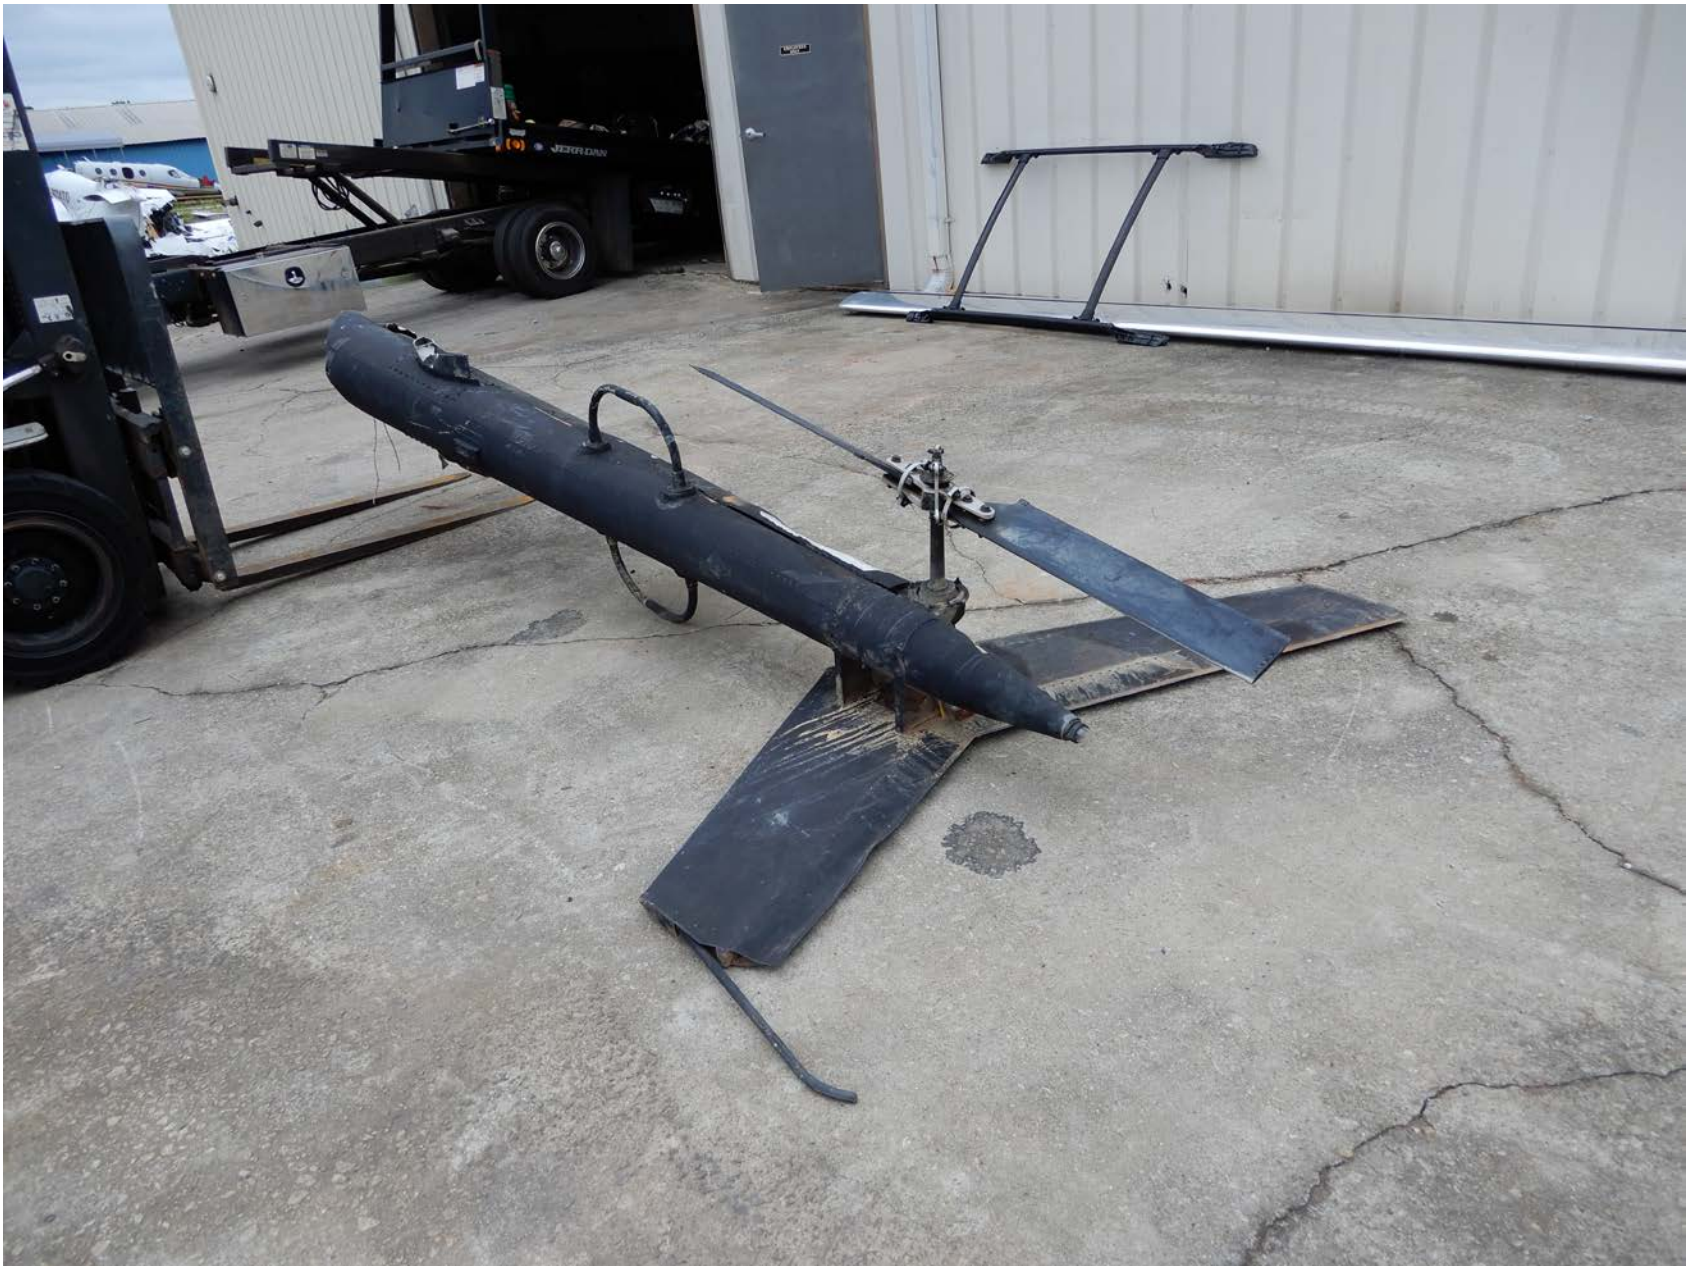
**Photo 3 – View of the separated tail boom.**
