## ENGINE EXAMINATION REPORT

| ENGINE MODEL | IO-550-N8B |
| AIRCRAFT REGISTRATION | N8448J |
| FILE NUMBER | 18-294 |

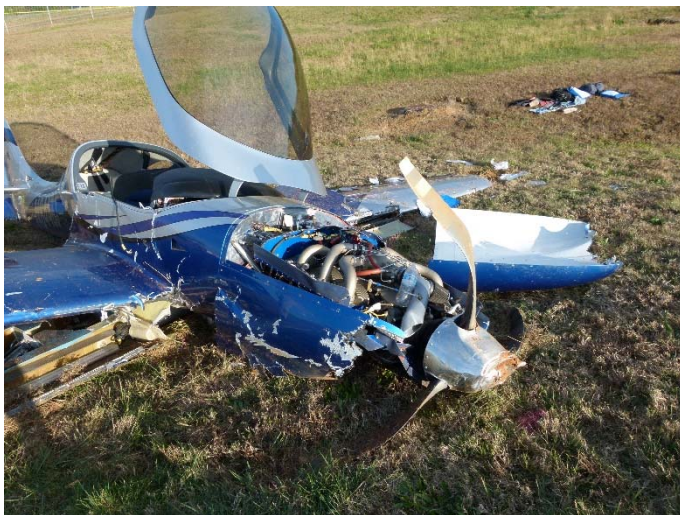
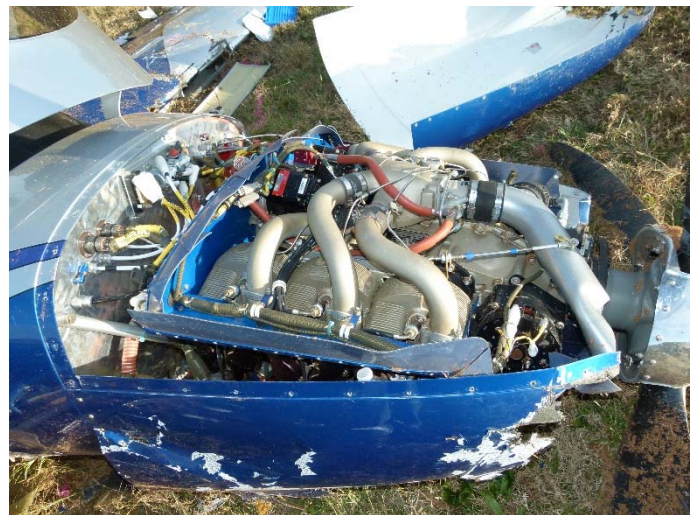
The engine remained attached to the airframe. The oil sump was crushed and breached. The exhaust system exhibited impact damage.

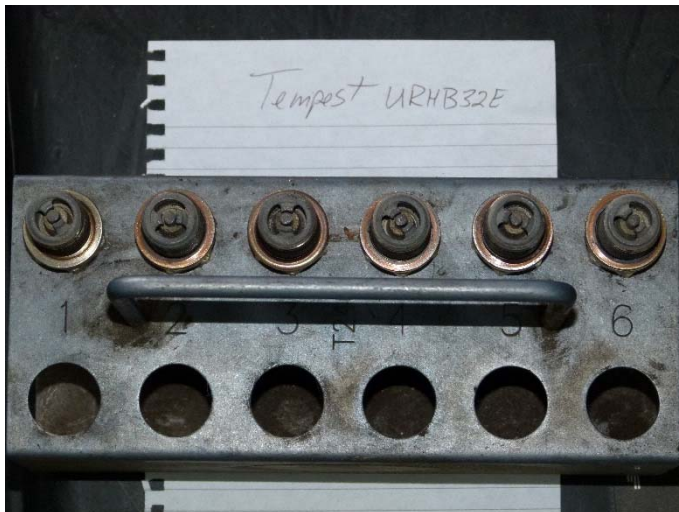
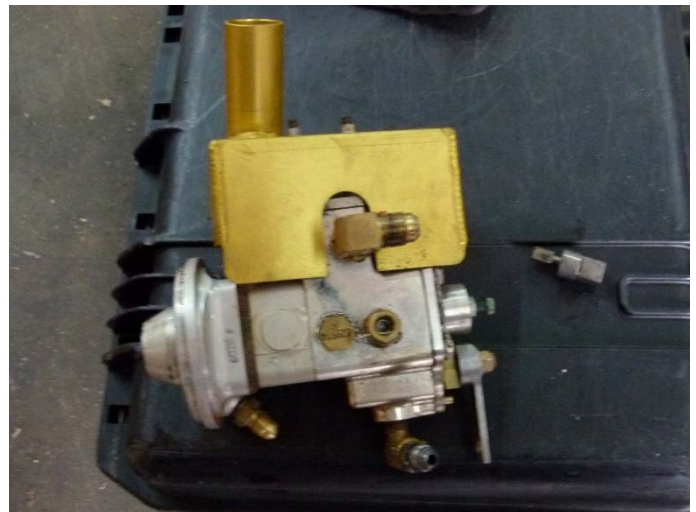
The top spark plugs were removed and exhibited light colored combustion deposits. The spark plug electrodes exhibited normal – worn out signatures when compared to the Champion Check A Plug chart. The cylinder combustion chambers were inspected with a lighted bore scope and no anomalies were noted.

The fuel pump remained attached to the engine and was removed. The drive coupling was intact, and the fuel pump drive turned freely by hand. When the fuel pump drive was rotated the pump discharged a small amount of fuel. The fuel nozzles were removed and found to be free of obstruction. The throttle and mixture control arms moved freely by hand from stop to stop.

The engine was rotated by hand using the propeller. The magnetos produced spark on all six top ignition leads. Thumb compression and suction was noted on all six cylinders with proper valve movement established. Continuity throughout the engine and accessory section was established.
